INVESTIGATION OF DIESEL FUEL FIRE VULNERABILITY PARAMETERS IN ARMORED PERSONNEL CARRIERS DUE TO BALLISTIC PENETRATION

INTERIM REPORT

AFLRL No. 194

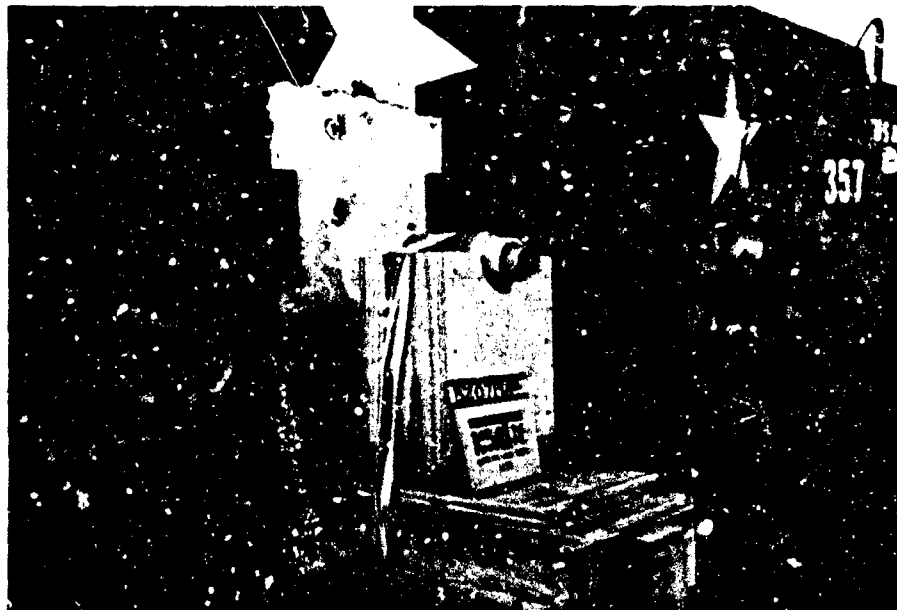
FIGURE 2. ALUMINUM ARMOR PLATE AND HEAT ROUND

An M84, armored personnel carrier (APC) was fitted with an aluminum armor plate (from a M113), through which a 90-mm HEAT round was fired into a nominal 60-gal. (227-liter) capacity aluminum fuel cell (Figures 1 and 2) containing 50 gal. (189 liters) of fuel.

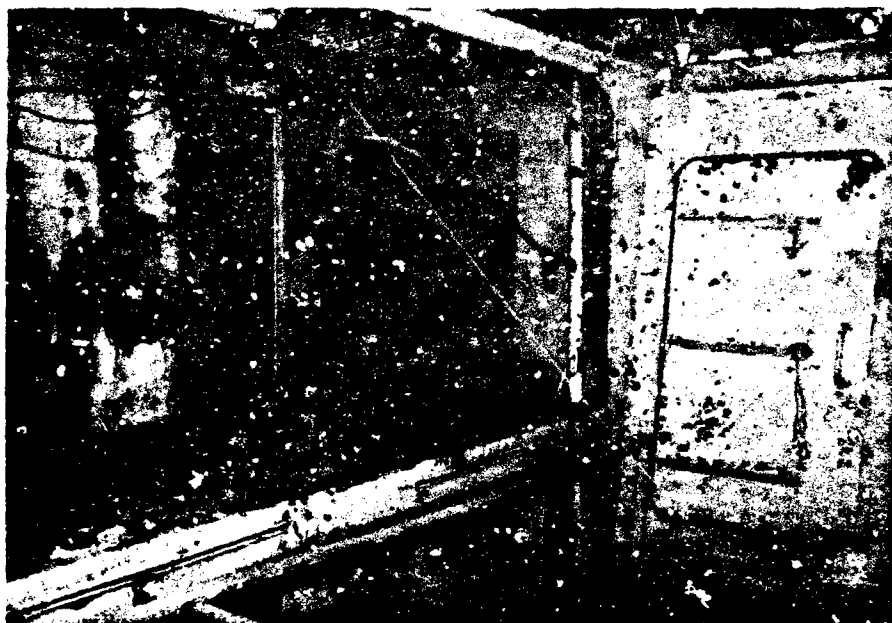
FIGURE 3. THE FUEL TANK

The fuel cells were fabricated by TERA from 1/8-inch (3 mm) thick aluminum plates with the dimensions of 40 in. (101 cm) wide X 30 in. (76 cm) high X 13 in. (33 cm) deep. The fuel cell was held against right hand wall in the rear corner by two steel bands as shown in Figure 3.

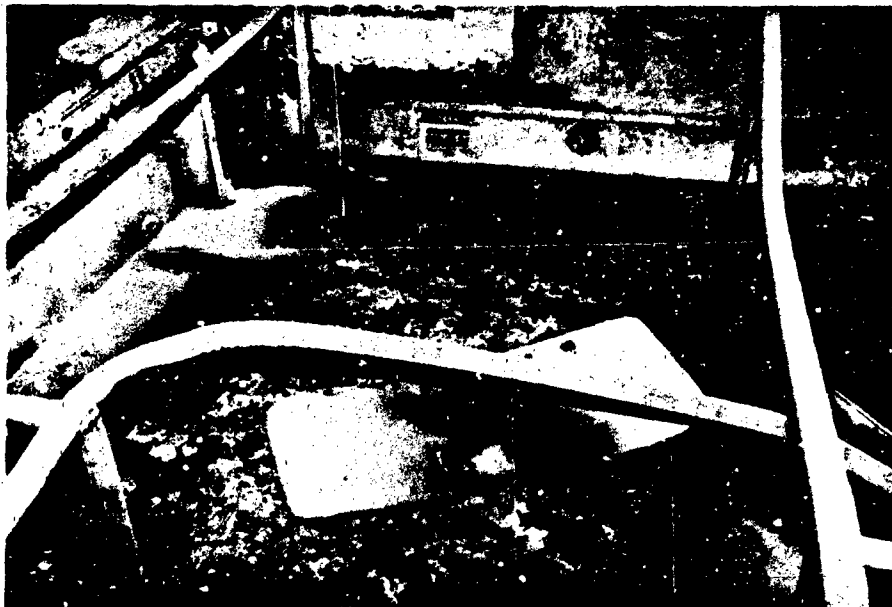
FIGURE A-2. END OF FUEL CELL AND FALSE FLOOR
AFTER TEST NO. 1

2. Results: The shaped charge perforated the aluminum armor and both sides of the fuel cell. One end of the tank was blown off by fuel cell pressure which peaked at 60 psi (414 kPa) (See Figures A-1 through A-3 at the end of this appendix). The fuel was dumped on the floor, and the rear door was blown open. Most of the fuel collected under the armored personnel carrier's false floor where air was very limited (See Figure A-2). Only a very small fire developed, and this was easily put out with a fire extinguisher.

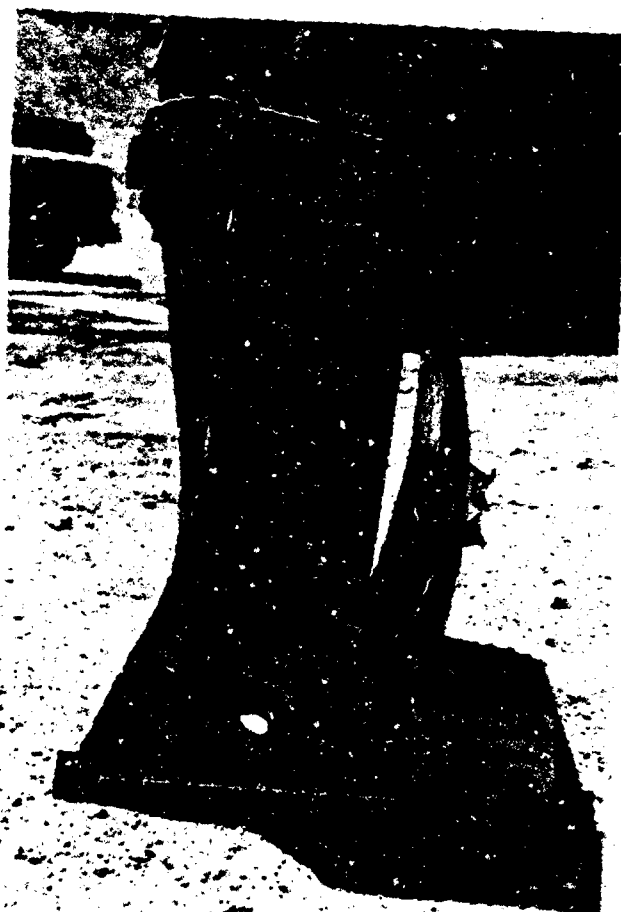
FIGURE A-3. END VIEW OF FUEL CELL AFTER TEST NO. 1

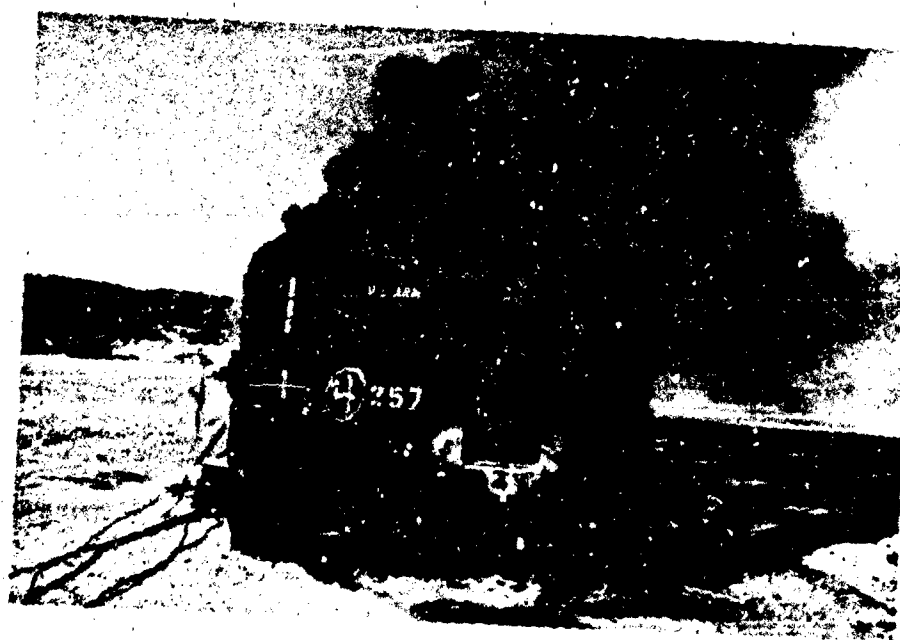
FIGURE A-7. FIRE AFTER FIRE EXTINGUISHER ATTEMPT

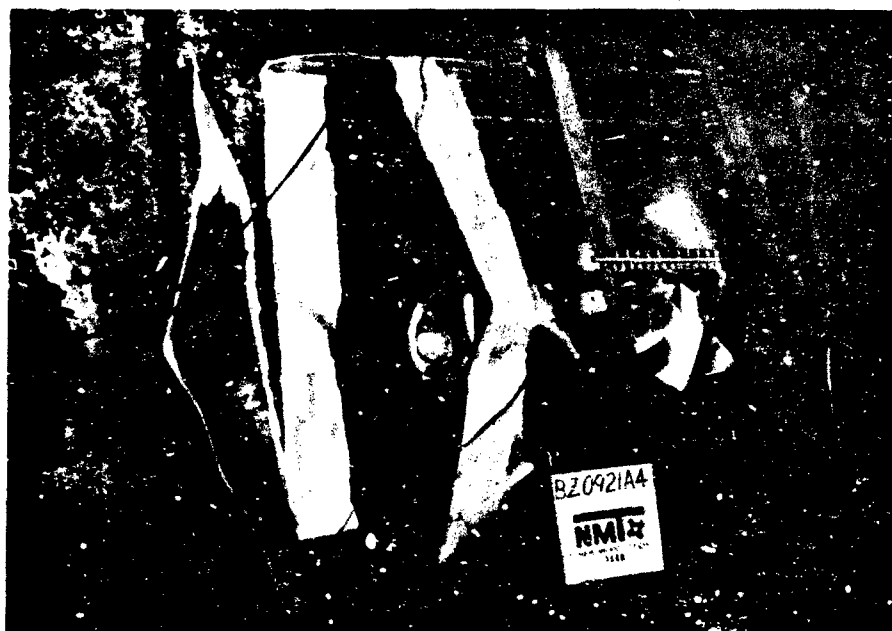
FIGURE A-11. FUEL CELL AFTER TEST NO. 9

2. Results: The shaped charge perforated the aluminum armor and both sides of the fuel cell. The fuel cell end welds were split, and all fuel was expelled. No pool fire was produced, and only a momentary increase in temperature was recorded (See Figures A-11 and A-12). The peak fuel cell pressure was 124 psi (855 kPa), and the high temperature in the personnel compartment was 84°F (29°C).

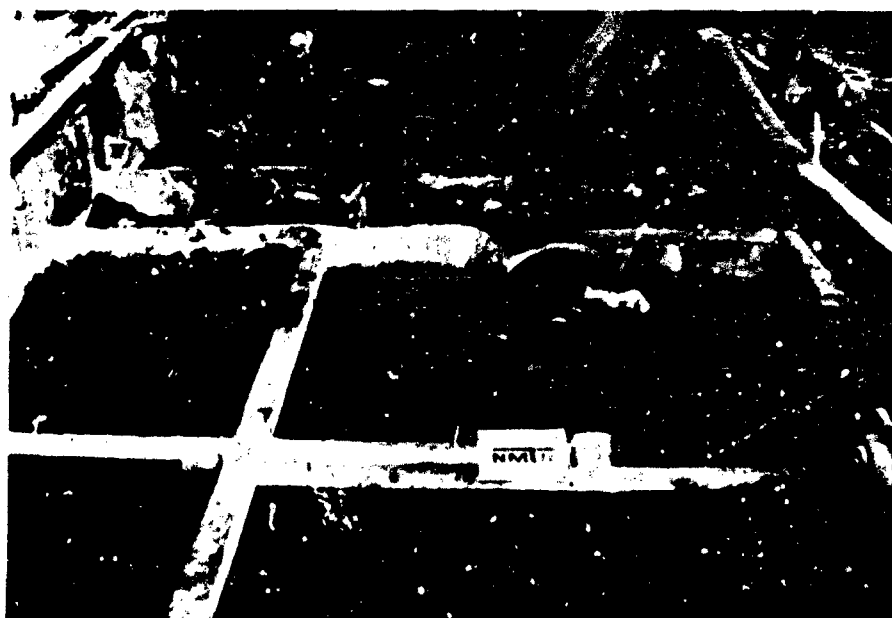
FIGURE A-12. NO FIRE AFTER TEST NO. 9

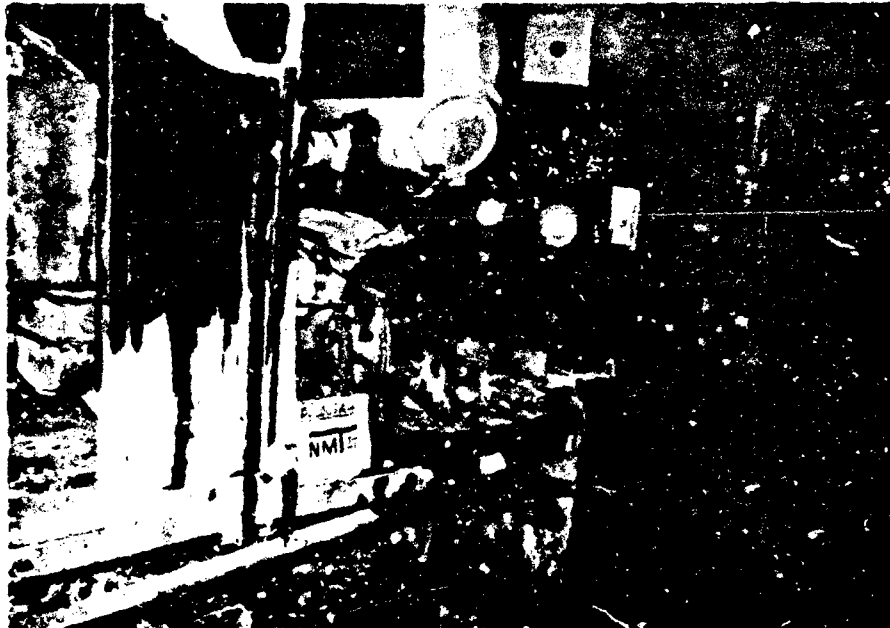
FIGURE A-13. SMALL FIRE AFTER TEST NO. 10

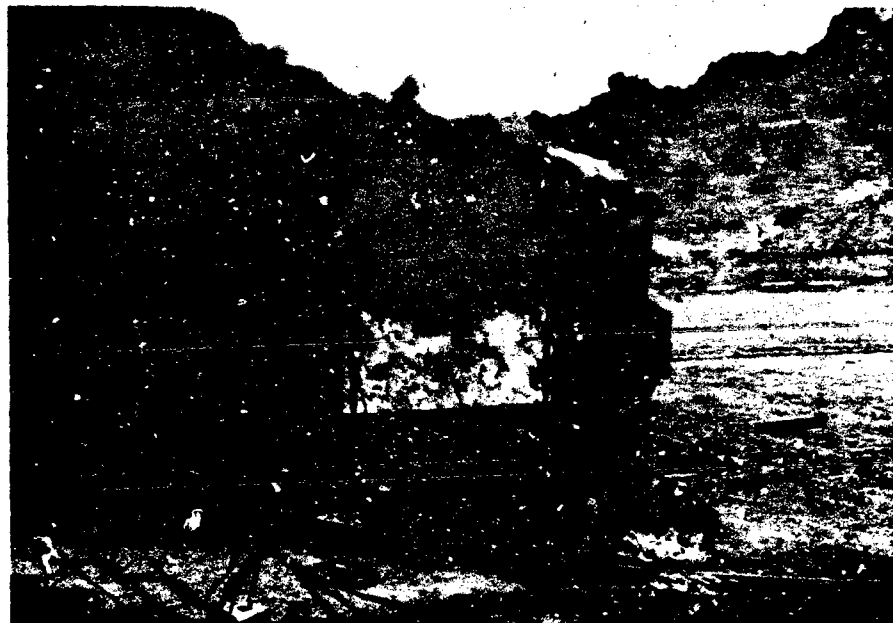
FIGURE A-15. FIRE AFTER TEST NO. 11

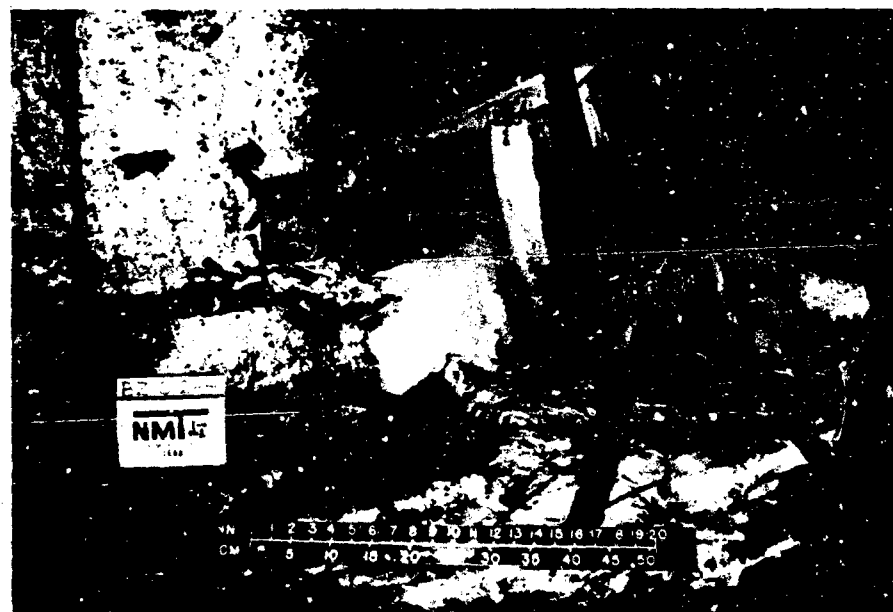
FIGURE A-16. FUEL CELL AFTER TEST NO. 11
