TECHNICAL REPORT GL-85-5

# THE VAIONT SLIDE, A GEOTECHNICAL ANALYSIS BASED ON NEW GEOLOGIC OBSERVATIONS OF THE FAILURE SURFACE

Volume II  
APPENDICES A THROUGH G

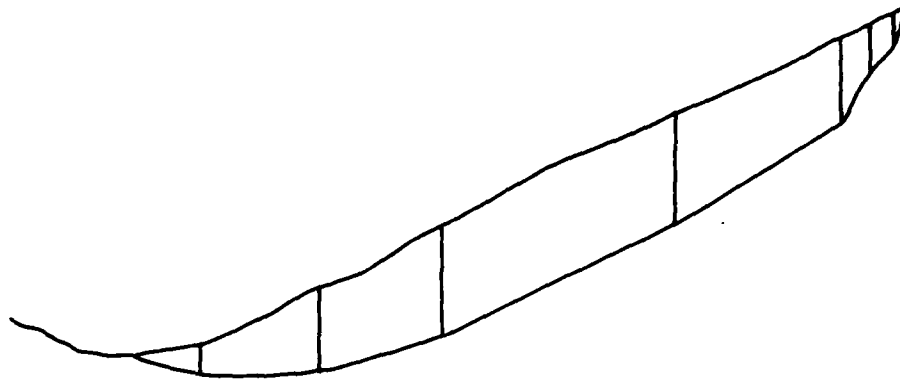
Figure B1. Subdivision of slide into slices

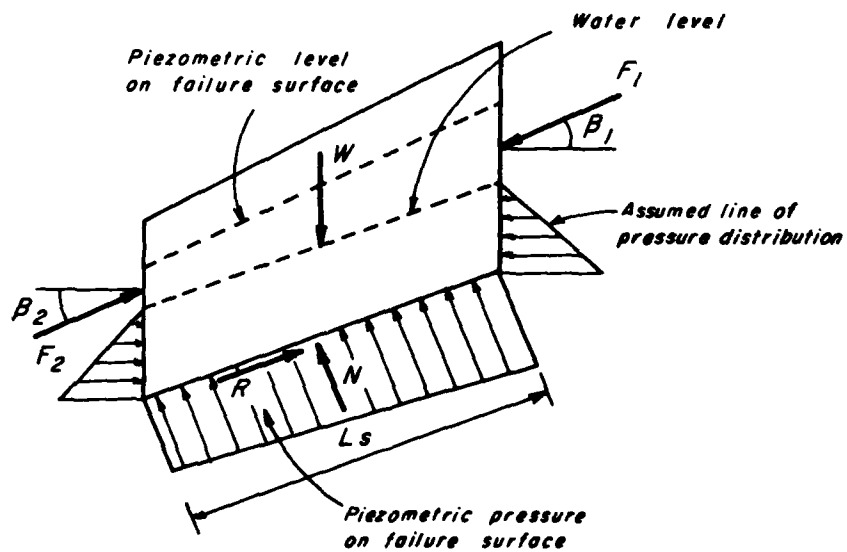
$W$  = total weight of soil and water above the failure surface  
 $N$  = effective reaction normal to the failure surface  
 $R$  = shearing resistance of the soil  
 $F_1, F_2$  = interelement forces between adjacent slices  
 $\beta_1, \beta_2$  = inclination of the interelement forces from the normals to the slice faces.

Figure B2. Forces on a typical slice of a slide

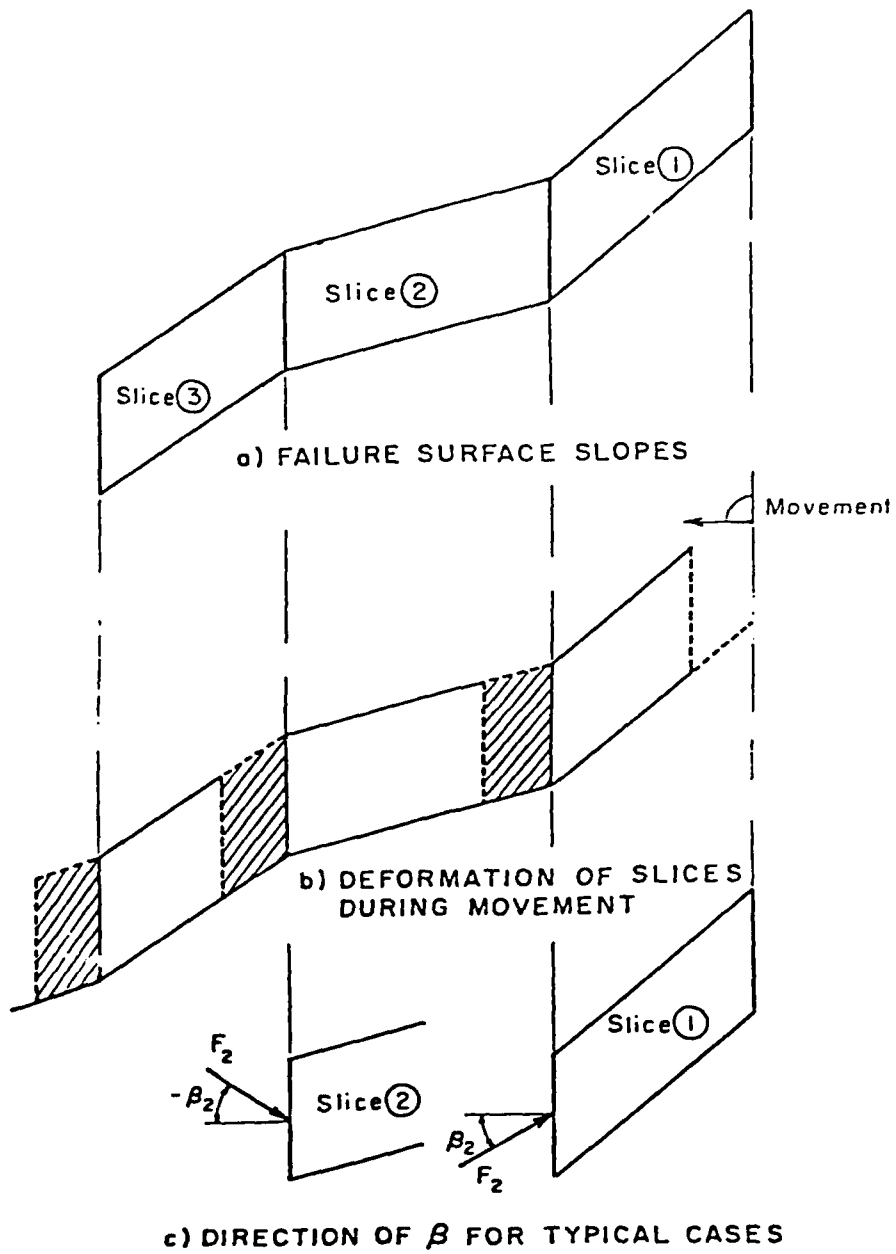
Figure B3. Illustration of method for assigning direction of frictional forces between slices

slices. If the failure surface of three slices is as shown in Figure B3a, and if the slide moves downhill, then the lower part of slice (1) must be deformed upward, as shown in Figure B3b, and so the inter-element force must provide an upward force on slice (1) as shown in Figure B3c. Thus,  $\beta_2$  for slice (1) would be positive (assuming  $F_2$  is positive). Following the same argument  $\beta_2$  would be negative for slice (2). Assigning these directions and performing the static analysis as previously described, gives the same results as accounting for the work done in deforming the slide as it moves over changes in the slope of the failure surface. The latter is similar to the upper-bound limit analysis of plasticity theory.

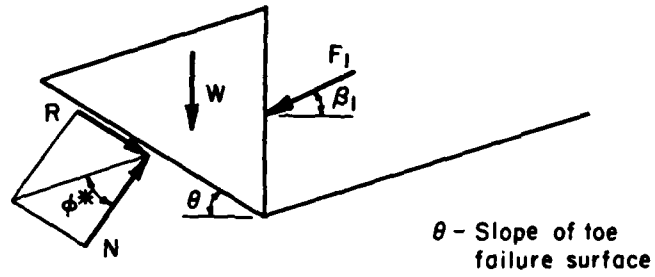
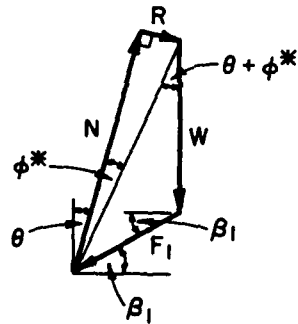
a) Forces on toe wedge

$\phi^* = \phi$  required for equilibrium

b) Vector Diagram of toe forces

If the toe has a sharply upturning failure surface, it may possibly form a toe wedge that theoretically makes the overall slide very stable, sometimes leading to an infinite value of the computed factor of safety, which is independent of the stability of the material above the toe wedge. In reality this would not occur as the toe would tend to fail along a different failure surface that did not provide this wedging

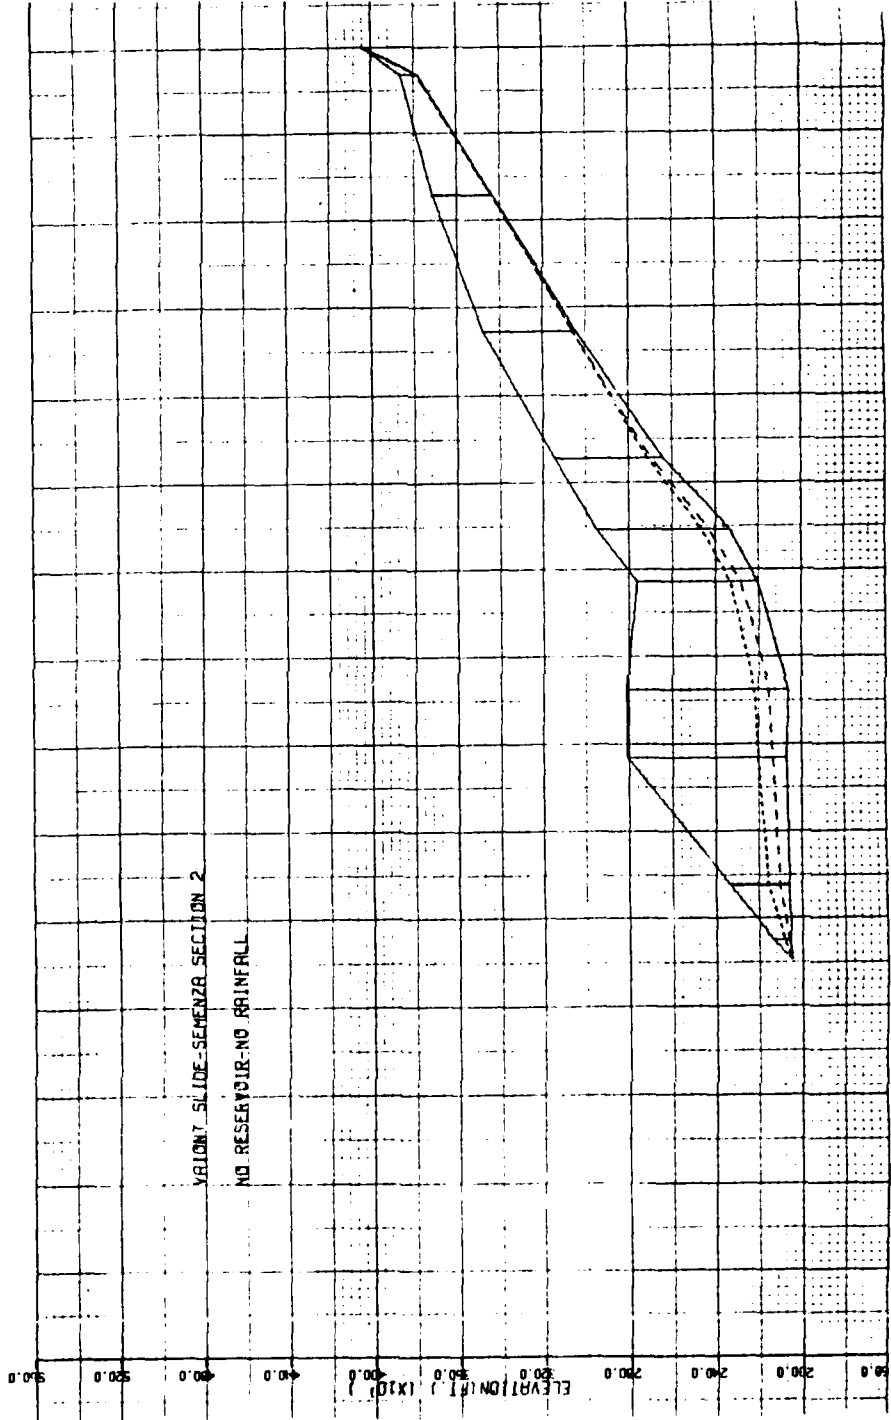
Figure C1. Vaiont Slide - Semenza Section 2, No reservoir, no rainfall

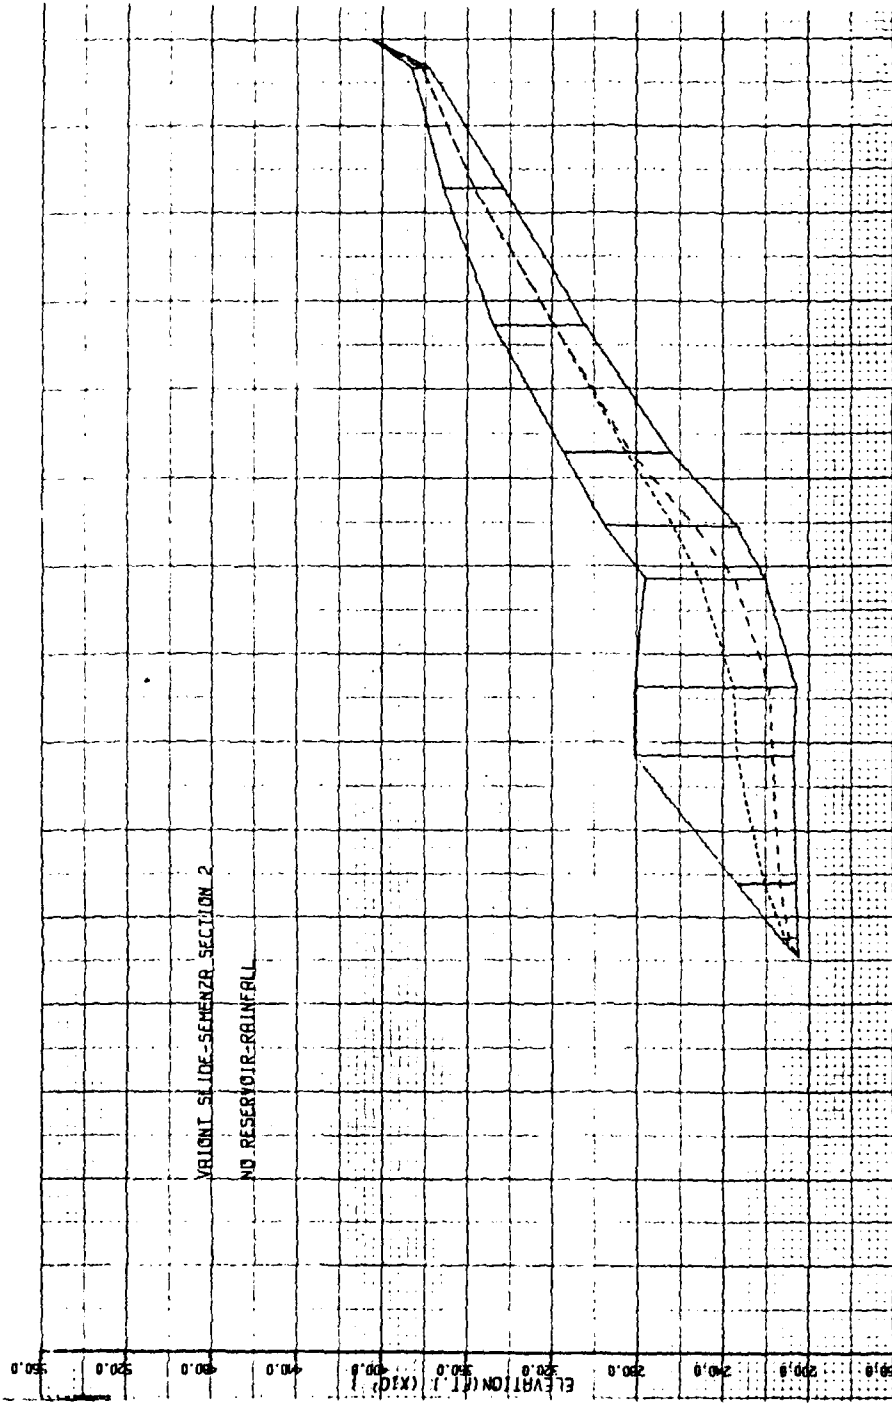
Figure C2. Vaiont Slide - Semenza Section 2, No reservoir, rainfall

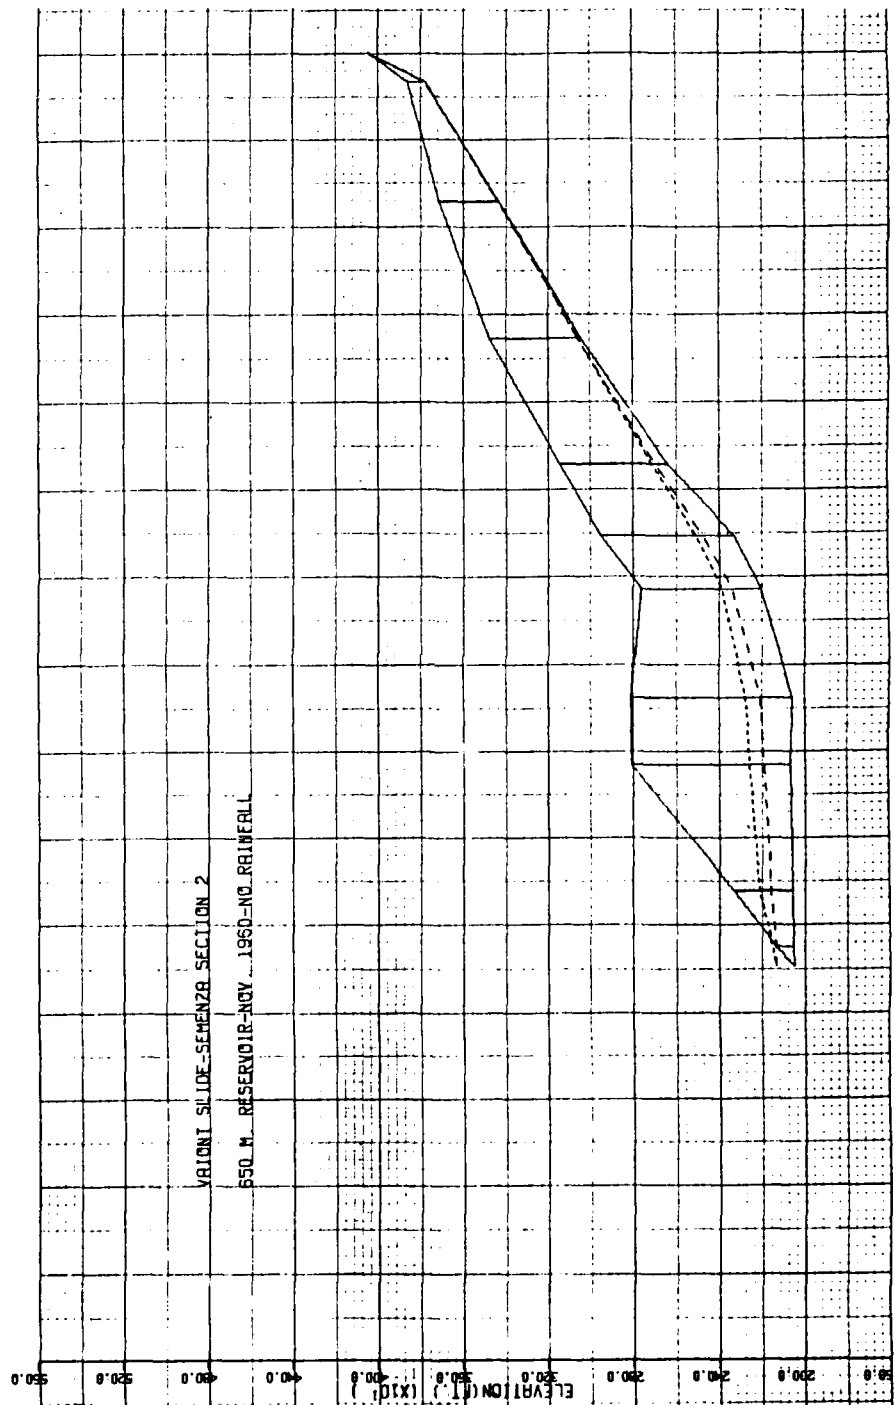
Figure C3. Vaiont Slide - Semenza Section 2, 650 m reservoir, November 1960, no rainfall

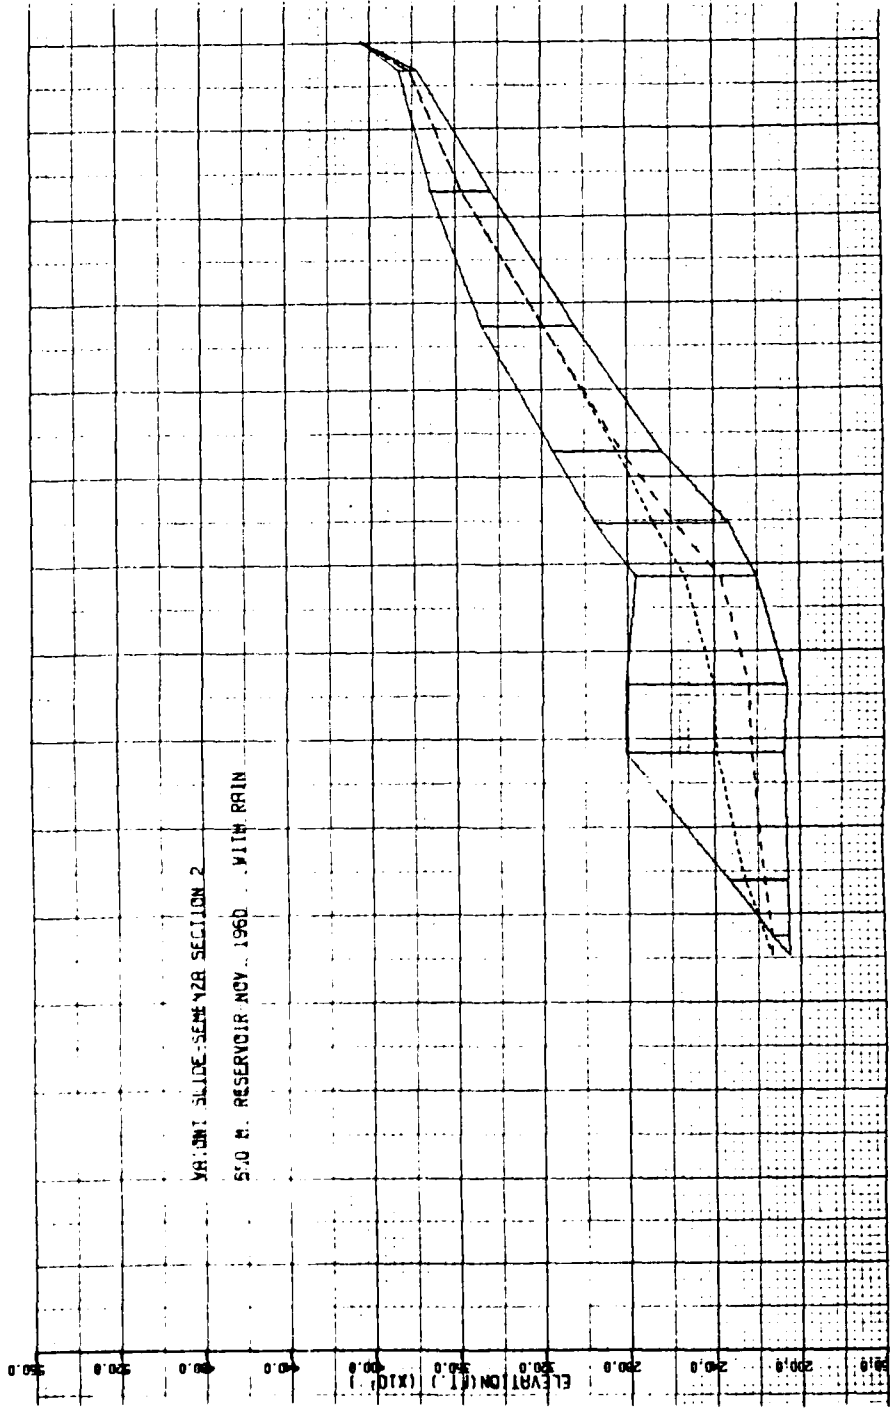
Figure C4. Vaiont Slide - Semenza Section 2, 650 m reservoir, November 1960, with rain

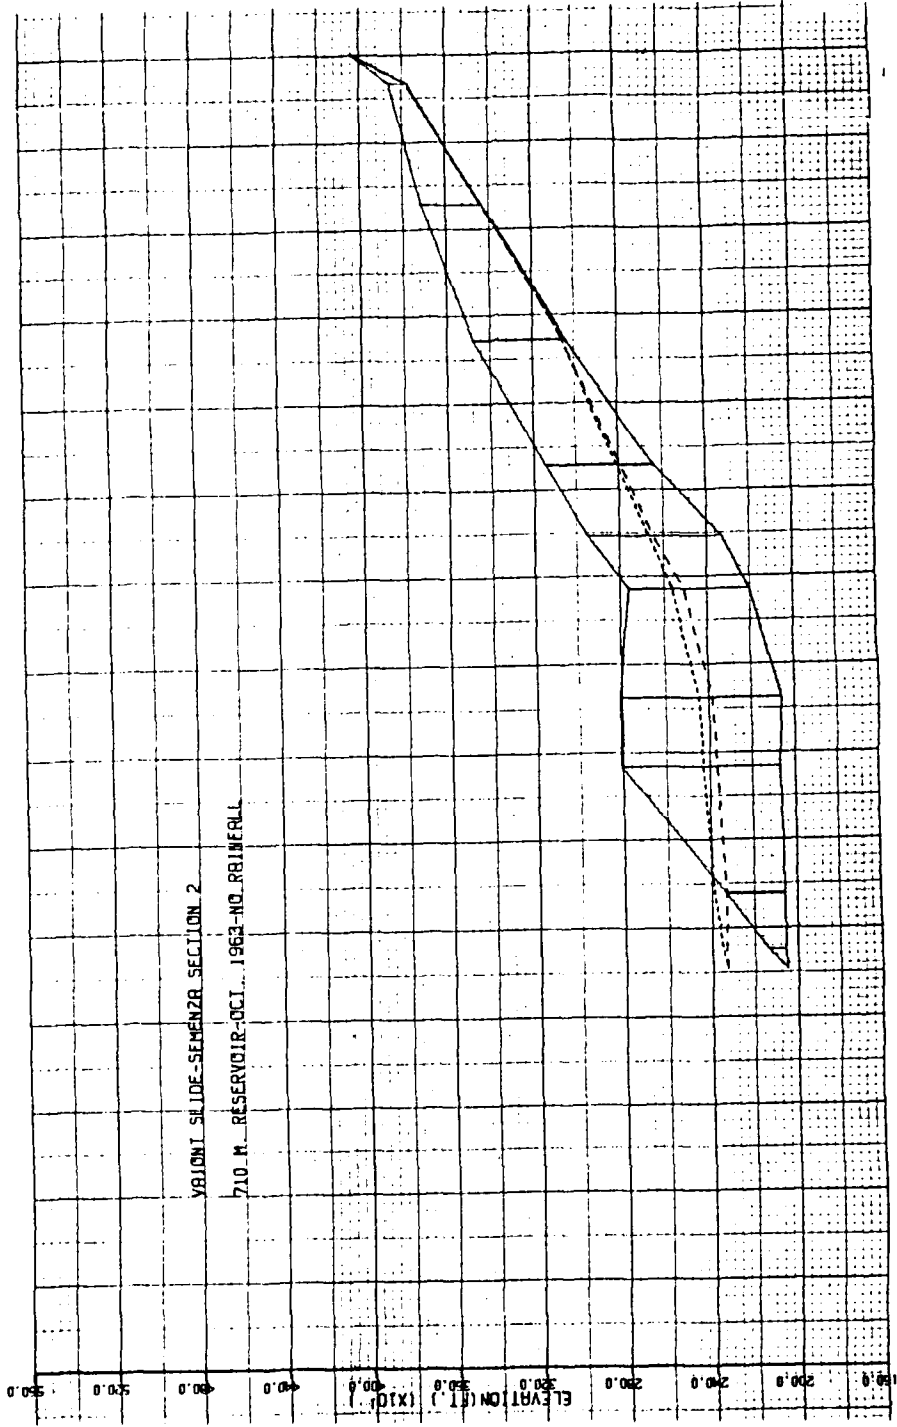
Figure C5. Vaiont Slide - Semenza Section 2, 710 m reservoir, October 1963, no rainfall

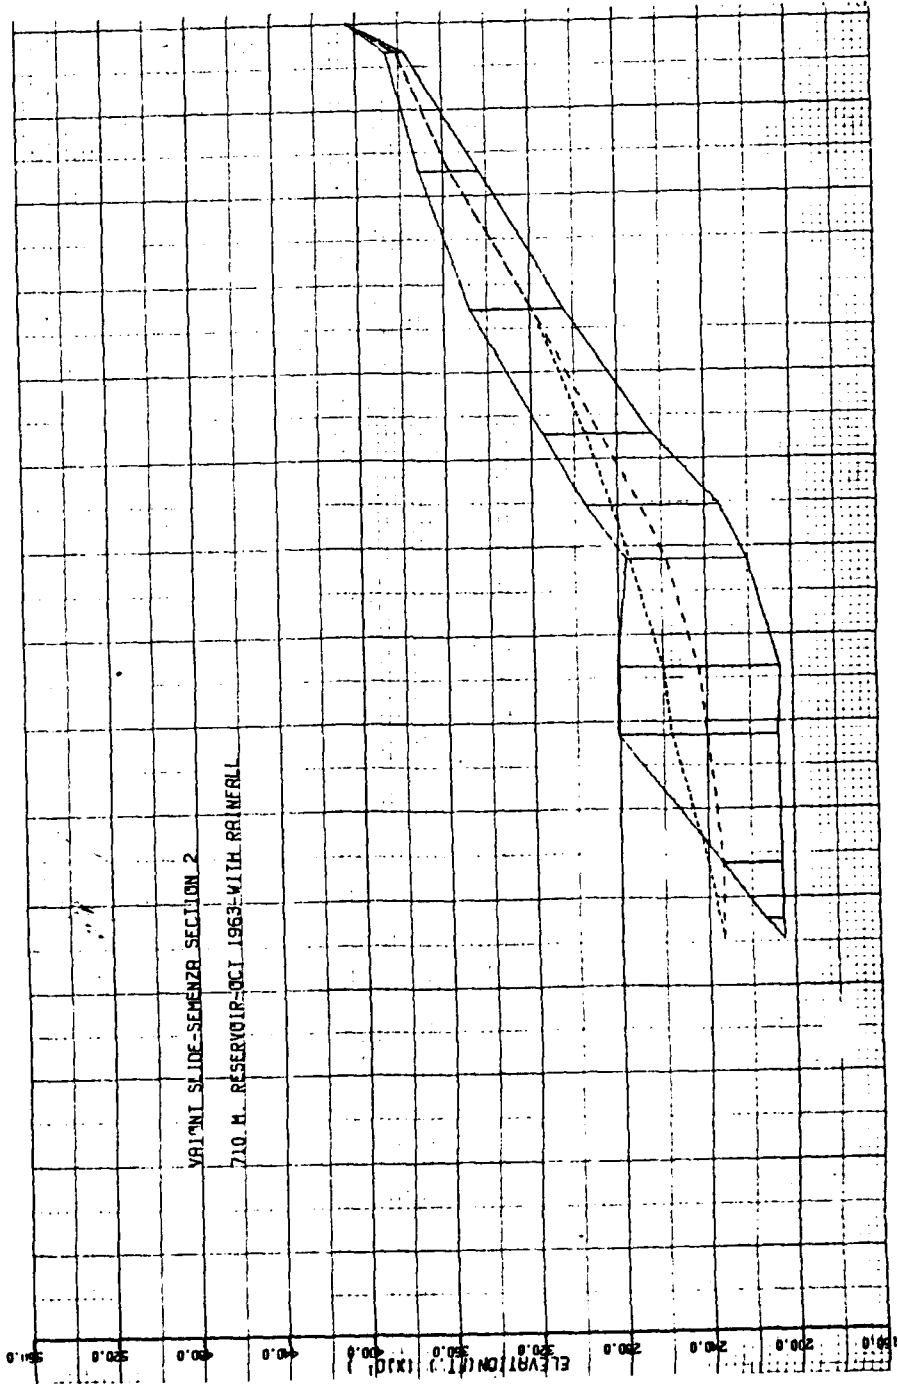
Figure C6. Vaiont Slide - Semenza Section 2, 710 m reservoir, October 1963, with rainfall

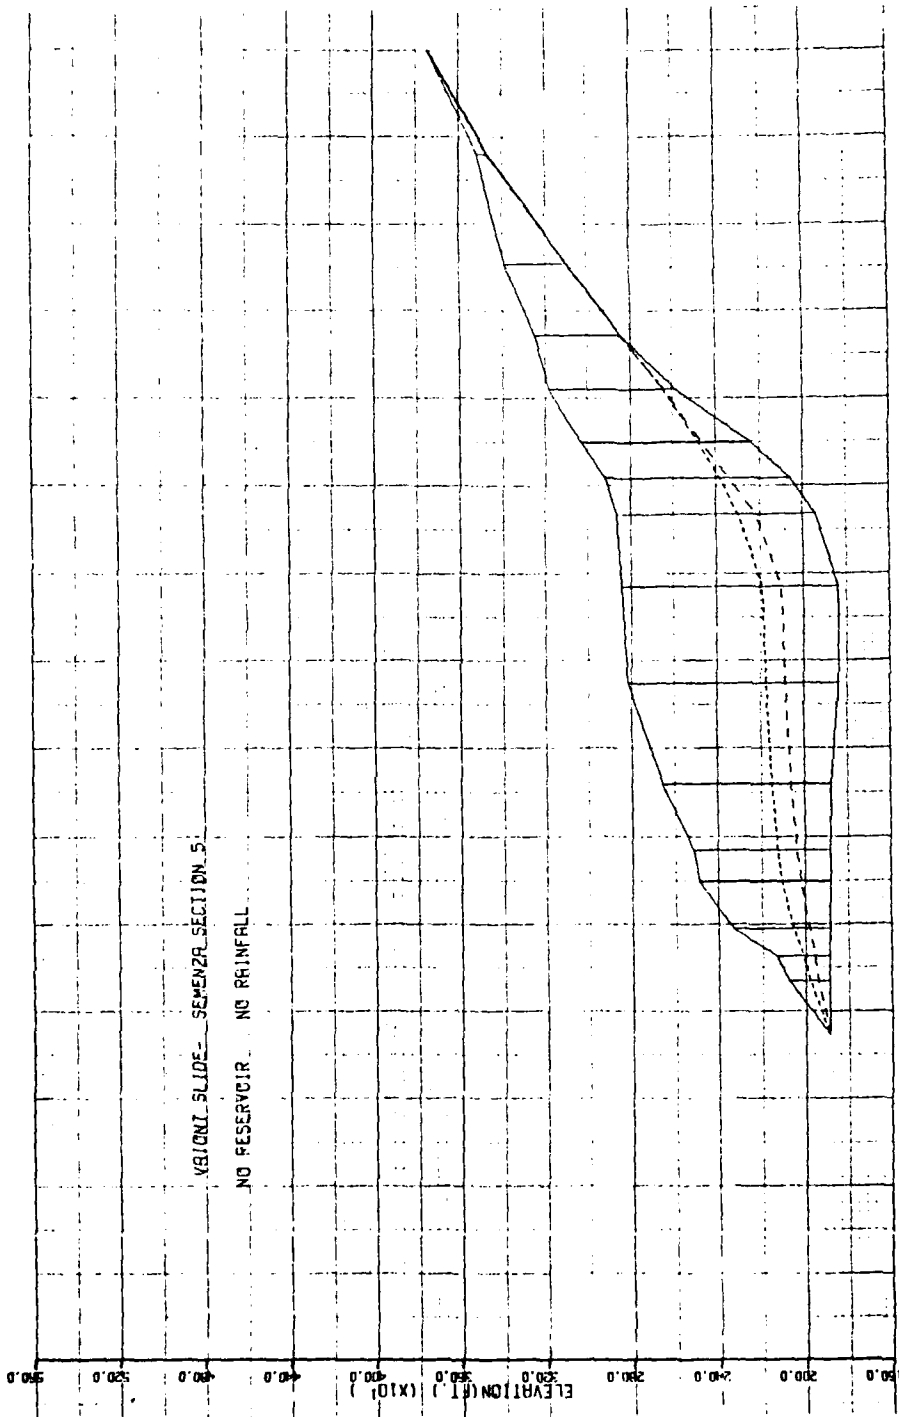
Figure C7. Vaiont Slide - Semenza Section 5, No reservoir, no rainfall

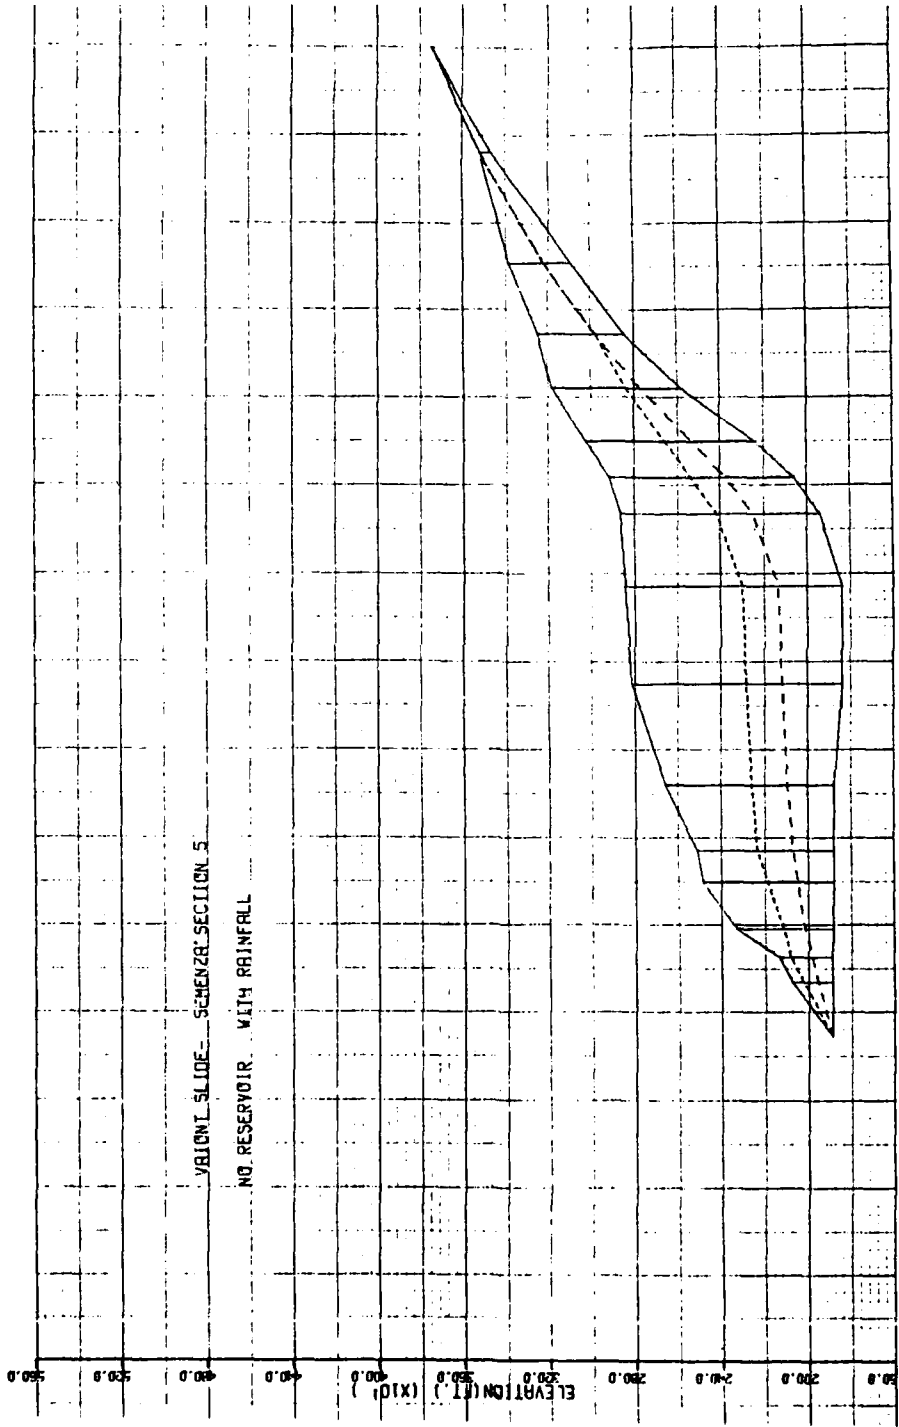
Figure C8. Vaiont Slide - Semenza Section 5, No reservoir, with rainfall

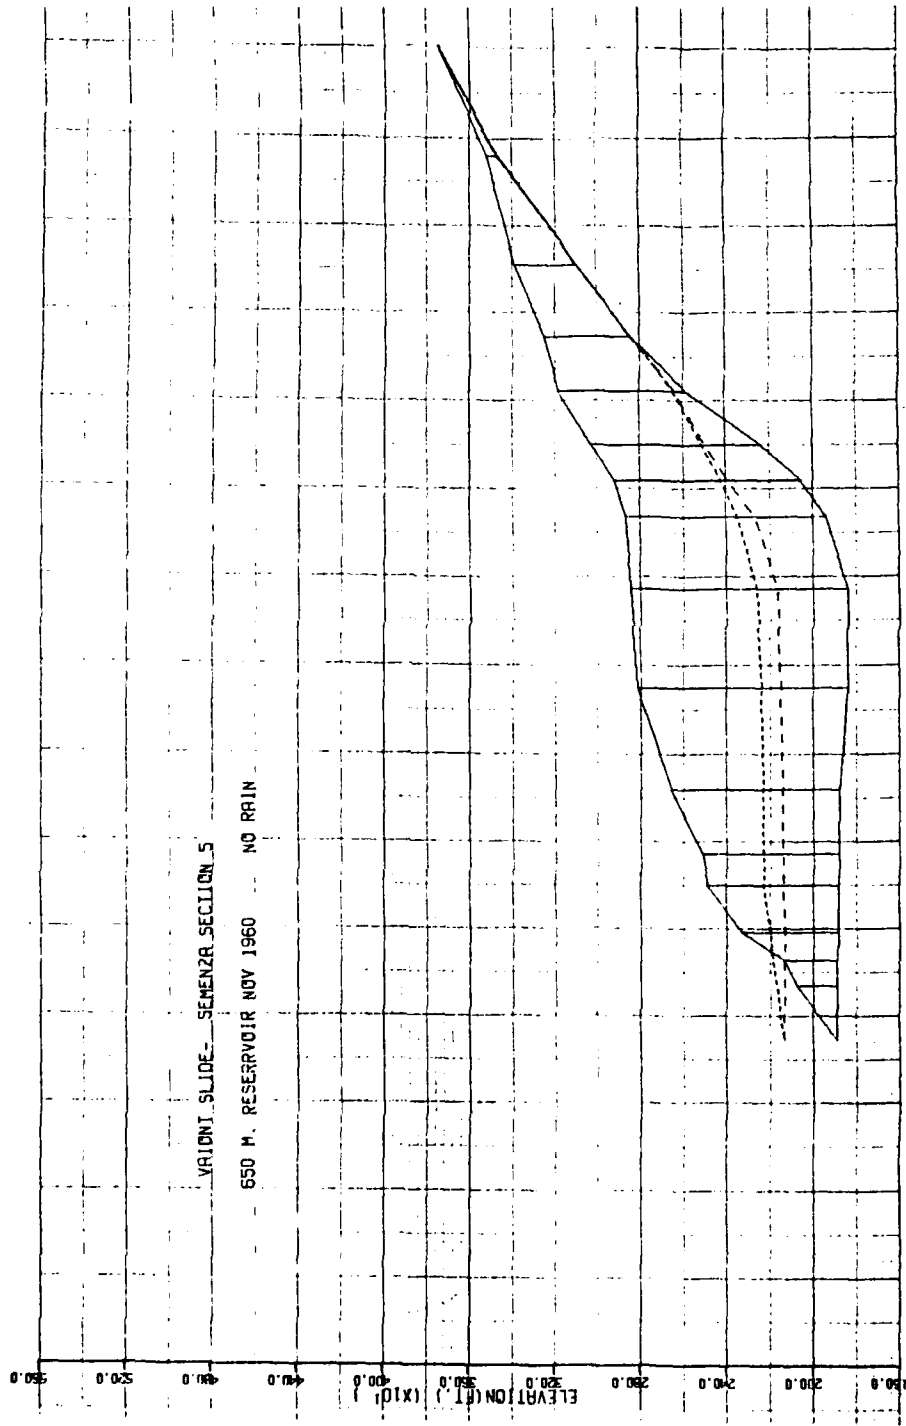
Figure C9. Vaiont Slide - Semenza Section 5, 650 m reservoir, November 1960, no rain

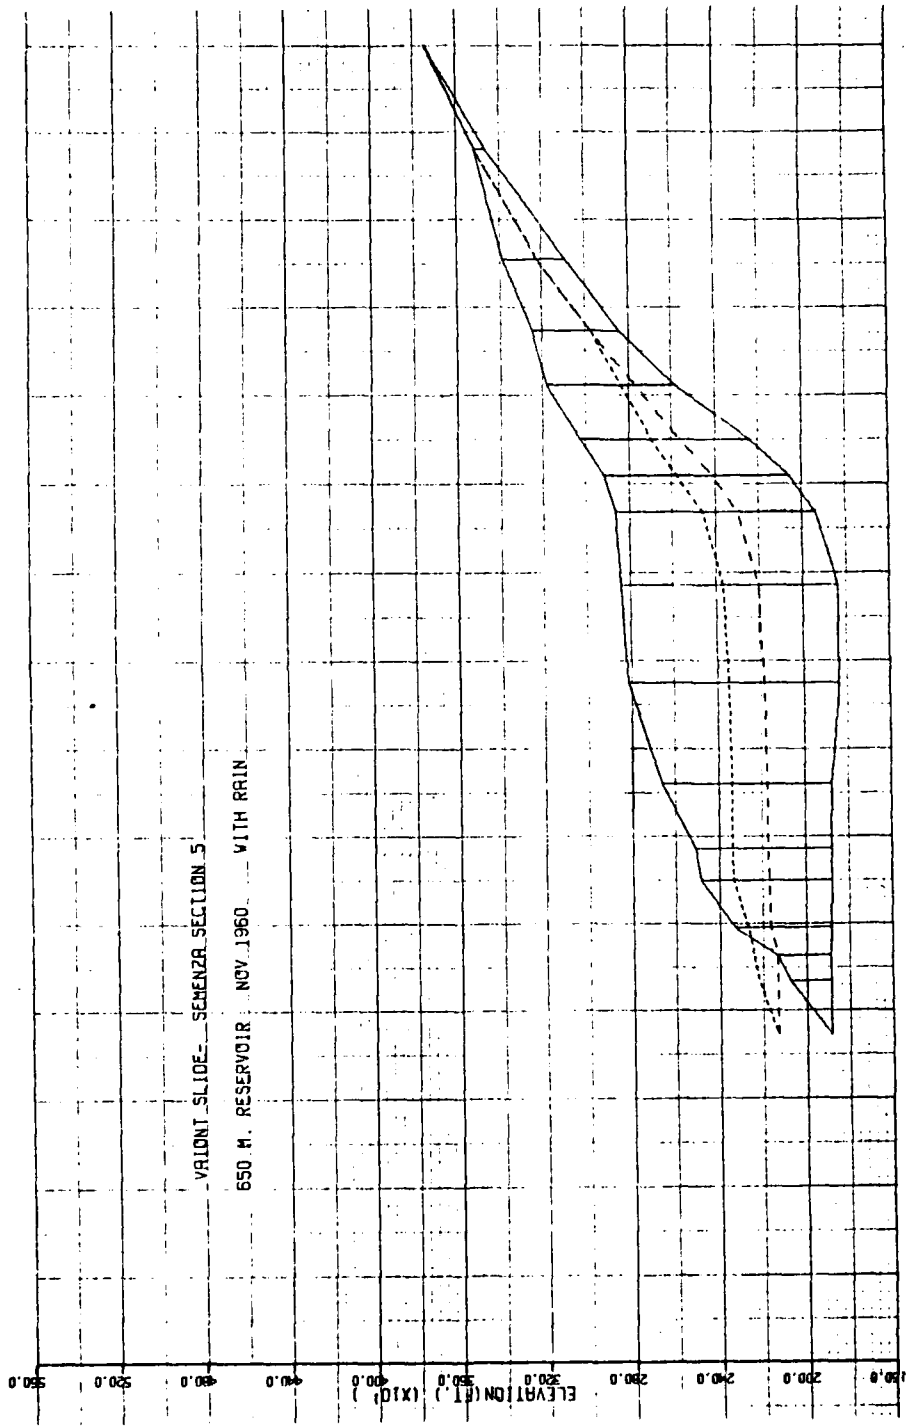
Figure C10. Vafont Slide - Semenza Section 5, 650 m reservoir, November 1960, with rain

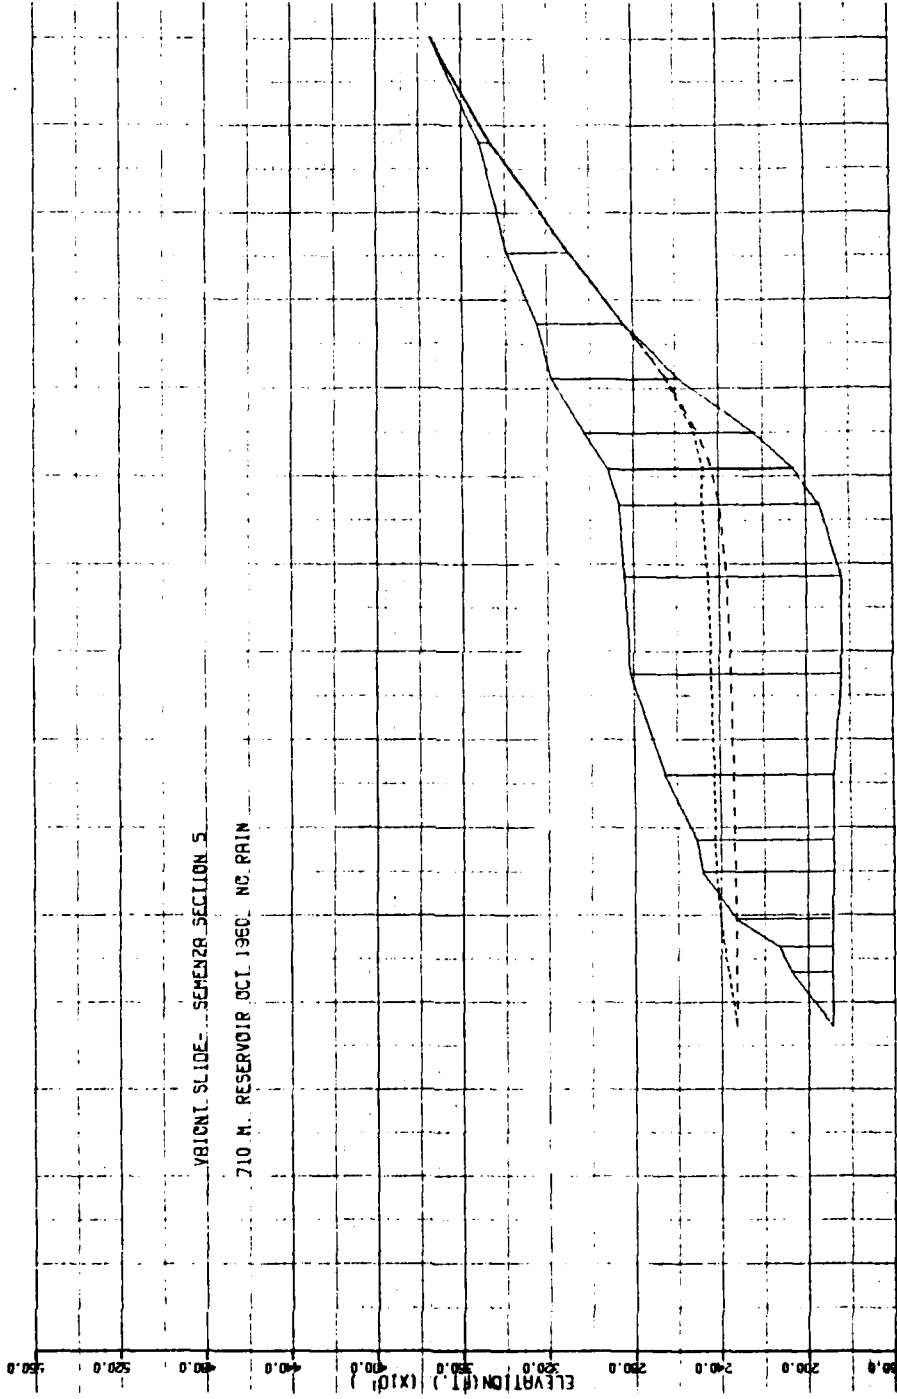
Figure C11. Vaiont Slide - Semenza Section 5, 710 m reservoir, October 1963, no rain

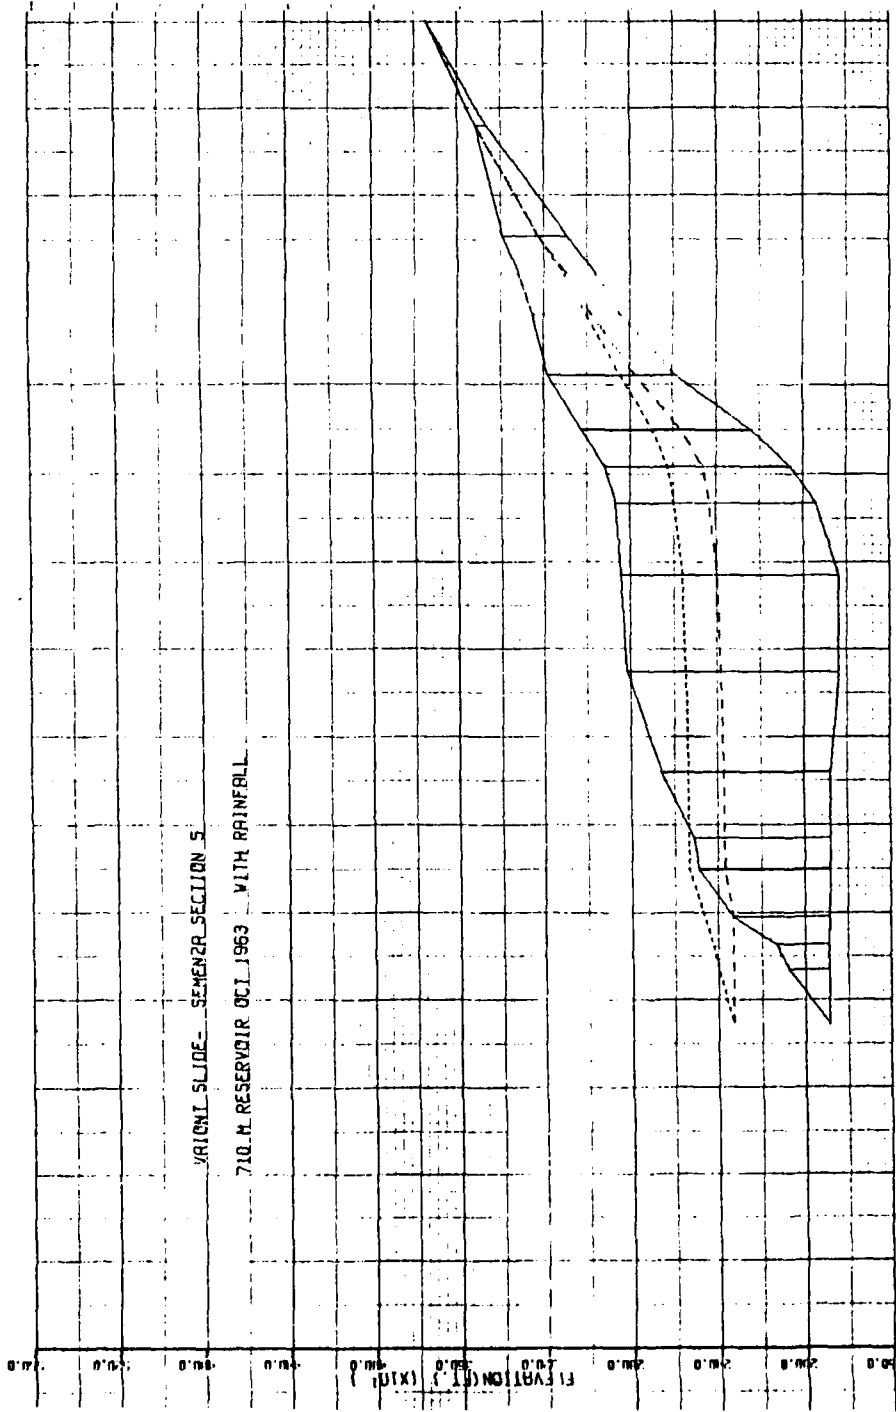
Figure C12. Vaiont Slide - Semenza Section 5, 710 m reservoir, October 1963, with rainfall

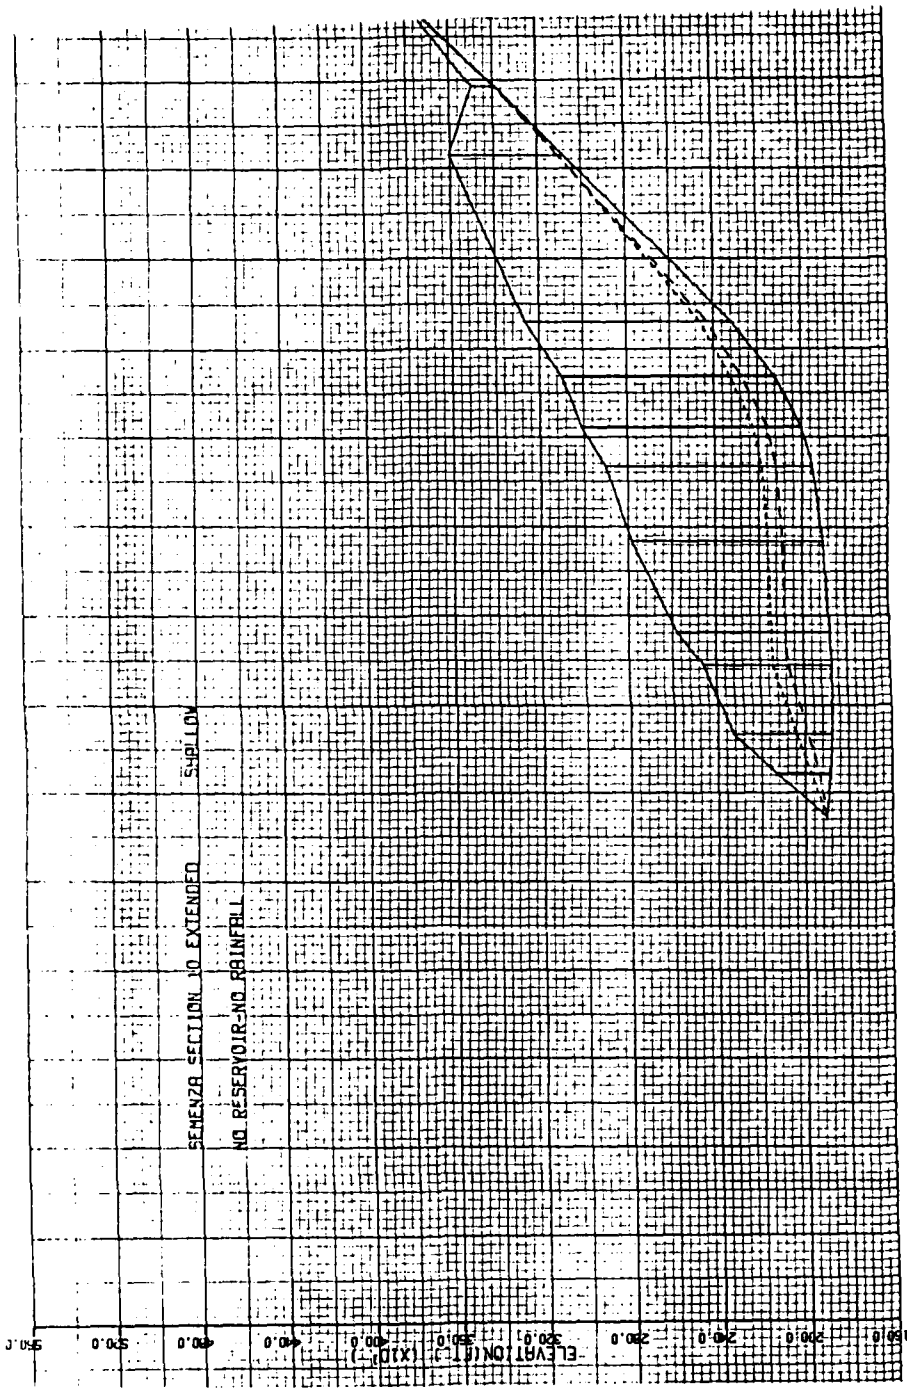
Figure C13. Vaiont Slide - Semenza Section 10 Extended, Shallow, No reservoir, no rainfall

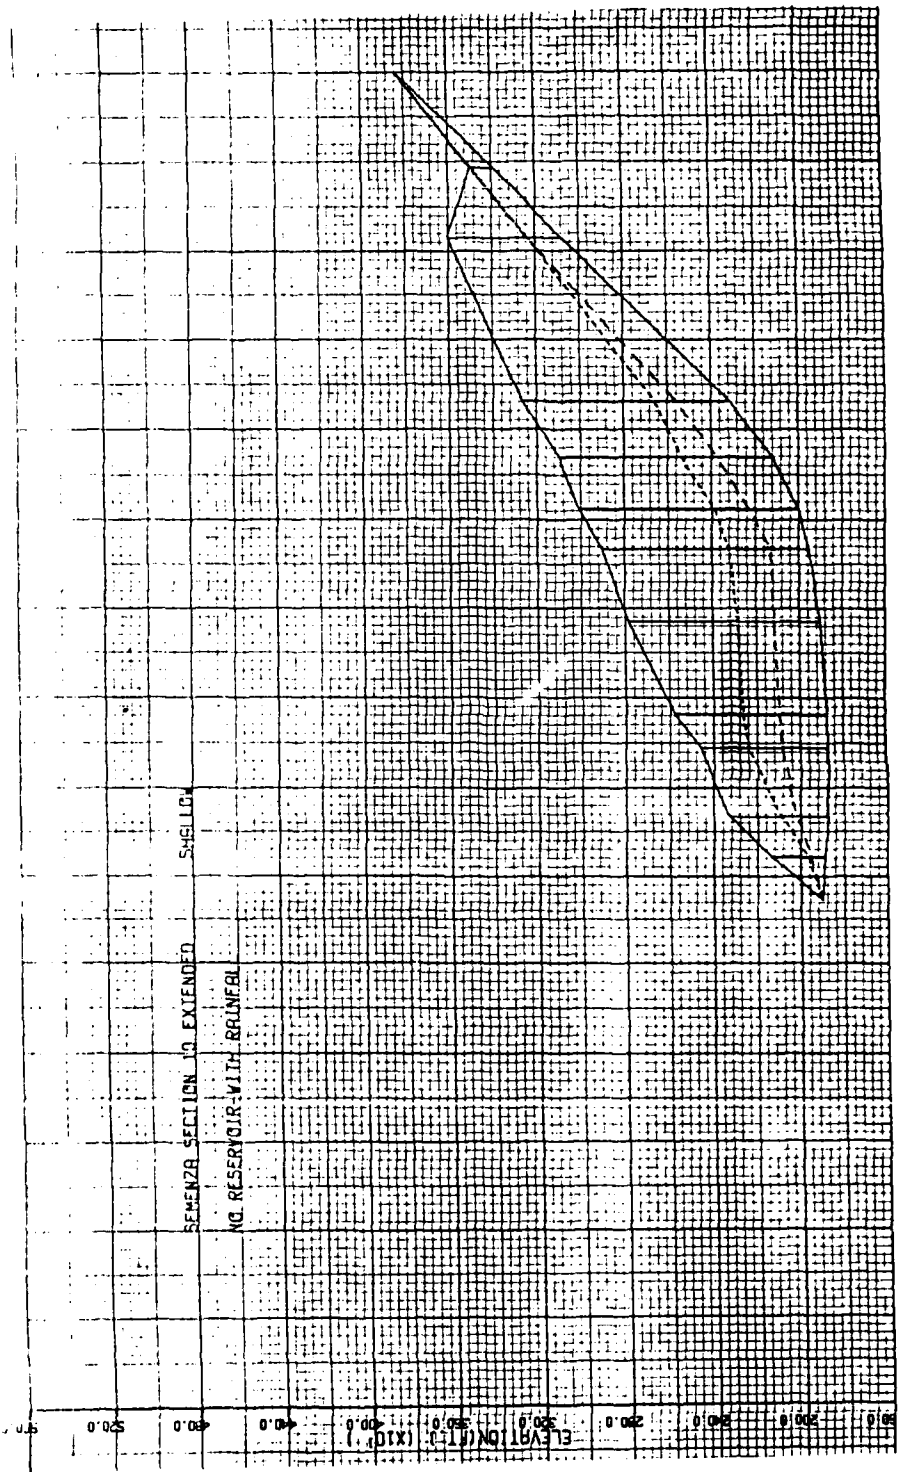
Figure C14. Vaiont Slide - Semenza Section 10 Extended, Shallow, No reservoir, with rainfall

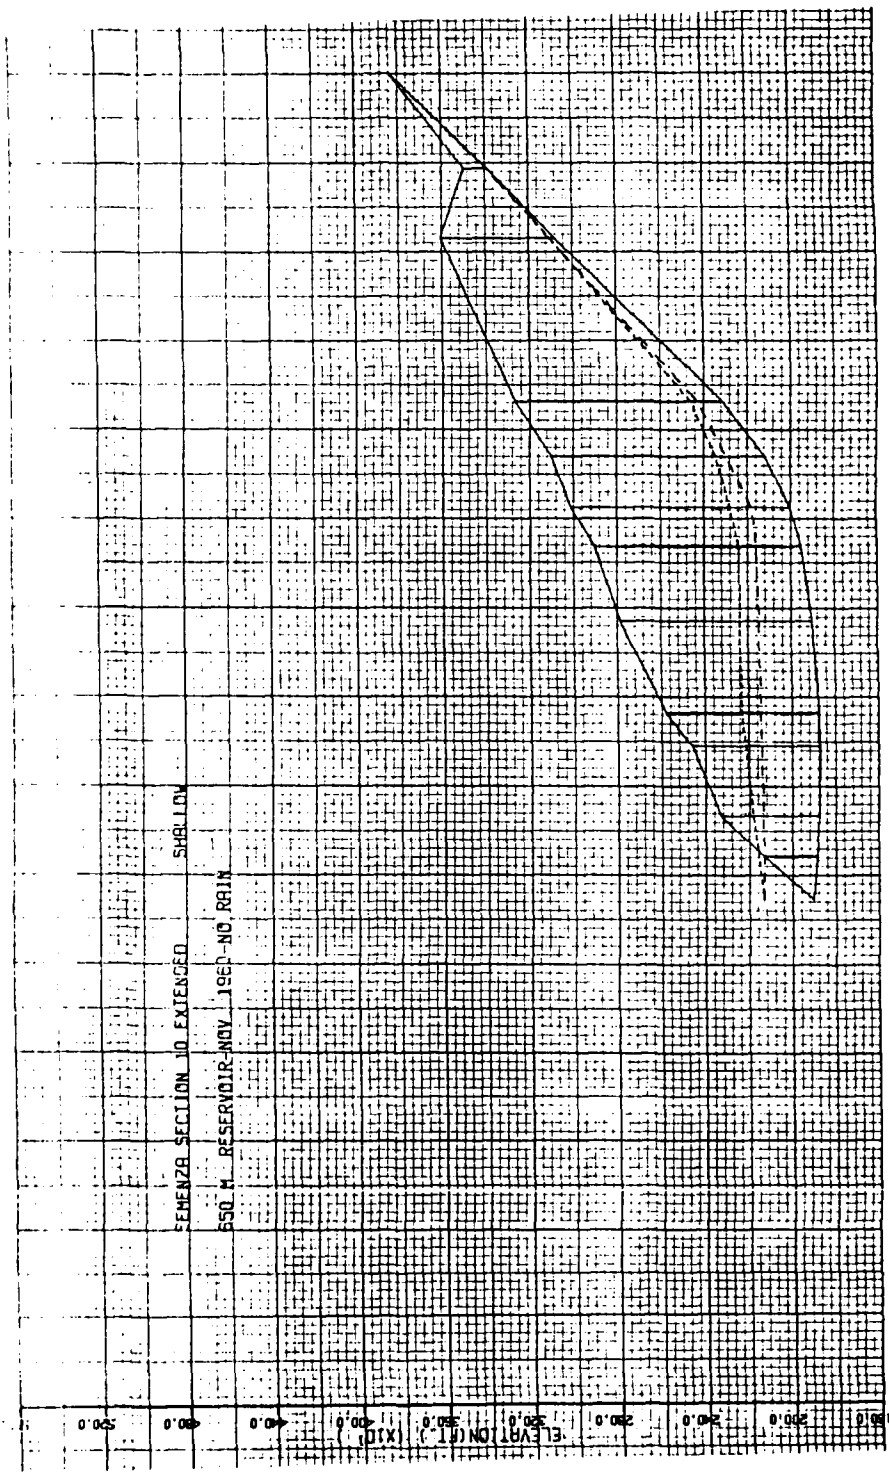
Figure C15. Vaiont Slide - Semenza Section 10 Extended, Shallow, 650 m reservoir, November 1960, no rain
