TECHNICAL REPORT GL-85-5

# THE VAIONT SLIDE, A GEOTECHNICAL ANALYSIS BASED ON NEW GEOLOGIC OBSERVATIONS OF THE FAILURE SURFACE

Volume II  
APPENDICES A THROUGH G

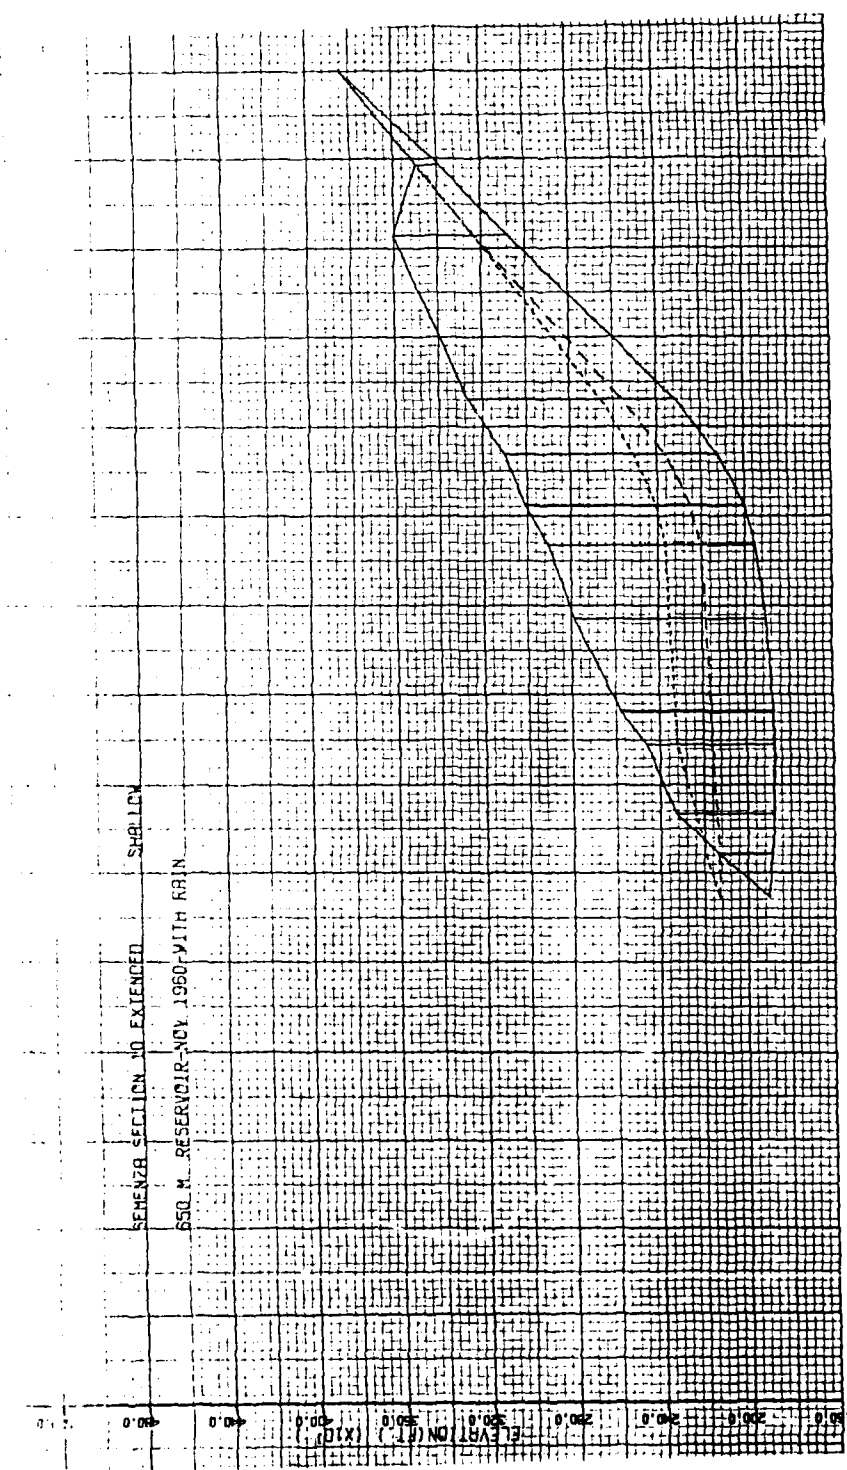
Figure C16. Vaiont Slide - Semenza Section 10 Extended, Shallow, 650 m reservoir, November 1960, with rain

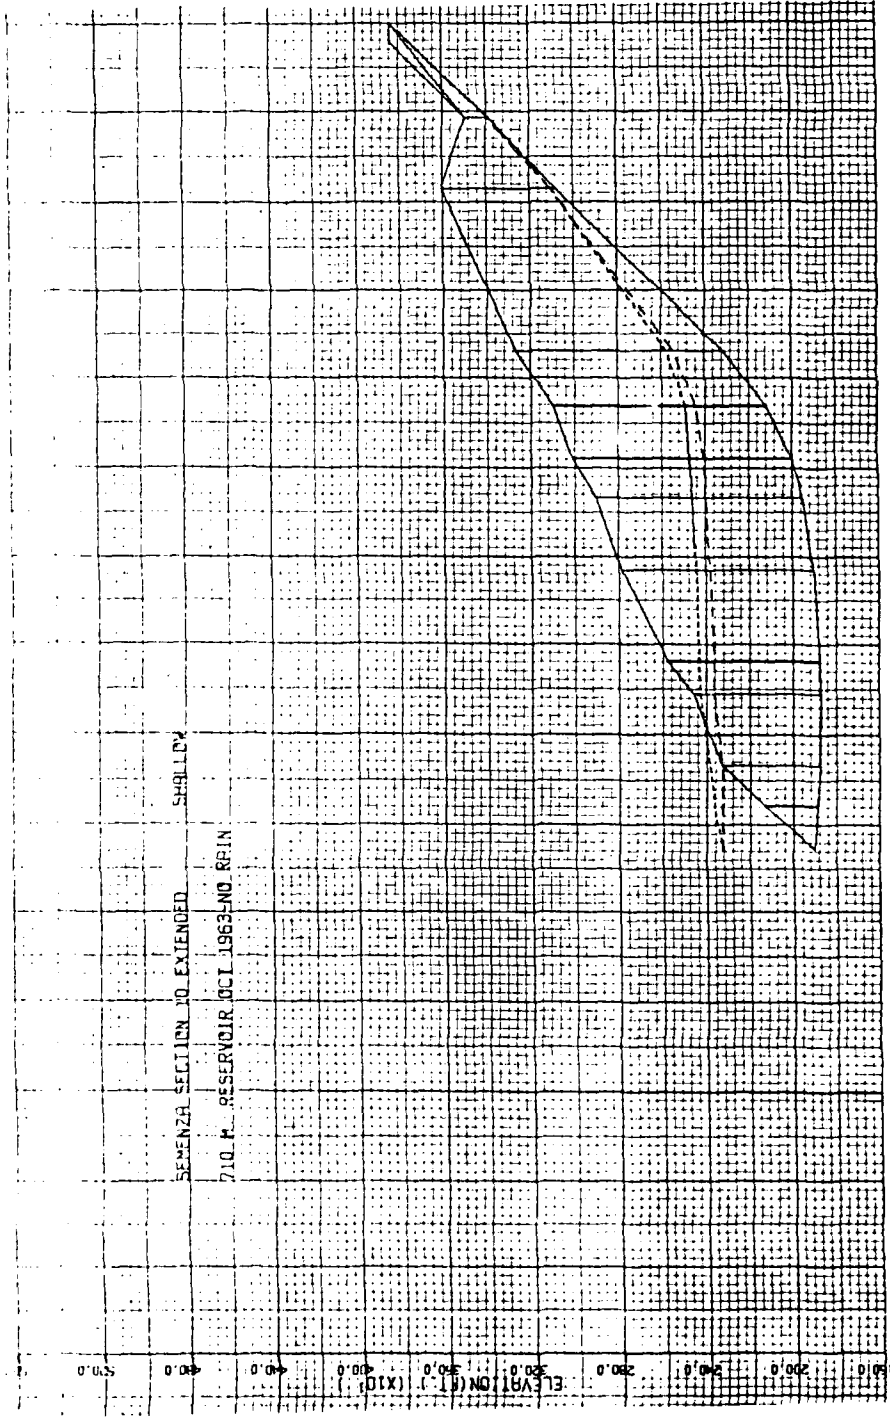
Figure C17. Vaiont Slide - Semenza Section 10 Extended, Shallow, 710 m reservoir, October 1963, no rain

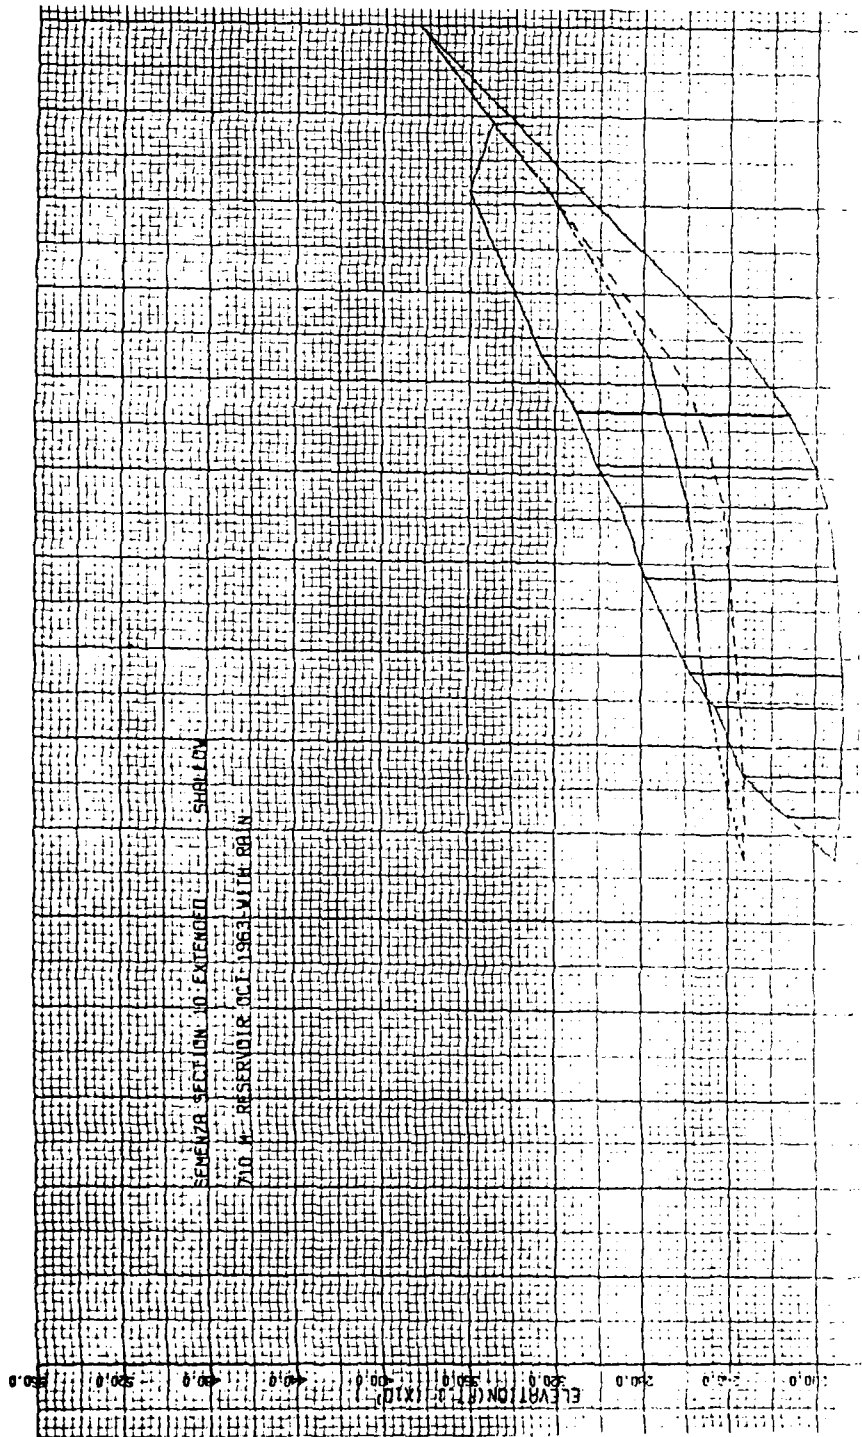
Figure C18. Vaiont Slide - Semenza Section 10 Extended, Shallow, 710 m reservoir, October 1963, with rain

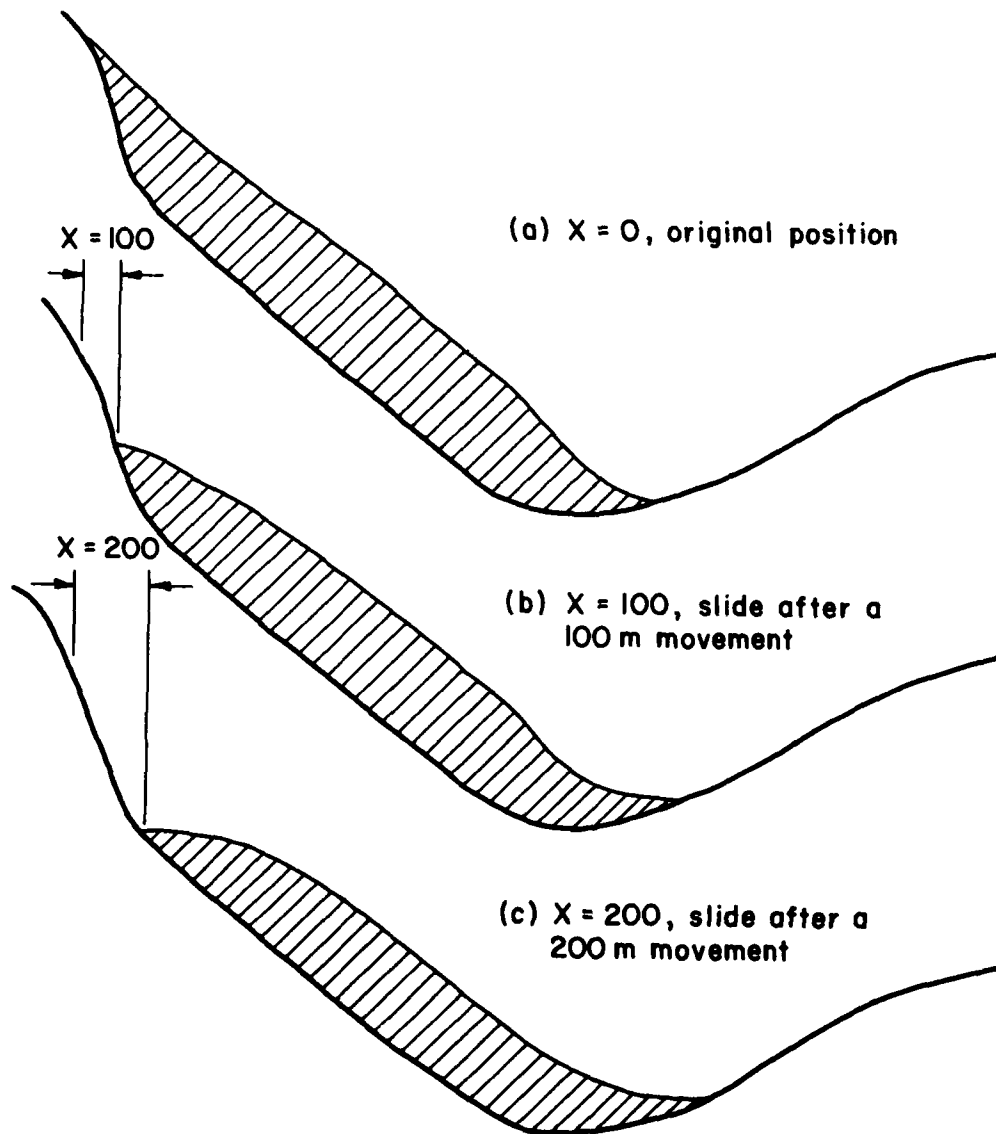
Figure E1. Slide at Various Stages of Movement

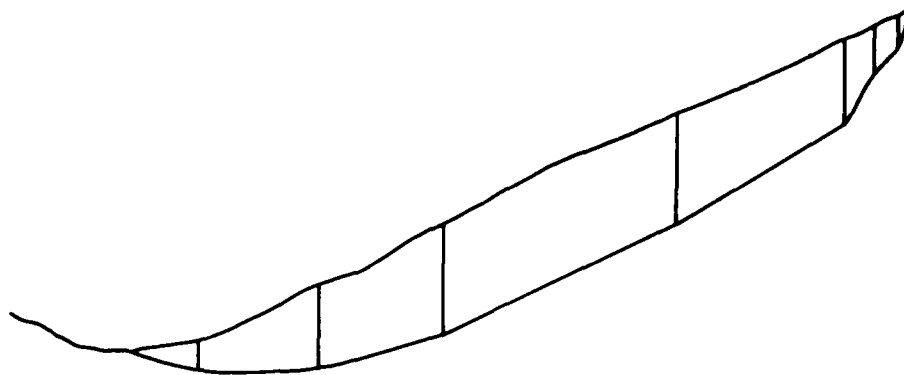
**a) SUBDIVISION OF SLIDE INTO SLICES**

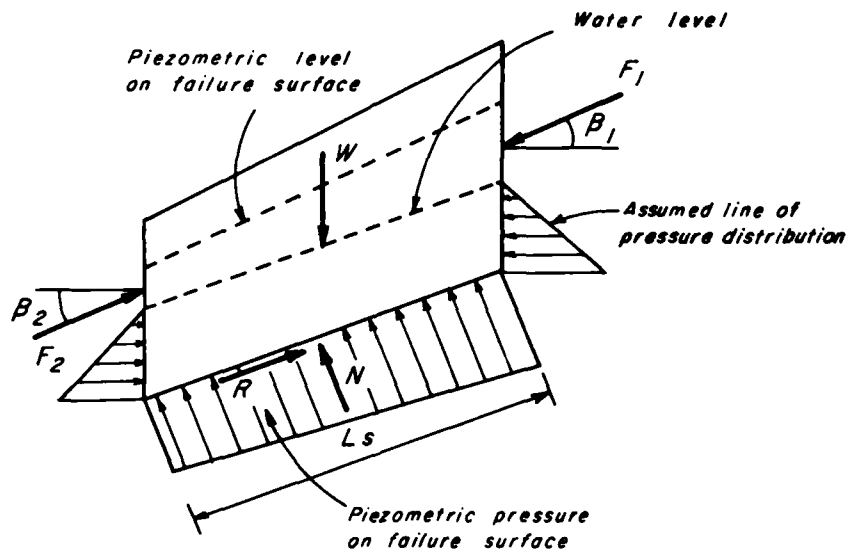
- $W$  = total weight of soil and water above the failure surface
- $N$  = effective reaction normal to the failure surface
- $R$  = shearing resistance of the soil
- $F_1, F_2$  = interelement forces between adjacent slices
- $\beta_1, \beta_2$  = inclination of the interelement forces from the normals to the slice faces.

**b) FORCES ON A TYPICAL SLICE OF THE SLIDE**

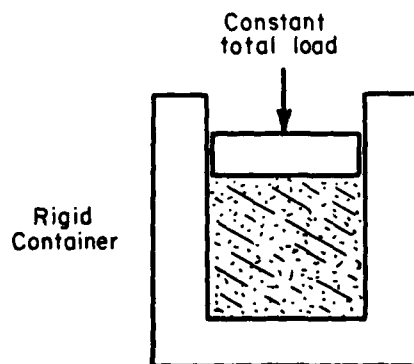
Figure F1. Idealization of vertical deformation with lateral restraint (uniaxial compression test)

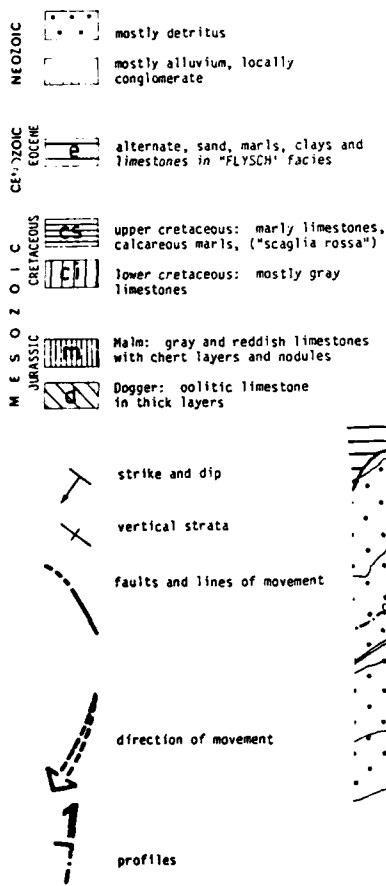
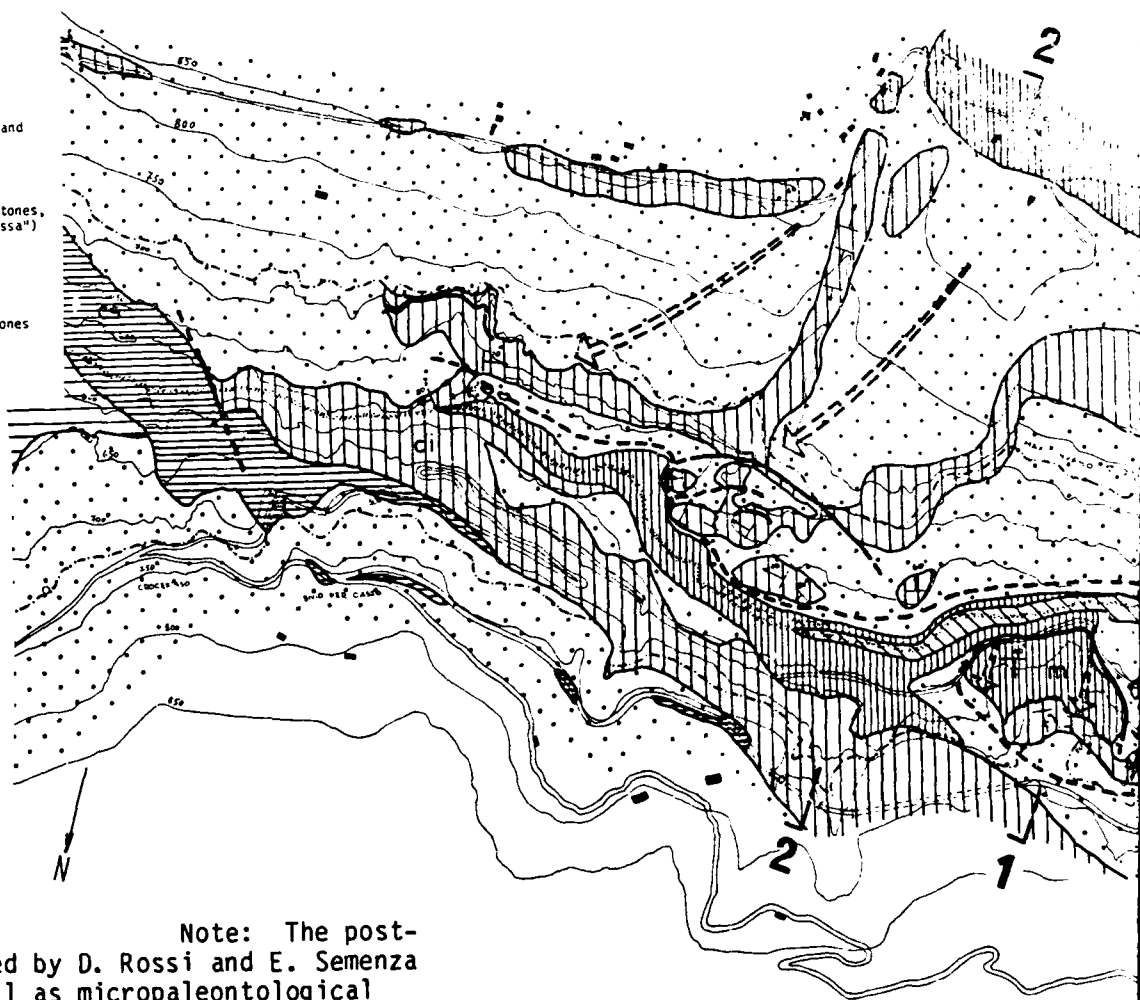
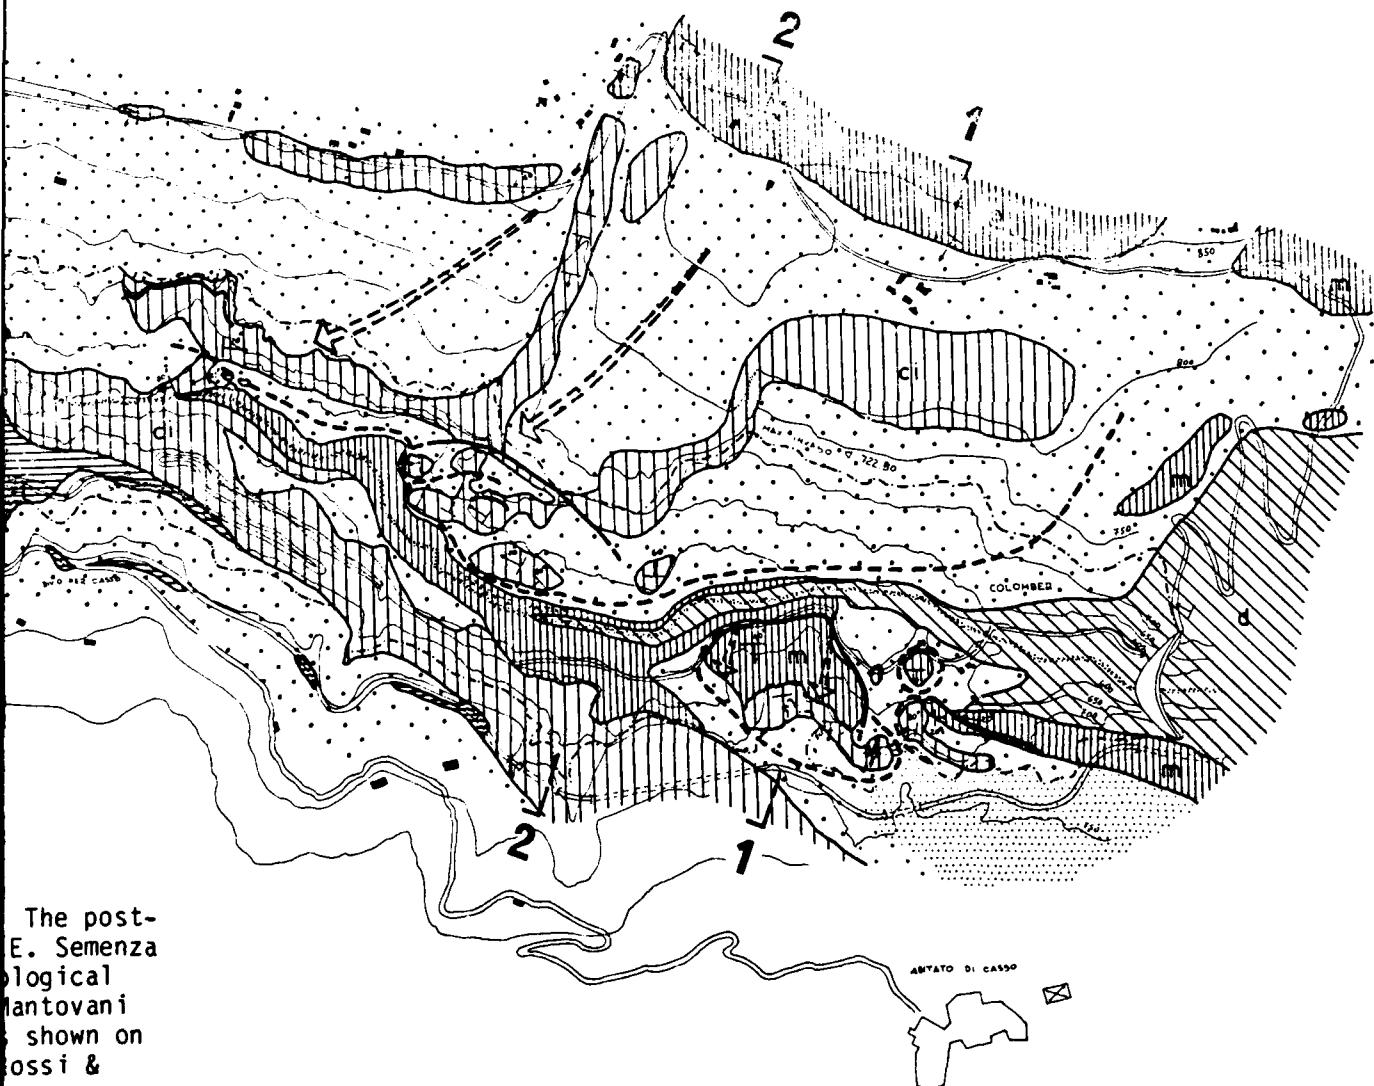
Note: The post-slide studies conducted by D. Rossi and E. Semenza (1963 to 1965), as well as micropaleontological studies by C. Broglio Loriga and M. G. Mantovani (1961 to 1965) proved that some outcrops shown on this map are erroneously dated (see D. Rossi & E. Semenza, 1965).

Figure G2. Geological map of the "Pian del Toc" zone taken from the "Geological Study of the Vaiont Reservoir" by F. Giudici and E. Semenza, 1960.

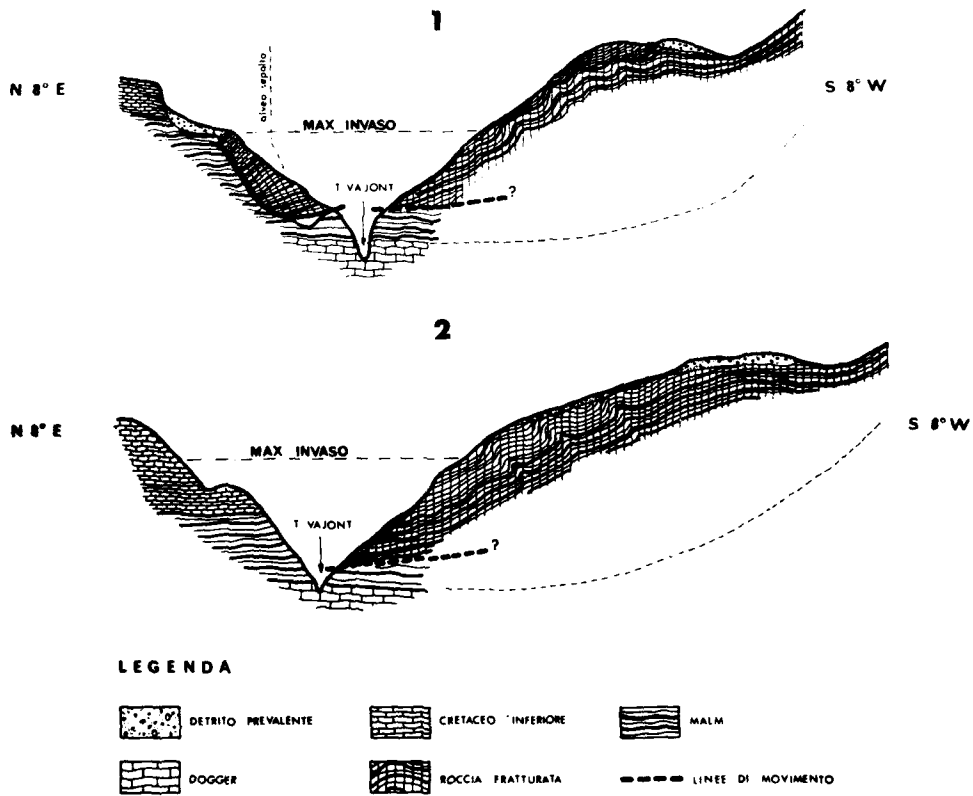
Figure G3. Geological profiles of the "Pian del Toc" zone, taken from the Geological Study of the Vaiont Reservoir" by F. Giudici and E. Semenza, 1960. (See note, Fig. G2)
