Movement of Tagged Dredged Sand at Thalweg Disposal Sites in the Upper Mississippi River

Volume 3:
Additional Results at Gordon's Ferry
and Whitney Island Sites

D. L. McCown and R. A. Paddock

April 1985

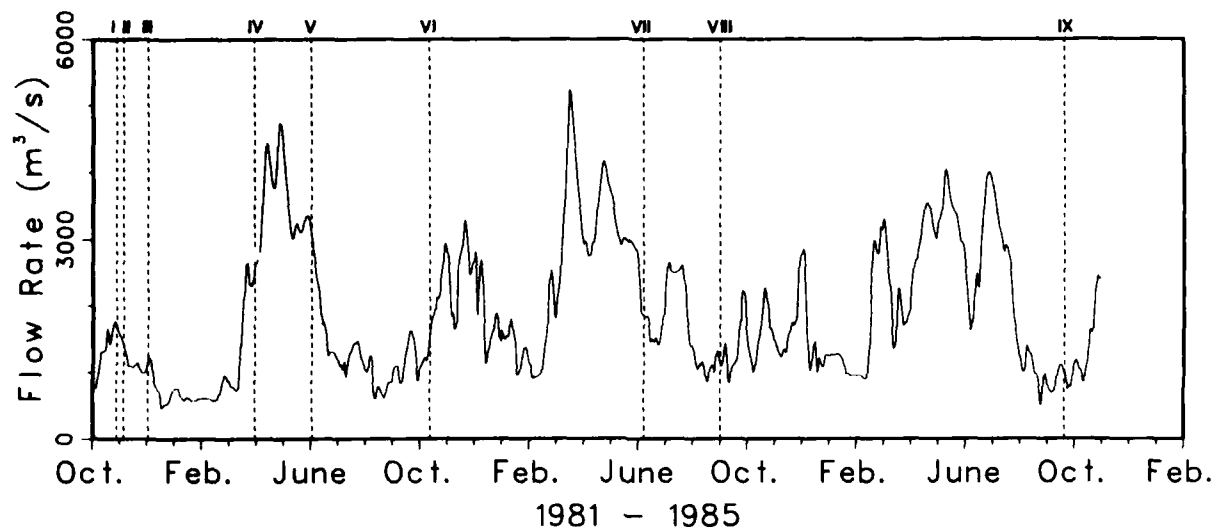
FIGURE 10 Mean Daily River Discharge for the Gordon's Ferry Site as Recorded at Lock and Dam 12, with the Dates of the Surveys Indicated

The disposal pile remained a distinct bathymetric feature until the first period of high flow after disposal (see Fig. 10) in the spring of 1982. Bathymetric measurements made after this spring flood showed that sand dunes were present in the disposal area, probably indicating a return to the bottom forms existing prior to disposal. However, it was not until after a second spring flood a year later (Survey VII) that significant downstream movement of the tagged sand was observed. Figure 14 shows the distribution of tagged sand at the Gordon's Ferry site immediately after disposal (Survey I) and

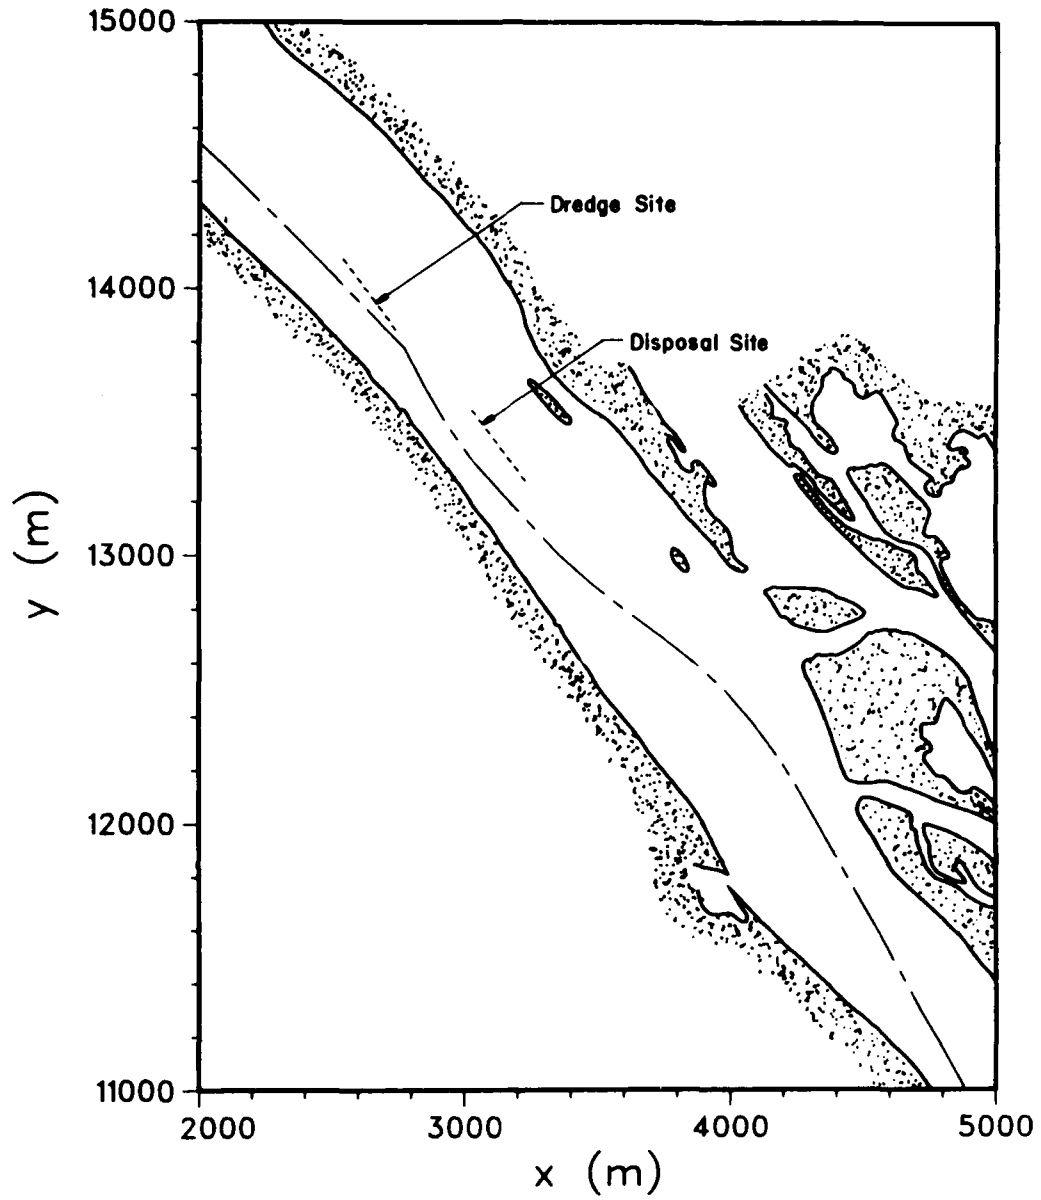
FIGURE 11 Map of Gordon's Ferry Site Showing Dredging and Disposal Areas

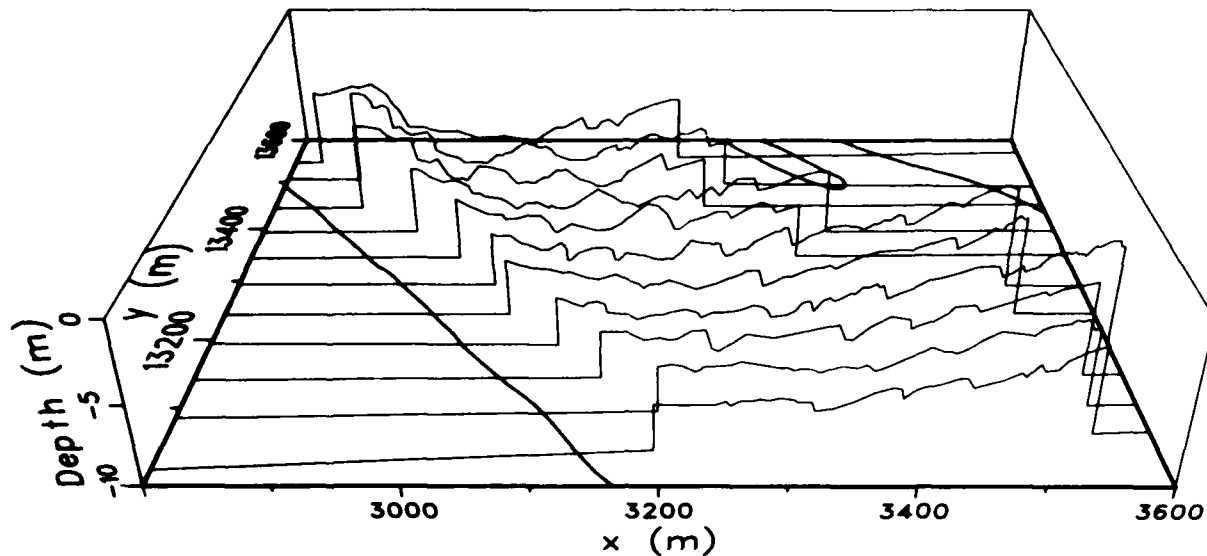
FIGURE 12 Perspective Plot of Bathymetric Transects for Survey I at the Gordon's Ferry Disposal Site

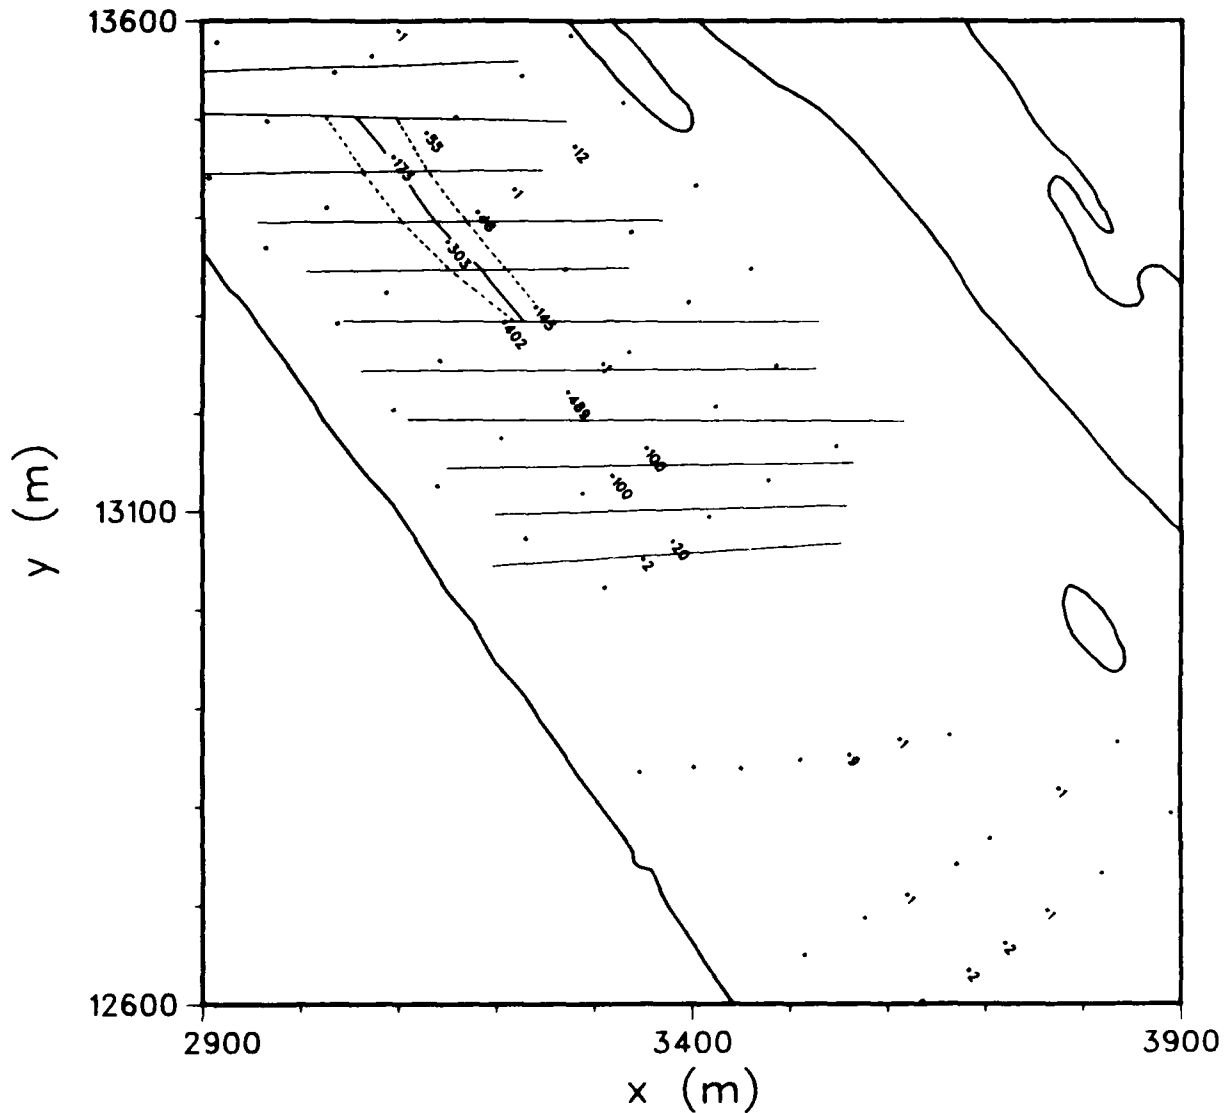
FIGURE 13 Location of Bathymetric Transects and Bottom Sampling Stations for Survey I at the Gordon's Ferry Disposal Site (location of the pile and the number of dyed sand grains observed are noted)

Figure 13 shows the bottom sampling locations for the first survey, the number of dyed sand grains observed on the surface of the sample tray at each location, the paths of the bathymetric transects, and the location of the peak and the lateral extent of the disposal pile as determined from the bathymetric survey. An area yielding samples with significant counts of dyed sand (>3) extended about 500 m downstream of where the physical pile appeared on the bathymetric transects.

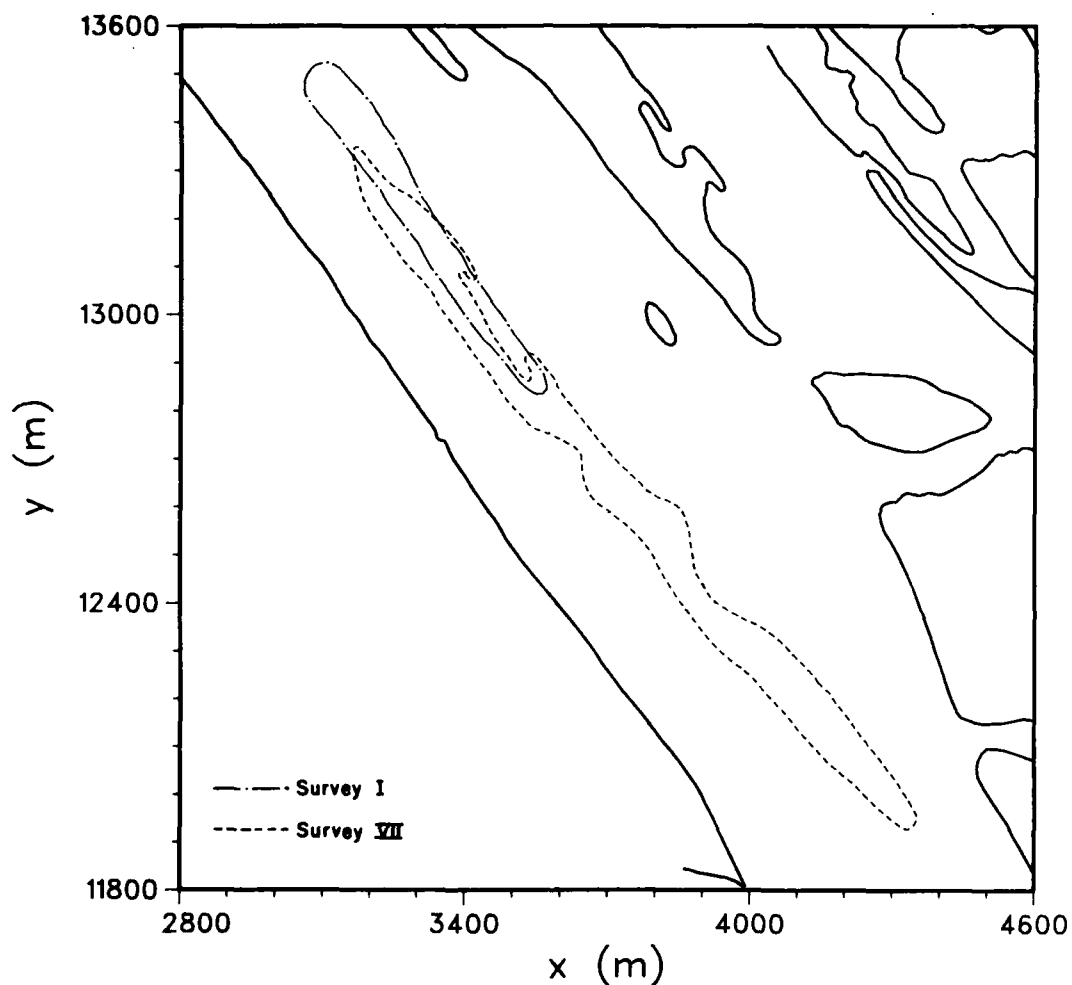
FIGURE 14 *Distribution of Tagged Sand after Disposal (Survey I) and after the Second Spring Flood (Survey VII) at the Gordon's Ferry Disposal Site*

after the second spring flood (Survey VII). The contour chosen as delineating the extent of the tagged sand was the contour that enclosed all sampling locations where three or more dyed sand grains were found on the surface of the sample tray. This choice was based on statistical arguments discussed in ANL/EES-TM-270, Vol. 1.¹ Even after the second spring flood, during which tagged sand had moved downstream, no evidence was found of migration of tagged sand out of the thalweg into main-channel borders, backwaters, or sloughs.

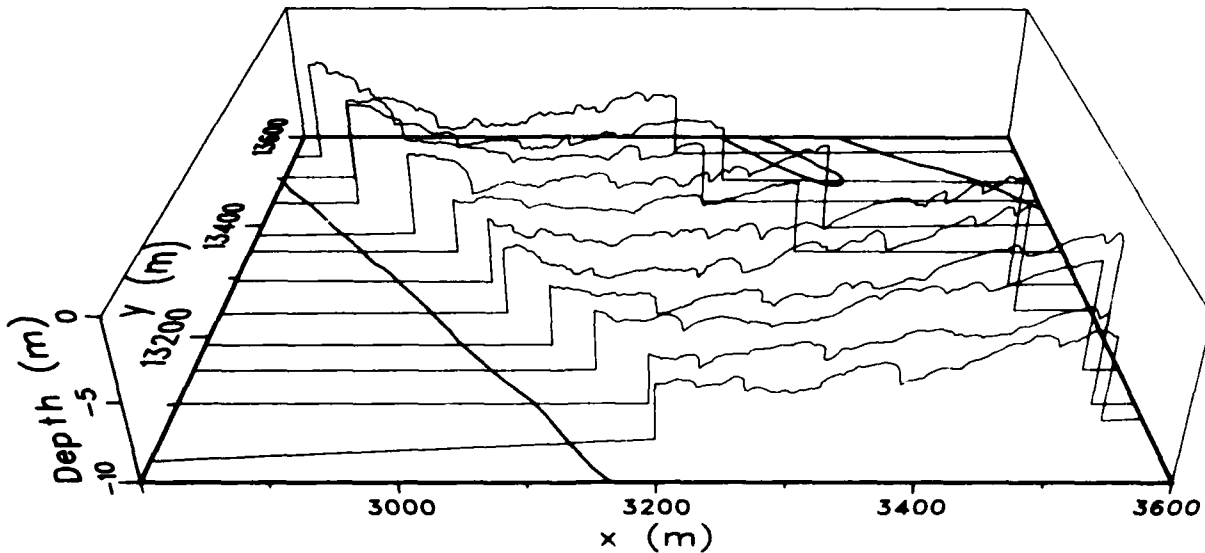
FIGURE 15 Perspective Plot of Transverse Bathymetric Transects for Survey VIII at the Gordon's Ferry Disposal Site

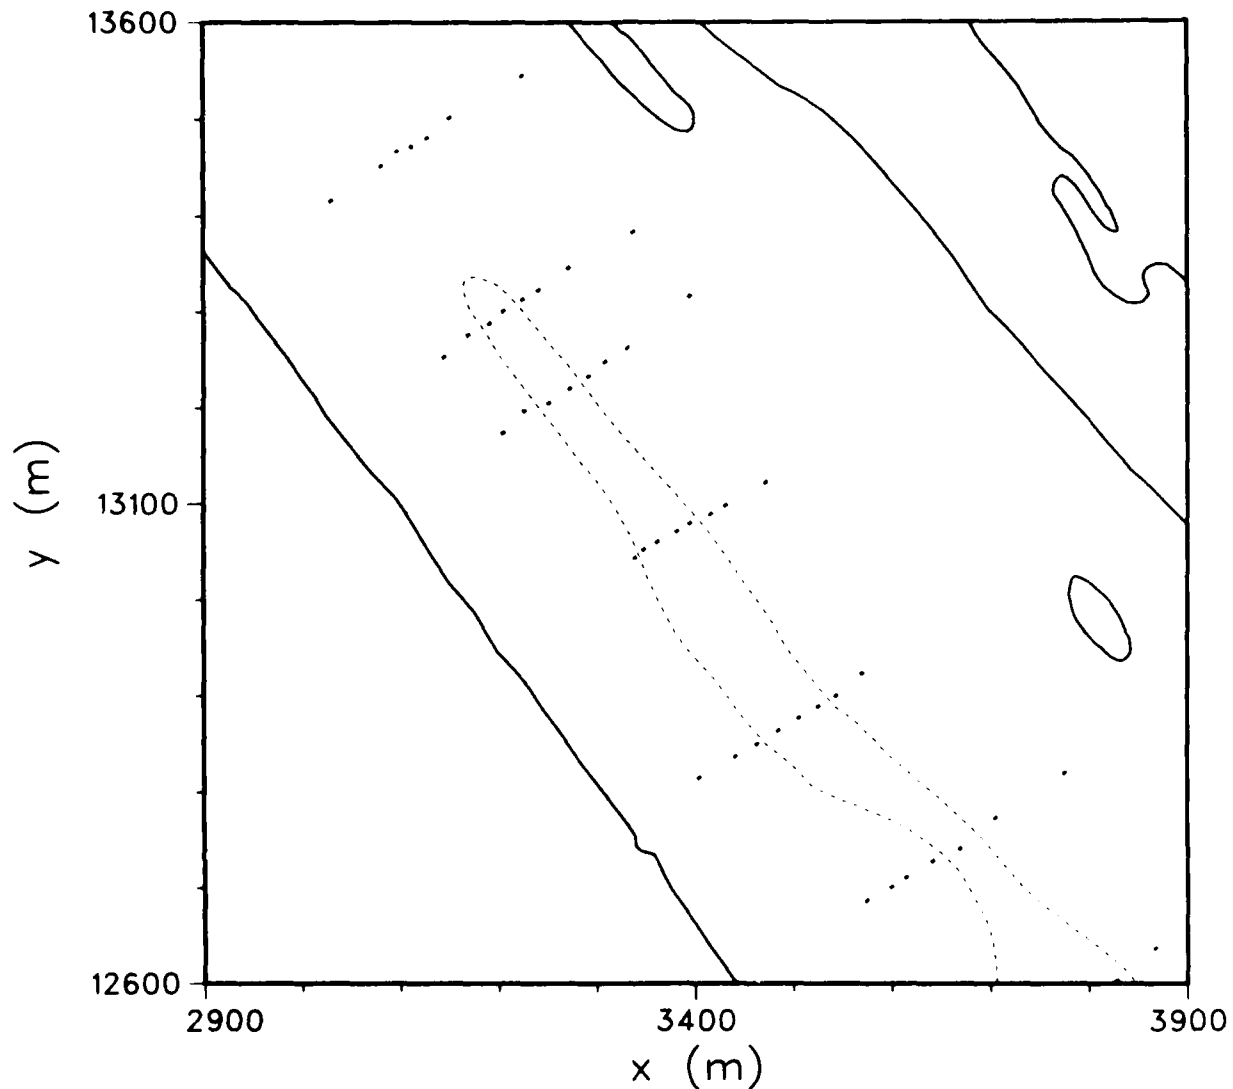
FIGURE 16 Sampling Locations and the Three-Dyed-Sand-Grain Contour for Survey VIII at the Gordon's Ferry Disposal Site

The bottom sampling locations and the three-dyed-sand-grain contour for Survey VIII are shown in Figs. 16 and 17. The contour is not complete near the downstream end because of the abbreviated nature of this survey. Little change had occurred since the previous survey, except that the contour does not appear to be quite as wide, especially near the upstream end. This narrowing may be related to a brief period of higher-than-average flow that occurred in July 1983 (see Fig. 10). The complete results from the

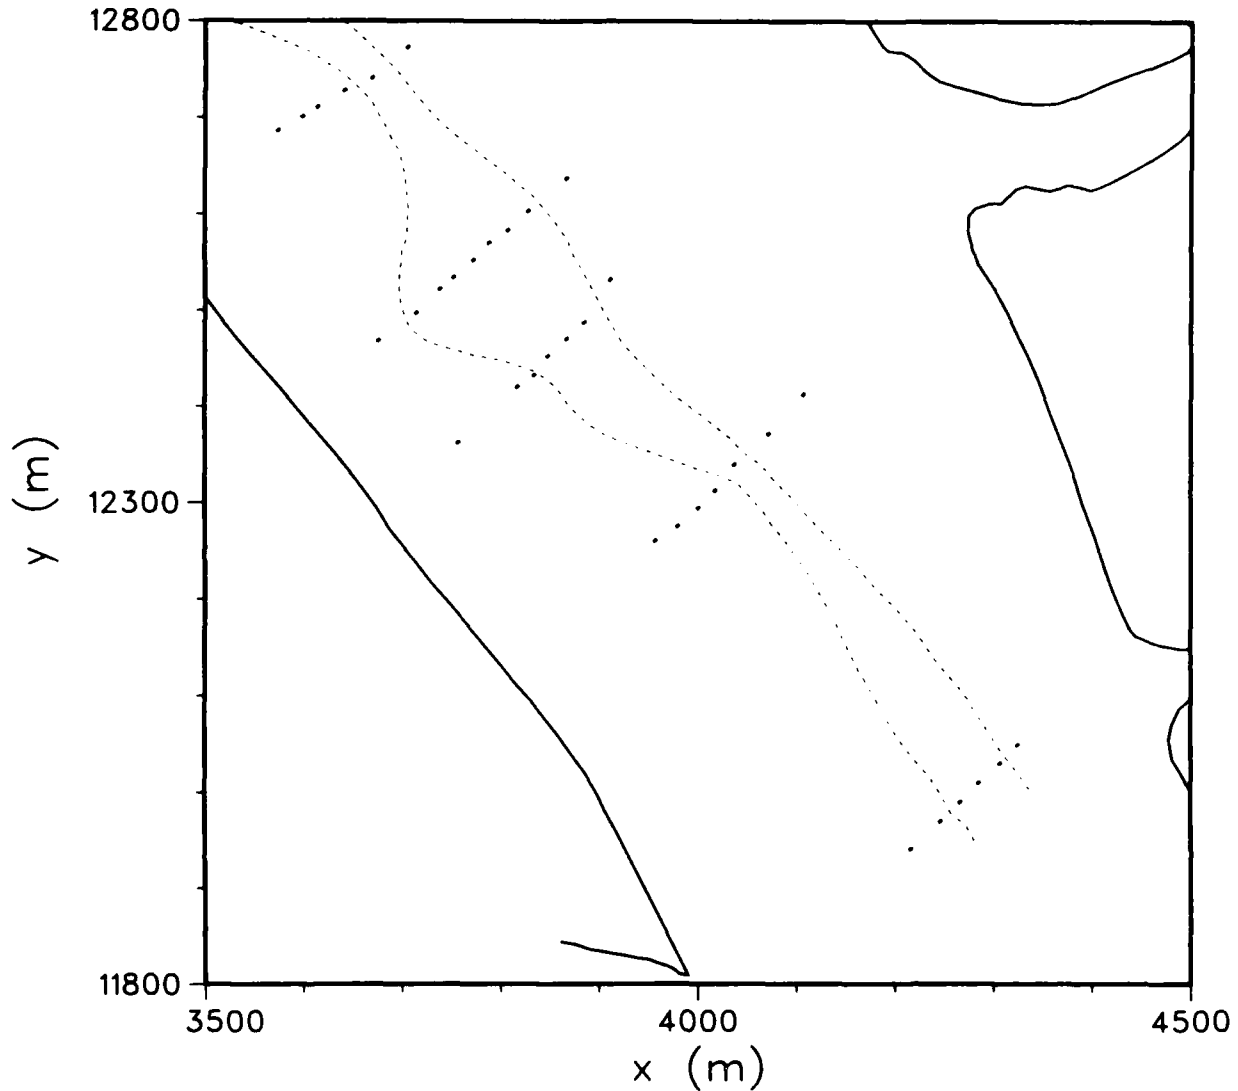
FIGURE 17 Sampling Locations and the Three-Dyed-Sand-Grain Contour for Survey VIII Downstream of the Gordon's Ferry Disposal Site

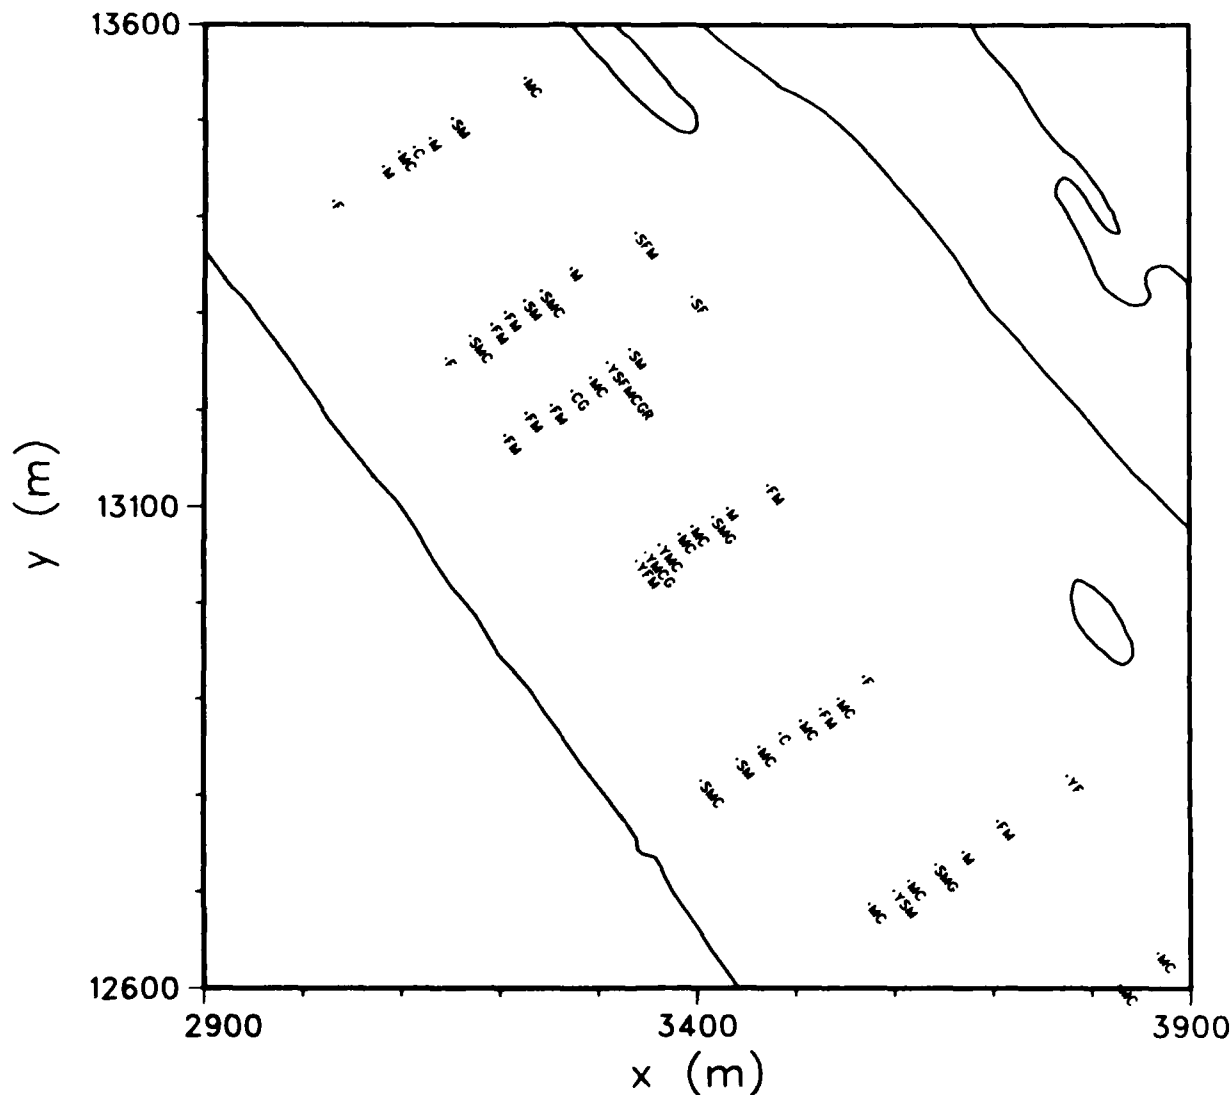
FIGURE 18 Approximate Classification of Bottom Sediments at Sampling Locations for Survey VIII at the Gordon's Ferry Disposal Site

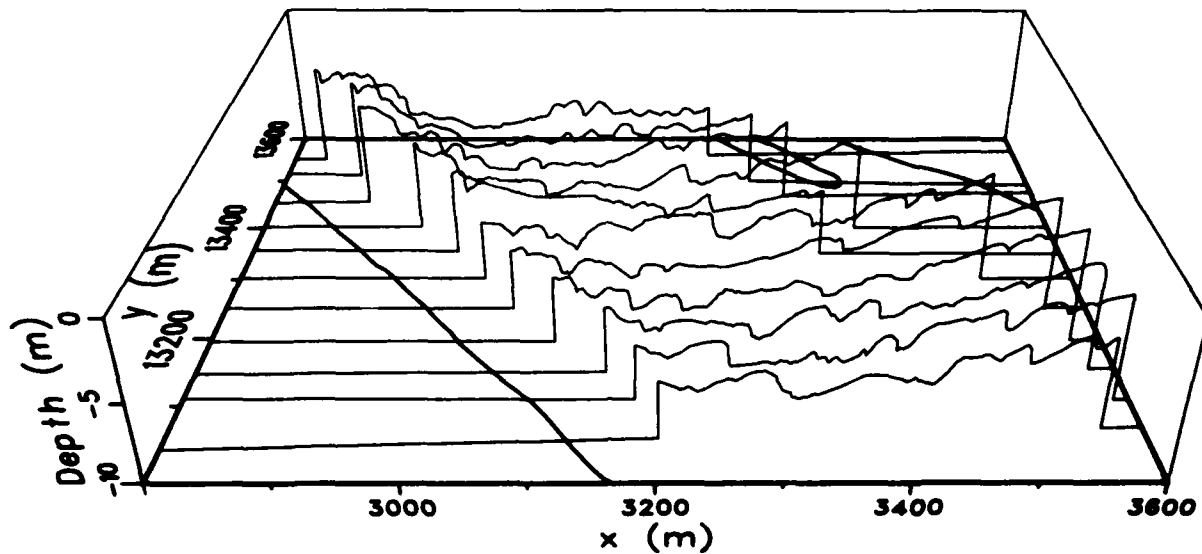
FIGURE 19 Perspective Plot of Transverse Bathymetric Transects for Survey IX at the Gordon's Ferry Disposal Site

Survey IX was conducted September 18-20, 1984, 1057 days and three spring floods after disposal. No further surveys are planned at the Gordon's Ferry site. The results of the bathymetric survey are shown in Fig. 19, and the individual transects are included in Sec. A.1 of App. A. No significant change in the bottom was apparent since the previous survey; the longitudinal transects exhibited the same wavelike structure that had been apparent on previous surveys.

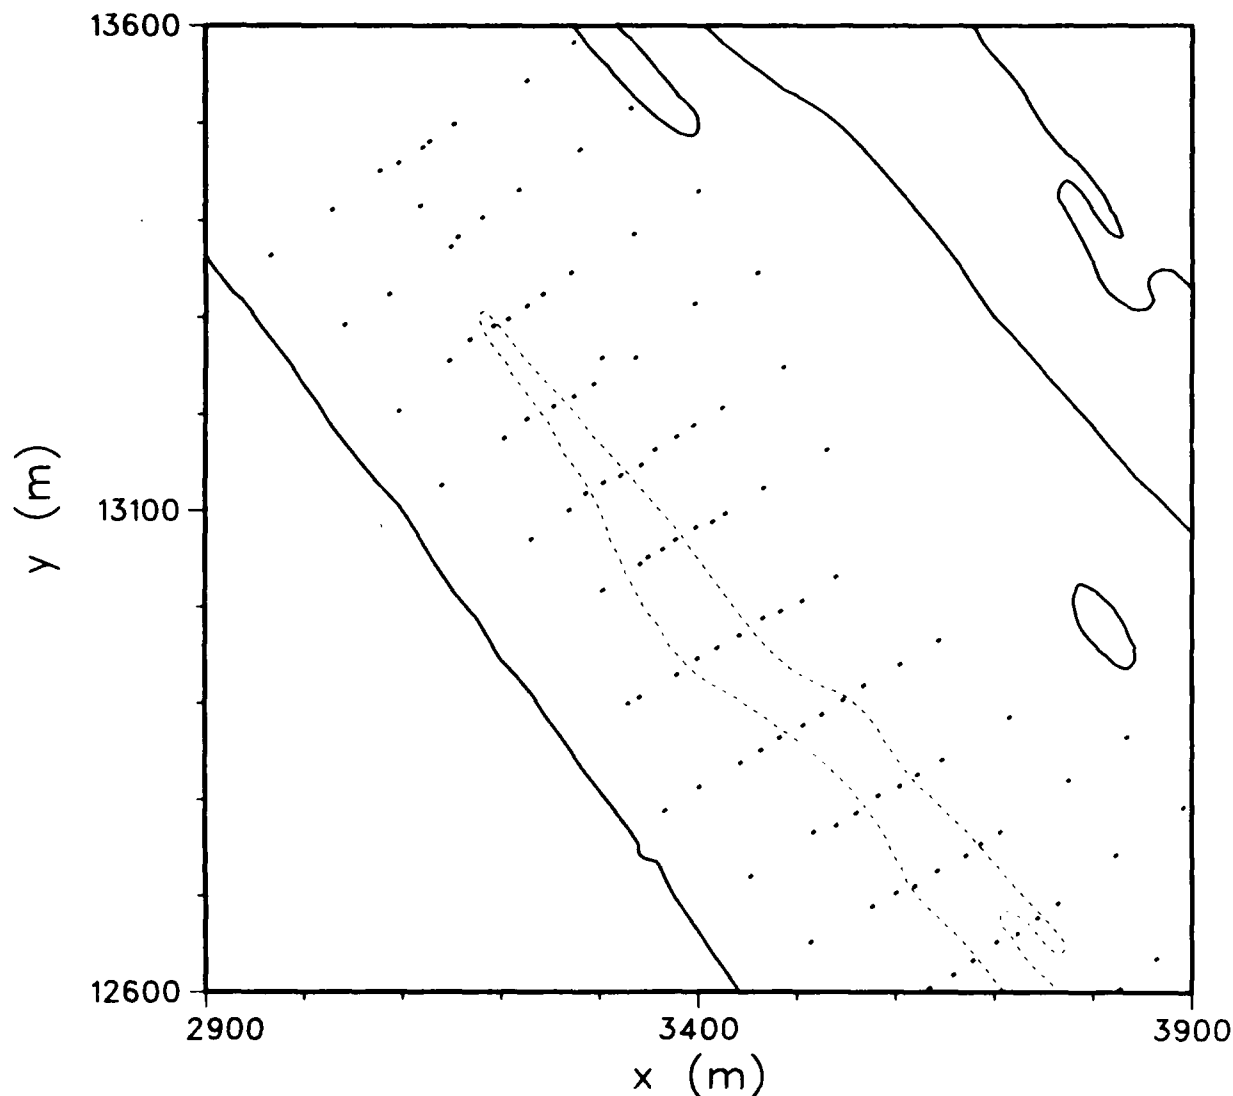
FIGURE 20 Sampling Locations and the Three-Dyed-Sand-Grain Contour for Survey IX at the Gordon's Ferry Disposal Site

Figures 20 and 21 are plots of the bottom sampling locations, with the three-dyed-sand-grain contour drawn. The area enclosed by the contour is about 30% less than it was on Survey VII due to the narrowing of the contour at the upstream end. The length of the contour was essentially unchanged since Survey VII. Complete results of the bottom sampling are given in Sec. A.2 of App. A. No dyed sand was noted in Stone Slough.

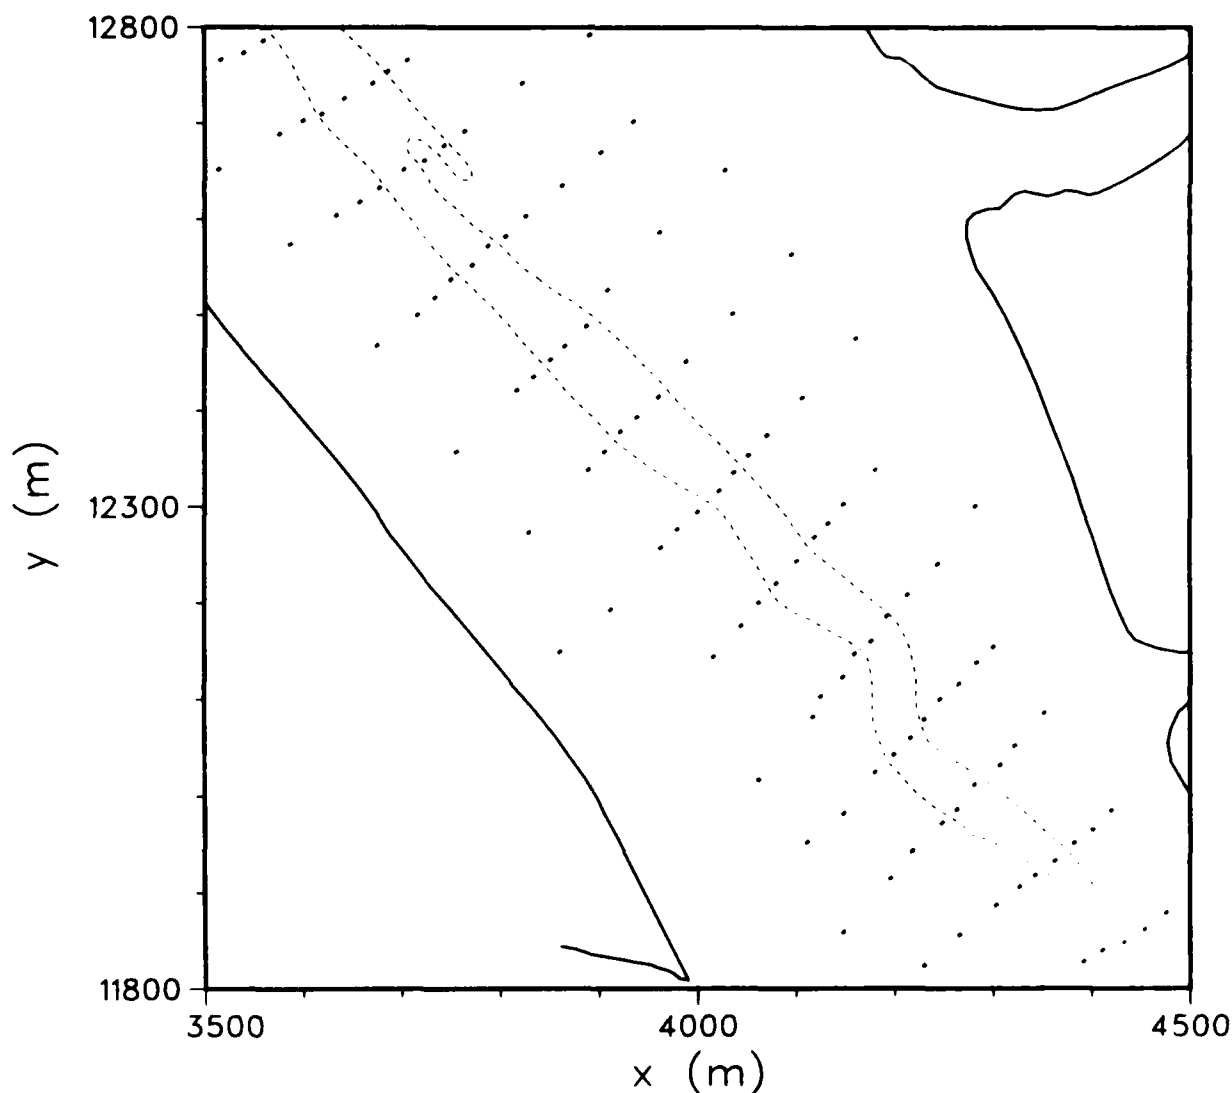
FIGURE 21 Sampling Locations and the Three-Dyed-Sand-Grain Contour for Survey IX Downstream of the Gordon's Ferry Disposal Site

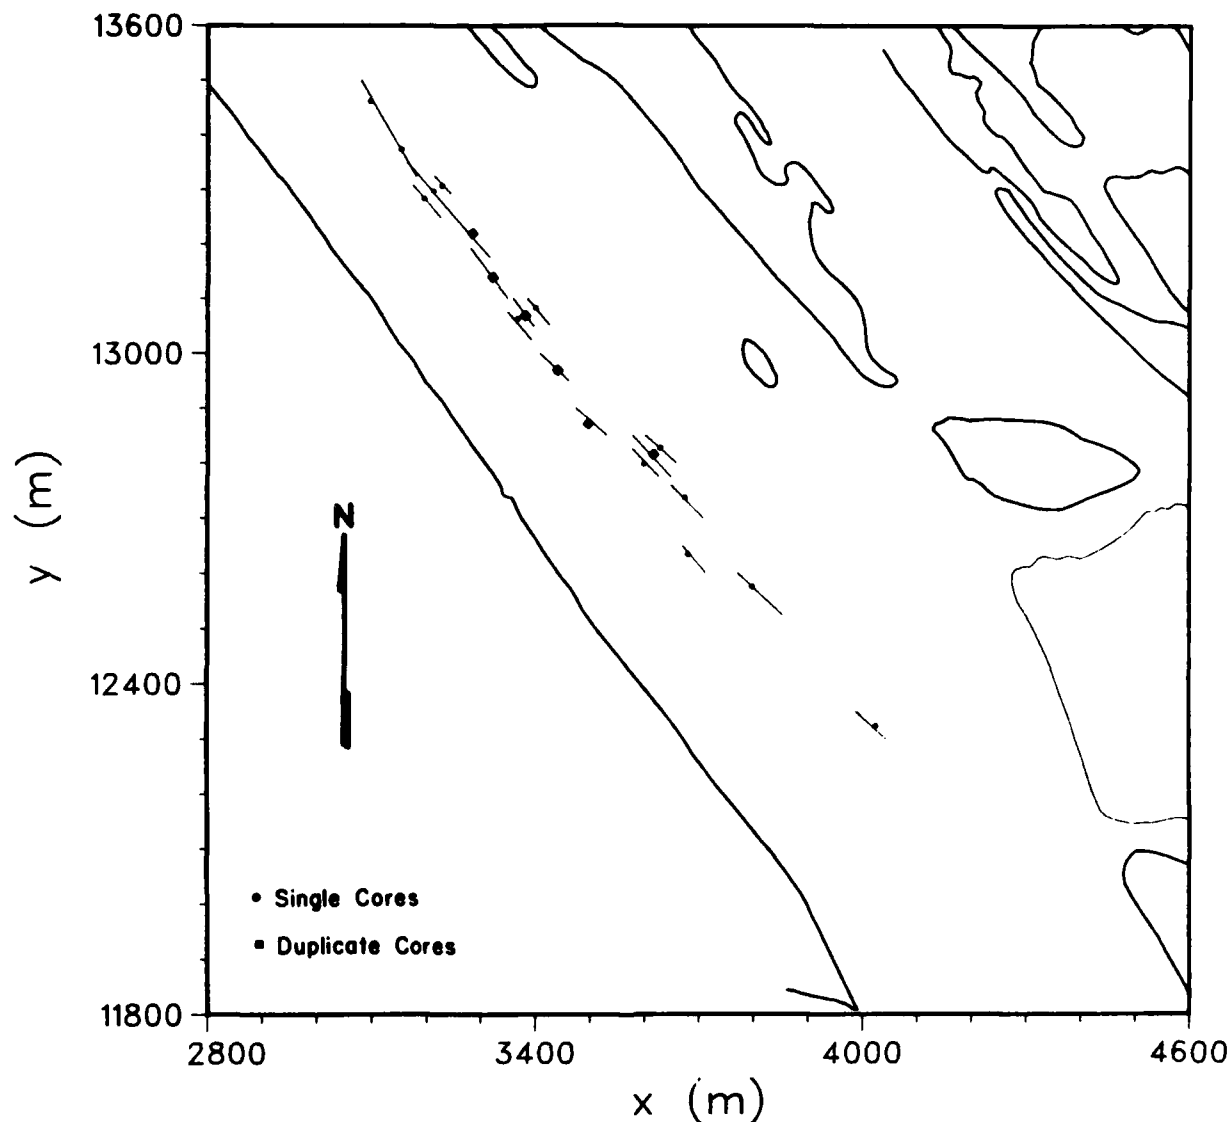
FIGURE 23 Map of Gordon's Ferry Site Showing Coring Locations and Bathymetric Transects

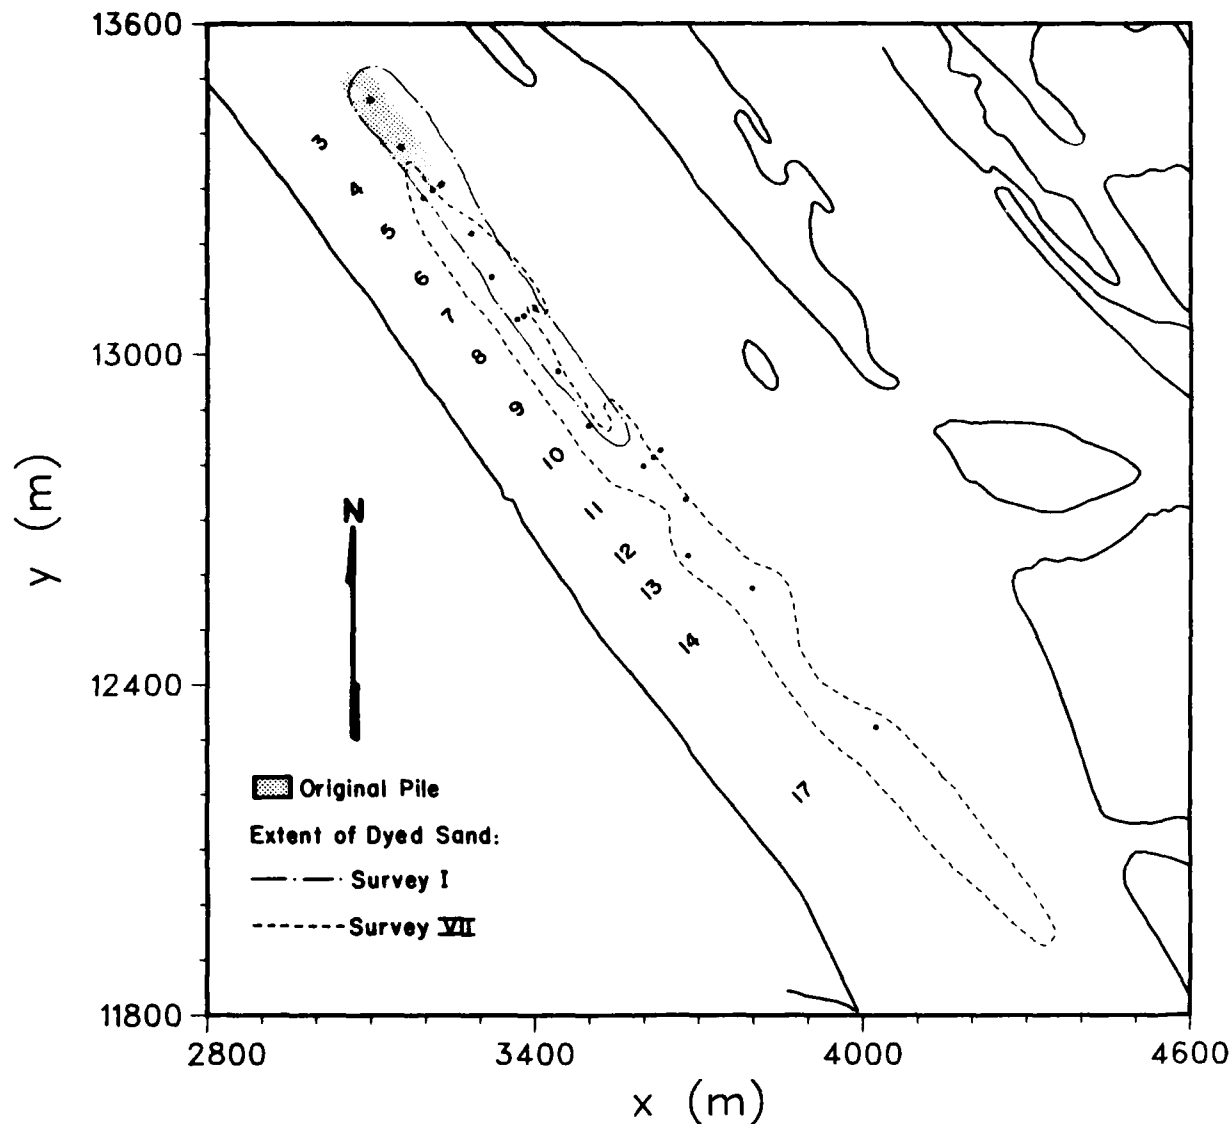
FIGURE 24 Map of Gordon's Ferry Site Showing the Coring Locations, the Original Disposal Pile, and the Three-Dyed-Sand-Grain Contours from Surveys I and VII

As shown in Fig. 24, the primary coring locations lie along the approximate centerline of the area enclosed by the three-dyed-sand-grain contour (i.e., area of highest counts of dyed sand grains). The cores are designated by Arabic numerals that correspond to the designations of the sampling transects for the bottom sampling surveys. The secondary locations to either side of the approximate centerline locations are designated either NE or SW according to whether they are northeast or southwest of the centerline. For example, core 5NE is located about 20 m northeast of core 5 along transect 5. If two cores were collected at the same location, they are designated by an A or B after the core location number. All duplicate cores were collected at the centerline locations.

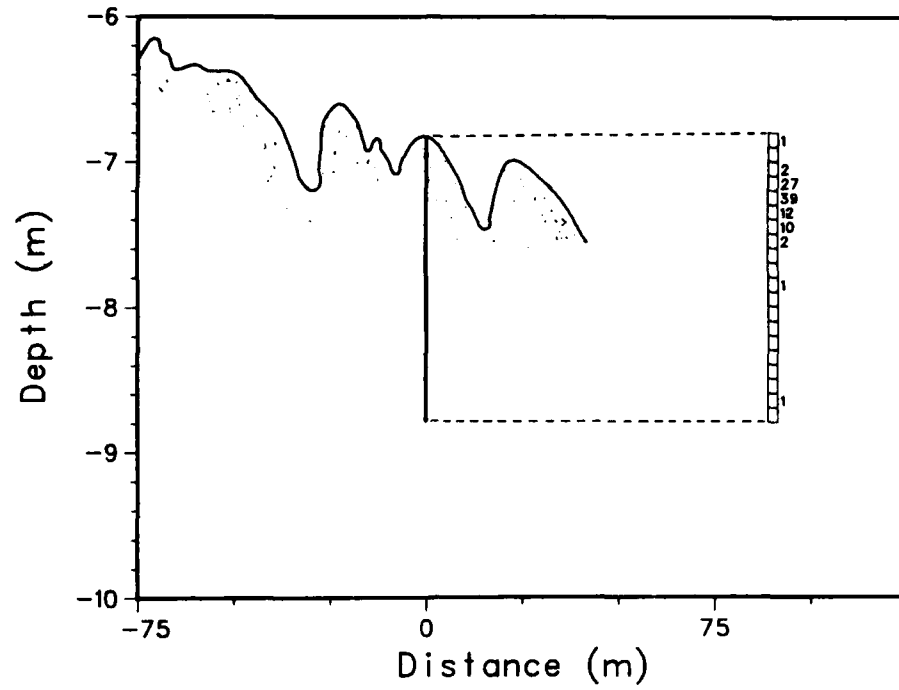
FIGURE 25 Plot Showing Distribution of Dyed Sand in Core 3 and Core Position Relative to Bottom Topography

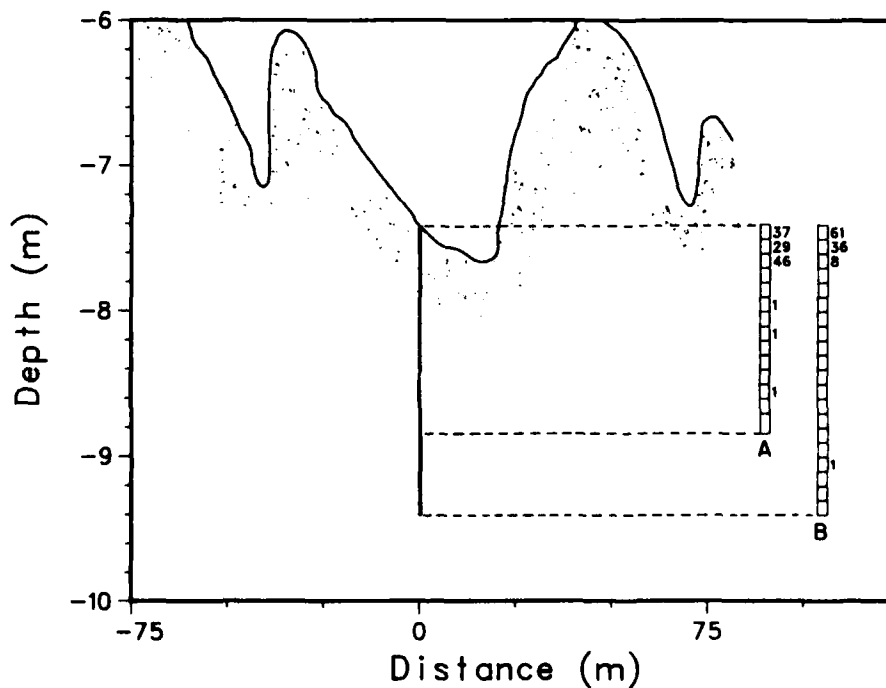
FIGURE 30 Plot Showing Distribution of Dyed Sand in Cores 6A and 6B and Core Position Relative to Bottom Topography

in a core, its vertical extent approximately corresponded to the height of the dune above nearby troughs. Four cores (6A, 6B, 8NE, and 12) collected near a trough contained dyed sand to depths of 30, 30, 40, and 30 cm, respectively. (Core 12 was actually about midway from the trough to the crest, but the dune was small.) The remaining cores were collected at or near dune crests; all contained dyed sand to at least a depth of 70 cm. With the exception of cores collected in troughs, dyed sand was found in all cores taken in locations where dyed sand was found in the surficial bottom sediments.

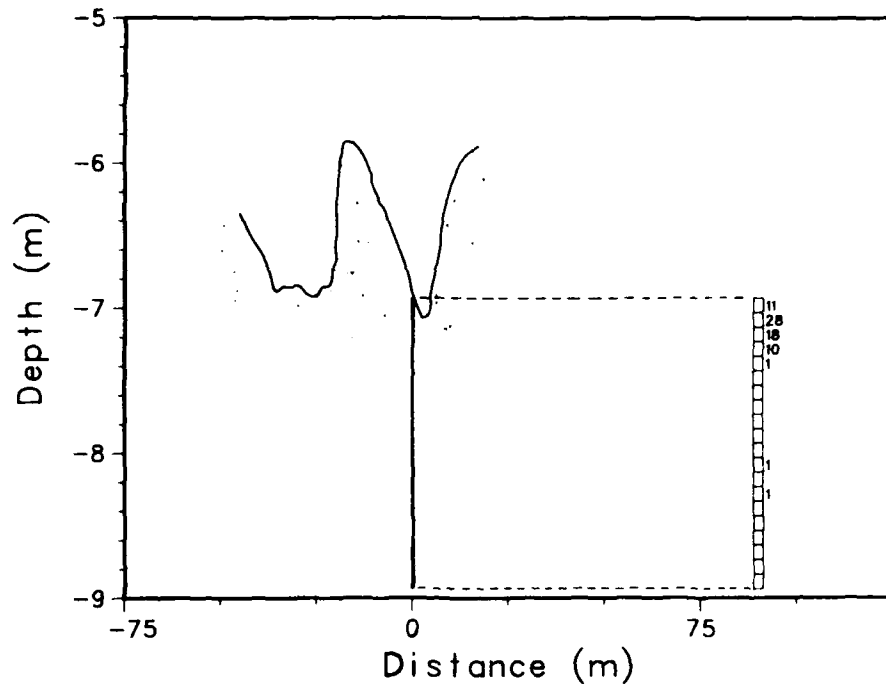
FIGURE 33 Plot Showing Distribution of Dyed Sand in Core 8NE and Core Position Relative to Bottom Topography

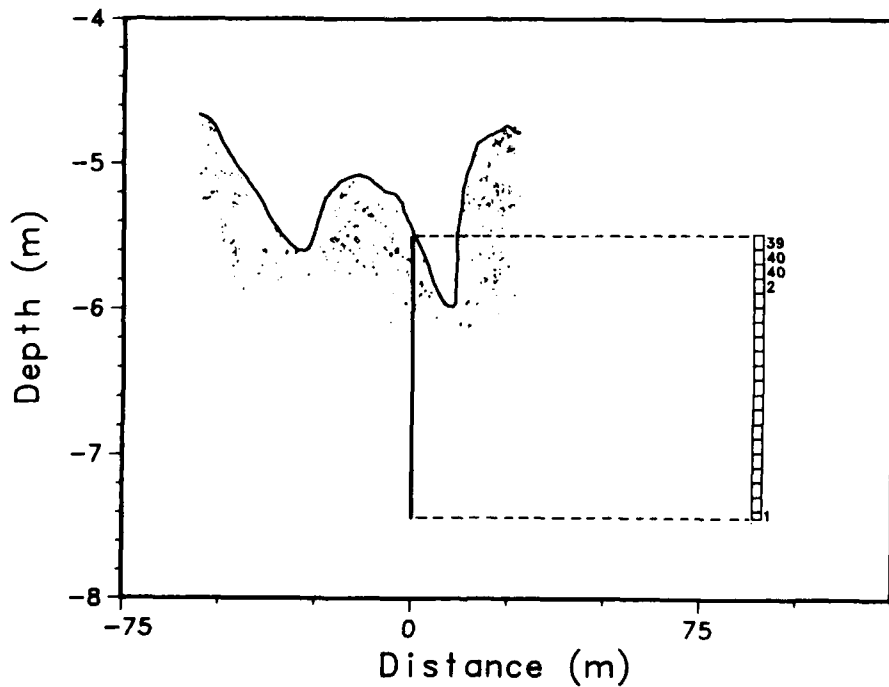
FIGURE 40 Plot Showing Distribution of Dyed Sand in Core 12 and Core Position Relative to Bottom Topography

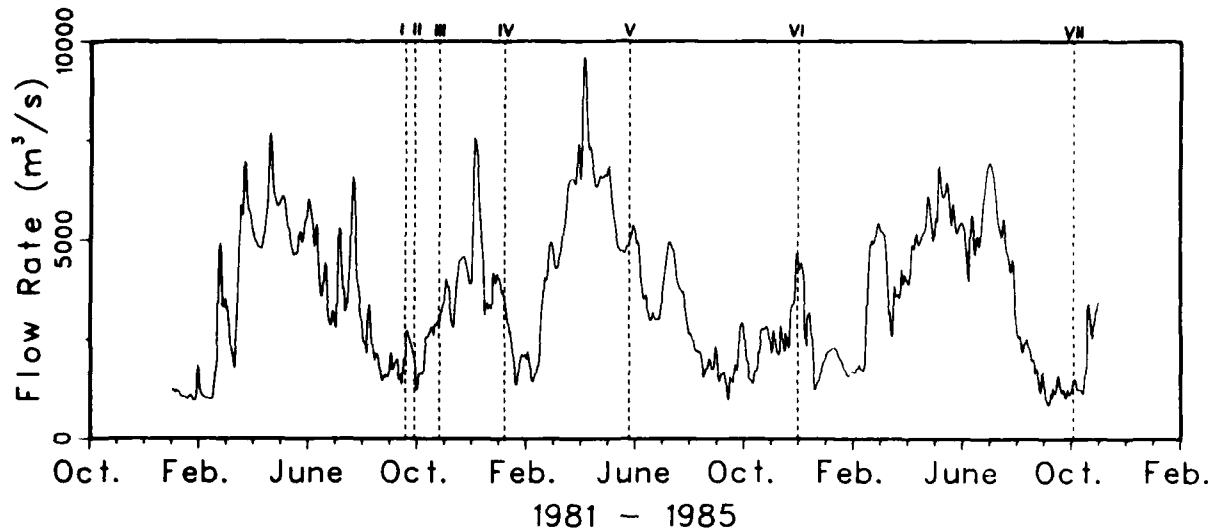
FIGURE 44 Mean Daily River Discharge for the Whitney Island Site as Recorded at Lock and Dam 22, with the Dates of the Surveys Indicated

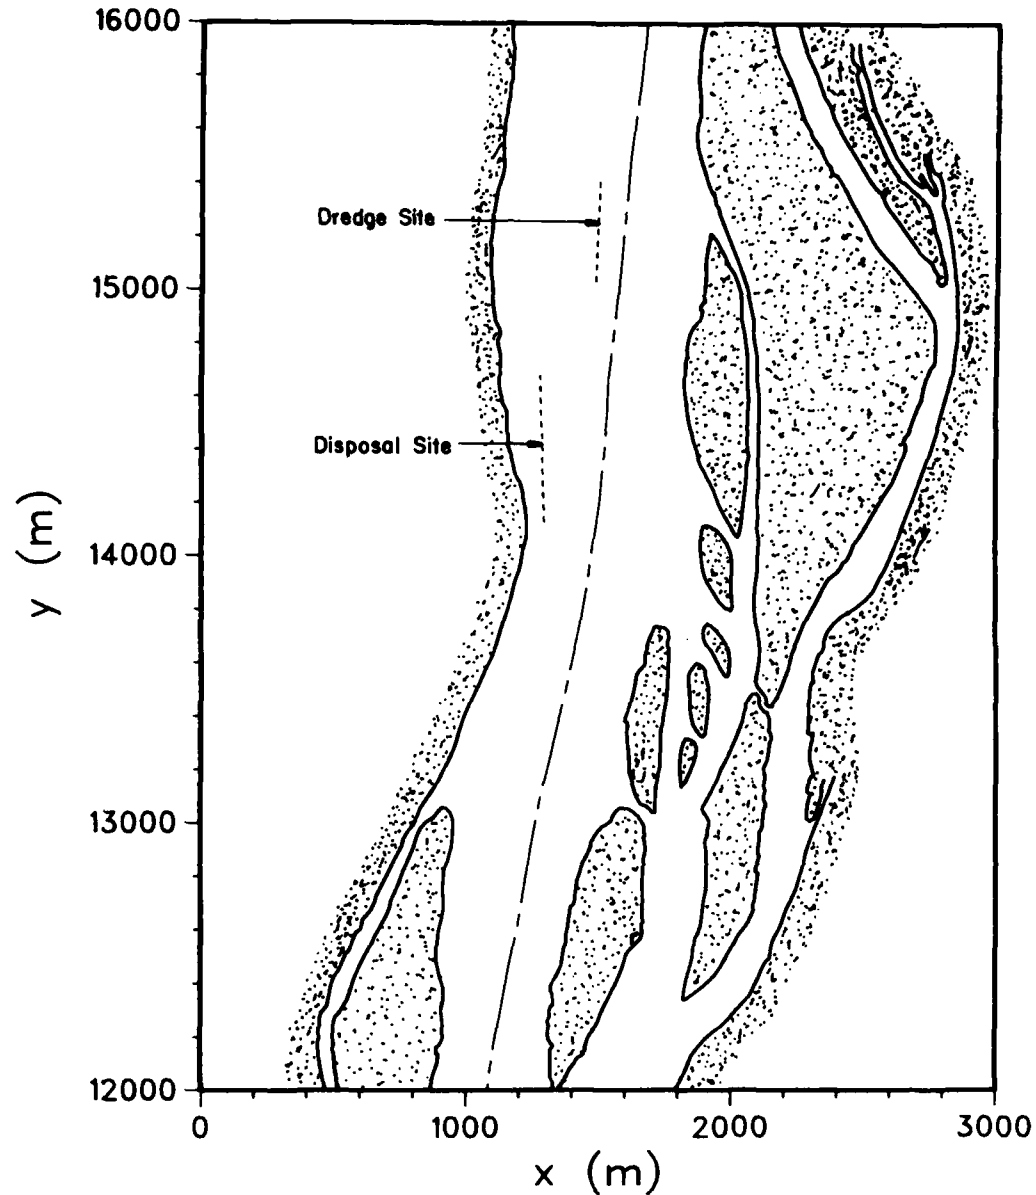
FIGURE 45 Map of Whitney Island Site Showing Dredging and Disposal Areas

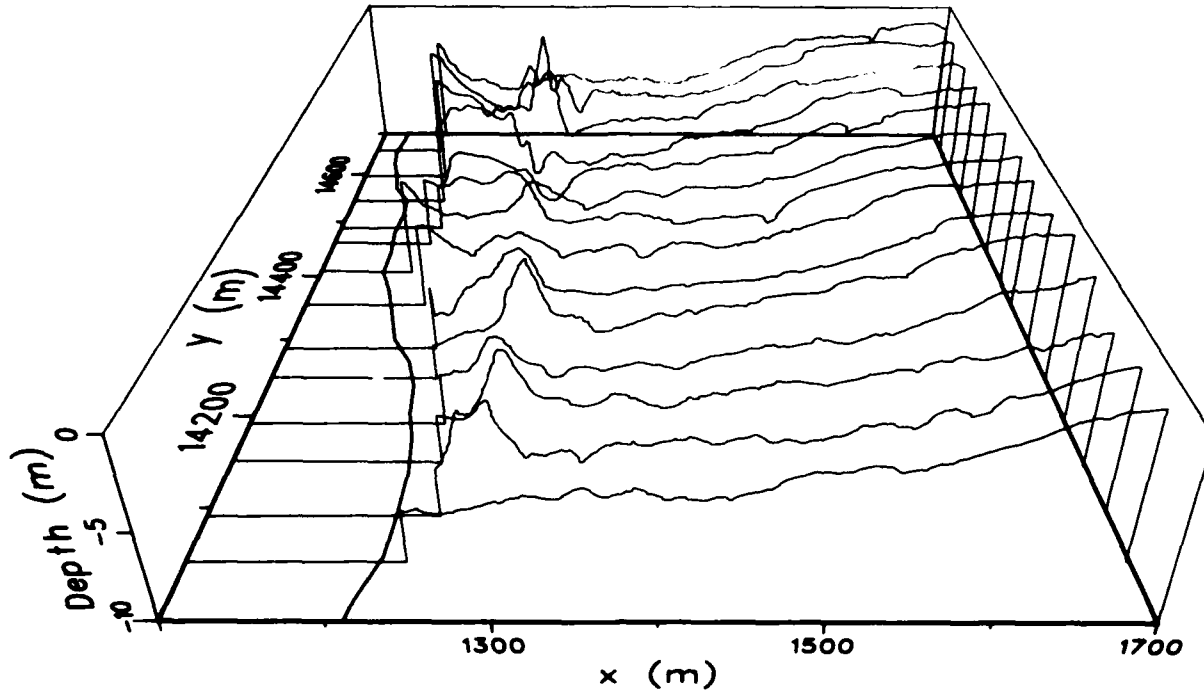
FIGURE 46 Perspective Plot of Transverse Bathymetric Transects for Survey I at the Whitney Island Disposal Site
