Movement of Tagged Dredged Sand at Thalweg Disposal Sites in the Upper Mississippi River

Volume 3:
Additional Results at Gordon's Ferry
and Whitney Island Sites

D. L. McCown and R. A. Paddock

April 1985

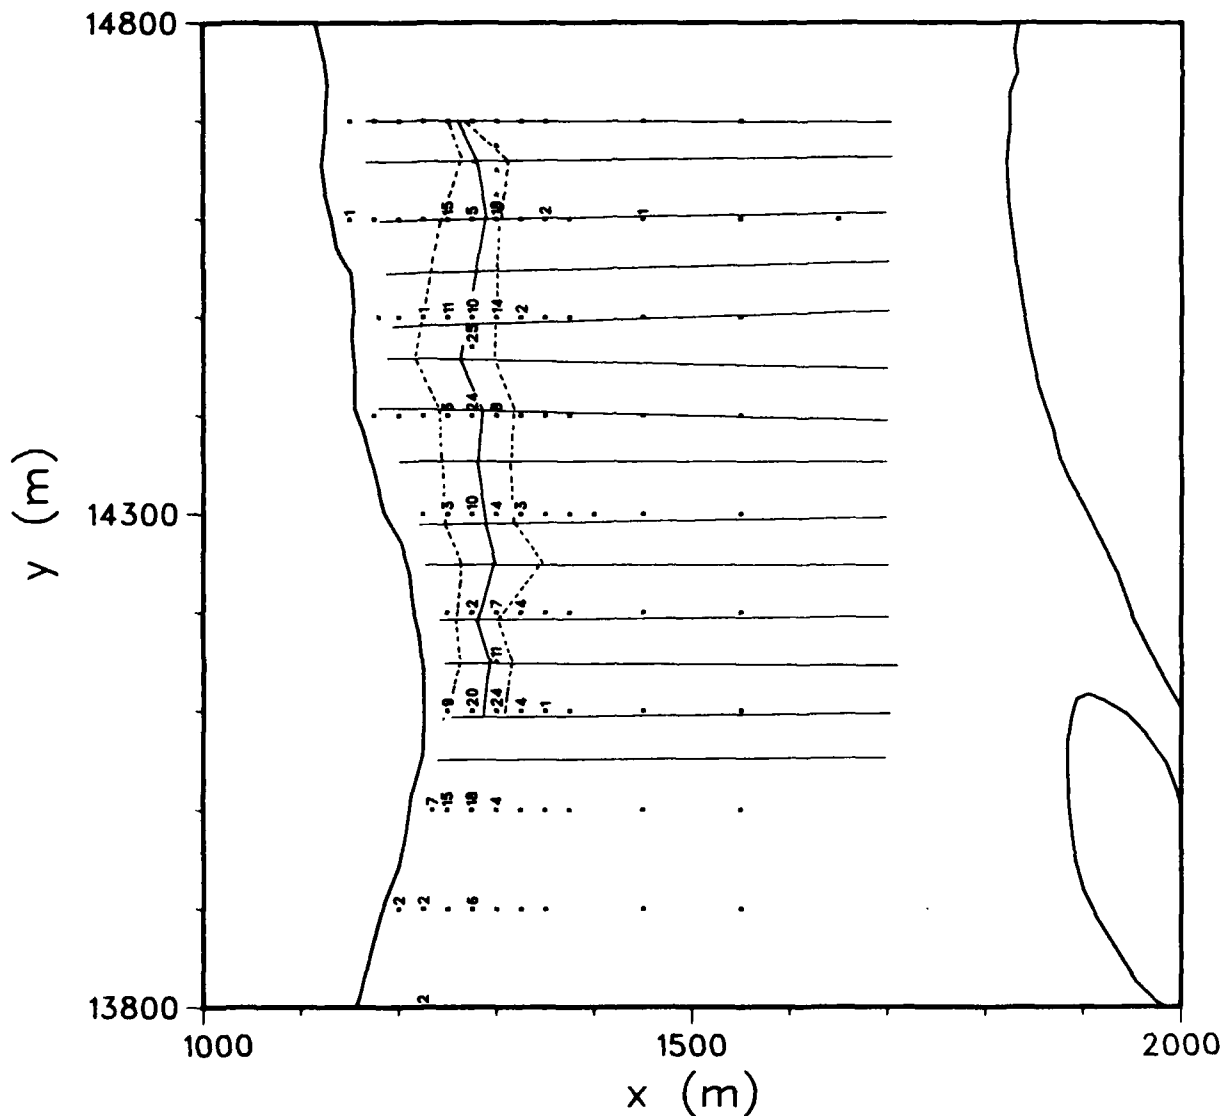
FIGURE 47 Location of Bathymetric Transects and Bottom Sampling Stations for Survey I at the Whitney Island Disposal Site (extent of the pile and number of dyed sand grains observed are also noted)

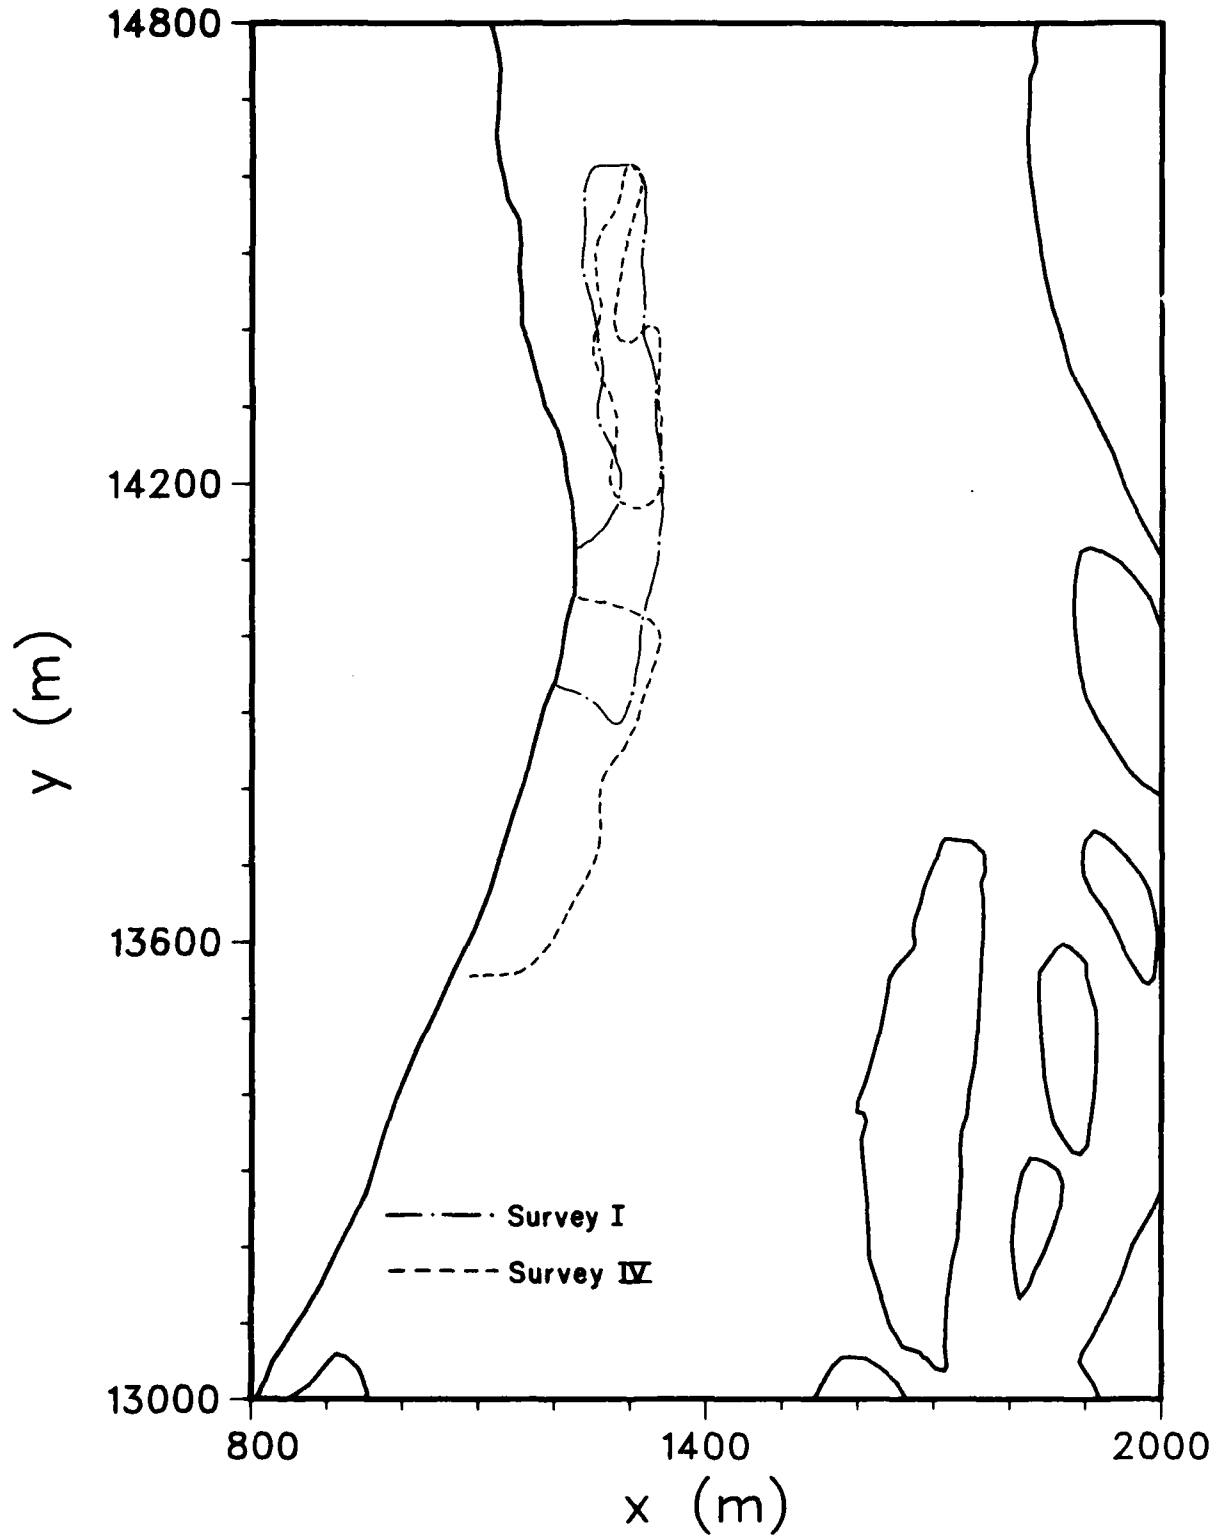
FIGURE 48 Distribution of Tagged Sand after Disposal and after the December 1982 Flood at the Whitney Island Disposal Site

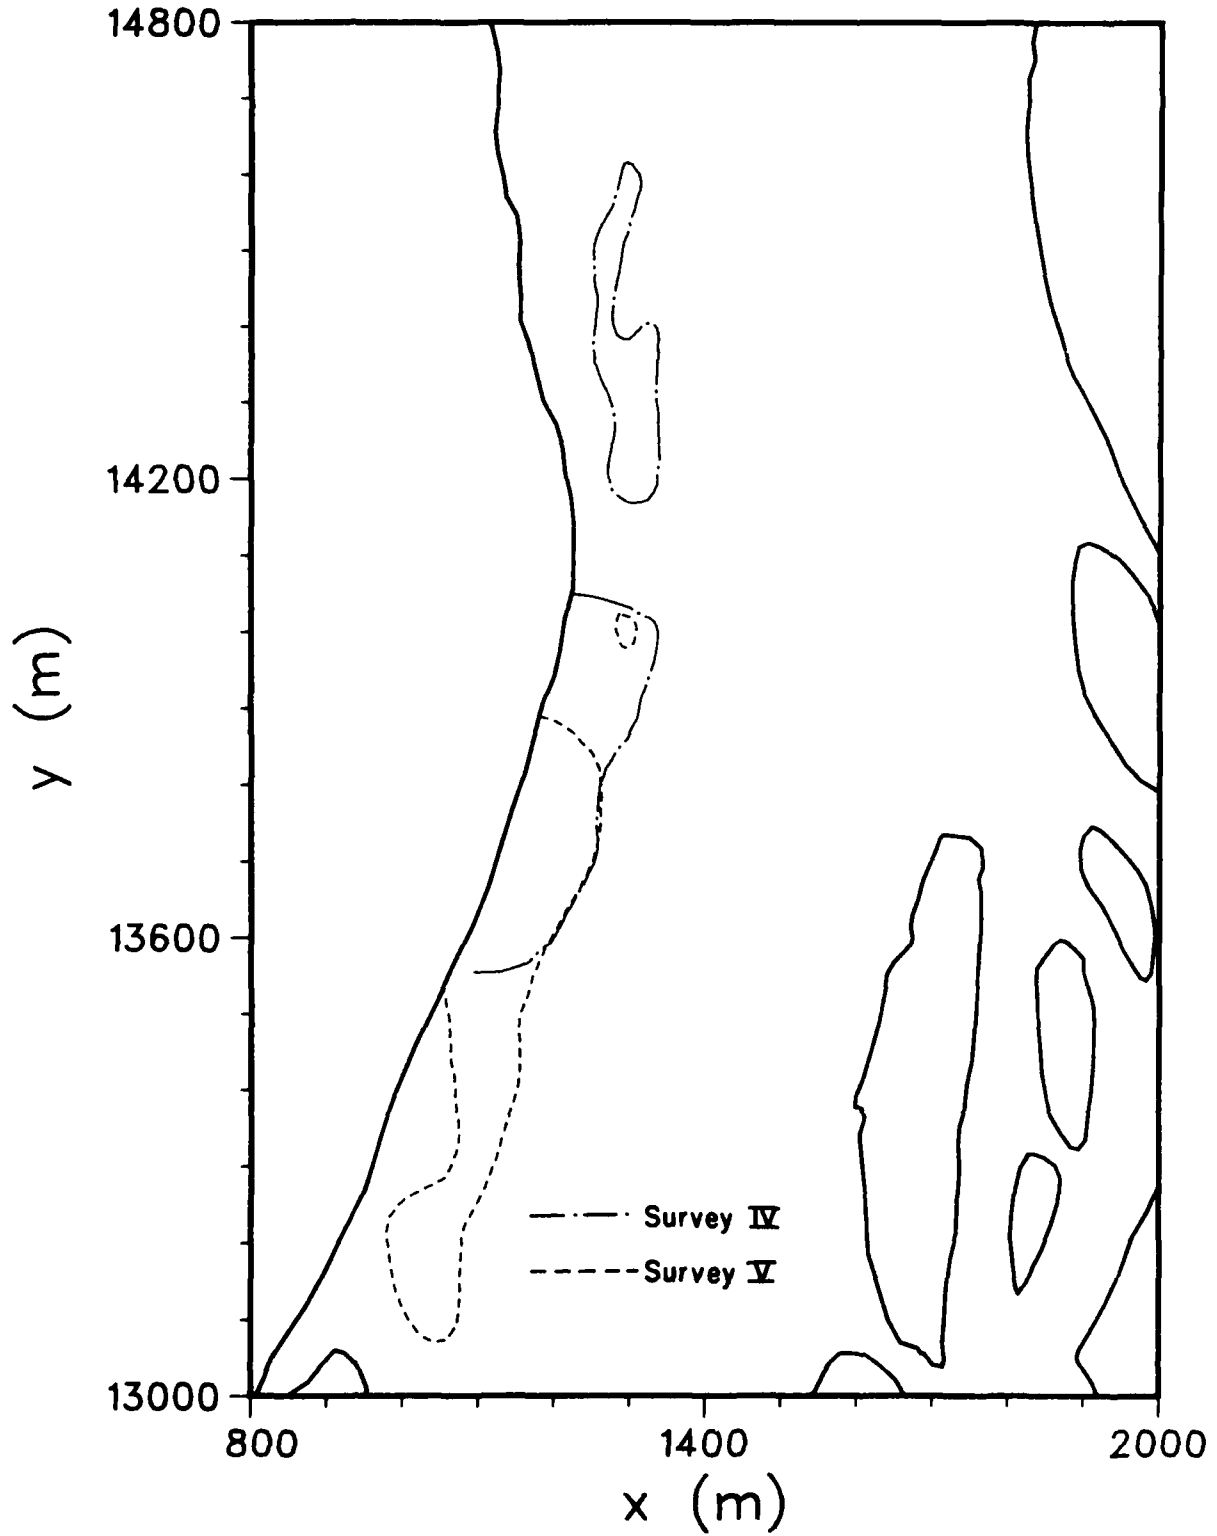
FIGURE 49 Distribution of Tagged Sand before and after the Spring 1983 Flood at the Whitney Island Disposal Site

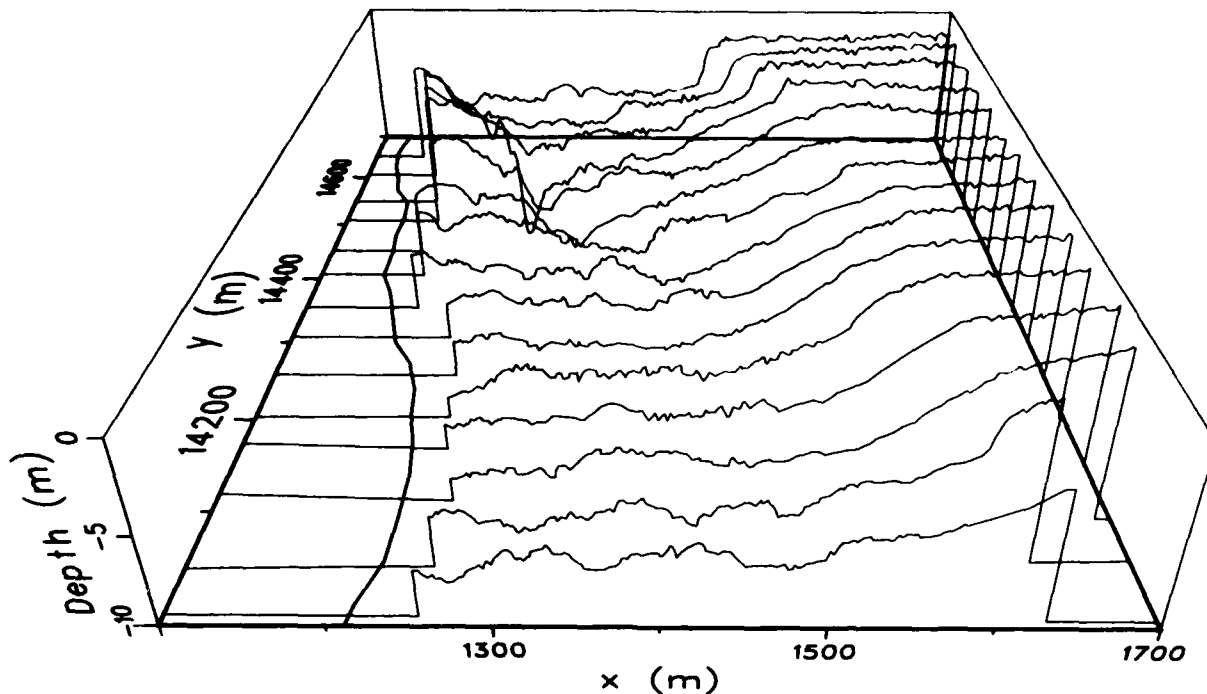
FIGURE 50 Perspective Plot of Transverse Bathymetric Transects for Survey VI at the Whitney Island Disposal Site

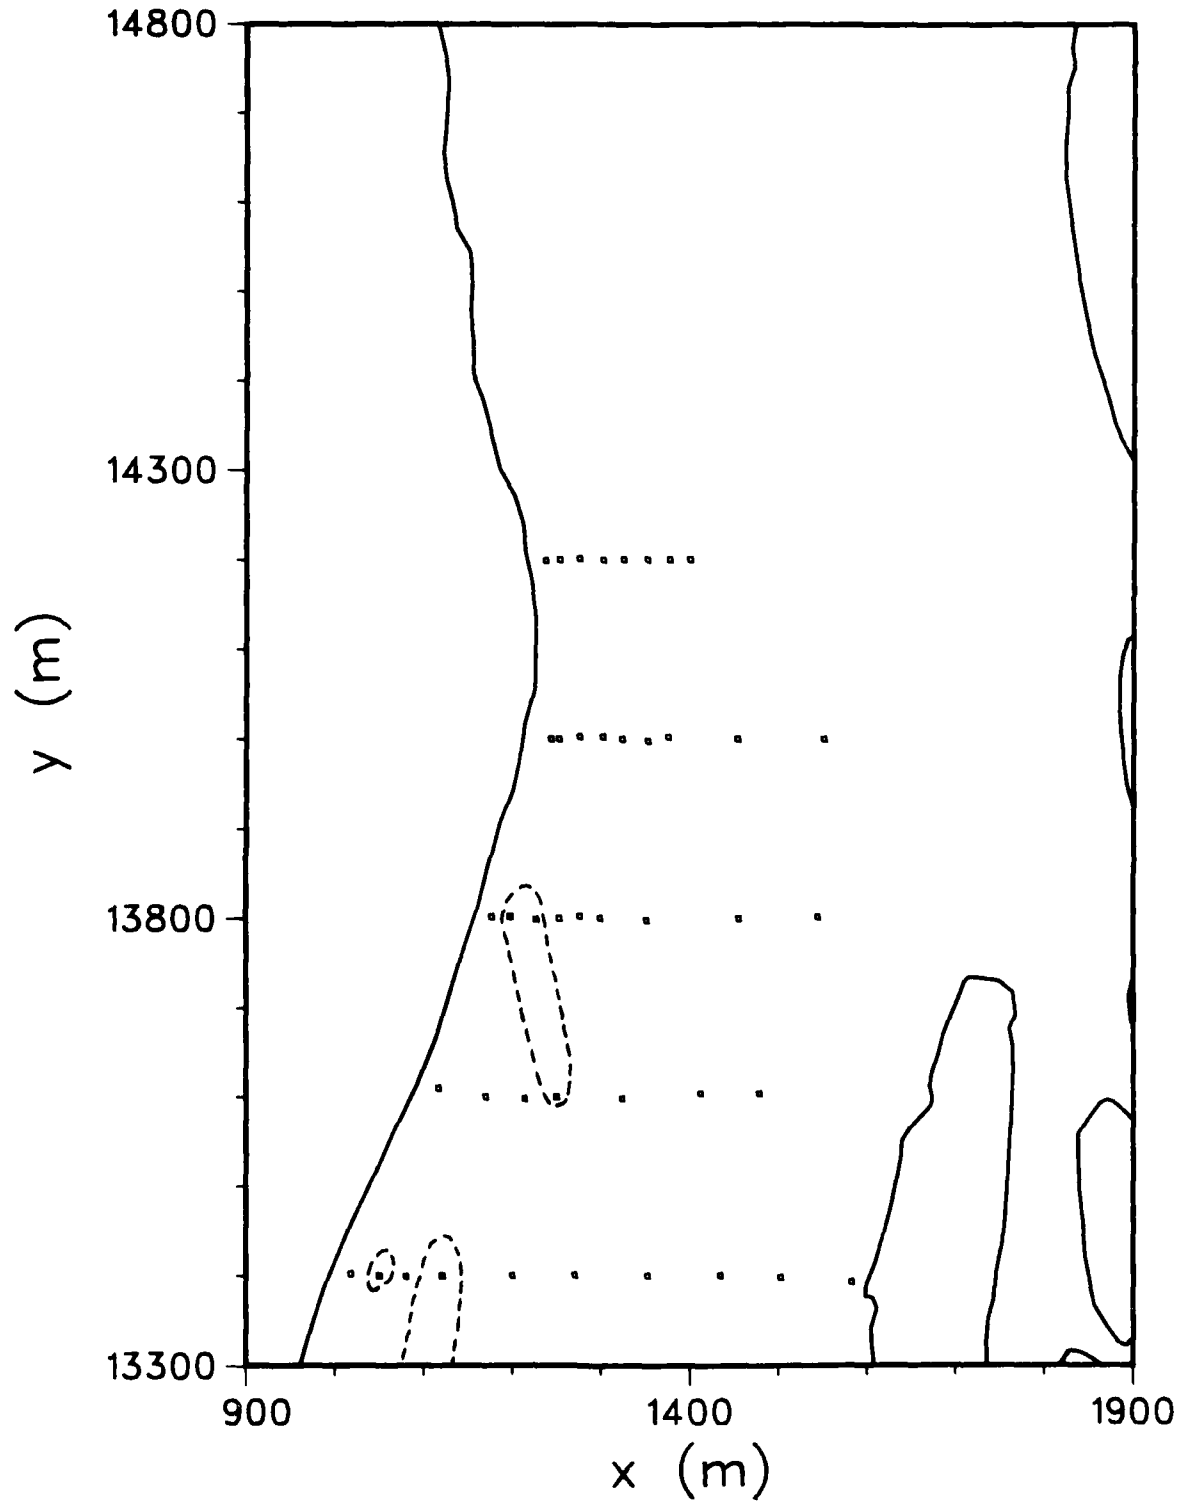
FIGURE 51 Sampling Locations for Survey VI at the Whitney Island Disposal Site (solid symbols show locations where more than three dyed sand grains were observed)

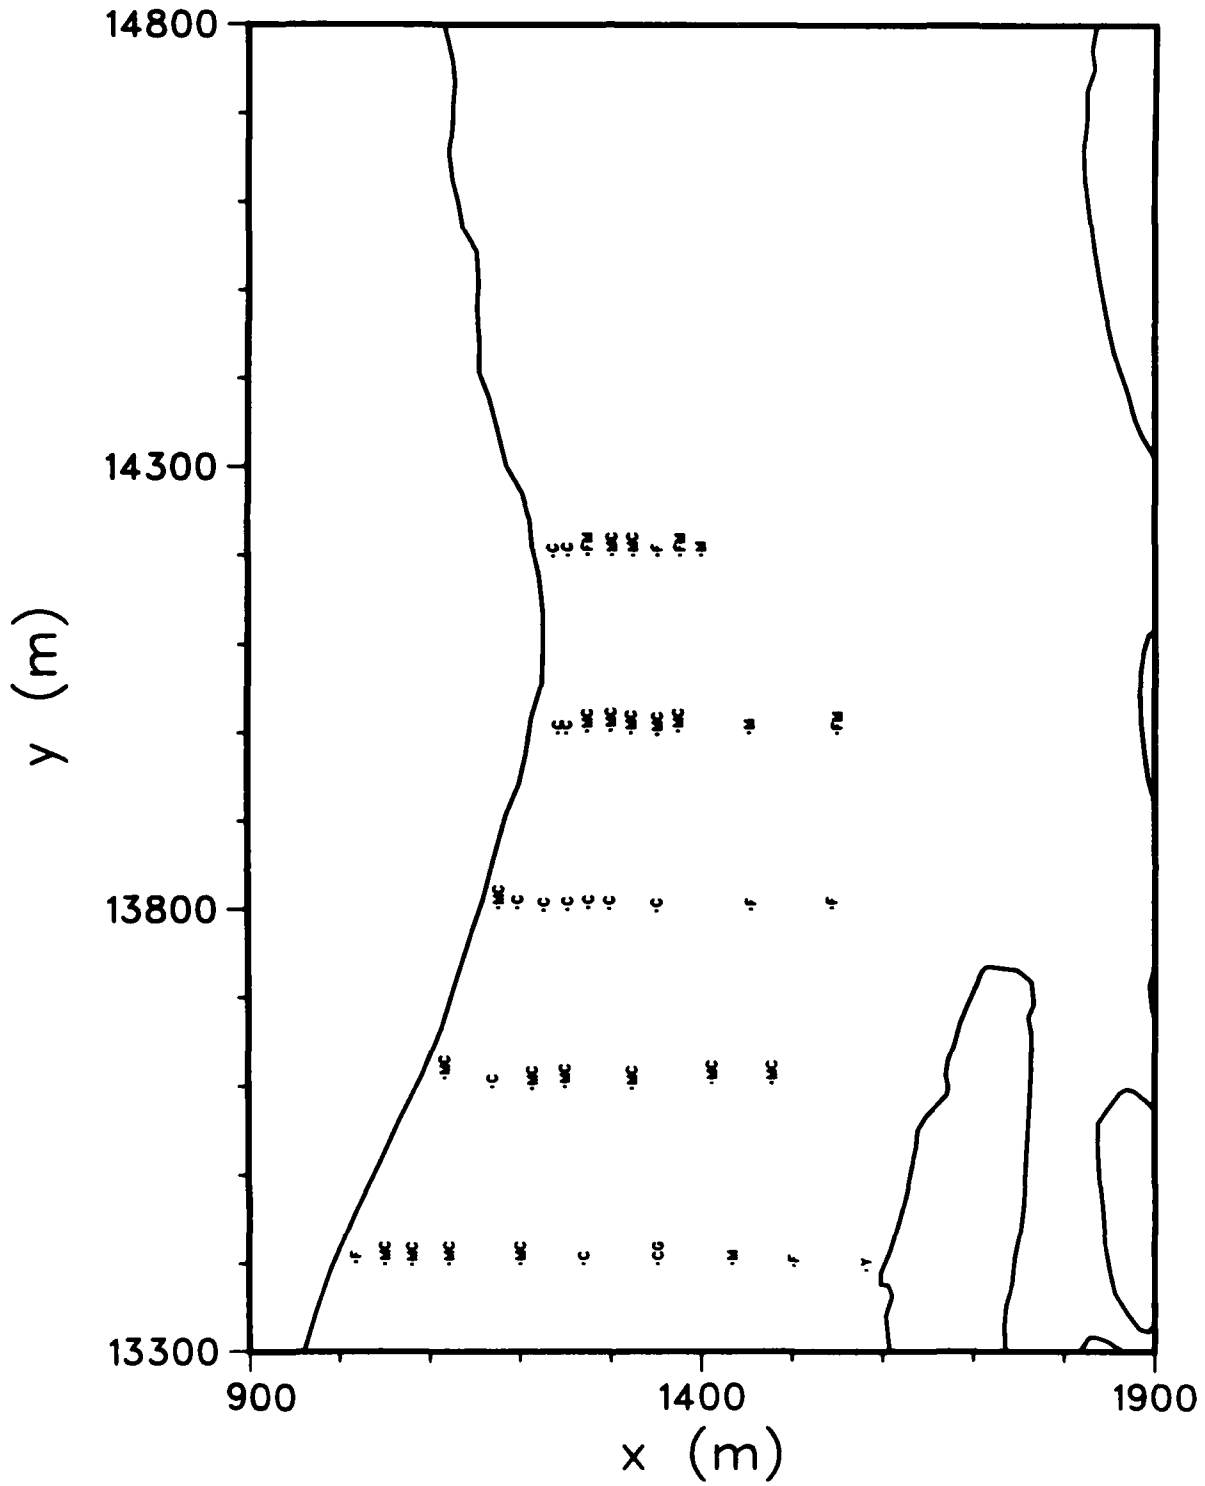
FIGURE 53 Approximate Classification of Bottom Sediments at Sampling Locations for Survey VI at the Whitney Island Disposal Site

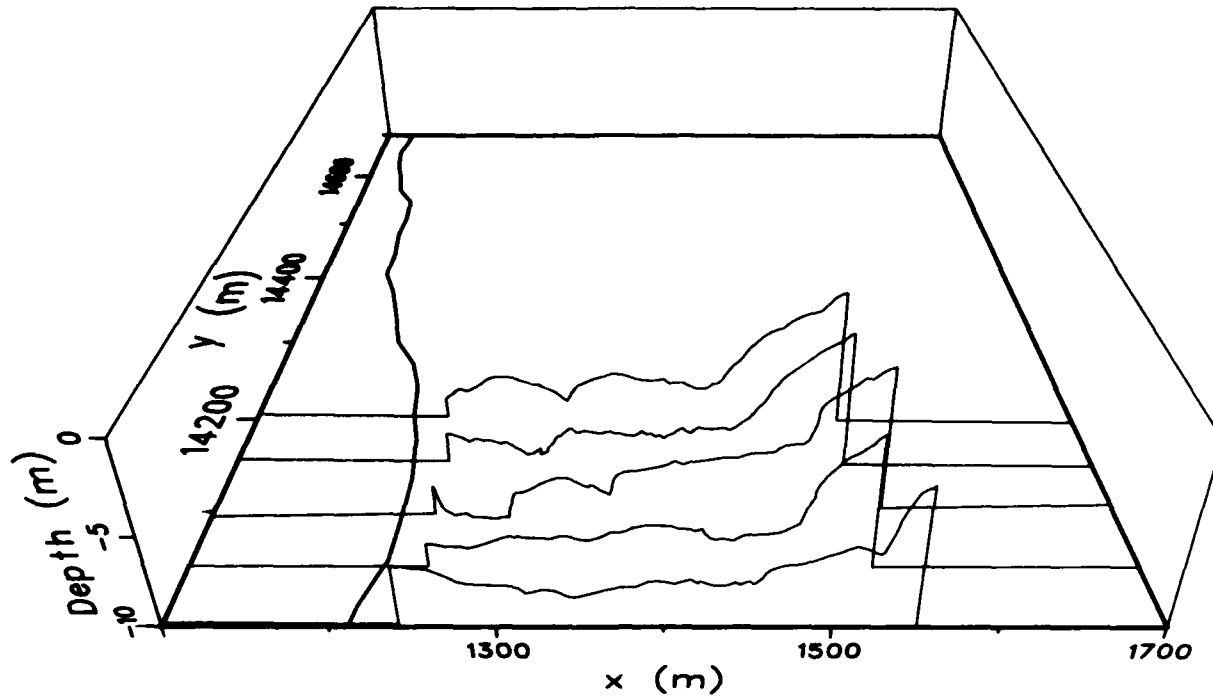
FIGURE 54 Perspective Plot of Transverse Bathymetric Transects for Survey VII at the Whitney Island Disposal Site

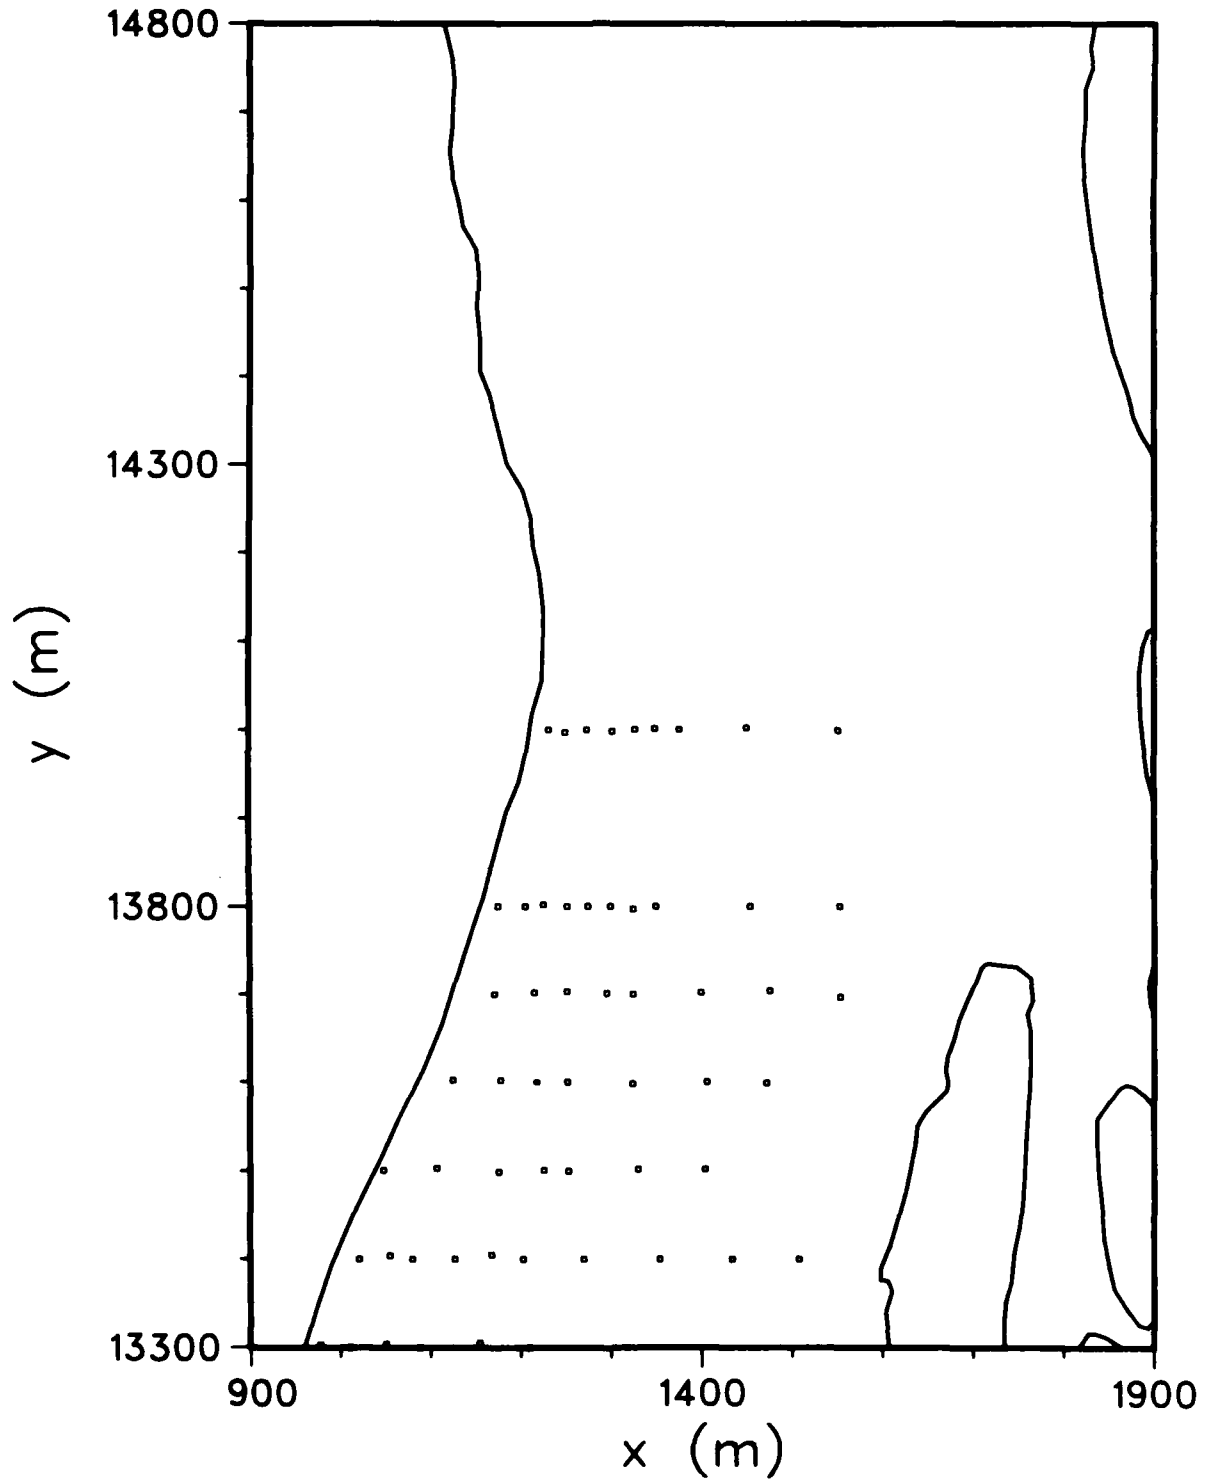
FIGURE 55 Sampling Locations for Survey VII at the Whitney Island Disposal Site (solid symbols show locations where more than three dyed sand grains were observed)

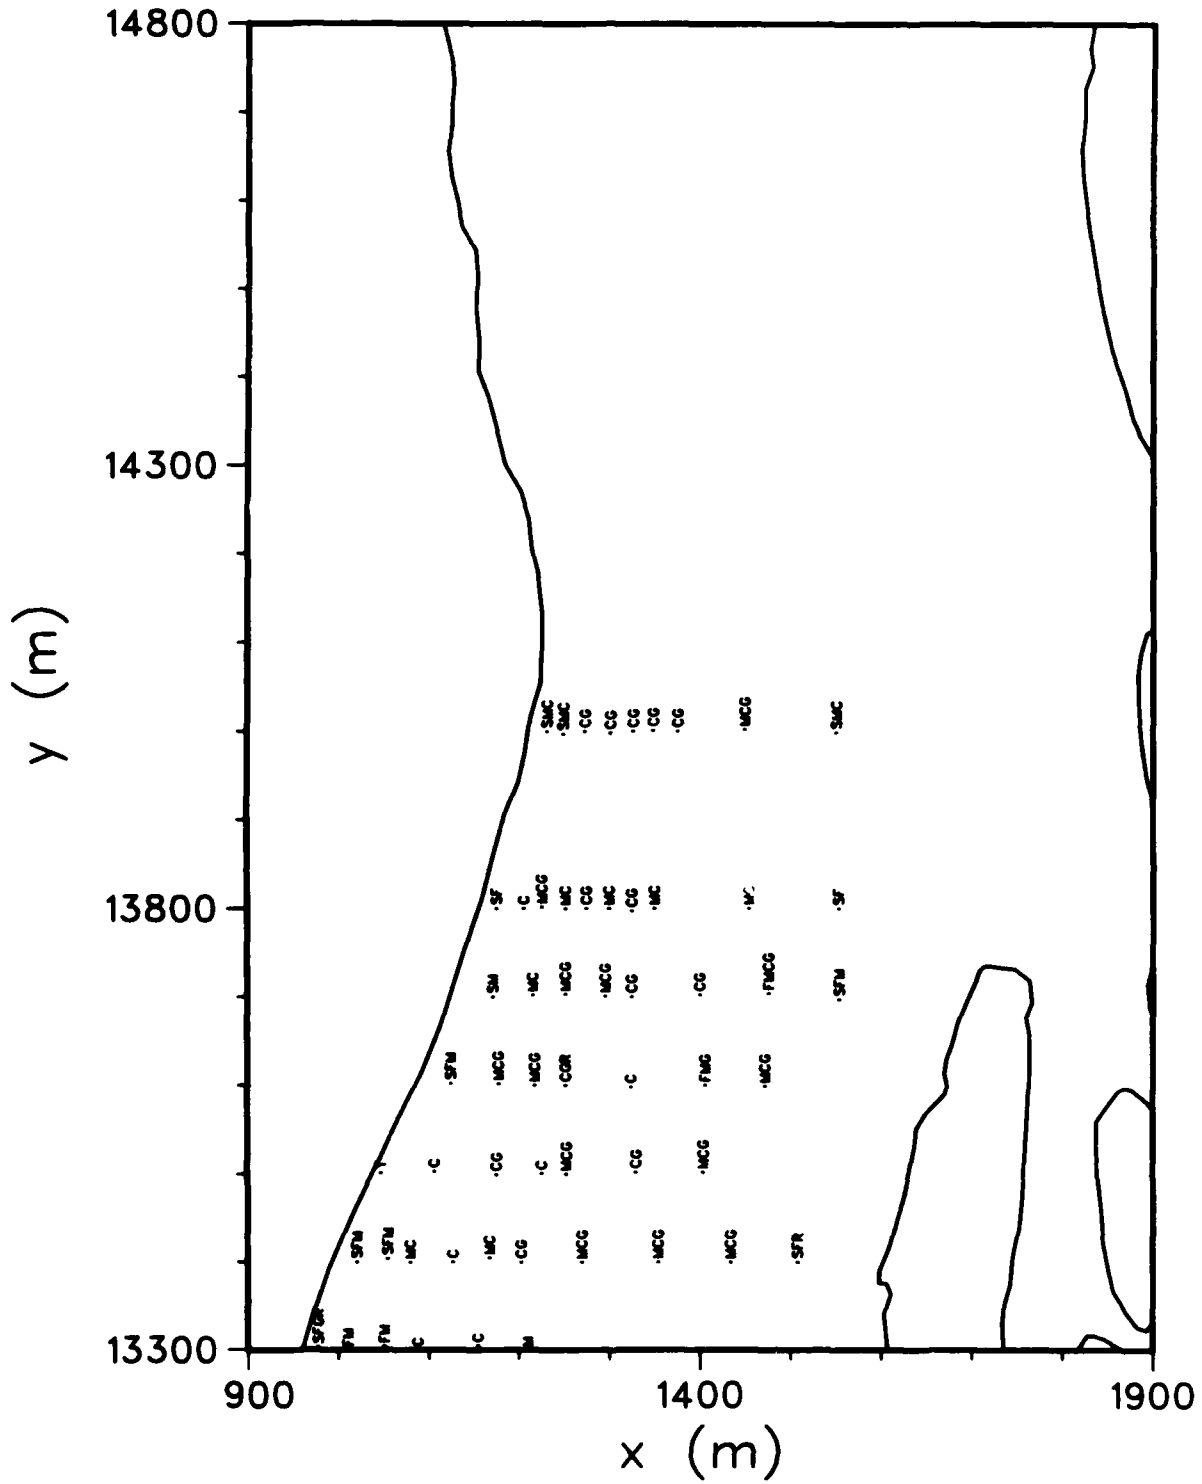
FIGURE 57 Approximate Classification of Bottom Sediments at Sampling Locations for Survey VII at the Whitney Island Disposal Site

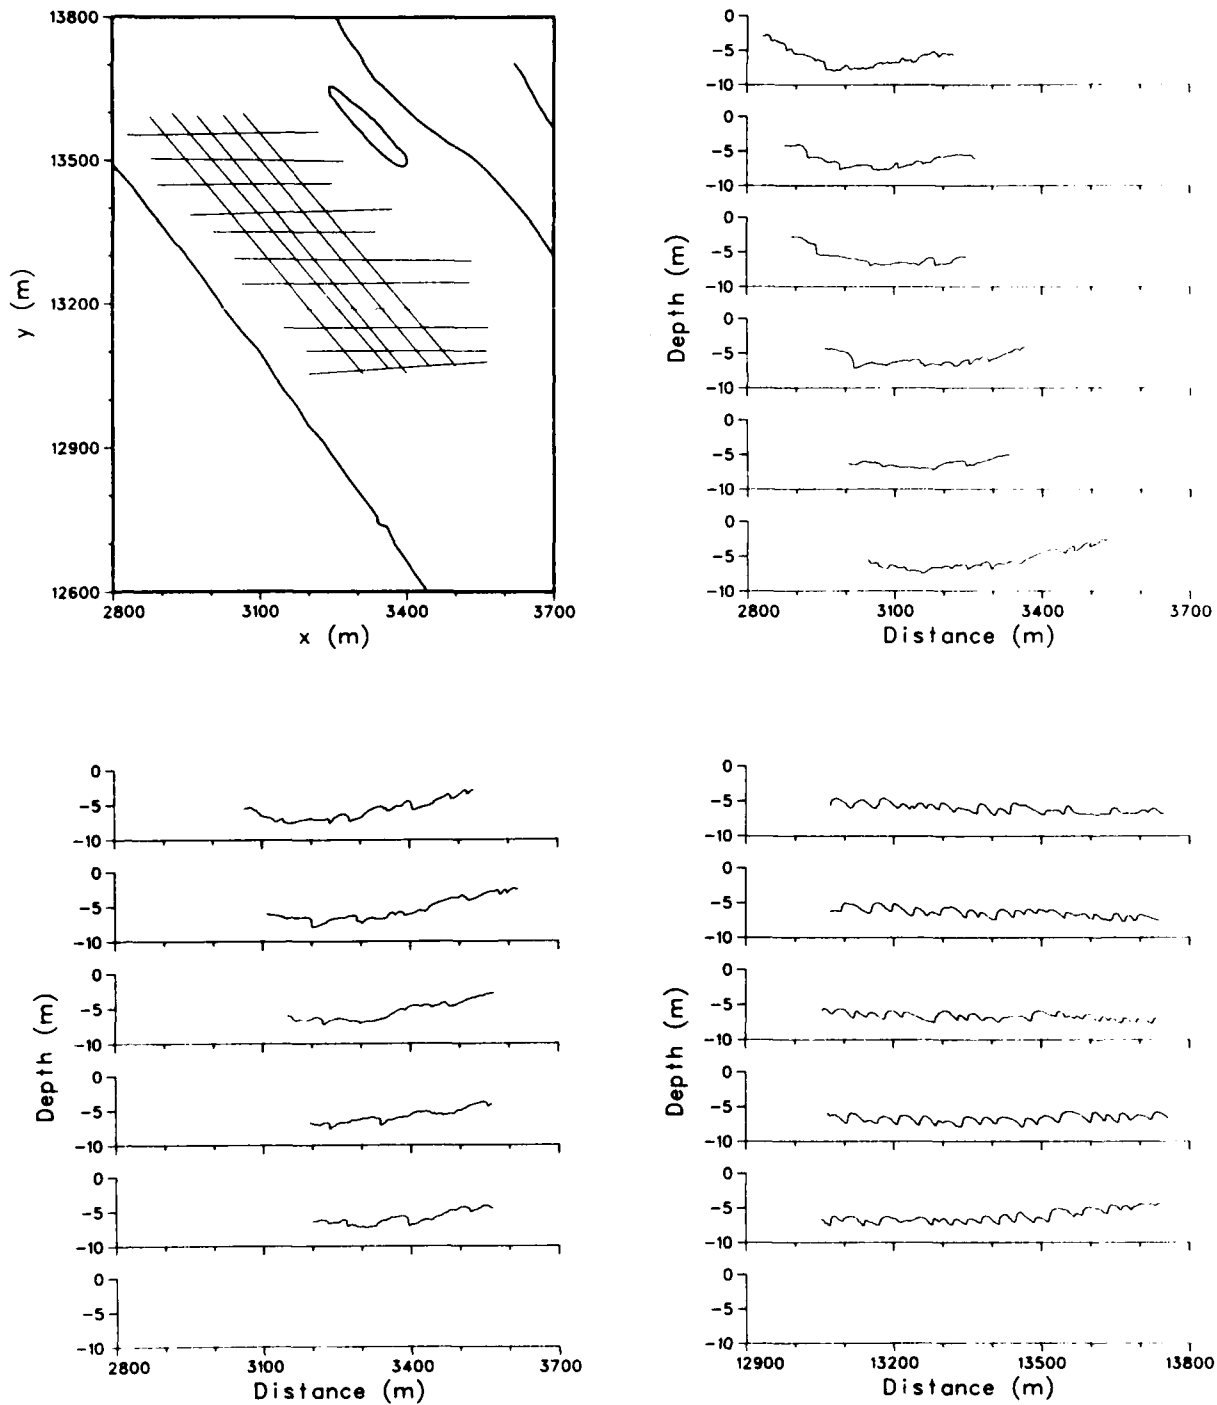
FIGURE A.1 Bathymetric Transects and Transverse and Longitudinal Bottom Profiles for Survey VIII at Gordon's Ferry on September 1, 1983

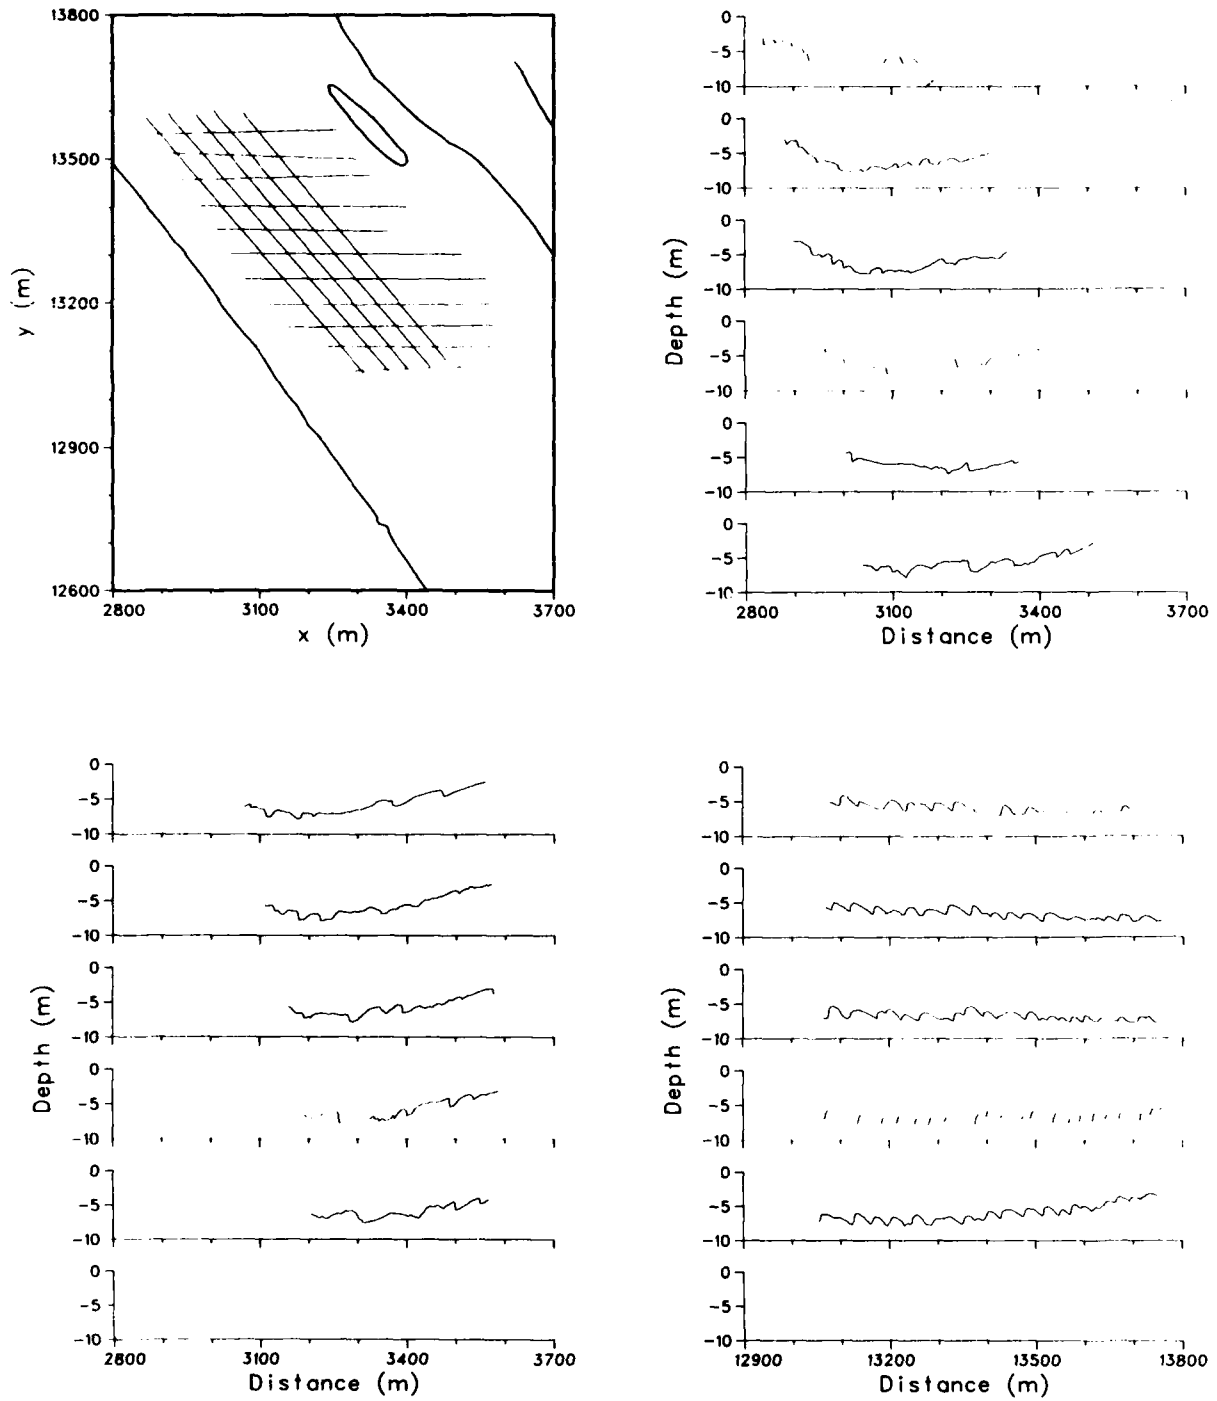
FIGURE A.2 Bathymetric Transects and Transverse and Longitudinal Bottom Profiles for Survey IX at Gordon's Ferry on September 20, 1984

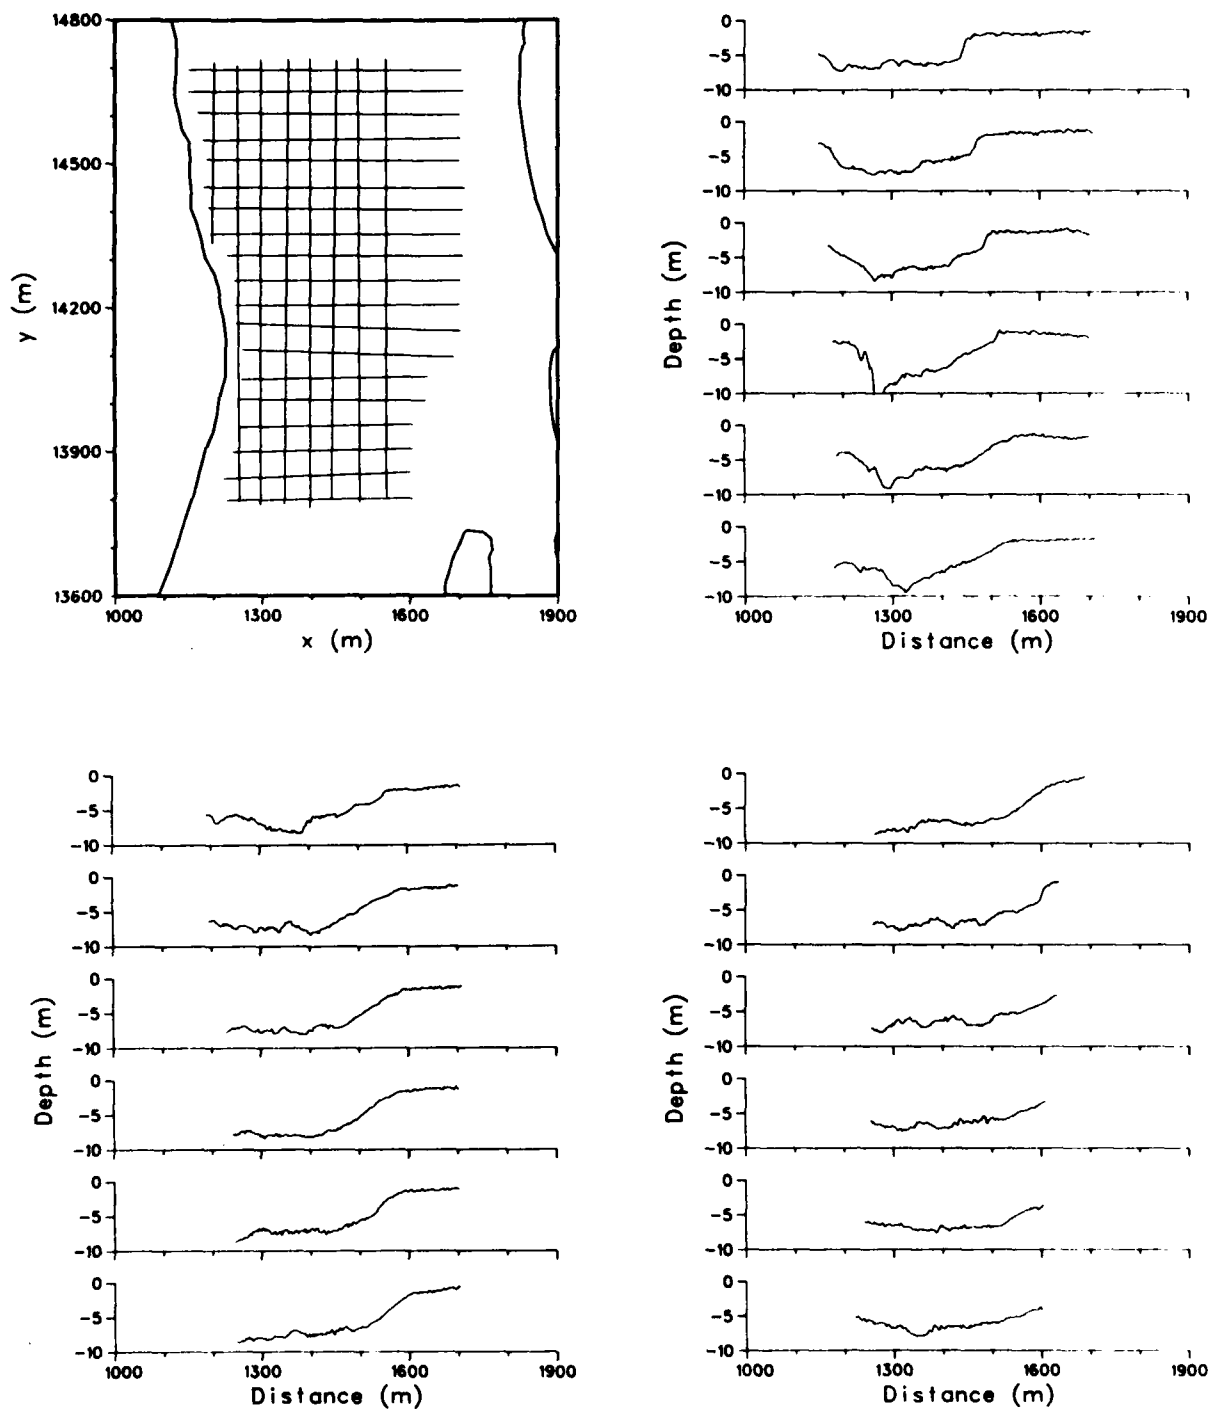
FIGURE B.1 Bathymetric Transects and Transverse Bottom Profiles for Survey VI at Whitney Island on November 30, 1983

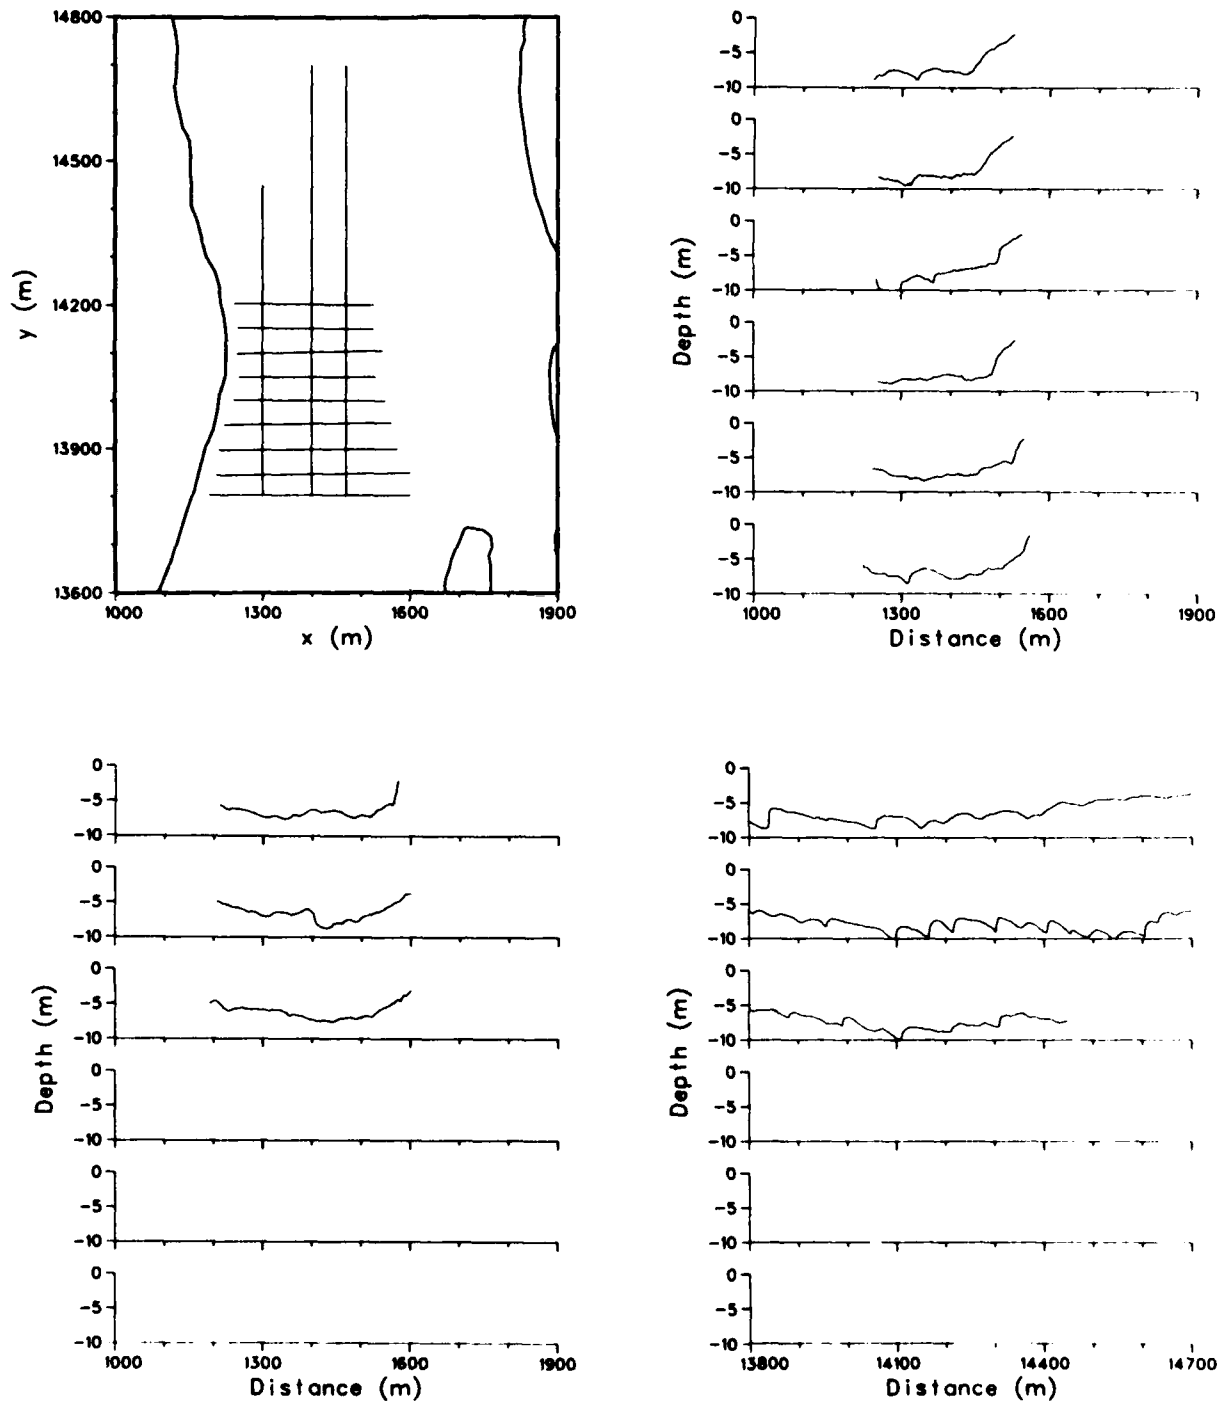
FIGURE B.3 Bathymetric Transects and Transverse and Longitudinal Bottom Profiles for Survey VII at Whitney Island on October 3, 1984
