HIGH SENSITIVITY, ONE-SIDED X-RAY INSPECTION SYSTEM

BY H. BERGER Y. T. CHENG E. L. CRISCUOLO
(INDUSTRIAL QUALITY, INC.)

FOR NAVAL SURFACE WEAPONS CENTER
RESEARCH AND TECHNOLOGY DEPARTMENT

JULY 1985

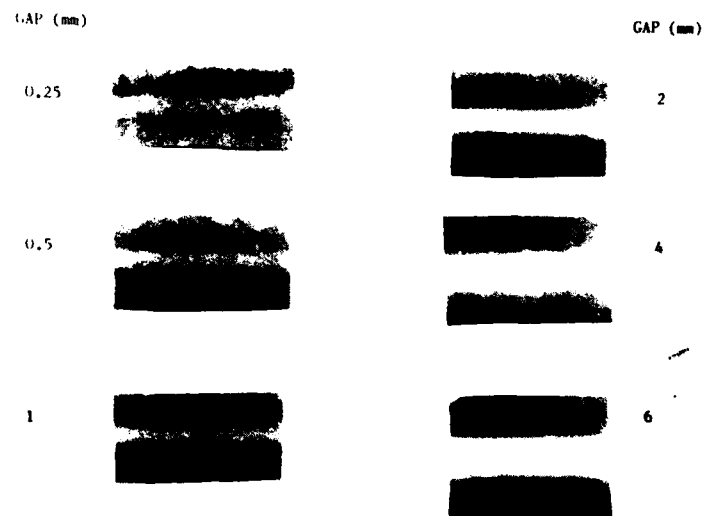
FIGURE 7. BACKSCATTER SLOT CAMERA FILM REPRODUCTIONS FOR SAMPLES SHOWN IN FIGURE 5A WITH VARIOUS GAPS (DELAMINATIONS). GAP SIZES WERE, LEFT COLUMN (TOP TO BOTTOM) 0.25, 0.5 AND 1.0mm. RIGHT COLUMN (TOP TO BOTTOM) 2, 4 AND 6mm

Contrast enhanced film images of the gaps are shown by the broad white lines (unexposed areas) in Figure 7. The widths of the white lines in Figure 7 are proportional to the gap widths for gap sizes larger than approximately 2 mm, and are constant for gap sizes less than 2 mm; also the density contrast of the lines decreases as the gap widths decrease below 2 mm. This behavior can be expected with the camera spatial resolution of approximately 2 mm (as estimated with ray diagrams) which was imposed by the 1 mm camera slot and x-ray beam collimator widths. These results suggest that density plots of each film image, in the direction of the x-ray beam penetration depth into the test object, can provide data for determining gap sizes, even for gaps that may be smaller than the spatial resolution of the camera.
