CRACK GROWTH BEHAVIOR OF ALUMINUM ALLOYS TESTED IN
LIQUID MERCURY(U) ARMY ARMAMENT RESEARCH AND
DEVELOPMENT CENTER WATERVIET NY L. J A KAPP ET AL.
SEP 85 ARLCB-TR-85034 SBI-AD-E448 309 F/G 11/6

4. TITLE (and Subtitle) CRACK GROWTH BEHAVIOR OF ALUMINUM ALLOYS TESTED IN LIQUID MERCURY		5. TYPE OF REPORT & PERIOD COVERED Final
		6. PERFORMING ORG. REPORT NUMBER

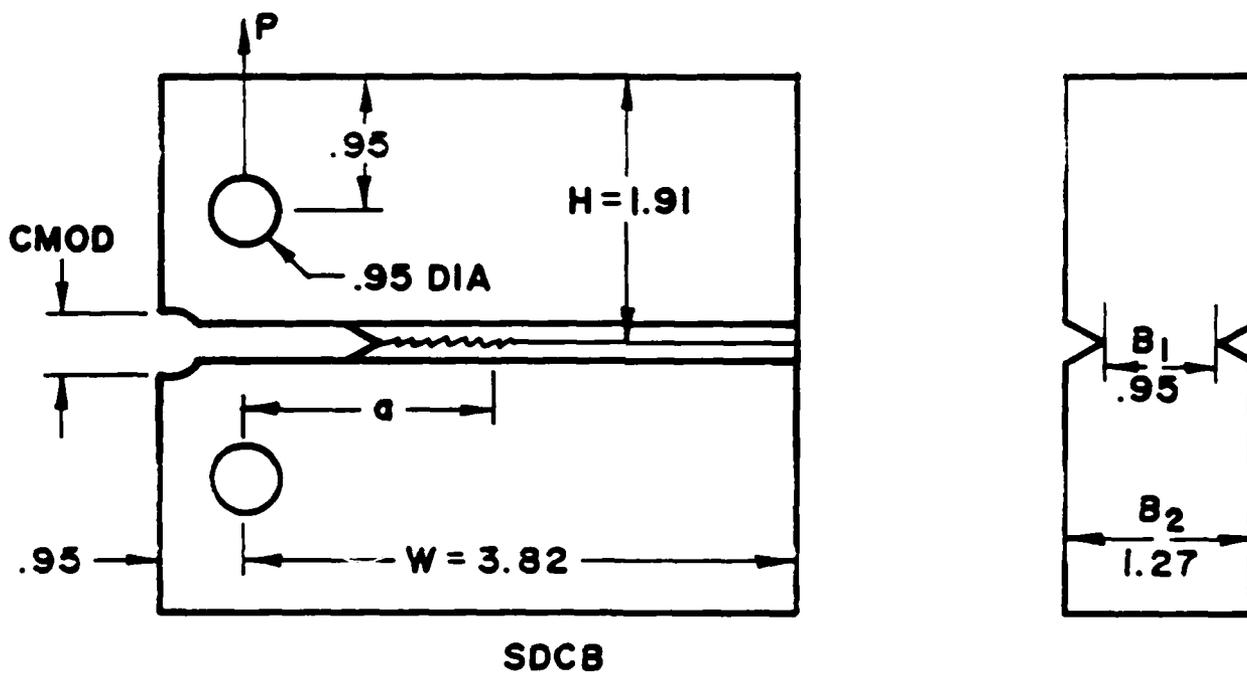
Figure 1. Crack growth specimen.

The specimen used to measure crack growth rates is pictured in Figure 1, a modified compact tension with side grooves. Load (P) was transmitted through the pin holes and the crack mouth opening displacement (CMOD) was measured as indicated. The side grooves were included to reduce unstable crack branching.

where B is the geometric mean of B_1 and B_2 ($B = \sqrt{B_1 B_2}$), and the other variables are defined in Figure 1. Equations (1) and (2) agree with the numerical K solution to within 0.5 percent over the change $0.2 < a/W < 1.0$.

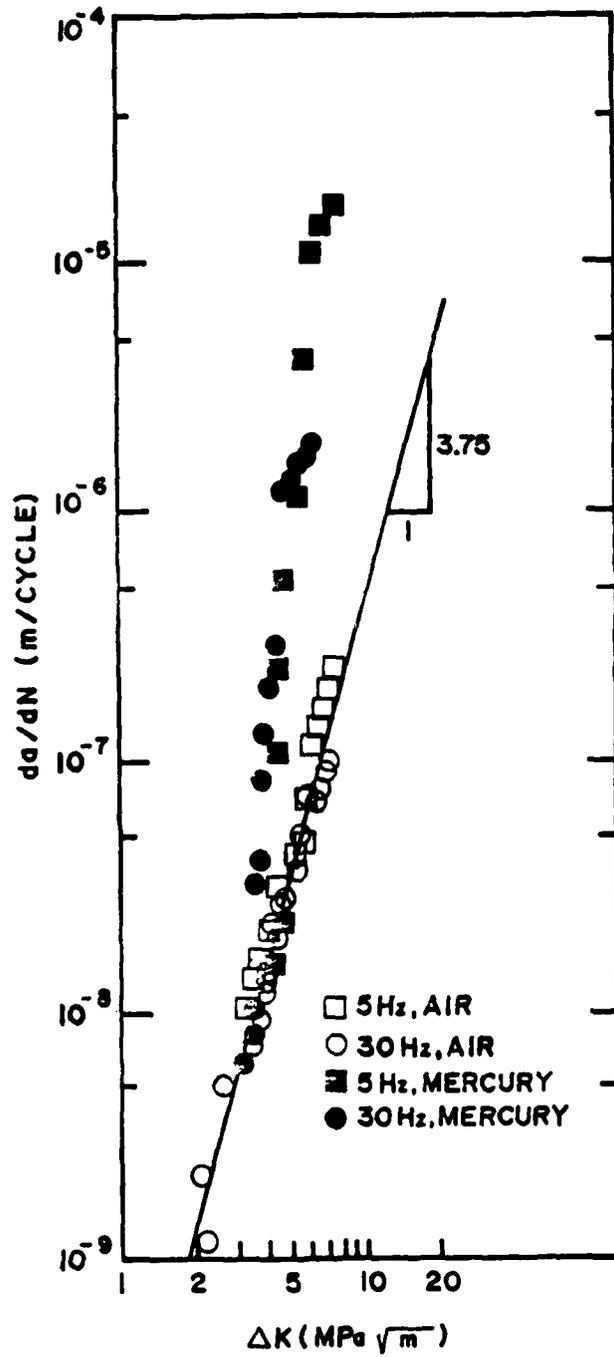
Figure 2. Fatigue loading results for 1100-0.

The results of the fatigue crack growth tests are shown in Figures 2 through 4 for the 1100, 6061, and 7075 alloys respectively. In all these plots the open symbols represent crack growth rate measurements obtained from testing in laboratory air, and the solid symbols represent data from testing performed in mercury. As was expected, the results of the tests in air followed the Paris power law. Also, severe embrittlement was observed in all of the alloys in mercury.

These results, treated as an aggregate, showed that the fatigue crack growth phenomenon of mercury embrittled aluminum is not unlike hydrogen embrittled steel (ref 7). Specifically, below a certain ΔK_{th} there was no effect of the mercury on crack growth. Once ΔK_{th} was exceeded, the fatigue crack growth rate increased very quickly with increasing ΔK . This initial region was followed by a range of ΔK where the crack growth rate increased very little.

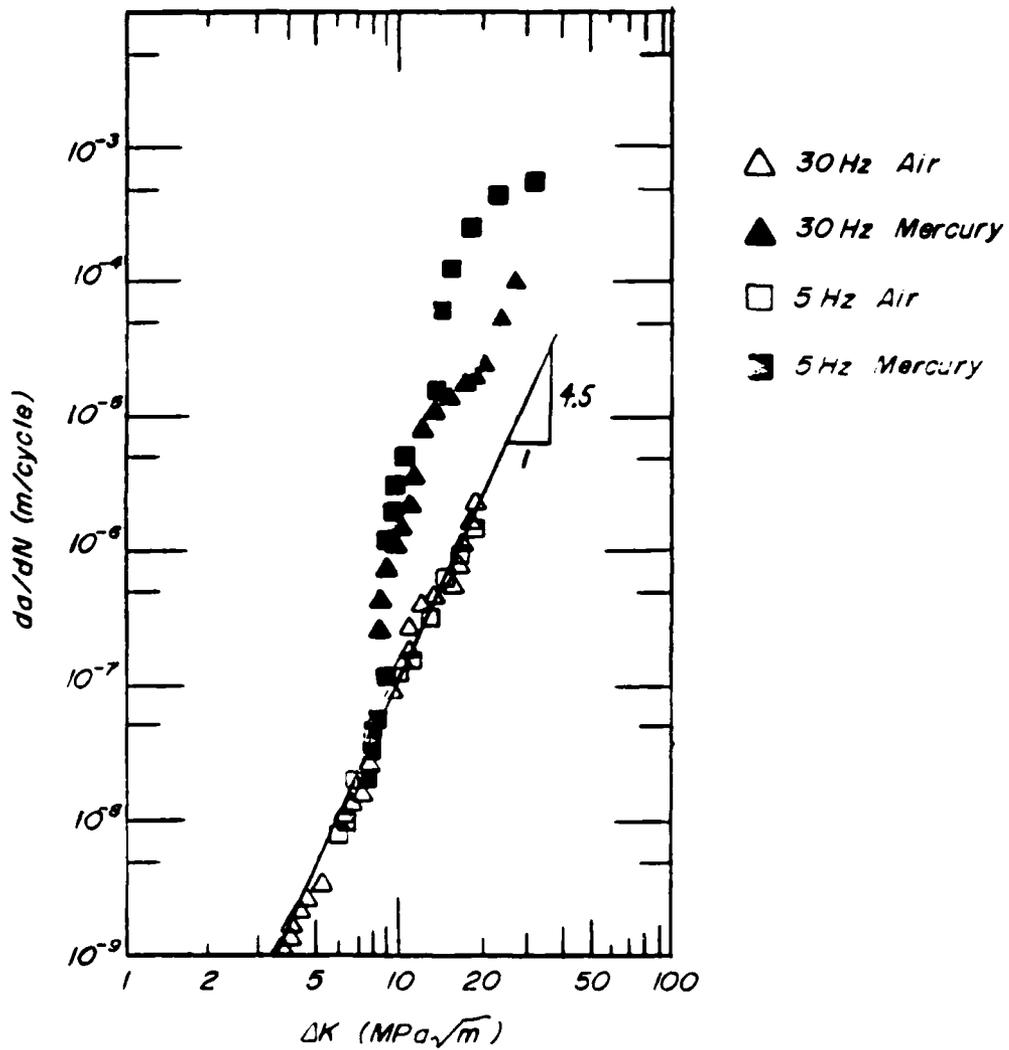
Figure 3. Fatigue loading results for 6061-T651.

In the results from the testing of 6061 and 7075 there was an effect of loading frequency on crack growth rate. At the low frequency (5 Hz), the crack growth rate was as much as two orders of magnitude greater than at the

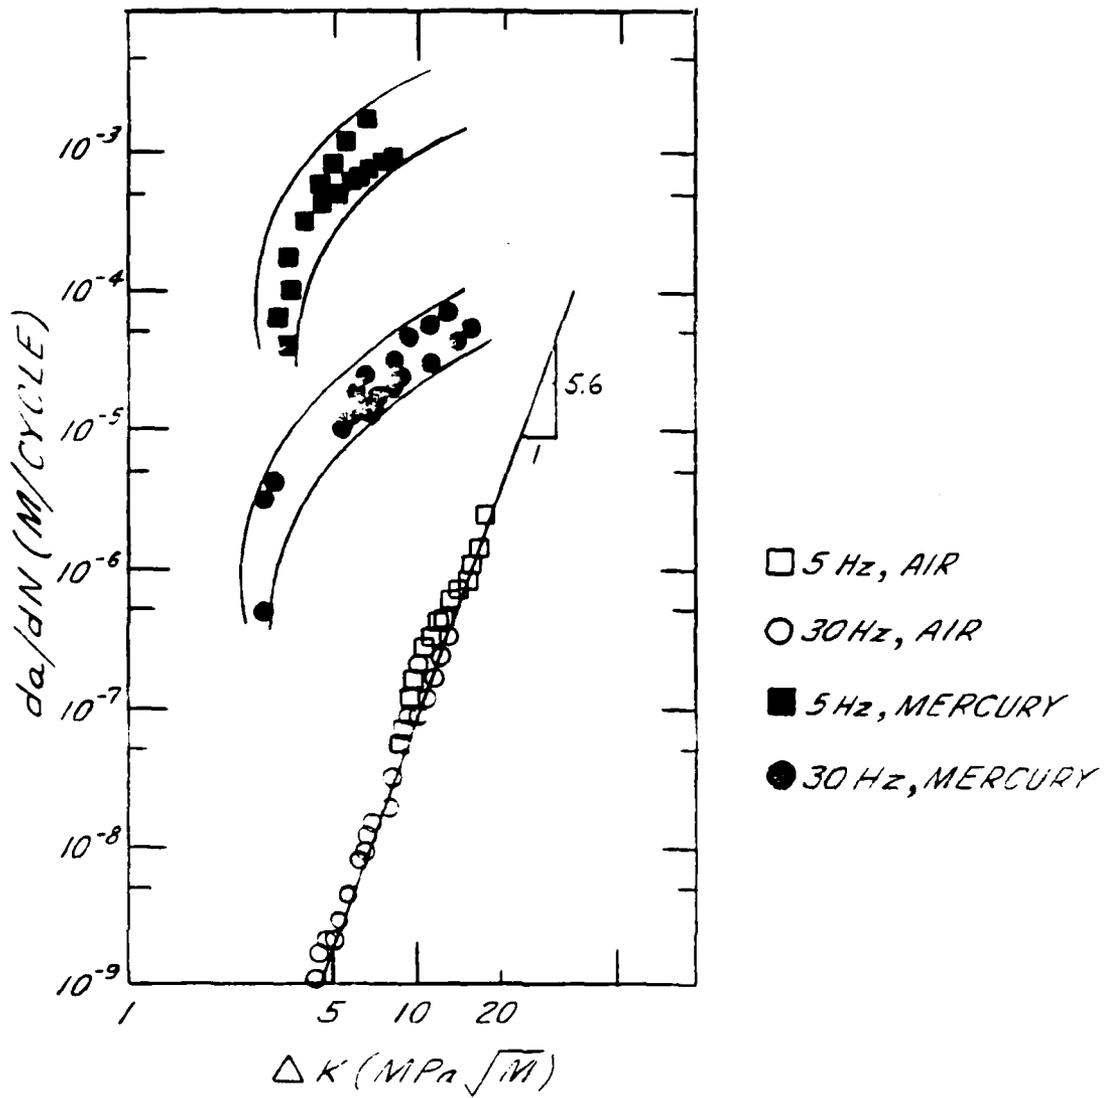
Figure 4. 7075-T651 Fatigue loading results.

higher frequency (30 Hz) in 7075. In 6061, the maximum difference was no greater than about a factor of 50. Although the distinct frequency effect was not observed in 1100, the maximum crack growth rate measured at 5 Hz was about an order of magnitude greater than the maximum rate observed at 30 Hz. The effect of frequency was not unlike the frequency effect observed in other environmentally assisted fracture phenomena (ref 7).

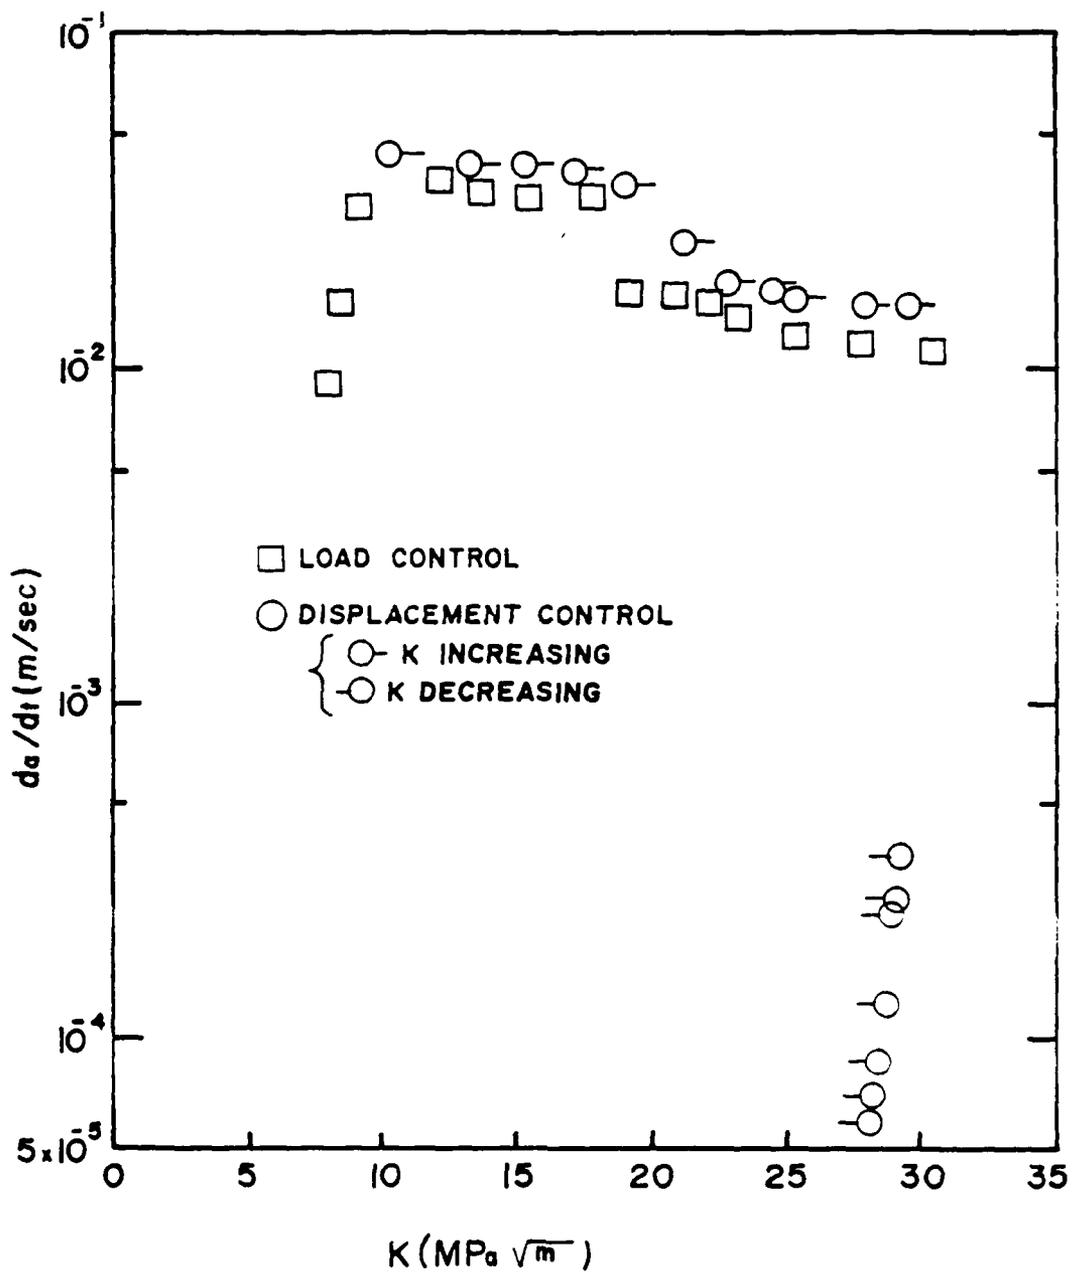
Figure 5. Static loading results for 1100-0.

The crack velocity measurements obtained under both fixed load and fixed displacement conditions are shown in Figures 5, 6, and 7 for 1100, 6061, and 7075 respectively. Considering the load control tests first, we observed the following. In all materials no crack growth was observed below a threshold K level (K_{ILME}). Once the applied K was greater than K_{ILME} , the crack velocity increased almost as a step function to a rate of between 4 cm/s and 10 cm/s, where it remained constant until the specimens fractured. The crack velocity decreased to about 1 cm/s or 2 cm/s in 1100 before fracture occurred. Again, this behavior was similar to that observed in hydrogen embrittled steel (ref 3).

The results obtained in the fixed displacement testing showed a much different behavior. In these tests the specimens were loaded very rapidly to a high K level. For 1100 and 6061, the initial loading was not sufficiently fast to prevent crack growth upon rising load. Thus, we observed crack growth

behavior similar to that observed under the fixed load conditions. This was to be expected since as the crack grew, the application of the external load resulted in an increase in K. Once the maximum K was attained further crack growth resulted in a reduction of the external load which caused K to decrease. Under these conditions, the behavior was different for each alloy. In the 1100 alloy, the crack arrested at a very high K level. The 6061 alloy exhibited crack growth behavior wherein the crack velocity decreased by about an order of magnitude and remained constant. When K was reduced to a sufficiently low level, the crack arrested. K_{ILME} under these conditions was somewhat lower than that necessary to initiate accelerated growth in the fixed load tests. Finally, in the case of 7075, the crack grew at the same velocity regardless of the loading condition. Also, K_{ILME} was smaller in displacement control for 7075.

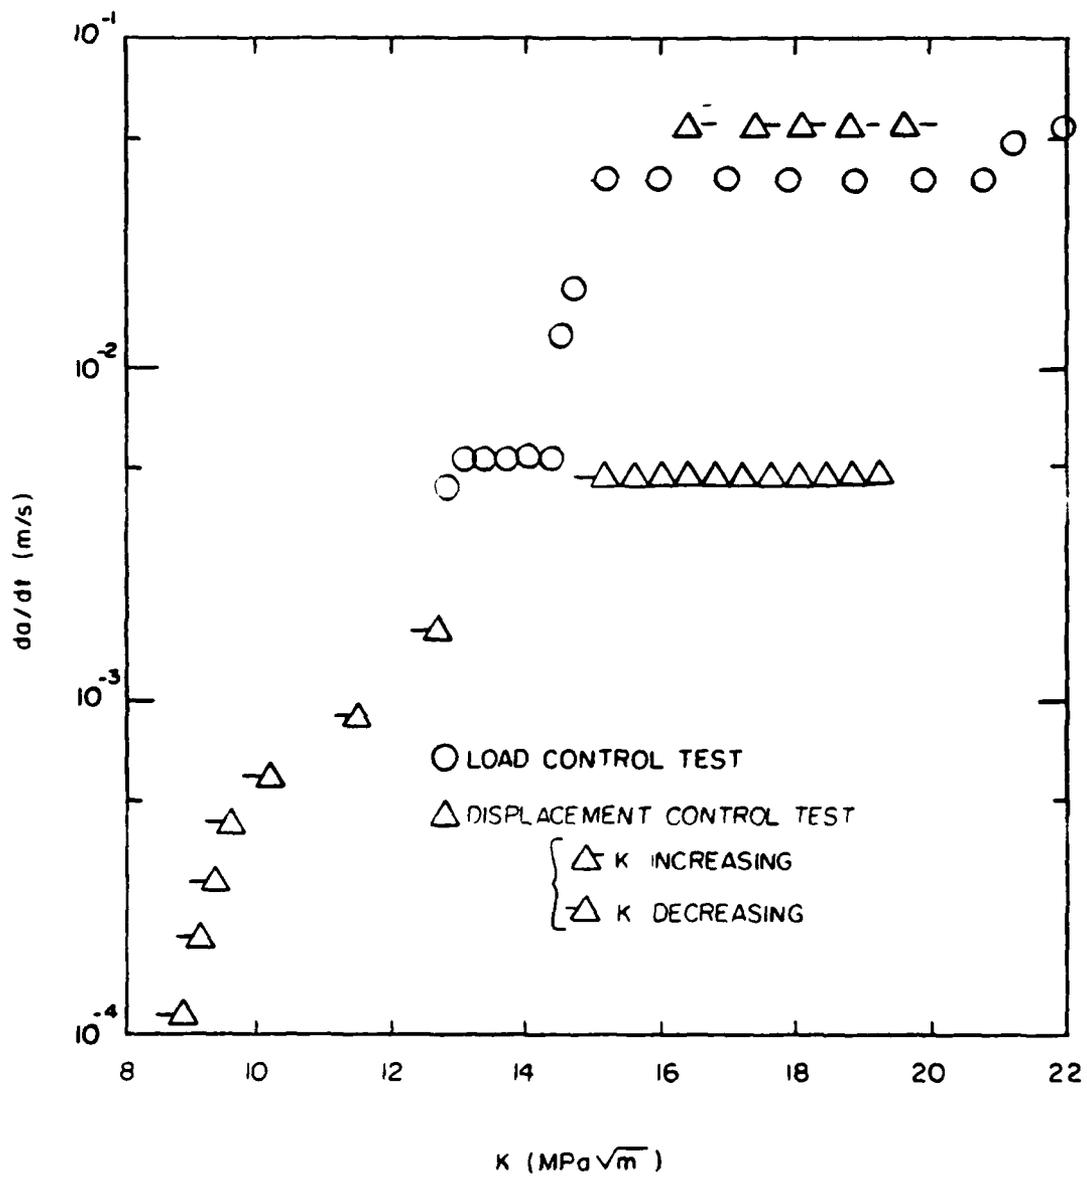
Figure 6. Static loading results for 6061-T651.

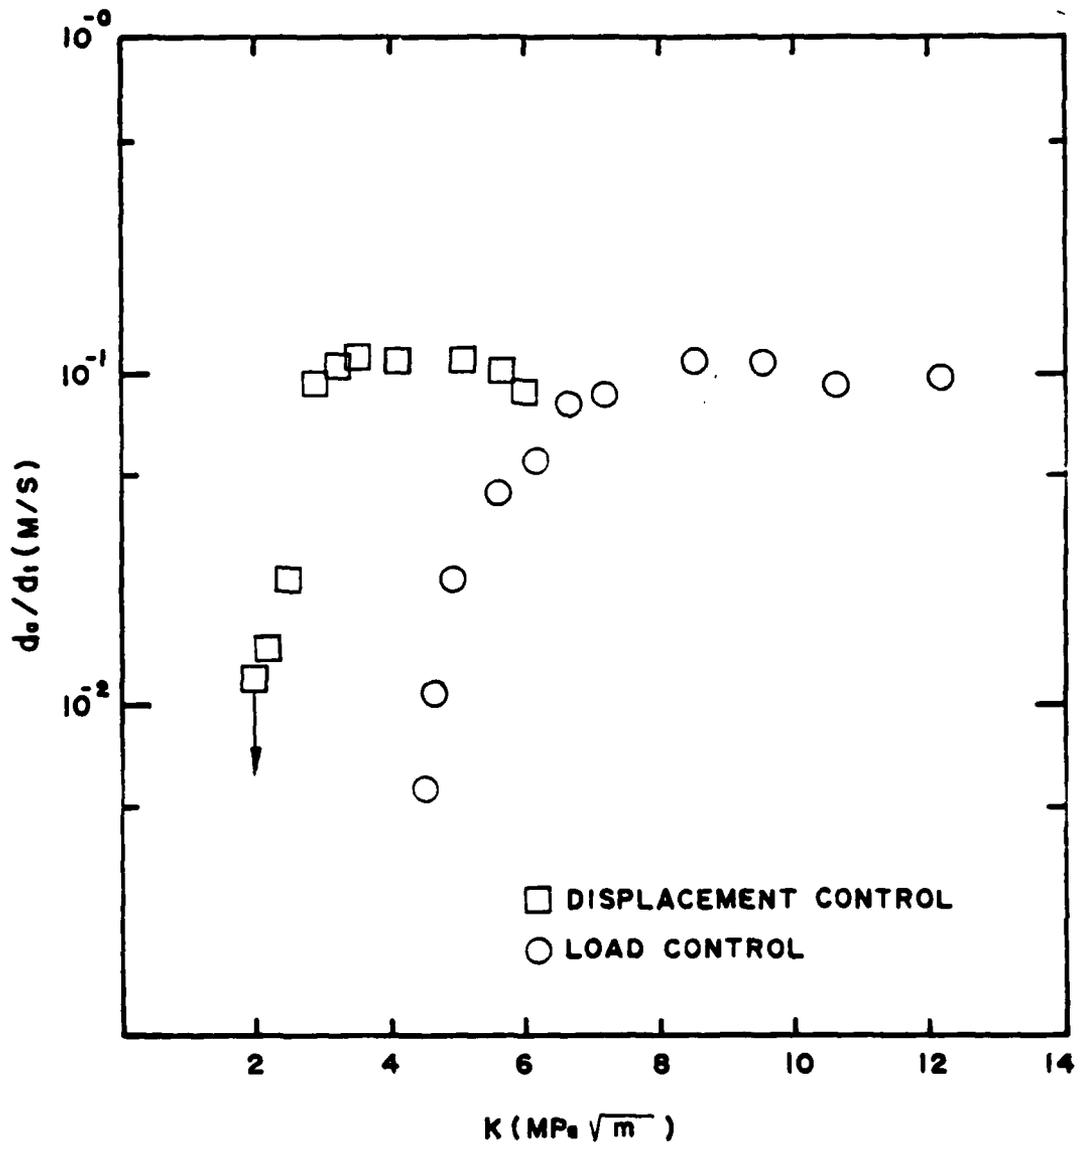
Figure 7. 7075-T651 Static loading results.
