MTL TR 86-17

CERAMIC BARRIER TURBINE BLADE DEMONSTRATION

DANIEL SHEA
Rockwell International
Rocketdyne Division
Canoga Park, California 91303

FINAL REPORT

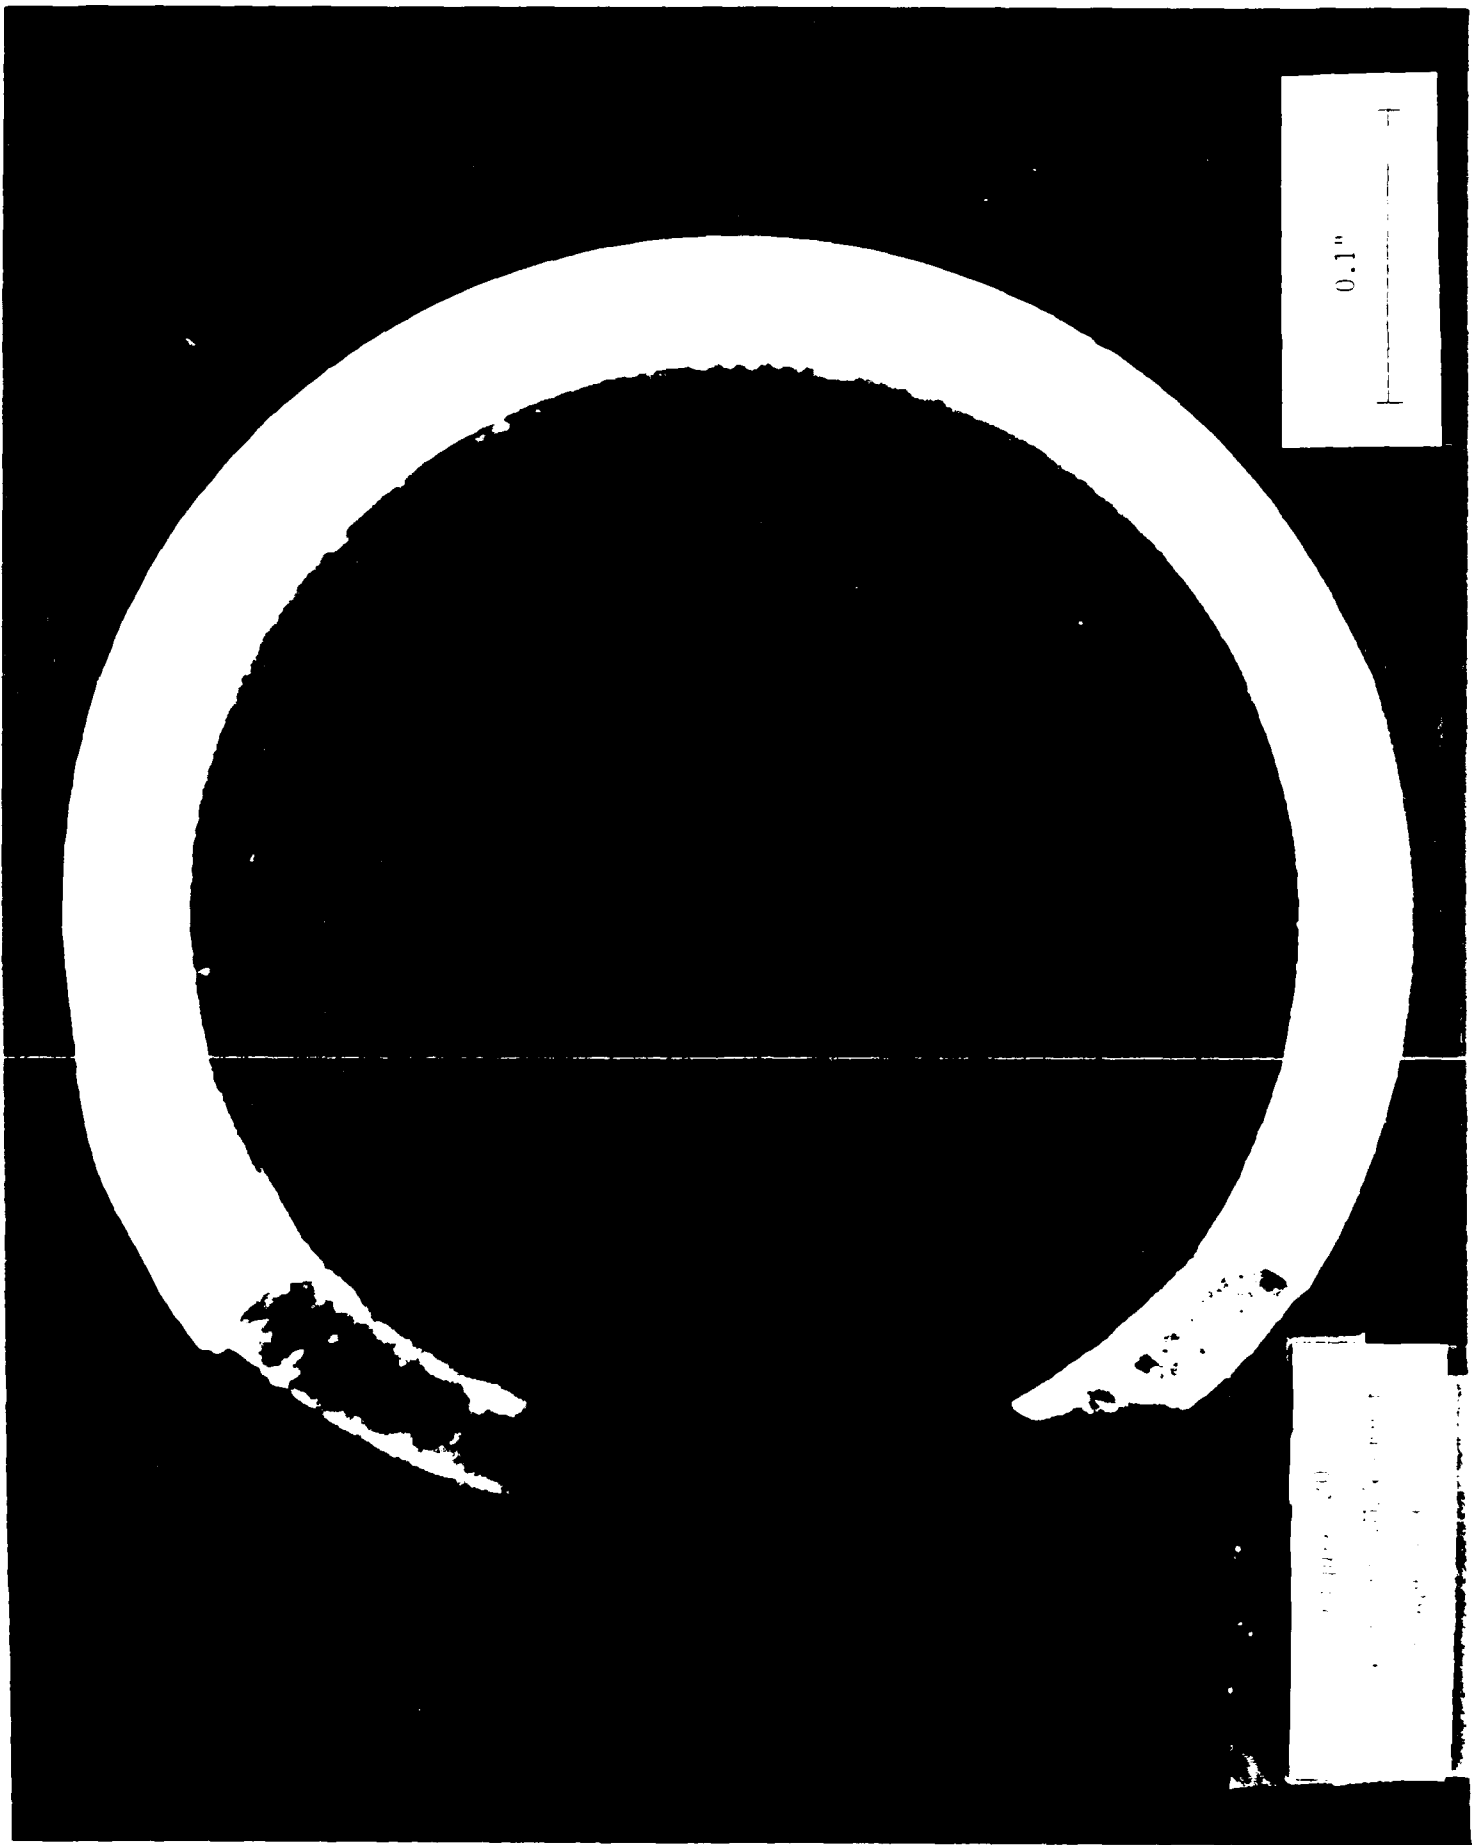
Two of cylinder specimens had cracked during the test. In cylinder #29, there was a single crack running the length of the cylinder. In cylinder #9, a 90 degree section of the cylinder had separated, (Figure 20). The separated section did not fly off of the stud and was recovered. These specimens had been inspected prior to the second spin and no cracks were found at that time.
