**AFWAL-TR-85-2006**

**COMPATIBILITY OF SODIUM AND  
LITHIUM IN SUPERALLOY HEAT PIPES**

**Warner B. Kaufman  
Leonard K. Tower**

**Final Report for Period 1 January - 31 December 84**

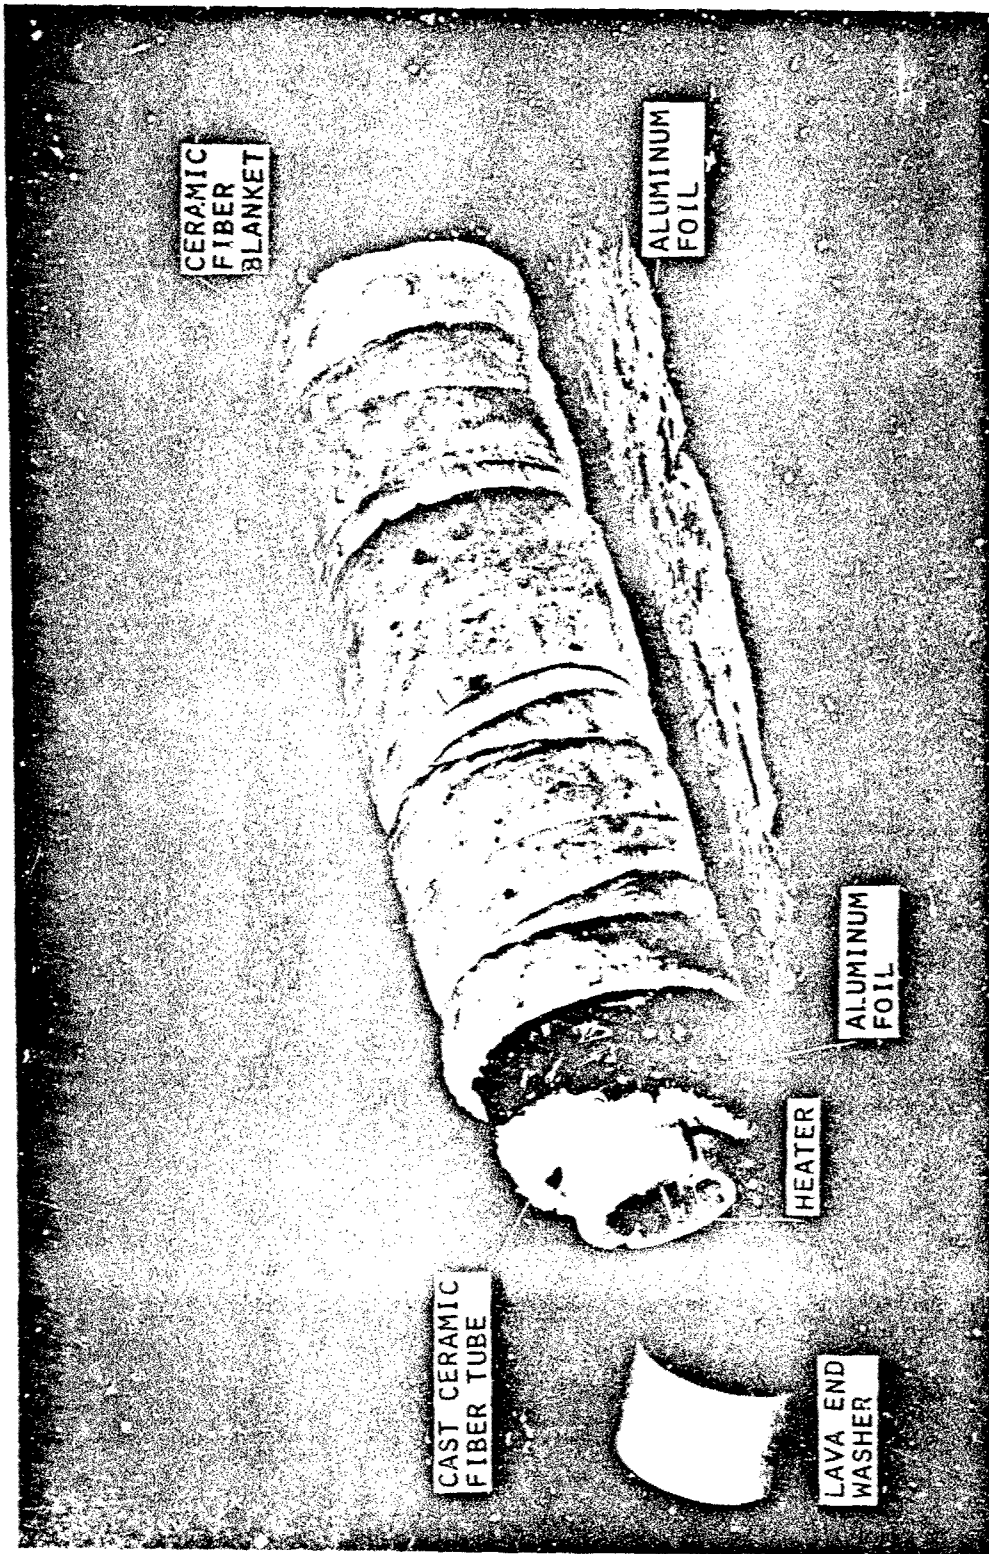
(B) HEATER, FINAL DESIGN.

FIGURE 3. - EVAPORATOR HEATERS FOR AIR ENVIRONMENT STATIONS.

A second evaporator heater was constructed using a commercially available electric heating element housed in silica-free alumina (Electro-Applications, Inc. Model SK-118). The 4.1 cm I.D. cylindrical tube was comprised of two halves as shown in Fig. 3(b). The wire ends of each half were twisted together so that the two halves operated in parallel to provide 1200 W. The unit, capable of temperatures to 1200 °C was inserted into the 10 cm O.D. insulating tube of cast alumina-silica fiber. Two layers of heavy gauge aluminum foil were wrapped over the outside of the tube followed by one layer of alumina-silica ceramic fiber blanket about 1.27 cm thick. Admittedly, the cast tube and the blanket contained silica but they operated at a much lower temperature than the heater core of the original heater. The whole assembly was then wrapped with another layer of aluminum foil. End losses were minimized by washers about 5 cm thick machined from lava.

Both heaters were supported and centered about the heat pipe by 1.3 cm long stainless steel cylindrical sections fastened to the first and second support disks. While a few failures were experienced over the course of the tests, the heaters as a whole operated satisfactorily as long as 15,000 to 23,000 hr of continuous testing.

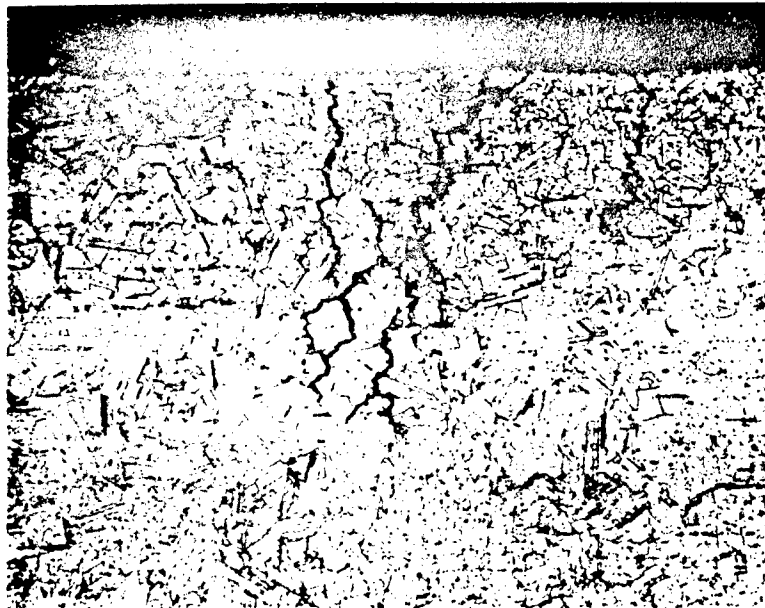
(A) CRACKS IN EXTERNAL SURFACE,  
MAGNIFICATION 100X.

(B) SECTION AT CRACKS, MAGNIFICATION 100X.

FIGURE 26. - WALL CRACKS IN EVAPORATOR END OF  
HAYNES 188 PIPE HA-1.

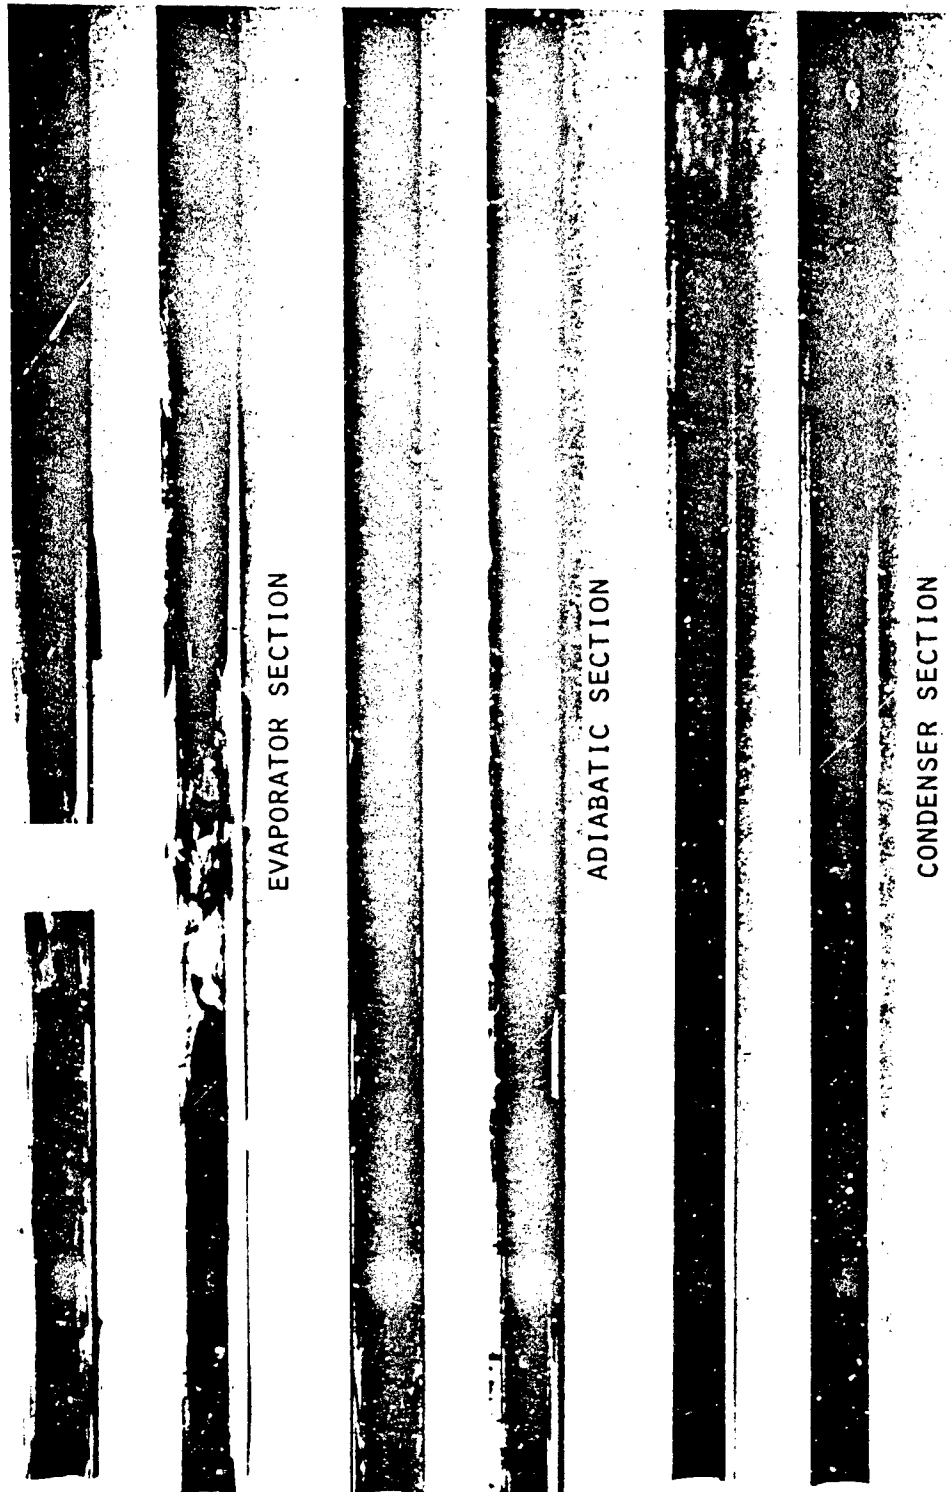
FIGURE 31. - LONGITUDINAL SECTIONS OF HASTALLOY B PIPE HB-6 SHOWING EXTENT OF LITHIUM CORROSION ALONG ENTIRE LENGTH OF PIPE.

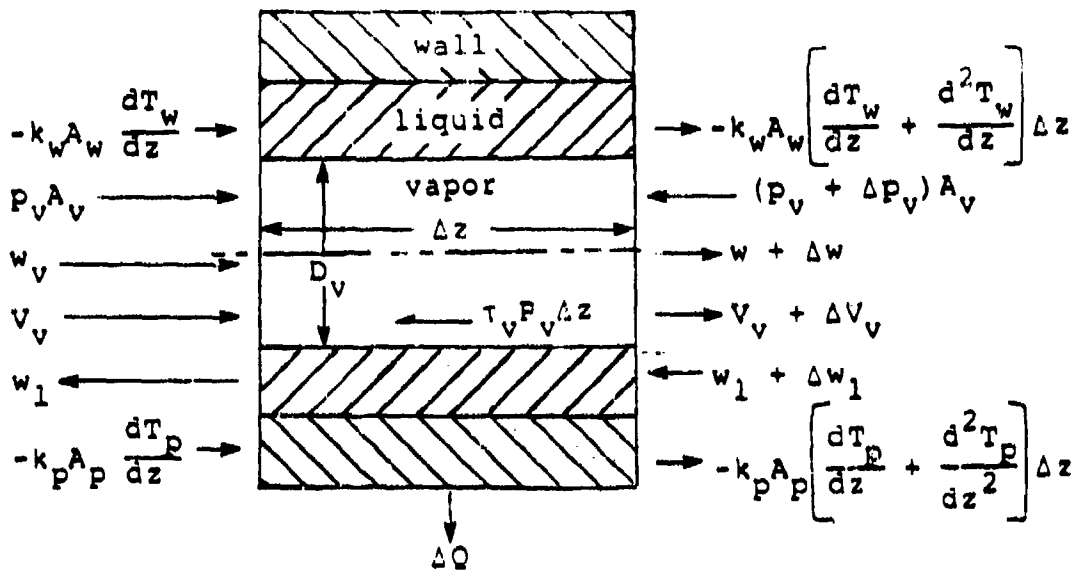
To facilitate computation of the flow in the condenser, a simple one dimensional flow analysis was constructed. The analysis differs from the customary one dimensional flow analysis of Shapiro (Ref. 13) since the control volume is drawn to include the heat pipe wall and fluid. By this means the conduction of heat along the heat pipe wall is easily accounted for. This sketch illustrates the model:
