NSWC TR 85-388

EVALUATION OF THE LMA™ SERIES OF WIRE ROPE TESTING INSTRUMENTS

BY PAUL M. GAMMELL (NSWC) LARRY D. UNDERBAKKE (NCEL)

30 SEPTEMBER 1985

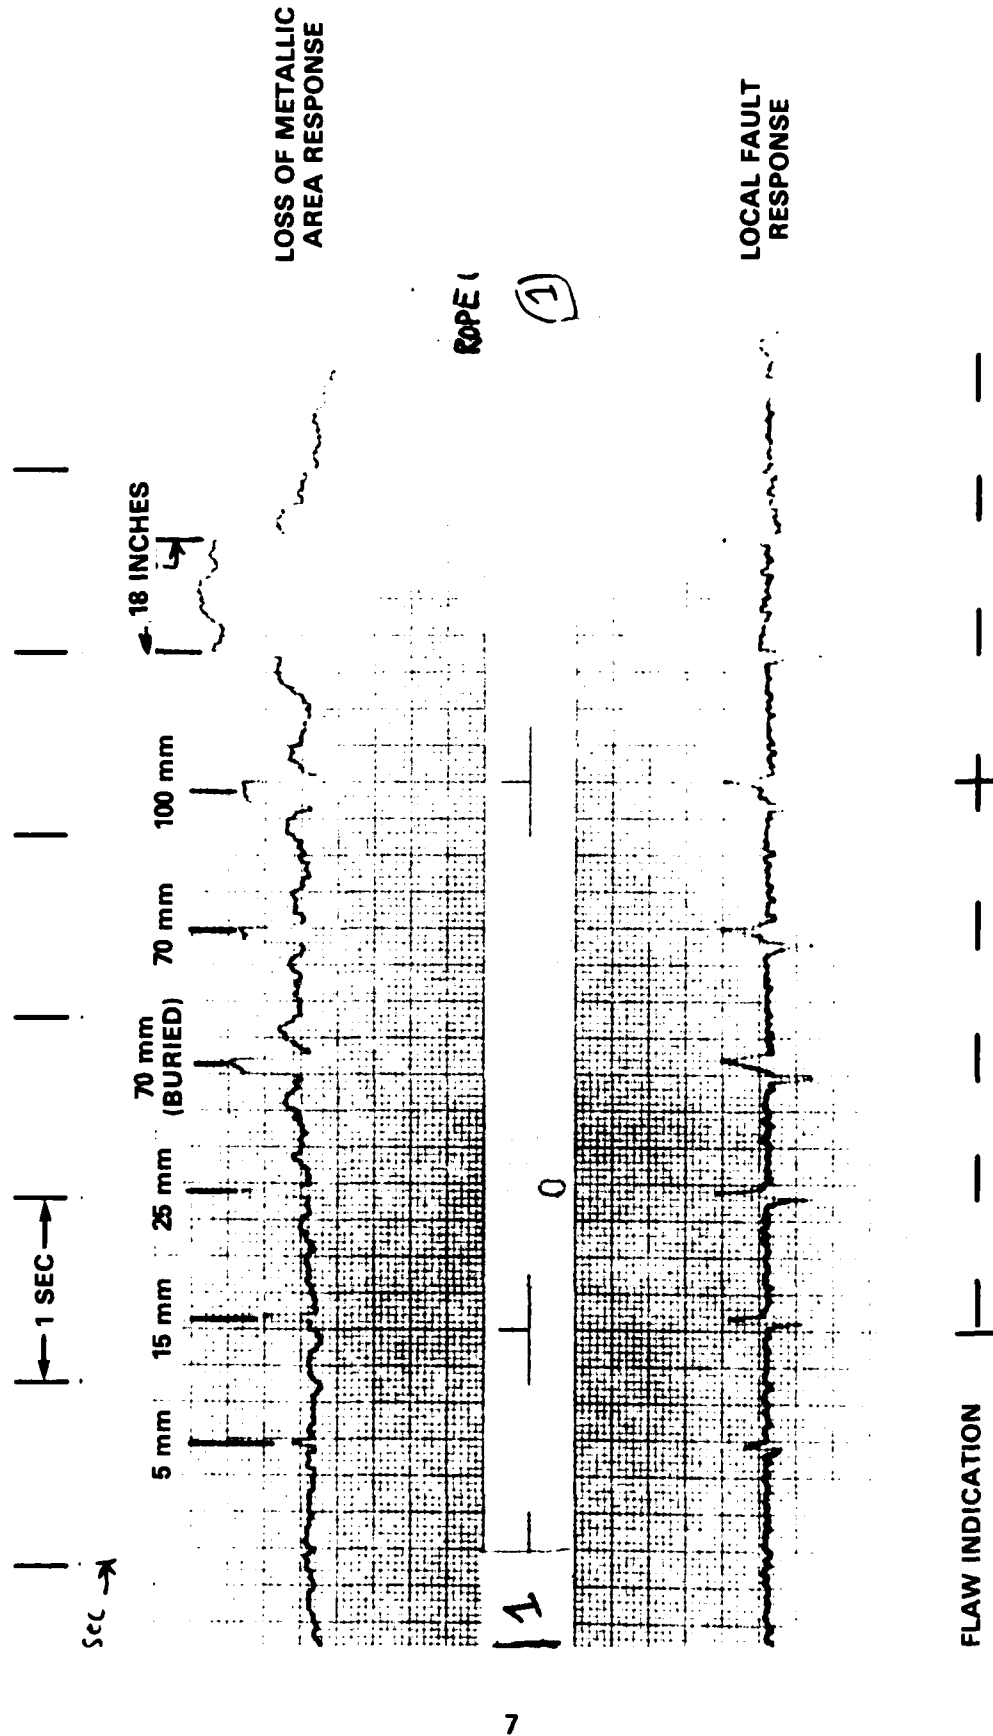
FIGURE 1A. RESPONSE OF LMA-125 TO SIMULATED DEFECTS IN A 0.75-INCH-DIAMETER, 6 x 19 FLOW-STEEL ROPE ON A TEST TRACK (DIRECTLY RECORDED DATA)

Figures 1A and 1B show the local fault and the loss-of-metallic-area signals for these defects. All of these defects are clearly indicated both on the local fault and on the loss-of-metallic-area channel. In this rope, the "rope noise" (background due to the texture of the rope) is well below the indication of a single missing wire. The sensitivity to the 70-mm defect is approximately the same whether it is buried or on the surface. The local fault indication is seen to be of opposite polarity at the beginning and at the end of the defect, both of which trigger the flaw indication at the bottom trace since the threshold has been set appropriately. (The flaw indication ignores the sign of the local fault response.)

This data gives confidence as to the detectability of a gap as small as 5 mm in a single wire. The rope noise of this rope is well below the indication of a single missing wire. The loss-of-metallic-area channel has more than adequate sensitivity. Baseline drift is a problem, however. Even this short record shows a slight drift; in 13 feet of travel, the baseline of the LMA channel shifts by a fifth of the indication of a single missing wire. This problem has been noted on instruments of other manufacturers.

The tape recorder interface faithfully reproduces the data as can be seen by comparing Figure 1B, which is the playback of a recorded signal, with Figure 1A, which is recorded directly from the LMA-125. On playback, the scales and offsets could have been adjusted to suit the operator's needs. The data quality is maintained and is independent of recorder gain since an fm modulation scheme is employed at the interface.

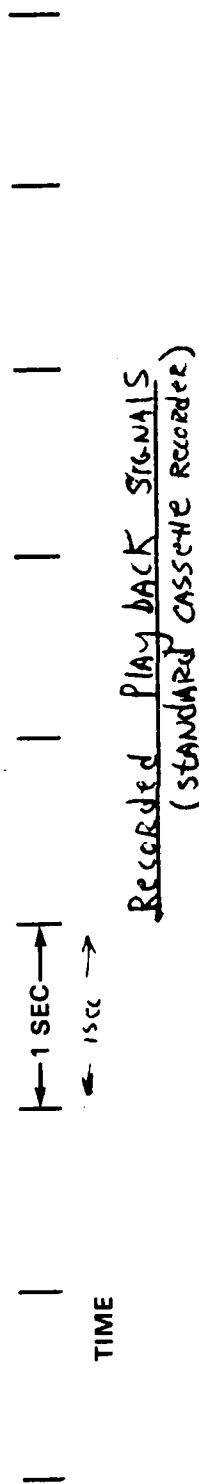
LOSS OF METALLIC
AREA RESPONSE

LOCAL FAULT
RESPONSE

FLAW INDICATION

FIGURE 1B. RESPONSE OF LMA-125 TO SIMULATED DEFECTS IN A 0.75-INCH-DIAMETER, 6 x 19
PLOW-STEEL ROPE ON A TEST TRACK (DATA PLAYED BACK
FROM MAGNETIC CASSETTE)

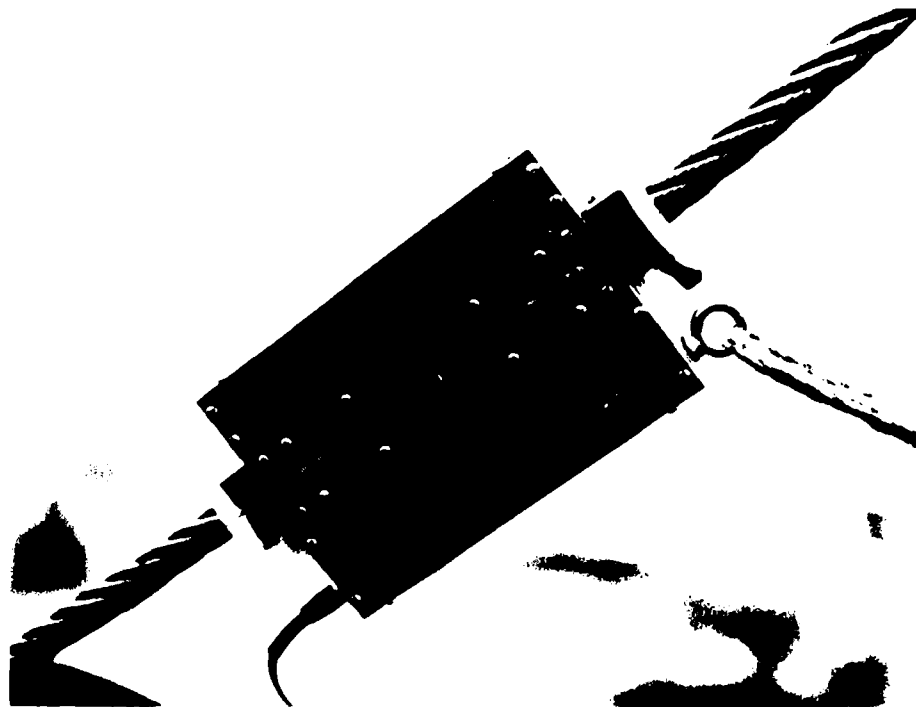
FIGURE 4. THE LMA-75 IN PLACE ON THE WIRE ROPE NEAR THE DRUM WITH THE INSTRUMENT HINGES CLOSED
(NOTE: THE ROPE TETHER (LOWER RIGHT) SAFELY HOLDS THE INSTRUMENT IN PLACE WHILE ALLOWING IT TO FOLLOW THE DRUM WINDINGS. ELECTRICAL CABLE EXITS THE INSTRUMENT AT THE BOTTOM OF THE PICTURE.)

Tests were also conducted using the LMA-75 on a PETTIBONE 50TK crane at Port Hueneme, California. It was equipped with a 5/8-inch, 6 x 25 IWRC rope, rigged in a 6-part line. This crane is shown in Figure 2. The actual testing is shown in Figures 3 to 5. The only load was the ball and hook. The rope was in fair shape, and about 12 indications were noted in around 400 feet of rope. The drum diameter was smaller than on the MANITOWOK crane and about 20 to 30 percent of the indications proved to be external, as expected. Unfortunately, the rope was still in active service and the operator did not want us to open it up with a Marlin spike to examine the interior.
