MTL TR 86-30

MECHANICAL PROPERTY CHARACTERIZATION OF VASCOMAX T-250

July 1986

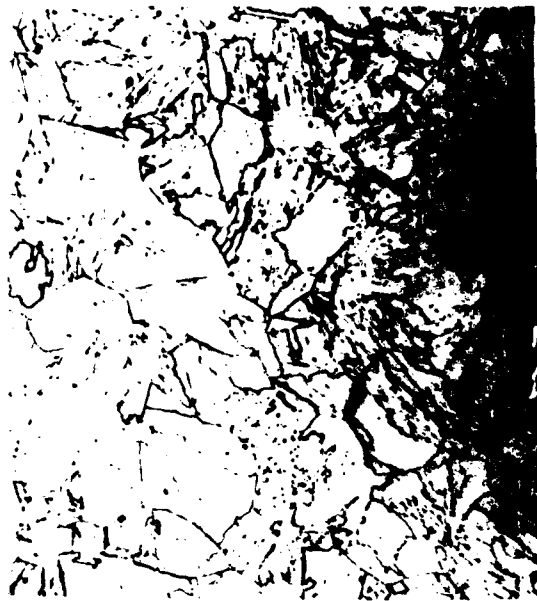
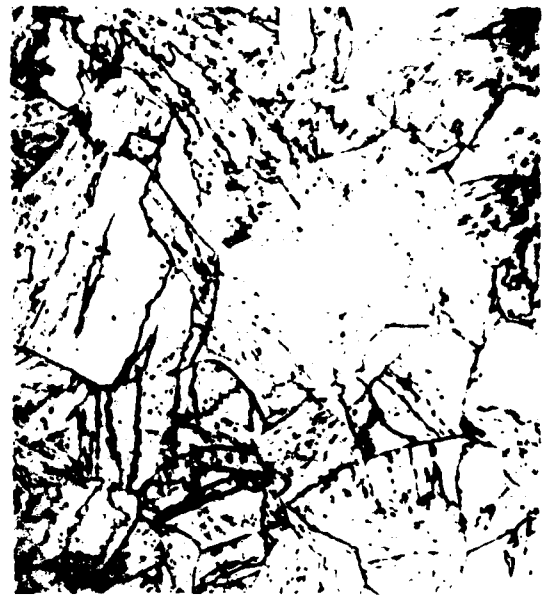
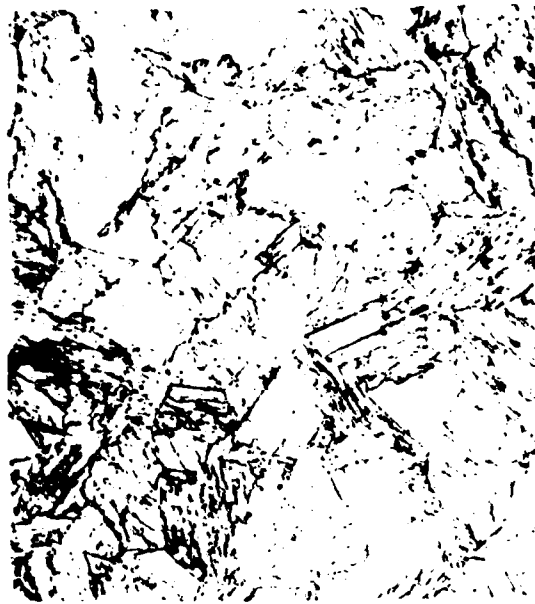
Figure 1. Microstructure from VascoMax T-250 Charpy impact specimens aged at 850°F as a function of aging time. Mag. 500X

Etchant: FeCl_3 in Ethanol with HCL

Orientation: Longitudinal

Microstructures, Figures 1 through 3, were obtained for all heat treatment conditions. All samples exhibit an ASTM grain size of 8 and contain randomly dispersed precipitates. The material aged at 850°F for 3 and 4 hours etches lighter than that aged at the same temperature for 8 hours. Also, all material aged at 850°F etches lighter than that aged at 900°F for 3, 4, or 8 hours. The microstructures from samples aged for various times at 900°F etch uniformly, and are difficult to distinguish from each other. Martensite laths are accentuated by aging at 950°F for 3, 4, or 8 hours, although it is not as obvious for the latter time. Explanations are not offered for these differences in microstructural response as a function of aging time and temperature because a more sophisticated examination is necessary to adequately address this behavior.

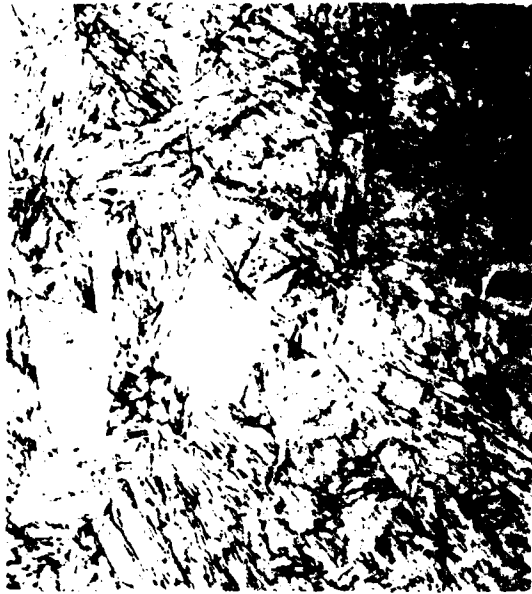
Figure 2. Microstructure from VascoMax T-250 Charpy impact specimens aged at 900°F as a function of aging time. Mag. 500X

Etchant: FeCl₃ in Ethanol with HCL

Orientation: Longitudinal

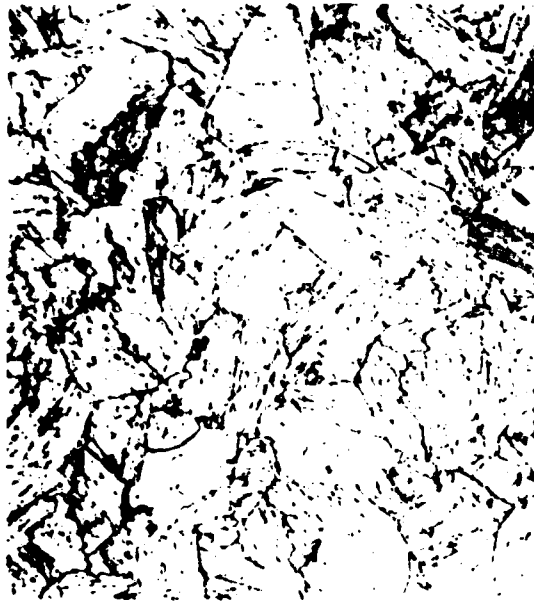
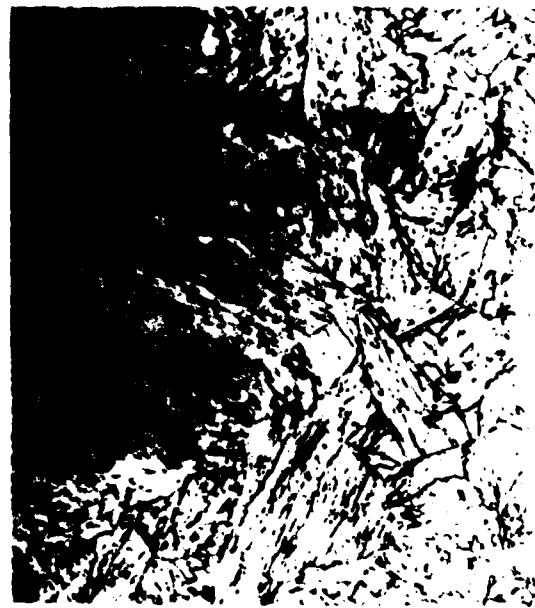
Figure 3. Microstructure from VascoMax T-250 Charpy impact specimens aged at 950°F as a function of aging time. Mag. 500X

Etchant: FeCl_3 in Ethanol with HCL

Orientation: Longitudinal

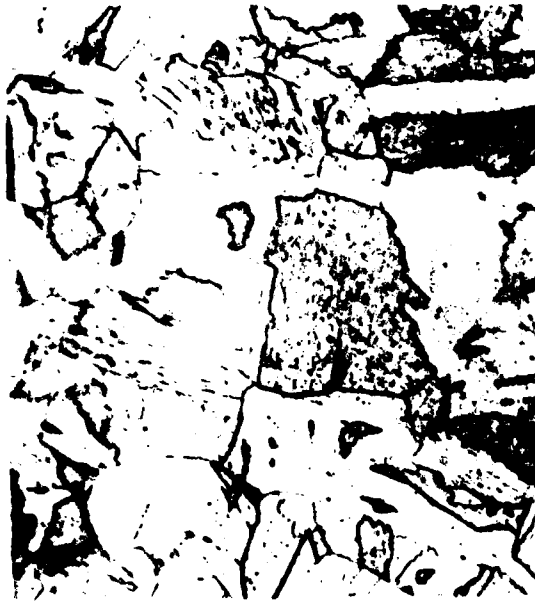
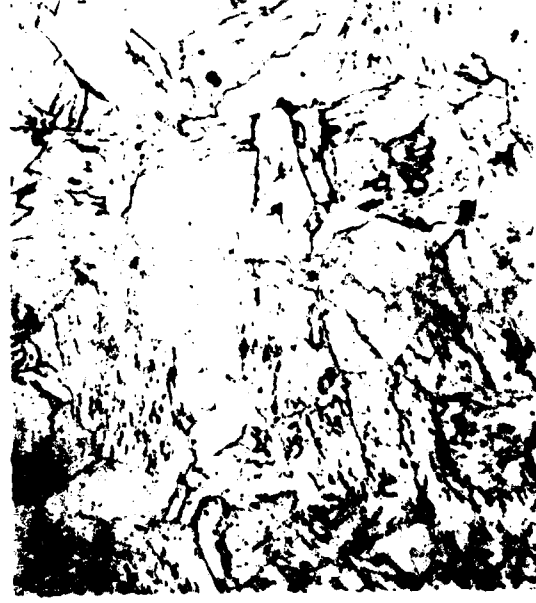
Figure 4. Microstructure from VascoMax T-250 button-head tensile specimens aged for 3 hours as a function of aging temperature. Mag. 500X

Etchant: FeCl_3 in Ethanol with HCL

Orientation: (a) Transverse
(b) Longitudinal
(c) Longitudinal

Microstructures were the first consideration when mechanical property differences were observed between similarly heat treated threaded and button head tensile specimens. Microstructures from samples in which such differences were observed are presented in Figures 4 and 5, where the same trends mentioned in the results with respect to aging temperature and time are seen. Further, Figures 4 versus 5 reveal that the button head samples have slightly larger grain sizes (less than one ASTM grain size number) than similarly heat treated threaded samples. Also, the button head samples took much longer to etch than the threaded samples. A potential explanation for this was a chemical composition difference, however, chemical analyses were run on samples from which the microstructures were obtained and no such difference was observed. It could not be verified that these observed differences in microstructure accounted for the magnitude of the differences in mechanical properties between the tensile bars. This indicated, again, that a knowledge of aging behavior in terms of microstructural aspects could aid the understanding of mechanical property variations with variations in aging treatment.

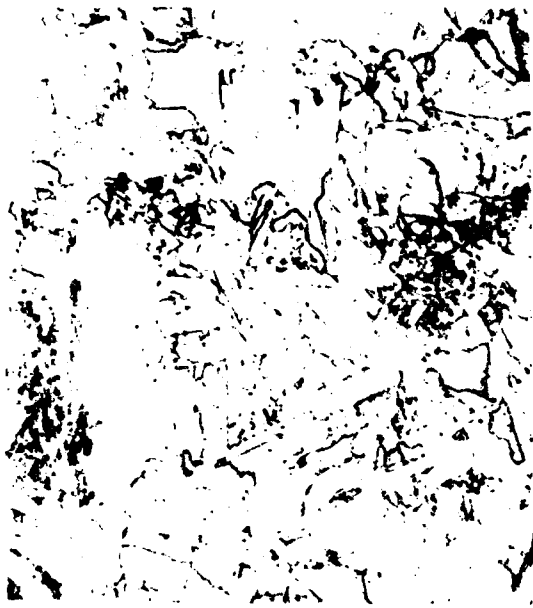
Figure 5. Microstructure from VascoMax T-250 threaded tensile specimens aged for 3 hours as a function of aging temperature. Mag. 500X

Etchant: FeCl_3 in Ethanol with HCL

Orientation: (a) Transverse
(b) Longitudinal
(c) Longitudinal

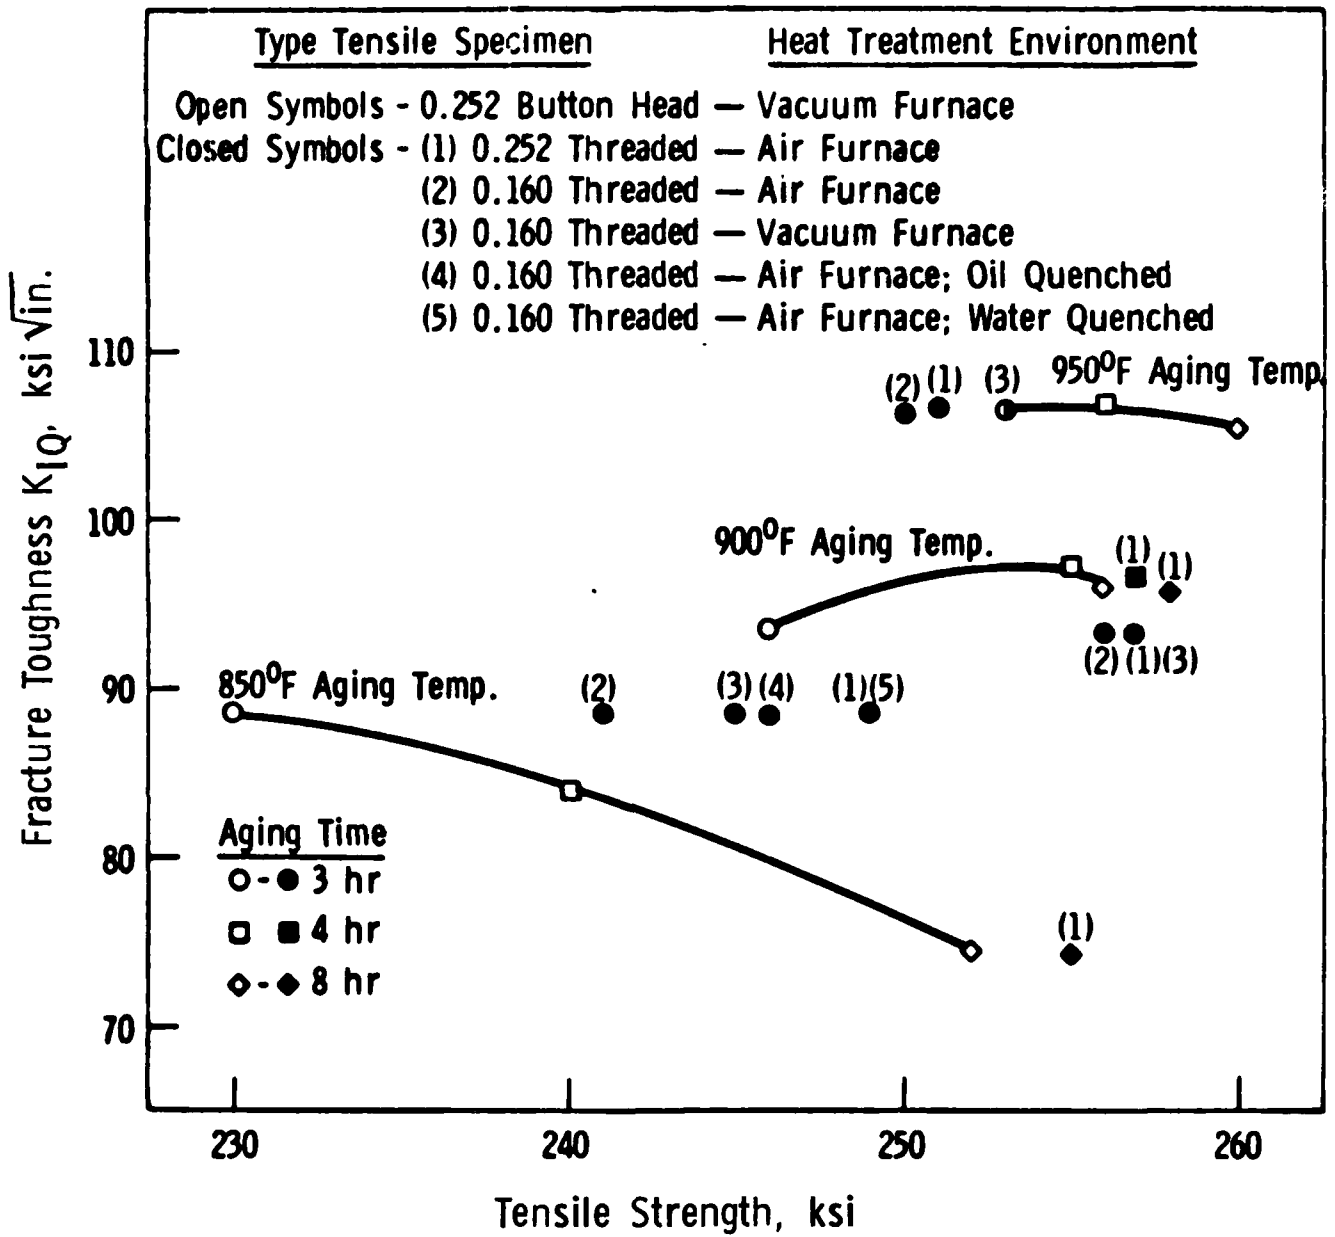
Figure 10. Tensile strength versus fracture toughness as a function of aging treatment.

Figure 10 is a plot of tensile strength versus fracture toughness as a function of aging temperature and time. Numerous observations can be made. First, both the tensile strength and K_{IQ} increase as a function of aging temperature. Based on this trend the 950°F aging temperature gives maximum strength for this alloy in the investigated form (a 900°F aging temperature is used to achieve optimum properties in the 18% Ni 250 and 300 grade maraging steel). For example, a 900°F 4 hour treatment results in 255 ksi/96.7 ksi $\sqrt{\text{in.}}$ tensile strength-fracture toughness combination whereas the respective values for a 950°F 4 hour treatment are 256 ksi

and 106.6 ksi $\sqrt{\text{in}}$. In addition, as shown in Table 4, there is a very significant increase in impact energy, 22.6 to 28.7 ft-lb, when aging temperature is increased from 900 to 950°F.

A second point of interest is the range which was obtained in tensile strength for the 850°F 3 hour age as a function of specimen type and cooling rate. The biggest difference existed between the 0.252-inch-diameter button head and threaded type tensile specimens with values of 230 and 249 ksi, respectively. This difference is believed to be associated with the sensitivity of aging response to temperature for this underaged condition.

A final observation is the decrease in K_{IQ} for the 850°F aging temperature as a function of aging time. Although this is not necessarily unexpected with an increase in strength, the trend does differ from what is observed with the 900 and 950°F aging treatment. These differences are likely associated with aging response. For example, it has been shown that the mechanical properties of aged maraging steel are affected by thermomechanical processing treatments and aging time and temperature which determine levels of retained austenite and precipitate morphology.^{8,9}
