~~AD-A172 991~~  
~~DOT/FAA/PM-86/24~~  
**Engineering Performance Evaluation of  
Small Community Airport  
Microwave Landing System (TI Model)  
at Philadelphia International Airport  
Runway 17**

August 1986

Final Report

| 7. Author(s)<br>G.D. Adams and C.E. Richardson | | | | 8. Performing Organization Report No. | |

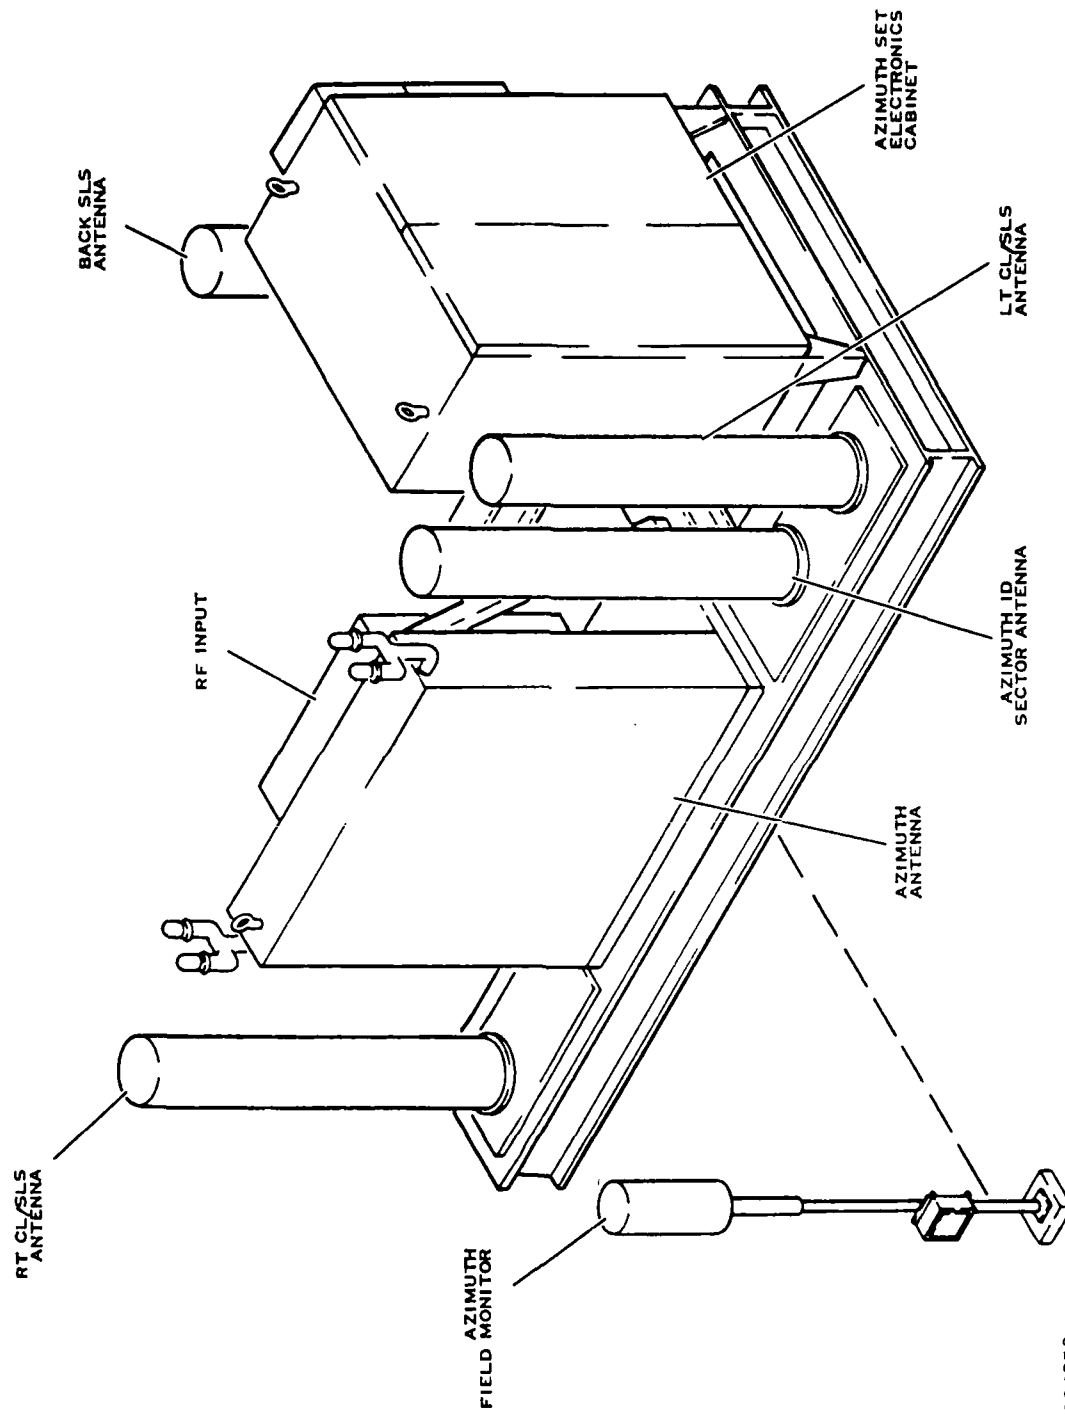
Figure 1 Azimuth Guidance Set

The azimuth unit uses a bifocal pillbox feeding a flat-plate array of 32 waveguides with 37 "C"-shaped slots in each waveguide spaced so as to form a vertical fan beam (3 degree beamwidth). Vertical coverage is provided from 1 degree to 15 degrees in elevation with a sharp underside cutoff (13 dB/degree). This prototype antenna scans a beam from left 12 degrees through centerline to right 12 degrees, providing proportional guidance from left 10 degrees to right 10 degrees. Built-in sector clearance antennas provide full fly-left and full fly-right coverage from left 40 degrees to left 10 degrees, and right 40 degrees to right 10 degrees. The same antennas provide right and left side lobe suppression (SLS) signals except that output power is reduced by 6 dB relative to the clearance signals. The back SLS antenna covers the region -90 degrees through 180 degrees to +90 degrees with 3 dB more power output than the left-right SLS signals.

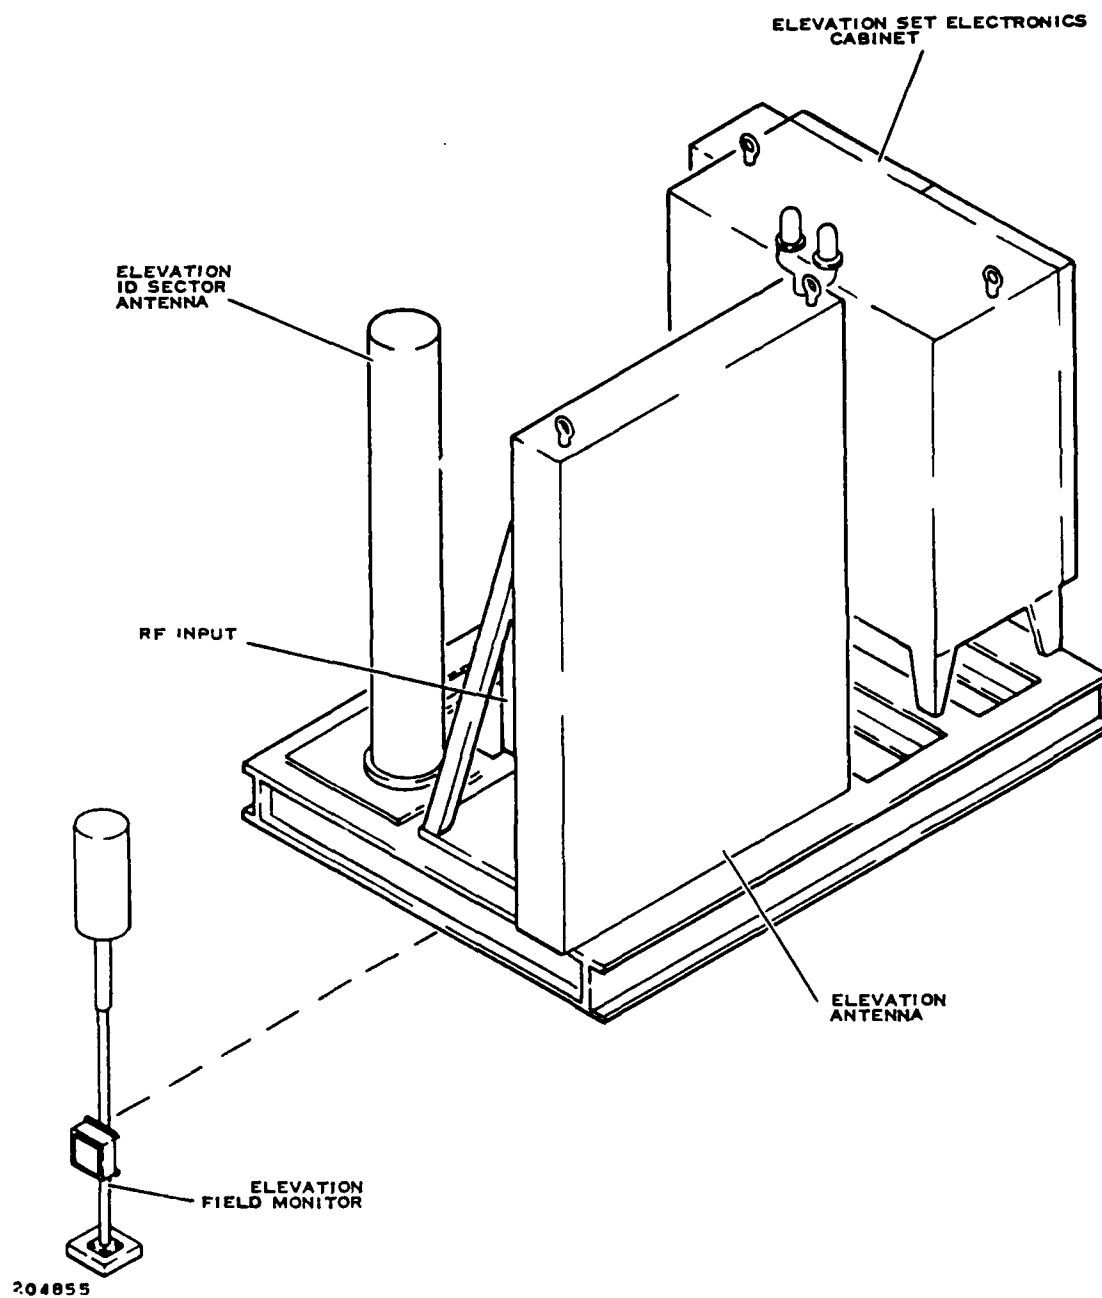
FIGURE 4 Elevation Guidance Set

Figure 4 shows the elevation guidance set consisting of the scanning antenna (40.5 Hz rate), the ID sector antenna, and the electronics cabinet. The scanning antenna is a bifocal pillbox array consisting of 12 monopoles feeding a sub-reflector which feeds a primary reflector. The antenna radiates a beam 2 degrees in width which can scan from 1 degree to 15 degrees in elevation. The ID antenna transmits a Differential Phase Shift Keying (DPSK) signal which conditions the airborne receiver to receive the scanning beam that follows. Figure 5 shows the azimuth pattern of the elevation antenna. The TI SCAMLS summary parameters are listed in Table 1.

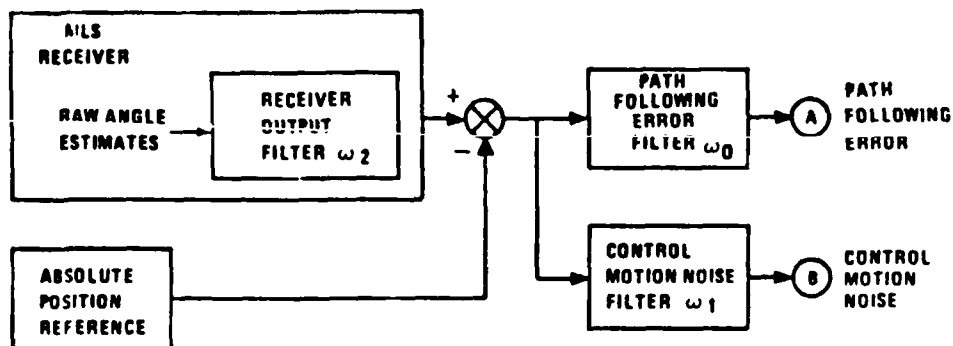
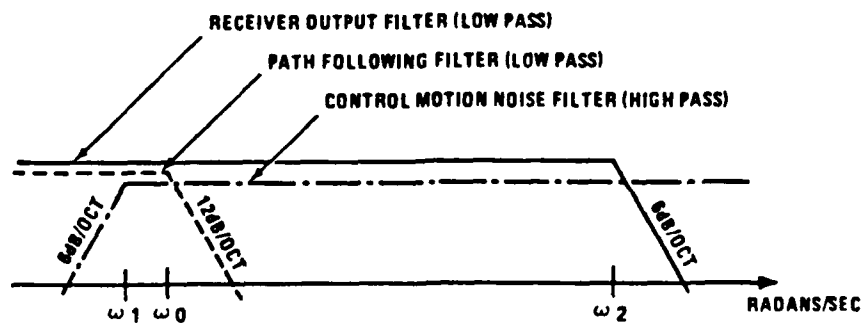
Figure 6. Filter Configurations and Corner Frequencies

PATH FOLLOWING FILTER  $\frac{\omega_n^2}{s^2 + 2\zeta\omega_n s + \omega_n^2} \quad \zeta = 1;$

CONTROL MOTION NOISE FILTER:  $\frac{s}{s + \omega_1} \quad \omega_n = 1.56 \omega_0$

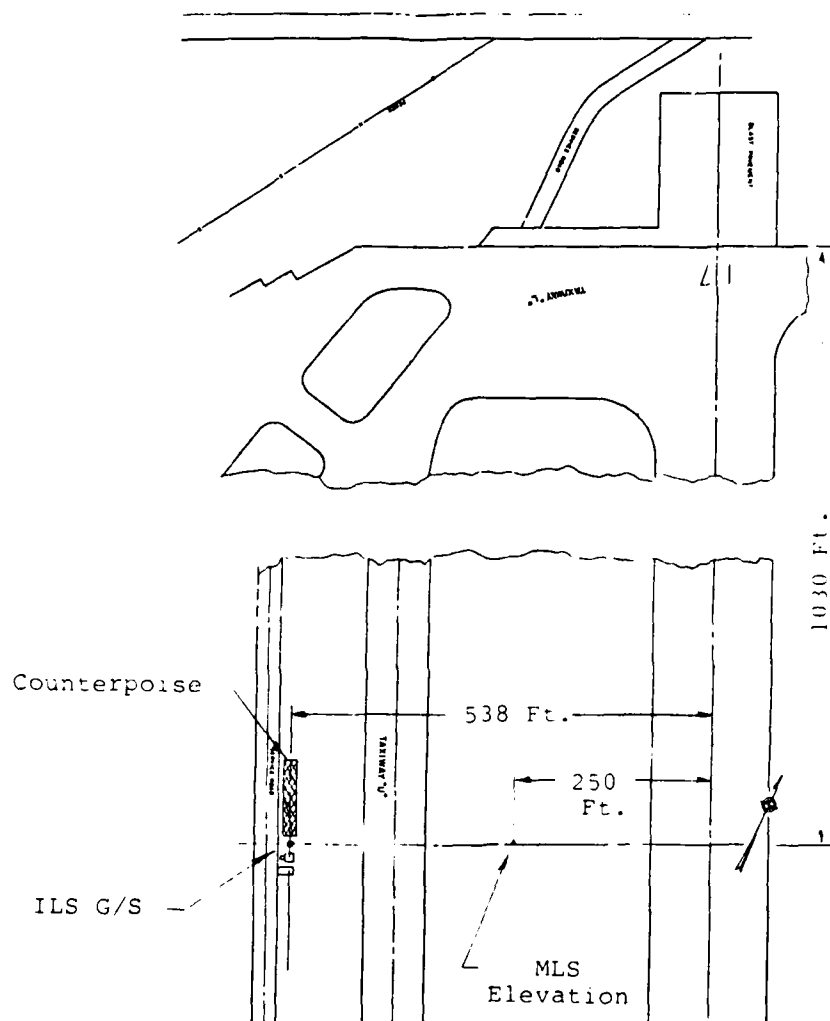
FIGURE 7 ILS and MLS Elevation Location

1. LOCATION. The Texas Instrument Small Community Airport MLS (SCAMLS) was located to serve Runway 17 at Philadelphia International Airport. The Morse code identifier was XZY. The assigned MLS channel was 596 (5059.8MHz). An ILS has also been installed to serve Runway 17. Although Runway 17 has a 743' displaced threshold due to obstacles outside of threshold, the elevation site is located to give a 55' crossing height over the normal threshold (beginning of the pavement). This may place the obstacles closer to the elevation beam lower limit than would be normal. Figure 7 shows the MLS elevation location 250 feet from centerline and also the ILS glide slope antenna location 538 feet from centerline.

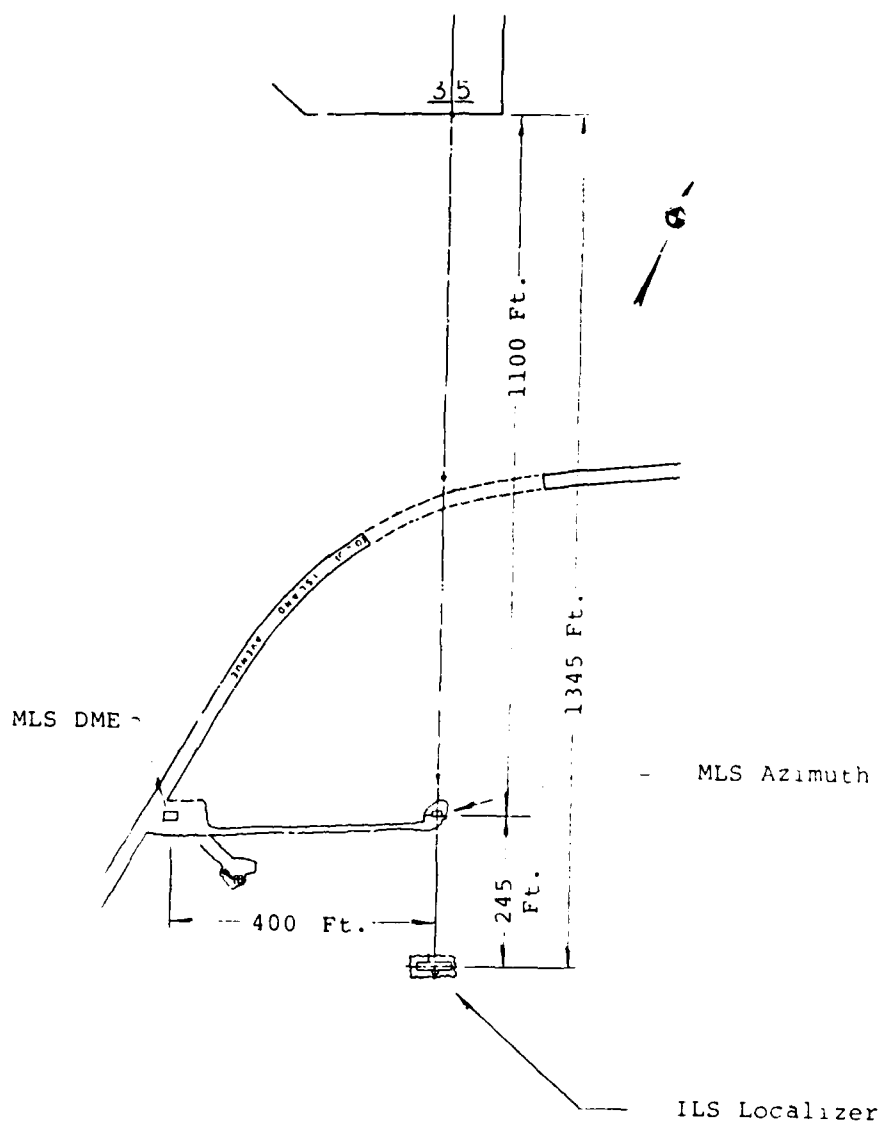
FIGURE 8 ILS Localizer MLS Azimuth and DME Location

The azimuth site is located on the centerline extended (Runway 17/35) 1100' beyond the stop end of Runway 17. This puts it well below the clearance surface for Runway 35. The nearest building to the runway is at an azimuth angle of about 7 degrees from runway centerline and at a maximum elevation of about 0.7 degree. In this position it should not cause noticeable interference on the approach path for either the elevation or azimuth signals. Figure 8 shows the MLS azimuth location on centerline with the DME antenna located 400 feet off centerline, and the ILS localizer located 245 feet behind the azimuth antenna.

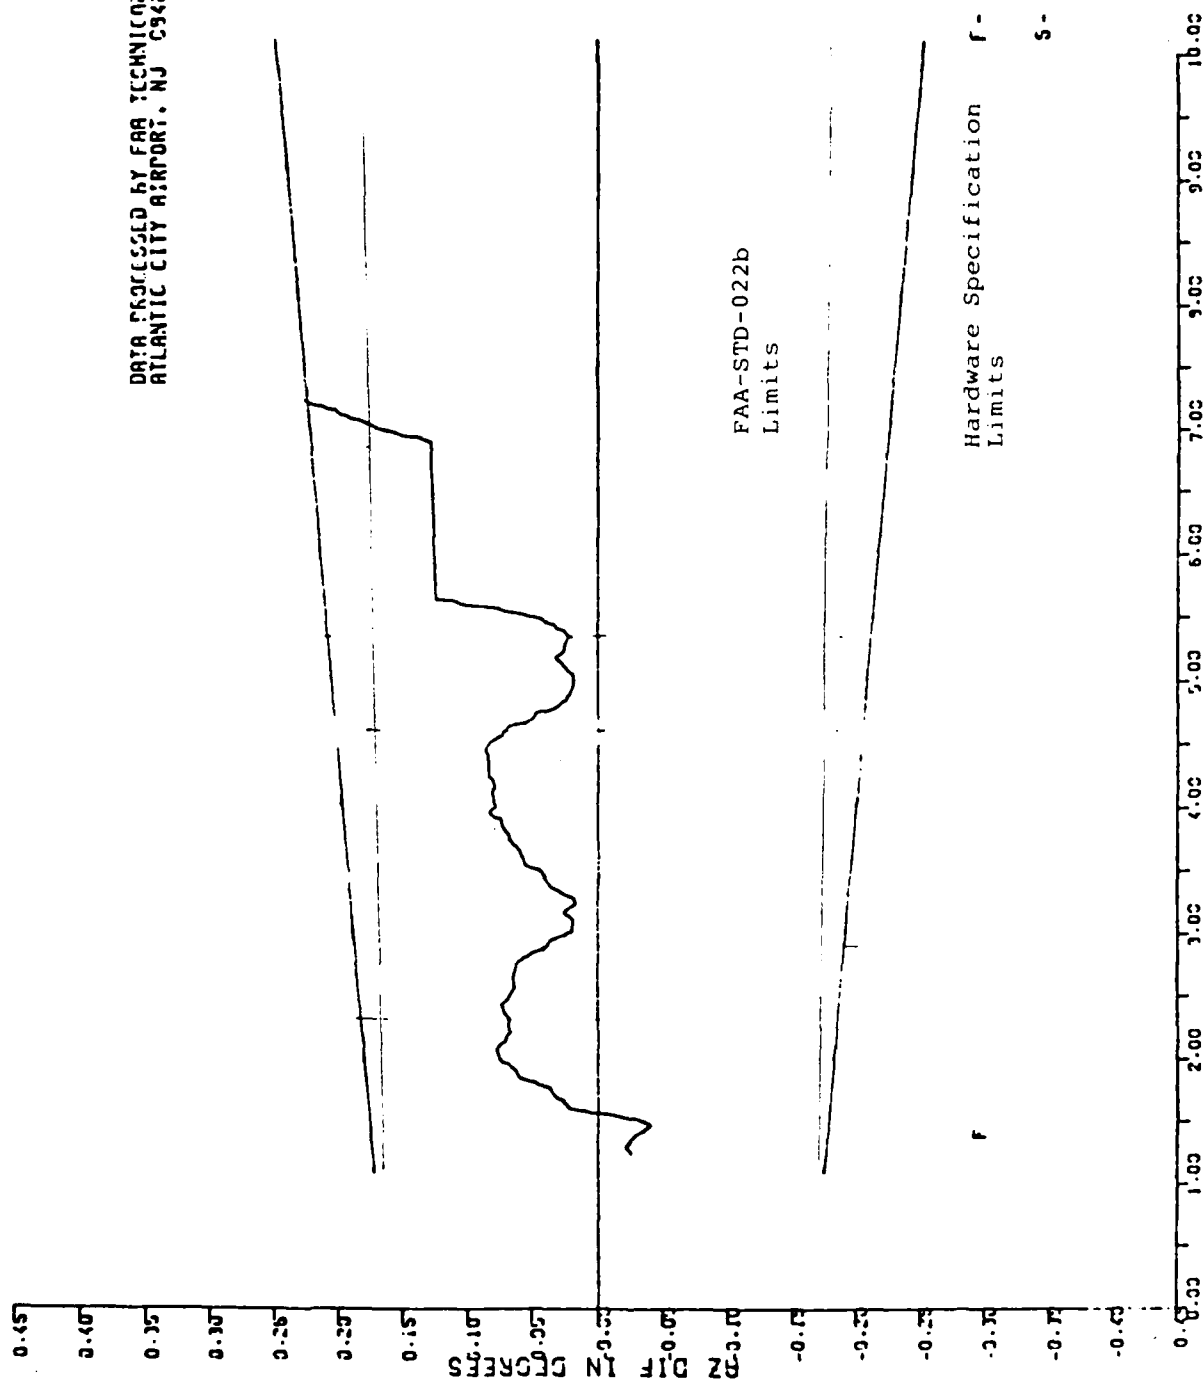
FIGURE 13 AZ DIF; RUN 3, APR 20, 1981, CL 4.5 DEG APP; PFE

Figure 13 is a plot of the azimuth PFE for Run 3 of 20 April 1981, showing the lower frequency effects. Figure 14 is the azimuth CMN for the same run. It can be seen that the lower frequency components cause the CMN to exceed the tolerance limits, and although actual peak-to-peak levels of the higher frequency "noise" are large but they would be within tolerance if the varying bias component is removed. The large excursion at about 5.5 nm must be considered a tracker fault and ignored since the tracker was not locked for the previous 1.4 nm and was locking on the reflector again at this time.

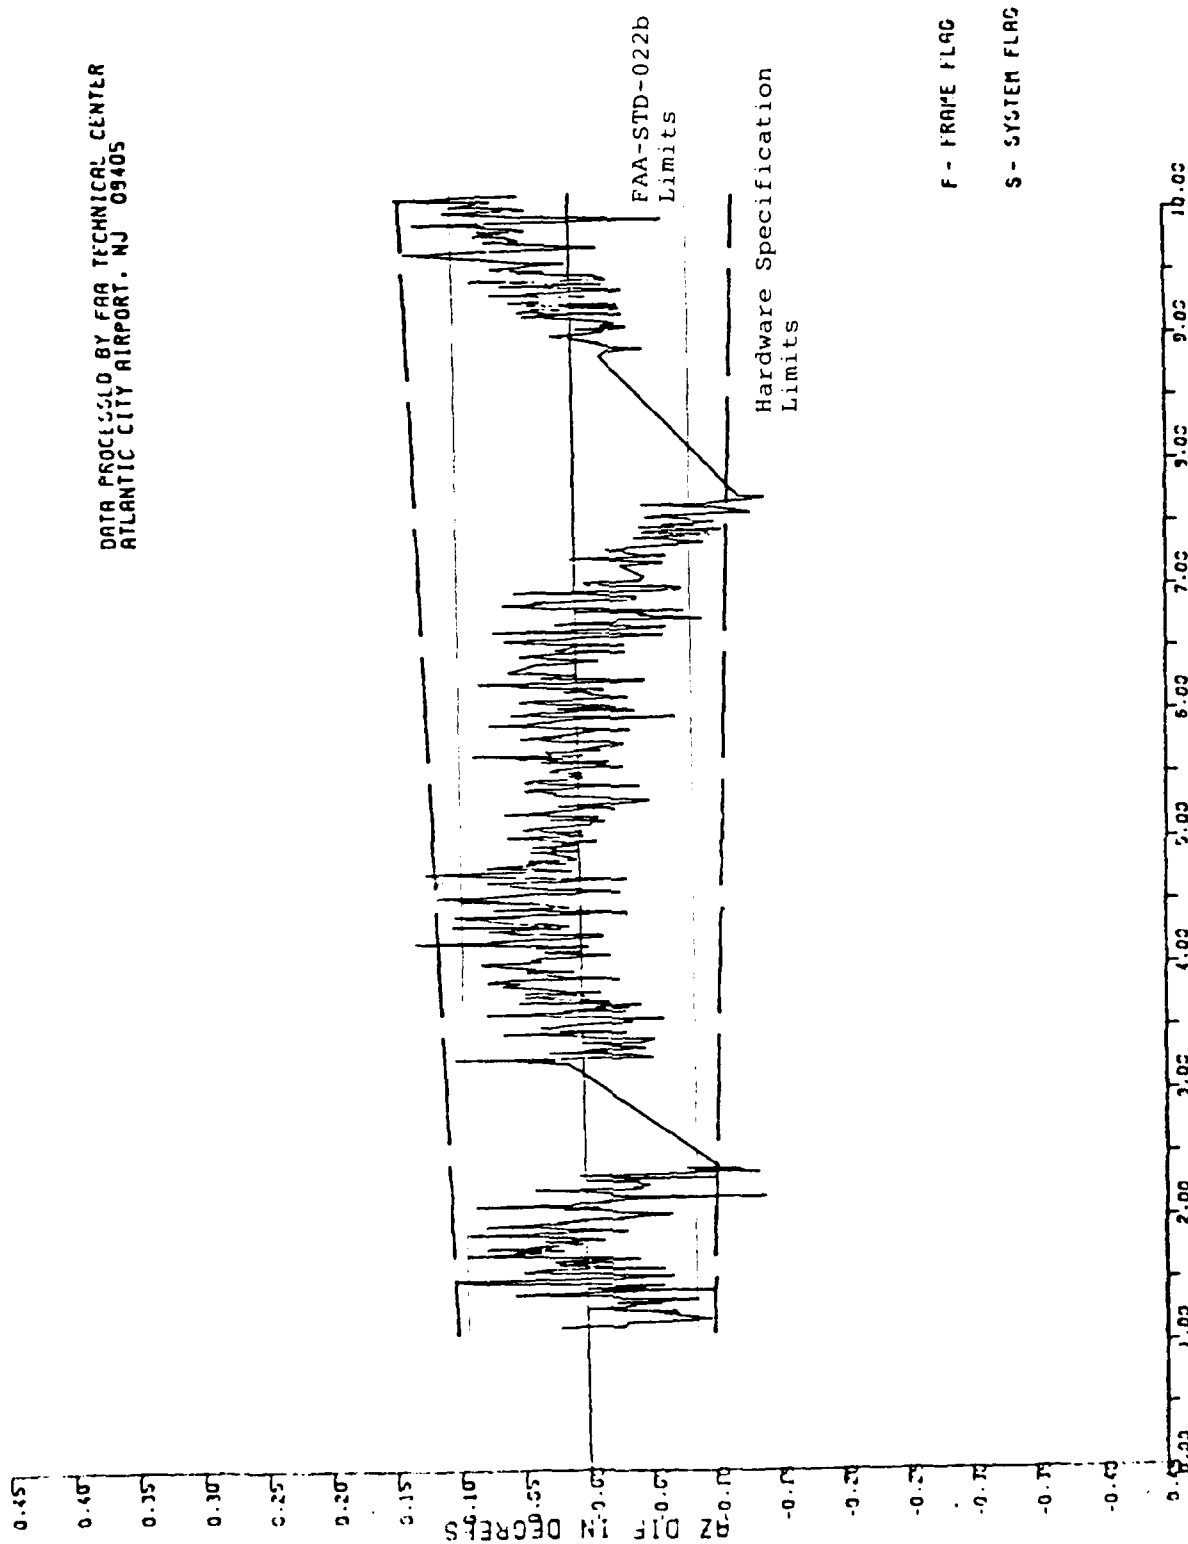
FIGURE 19 AZ DIFF; RUN 3, MAY 13, 1981, CL 6 DEG APP; CMN

The azimuth Control Motion Noise (CMN) data are considered not to meet the hardware or the FAA-STD-022b specification limits, having too many points outside the limits. However, the data are also considered to have a high likelihood of being contaminated by propeller multipath effects. The 6° approach data shown in Figure 19 come close to meeting requirements.

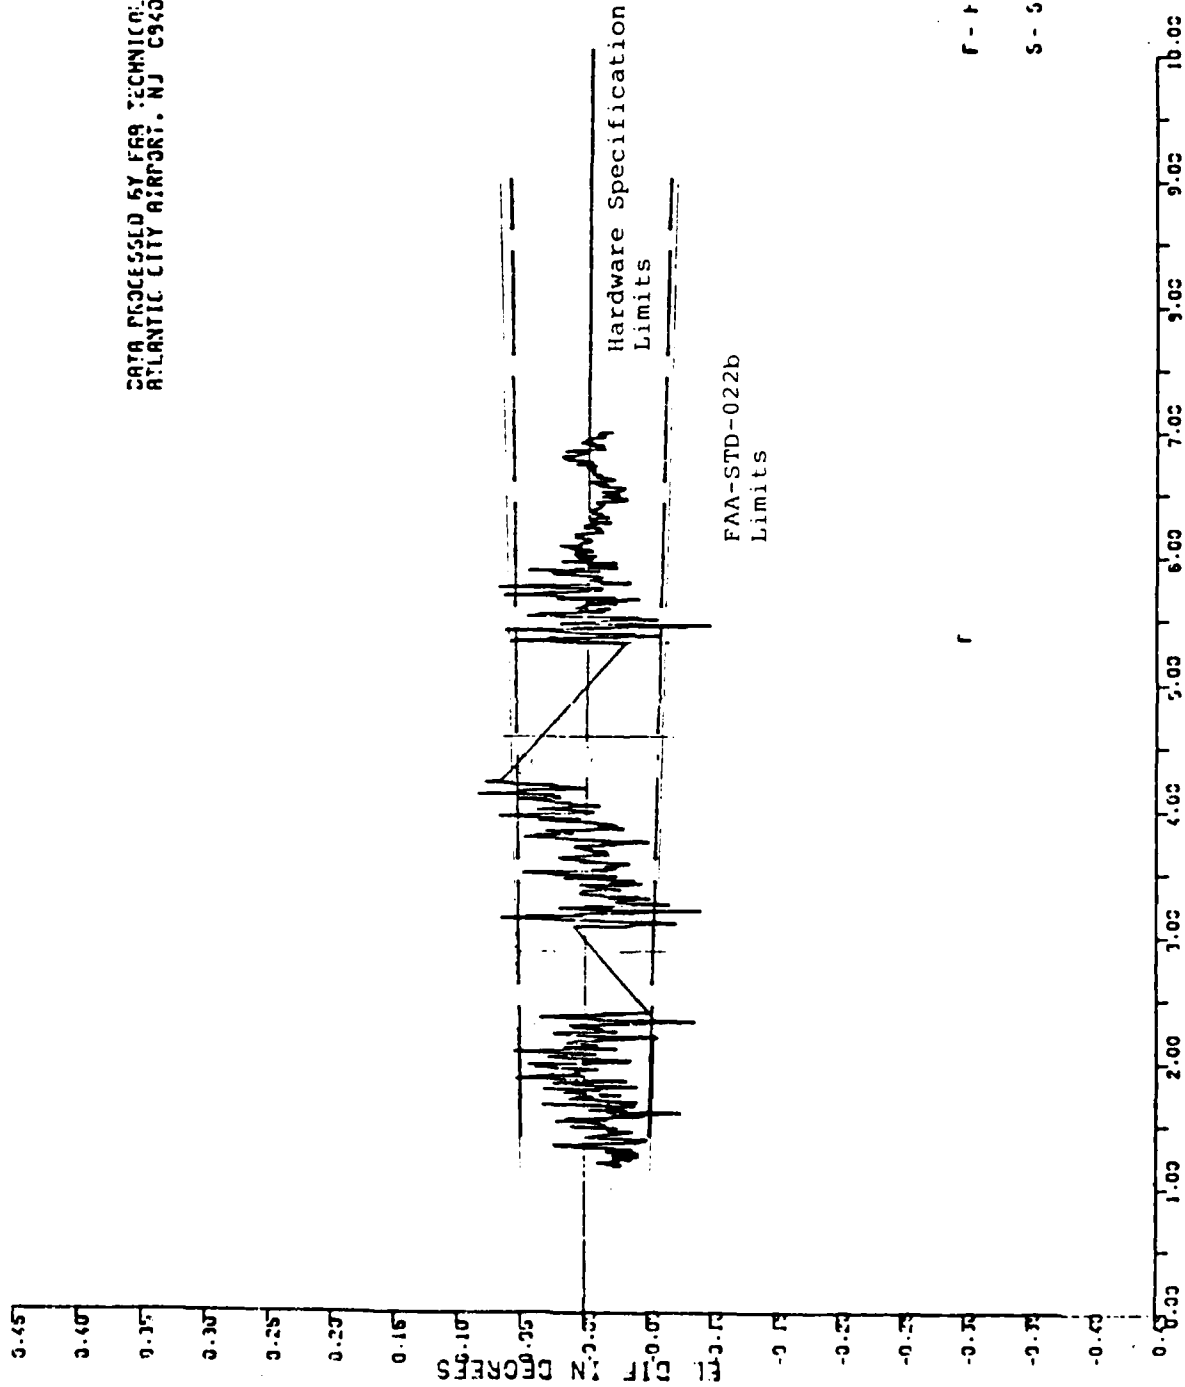
FIGURE 21 EL DIFF; RUN 1, APR 20, 1981, CL 3 DEG APP; CMN

d. Control Motion Noise (C-L). The elevation CMN has low frequency components that tend to drive peaks (probably exceeding the 5% allowed) out of the established tolerances at the lower elevation angles. This can be seen on Figure 21, Run 1 of 20 April 1981, where the low frequency (bias) takes the form of a ramp function during the middle section of the run. However, the ramp may be due to the CMN filter response to the one mile break in the data and the amplitude change from negative errors to positive errors (Figure 22) during the break.

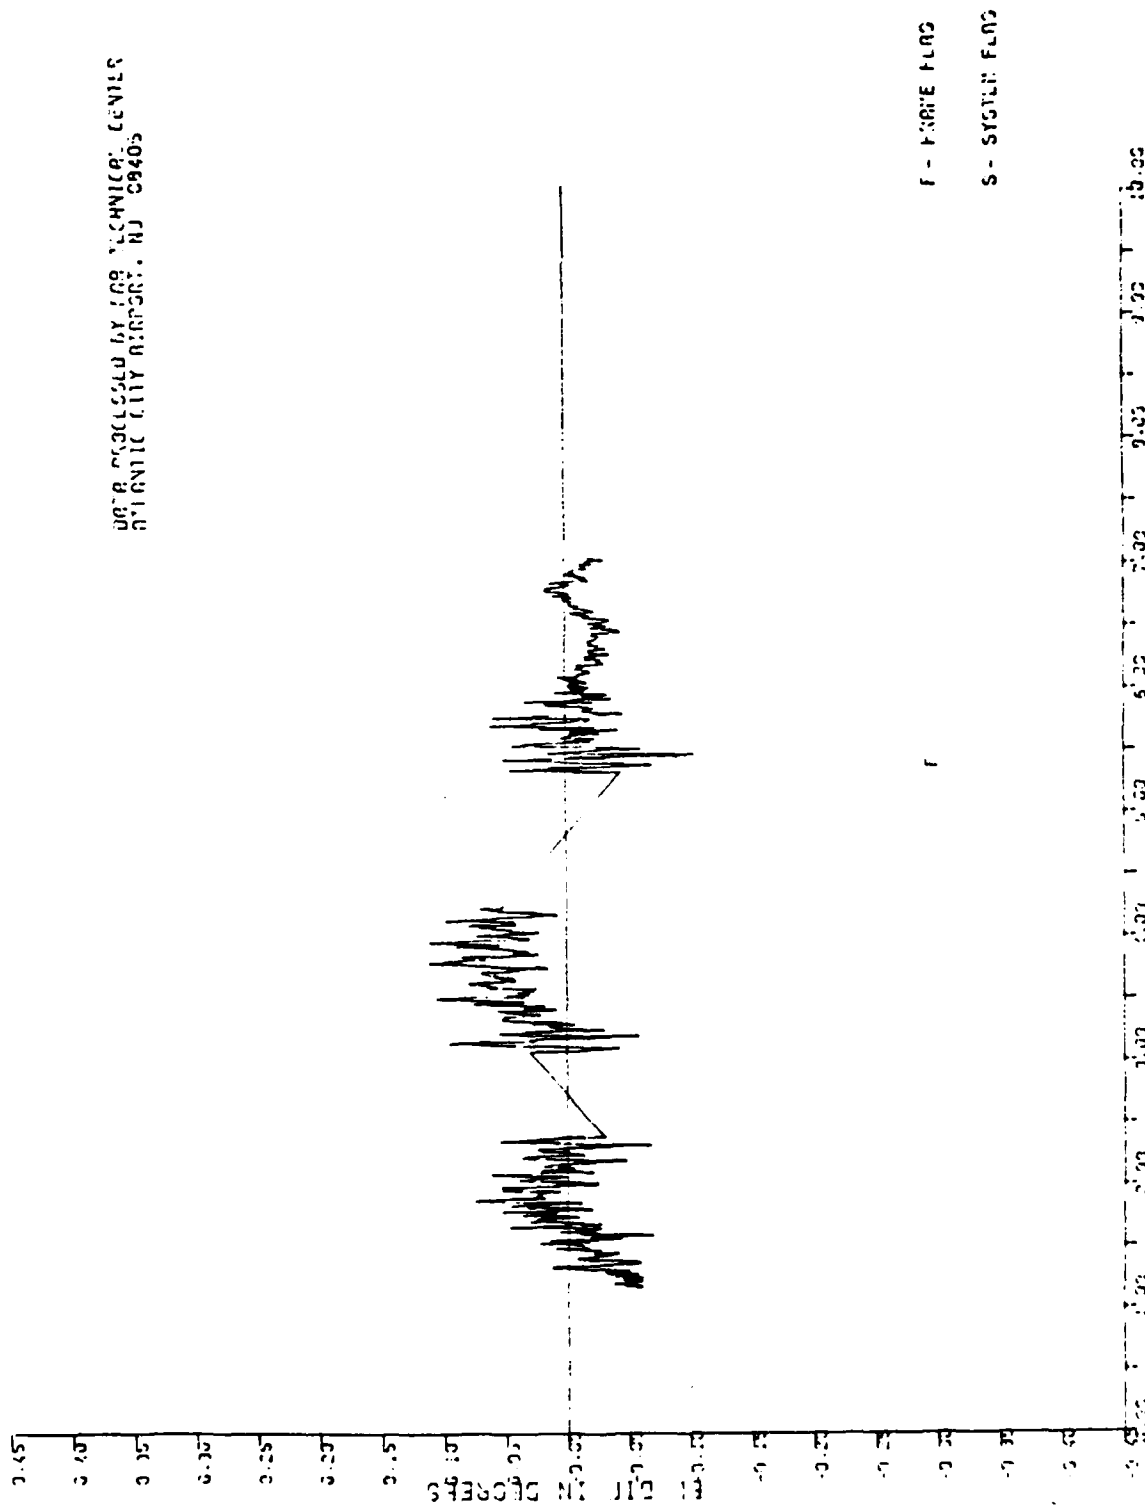
FIGURE 22 EL DIFF; RUN 1, APR 20, 1981, CL 3 DEG APP

As the elevation angle increases the control motion noise moderates from peak-to-peak of 0.1° at 3° elevation to about 0.05° at 6° elevation (Figures 22 & 23). However, a significant portion of the CMN is believed due to the propeller pitch during the aircraft's approach configuration causing a multipath reflection forward into the omni receiving antenna.

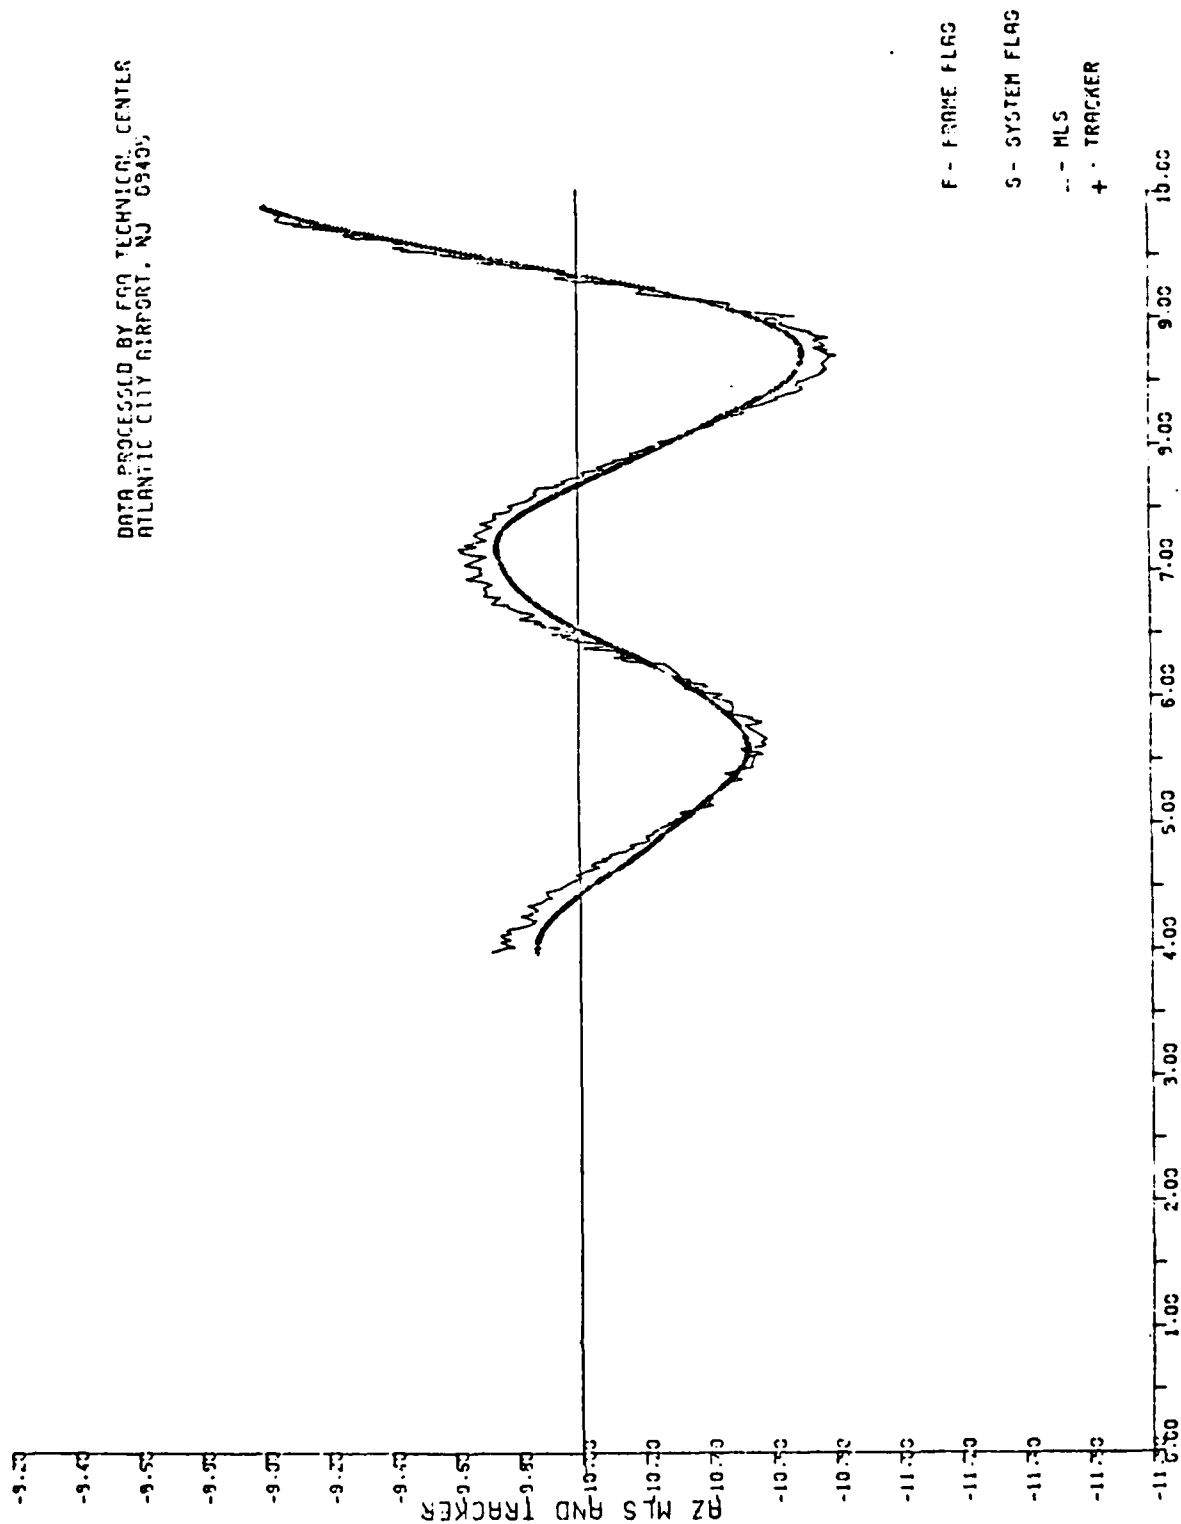
FIGURE 24 AZ; MLS AND TRACKER; RUN 11, MAR 31, 1981,  
10R RADIAL 3000 FT

a. Path Following Error (Radial). The path following error was within tolerances for all radial runs. Some of the plotted PFE can be attributed to antenna pointing errors and to the aircraft flight path corrections. This can be seen in Figures 24 and 25 which represent the tracker vs MLS and azimuth error plots for Run 11 of 31 March 1981. The effects were reflected in the CMN as indicated in Figure 26. A positive bias error of about 0.06° was evident on the 5° right radial while a negative error of about the same magnitude was present on the 5° left radial. Figures 27 and 28 illustrate this bias. At centerline and 10° on either side of centerline there was no significant bias.

The Philadelphia flight data are noisier than the flight data taken at the Technical Center. The radial data are taken as an example because of the apparent propeller induced noise on the approaches. See Figures 24, 25, and 26 (10° R radial) at Philadelphia and Figures 39, 40, and 41 (9° R radial) at the Technical Center, N.J. The source of the extra noise is not identified here. Some factors may be:

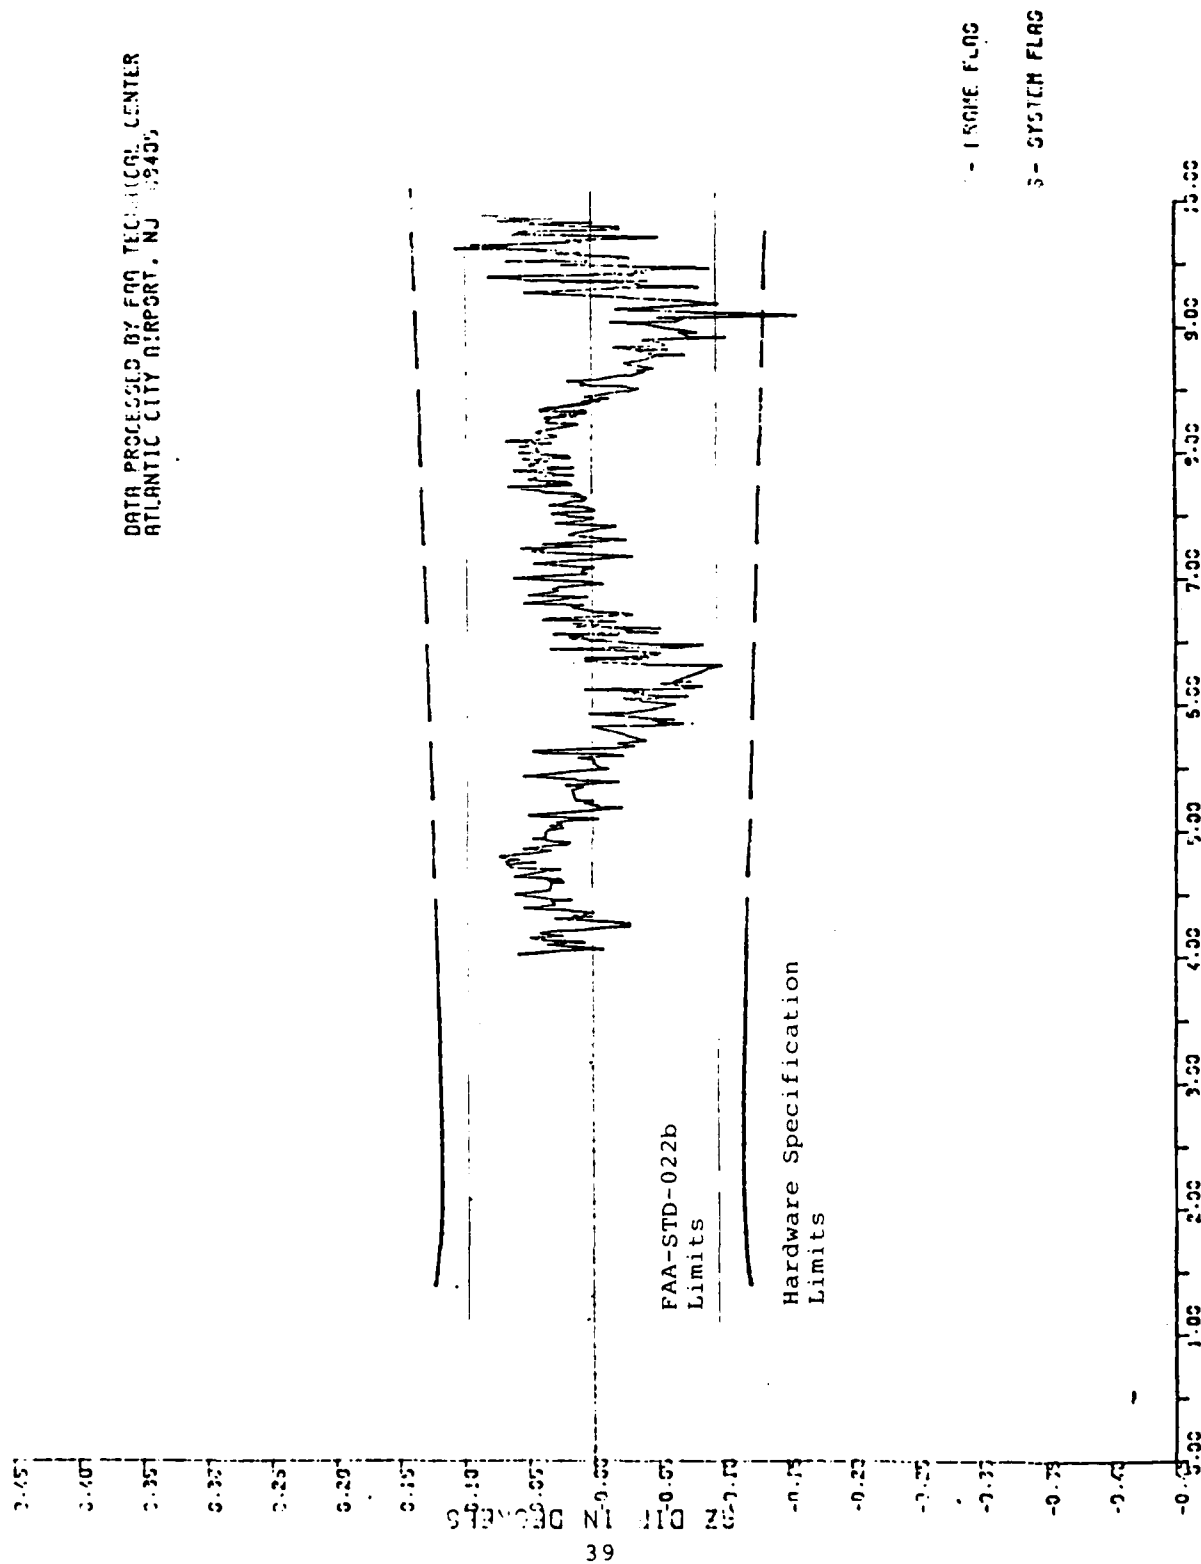
FIGURE 26 AZ DIFF; RUN 11, MAR 31, 1981, IOR RADIAL 3000 FT

Early in the MLS development program, the errors due to signal blockage by, or reflection from, propellers were investigated. It was concluded the reflected interference under these conditions would only cause small amplitude variations in the received scanning beam envelope. More recently, noise effects have been noticed in certain MLS flight data collected on wider beamwidth systems installed to support the MLS STEP. The peak errors recorded are not consistent with signal-to-noise ratios in the receiver and become particularly noticeable after a change of MLS antennas on the CV-580 test aircraft. The MLS receiving antenna for these flights was an omni-directional stub mounted on the aircraft nose in front of the windshield. This turbo-prop aircraft has unusually large propeller blades, and the typical propeller rotation rates are high enough to cause a significant relative phase change (and thus a distortion of the direct signal) during the dwell time of the wider scanning beam envelopes. The effects appear to be function of the propeller pitch, becoming noticeable when the pitch is set for approach power settings. This may be the effect shown in Figure 15 with the lower noise levels at greater ranges corresponding to cruise configuration. This is further supported by noting the lower noise levels on the level flyovers, (Figure 26, 30) which would be in cruise configuration.

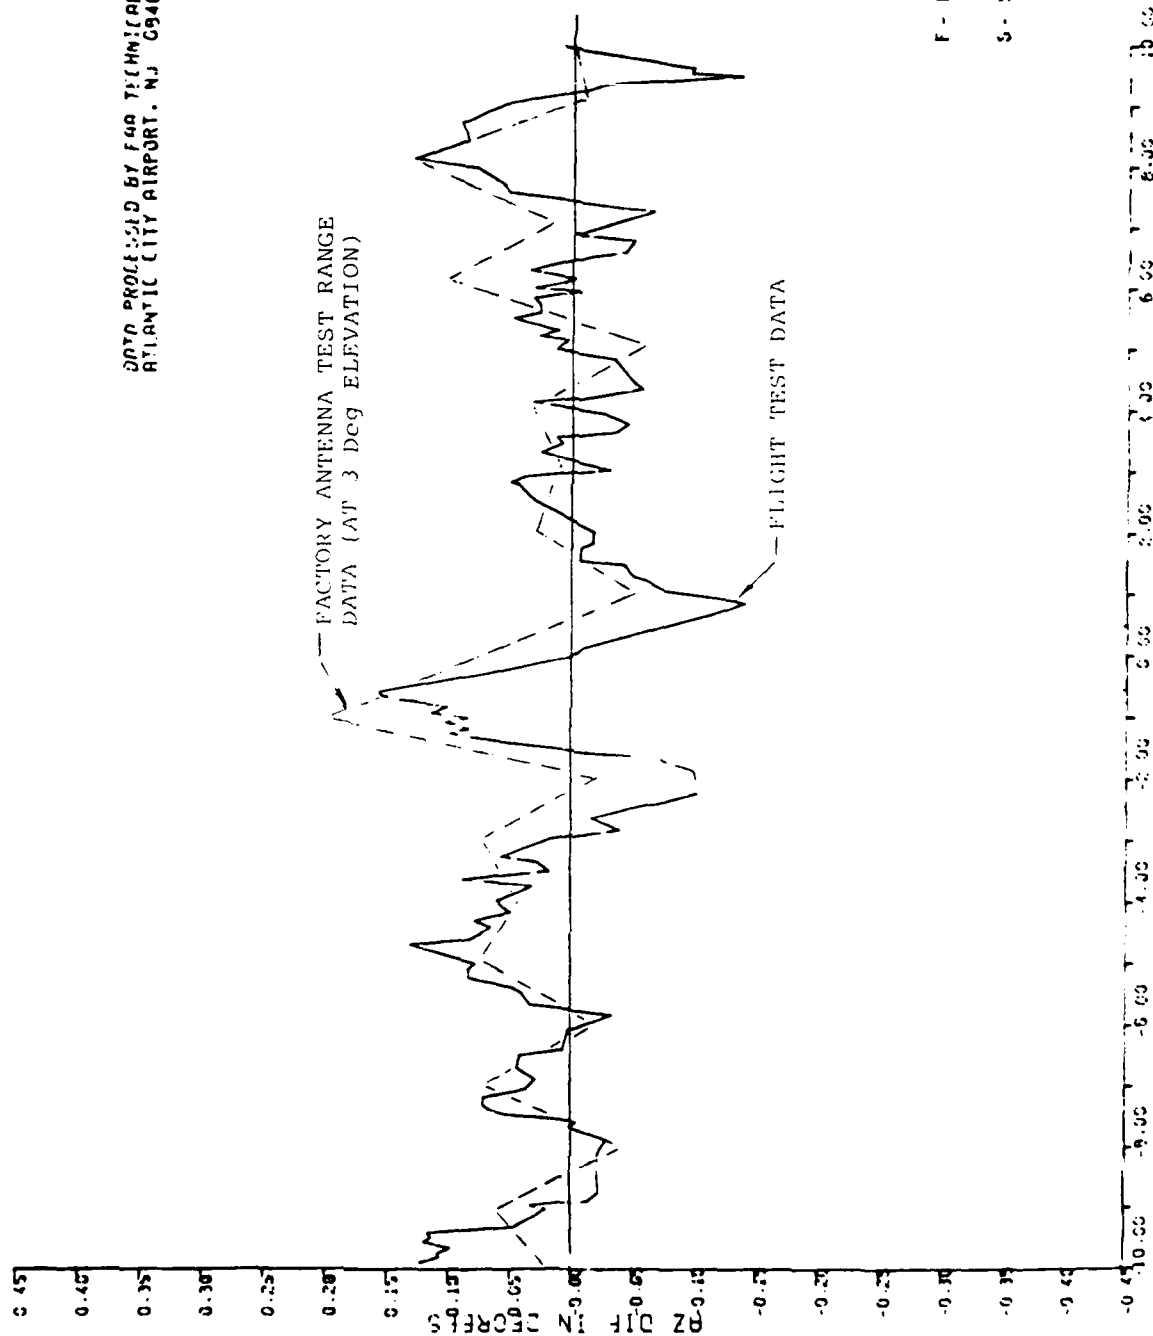
FIGURE 31 AZ DIFF; RUN 6, MAY 13, 1981, 6NM CCW ORB 3000 FT  
(WITH FACTORY ANTENNA TEST DATA SUPERIMPOSED)

Around centerline, where the  $0.1^\circ$  error per degree of angle linearity requirement (FAA-STD-022b) applies, large error changes are noted in Figure 31. These are calculated as  $0.18^\circ$  error per degree of angle or larger.

4. Comparison with Previous Data. Figure 31 (page 45) shows orbital flight data for the azimuth. Also plotted on that figure is the factory antenna range data taken at an elevation angle of  $3^\circ$ . This is a degree or two below the elevation angle on the orbit, but the two sets of data show a good correlation. The lapsed time was about 4 years and the system was installed at the FAA Technical Center before being moved to Philadelphia.

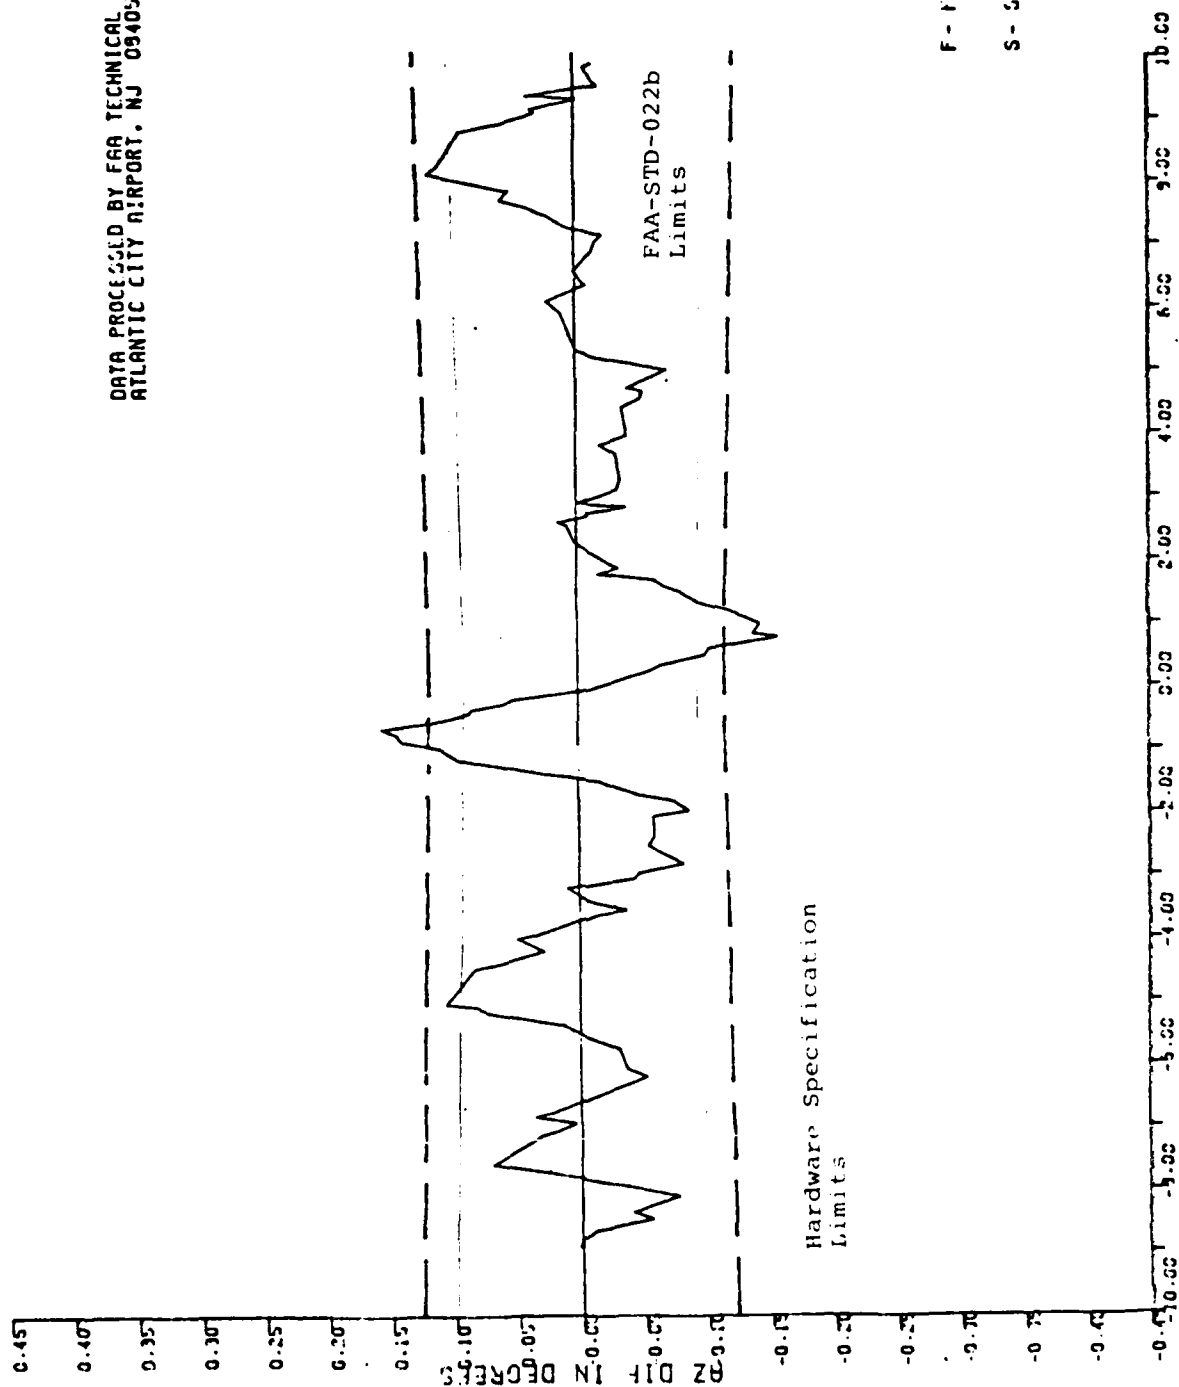
FIGURE 33 AZ DIFF; RUN 5, MAY 13, 1981, 6NM CCW ORB 3000 FT; CMN

b. Azimuth Control Motion (ORB). Figure 33 from Run 5 of 13 May 1980 indicates two out-of-tolerance conditions on a single cycle of about eight seconds duration. This would be representative of a noise frequency of 0.13Hz, about 0.8 radians/s. This is well within the CMN band which includes frequencies from 0.3 to 10 radians/s. These excursions are due to azimuth beam pointing errors.
