~~AD-A172 991~~  
~~DOT/FAA/PM-86/24~~  
**Engineering Performance Evaluation of  
Small Community Airport  
Microwave Landing System (TI Model)  
at Philadelphia International Airport  
Runway 17**

August 1986

Final Report

| 7. Author(s)<br>G.D. Adams and C.E. Richardson | | | | 8. Performing Organization Report No. | |

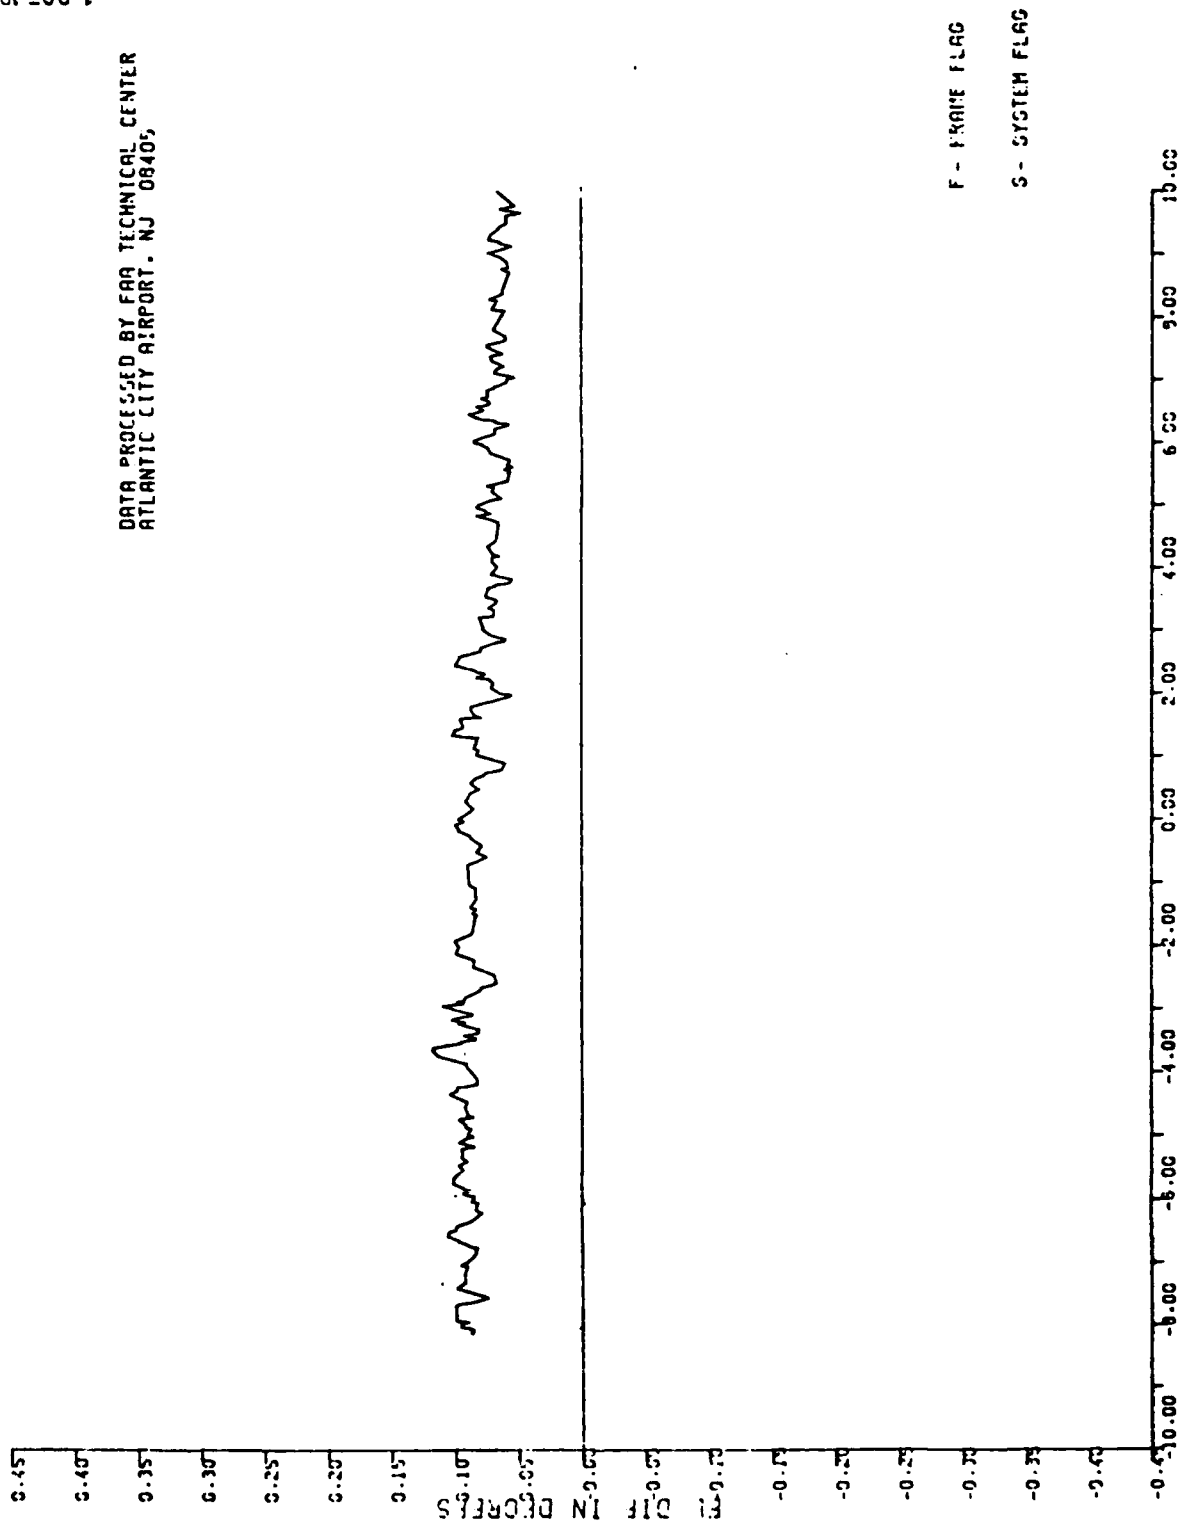
FIGURE 37 EL DIFF; RUN 8, APR 15, 1981, 6NM CW ORB 4500 FT

d. Elevation Control Motion Noise (ORB). The control motion noise was within tolerance for all runs. Almost all the raw error frequency spectrum was included as CMN as can be seen from Figures 37 and 38 of the raw error and the CMN for Run 8 of 15 April 1981. The CMN indicated a positive bias in Figure 38, probably caused by early initialization but should not be considered a part of the "noise".

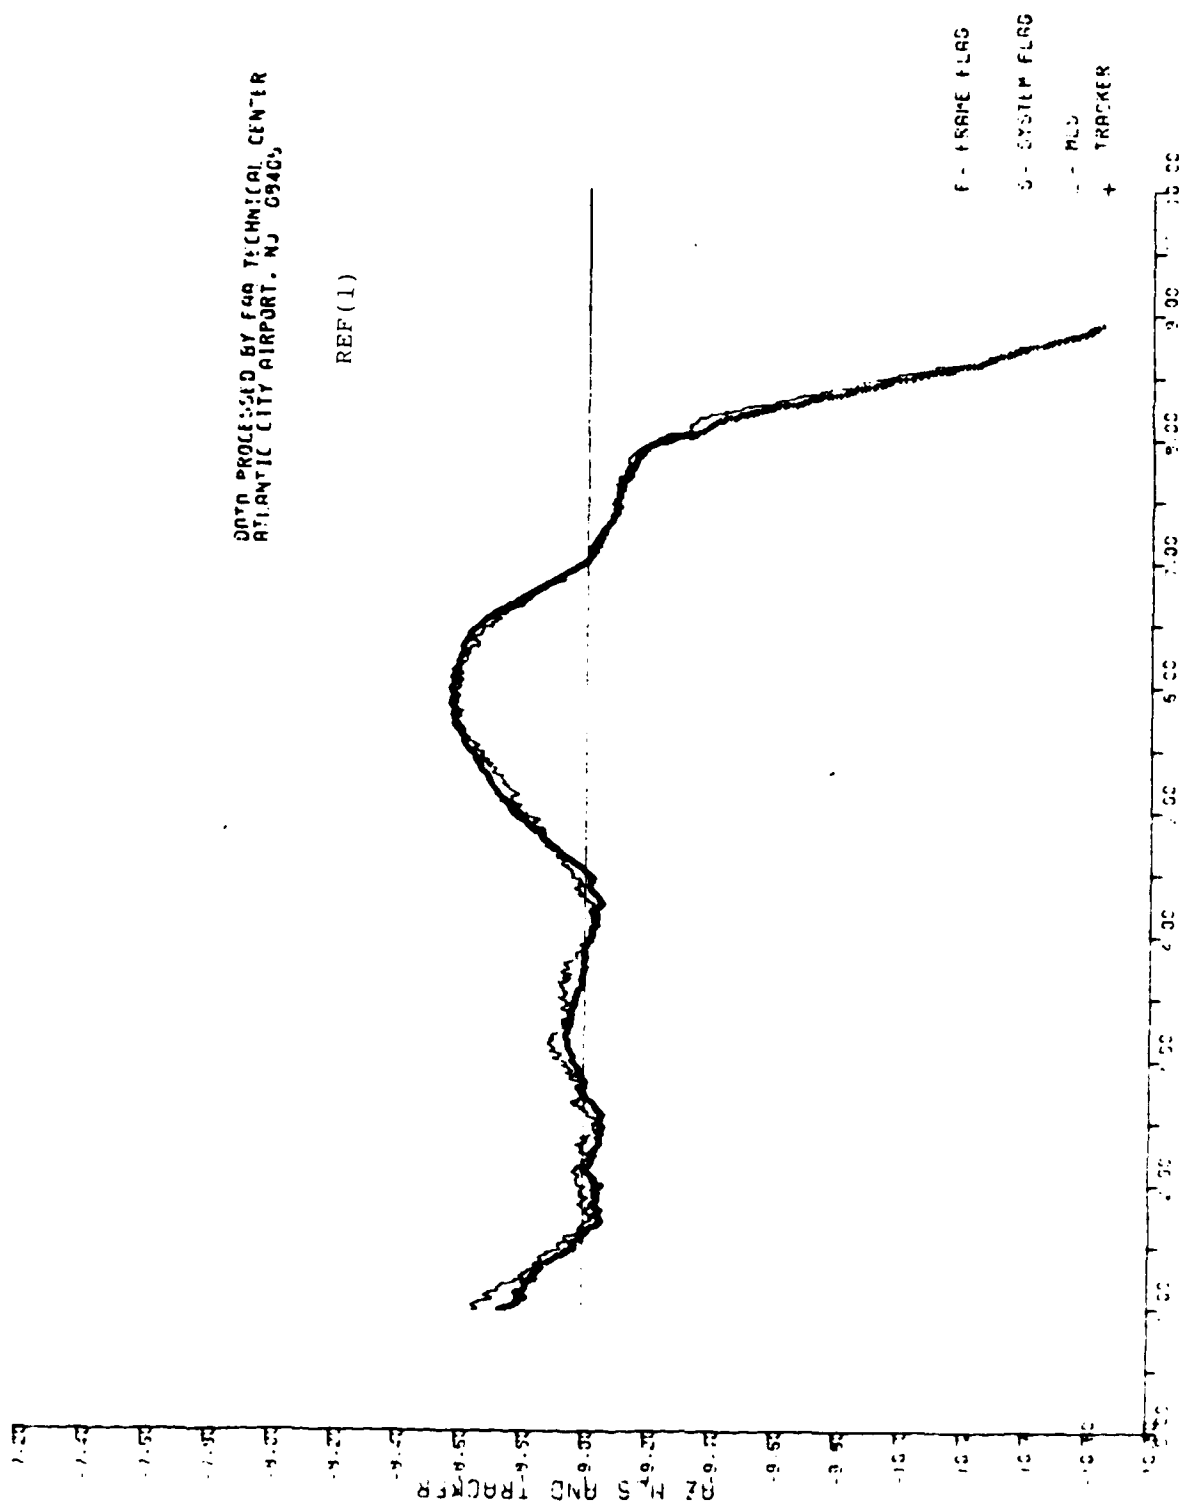
FIGURE 39 AZ; MLS AND TRACKER; RUN 7, AUG 21, 1978, 9R RADIAL  
(AT ATLANTIC CITY, NJ) 79-34-A-61

The Philadelphia flight data are noisier than the flight data taken at the Technical Center. The radial data are taken as an example because of the apparent propeller induced noise on the approaches. See Figures 24, 25, and 26 (10° R radial) at Philadelphia and Figures 39, 40, and 41 (9° R radial) at the Technical Center, N.J. The source of the extra noise is not identified here. Some factors may be:
