USAFOEHL REPORT

86-072EH0021HGA

**AIR FORCE ASBESTOS GUIDANCE FOR RATING AND  
ASSESSING DAMAGE AND EXPOSURE (GRADE)  
SYSTEM**

**August 1986**

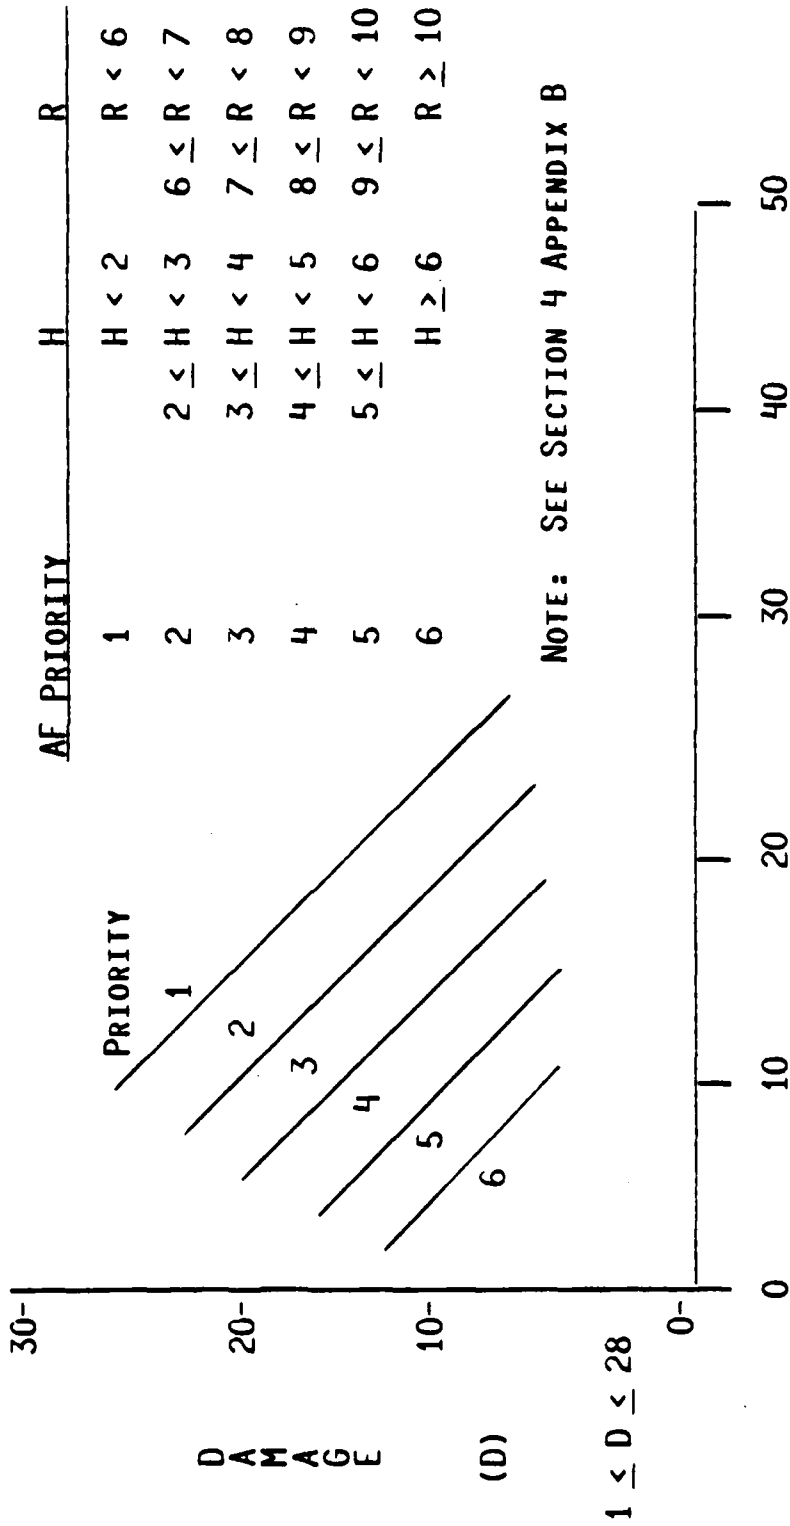
FIGURE 1. AF PRIORITY VS VERSAR H VS AF GRADE R

VERSAR REGRESS.  $H = 8.0324 - (0.1683 * D) - (0.1693 * E)$   
 $-3.9599 \leq H \leq 7.0176$

AF GRADE  $R = 12.0324 - (0.1683 * D) - (0.1693 * E)$   
 $0.0401 \leq R \leq 11.0176$

EXPOSURE FACTORS (E)  $5 \leq E \leq 43$

As mentioned above, in developing their model Versar defined six hazard zones based upon their expertise in asbestos assessment. Since the multiple regression model for calculating H correlated well with their empirically determined parabolic curves which separated each of their six hazard zones, we decided to forego the use of the graph and curves and to use a modified version of Versar's statistical model as our numerical prioritizing methodology. We decided against using the recommended management action guidance as an indication for asbestos abatement action. Instead, we opted to categorize action by recommending priority be given to those "assessment cells" or areas falling within a certain R range. Thus, we made the rating system a means for prioritizing asbestos abatement as opposed to a means for requiring abatement. According to the present Air Force, EPA, and Occupational Safety and Health Act (OSHA) regulations, air sampling results are the only basis upon which one is required to institute engineering or abatement activities to reduce asbestos exposure or hazard.

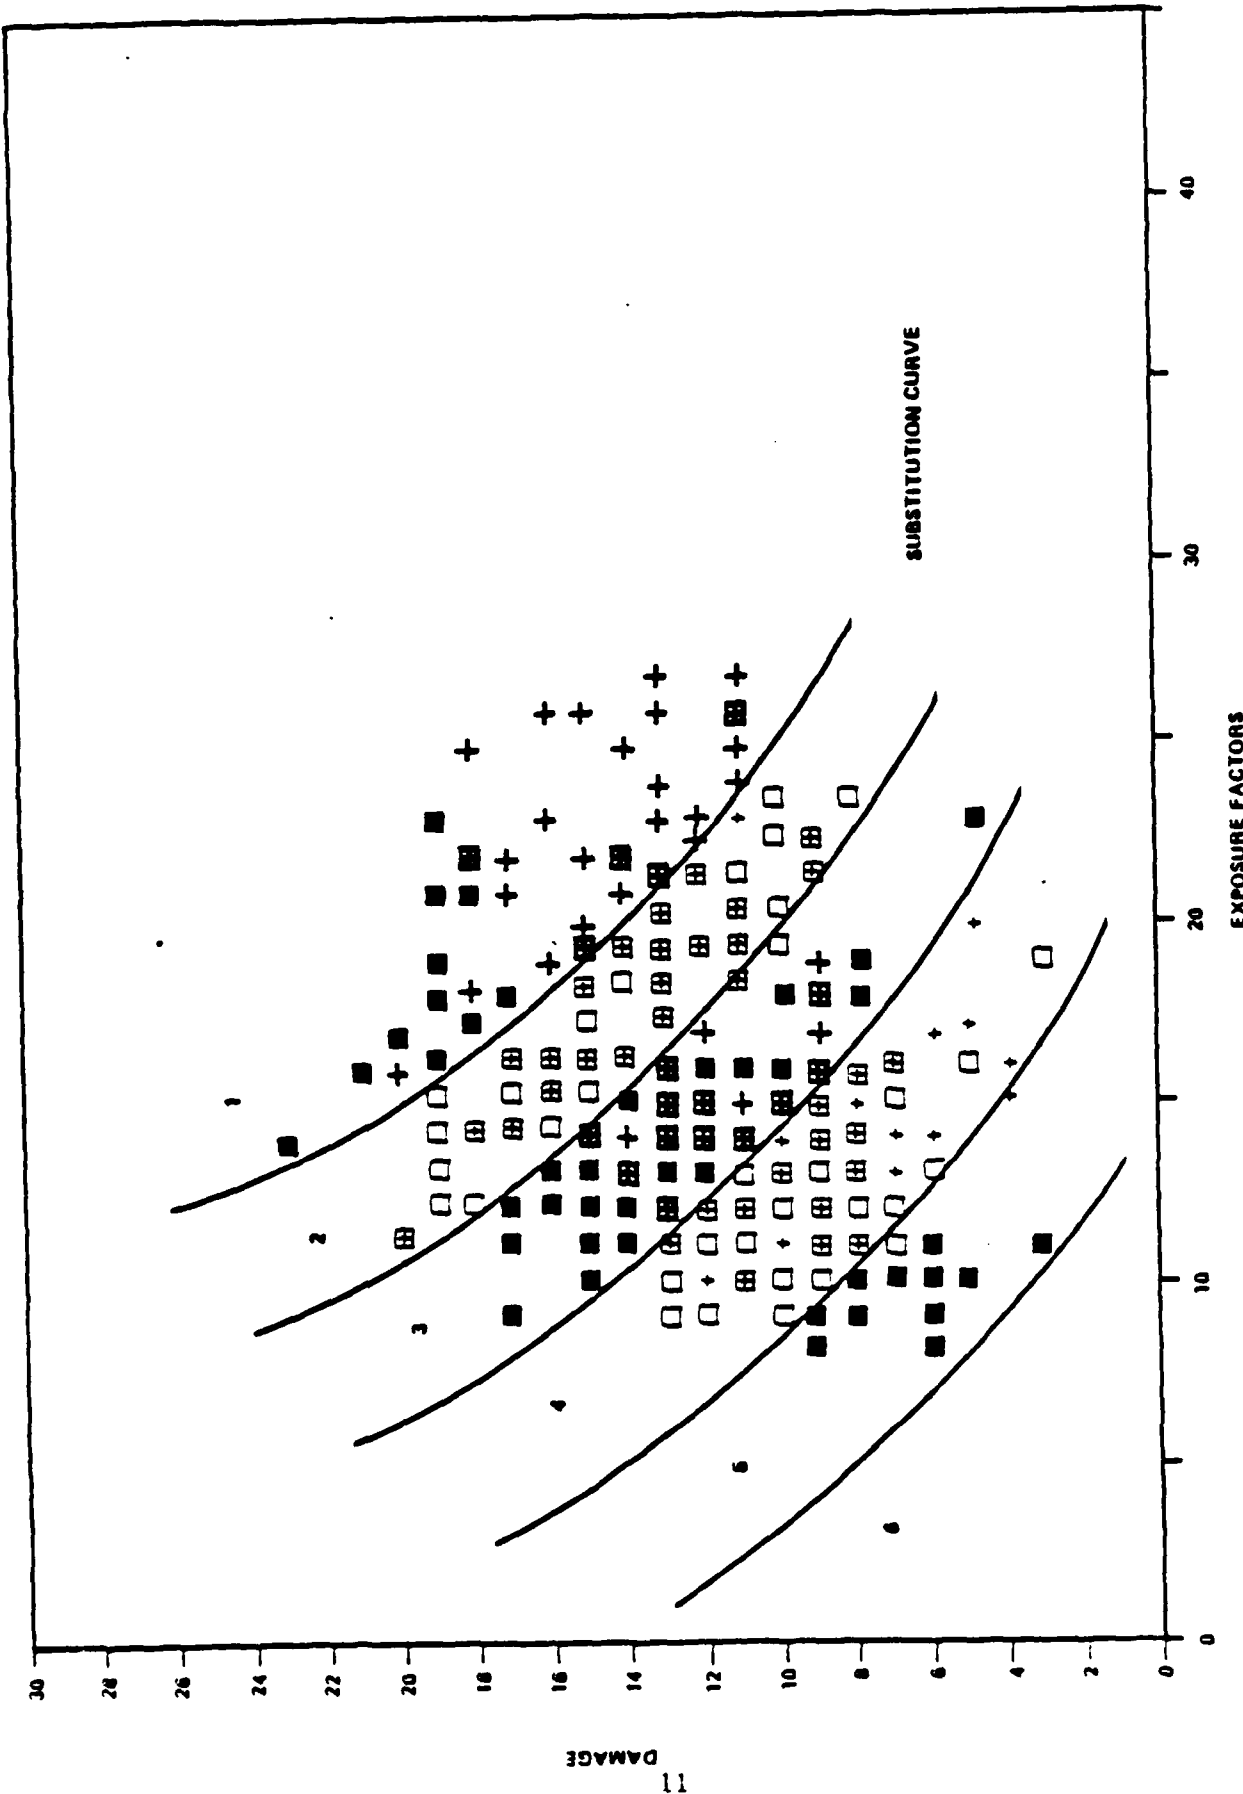
TABLE 4  
VERSAR HAZARD GRAPH

A mechanical and mathematical scoring, ranking, and prioritization scheme is not the full answer. Many external factors and conditions ranging from political considerations to socio-economic issues, to physical arrangements, to existing programs all contribute to shape a realistic program. The methods described in this article are a powerful adjunct to the normal decision-making process. They are not the only nor the full answer to the difficult problems of long-range planning. Still the hazard graph can be divided into six regions, defining levels of increasing concern (from 6 to 1) and possibly the sets of management actions that could be undertaken. In the example presented, the management actions corresponding to hazard ranks 1 to 6 are as follows (Table 4):

1. Immediate Removal. This area of the graph represents the major concern. The situation is such in terms of both damage and exposure potential to warrant immediate removal in spite of the large potential for fiber release during abatement.

2. Removal as Soon as Possible. Like the area above, this is a guide to management that the asbestos containing material should be removed as soon as possible, not waiting for the normal repair and maintenance cycle. In a school, for instance, removal should be accomplished during the summer or during recess periods. In a commercial building, it can be accomplished at night over a period of days. Prior to actual removal, it may be wise to limit access to that part of the building.

3. Planned Removal. The hazard involved in these areas is such that removal should take place as part of the normal maintenance and repair cycle of a facility. This approach minimizes cost and disturbance.

4. Repair. The most damaged areas should be repaired by proper covering, encapsulation or replacement.
5. Monitoring. Periodic monitoring of these areas should be planned to insure that no further damage takes place.

6. No Immediate Action. These cases show little damage to structure and little exposure. In most cases the material is well protected so that fiber release is very unlikely. No current action should be undertaken.
