THESIS

A COMPARISON OF TRIPPING BEHAVIOR OF WIDE
AND NARROW FLANGED "T" AND "Z"
STIFFENED PANELS

Robert Bruce Miller

March 1987

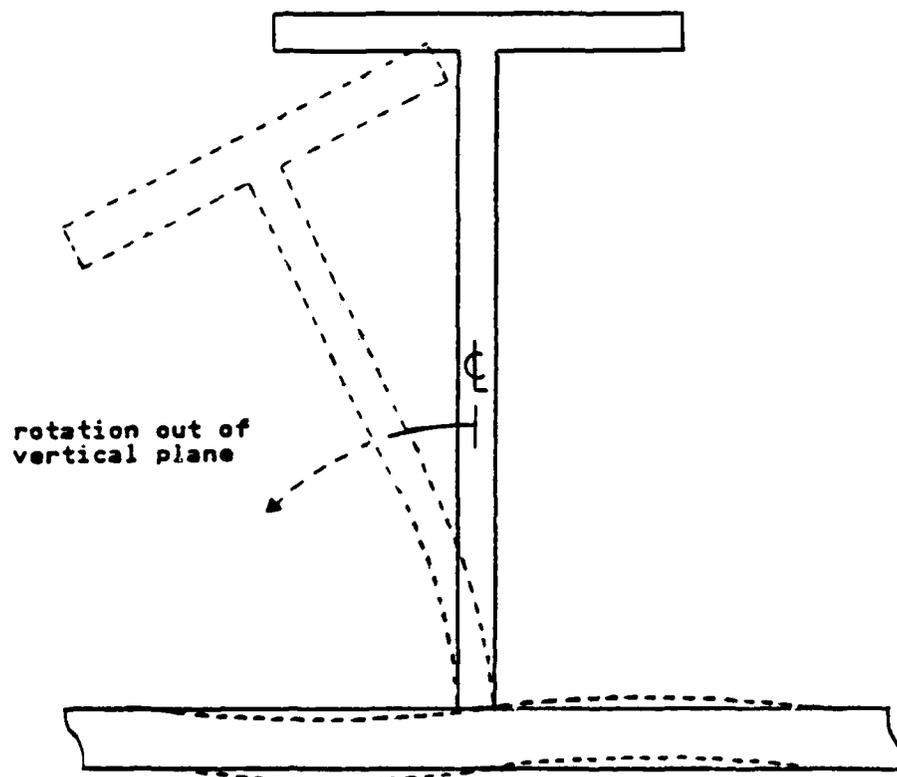
Figure 1.1 Stiffener Tripping

conversely, under similar loading the flange tends to buckle in a mode producing fewer waves. This incompatibility in failure modes produces an inherent competition which tends to make the overall buckling load requirement higher than it would be for either the web or flange by itself [Ref. 10:p. 2]. Because of these considerations various combinations of these components allow the plate to support ultimate loads far above the ultimate buckling load of the plate alone. When the load finally does exceed the buckling load for the system the fact that the toe of the stiffener is welded to the plate, thereby being laterally constrained, dictates the form of the stiffener deformation. This deformation consists of a twisting of the stiffener about its line of attachment to the plate as shown in Figure 1.1. [Ref. 2: p. 732]

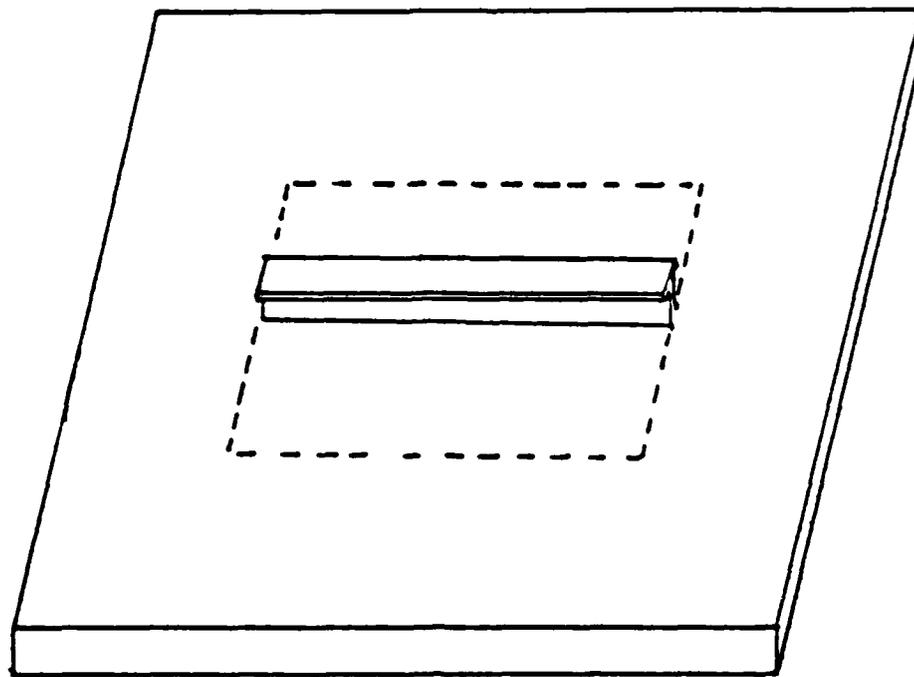
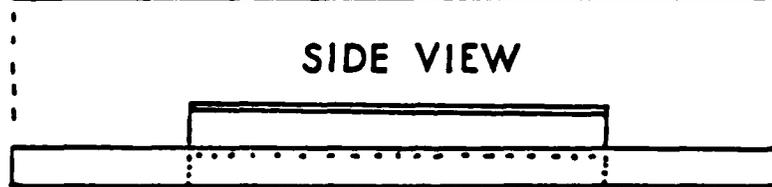
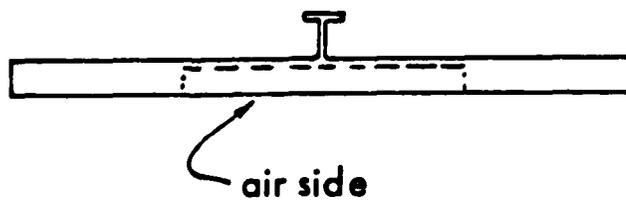
Figure 2.1 Dynamic Test Panel Configuration

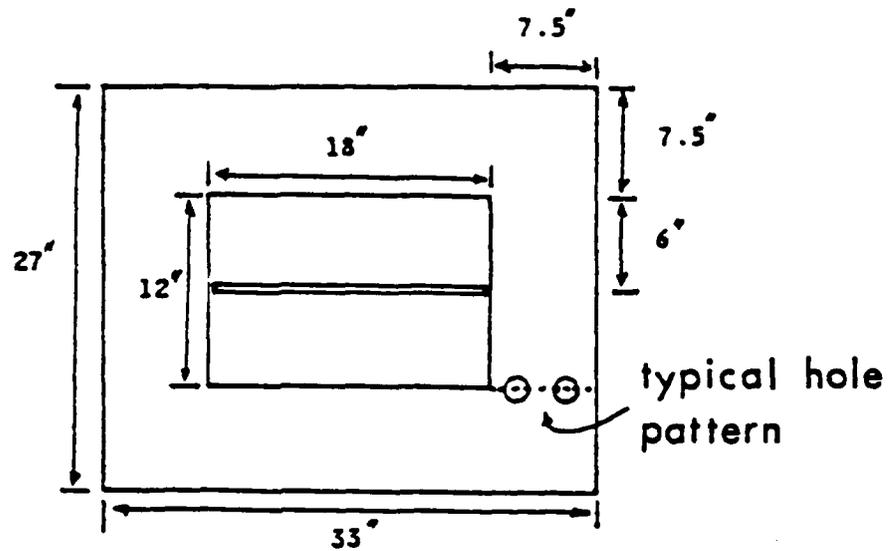
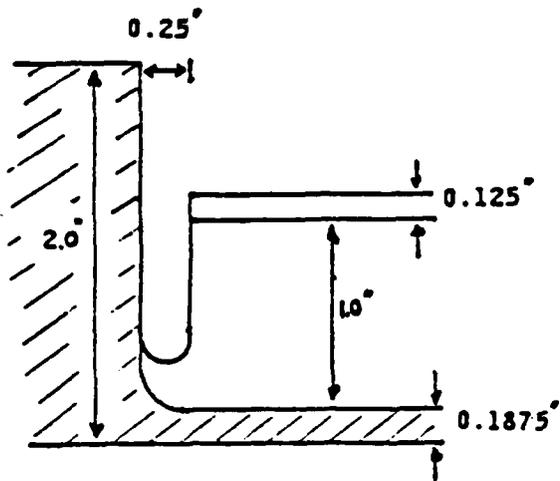
Figure 2.2 Hydrostatic Test Panel Configuration

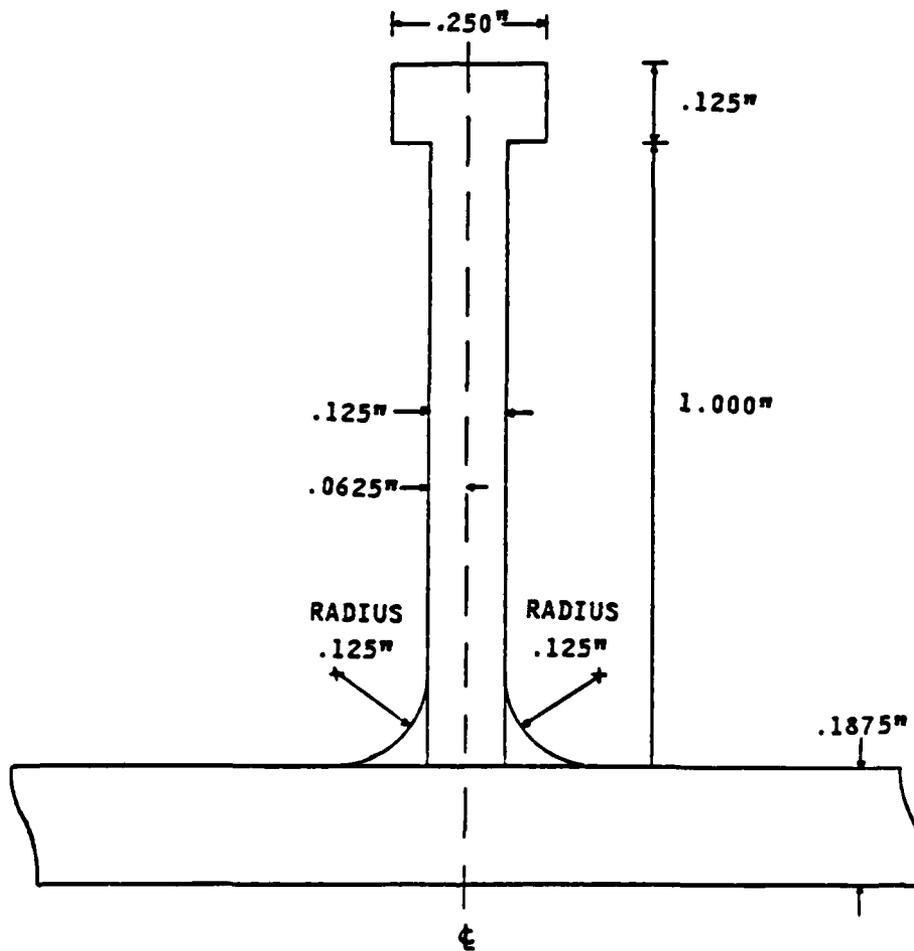
Figure 2.3 Narrow Flanged "T" Stiffener Cross-Section

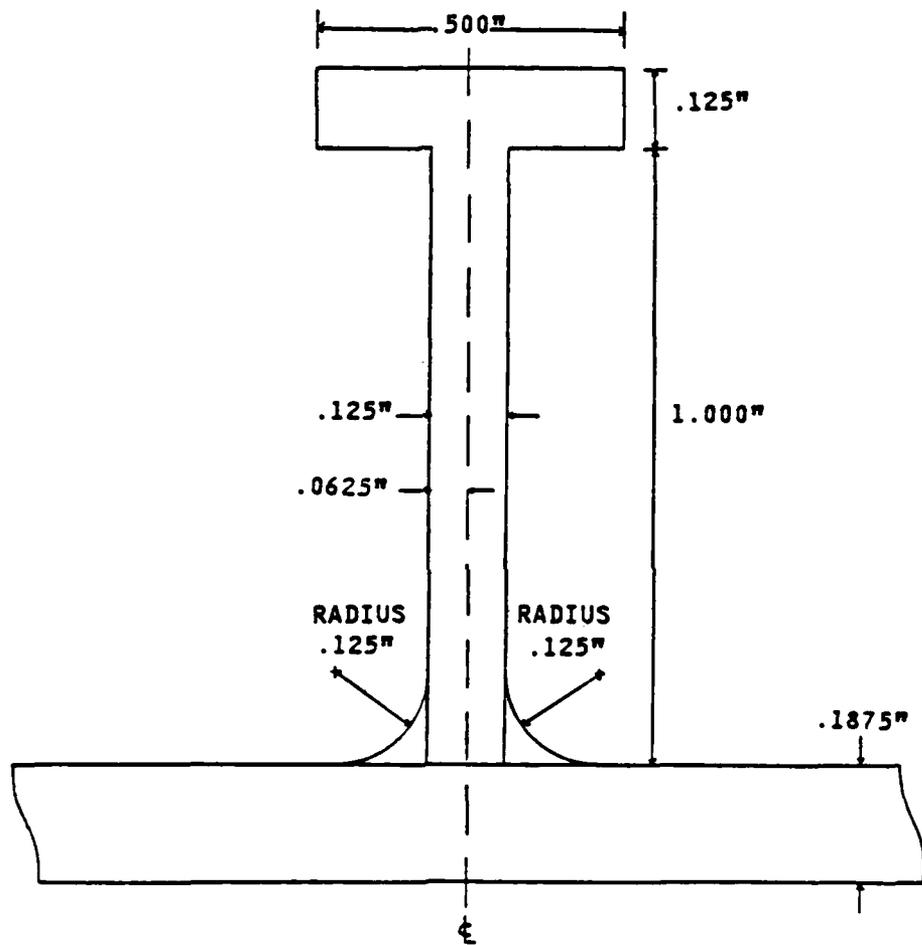
Figure 2.4 Wide Flanged "T" Stiffener Cross-Section

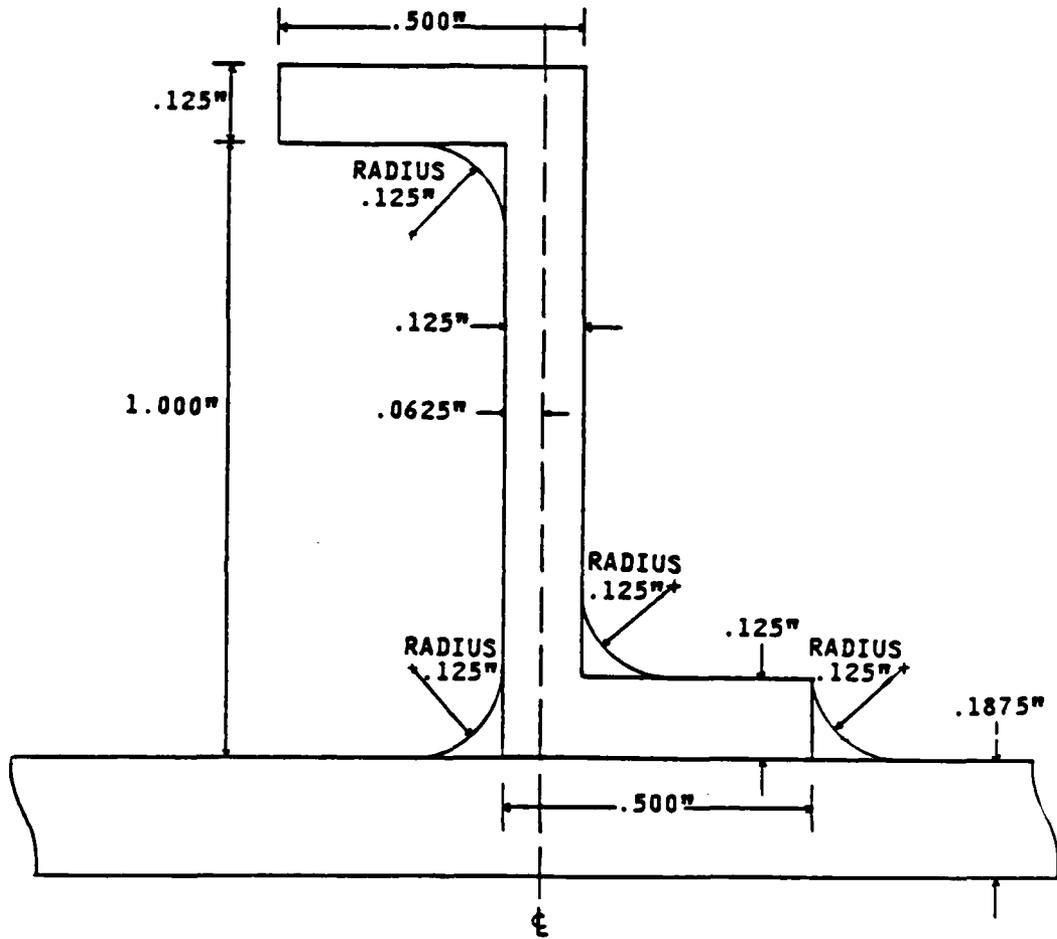
Figure 2.5 "z" Stiffener Cross-Section

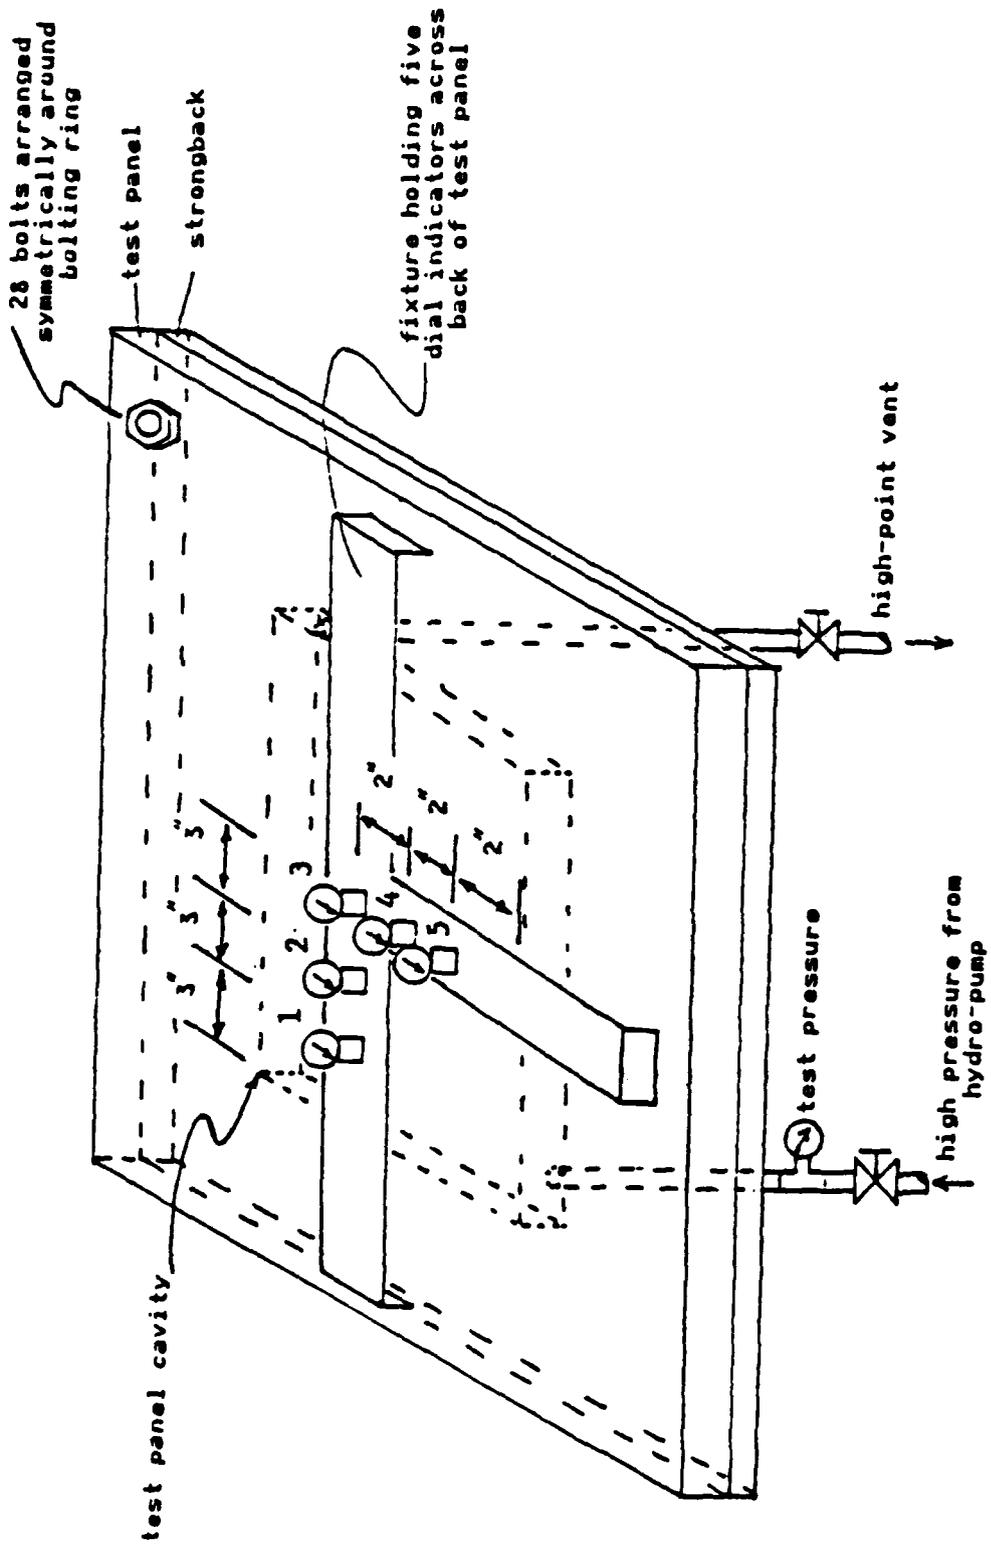
Figure 2.6 Hydrostatic Test Configuration

directions. These positions and the hydrostatic test configuration are represented schematically in Figure 2.6.

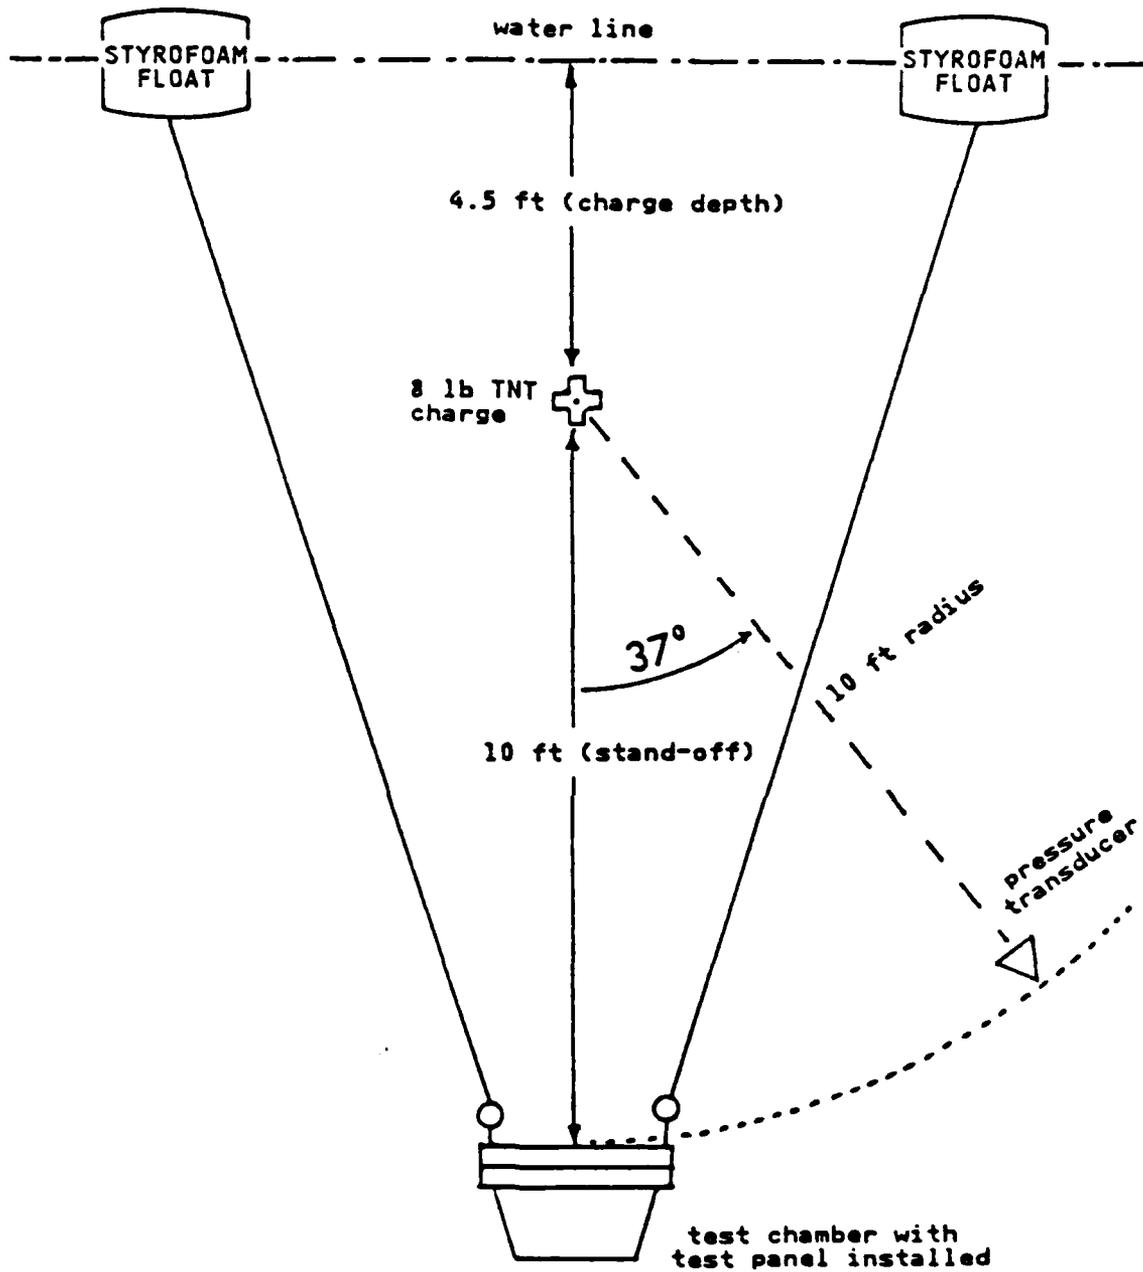
Figure 2.7 Schematic of the Dynamic Test Geometry

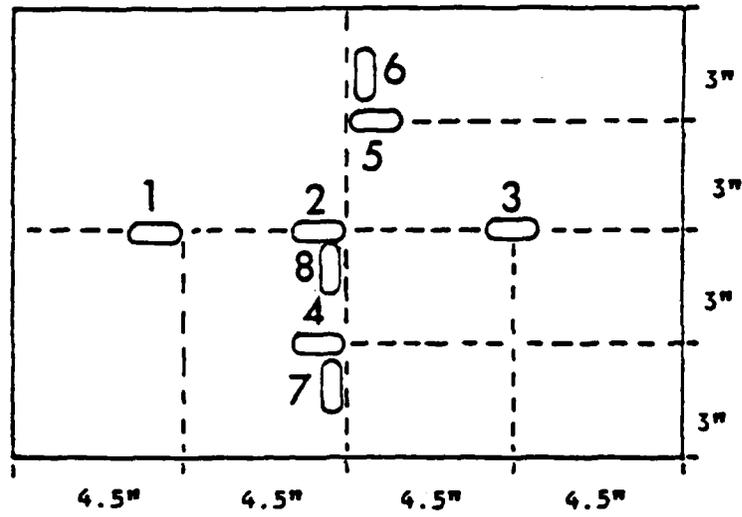
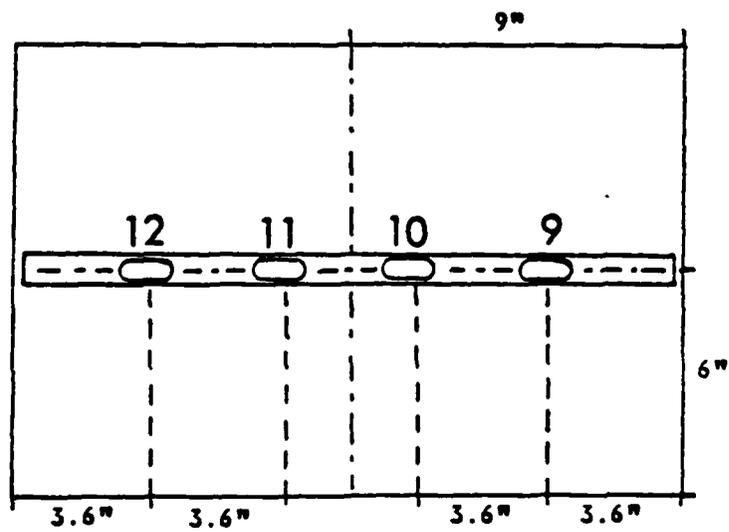
Figure 2.8 Diagram of Strain Gauge Placement

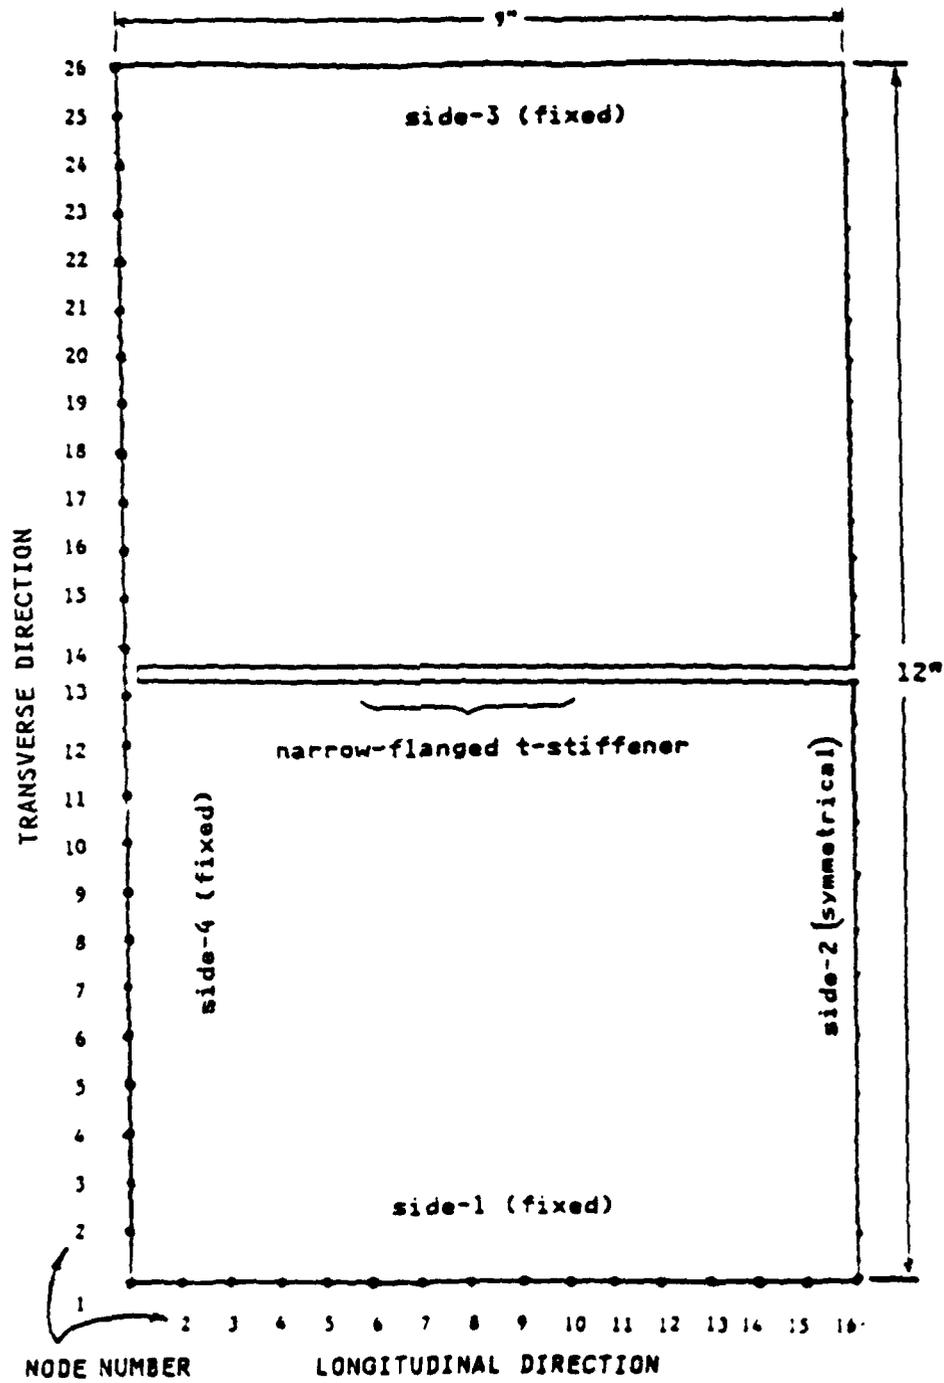
Figure 3.1 Segmentation of Half-plate

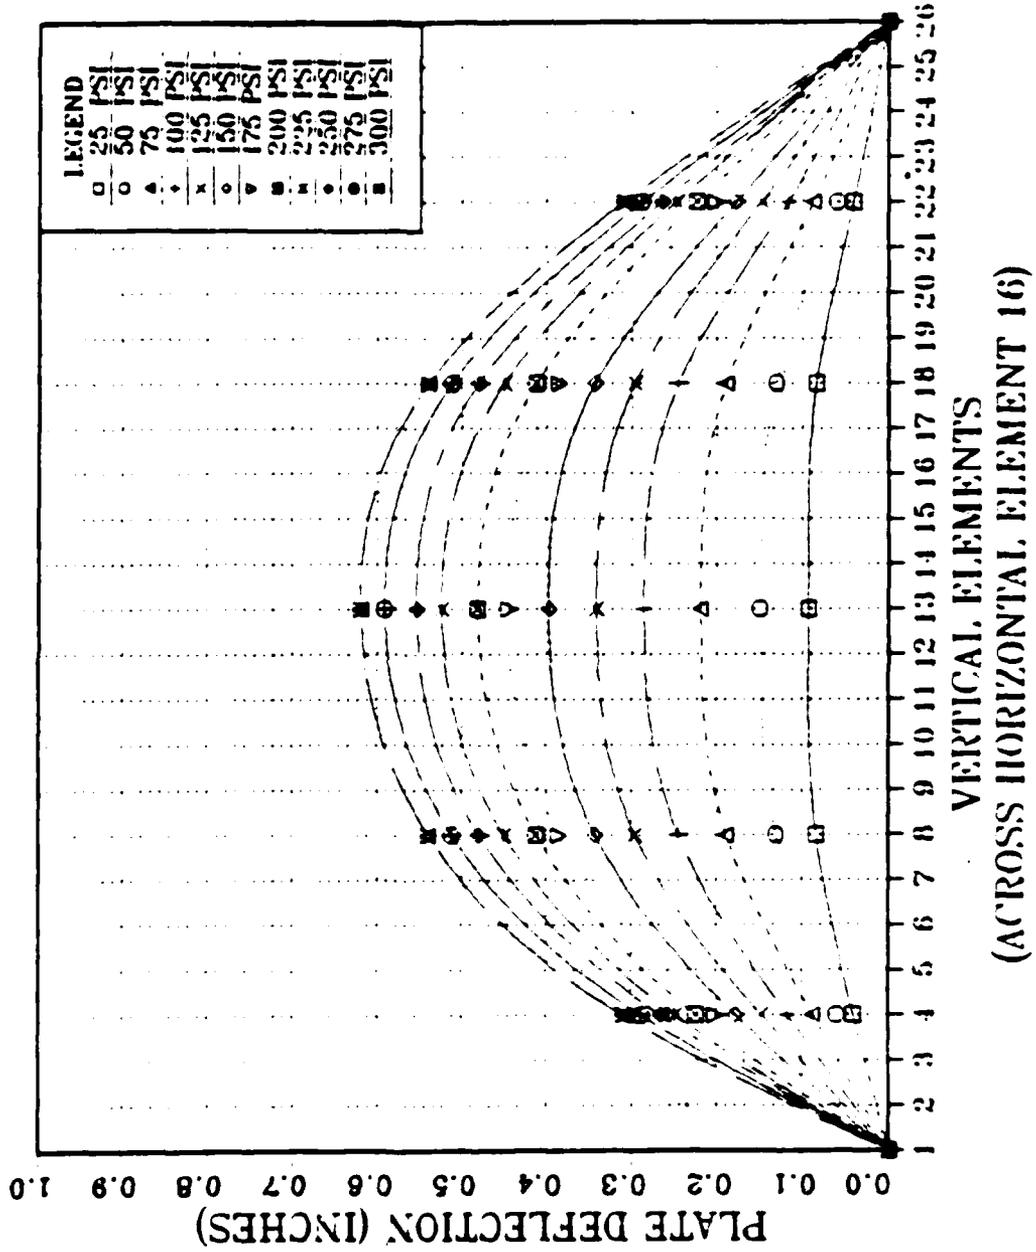
Figure 3.2 Plot of Wide Flanged "T" Static Test Deflection Results

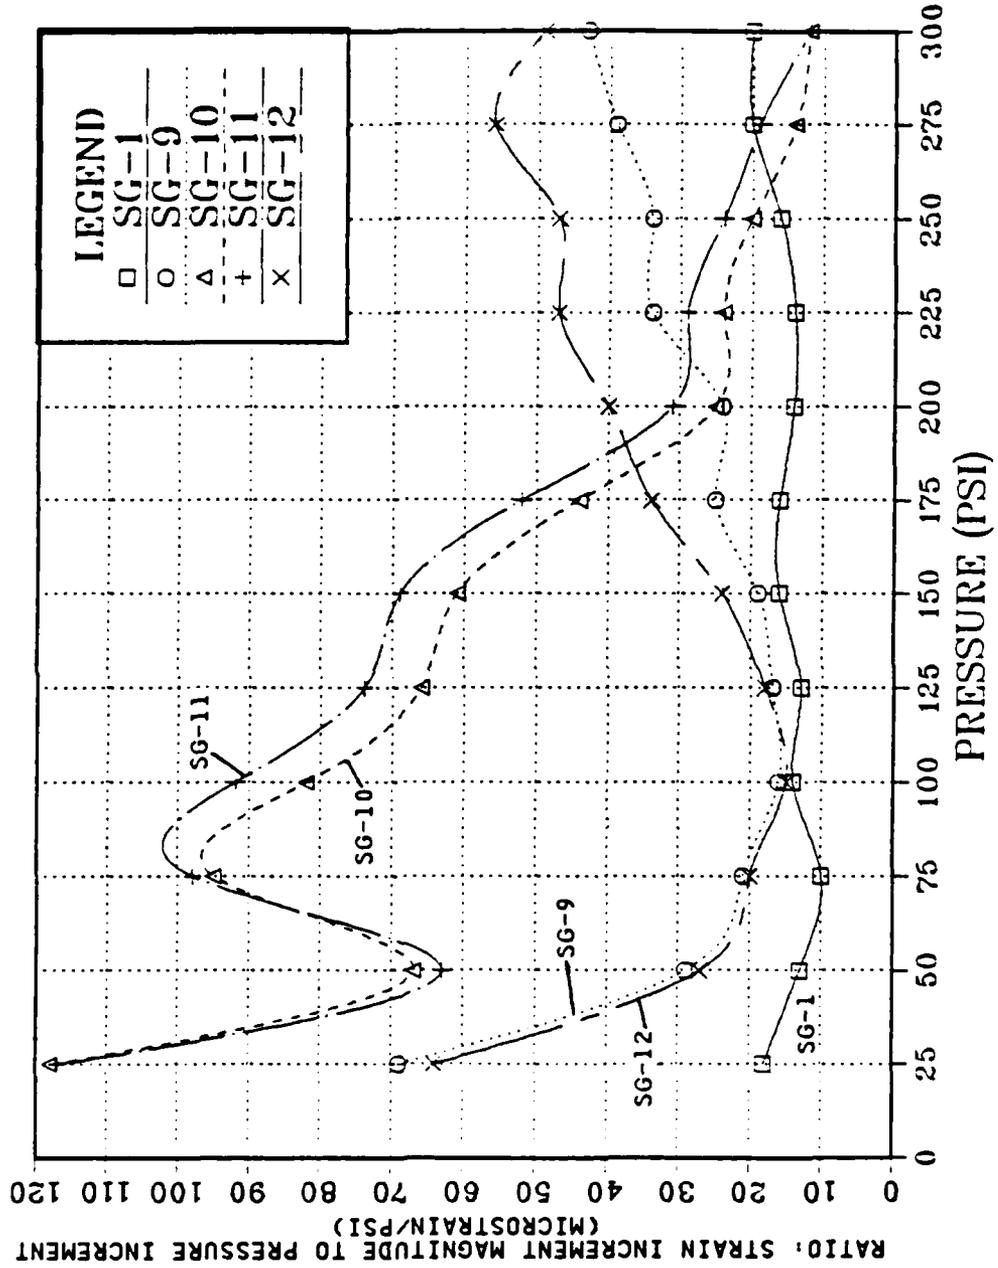
Figure 3.9 Plot of Wide Flanged "T" Static Test Ratio of Strain Increment to Pressure Increment vs. Test Pressure

In reviewing Figure 3.9 as well as the actual strain and deflection data, specific regions of elastic plate reaction, plastic plate reaction, and elastic stiffener tripping can be observed. From the deflection data a permanent set of .350 inches existed in the center of the plate (node (16,13)) after venting from a deflection of

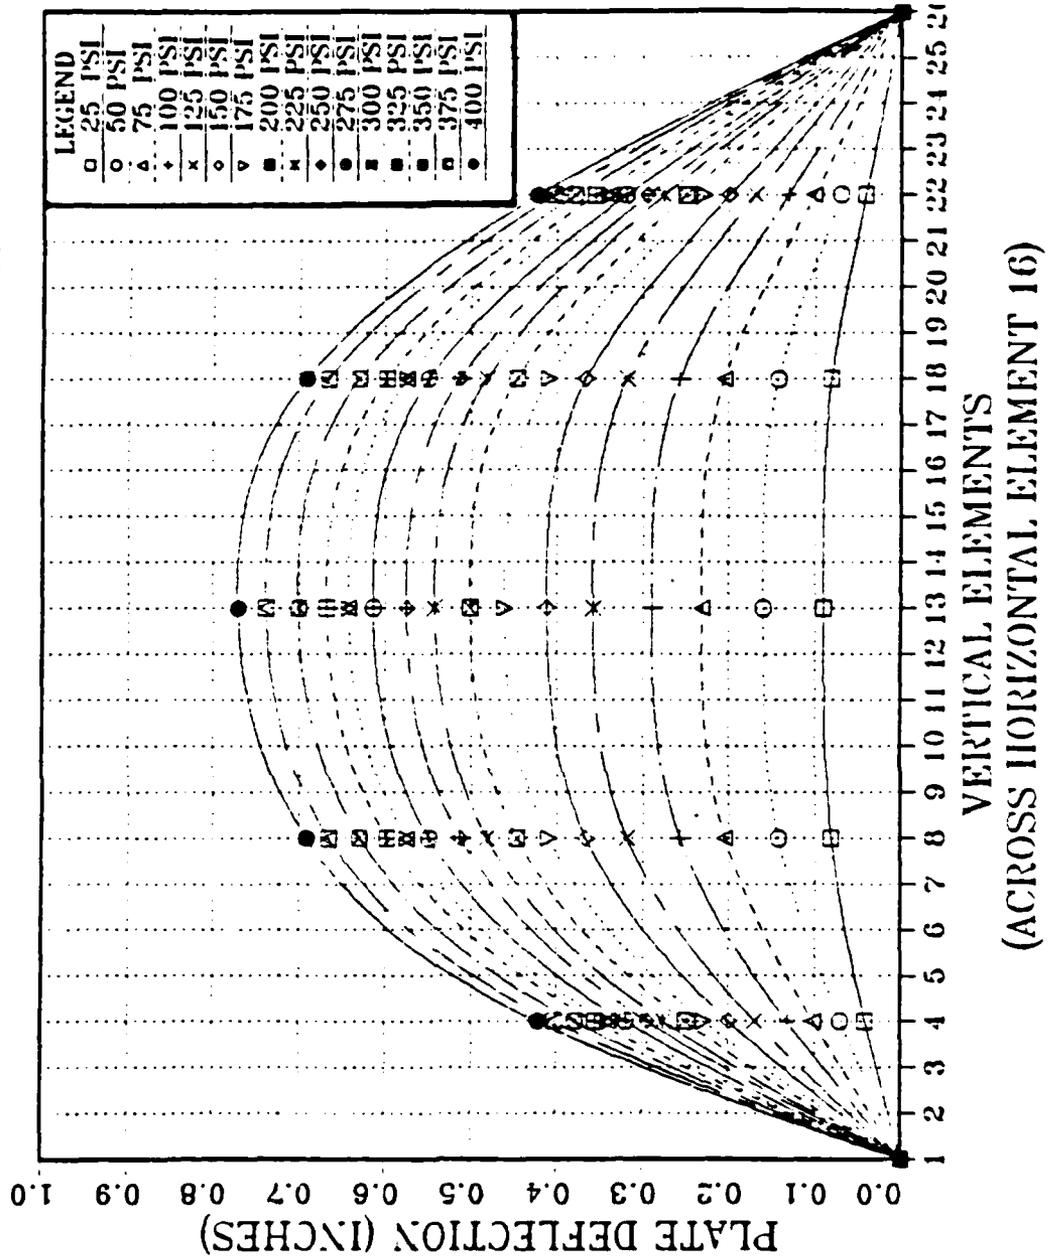
Figure 3.10 Plot of "z" Stiffener Static Test Deflection Results

Analysis of the deflection data for this test was conducted by methods similar to those used on the wide flanged "T" stiffener. Graphical representations of the transverse plate profiles are provided in Figure 3.10. Strain history traces resulting from data obtained throughout the test are provided in Figures 3.11 through 3.16. In addition, the numerical values for deflection and strain at their associated positions throughout the test can be found in Tables 4 and 5. The plotted behavior of the strain increment to pressure increment ratio is shown in Figure 3.17.

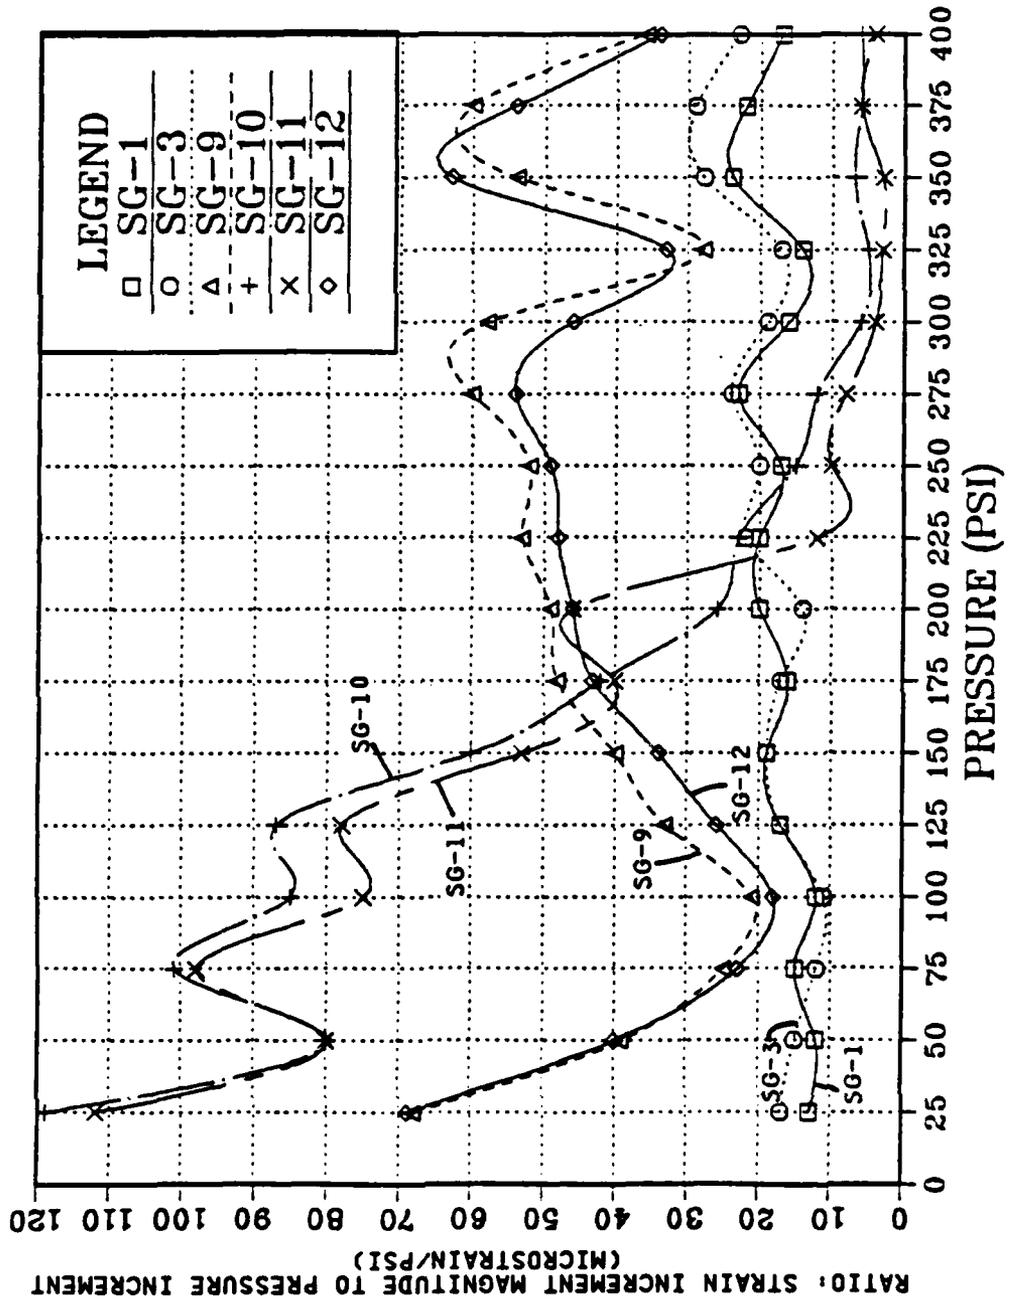
Figure 3.17 Plot of "z" Stiffener Static Test Ratio of Strain Increment to Pressure Increment vs. Test Pressure

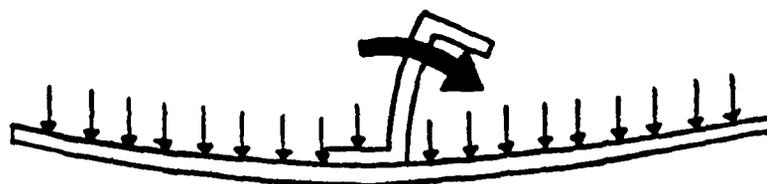
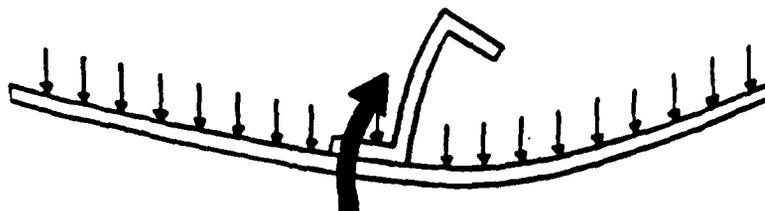
INITIAL TRIPPING BY WEB BUCKLING AND
THE UPPER FLANGE ROLLING OVER.

CONTINUATION OF TRIPPING BY A ROTATION OF THE STIFFENER
AND A PORTION OF THE PLATE ABOUT THE BASE OF THE STIFFENER.

Figure 3.18 Schematic Diagram of the "Z"
Stiffener Tripping Mechanism

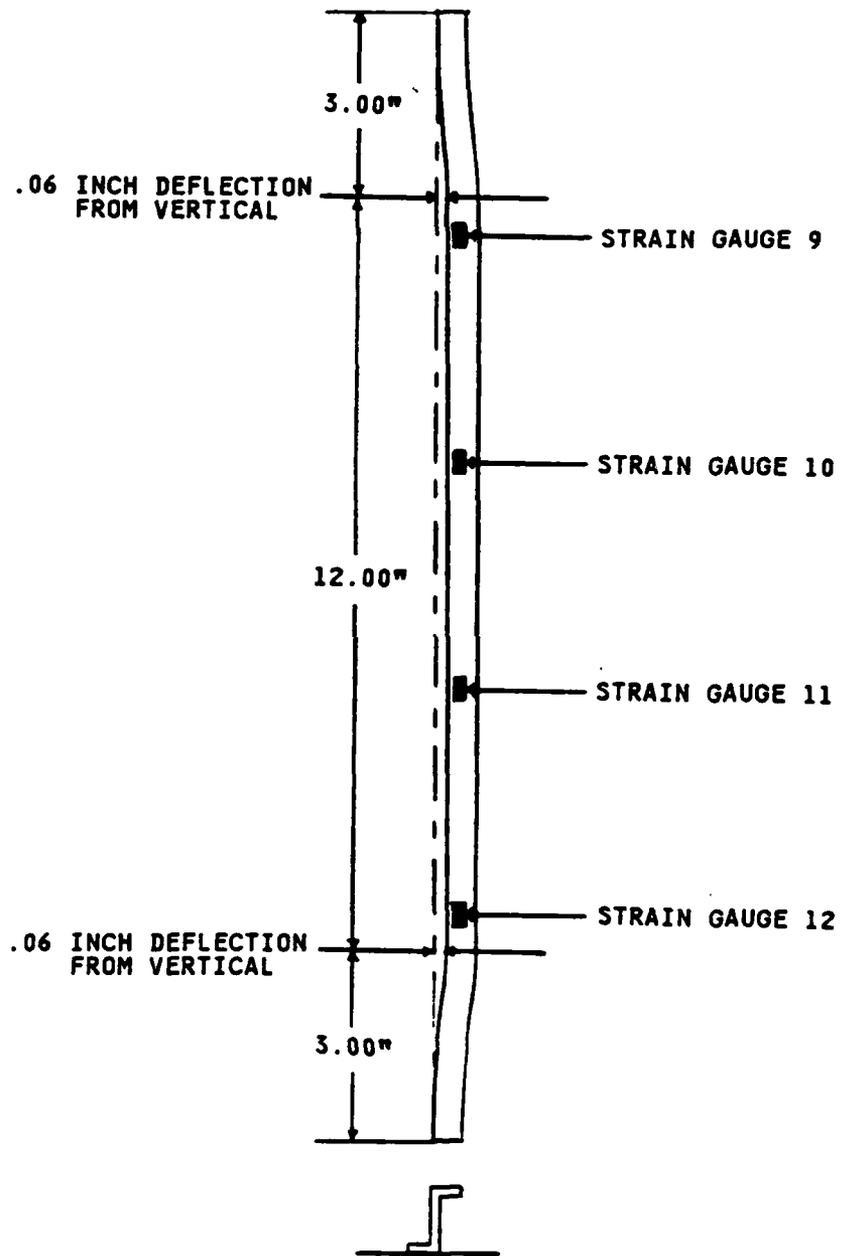
Figure 3.19 Schematic of the Resultant Plastic Tripping of the "Z" Stiffener

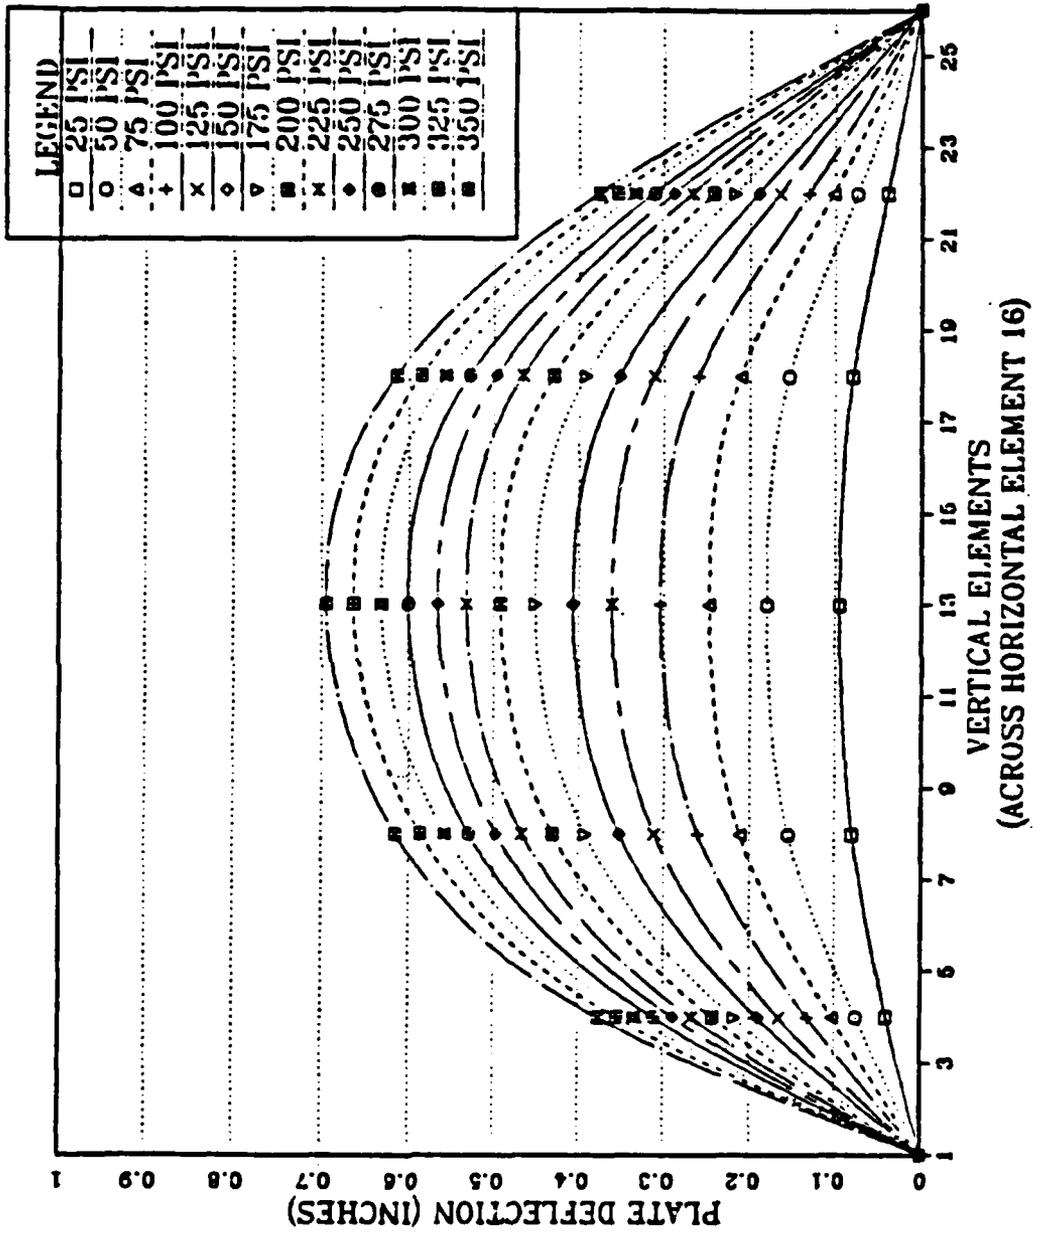
Figure 3.20 Plot of Narrow Flanged "T" Static Test Deflection Results

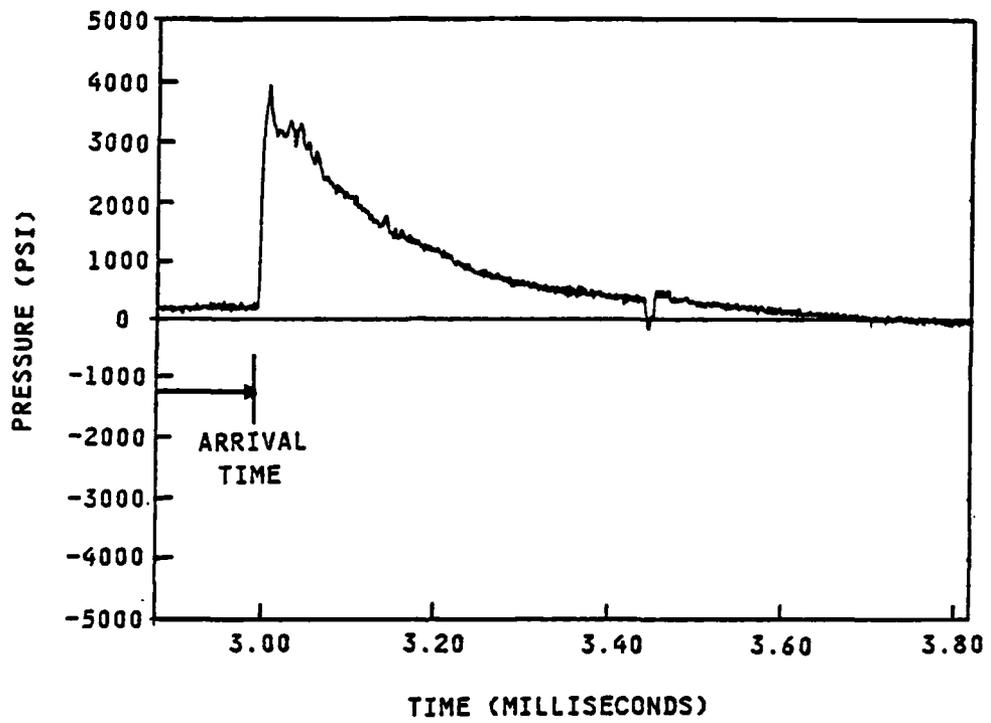
Figure 3.26 Wide Flanged "T" Dynamic Test
Incident Pressure Pulse

(Figure 3.34) does indeed show a much smaller peak magnitude than the previous test (Figure 3.26), however, it shows additional peaks of a similar magnitude and the characteristic exponential decay appeared delayed in its commencement.

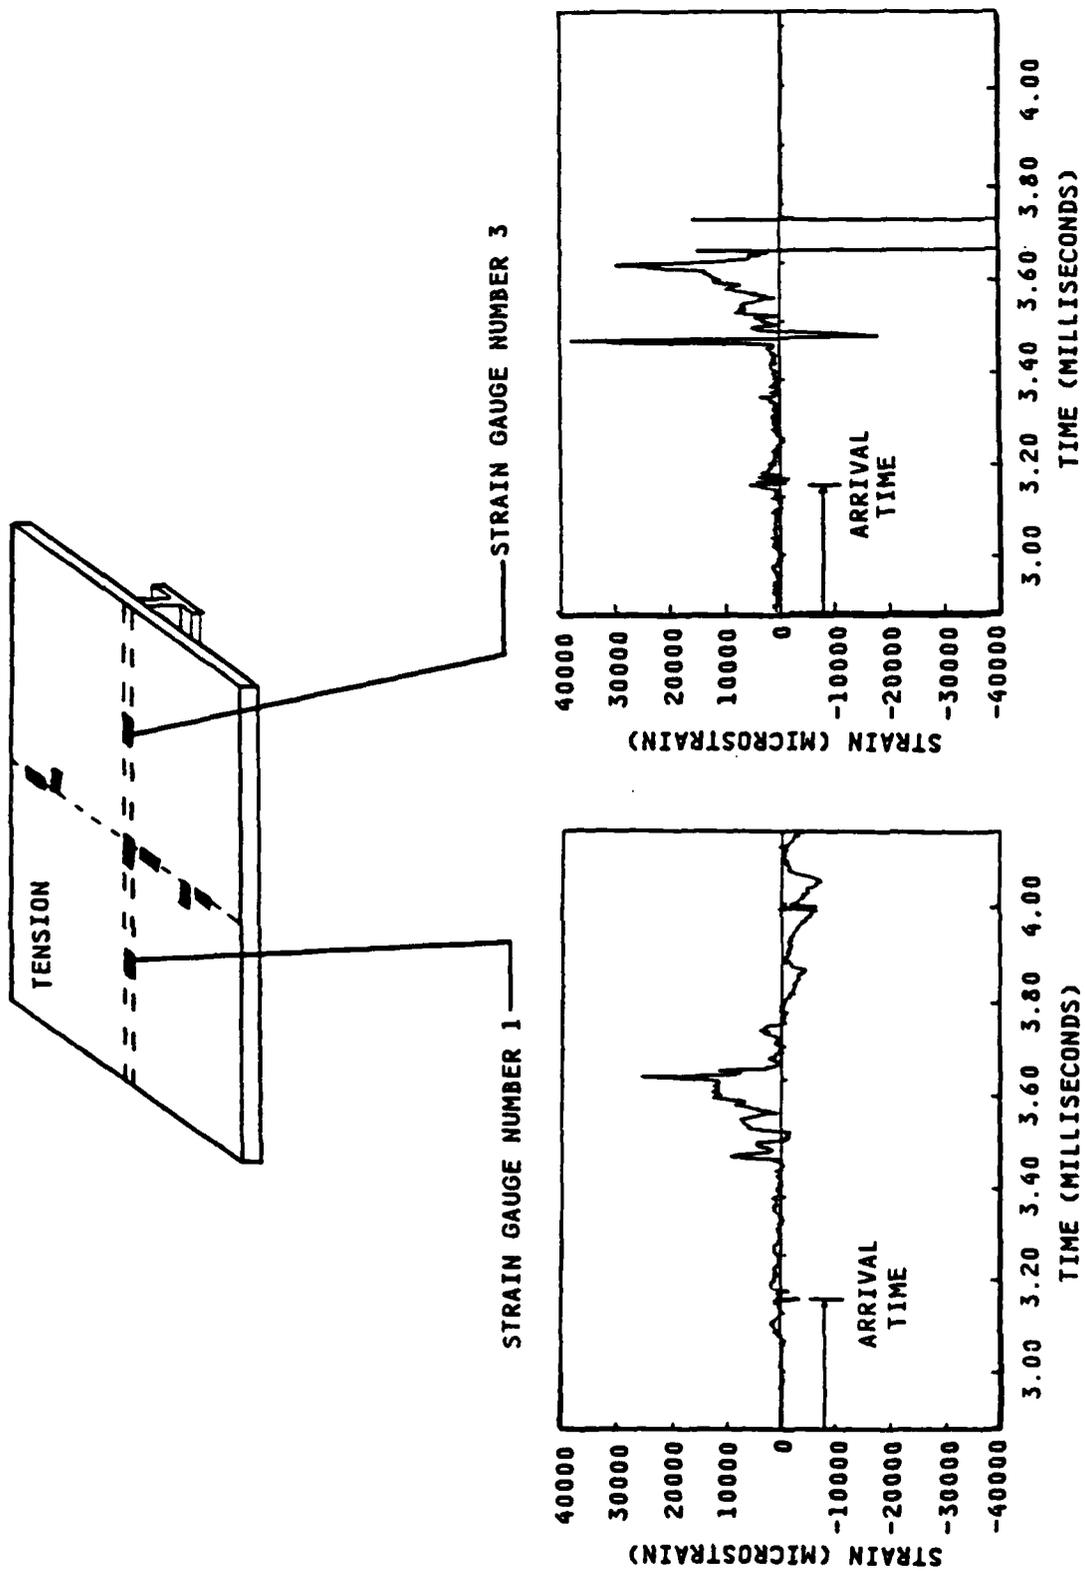
Figure 3.27 Strain Gauge Nos. 1 and 3 Strain Histories, Wide Flanged "T" Dynamic Test

In all of the strain gauges mounted on the plate directly beneath the stiffener (gauges 1, 3, 2 and 8 as shown in Figures 3.27 and 3.28) there was only minor strain action until the primary tripping of the stiffener occurred. In the open area plate mounted gauges (gauges 4, 5, 6 and 7 as shown in Figures 3.29 and 3.30) the strains associated with the loading, unloading, and reloading caused by the incident pressure pulse, resultant cavitation and reimpingement water surge prior to the stiffener tripping are readily evident. The minor strain action of the gauges mentioned previously as located under the stiffener did show some minimal peaks whose occurrence times closely correspond to the peaks present in the open areas prior to tripping. More importantly, the gauges mounted on the stiffener (gauges 9, 10, 11, and 12 shown in Figures 3.31 and 3.32) show peaks of much greater magnitude which also correspond to the peaks of the open areas. The significance of these peaks and their associated magnitudes is that it shows that load being borne by the stiffener
