THESIS

A COMPARISON OF TRIPPING BEHAVIOR OF WIDE
AND NARROW FLANGED "T" AND "Z"
STIFFENED PANELS

Robert Bruce Miller

March 1987

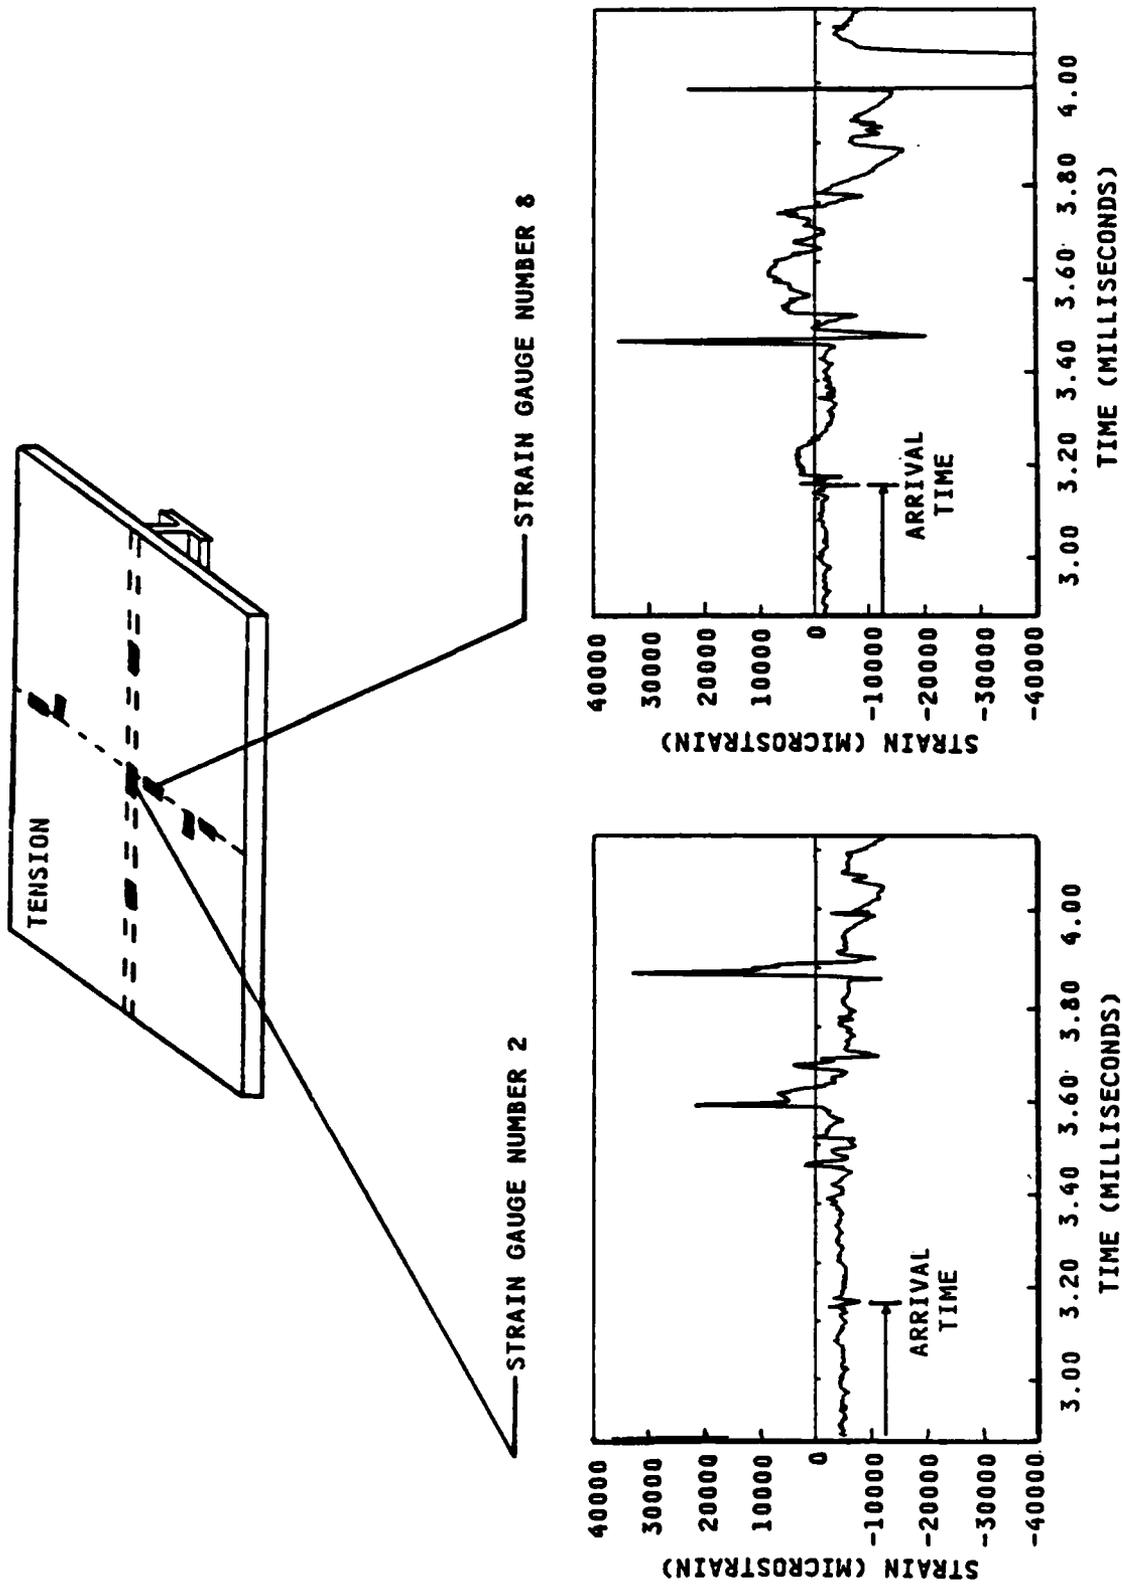
Figure 3.28 Strain Gauge Nos. 2 and 8 Strain Histories, Wide Flanged "T" Dynamic Test

In all of the strain gauges mounted on the plate directly beneath the stiffener (gauges 1, 3, 2 and 8 as shown in Figures 3.27 and 3.28) there was only minor strain action until the primary tripping of the stiffener occurred. In the open area plate mounted gauges (gauges 4, 5, 6 and 7 as shown in Figures 3.29 and 3.30) the strains associated with the loading, unloading, and reloading caused by the incident pressure pulse, resultant cavitation and reimpingement water surge prior to the stiffener tripping are readily evident. The minor strain action of the gauges mentioned previously as located under the stiffener did show some minimal peaks whose occurrence times closely correspond to the peaks present in the open areas prior to tripping. More importantly, the gauges mounted on the stiffener (gauges 9, 10, 11, and 12 shown in Figures 3.31 and 3.32) show peaks of much greater magnitude which also correspond to the peaks of the open areas. The significance of these peaks and their associated magnitudes is that it shows that load being borne by the stiffener

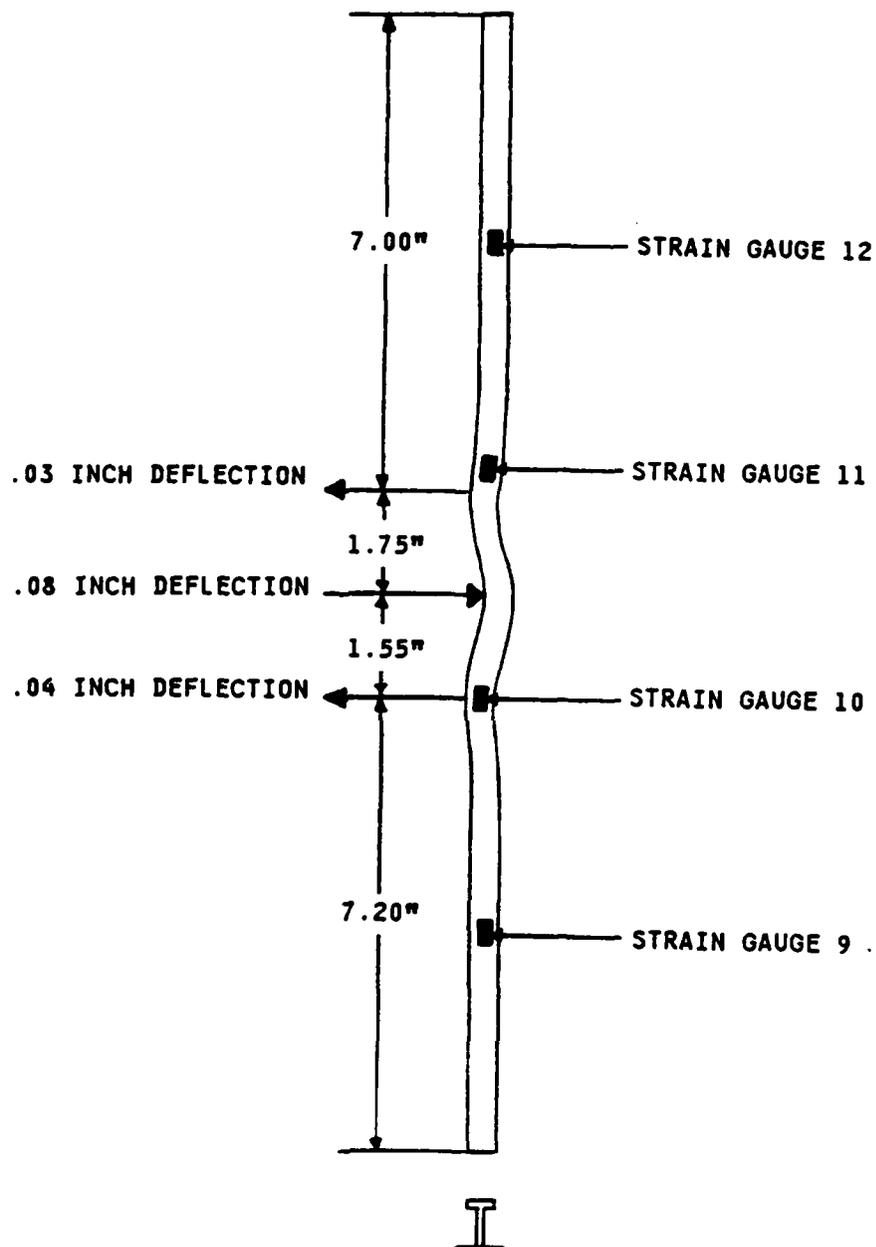
Figure 3.33 Schematic of the Wide Flanged "T" Stiffener Tripping Resultant from Dynamic Testing

Upon observation of the failed plate the primary and secondary tripping actions of the stiffener are readily evident. The area of tripping with the largest magnitude of deflection was the primary tripping point in the center of the plate. This was as should be expected because the center portion of the plate experiences the highest compressive stresses during deformation. The outermost points of tripping of the stiffener were determined to be the secondary tripping points because the magnitudes of deflection were less. These smaller deflections required less load in the stiffener. After the primary tripping the outer portions of the stiffener could only build to low levels of strain prior

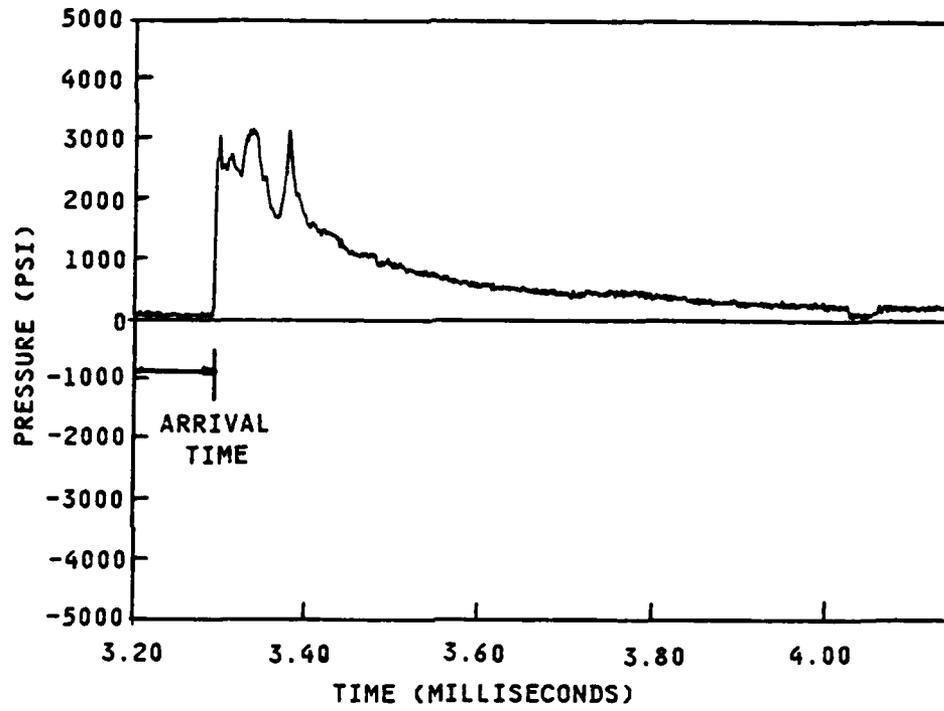
Figure 3.34 "z" Stiffener Dynamic Test
Incident Pressure Pulse

(Figure 3.34) does indeed show a much smaller peak magnitude than the previous test (Figure 3.26), however, it shows additional peaks of a similar magnitude and the characteristic exponential decay appeared delayed in its commencement.

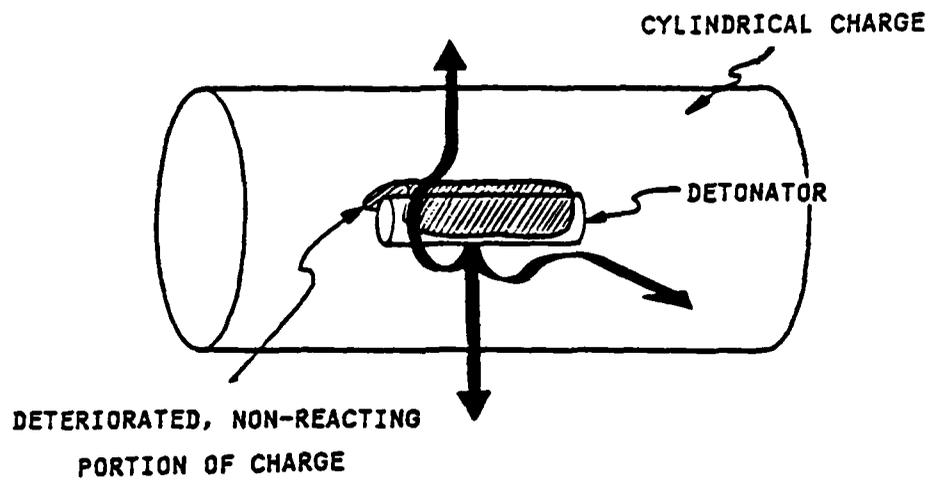
THE REACTION MUST PROPAGATE AROUND THE
"DEAD" PORTIONS OF THE CHARGE.

Figure 3.35 Explosive Charge Detonation
Reaction Propagation

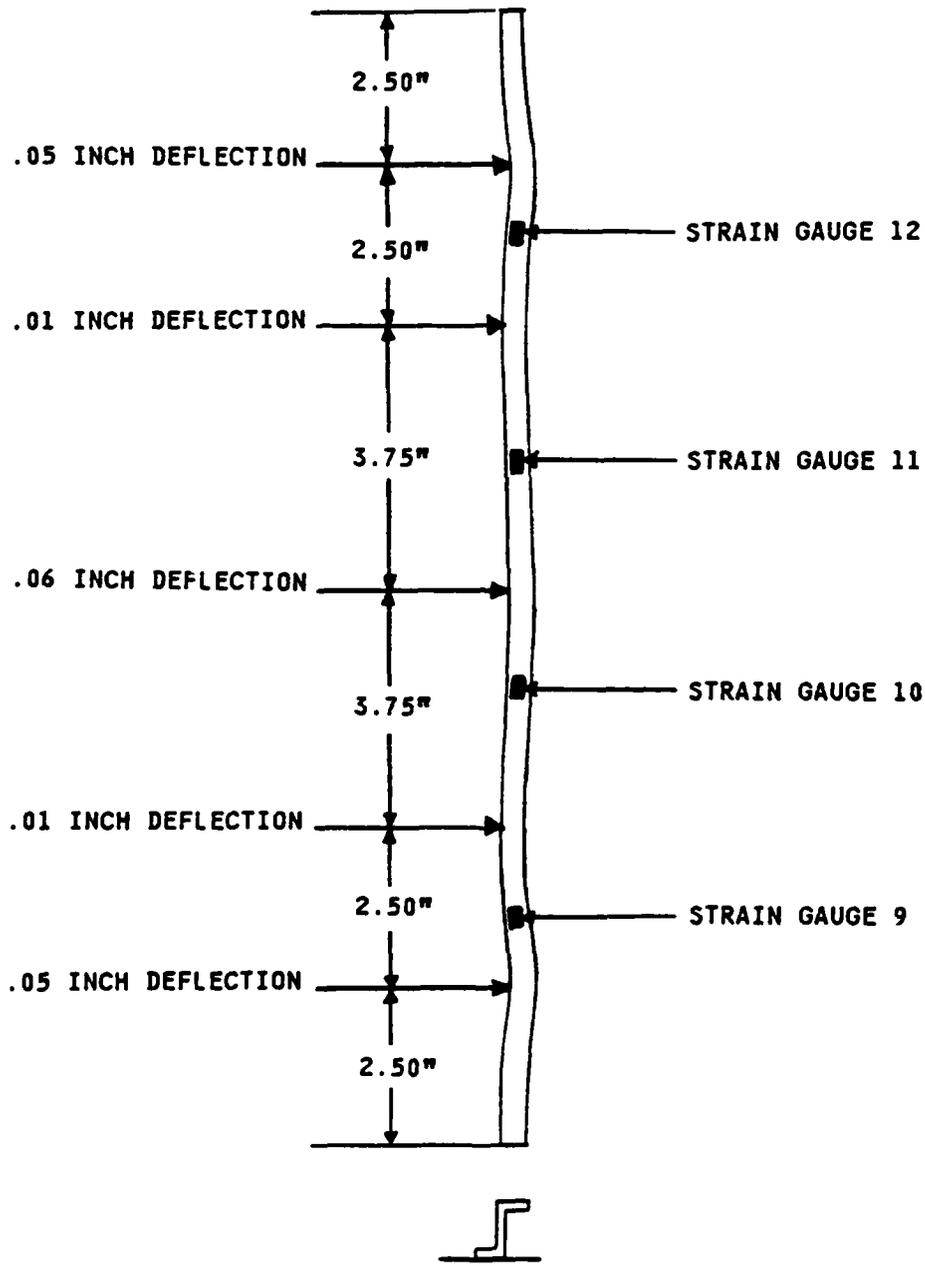
Figure 3.42 Schematic of the "Z" Stiffener Tripping Resulting from Dynamic Testing

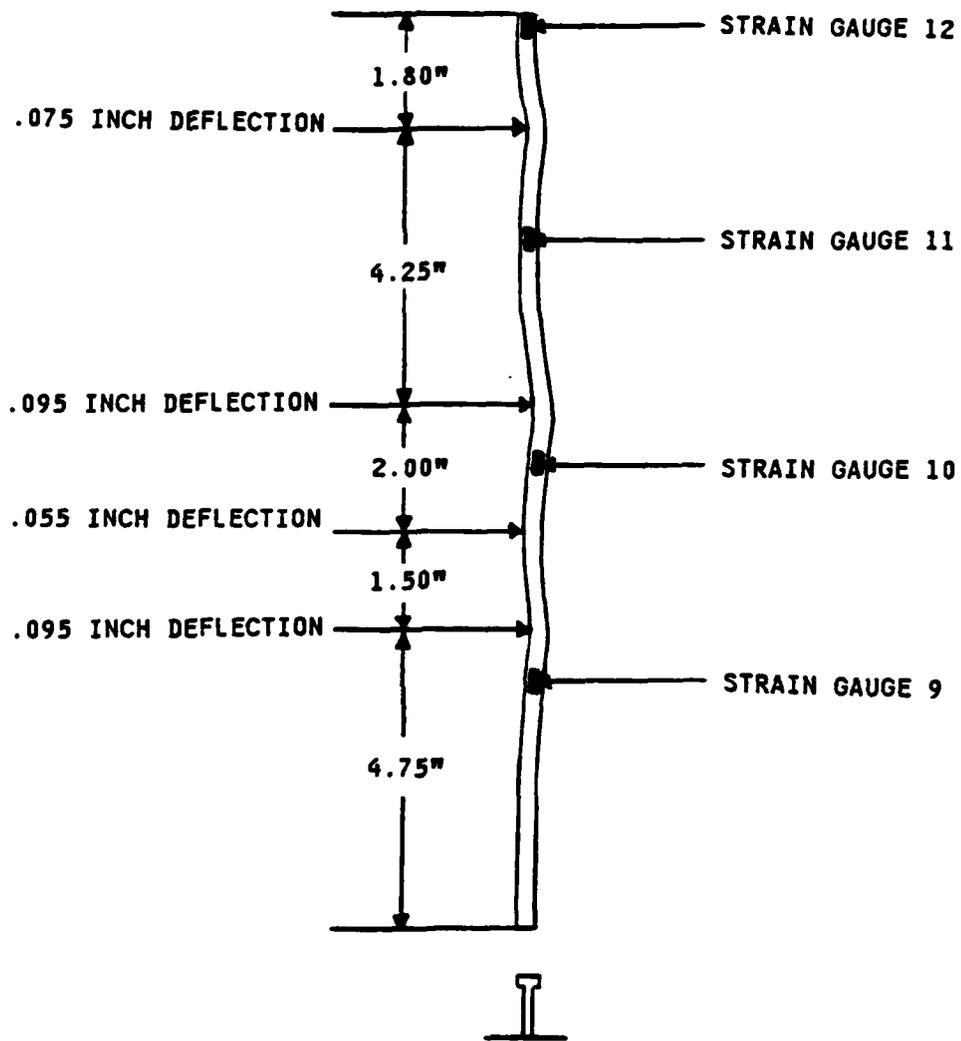
Figure 3.48 Schematic of the Narrow Flanged "T" Stiffener Tripping Resulting from Dynamic Testing
