ENGINEERING DEVELOPMENT ESTABLISHMENT

GRID COMPASS COMPUTERS

ENGINEERING EVALUATION

EDE-PUBLICATION 4/87 ✓

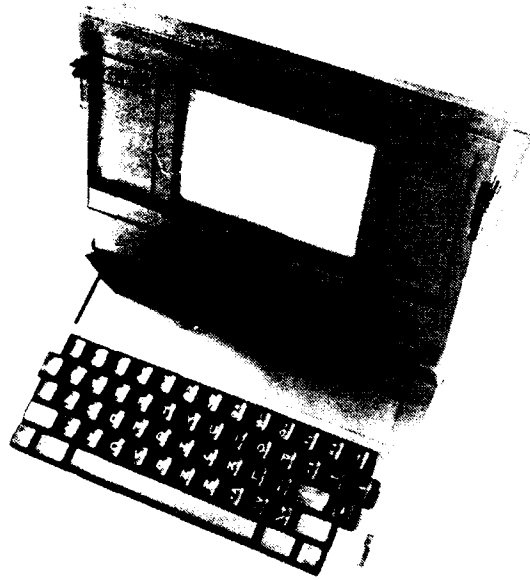
8887 II

FIG 1 - GRID COMPUTER WITH DISPLAY PANEL RAISED

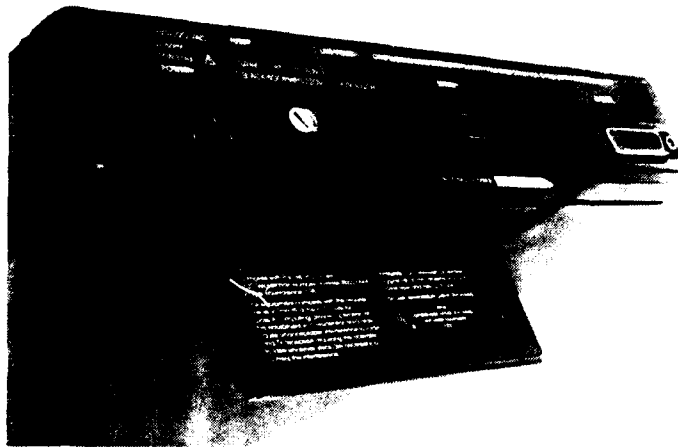
8887 I

FIG 2 - REAR PANEL OF GRID COMPUTER

12. A slot on each side of the case near the display hinges provides some limited air ventilation but will also allow the ingress of dust and moisture. In addition, the Tempest GRID computer has a small fan for forced air flow through the unit. The air inlet for the fan is on the rear panel. No dust filter is provided.

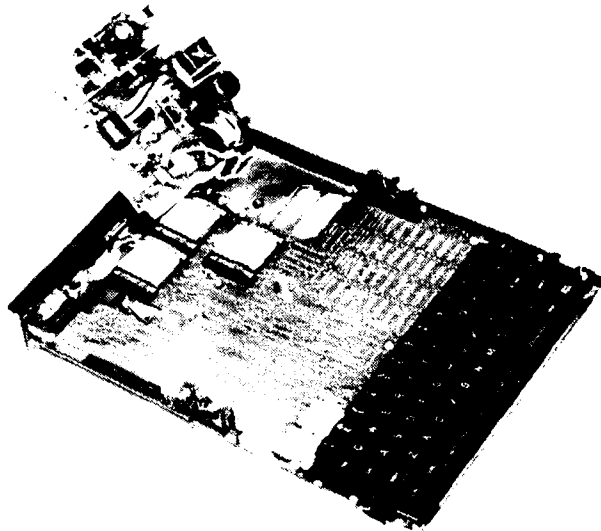
8887 E

FIG 3 - INTERNAL VIEW OF STANDARD MODEL 1100
GRID COMPUTER

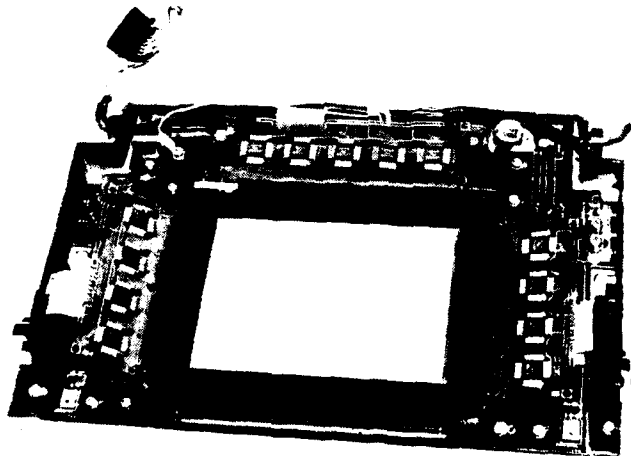
8887 D

FIG 4 - INTERNAL VIEW OF DISPLAY PANEL OF
STANDARD MODEL 1100 GRID COMPUTER

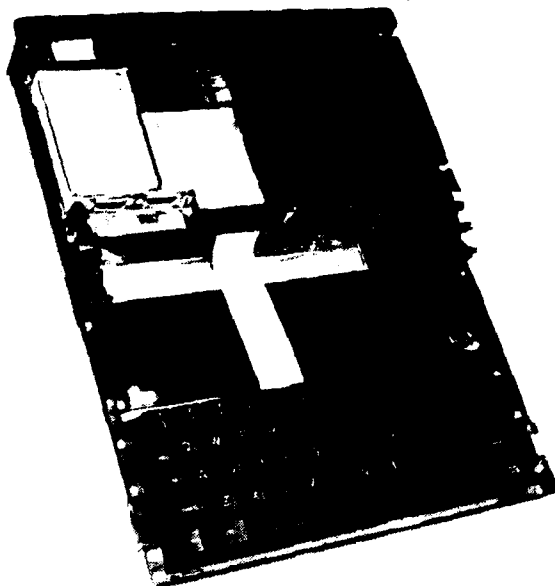
8887 L

FIG 5 - INTERNAL VIEW OF TEMPEST MODEL 1107 GRID COMPUTER

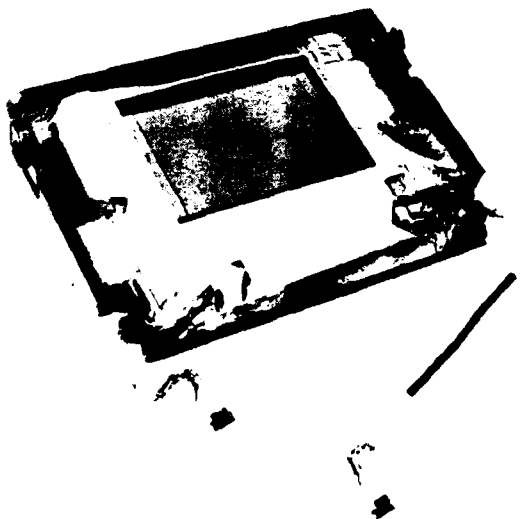
8887 O

FIG 6 - INTERNAL VIEW OF DISPLAY PANEL OF
TEMPEST MODEL 1107 GRID COMPUTER

28. The display has good readability in dim to bright lighting situations. Direct incident light makes the display extremely difficult to read. The addition of the transparent conductive screen covering the display of the Tempest GRID computer attenuates the light emitted resulting in further degradation of readability in difficult lighting conditions.

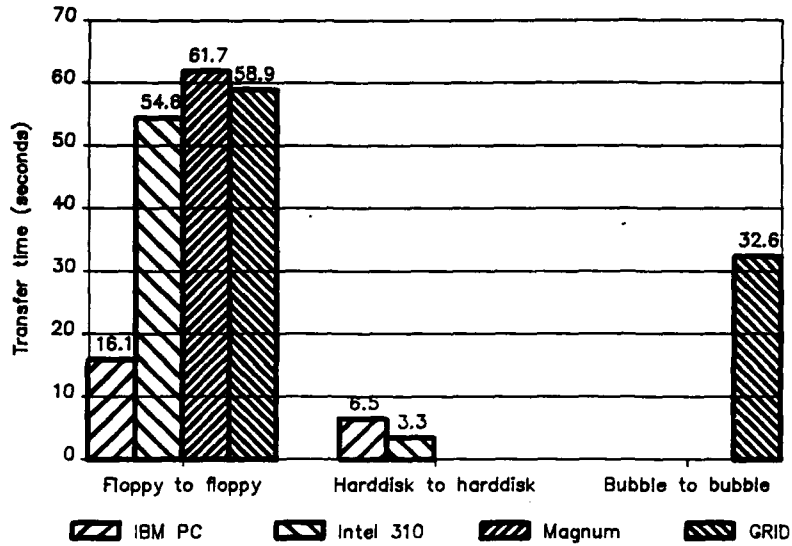
MASS STORAGE BENCHMARK (Copying one 113 Kbyte file)

FIG 7 - MASS STORAGE BENCHMARK RESULTS

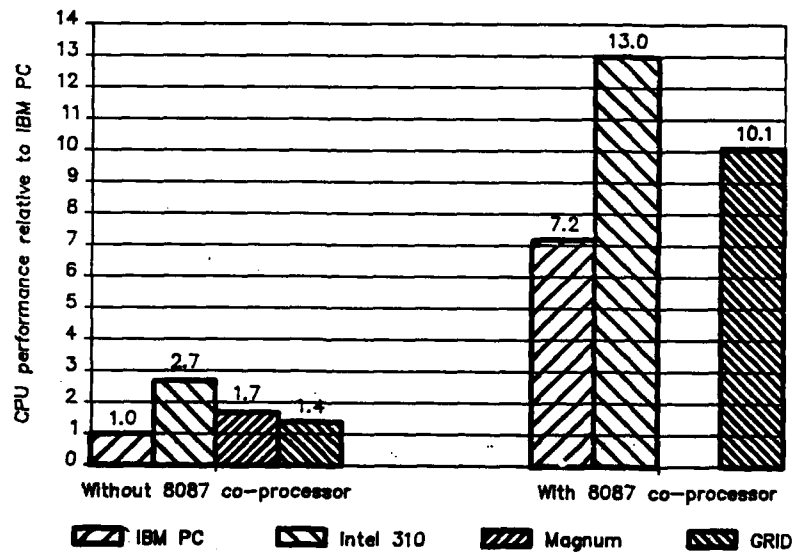
CPU PERFORMANCE BENCHMARK (Sieve prime number generator)

FIG 8 - CPU PERFORMANCE BENCHMARK RESULTS

51. In summary, the GRID computers have a processor performance which is slightly faster than a standard IBM PC. The GRID computers are considered to have adequate performance for most applications not requiring extensive processing power (eg word processing, communications). For applications requiring extensive processing power (eg. graphics, matrix manipulations) the performance of the GRID computers may be found inadequate unless the application software makes specific use of the 8087 coprocessor.

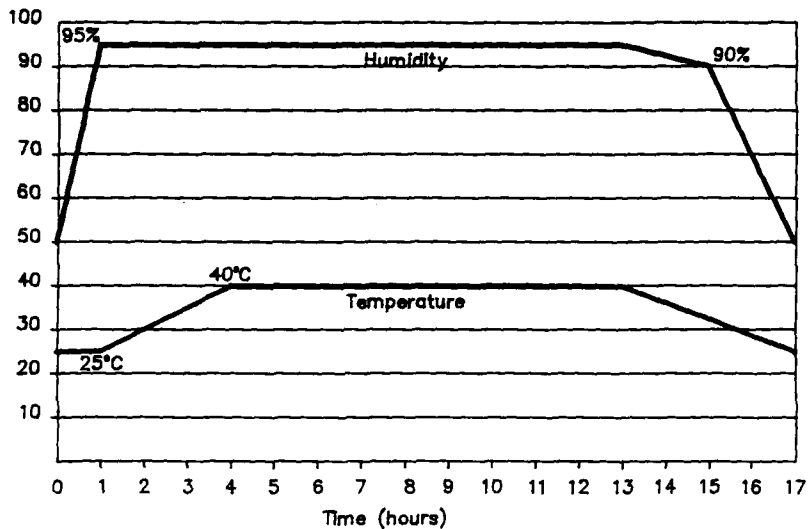
FIG 9 - HIGH TEMPERATURE, HIGH HUMIDITY CHARACTERISTICS
DEF STAN 07-55 PART 2 SECTION 2/1 TEST B6 SEVERITY A

100. Test Procedure. Both GRID computers were subjected to a High Temperature, Diurnal Cycle - High Humidity test as outlined in Ref E Test B6 Severity A Procedure A with a cyclic temperature of 40°C maximum for 16 hours. Both computers were placed in the test chamber and operated with the test program. The humidity and temperature test conditions are shown in Fig 9.

101. Results. Both GRID Compass computers operated correctly throughout the test cycle. The displays, keyboards and serial ports all operated correctly. The access times to the bubble memories were normal (see discussion for the High Temperature, Low Humidity test B2 in paragraph 83).

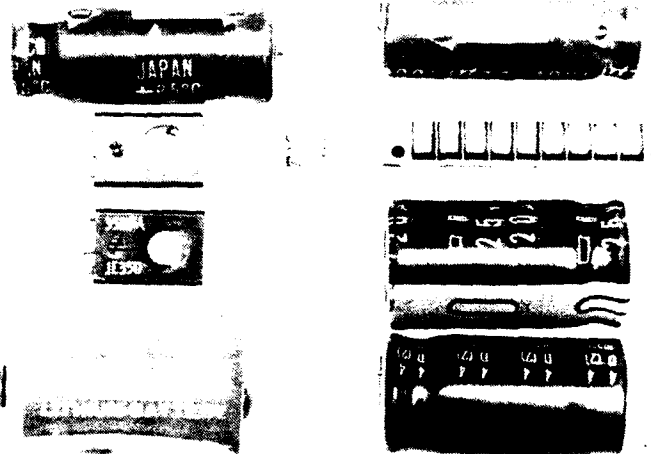
8887 H

FIG 10 - COMPONENTS OF STANDARD MODEL 1100 GRID COMPUTER THAT
CAME ADRIFT DURING VIBRATION TEST (RANDOM, TRACKED
VEHICLES) DEF STAN 07-55 PART 2 SECTION 1/1 TEST A2

121. The following damage was observed :-

- a. The body of the lithium battery had broken from its mounting due to broken leads and failure of the bonding of the silastic-type compound securing it to the board.
- b. Two large electrolytic capacitors had broken from their mounting points on the power supply board due to broken leads.
- c. On the display board two smaller electrolytic capacitors, two transistors, a ceramic filter, and one edge connector for flexible circuit boards had become free as a result of broken leads.
- d. One bracket securing the the electro-luminescent display panel to its printed circuit board was fractured and bent out of shape such that the display was not longer securely mounted.

123. Discussion. It is relatively straight forward to prevent the type of failures discussed in paragraph 121 by applying a structural adhesive to stabilise insecurely mounted components, and by manufacturing more substantial mounting brackets for the display. It is recommended that vibration mounts be used if the computers are installed in tracked vehicles.

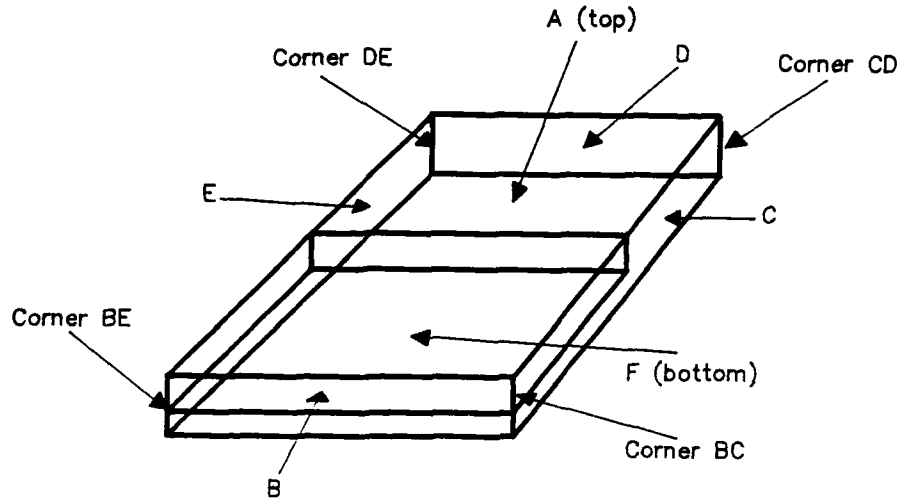
FIG 11 - FACE AND CORNER LABELLING FOR FREE FALL TEST
DEF STAN 07-55 PART 2 SECTION 1/1 TEST A9

132. Results. The computer passed the drop tests from 15 cm and was fully operational without any noticed surface damage. When dropped onto face B and corner BE the display panel sprung open approximately 30°.

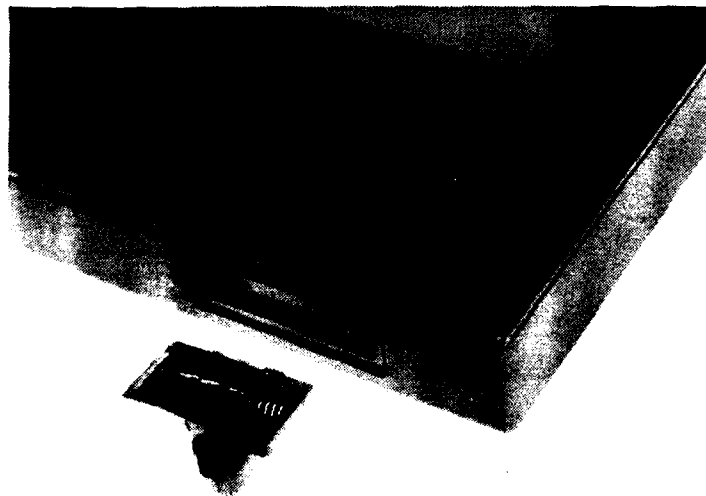
8887 J

FIG 12 - DISPLAY LATCH FAILURE OF TEMPEST MODEL 1107 GRID
COMPUTER FROM FREE FALL TEST DEF STAN 07-55 PART 2
SECTION 1/1 TEST A9

Face	Observation
F	The right display panel latch broke off when a thermal weld within the latch failed (see Fig 12). The computer was still operational. The display panel was secured in the closed position by large rubber bands in order to continue the test.
A	No further damage.
E	A small fragment of the case broke away from the left rear corner of the computer (see Fig 13). The TAB key top was broken from its switch probably due to side ways movement of the display panel (see Fig 14). The computer was still operational.
B	Some mis-alignment and case cracking near the left hand pivot of the display panel was evident. The computer was still operational.

135. Discussion. The magnesium case and general construction of the GRID computers is not sufficiently robust to withstand free fall drops from carrying height on to a hard surface. However, the capability to withstand drops could be improved significantly if the existing carry satchel is replaced by an appropriately designed transit case.

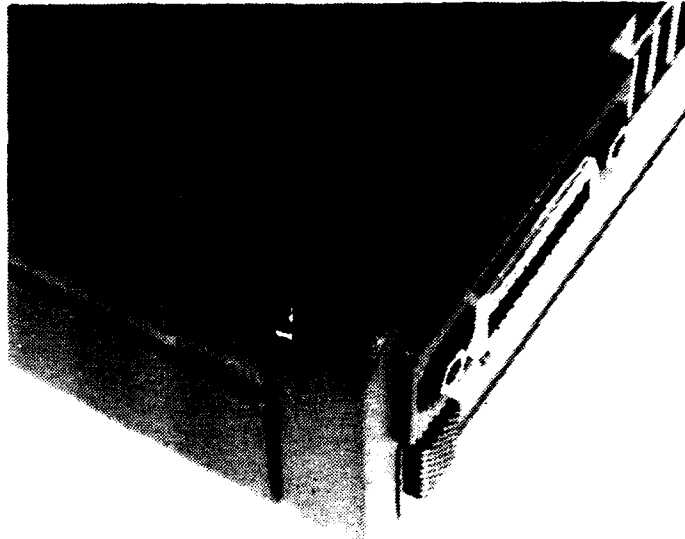
8887 P

FIG 13 - CASE FRACTURE AT LEFT REAR CORNER OF TEMPEST MODEL
1107 GRID COMPUTER FROM FREE FALL TEST
DEF STAN 07-55 PART 2 SECTION 1/1 TEST A9

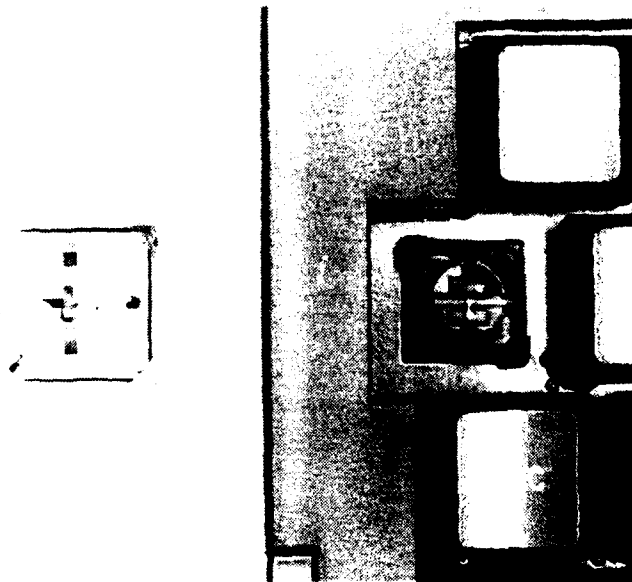
8887 K

FIG 14 - TAB KEY FAILURE OF TEMPEST MODEL 1107 GRID
FROM FREE FALL TEST DEF STAN 07-55 PART 2
SECTION 1/1 TEST A9

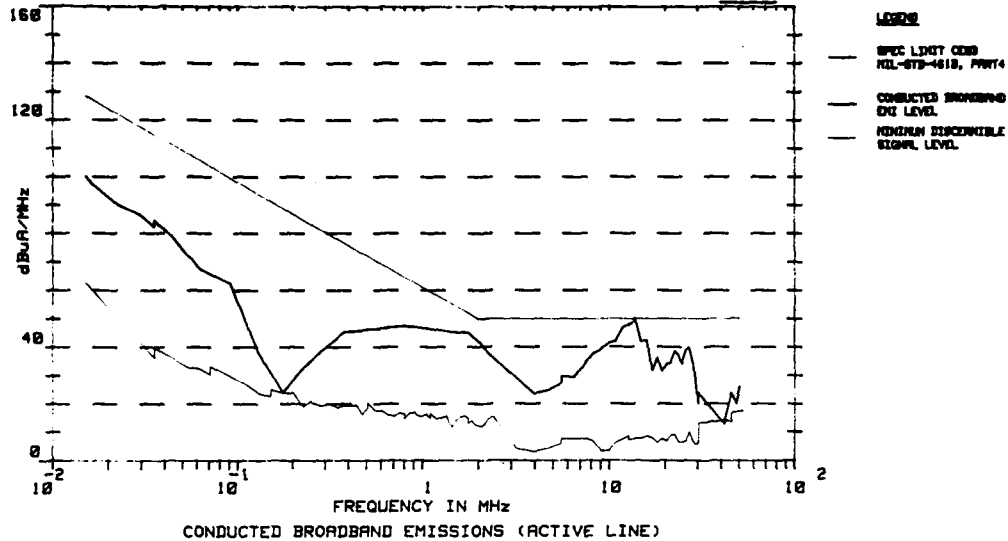
TEST SAMPLE: GRID COMPUTER MODEL No 1100
MIL-STD-461B CE03, PART 4
MODE OF TEST: SEND QUICK BROWN FOX TO SCREEN
REMARKS:

FIG 15 - STANDARD MODEL 1100 GRID COMPUTER
CONDUCTED BROADBAND EMISSIONS (ACTIVE LINE)

62. Conducted Broadband Results. The Tempest GRID computer failed to meet the specification limit CE03 of Ref B for conducted broadband emissions over the frequency range 1.2 MHz to 2.5 MHz by up to 5 dB on both the active (Annex B Fig 16) and neutral (Annex B Fig 18) power supply lines. The Standard GRID computer met this specification limit on the active (Annex B Fig 15) and neutral lines (Annex B Fig 17).

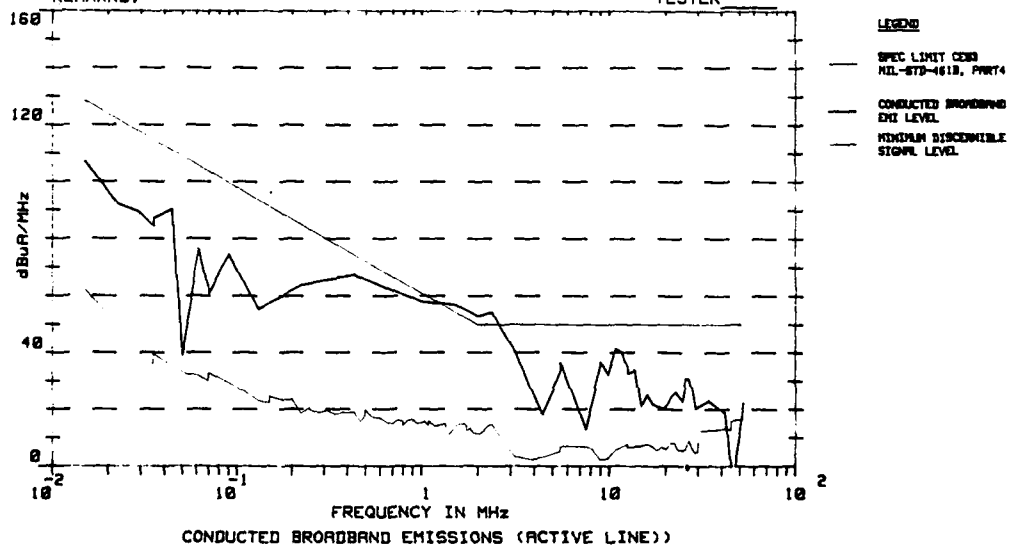
TEST SAMPLE: GRID COMPUTER MODEL No 1107
MIL-STD-461B CE03, PART 4
MODE OF TEST: SEND QUICK BROWN FOX TO SCREEN
REMARKS:

FIG 16 - TEMPEST MODEL 1107 GRID COMPUTER
CONDUCTED BROADBAND EMISSIONS (ACTIVE LINE)

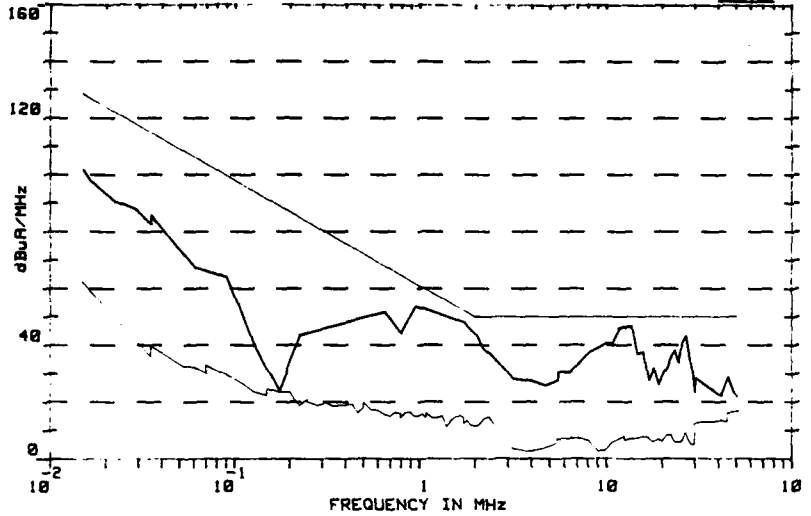
TEST SAMPLE: GRID COMPUTER MODEL No 1100
MIL-STD-461B CE03, PART 4
MODE OF TEST: SEND QUICK BROWN FOX TO SCREEN
REMARKS:

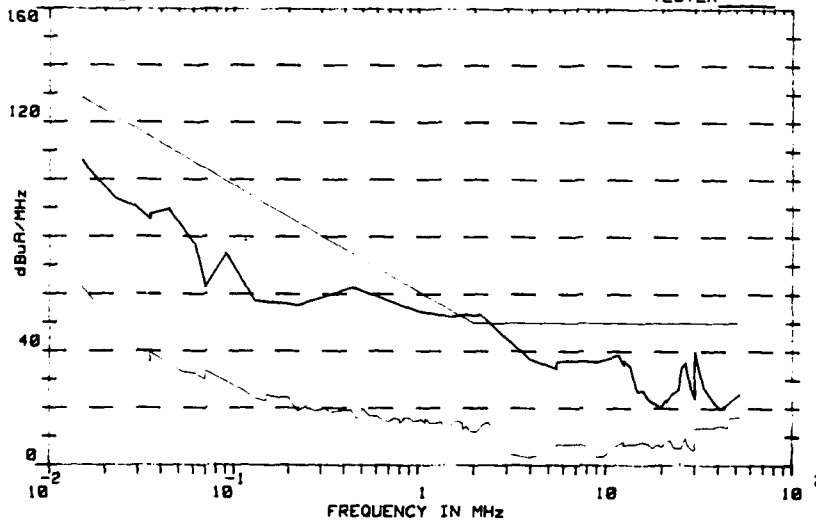
TEST SAMPLE: GRID COMPUTER MODEL No 1107
MIL-STD-461B CE03, PART 4
MODE OF TEST: SEND QUICK BROWN FOX TO SCREEN
REMARKS:

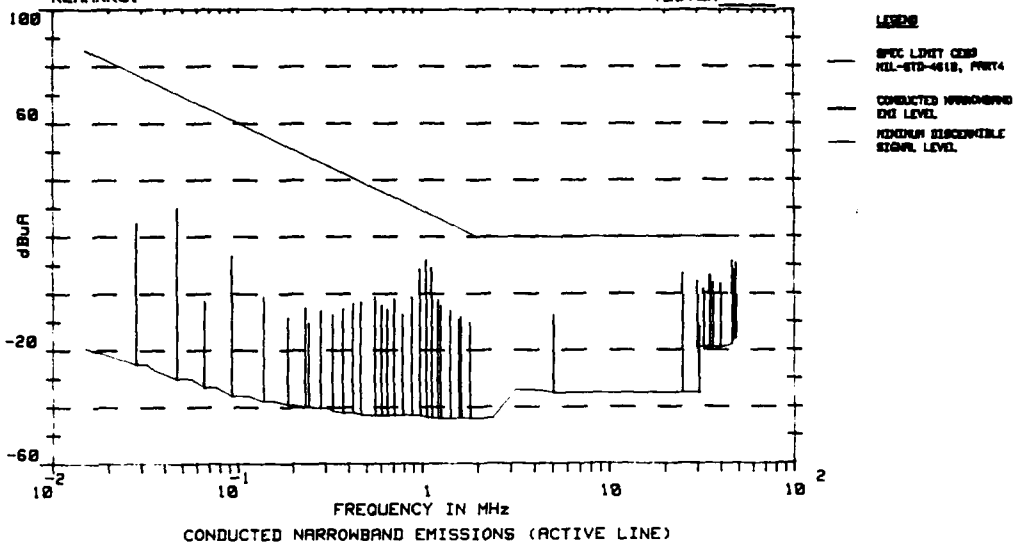
FIG 19 - STANDARD MODEL 1100 GRID COMPUTER
CONDUCTED NARROWBAND EMISSIONS (ACTIVE LINE)

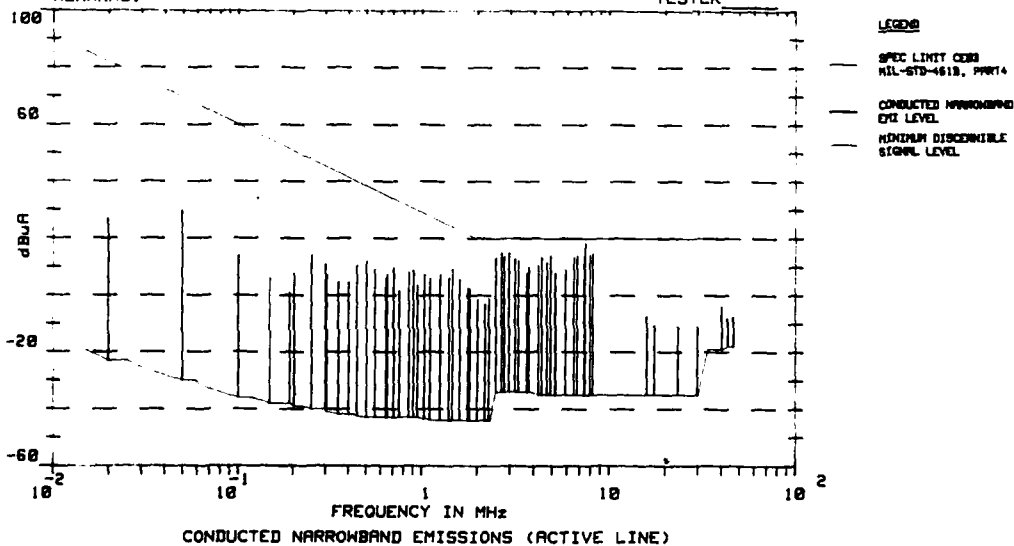
FIG 20 - TEMPEST MODEL 1107 GRID COMPUTER
CONDUCTED NARROWBAND EMISSIONS (ACTIVE LINE)

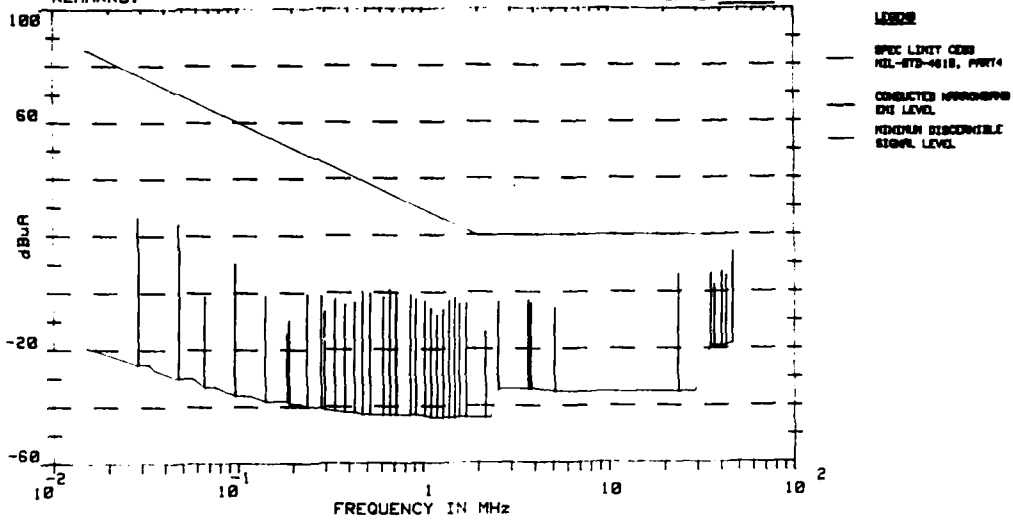
FIG 21 - STANDARD MODEL 1100 GRID COMPUTER
CONDUCTED NARROWBAND EMISSIONS (NEUTRAL LINE)

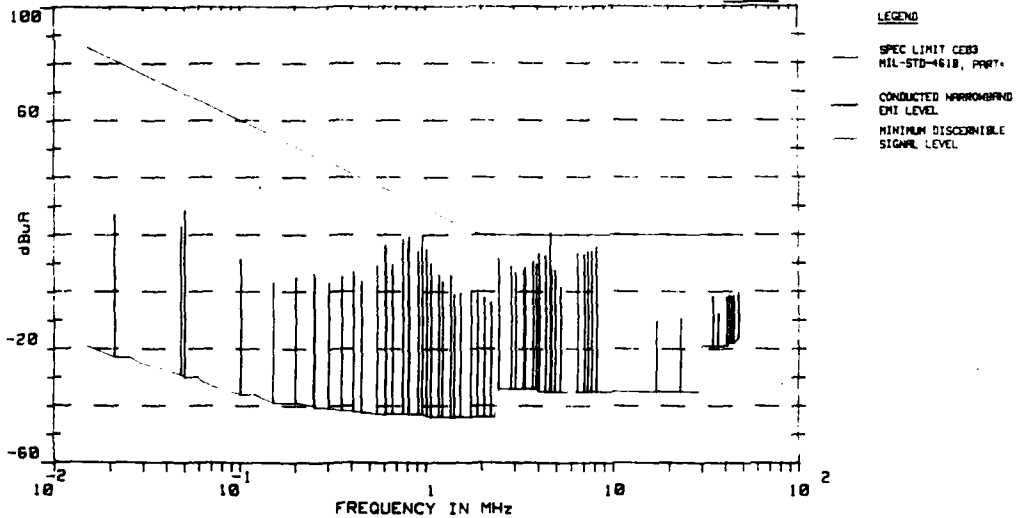
FIG 22 - TEMPEST MODEL 1107 GRID COMPUTER
CONDUCTED NARROWBAND EMISSIONS (NEUTRAL LINE)

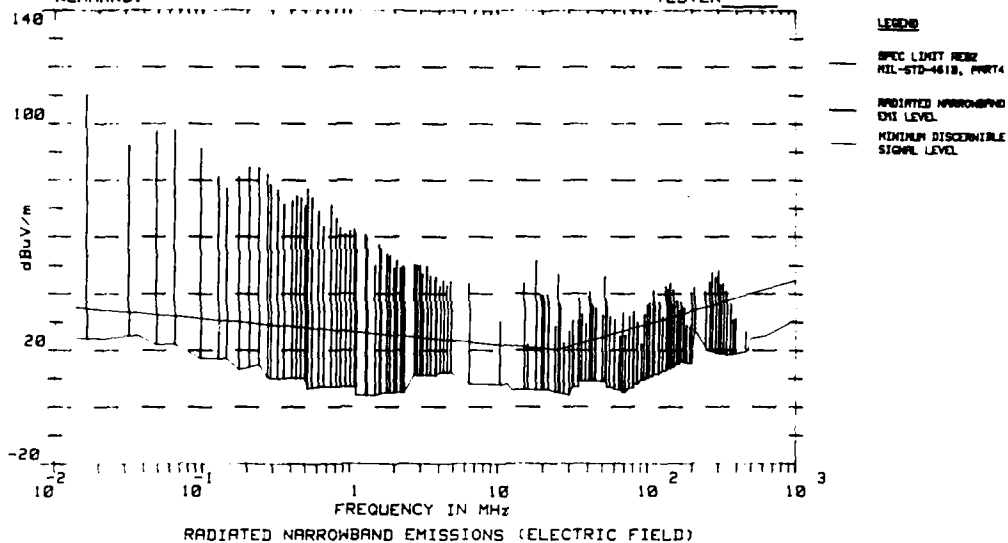
FIG 23 - STANDARD MODEL 1100 GRID COMPUTER
RADIATED NARROWBAND EMISSIONS (ELECTRIC)

65. Radiated Narrowband Results. Using the test setup described in paragraph 59, both GRID models failed to meet the specification limit RS02 of Ref B. The radiated emissions tests on both GRID computers show that the Standard GRID computer generates a much higher level (approximately 40 dBuV/m) of electromagnetic interference over the entire frequency range from 18 kHz to 429 MHz (Annex B Fig 23) than does the Tempest GRID computer (Annex B Fig 24).

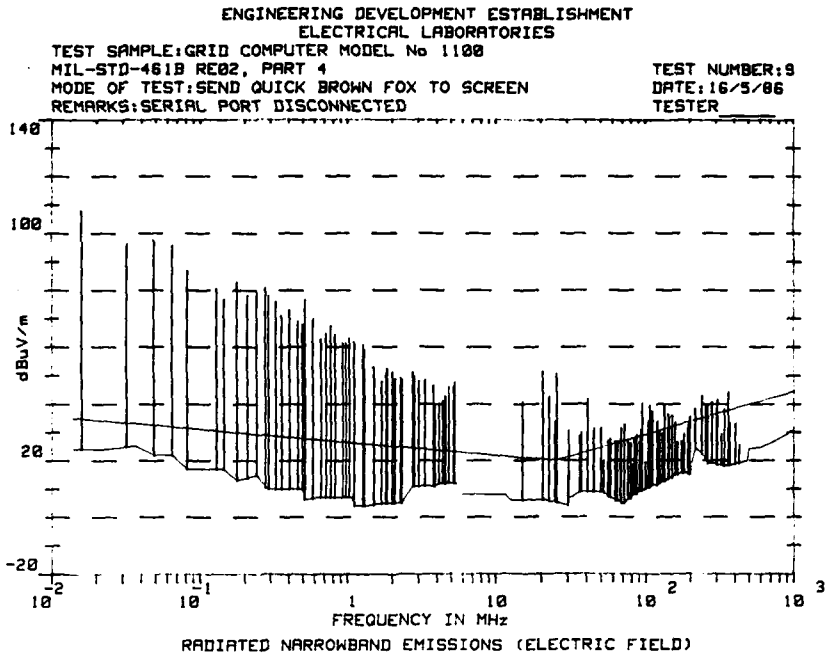
**FIG 25 - STANDARD MODEL 1100 GRID COMPUTER
RADIATED NARROWBAND EMISSIONS (ELECTRIC)
SERIAL CABLE DISCONNECTED**

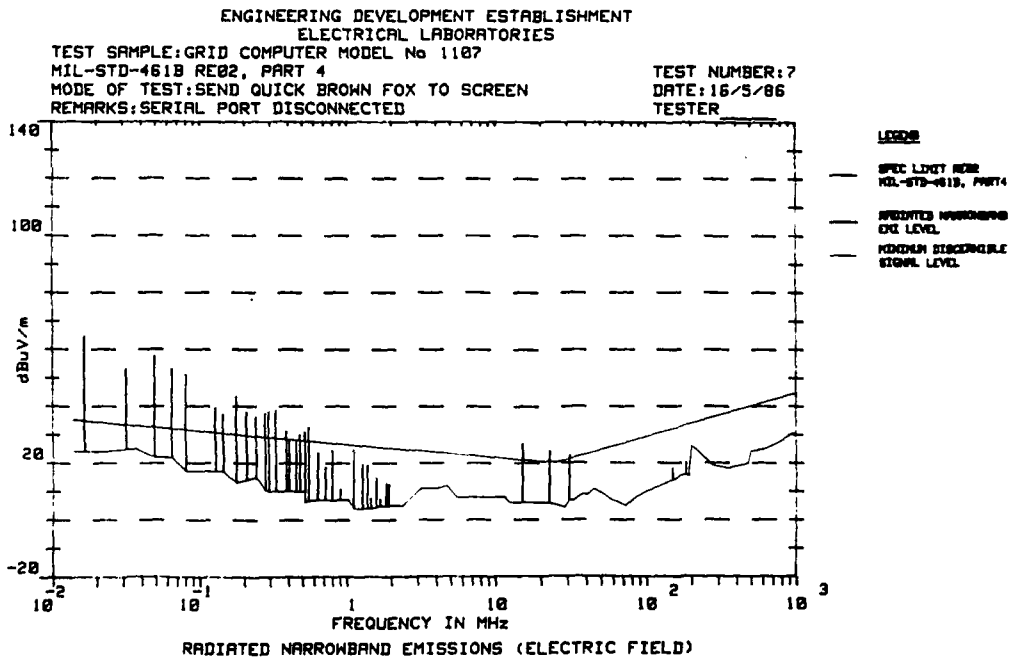
**FIG 26 - TEMPEST MODEL 1107 GRID COMPUTER
RADIATED NARROWBAND EMISSIONS (ELECTRIC)
SERIAL CABLE DISCONNECTED**

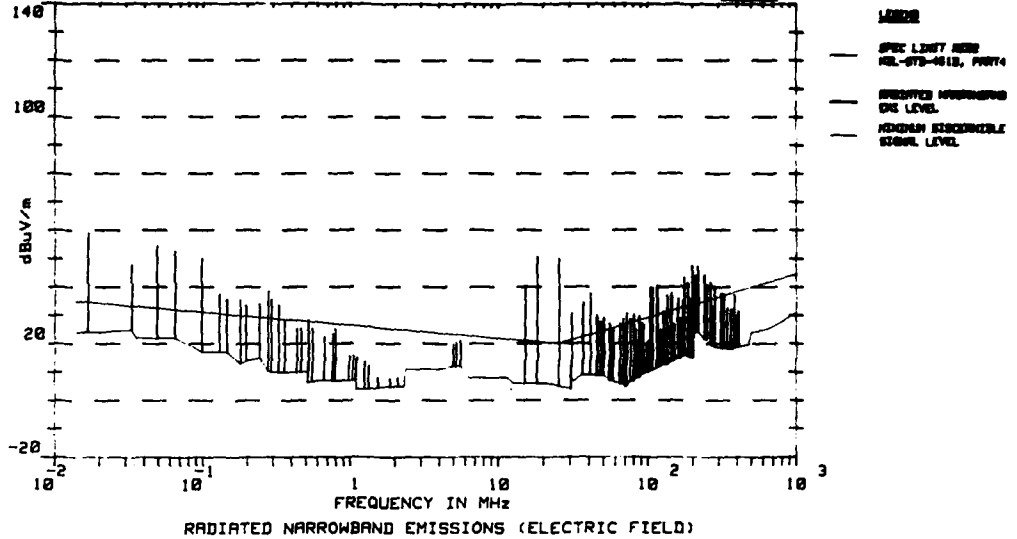
TEST SAMPLE: GRID COMPUTER MODEL No 1106
MIL-STD-461B RE02, PART 4
MODE OF TEST: SEND QUICK BROWN FOX TO SCREEN
REMARKS: DISPLAY PANEL FOLDED DOWN

**FIG 27 - STANDARD MODEL 1100 GRID COMPUTER
RADIATED NARROWBAND EMISSIONS (ELECTRIC)
DISPLAY PANEL FOLDED DOWN**

67. Radiated Narrowband Results (Panel down). Folding down the display panel produced a significant drop in radiated narrowband emission levels for both computers across the whole frequency range of 18 kHz to 420 MHz. The results are shown in Annex B Fig 27 for the Standard GRID computer and in Annex B Fig 28 for Tempest GRID computer. The Tempest GRID computer almost meets the specification limit RE02 of Ref B with the display panel folded down. The Standard GRID computer fails to meet the specification. Note that operation with the display panel down would not be the normal operating normal mode.

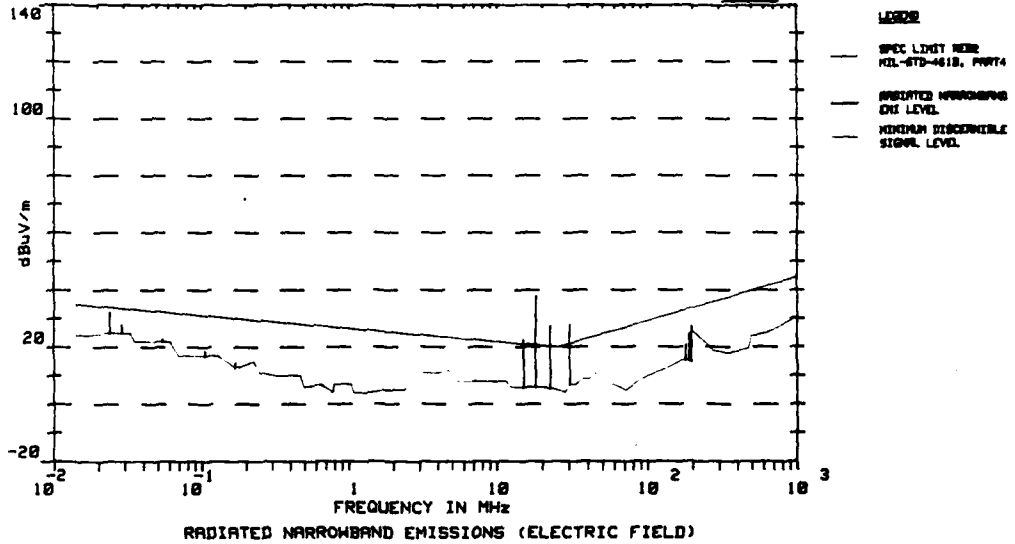
TEST SAMPLE: GRID COMPUTER MODEL No 1107
MIL-STD-461B RE02, PART 4
MODE OF TEST: SEND QUICK BROWN FOX TO SCREEN
REMARKS: DISPLAY PANEL FOLDED DOWN

**FIG 28 - TEMPEST MODEL 1107 GRID COMPUTER
RADIATED NARROWBAND EMISSIONS (ELECTRIC)
DISPLAY PANEL FOLDED DOWN**

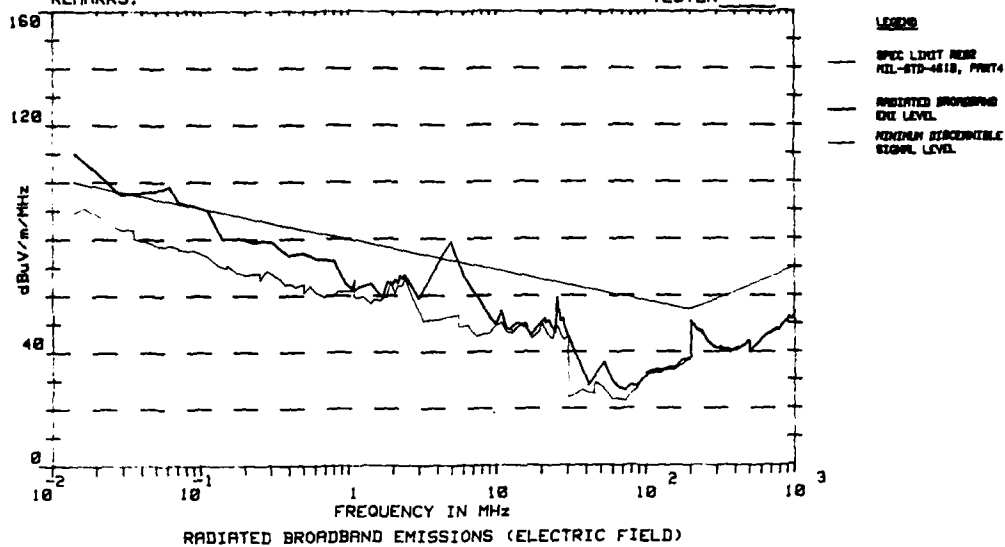
FIG 29 - TEMPEST MODEL 1107 GRID COMPUTER
RADIATED BROADBAND EMISSIONS (ELECTRIC)

69. Radiated Broadband Results. The Tempest GRID computer failed to meet the specification limit RE02 of Ref B for radiated broadband emissions over the frequency range 15 kHz to 120 kHz and 4 MHz to 6 MHz by up to 10 dBuV/m/MHz (Annex B Fig 29). The Standard GRID computer failed to meet the specification and exhibited numerous radiated broadband emissions. Accurate broadband emissions measurements were not taken for the Standard GRID computer as they serve no useful purpose in a unit which also exhibits a large amount of narrowband emissions; therefore no graph is provided.
