MISCELLANEOUS PAPER GL-87-16

# OPEN-GRADED BASES FOR AIRFIELD PAVEMENTS

by  
Walter R. Barker

July 1987  
Final Report

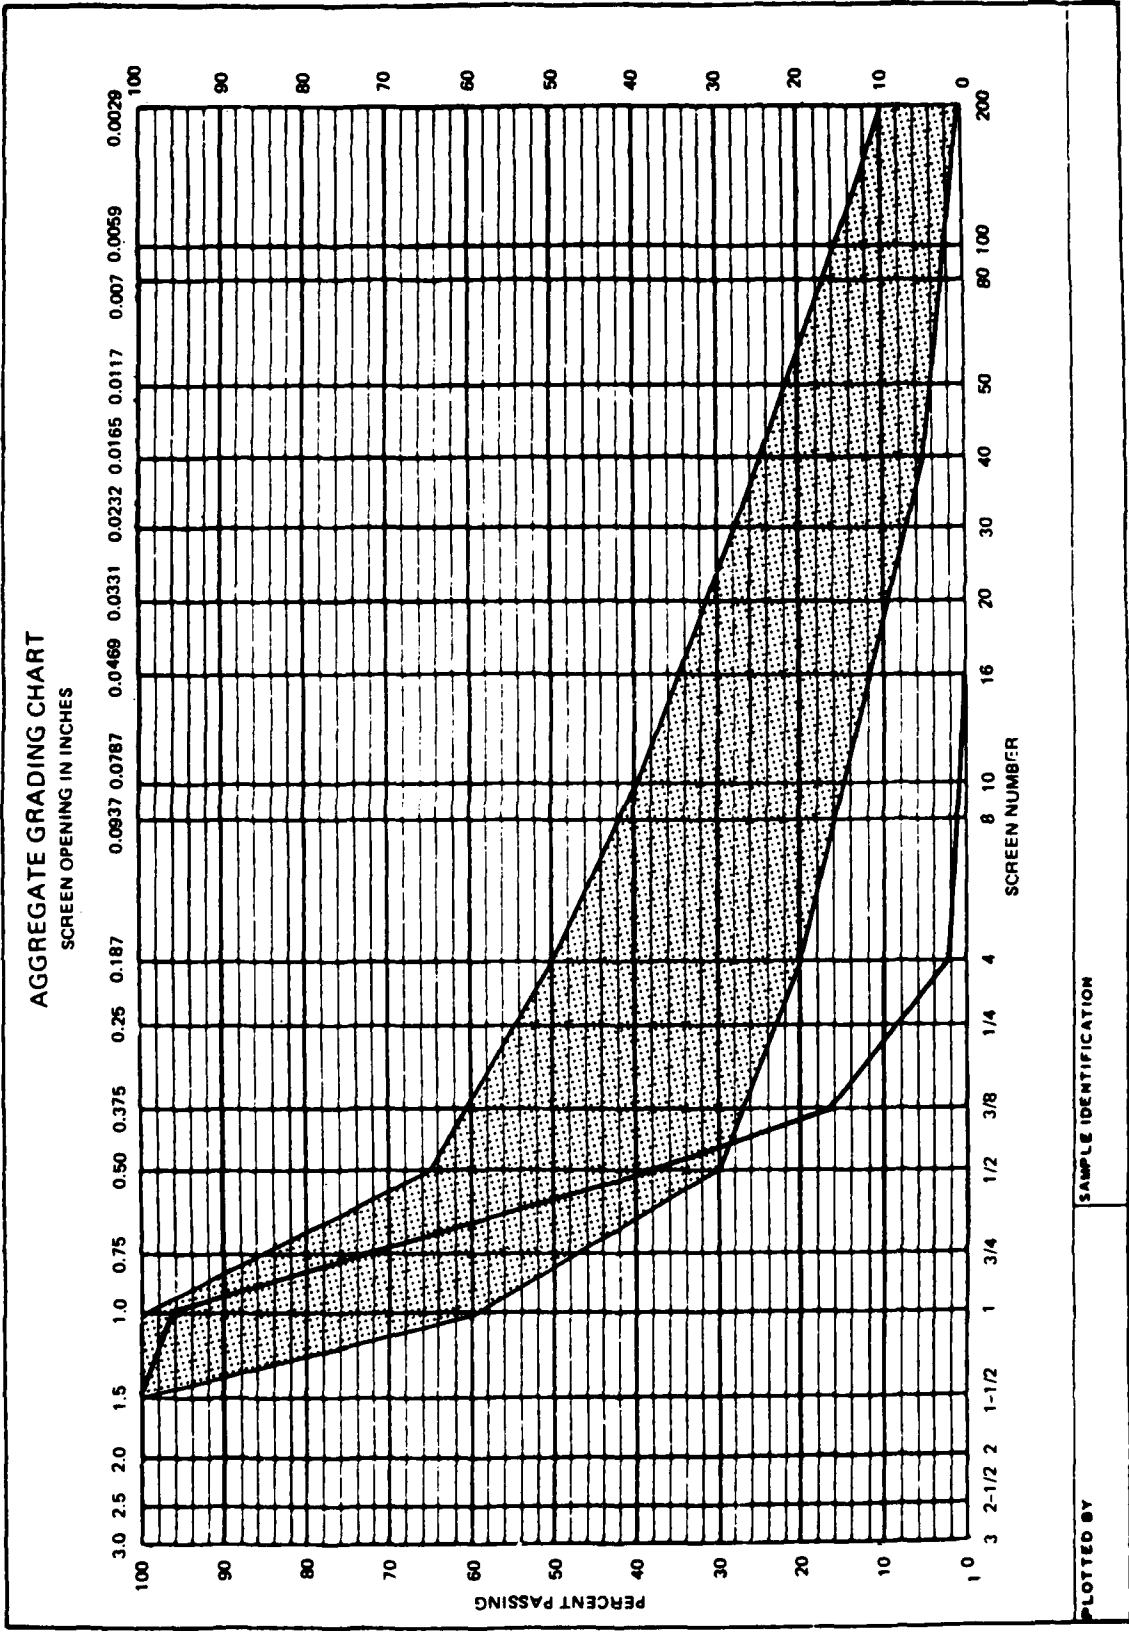
Figure 1. Gradation curve for No. 57 crushed limestone and equivalent limits limits for Corps of Engineers dense-graded aggregate

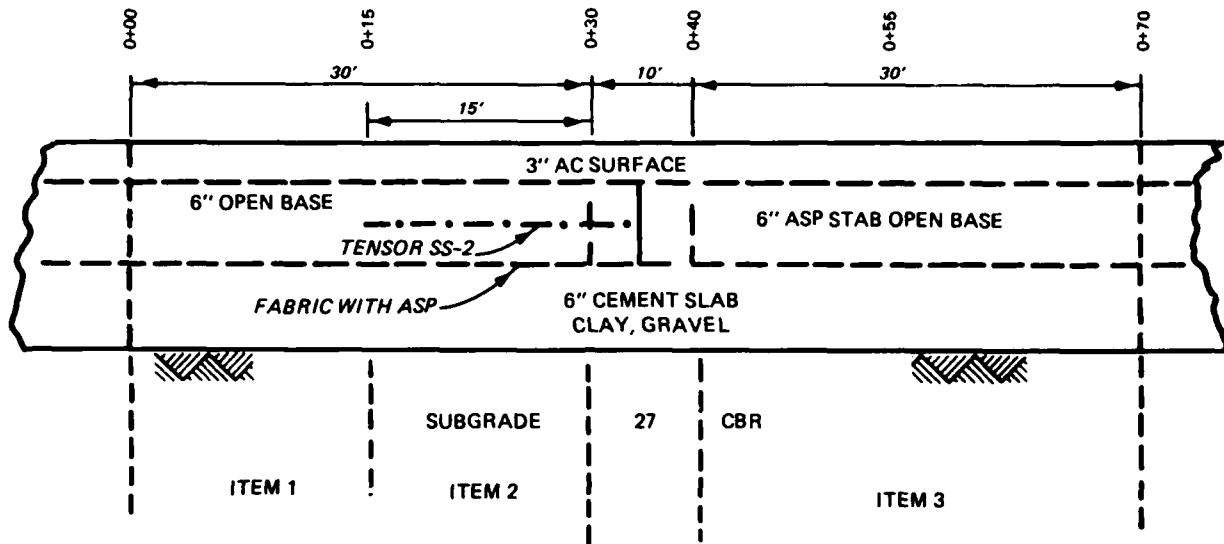
Figure 2. Typical longitudinal section

17. The construction details of the test section are given in typical longitudinal section in Figure 2.

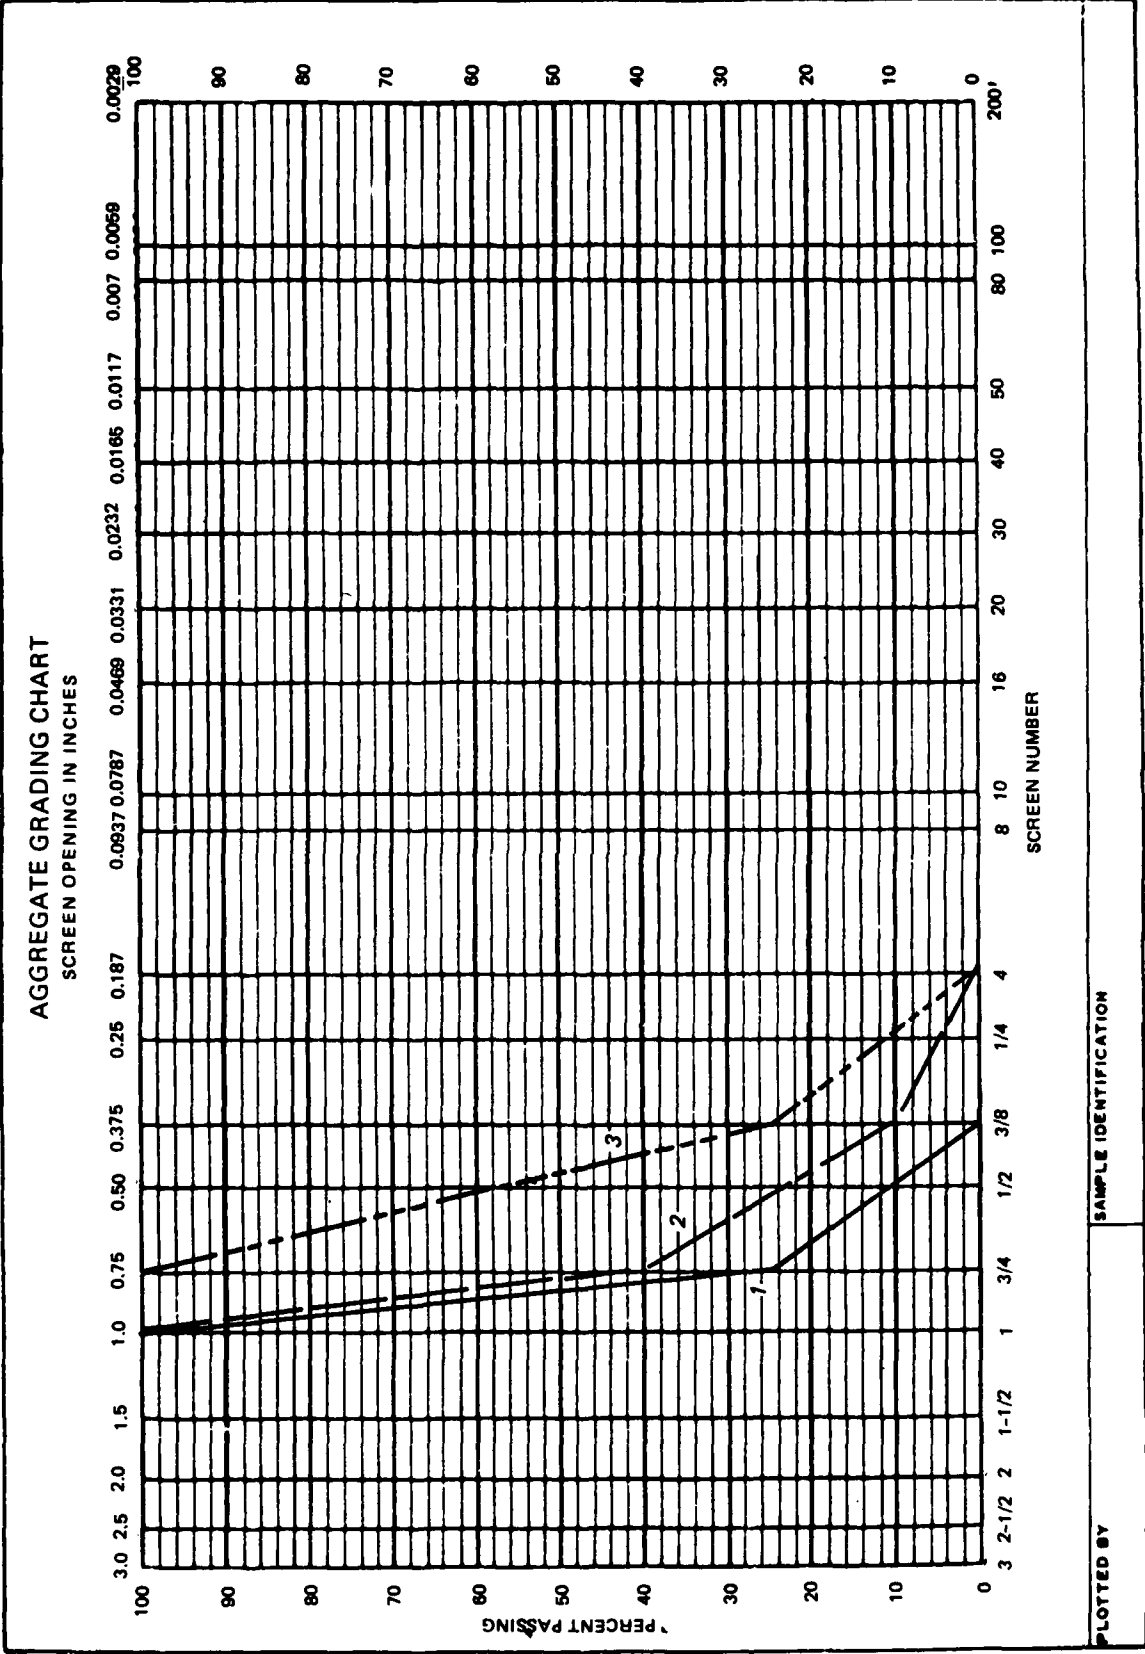
Figure 3. Gradations for open stabilized base

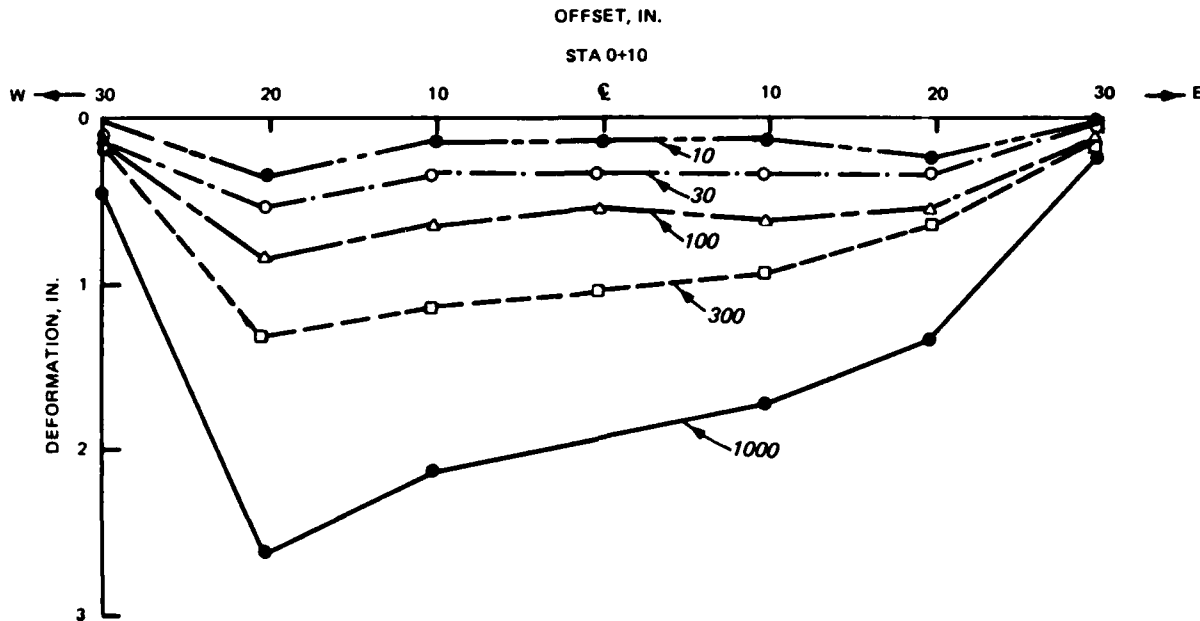
Figure 4. Cross section of Item 1 at sta 0+10

34. Cross-section data were taken at sta 0+10, 0+15, 0+25, 0+30, 0+47.5, 0+55, and 0+62.5 using a rod and level. These cross sections gave two cross sections for Items 1 and 2 and three cross sections for Item 3. The cross-section data relative to the beginning surface are shown in Figures 4 through 10.

(Items 1 and 2) base consistent with the effects of base movement observed during rolling of the asphalt surface. The comparisons are also consistent with eventual depression magnitudes under traffic as shown in Figures 4 and 10 and discussed in the following section.

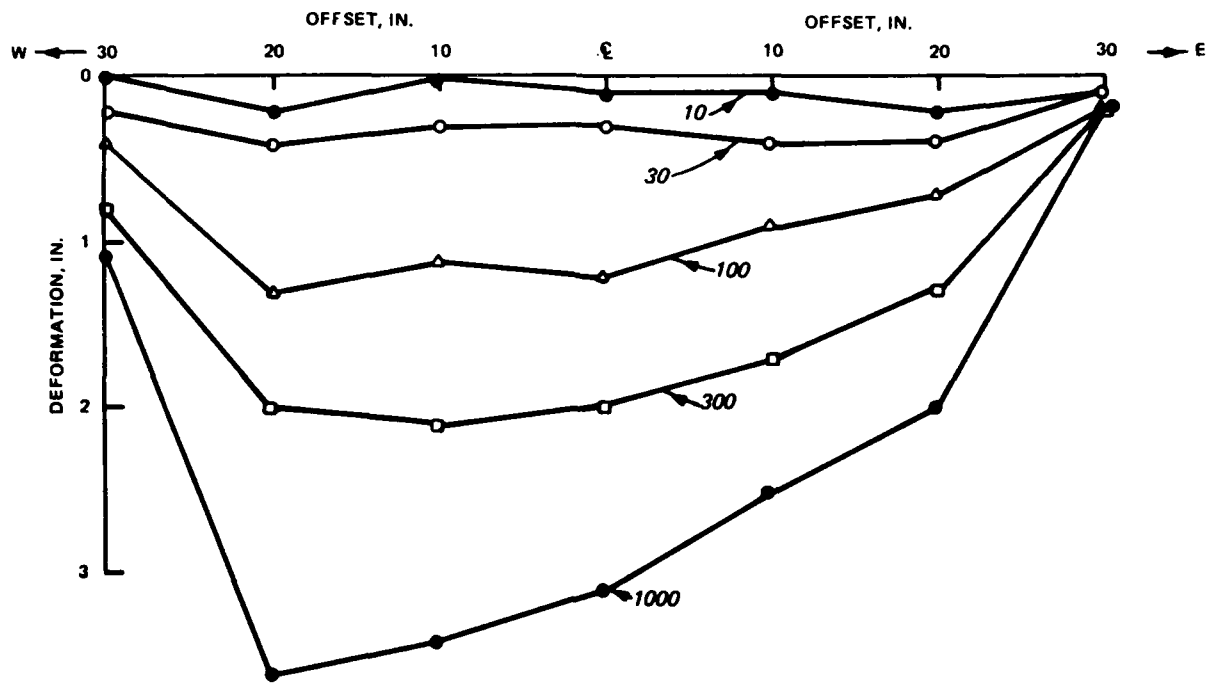
Figure 5. Cross section of Item 1 at sta 0+15

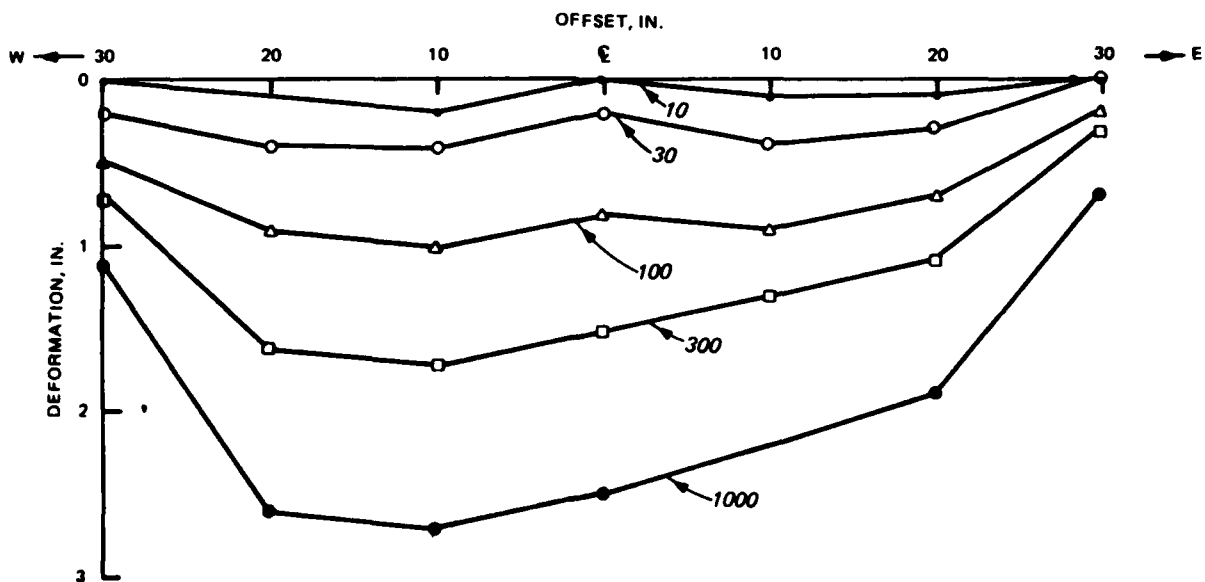
Figure 6. Cross section of Item 2 at sta 0+25

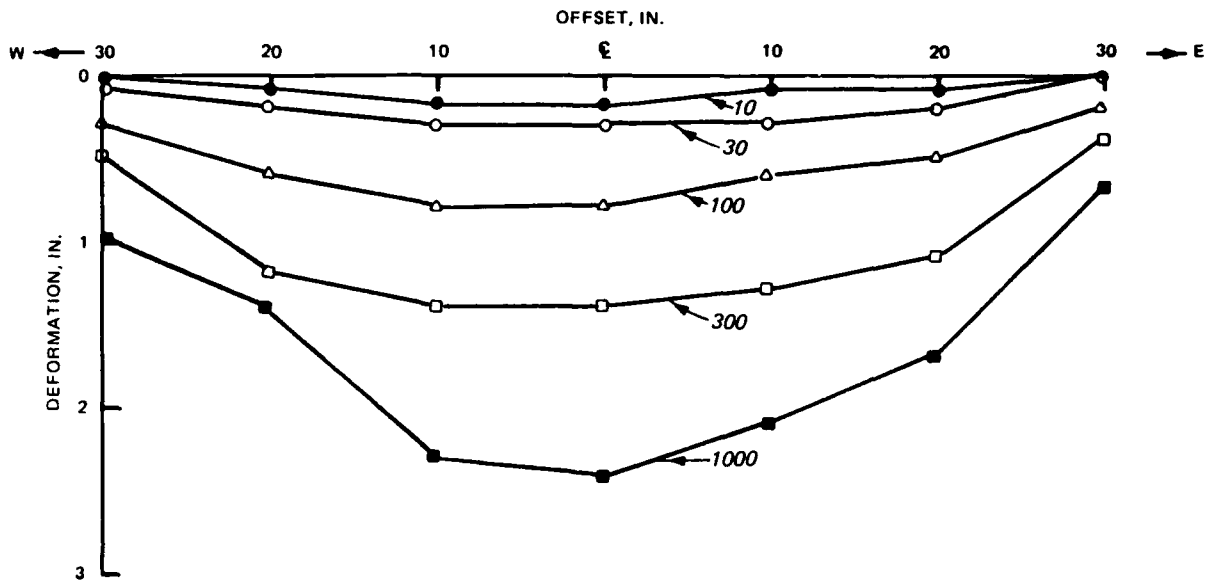
Figure 7. Cross section of Item 2 at sta 0+30

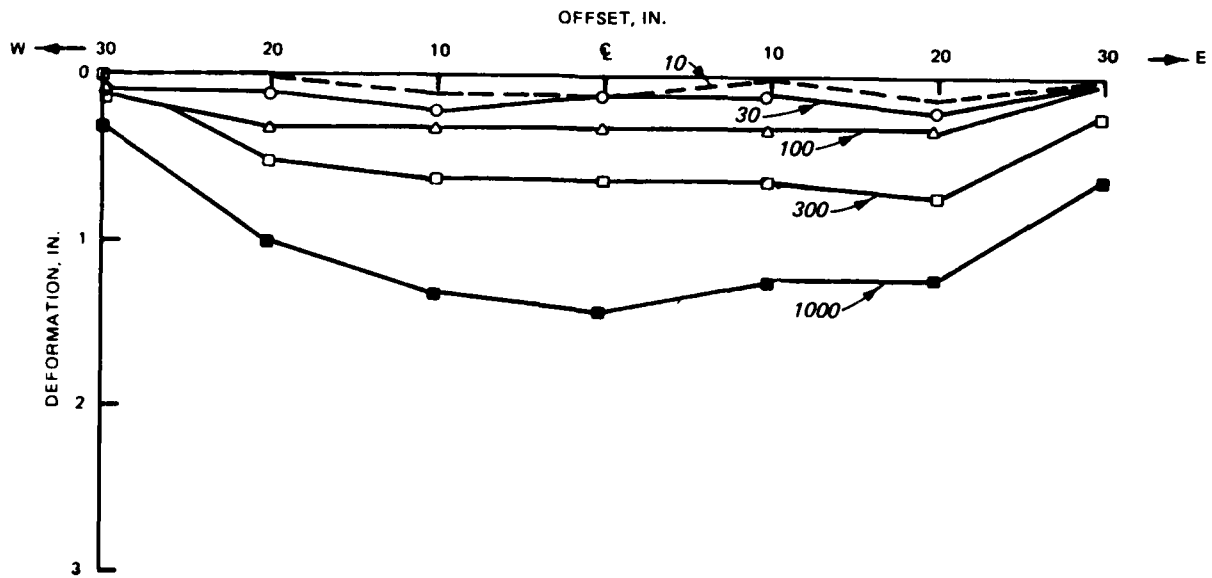
Figure 8. Cross section of Item 3 at sta 0+47.5

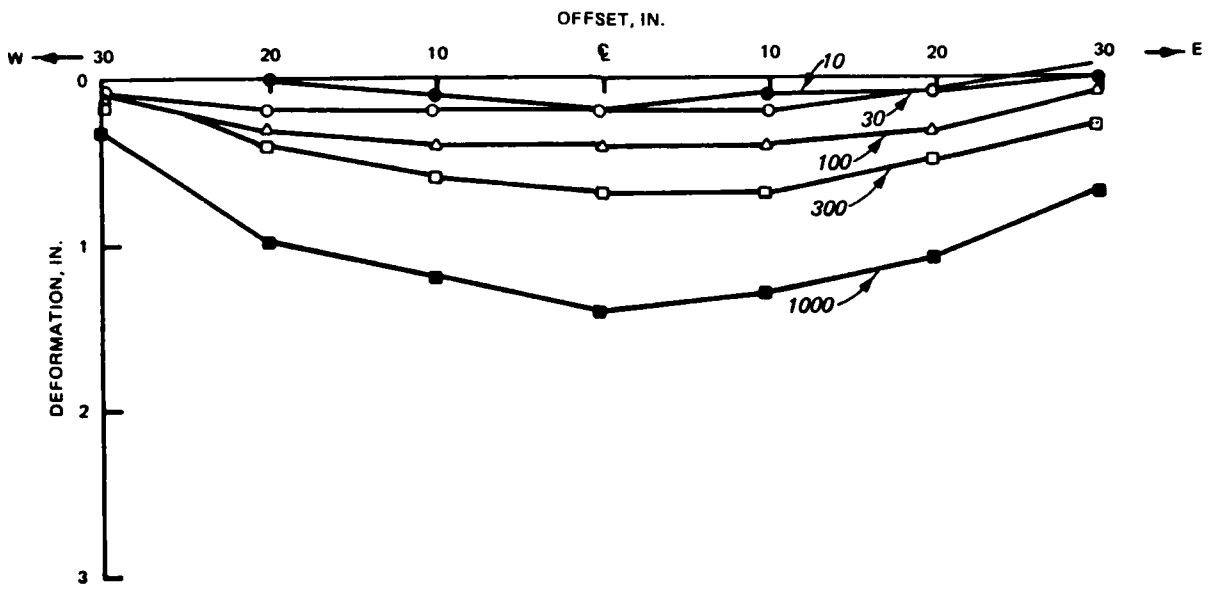
Figure 9. Cross section of Item 3 at sta 0+55

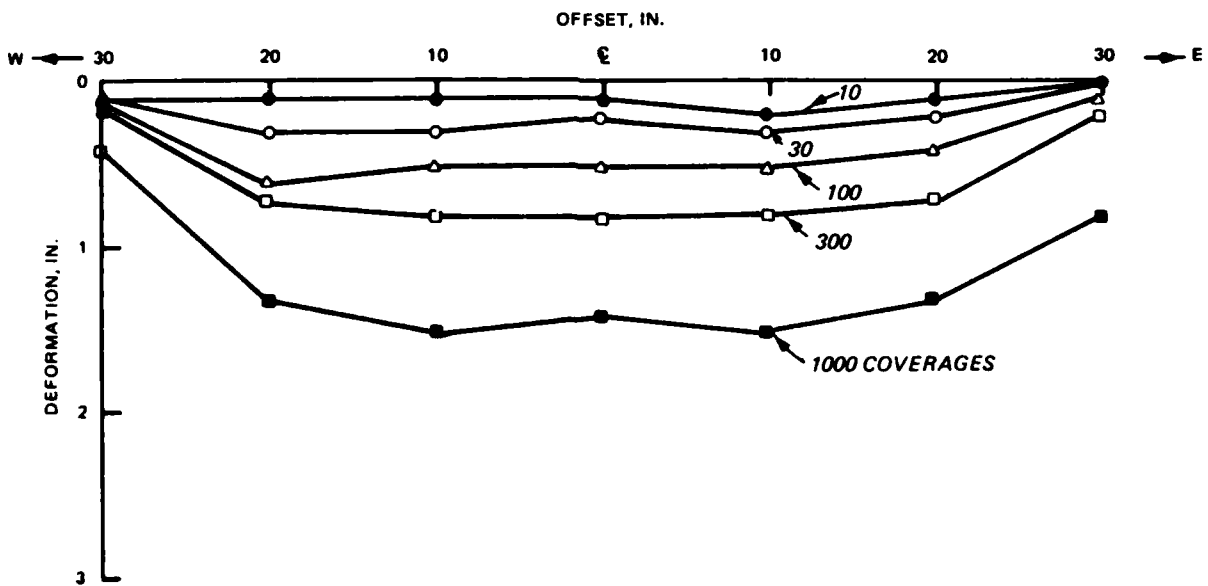
Figure 10. Cross section of Item 3 at sta 0+62.5

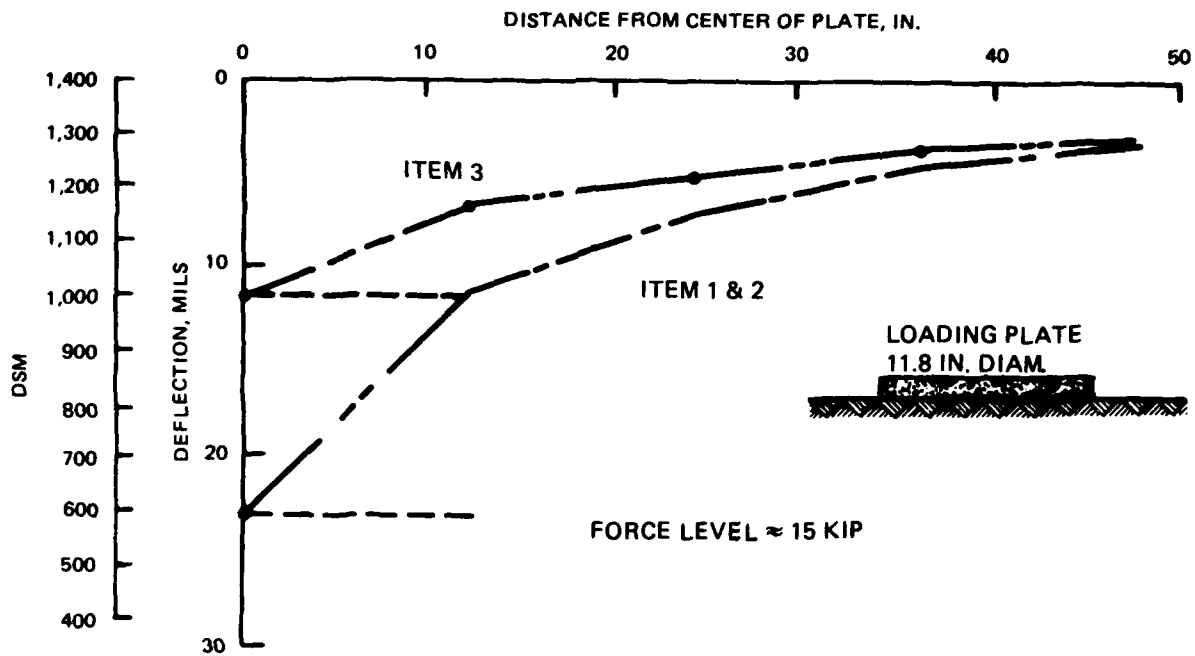
Figure 11. FWD deflection basin at "0" coverage

39. The FWD test conducted before and during traffic revealed interesting information concerning the behavior of the test section. It is seen by comparing the deflection basin before traffic to the deflection basin at 100 coverages that the maximum deflections from the FWD doubled with the start of traffic. As traffic increased after 100 coverages, the deformations measured in the FWD tests (Figure 12) decreased for Items 1 and 2, but increased for Item 3. One possible explanation for results obtained in the FWD test would be in the performance of the PCC stabilized layer under the base. This layer prior to traffic would have been intact. During traffic the cement-stabilized layer cracked, the cracking being more rapid in Items 1 and 2 than in Item 3. Prior to 100 coverages of traffic, the cracking for Items 1 and 2 was complete and then the section began to stiffen because of consolidation of the lower layer. For Item 3 the stiffer base prevented the rapid breakup of the cement-stabilized layer. The continued increase in the FWD deflection of Item 3 could indicate a breakup of the asphalt-stabilized base.

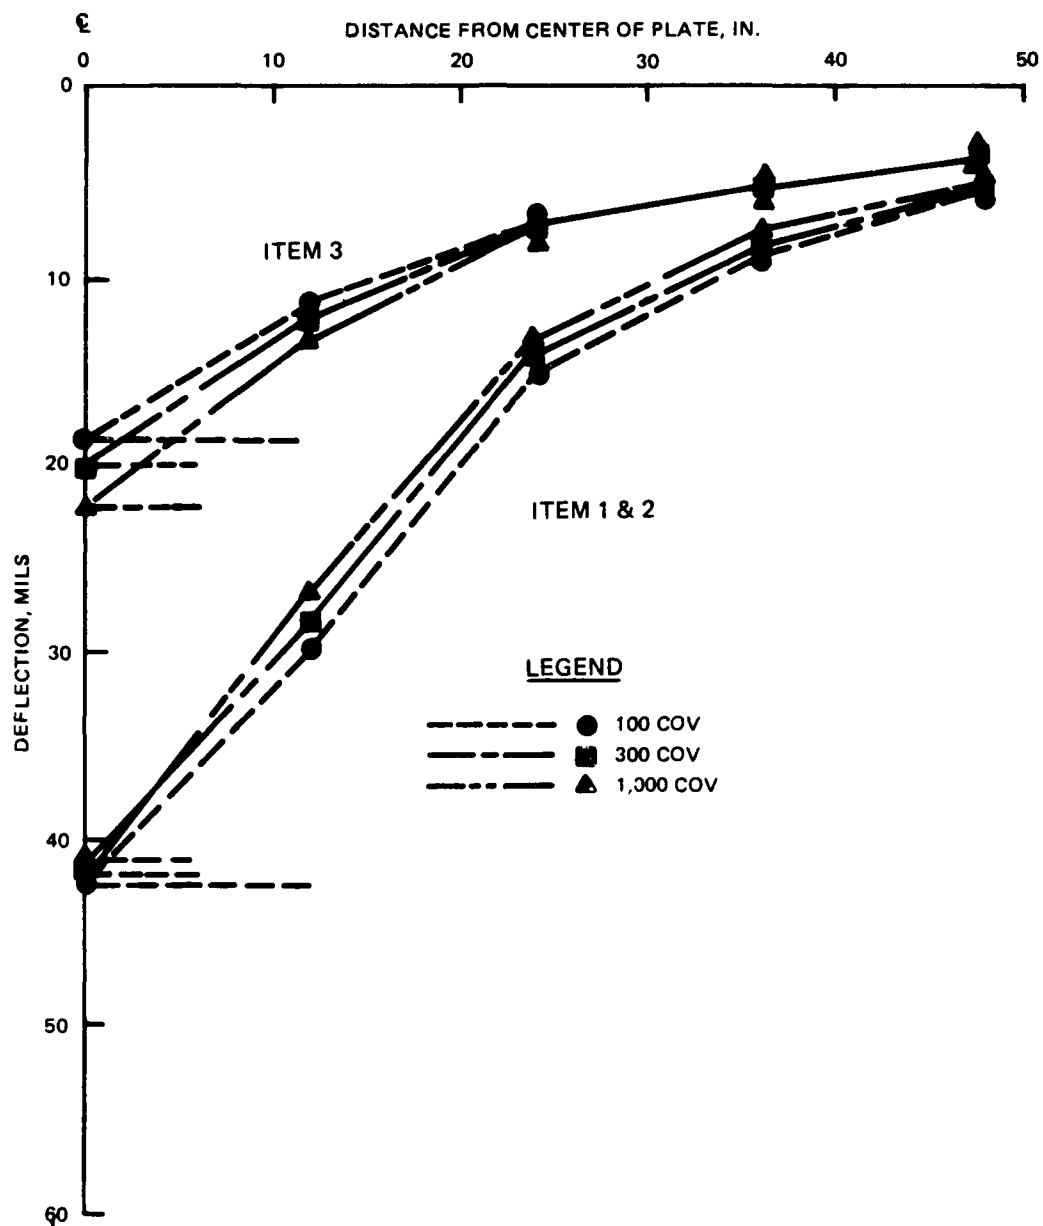
Figure 12. Deflected surface for FWD tests at coverage levels of 100, 300, and 1,000

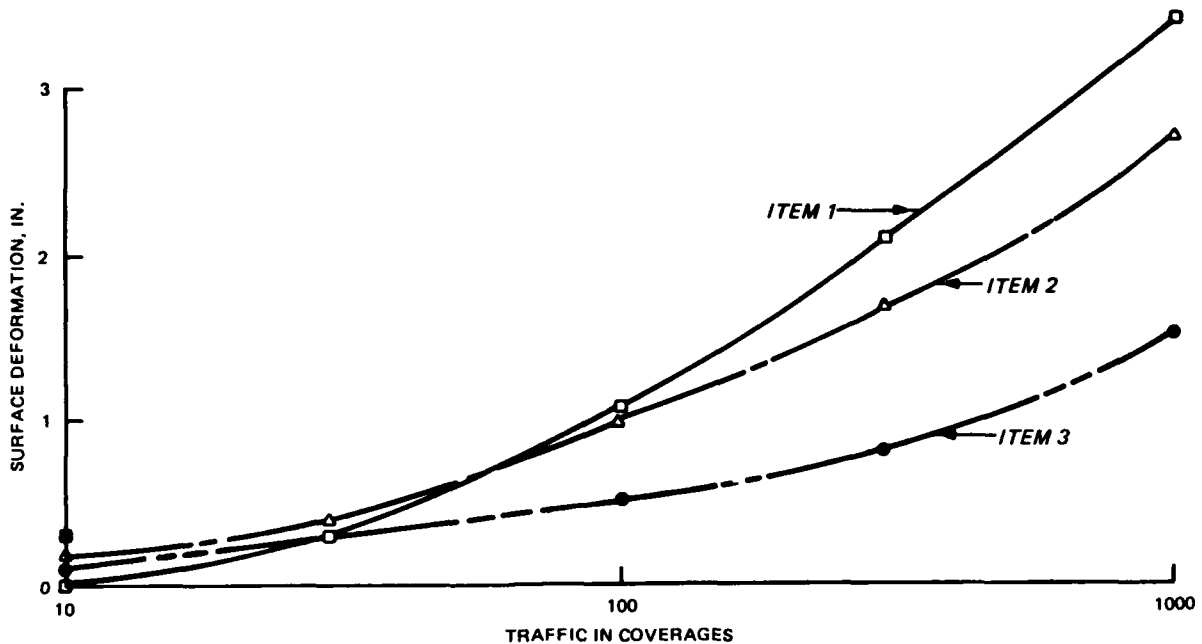
Figure 13. Maximum surface deformation as a function of traffic

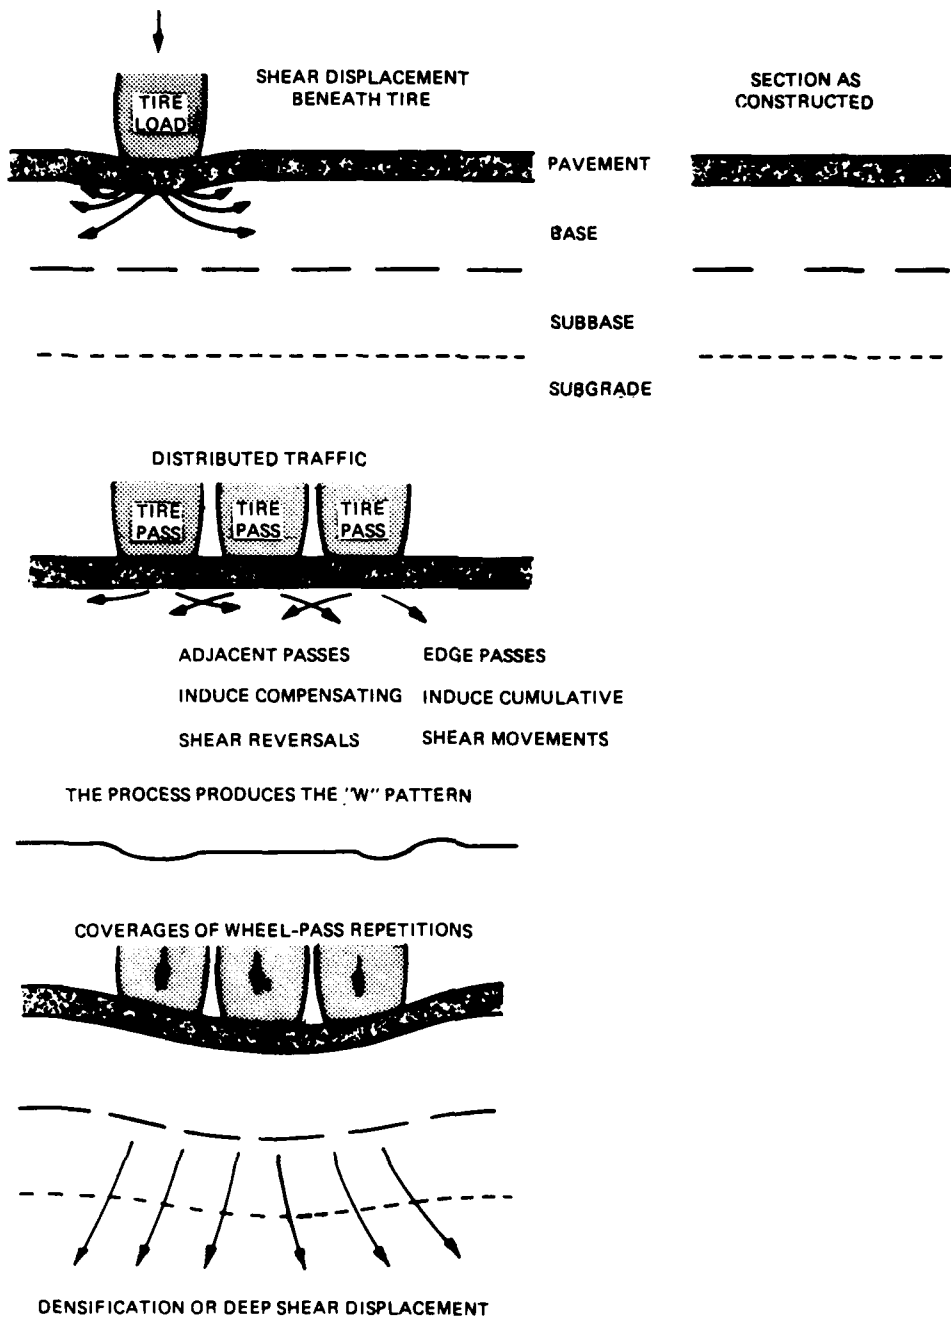
Figure 14. Schematic representation of traffic effects

37. During the early part of traffic, it was noted that for Items 1 and 2, the deformed surface formed a "W." This W shape can be noted in the cross sections given in Figures 5 and 6. The development of the W is an indication that some shear movement is taking place in the upper layers. Later in traffic the deformation basin formed a deep bowl-type basin without upheaval at the edge which would be an indication that the deformation is a result of deep consolidation. Figure 14 presents a schematic representation of traffic effects.

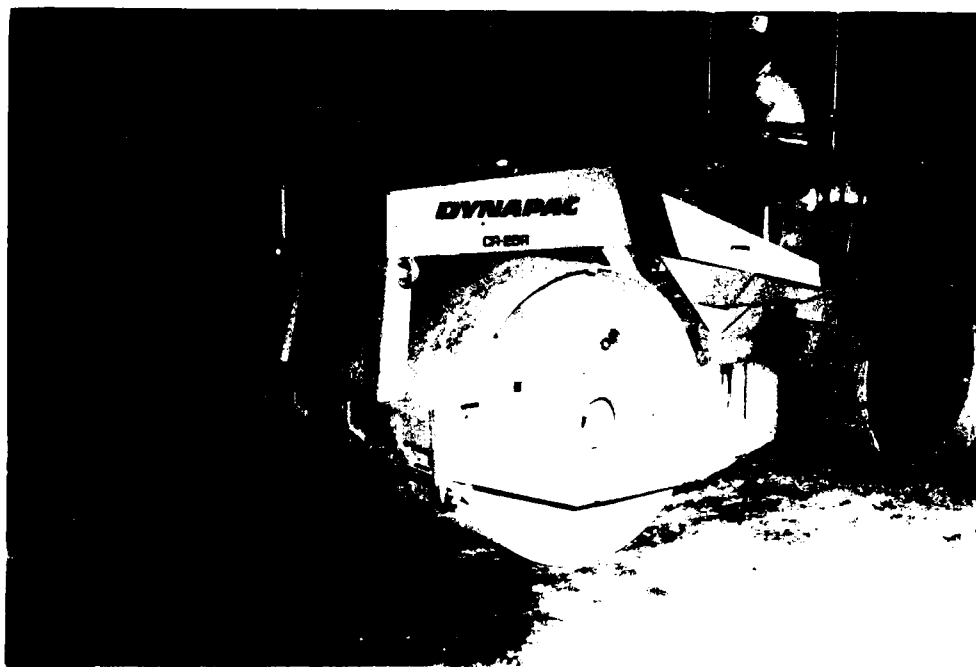
Photo 8. Vibratory roller used in compacting test section

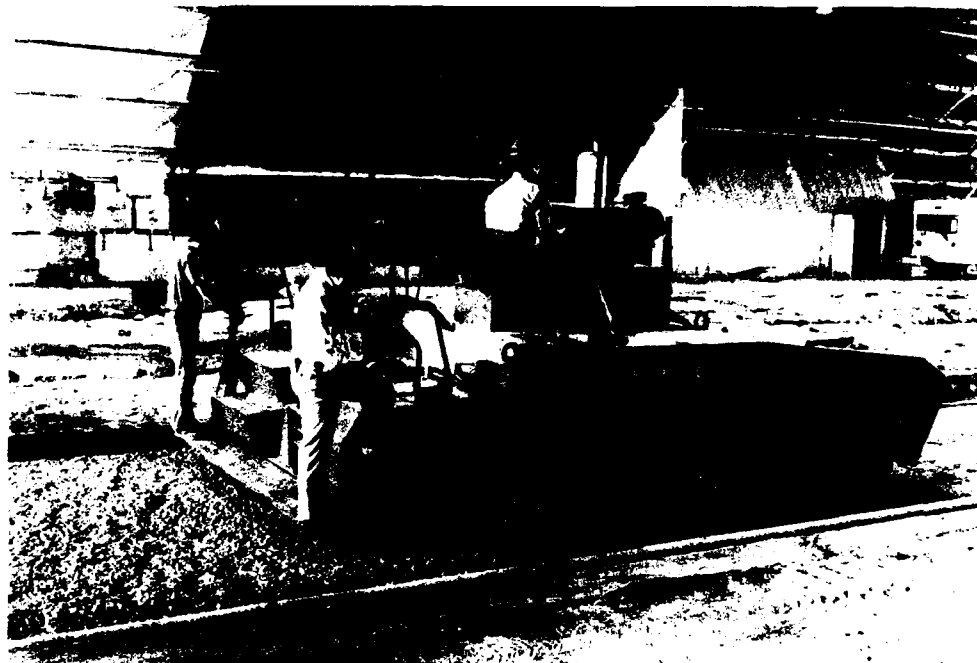
Photo 11. Placing open-graded base

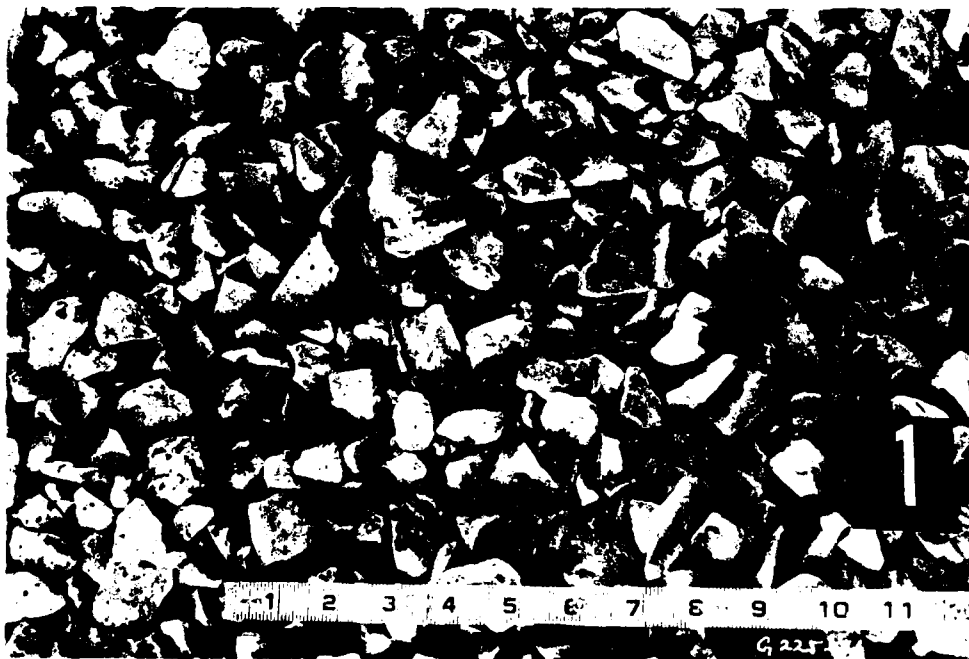
Photo 12. Close-up of unstabilized open-graded base

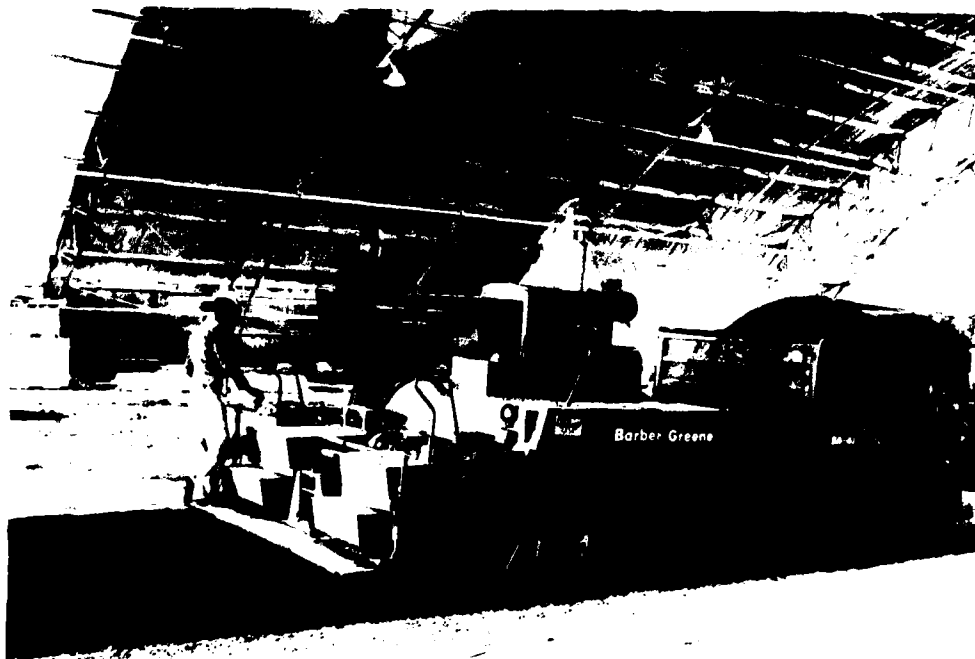
Photo 14. Placing of AC surfacing

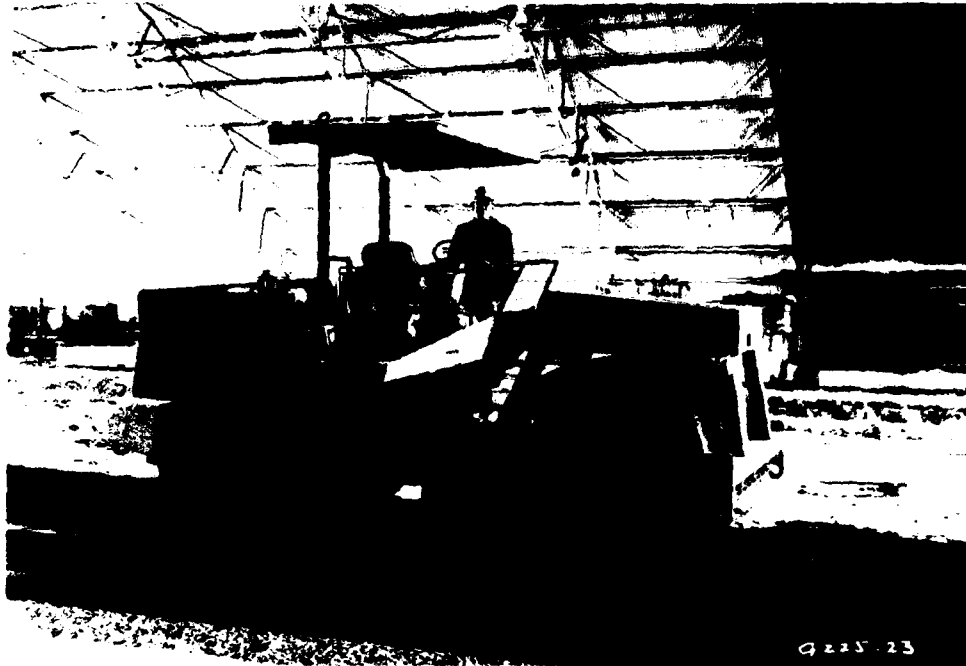
Photo 15. Compaction of surface layer

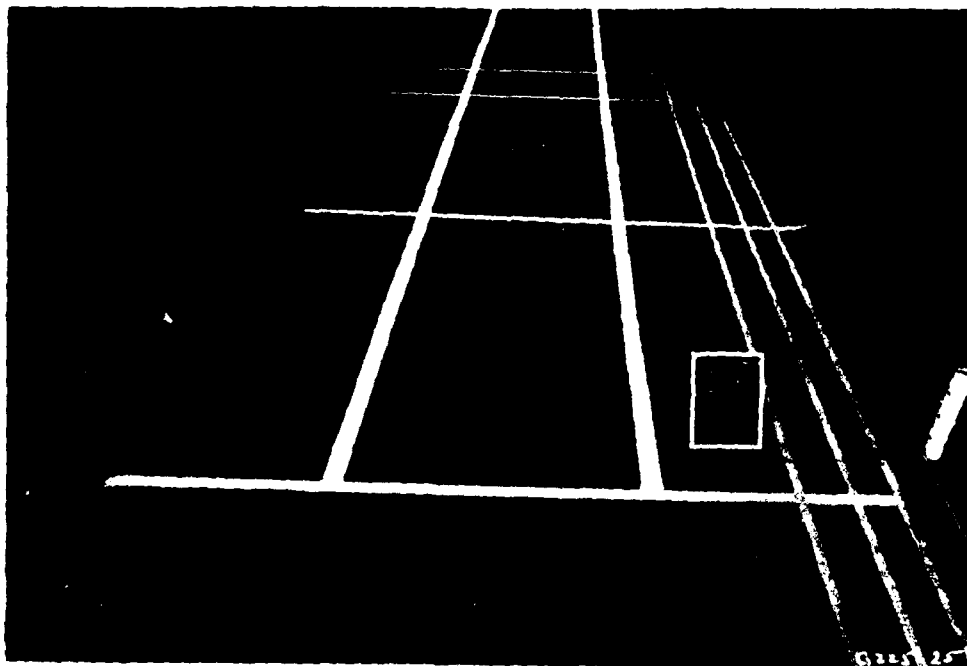
Photo 16. Completed test section

cement was approximately 300° F. Vibratory rolling was first attempted with the temperature still at 200° F but was discontinued due to the instability of the surface. The surface was allowed to cool to 160° F and rolled with a vibratory roller. Considerable movement in the base of both items could be noted. The movement of the base of Items 1 and 2 was greater than the movement of the base of Item 3. The second lift was placed (Photo 14) and rolled (Photo 15) in a manner similar to the first lift. In the final rolling of the surface, the instability of the base of all items could be noted. The completed test section is shown in Photo 16.

30. These indications of base movement or instability under rolling, while visually evident as "weaving" of the surface and some cracking of the bending surface as it emerged from beneath the roller, did not result in significant irregularity of the surface either longitudinally or in cross section. Finish rolling with eight coverages using a seven tire, 50-kip gross weight roller, 60-psi inflation pressure, generally sealed the cracks, and a final pass of the steel drum roller with no vibration resulted in a satisfactorily smooth and level test section as shown in Photo 16.

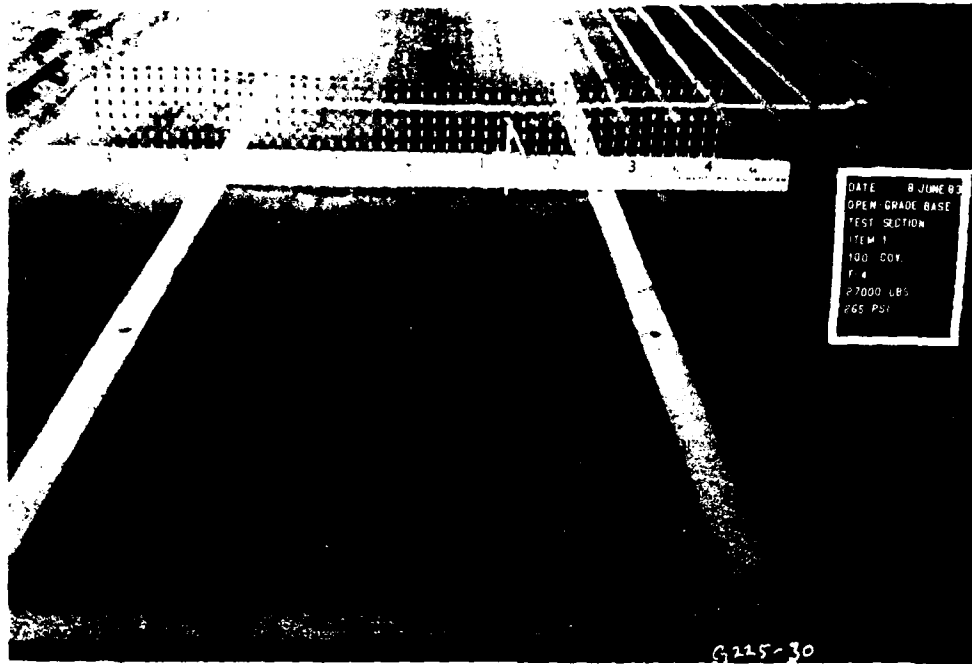
Photo 17. Rutting of Item 1 after 100 coverages

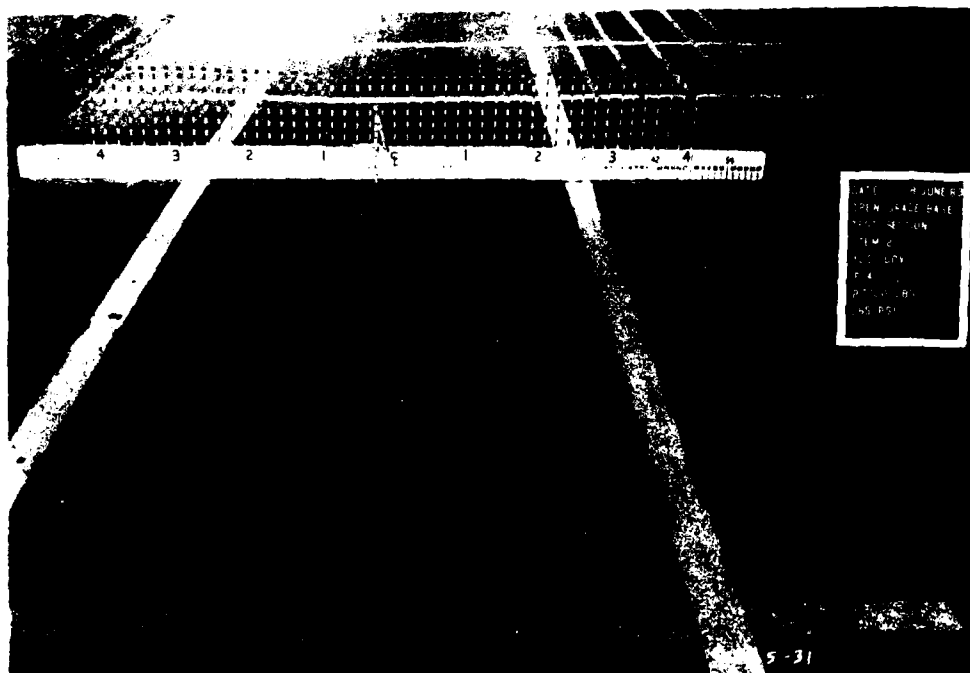
Photo 18. Rutting of Item 2 after 100 coverages

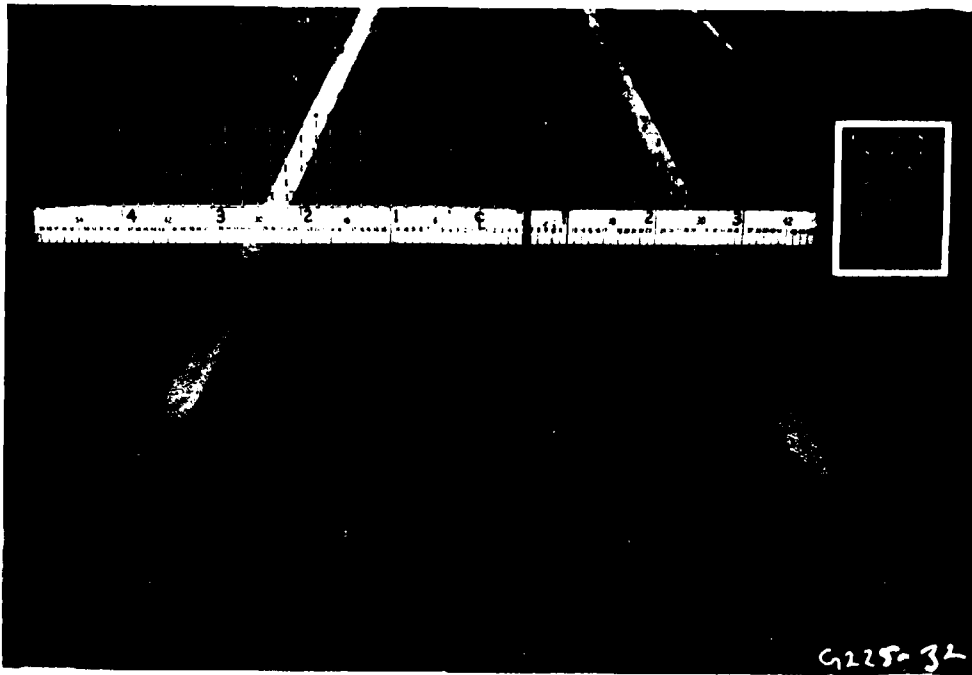
Photo 19. Rutting of Item 3 after 100 coverages

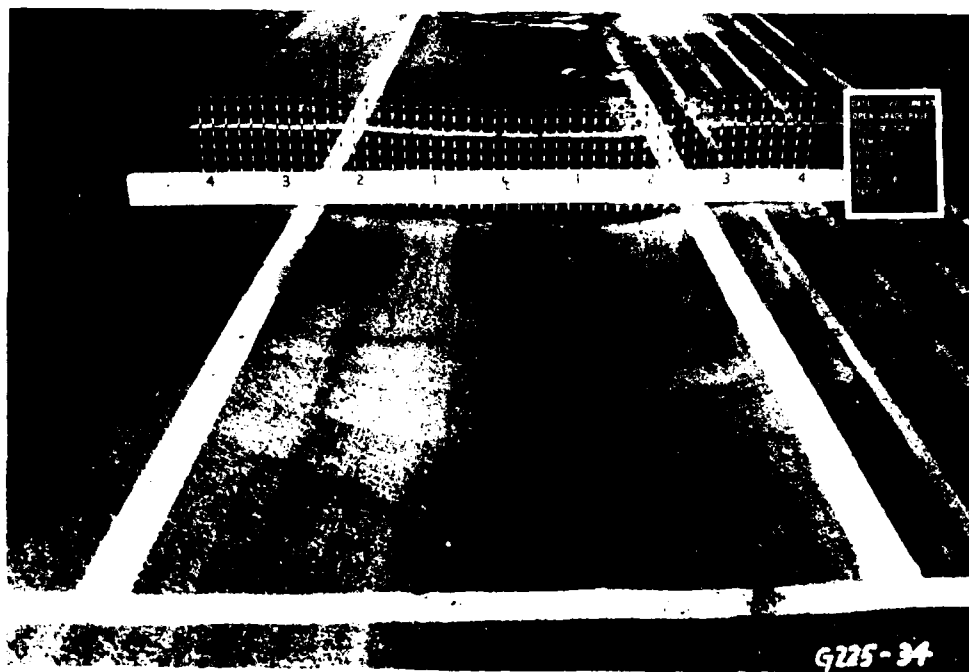
Photo 20. Rutting of Item 1 after 300 coverages

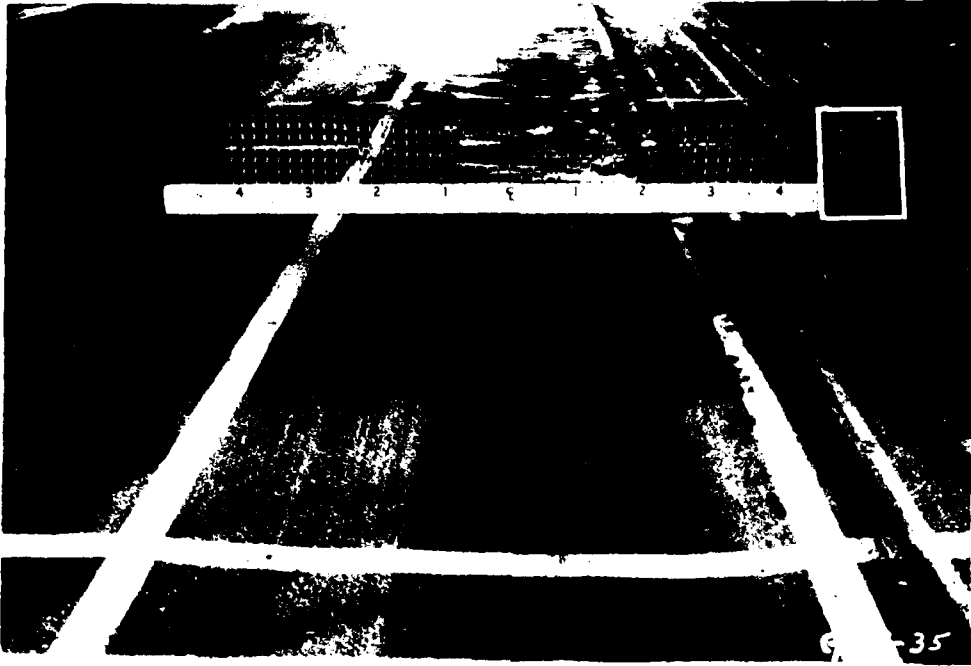
Photo 21. Rutting of Item 2 after 300 coverages

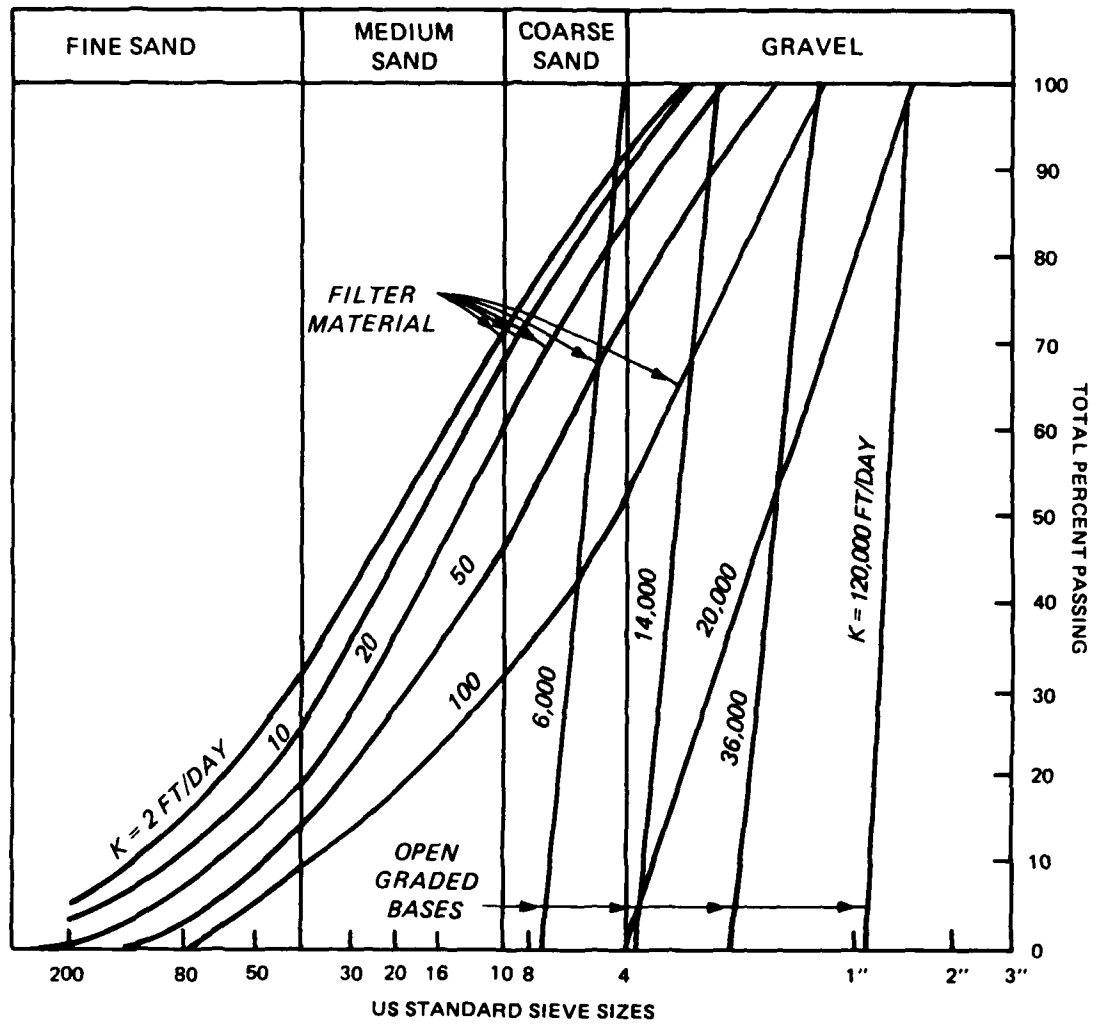
Figure A1. Typical gradations and permeabilities of open-graded bases and filter materials (From FHWA 1980a)
