FLOOD PROOFING INFORMATION WATERTOWN, MINNESOTA

Department of the Army
St. Paul District, Corps of Engineers
1135 U.S. Post Office and Custom House
St. Paul, Minnesota 55101-1479

MARCH 1986

WATERTOWN, MINNESOTA FLOOD PROOFING CONSIDERATIONS

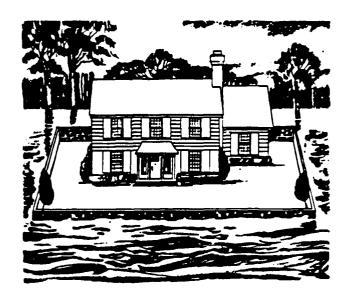
Figure 9 - Diagram of House with Surrounding Flood Wall

As shown in figure 9, small walls can be an attractive addition to property as well as a measure that helps protect against floods. However, they must be properly designed by a registered professional engineer. Openings in the walls for access during non-flood periods can be provided as well. Earthen berms are typically cheaper to construct than mesonry or concrete flood walls.
