**A PHYSICAL DESCRIPTION OF MAIN STEM LEVEE  
BORROW PITS ALONG THE LOWER MISSISSIPPI RIVER**

LOWER MISSISSIPPI RIVER ENVIRONMENTAL PROGRAM

REPORT 2

FEBRUARY 1988

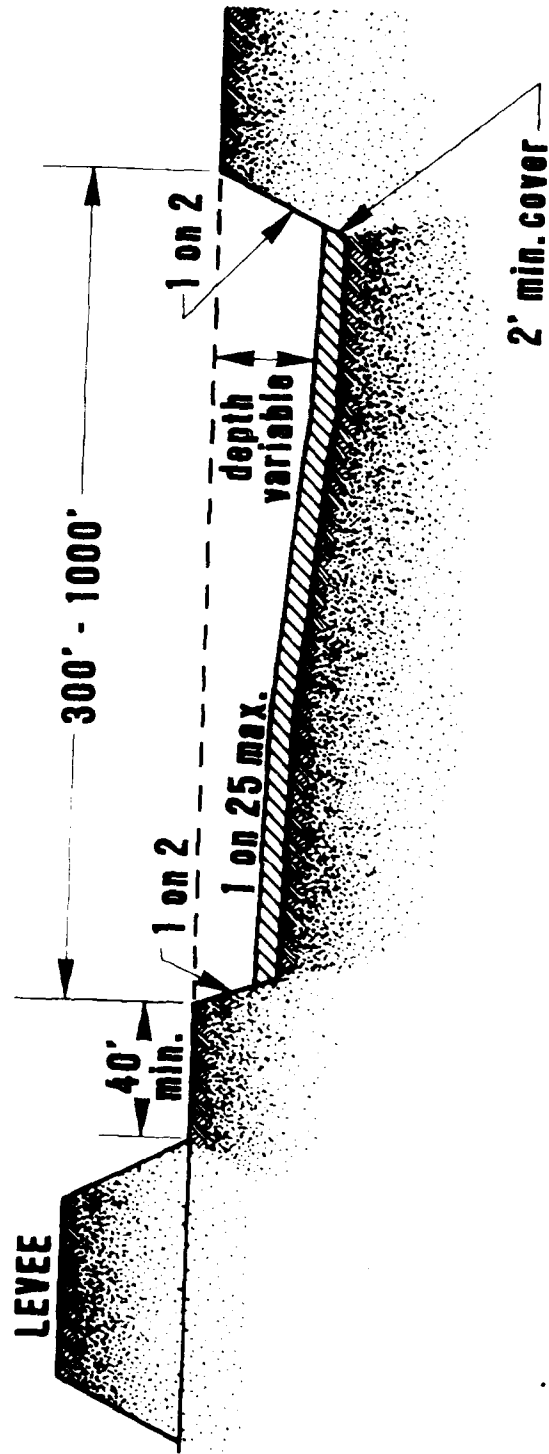
Figure 4. Cross section of typical borrow pit

24. Borrow pits are located on the riverside of the levee unless suitable material is unavailable. Borrow pits may extend to within 50 feet of the river if excavated in impervious soil. Borrow pits are placed a minimum of 40 feet from the toe of the levee or stability berm. The leveeward slope of the pit walls is no greater than 1 on 2, and the maximum slope of the pit riverward is 1 on 25.

25. The depth of excavation is variable and determined by borings so that from 2 to 5 feet of impervious cover soil, usually clay, will remain to prevent seepage at high water levels. Traverses are normally left at 1,000-foot intervals in pits near levees to prevent levee wash and encourage sedimentation. Traverses are constructed only for haul roads in pits located away from the levee. A typical borrow pit section is illustrated in Figure 4.

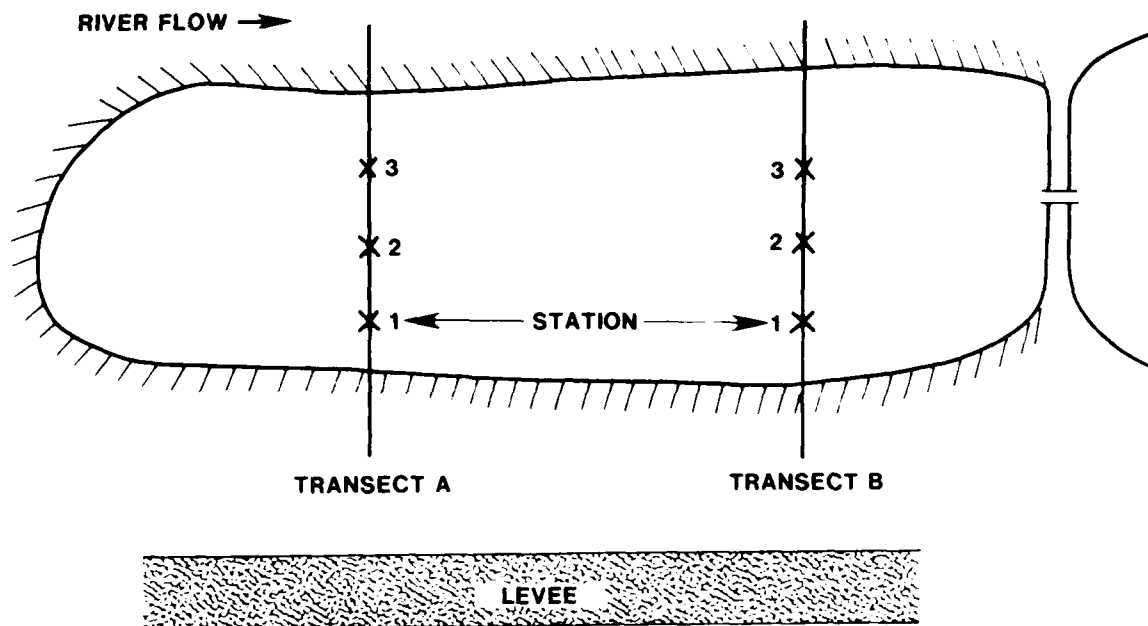
Figure 6. Transect and station sampling scheme for 25 borrow pits along the Lower Mississippi River

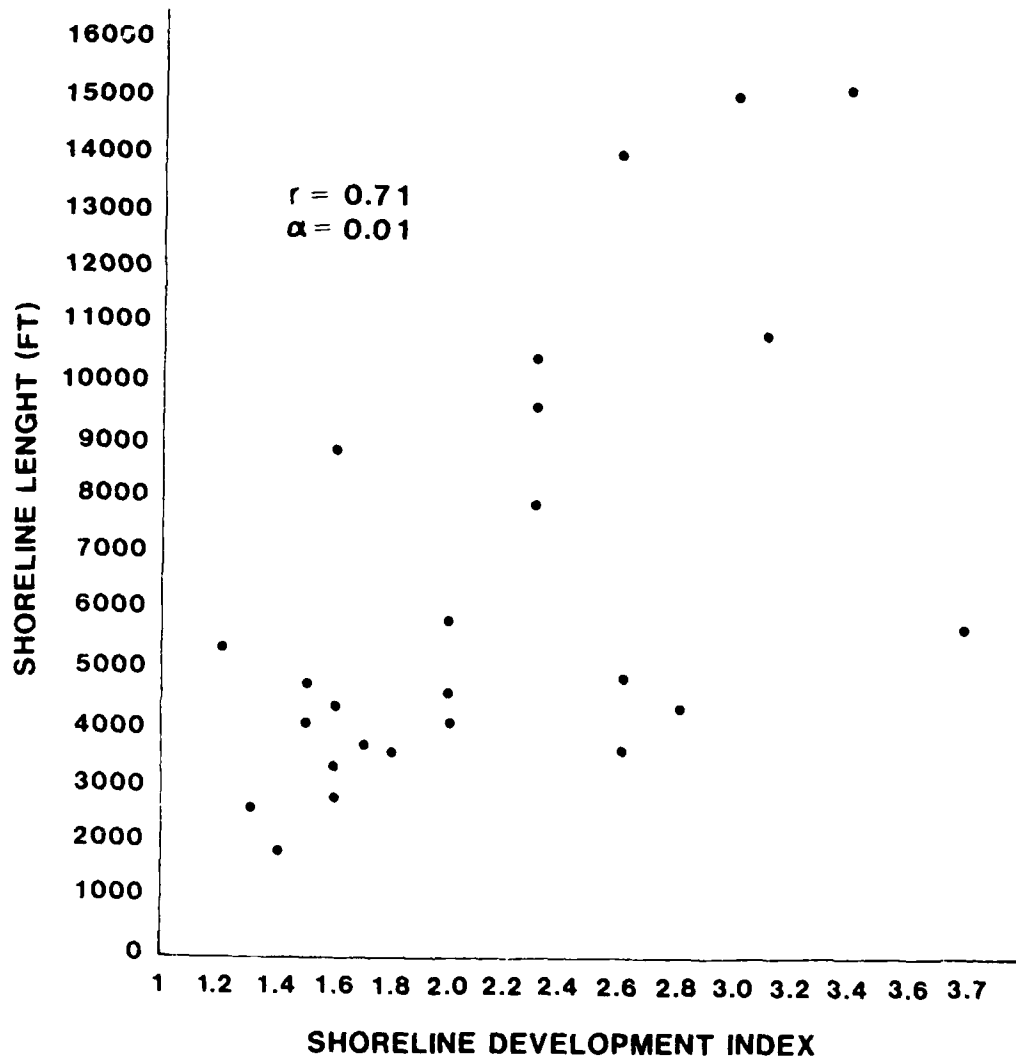
Figure 7. Plot of shoreline length of shoreline development index, for 25 borrow pits along the Lower Mississippi River

43. Shoreline irregularity reflects the potential for development of the littoral community. The combination of in-lake, or autochthonous productivity, the allochthonous detrital and nutrient input from the surrounding terrestrial environment, and eventual decomposition of this material in bottom sediments makes the shallow water of the shoreline a biologically productive zone. In this study, SDI values ranged from 1.2 for Borrow Pit 3 to 3.7 for Borrow Pit 6; the mean value was 2.2 and the median was 2.0 (Table 3). Shoreline length and SDI were significantly correlated at the one percent level ( $r = 0.71$ ,  $df = 23$ ) (Table 4). The plot of shoreline length to SDI showed four groups of borrow pits based on this relationship (Figure 7). Thirteen pits with less than 6,000 feet of shoreline had SDI values ranging from 1.2 to 2.0, and three pits had shorelines of 9,500 to 11,000 feet with SDI's of 2.3 to 3.0. Eight pits showed SDI values of 2.6 or greater; however, the shorelines of Borrow Pits 13, 14, 24, and 25 were greater than 10,000 feet, whereas, those of Borrow Pits 6, 11, 18, and 22 were less than 6,000 feet. All borrow pits with an SDI greater than 2.2 were long and narrow with the exception of Borrow Pit 6. Borrow Pit 25 with the second highest SDI (3.4) was very long and was the narrowest pit studied. Borrow Pit 6, however, was a square-shaped pit which was divided into compartments by peninsulas protruding into the pit. Borrow Pit 15 fit into none of the above described groups. Based on Borrow Pit 15's shoreline length, 8,881 feet, the SDI value should have been within the middle range of SDI values 2.0 to 2.2; however, the borrow pit was wide as compared with its length and the resulting SDI was low, SDI = 1.6. Borrow Pit 24, SDI = 3.1, had a SDI value higher than Borrow Pit 14, SDI = 3.0, but the latter had 4,268 more feet in its shoreline. Although both pits were long and narrow, Borrow Pit 24 was not as wide as Borrow Pit 14. It therefore, contained more shoreline per surface area and reflected a slightly larger SDI.

44. In general, the long, narrow borrow pits tended to provide more shoreline per surface acre than smaller, more square borrow pits. The presence of peninsulas and islands significantly affected shoreline length, and tended to increase the SDI value.

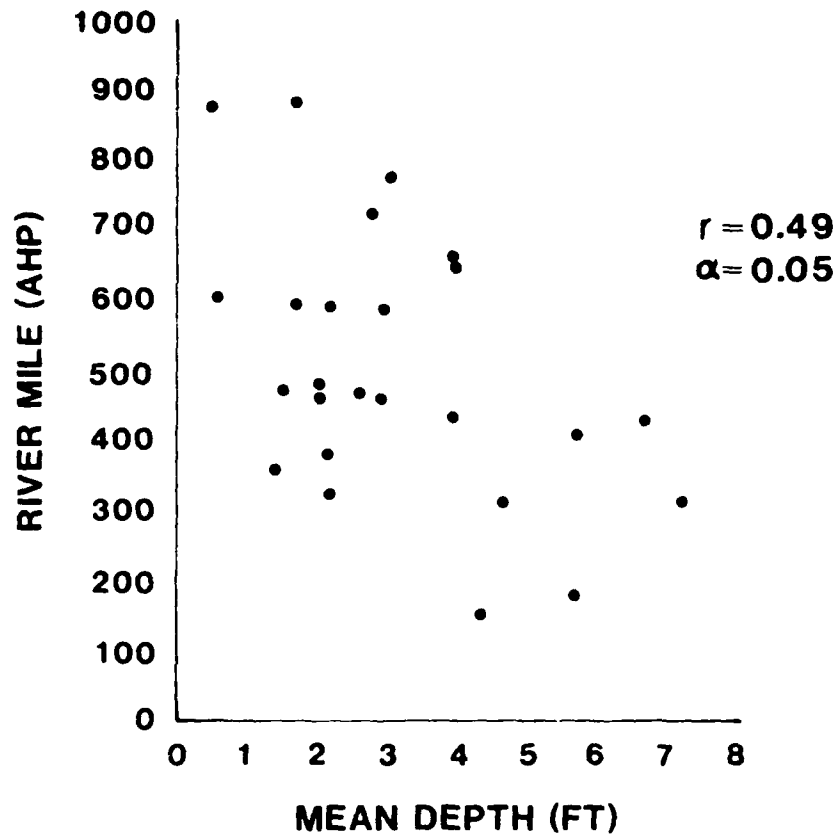
Figure 9. Plot of river mile versus mean depth of 25 borrow pits along the Lower Mississippi River

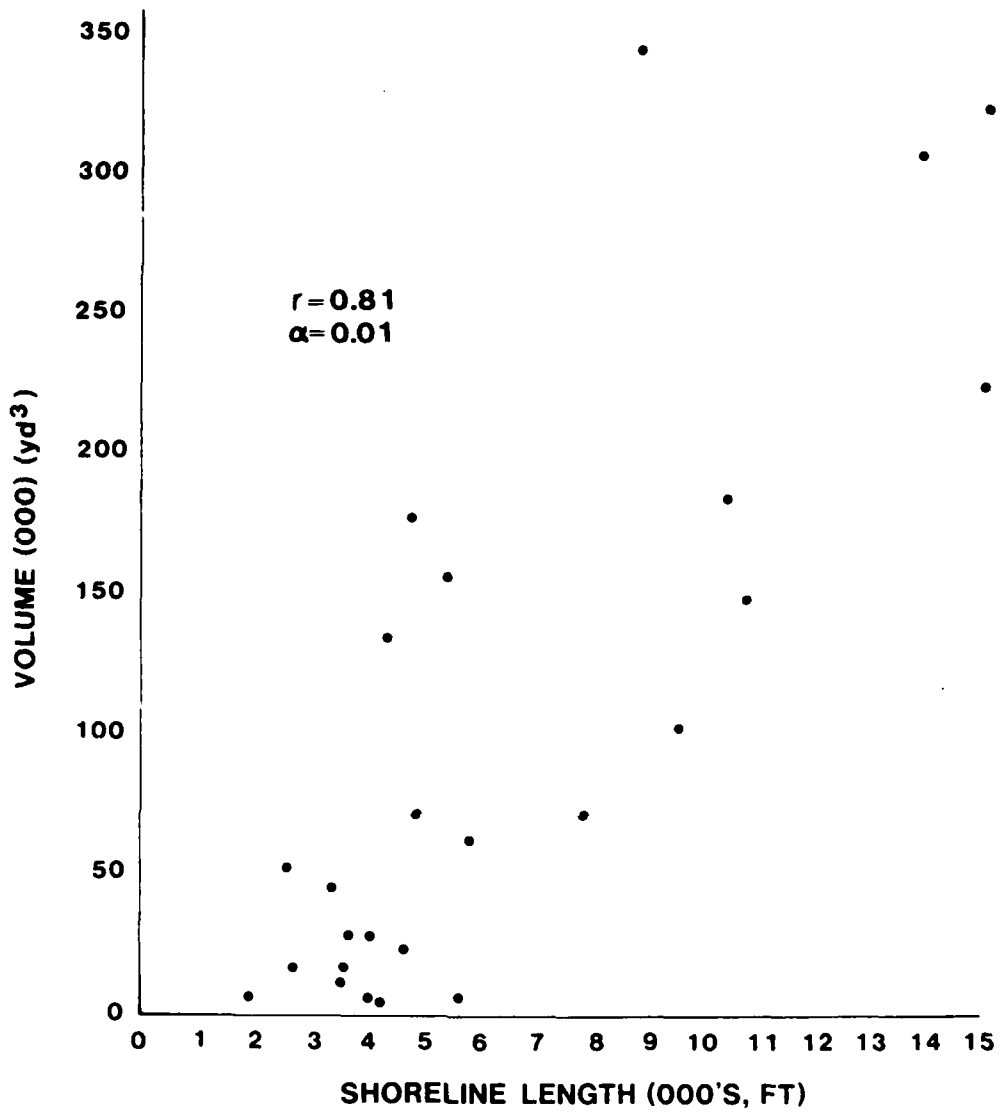
Figure 10. Plot of volume versus shoreline length for 25 borrow pits along the Lower Mississippi River

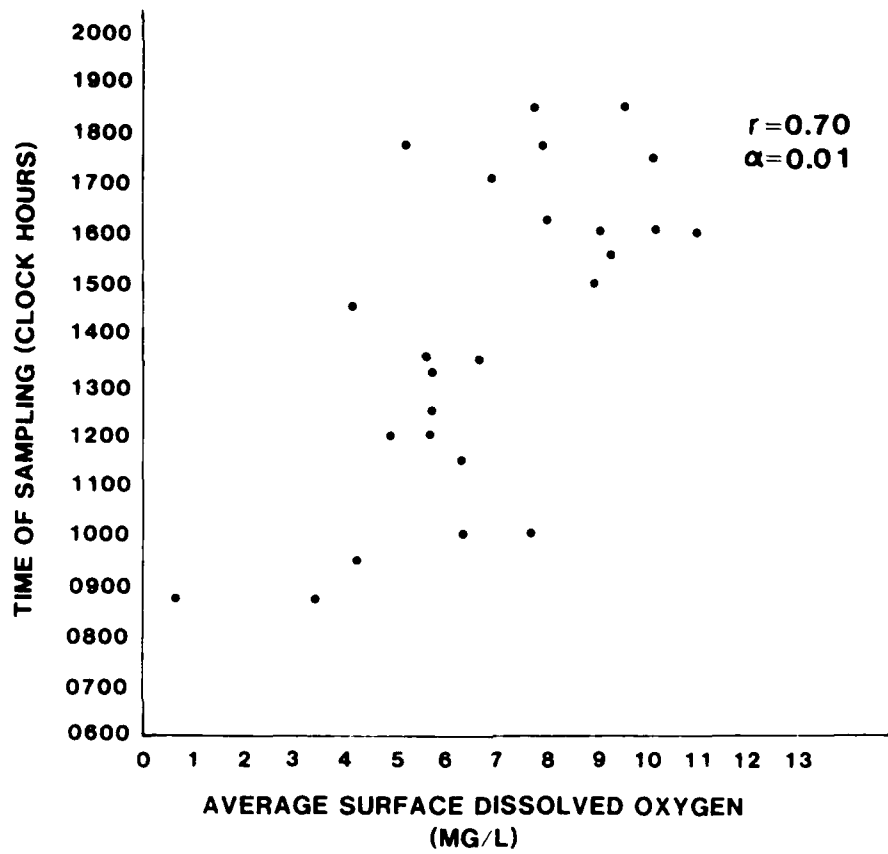
Figure 12. Plot of average surface dissolved oxygen versus time of sampling for 25 borrow pits along the lower Mississippi River.

64. There were no within-pit transect or station trends observed for dissolved oxygen. A correlation  $r = 0.53$  ( $df = 23$ ) significant at the 1 percent level between average surface dissolved oxygen concentration and river mile, and between dissolved oxygen and controlling elevation ( $r = 0.50$ ,  $df = 23$ ) significant at the 5 percent level, and other similar correlations for saturation values and these same physical variables (Table 7) indicated a trend of increasing dissolved oxygen values from south to north in the Lower Mississippi River Valley. There were no other significant correlations between dissolved oxygen and other physical or morphological variables. A correlation of  $r = 0.70$  ( $df = 23$ ) significant at the 1 percent level existed between time of sampling and average surface dissolved oxygen concentration. A plot of average surface dissolved oxygen versus time of sampling is shown in Figure 12 and suggests the influence of algal and macrophyte oxygen production on the dissolved oxygen concentrations in the borrow pits.

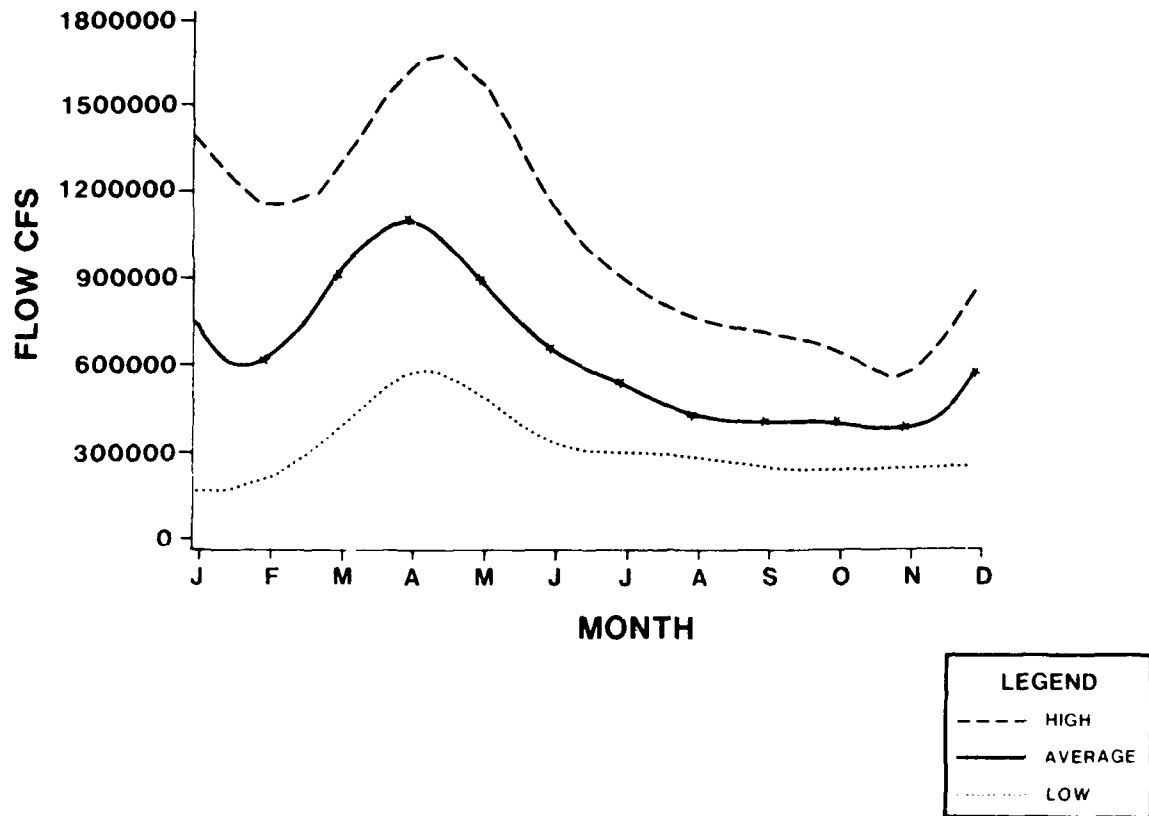
Figure 14. Plot of monthly range of flow readings for the Mississippi River at Vicksburg, January 1974 to January 1984

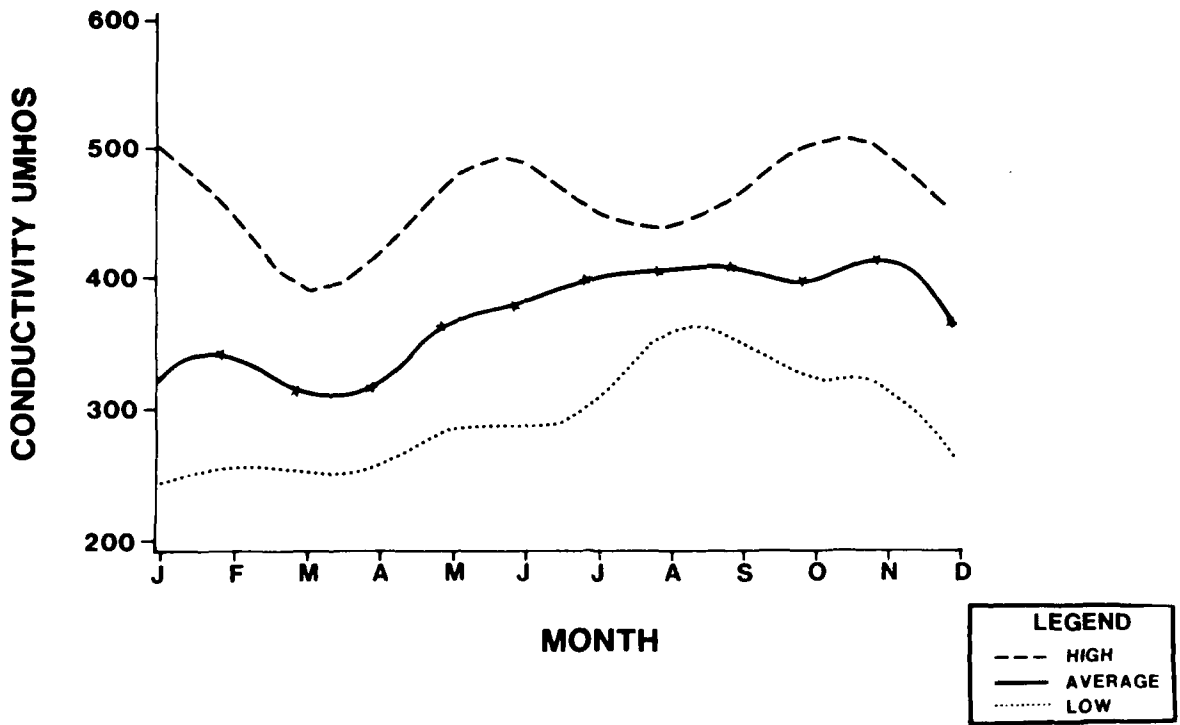
Figure 15. Plot of monthly range of conductivity readings for the Mississippi River at Vicksburg, January 1974 to January 1984

5 percent level, and between mean surface pH and average surface conductivity at the 10 percent level ( $r = -0.38$ ,  $df = 23$ ) (Table 8). This suggests that conductivity or total ion concentration in borrow pits is more closely tied to within-borrow pit chemical and biological processes than to major physical influences such as flooding, location, basin shape or volume.
