MTL TR 89-17

SOLVENT ASSISTED DELAMINATION CRACK GROWTH BEHAVIOR OF AMORPHOUS THERMOPLASTIC MATERIALS

ALEX J. HSIEH and JANICE J. VANSELOW
POLYMER RESEARCH BRANCH

February 1989

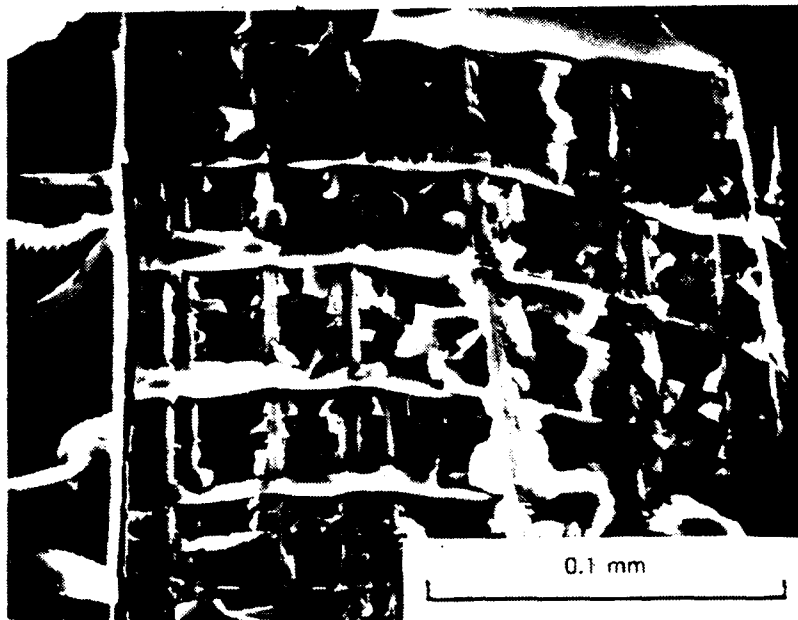
Figure 10. SEM micrograph shows matrix cracks perpendicular to the fibers on the fractured composite specimen.

Figure 8 shows that the crack growth rates in the composite are much slower than in the neat resin at most G_I values. Multiple cracking on the adjacent layers, as well as ahead of the main crack tip, was noticed on the profile of the tested composite specimen. In addition, matrix cracks perpendicular to the fiber direction within the weave are shown in Figures 9 and 10. This solvent-assisted stress cracking is attributed to the presence of residual thermal stress between the fibers and their surrounding matrix, resulting from the cool-down process.

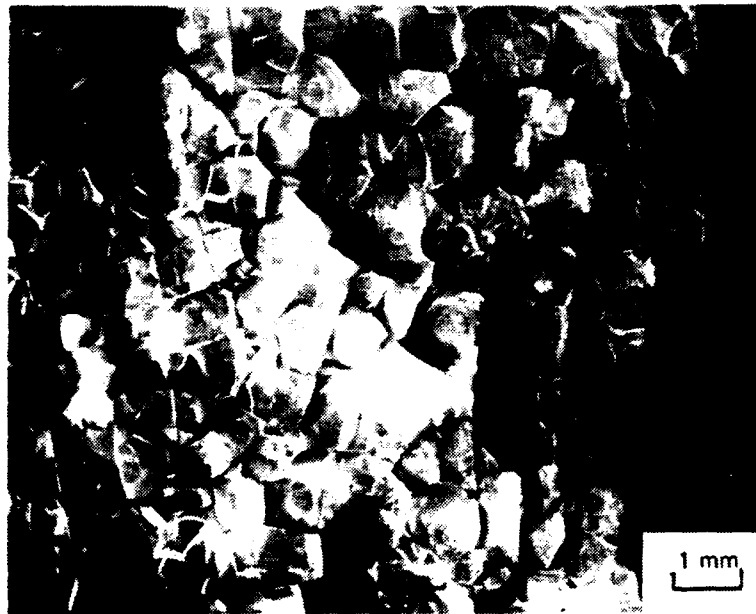
Figure 13. SEM micrograph shows a characteristic mosaic crack pattern on the fracture surface of the composite specimen with 18-mil-thick PEI film adhesive.

In the adhesively bonded PEI composites, the delamination crack growth rates are shown in Figure 11 to increase with the thickness of the adhesive layer.⁸ Figure 12 compares the neat resin data with data for the adhesively bonded composites. Results show that the rates of crack propagation in the adhesive systems are much slower than in the neat resin. Figures 13 to 15 of the fracture surfaces show a characteristic mosaic fracture pattern. The thicker the adhesive layer, the larger the size of mosaic cracks. This indicates that the residual biaxial tensile stress field is sufficient to drive the solvent-assisted cracks throughout the adhesive region prior to the growth of the main crack. While the bidirectional crack pattern propagates through the adhesive layer, it draws in more and more solvent to feed further expansion of the crack system. When the main crack finally passes, it must continually reinitiate failures in the individual blocks of the remaining adhesive, which are still well-bonded to the laminate.

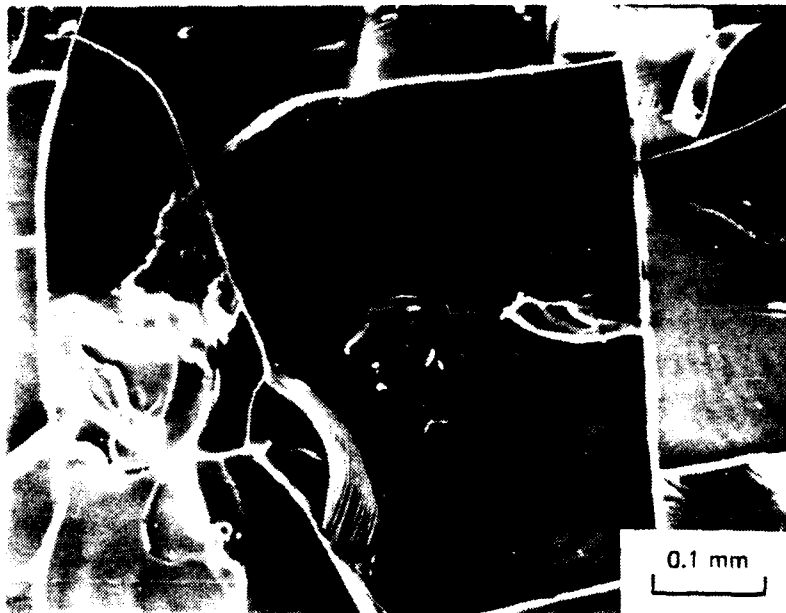
Figure 16. SEM micrograph shows nucleation point and growth band markings on the composite fracture surface.

In the case of a thick adhesive, the nucleation points and crack growth band markings within each block are seen in Figure 16; thinner adhesives show some propagation from block to block (Figure 17). Smaller band spacings, seen in the adhesively bonded composites compared to those in the neat resins, indicate that crack reinitiation occurs at lower G_I level within each mosaic block.
