**MANUFACTURING METHODS AND TECHNOLOGY
(MANTECH) PROGRAM: MANUFACTURING TECHNIQUES
FOR A COMPOSITE MAIN ROTOR BLADE FOR THE
ADVANCED ATTACK HELICOPTER**

FINAL REPORT

4. TITLE (and Subtitle) Manufacturing Methods and Technology (MANTECH) Program: Manufacturing Techniques for a Composite Main Rotor Blade for the Advanced Attack Helicopter - Appendicies		5. TYPE OF REPORT & PERIOD COVERED Final Report

7. AUTHOR(s) R. Kiraly R. E. Head		6. PERFORMING ORG. REPORT NUMBER HHI 82-143
9. PERFORMING ORGANIZATION NAME AND ADDRESS Hughes Helicopters, Inc. Cent nela and Teale Streets Culver City, CA 90230		8. CONTRACT OR GRANT NUMBER(s) DAAK50-78-G-0004 (D0-0003)

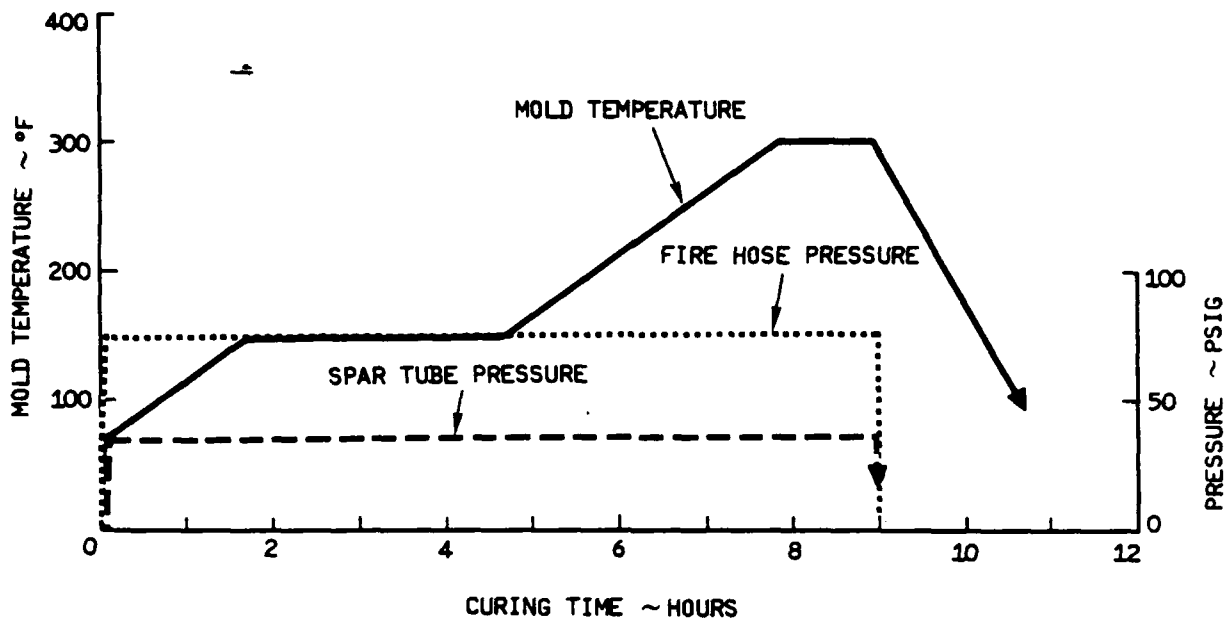
FIGURE MTR-13. CMRB TEMPERATURE/PRESSURE/TIME CURE SCHEDULE

Evaluation tests have shown that the APCO 2434/2347 resin system has optimum properties when cured according to the time/temperature cycle shown in Figure 20. This cycle raises the glass transition temperature above the range of normal operating temperatures for strength at elevated temperatures, and for minimized micro-cracking. The 2180 and 2340 hardeners are used for certain subcomponents.

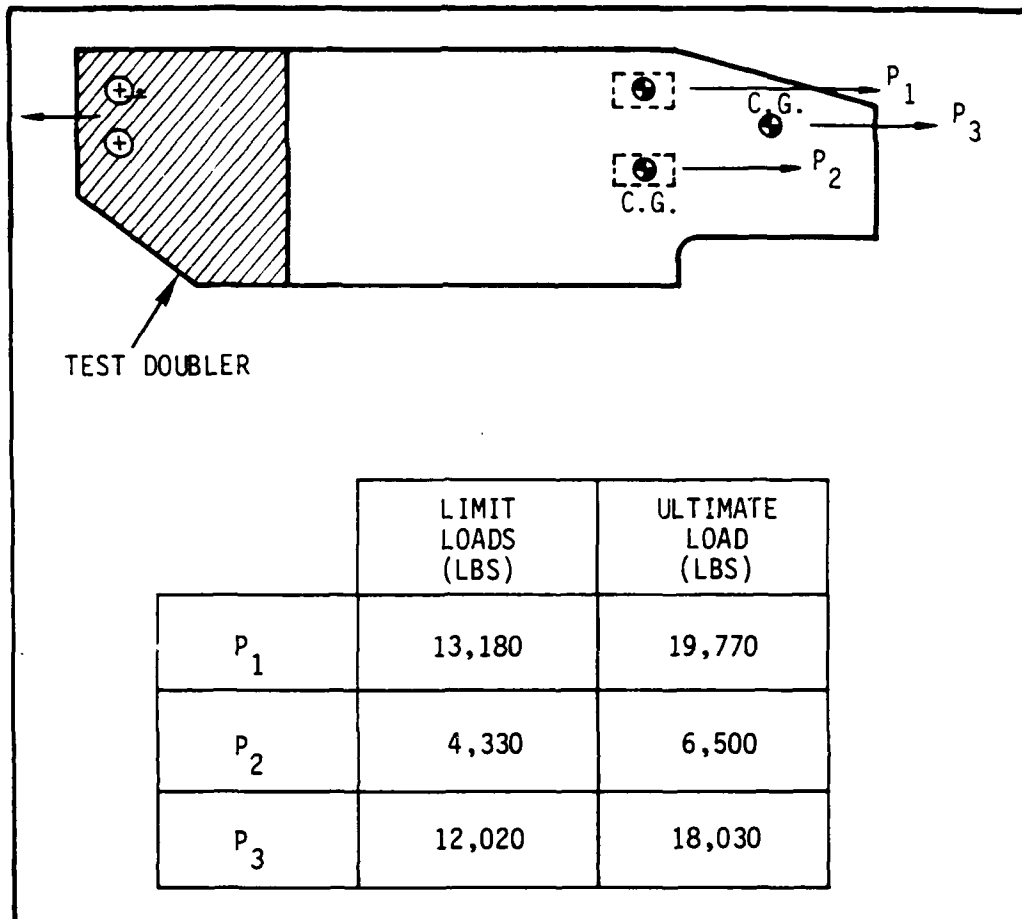
Figure 24. Load configuration, swept tip radial static test.

An axial load test was made in the Universal test machine with the setup shown in Figures 23 and 24. The loads were applied in a manner to load the entire tip structure and also to pull on the tip weights. The tip sustained 356 percent of limit load before one of the load application pads failed as described in Table 2 and dumped the entire load into remaining weight. A second test used a hydraulic jack to try to pull the aft tip weight out of the bottom of the blade. Figures 25 and 26 show the setup and Table 2 shows that the ultimate load was carried satisfactorily.

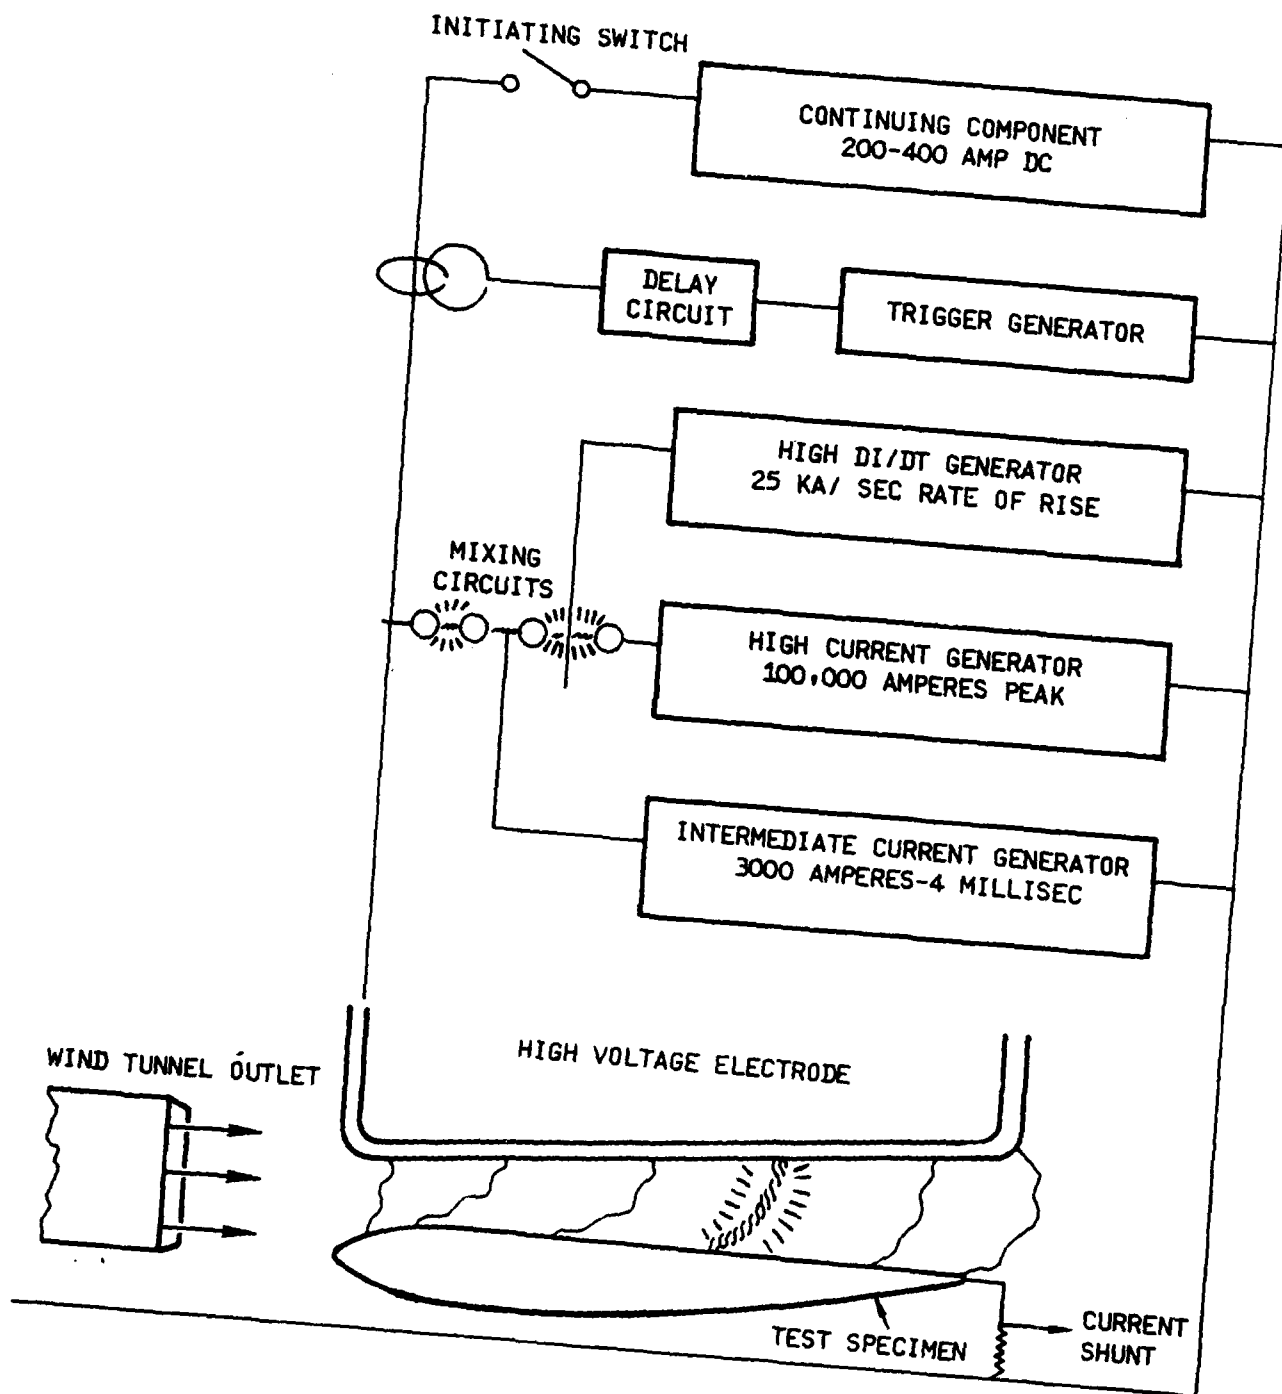
Figure 41. Test arrangement for swept stroke tests.

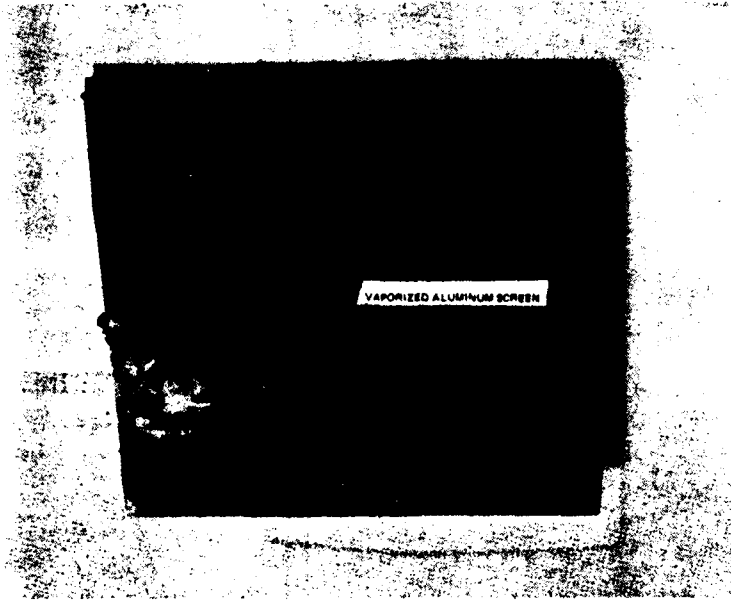
Figure 44. High current, trailing edge lightning test.

A high voltage, long arc test that was set up as in Figure 39 resulted in the 1.5-megavolt discharge flashing over the exterior of the blade and causing essentially no damage except the small spot on the leading edge that is shown in Figure 40. A swept stroke test using the test arrangement shown in Figure 41 discharged a 100-kiloampere high-current restrike onto the midchord region of the blade and did no more damage than a 12.7 mm API projectile would do (Figure 42). However, penetration was achieved only after a small hole had been drilled through the blade surface into the underlying graphite. A 228-kiloampere high-current test was conducted on the trailing edge region of the blade where the graphite trailing edge longo is covered by an aluminum screen as Figure 43 shows. The aluminum screen was vaporized (see Figure 44) but there was no structural damage.

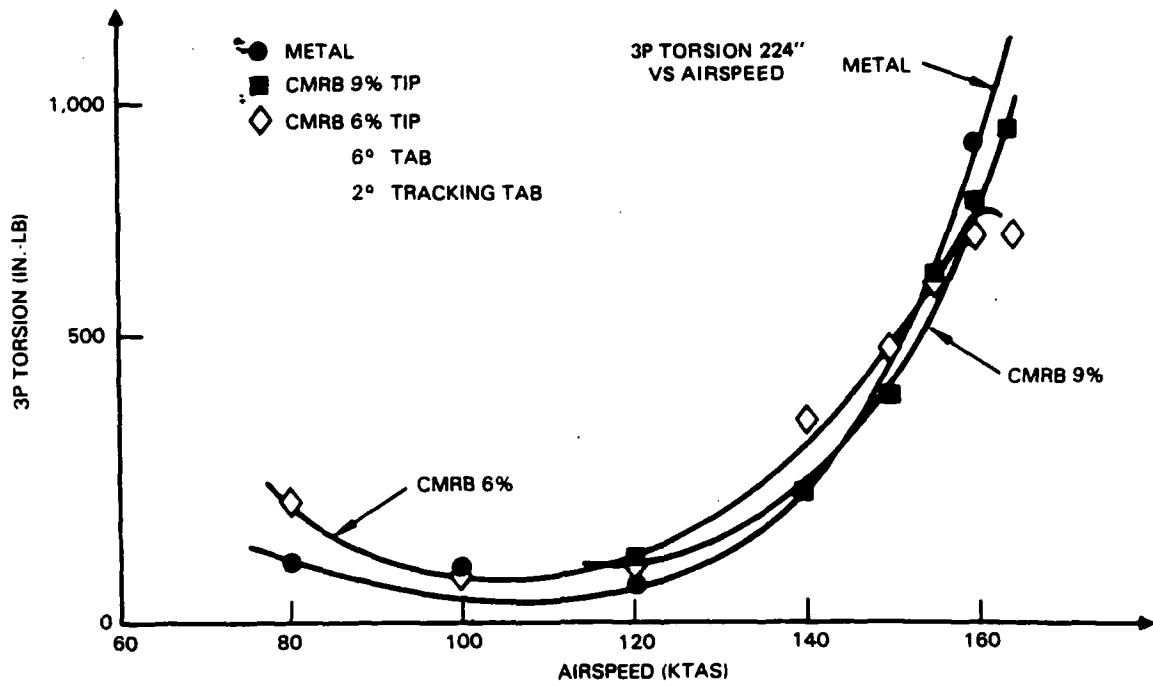
Figure 73. Torsion versus airspeed (station 224) (Sheet 1 of 2)

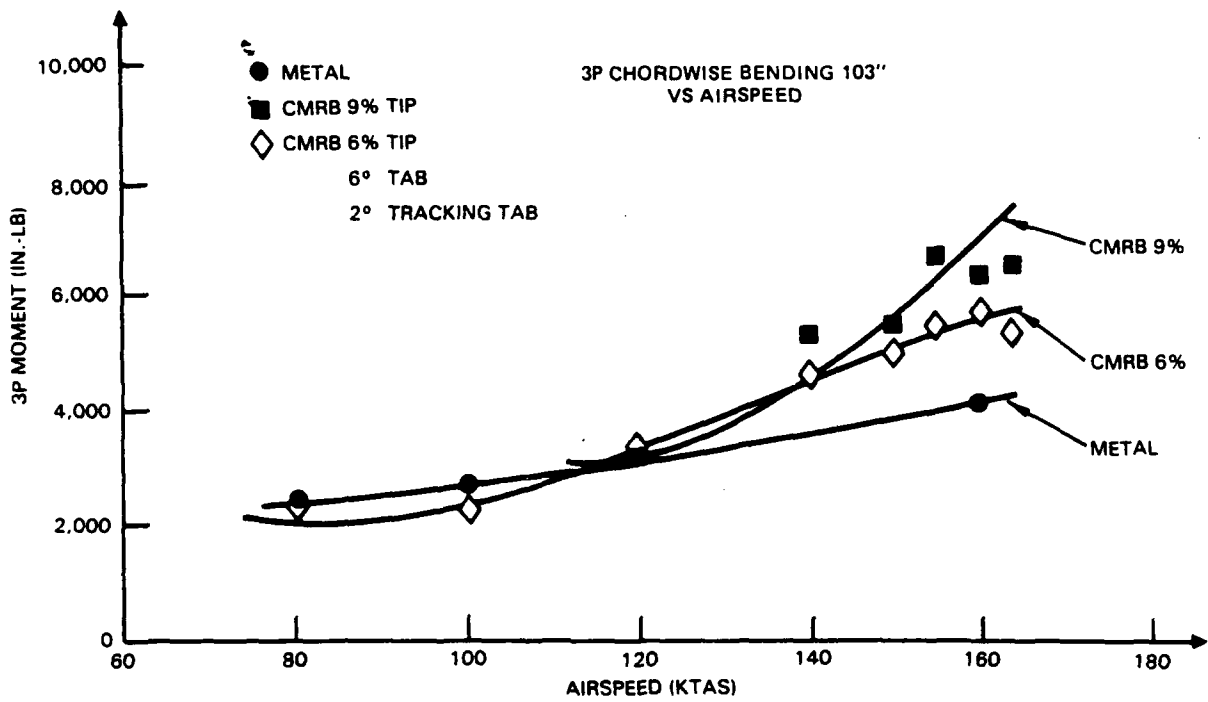
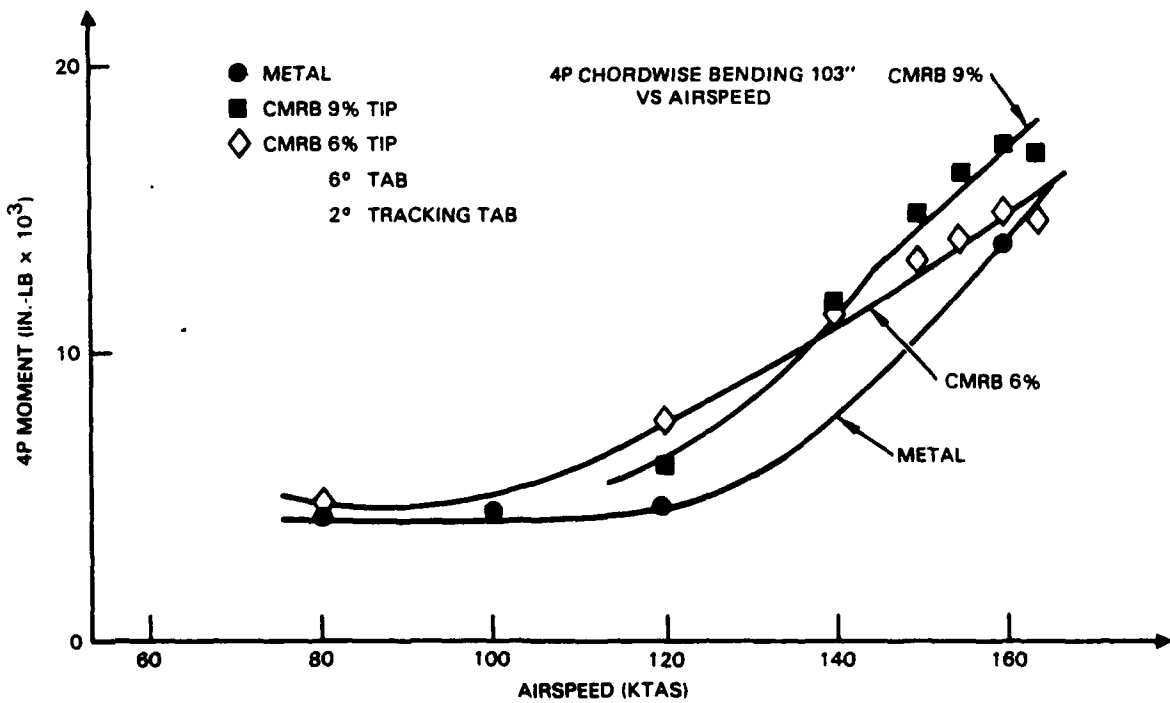
Figure 76. Chordwise bending versus airspeed (station 103)
(Sheet 1 of 2)
