MISCELLANEOUS PAPER GL-89-22

THE EFFECTS OF THE CONSTRUCTION PROCESS ON SELECTED FRESH AND HARDENED PROPERTIES OF ROLLER-COMPACTED CONCRETE (RCC) PAVEMENTS

David W. Pittman

Geotechnical Laboratory

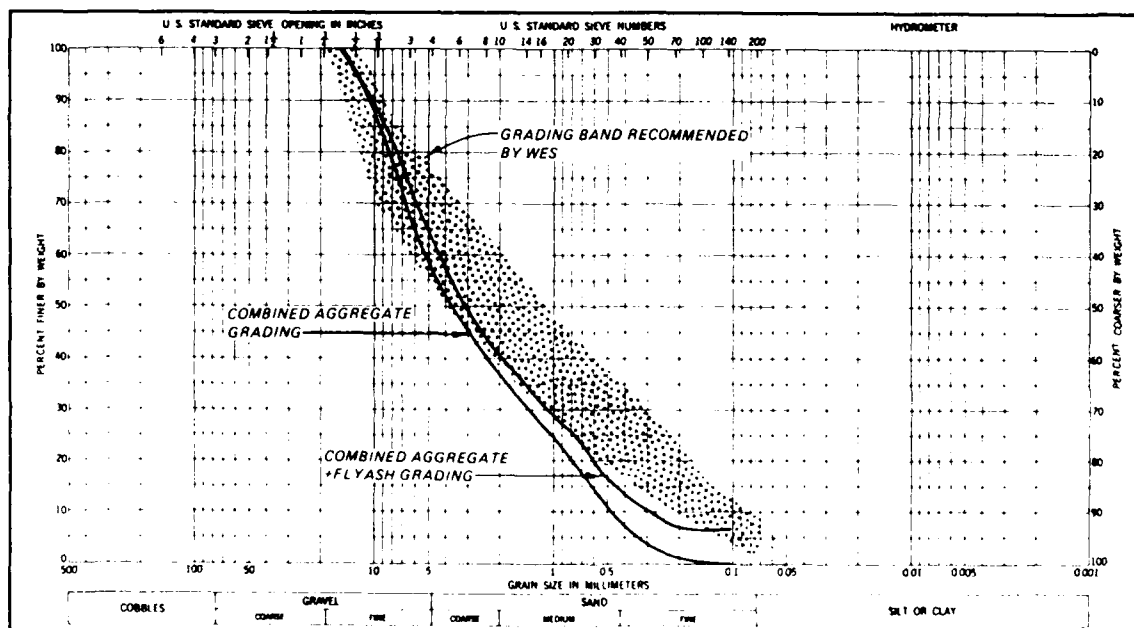
Figure 2. RCC Aggregate Grading

Two trial mixtures were prepared at the WES CTD, with different cement and flyash contents to provide a range of flexural strengths and surface characteristics (Table 2). A generous portion of flyash was used in both mixtures as a mineral filler to compensate for the lack of fines in the aggregate. When this extra flyash is considered as aggregate fines, the combined aggregate grading shifts closer to the recommended grading in the lower aggregate sizes (Figure 2).

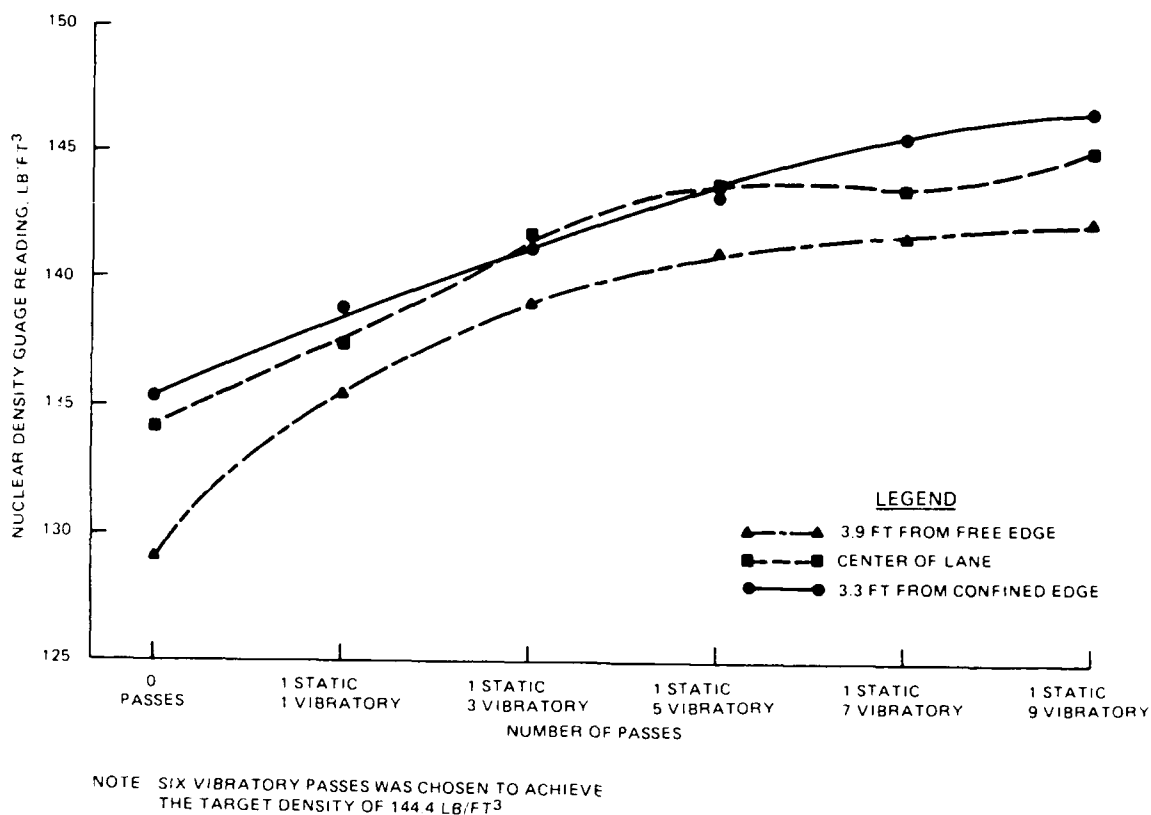
Figure 11. Roller Passes Versus RCC Density

The relationship between number of roller passes and full-depth density as measured with the nuclear density gauge (6-inch reading, direct transmission mode) was also obtained in the first portion of Lane 1 (Figure 11). Nuclear density gauge readings were taken close to the confined edge along the curb, in the center of the lane, and close to the free edge of the lane. A definite trend of decreasing density across the width of the paving lane from the confined edge to the free edge was noticed, emphasizing the need to pay careful attention to compaction of the joints. Since the target density was set at 144.4 pounds per cubic foot (96 percent of 150.4), six passes was selected as the required minimum number of vibratory passes for the test section and hardstand construction.

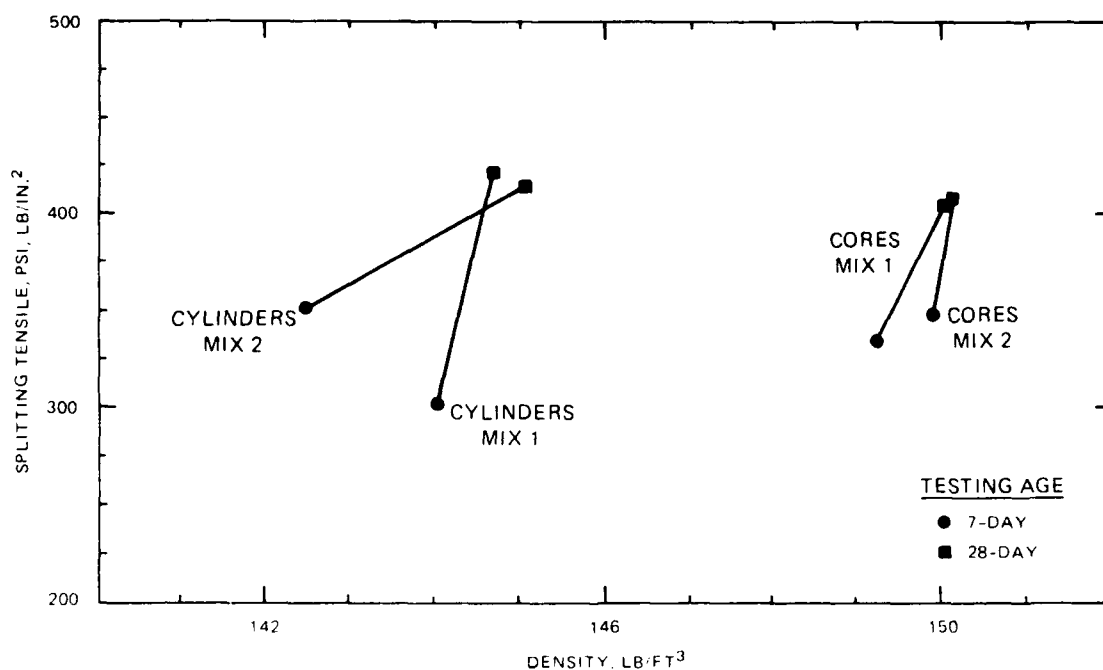
Figure 12. Splitting Tensile Strength Versus Density

The higher strengths associated with the fabricated specimens were not due to higher densities, however. Figure 12 shows the relationship between the core and cylinder densities and splitting tensile strength at 7 and 28 day's age for Mix 1 and Mix 2. The density of the cores averaged 4 percent higher than the cylinder densities. Also, the density of both the cores and cylinders tended to increase slightly with age, in addition to the increase in strength. This could be due

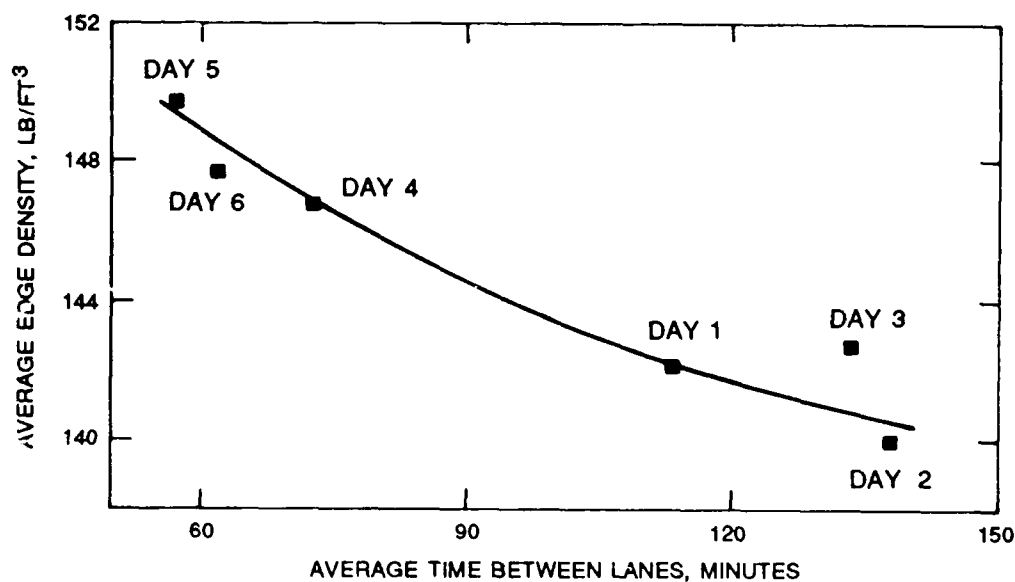
Figure 16. Effect of Delayed Compaction on Joint Density

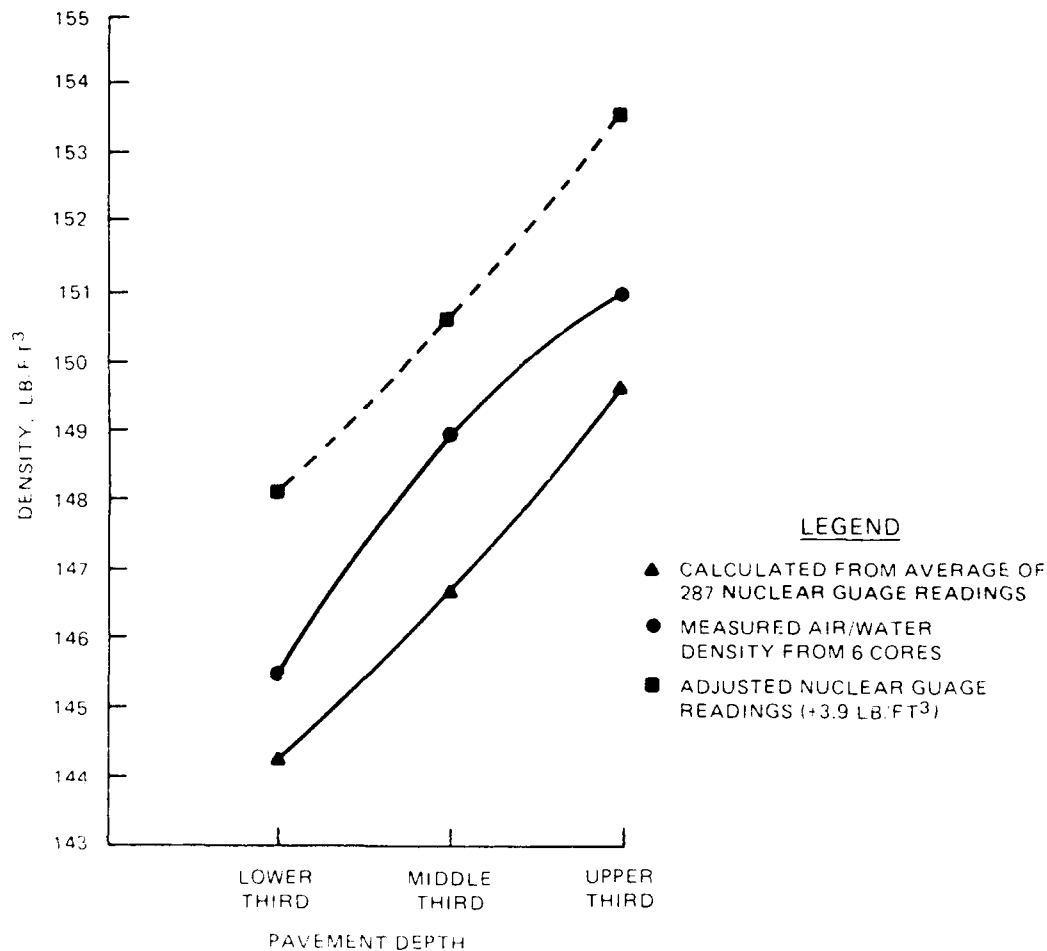
Figure 18. RCC Density Versus Pavement Depth

The decrease in density with depth was also indicated by sawing one core from each day's placement into thirds, obtaining the unit weight of the upper, middle, and lower thirds of the cores, and determining the mean density of the six cores for each increment of depth (Figure 18). The average density of the lower third of the cores was

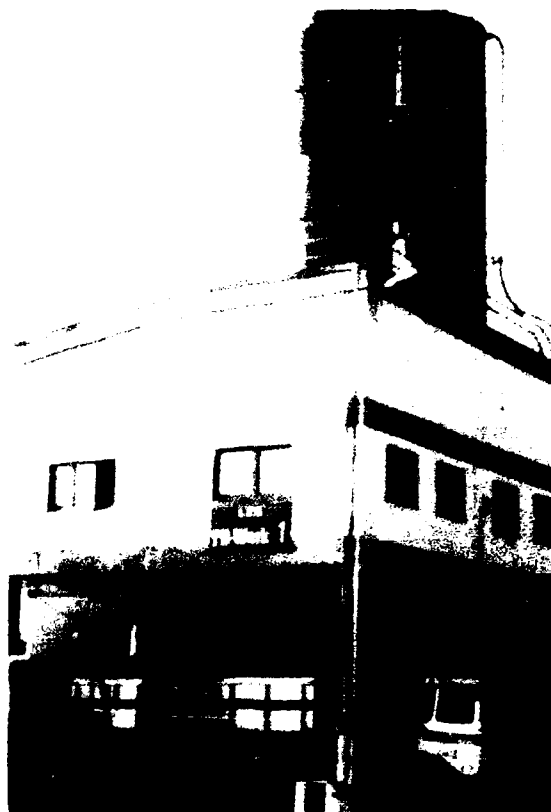
Photo 1. A stationary weigh-batch plant was used to mix the RCC

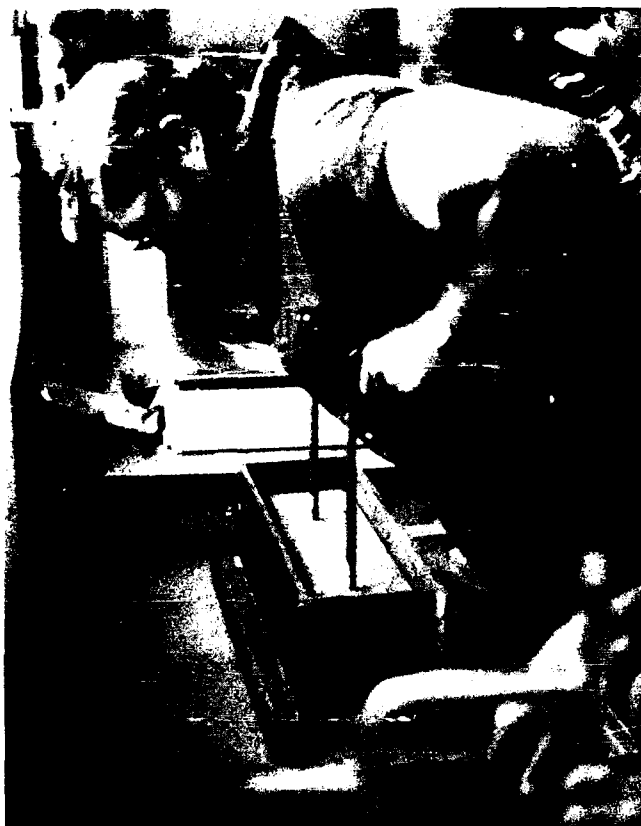
Photo 3. Beam samples were fabricated in two layers using a subcharge weight and a vibrating table

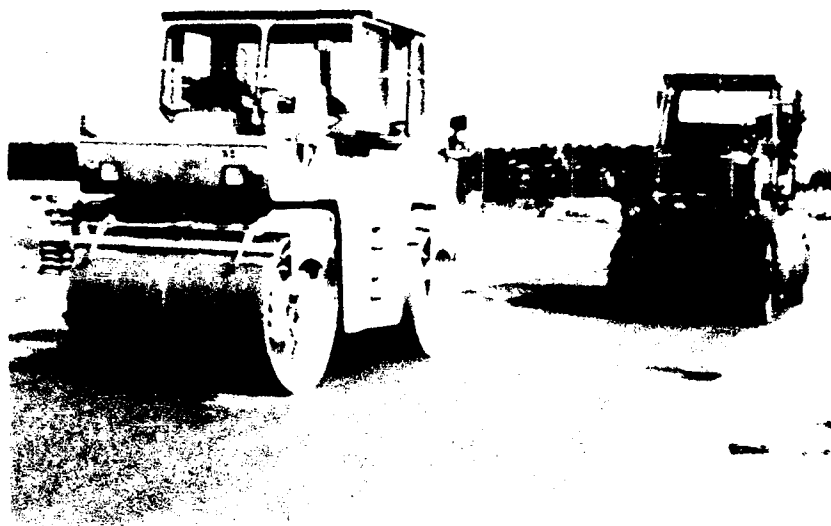
Photo 35. After six or more vibratory passes, the rubber-tire roller made six or more passes to tighten the surface texture

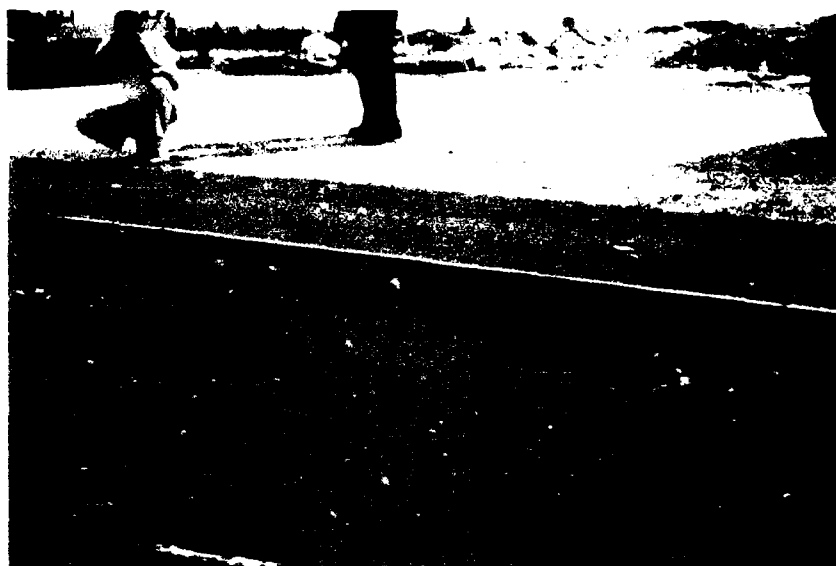
Photo 39. These transverse depressions were formed when the vibrator was left on as the roller stopped

Pittman and Ragan (1986) note the influence of the rolling operation on the smoothness, recommending that the stopping points of successive vibratory roller passes be staggered to avoid depressions in the surface. They also warn that the vibratory roller should never stop on the pavement in the vibrating mode; rather, the vibrator should be turned on only after the roller is in motion and turned off several feet before the roller stops moving.
