## Enhanced Preliminary Assessment Report:

**Slatersville Army Housing Units  
North Smithfield, Rhode Island**

October 1989

Environmental Research Division  
Argonne National Laboratory  
Argonne, Illinois 60439

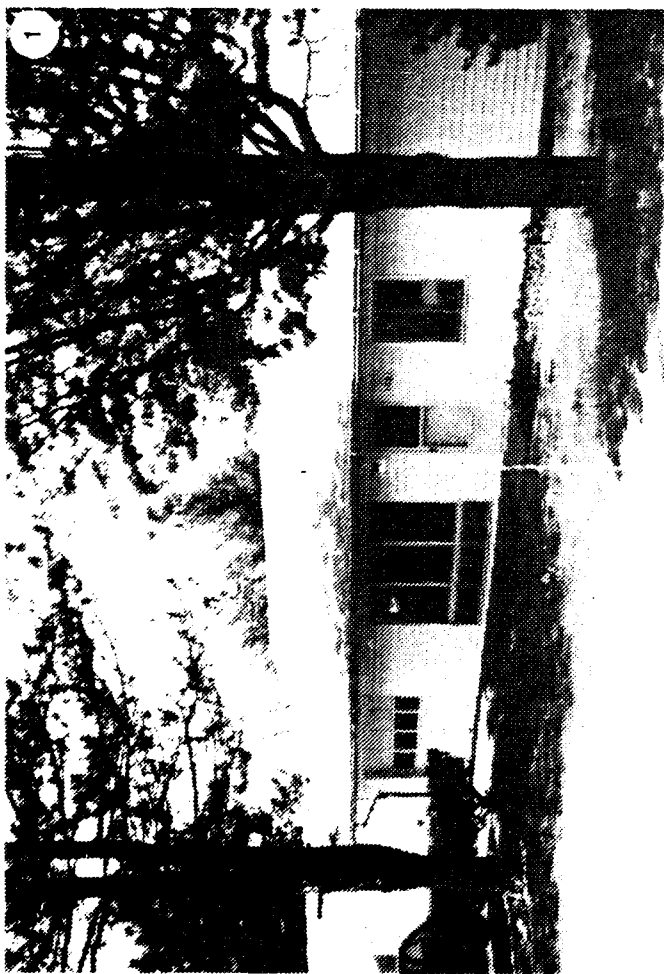
1

1. Three-bedroom housing unit with attached garage.
2. Wooded area behind a housing unit.
3. Improvement work (construction of a concrete patio) in progress outside a housing unit.
4. Army National Guard base near the housing facility.
5. Pump house and water-storage tank operated by the Army National Guard, located up the road from the housing facility.
6. Fill pipe for an underground storage tank, located in the front yard of a housing unit; note oil stains and contaminated soil surrounding the rising pipe.
7. In-ground trash bin, no longer in use at the facility.
