TECHNICAL REPORT ARCCB-TR-90035

**EFFECTS OF NOTCH GEOMETRY AND MOISTURE  
ON FRACTURE STRENGTH OF CARBON/EPOXY  
AND CARBON/BISMALEIMIDE LAMINATES**

<p><b>US ARMY ARMAMENT RESEARCH, DEVELOPMENT AND ENGINEERING CENTER CLOSE COMBAT ARMAMENTS CENTER BENÉT LABORATORIES WATERVLIET, N.Y. 12189-4050</b></p>	 
--	--	---

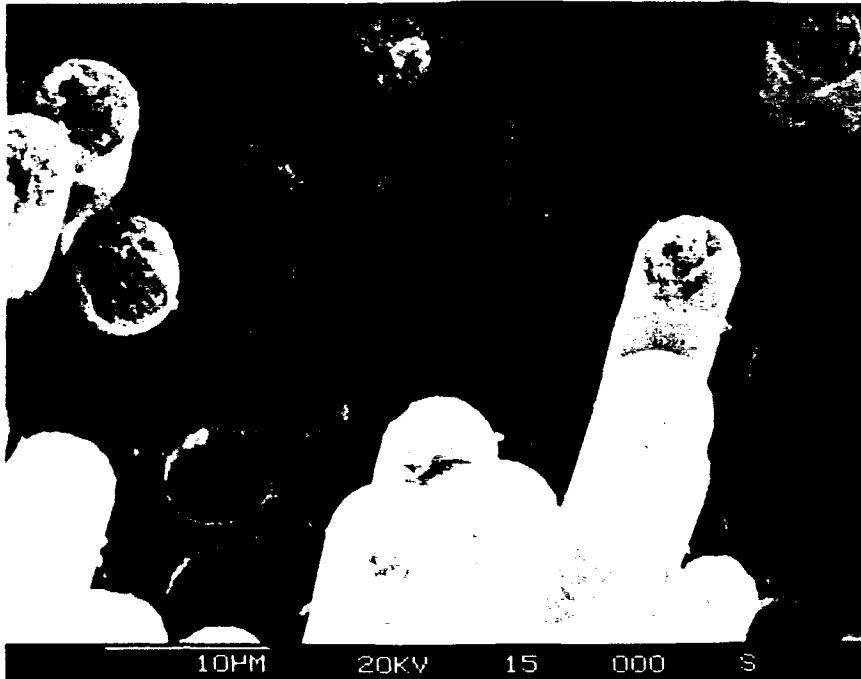
Figure 9. High magnification SEM fractographs 3 mm from notch tip.

(a) 90/0 carbon/epoxy, predominantly failure of fiber bundles.

(b) 90/0 carbon/bismaleimide, predominantly pullout of individual fibers.

Higher magnification fractographs in Figure 9 show that the only evidence of pullout for the carbon/epoxy is a limited amount of pullout of fiber bundles before failure of the intact bundles. In contrast, extensive individual fiber pullout is observed for carbon/bismaleimide. Individual fiber pullout involves significantly more interfacial area and therefore is expected to result in more dissipation of energy during fracture and a higher fracture toughness. It is interesting to note that Evans and Marshall (ref 13) presented fractographs nearly identical in appearance to Figure 9b but from a ceramic/ceramic composite which showed greatly improved toughness over that of the ceramic matrix. They attributed the increase in toughness to the same mechanism under discussion here--extensive individual fiber pullout and related dissipation of energy.
