# *Effect of Shrapnel Penetration on Lithium-Carbon Monofluoride and Lithium-Manganese Dioxide Batteries*

*W.N.C. Garrard*

MRL Technical Note  
MRL-TN-579

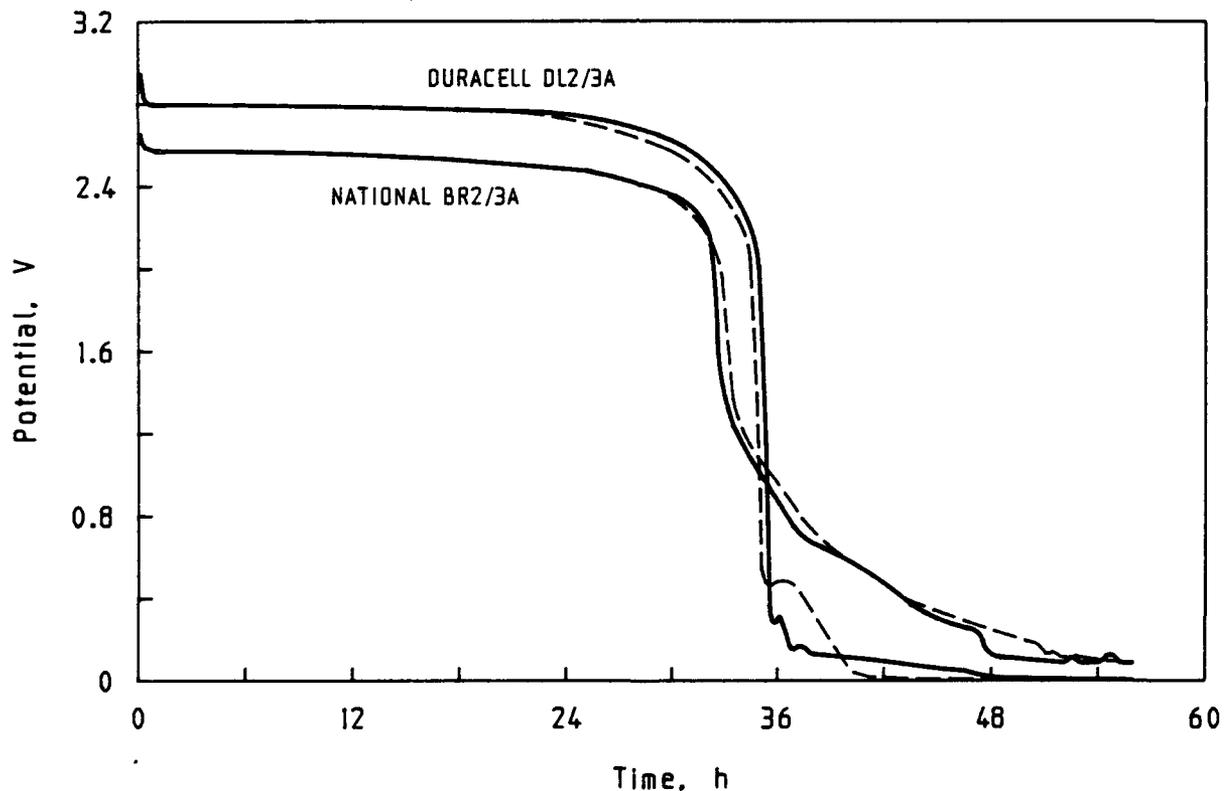
Figure 1: Duplicate discharge curves for (a) National BR2/3A and (b) Duracell DL2/3A batteries. Batteries were discharged through 75 ohm loads.

Duracell DL2/3A lithium-manganese dioxide and National BR2/3A lithium-carbon monofluoride batteries were subjected to various assessments to ensure that they met the manufacturers' specifications. Figure 1 displays typical discharge curves for the batteries when they were discharged through 75 ohm resistors. For the shrapnel penetration tests, batteries were divided into three categories depending on their state of charge, namely fully charged, 50% discharged, and 100% discharged. Batteries in the 50% discharged category were brought to the required state by discharging them through 150 ohm loads for 15.57 h (Duracell) or 15.27 h (National), assuming a common cutoff voltage of 1.80 V. Fully discharged batteries were obtained by discharging the batteries through 150 ohm loads for a period of one week.
