MTL TR 91-10

EVALUATION OF ENVIRONMENTALLY AGED POLYMER/COMPOSITE MATERIAL BY ULTRASONIC INSPECTION

ROBERT F. ANASTASI
MATERIALS TESTING AND EVALUATION BRANCH

March 1991

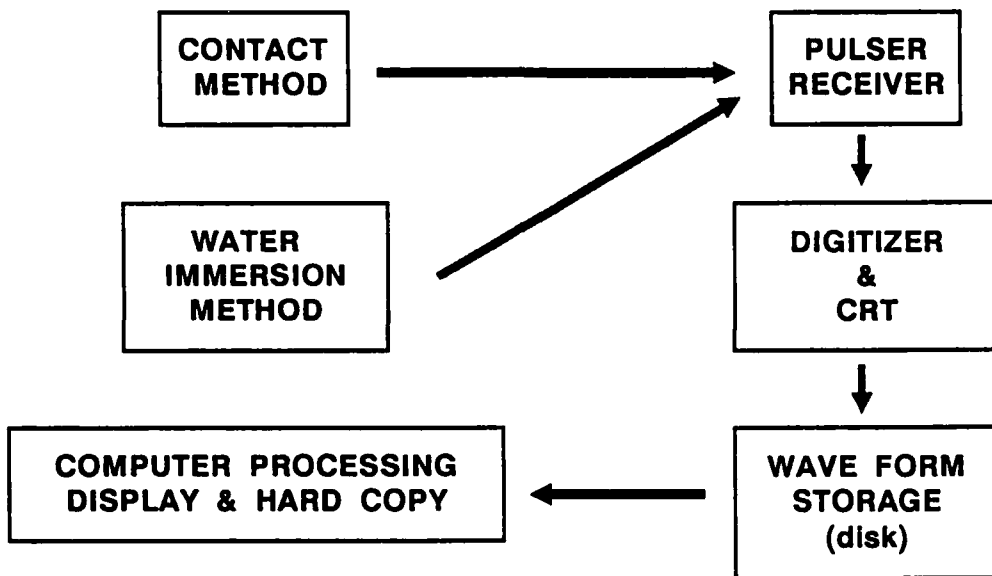
Figure 1. Block diagram of experimental test setup.

The experimental arrangement for both contact and water immersion method A-scans are schematically shown in Figure 1. A pulser/receiver, Panametrics Model 5052PRX, was used to send and receive ultrasonic signals to and from various transducers. The A-scan signals received were recorded and displayed on a digital data acquisition system, Data Precisions Data 6000. For each signal, 512 data points were recorded at a period of 10 nanoseconds (or frequency of 100 MHz). The recorded A-scans could be plotted on a Hewlett Packard Plotter or transferred to a personal computer for signal processing, display, or hard copy.

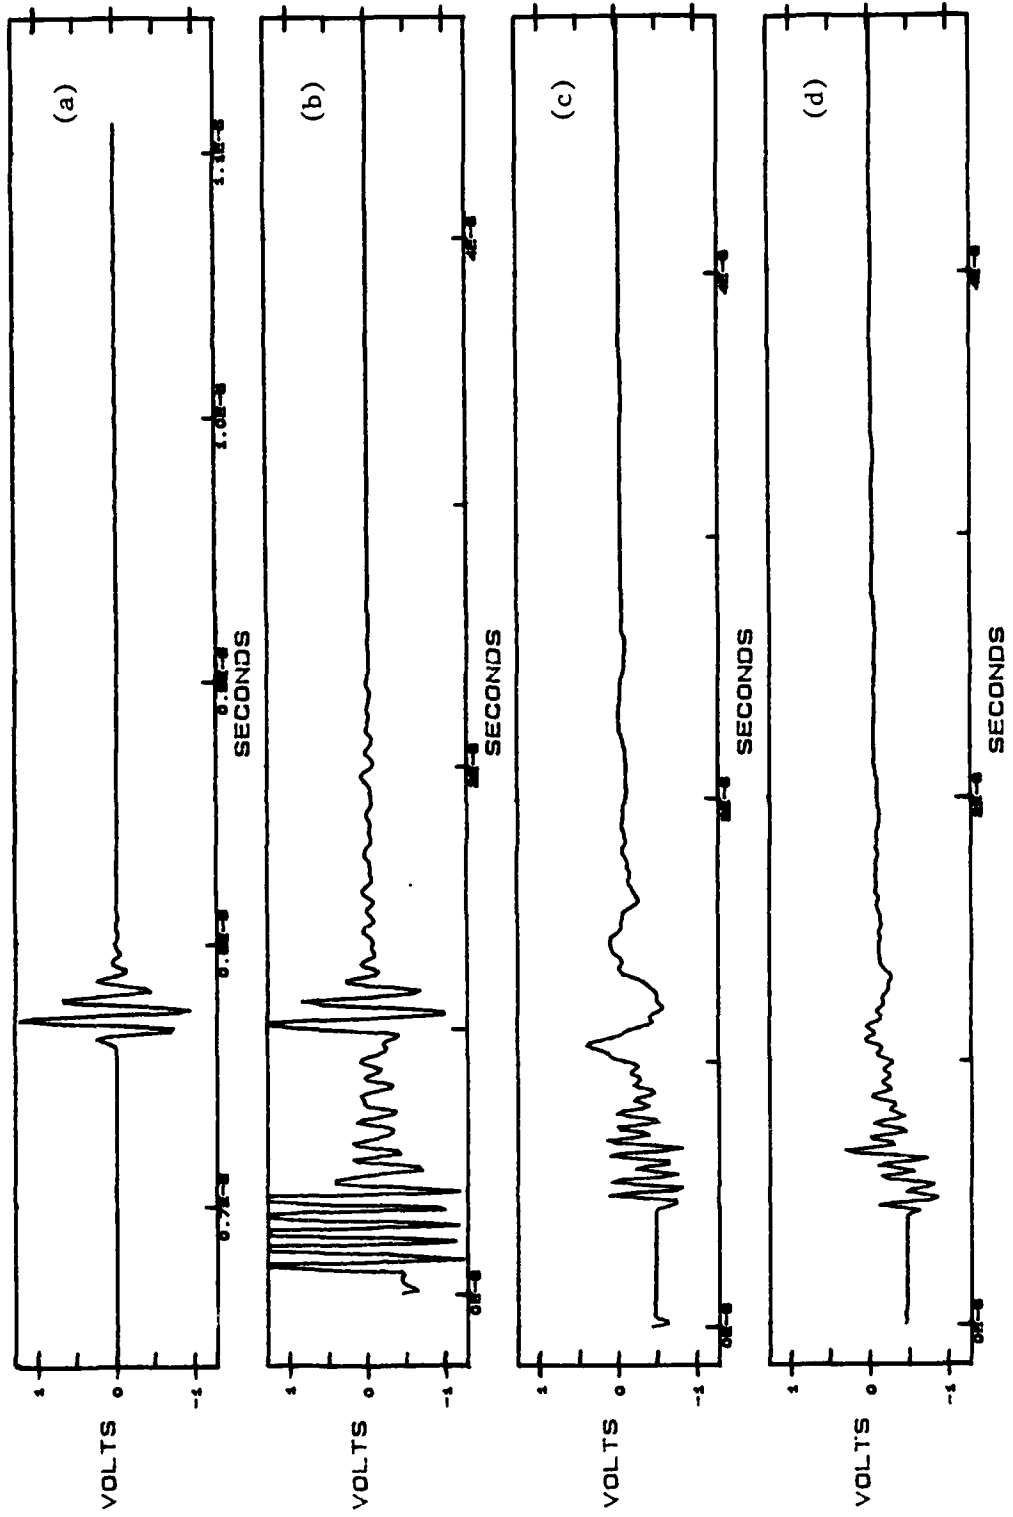
Figure 5. A-scans for contact method, 15 MHz/0.5" longitudinal wave; a) transducer response, b) specimen ID S335, c) specimen ID S319, and d) specimen ID S329.

In the contact pulse-echo technique, various frequency and diameter longitudinal wave transducers and a shear wave transducer were used to inspect the specimens. A series of A-scans for various diameter and frequency longitudinal wave transducers are shown in Figures 2 through 5. A-scans using a shear wave transducer are shown in Figure 6. In each figure the transducer response and signals for the three specimens are shown. The main bang and back surface echoes can clearly be seen in the unweathered specimen, ID S335. In the weathered specimens, ID S3319 and ID S3329, the main bang can be seen clearly while the back echoes are highly attenuated. The lower frequency transducer gives the best result even though back echoes are barely distinguishable in the weathered specimens. This signal attenuation as a function of frequency is illustrated in Figure 7 where A-scan signals of specimen ID S335 for different transducer frequencies are shown.
