TECHNICAL REPORT 9201

ENVIRONMENTAL TESTING OF THE XISCAN 1000, PORTABLE
FLUOROSCOPIC AND RADIOGRAPHIC IMAGING SYSTEM

FINAL REPORT

U S ARMY BIOMEDICAL RESEARCH & DEVELOPMENT LABORATORY

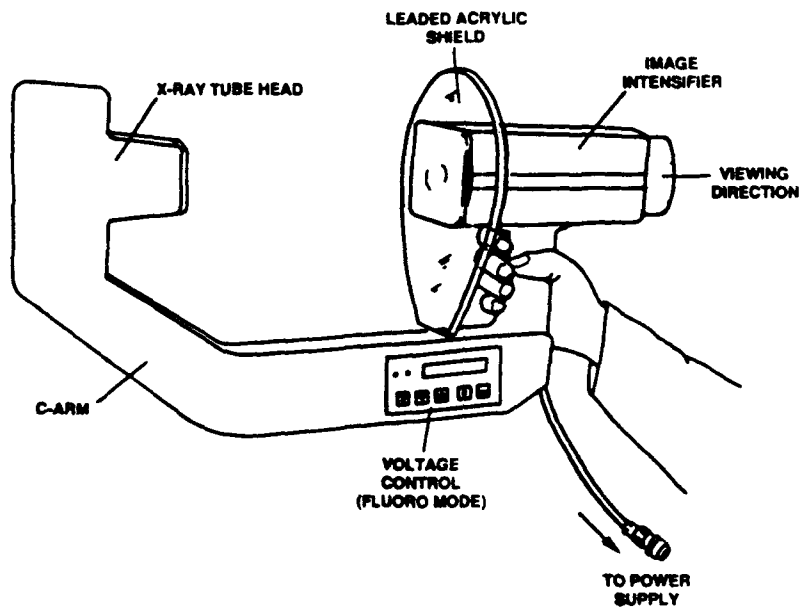
FIGURE 1: XI SCAN 1000 SYSTEM CONFIGURED FOR FLUOROSCOPY

The Xi Scan 1000, Portable Fluoroscopic and Radiographic Imaging System, (Xi Tech, Inc., Windsor Locks, CT), is a hand-held unit designed primarily for podiatric, pediatric, sports medicine, and veterinary practitioners. The complete system consists of a C-arm assembly, X-ray cassette tray, image intensifier with beam limiting device, video monitor, thermal printer, digital image storage device, mobile stand, and rechargeable battery power supply. It can be purchased in several configuration packages that include various subsets of the complete system. This study utilized the "System 3" package which includes the C-arm, cassette tray, image intensifier, and rechargeable battery power supply which weigh 30 pounds in the commercial carrying case. The system's modular design allows configuration as a 2.6 inch field of view fluoroscope (see Figure 1) or a standard X-ray machine (see Figure 2) with 8 by 10 inch film capacity. In either mode, the system is capable of imaging the extremities only. The system can operate continuously from line power (110 VAC) or from a NiCad battery pack which supports two hours of continuous fluoroscopy or up to 100 radiographic exposures.

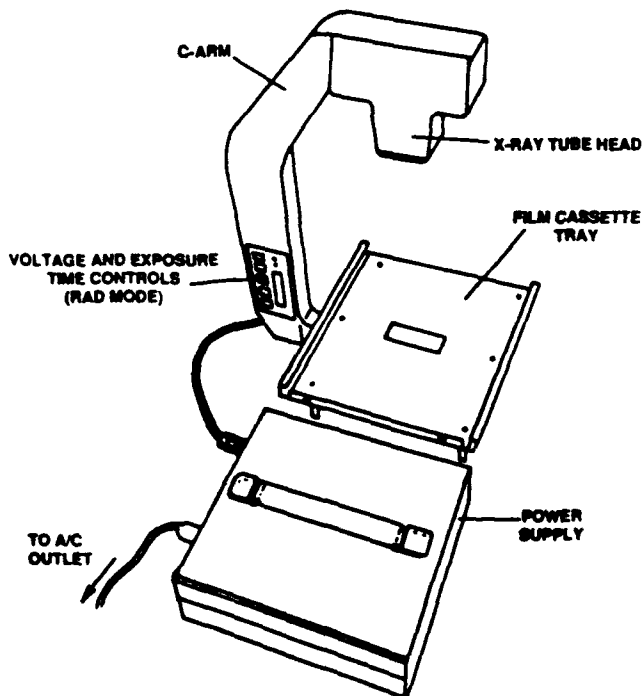
FIGURE 2: XI SCAN 1000 SYSTEM CONFIGURED FOR RADIOGRAPHY

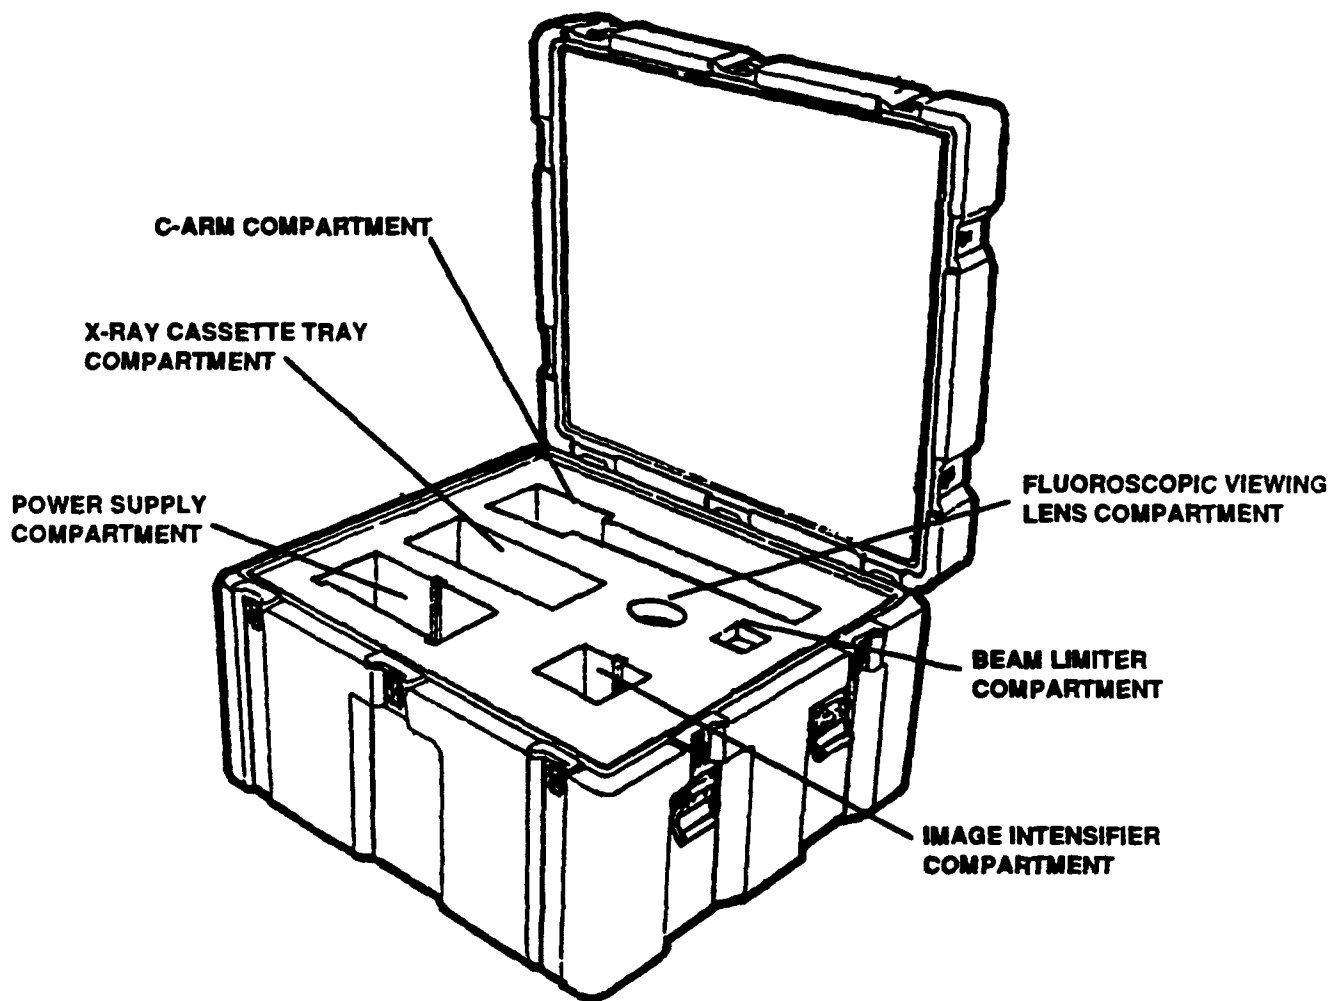
**FIGURE 3: ROTOMOLDED POLYETHYLENE SHIPPING CONTAINER
(HARDIGG INDUSTRIES, INC., SOUTH DEERFIELD, MA.) FOR THE XI SCAN
1000 X-RAY SYSTEM**

To optimize protection against environmental insult, a shipping container meeting the Deployable Medical Systems (DEPMEDS) packaging standard (MIL-D-42048) was procured for the basic Xi Scan 1000 (see Figure 3). The rotationally molded polyethylene container (Hardigg Industries, Inc., South Deerfield, MA) was 27 inches long by 26 inches wide by 14.8 inches high, weighed 30 pounds, and contained custom fabricated polyurethane foam cushioning.
