Report No. CG-D-06-93

Innovative Inspection Techniques

MAR, Inc.
6110 Executive Boulevard, Suite 410
Rockville, Maryland 20852

FINAL REPORT
JANUARY 1993

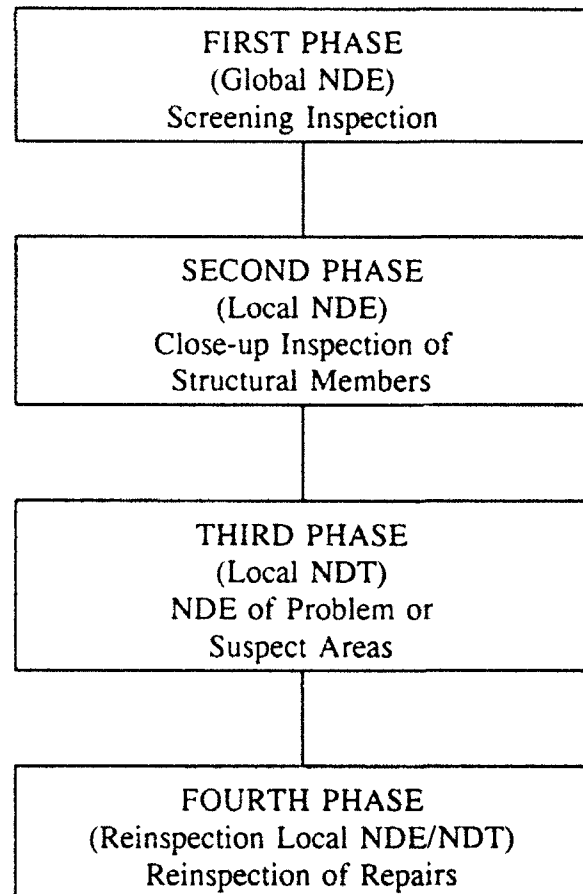
Figure 1 General Inspection Phases

The second phase is an actual close-up inspection, preferably involving close physical proximity, of areas or structural members which were identified during the screening phase as warranting closer attention, or which are known to be susceptible to failure by virtue of the vessel's repair history or for other reasons. This phase of the inspection is also always conducted by the CG inspector, who may be accompanied by others.

The third phase of an inspection is nondestructive testing of areas identified as having problems. This phase is conducted by shipyard personnel or independent NDT contractors, at the expense of the vessel's owners, and is done at the request of the Coast Guard. A CG inspector may or may not observe the actual inspection; but, the results are reported to the CG inspector.

The final phase is the reinspection of repairs required or suggested by the CG. This is also always done by a CG inspector, although not necessarily the same inspector who conducted

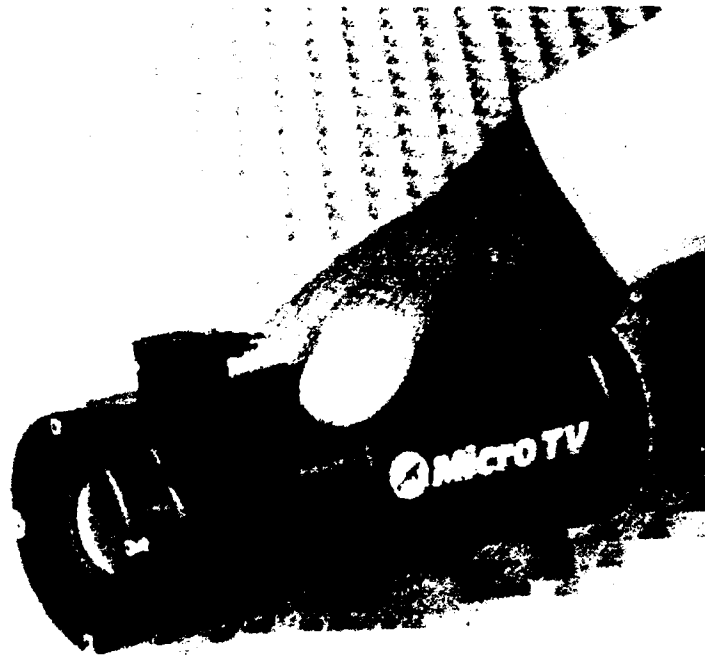
Figure 4 Typical Mini Camera Size

Figure 4 shows a typical camera size available today although smaller cameras are available. A typical mono video system proposed by Connecticut Analytical Corporation utilizes a color Charge-Coupled-Device (CCD) camera, a zoom lens and a high intensity illumination source parallel to the camera lens. The camera and light are mounted on a motor driven turntable capable of 0° - 360° rotation with an integral 0° - 90° axis drive head. The camera unit has a tether line attached to the power supply and control panel. The control panel incorporates user controls and indication of camera position, zoom and illumination. A color monitor and video tape recorder complete the system. The system is made rugged enough for use in the tank environment. The equipment necessary to put the package together is available commercially.

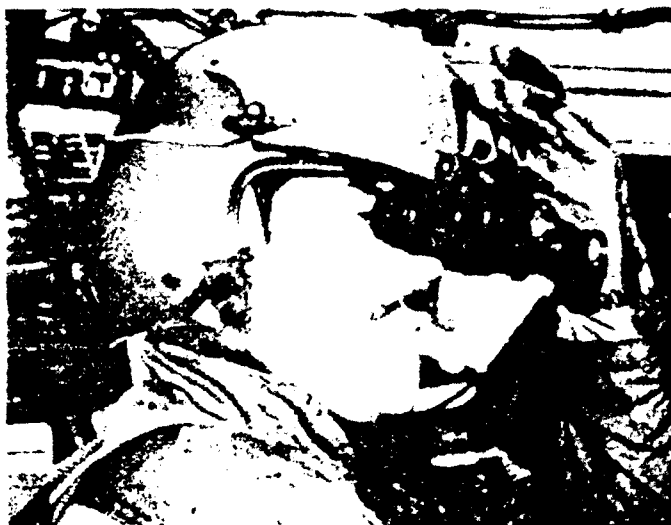
Figure 5 Helmet Mounted Night Vision Device

The following devices are typical. The Varo Model 2000 (ANVIS) is a helmet mounted type of night vision goggle which weighs about 1.25 pounds, as shown in Figure 5. It allows the user to view objects from ranges of 11 inches to infinity. The goggles can be suspended from a neck cord when removed. However, the goggles are easily damaged and may not be rugged enough for marine inspection use. Another night vision device is the NVEC 500/520 pocketoscope shown in Figure 6. This is a single lens, combination hand-held viewer and camera lens system. This unit weighs less than a pound and used 2-"AA" batteries. The eyepiece can also mate directly to popular 35mm SLR cameras and camcorders using a 55mm step up ring.

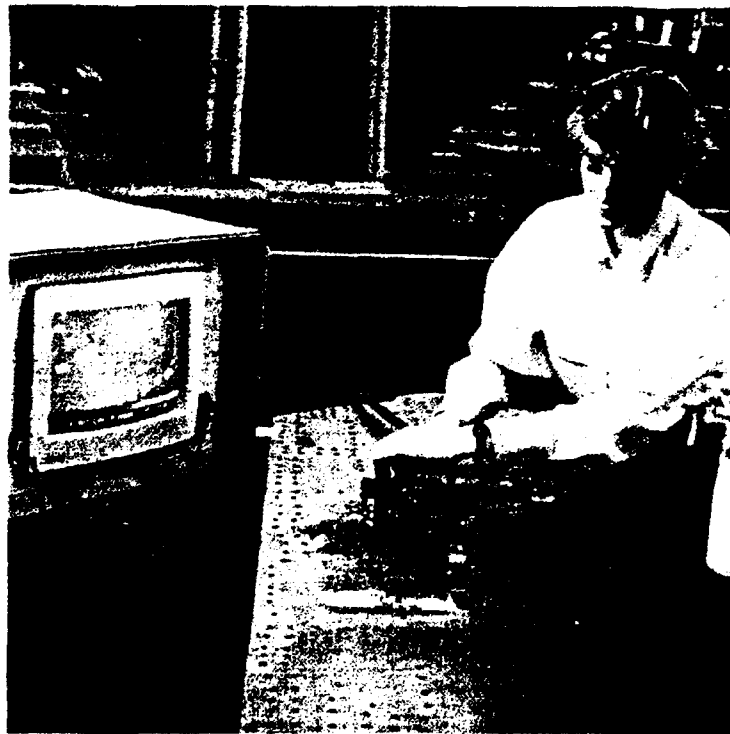
Figure 12 MAUS II

Developments in ultrasonic measurement systems are currently underway that may have some future application to marine inspection. In the aircraft industry, McDonnell Aircraft Company has developed the Mobile Automated Ultrasonic Scanner II (MAUS II). This instrument is shown in Figure 12. The MAUS II uses a 'C'-Scan ultrasonic technique to provide a thickness map for the

entire surface inspected. In the 'C'-Scan approach, multiple sensors are used. The signals received must be computer processed to determine the thickness of plating under each sensor plus the thickness of plating in the span between sensors. By moving the probes at a uniform rate, a band of the plate can be thoroughly inspected. This inspection system significantly reduces the amount of time required to manually perform inspections, interpret the information, and archive the results. Inspection options available include ultrasonic pulse-echo, ultrasonic resonance and eddy current methods. The system can inspect large surfaces at rates of up to 100 square feet/hour.

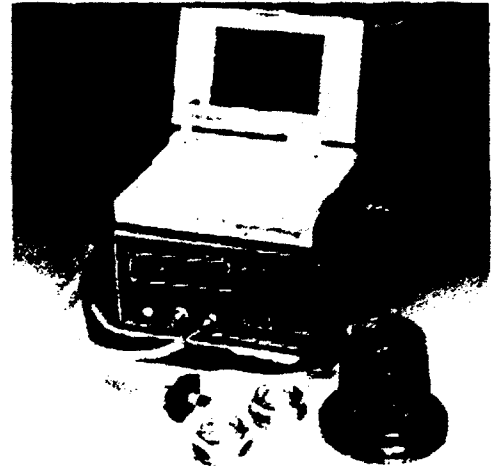
Figure 14 ACFM Equipment

A new method developed from the ACPD technique is known as alternating current field measurement (ACFM). Equipment for this technique is shown in Figure 14. This method enables crack detection as well as sizing, using probes that do not contact the surface. The standard ACFM probes contain both the field induction unit and the magnetic field sensors in one integral probe head. No electrical connection is required to the structure being inspected, so a minimum of cleaning is necessary. The probes are designed primarily to run along a weld toe, where most fatigue cracks are found. A standard inspection involves two probe passes, one along each weld toe. A standard ACFM probe can inspect an area about 10mm either side of the probe center. The speed of the scan is about 10-20mm/sec. An inspection consists first of a series of initial probe scans for detection. Having found a defect indication, a crack size estimate can then be performed to determine the length and depth. Subspec Oceanics, LTD has a system specifically developed to perform underwater inspection of welds for the offshore industry. The company claims its ACFM Microgage provides reliable and repeatable inspection results, and requires minimal operator interpretation. This system is sold in the United Kingdom. Cost for an above water ACFM inspection system is about \$12,600 (\$1.57/£).
