**THE DISTRIBUTION OF FLIGHT TRACKS ACROSS
TAC VFR MILITARY TRAINING ROUTES**

Kenneth D. Frampton
Kevin A. Bradley
Kenneth J. Plotkin

WYLE LABORATORIES
2001 JEFFERSON DAVIS HIGHWAY
ARLINGTON, VIRGINIA 22202

AUGUST 1992

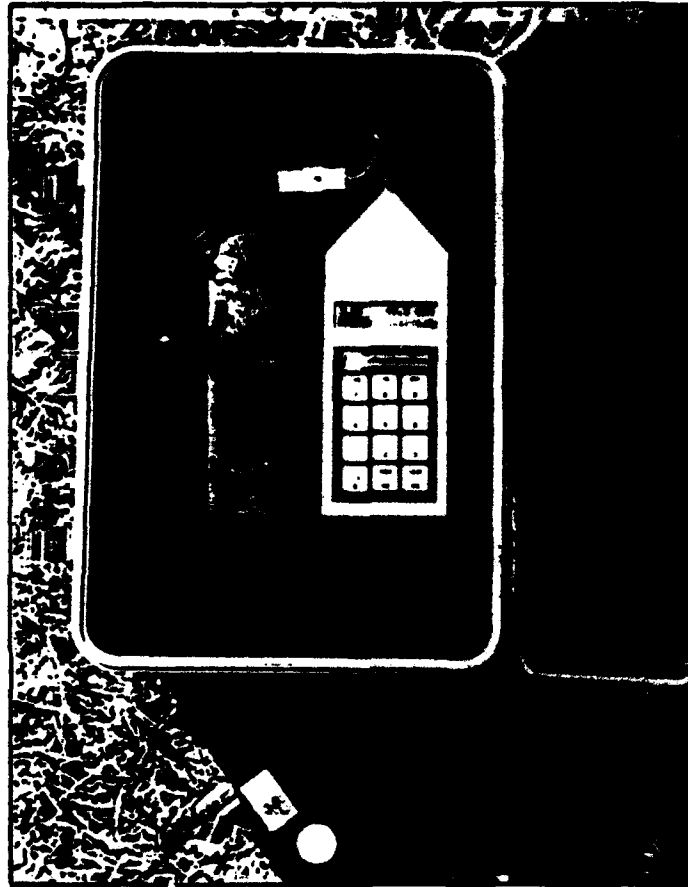
on the ground. Each LD-700, together with a battery, was placed in an environmentally sealed container. Figure 9 shows a typical monitor site installation. Figure 10 shows the LD-700 and its battery inside the container. Field calibration of the monitors was accomplished using a B&K Type 4230 calibrator.

Figure 10. LD-700 and Battery Inside Environmental Case.

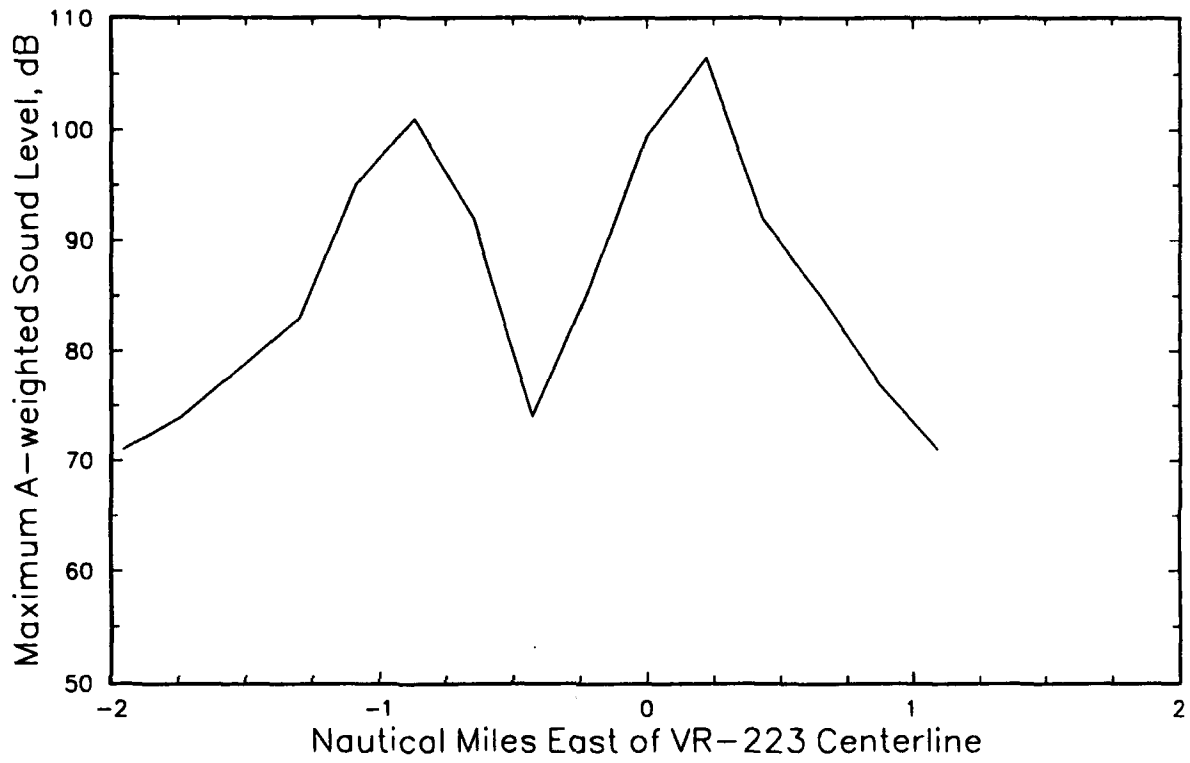
Figure 12. Sound Level Distribution for a Two-Ship Formation.

sources. An aircraft overflight would be recorded by at least three monitors simultaneously with the characteristics discussed previously. Other noise sources rarely triggered more than one monitor at a time.

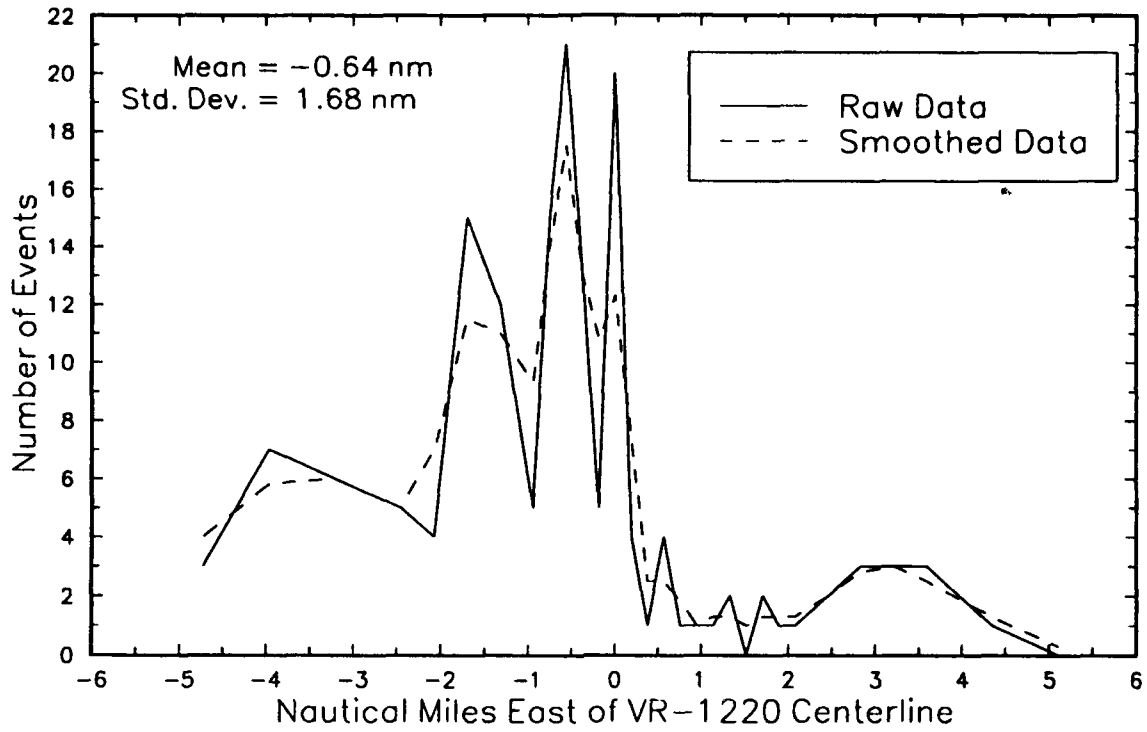
- Figure 13 shows the distribution of sorties recorded by the measurement arrays. The positions of individual sorties were assumed to be over the monitor site which recorded the maximum level. In each figure a plot of the raw data and smoothed data are shown. The smoothed data was calculated from the weighted average of the site and the two sites adjacent to it. The site was weighted 50 percent and the two adjacent sites were weighted 25 percent. Since the total number of events at any particular site were statistically low, the smoothed distribution is probably a better representation of the data.
- Figure 14 shows the cumulative probability distribution of position. In the case of a perfectly Gaussian distribution this plot would appear as a

Figure 13. VR-1220 Event Distribution.

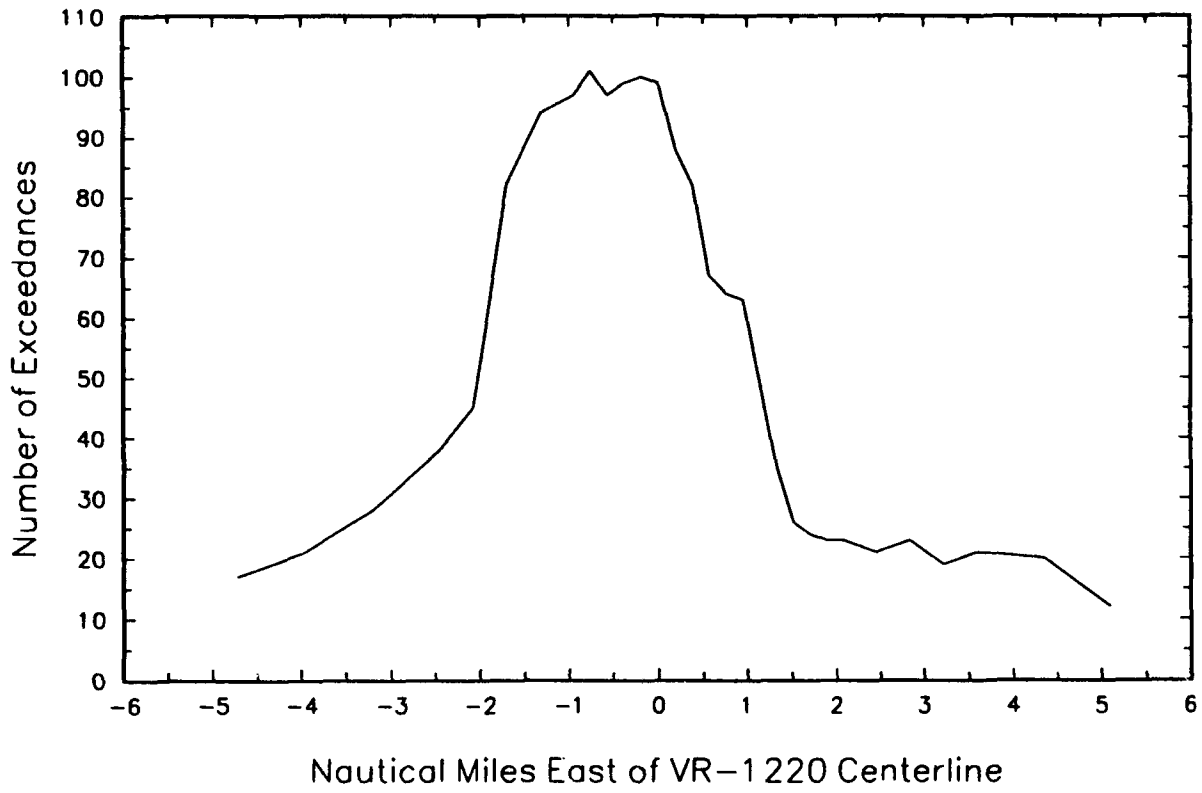
Figure 15. VR-1220 Total Events at Each Site.

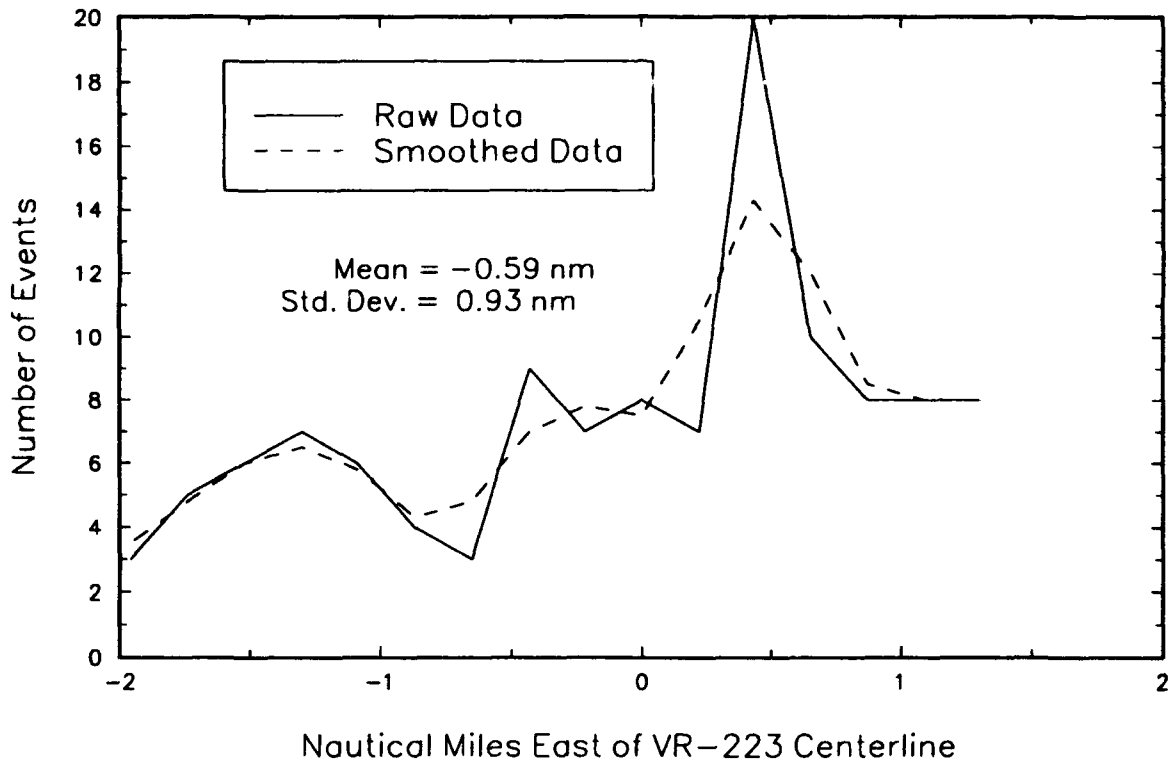
Unlike VR-1220, where all operations were well contained within the route boundaries, operations on VR-223 extended to the western edge. It appears that the three miles available at this choke point is close to the minimum necessary for this type of route. The standard deviation is the smallest measured on any TAC route.

Figure 17. VR-223 Event Distribution.

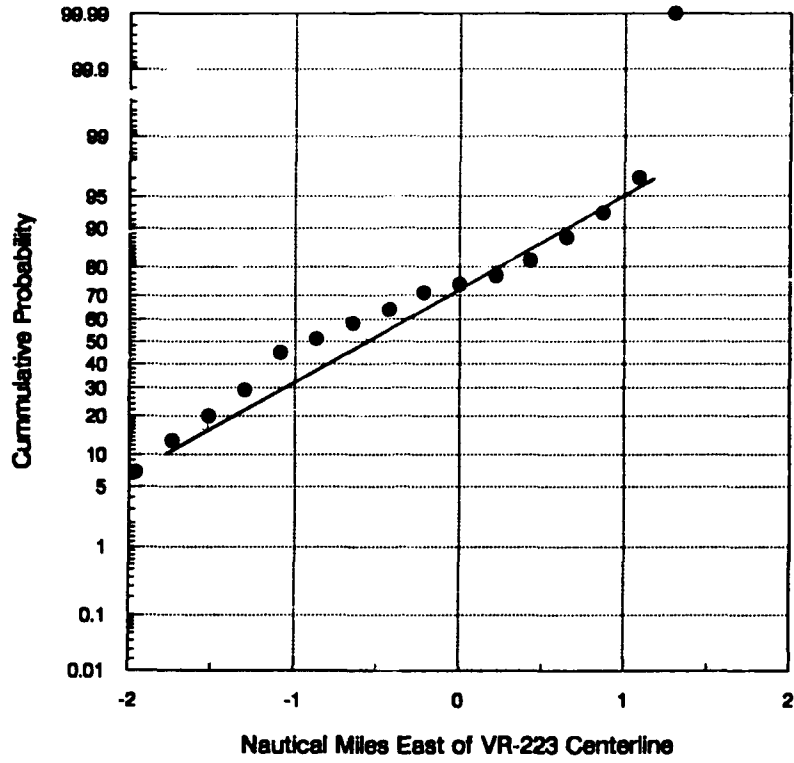
Figure 18. VR-223 Event Cumulative Probability Distribution.

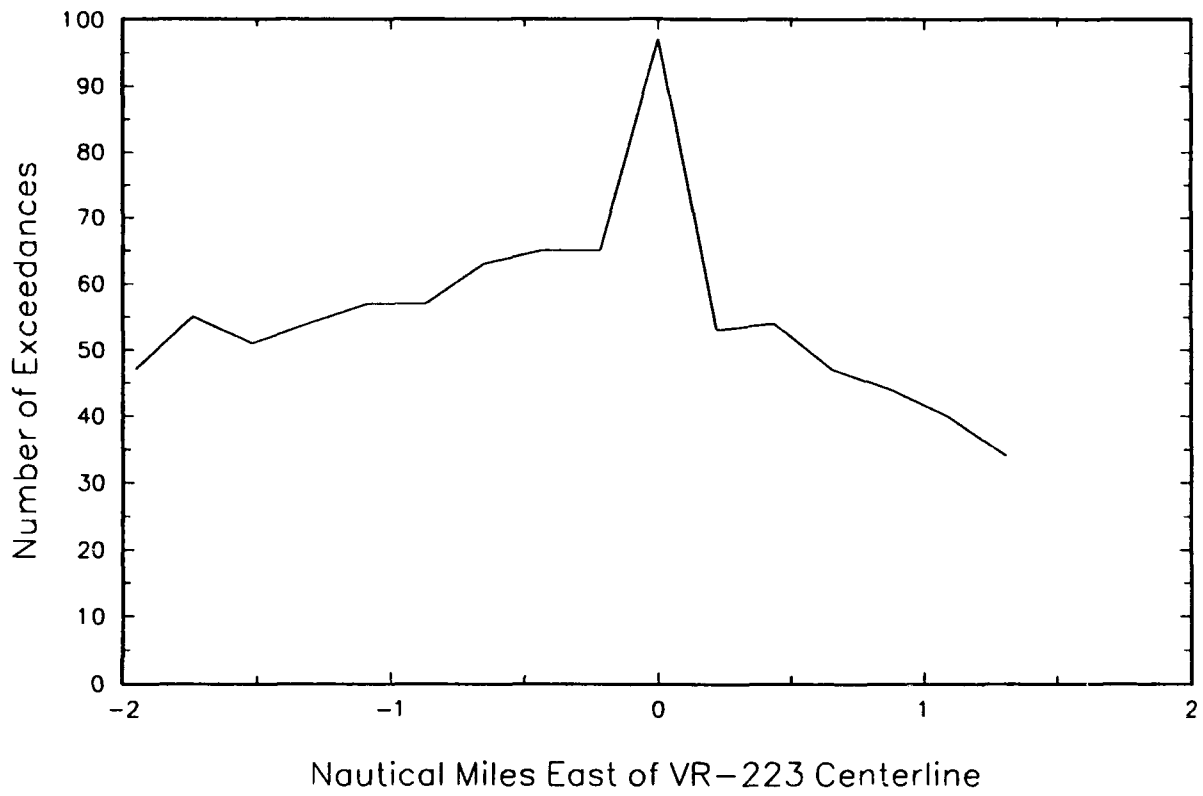
Figure 19. VR-223 Total Events at Each Site.

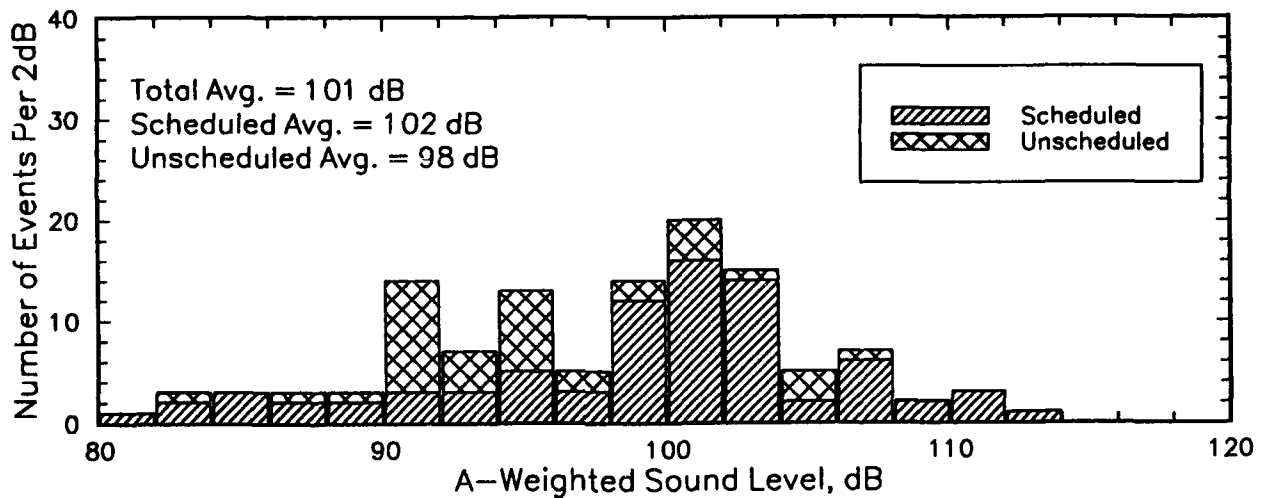
Figure 20(a) shows the distribution of SELs per 2 dB for each measured event. The energy average associated with these measurements is 105.1 dB. This

(a) Distribution of Highest SEL for Each Event.

(b) Distribution of Highest Maximum Level for Each Event.

Figure 20. Distribution of Event Sound Levels, VR-223.

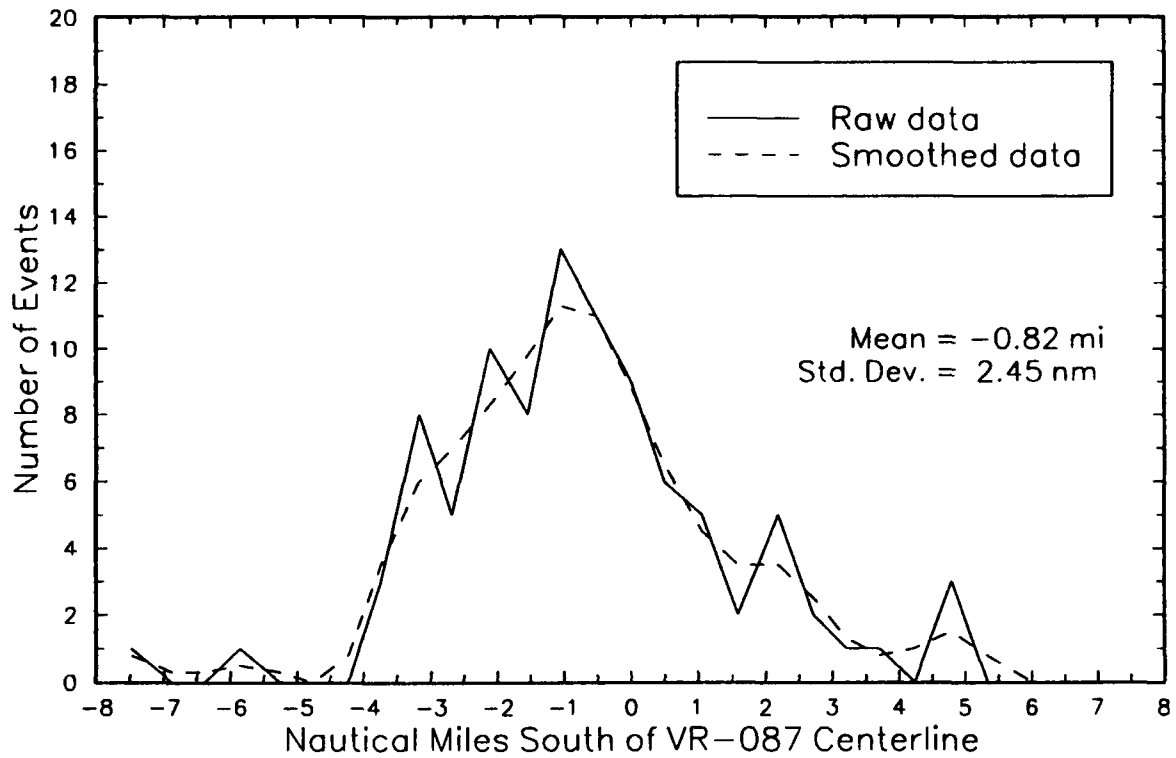
Figure 21. VR-087 Event Distribution.

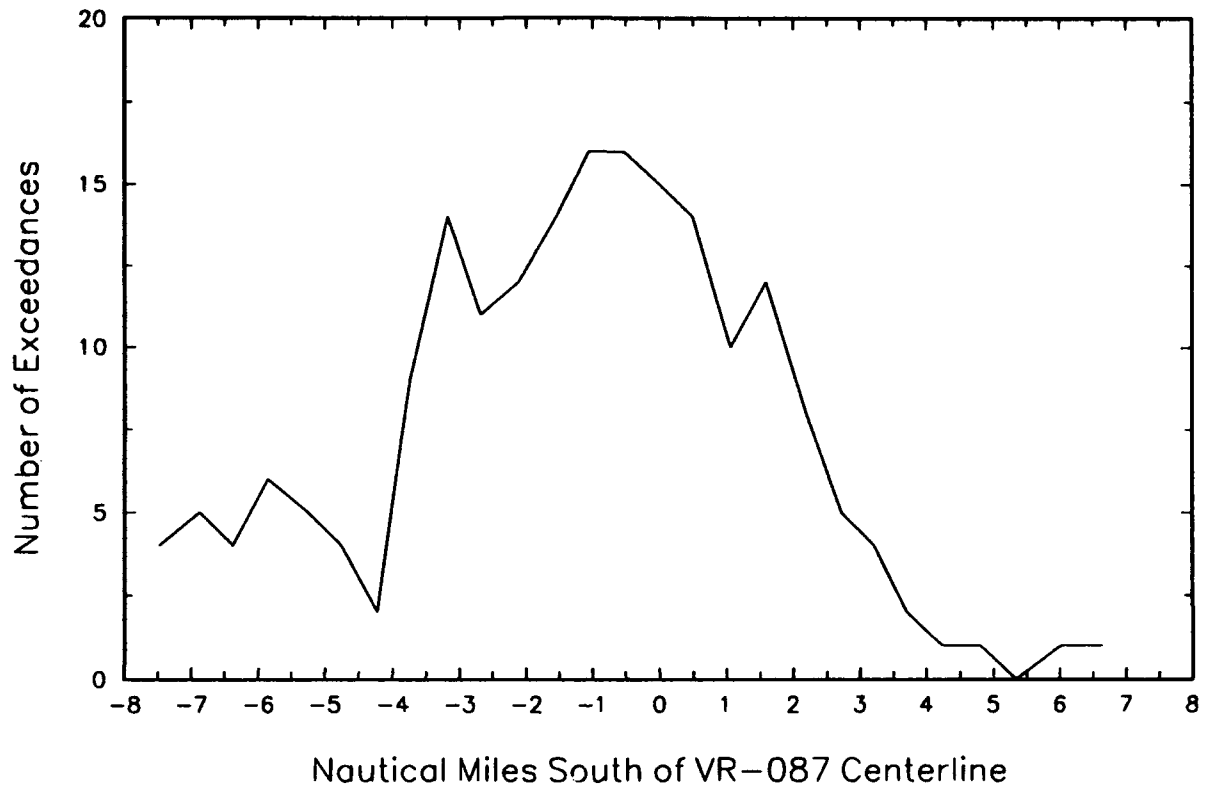
Figure 23. VR-087 Total Events at Each Site.

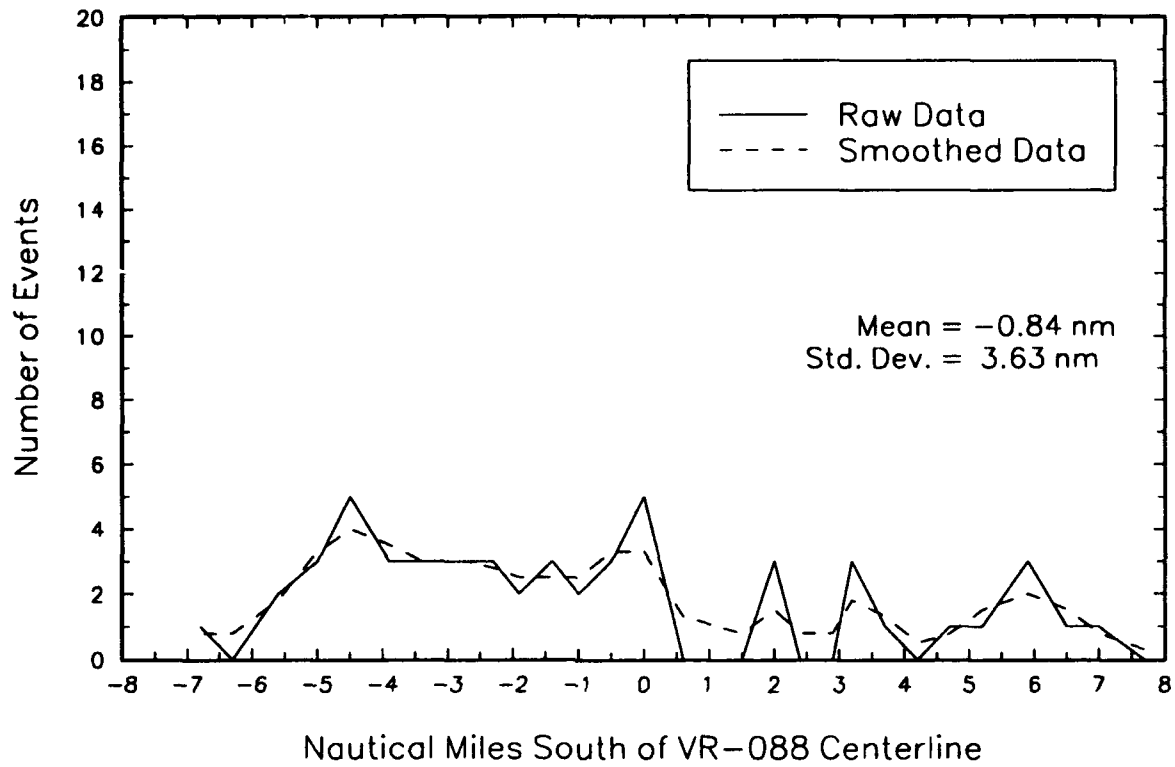
The distribution of events along VR-088, shown in Figure 25, has a mean of -0.84 nautical mile and a standard deviation of 3.63 nautical miles. Notice that the data in Figure 25 does not appear normal in shape, but appears to be uniform across the route. This is probably due to the low number of events recorded on the route, and the reliability of the standard deviation is questionable. The offset of the mean may be due to the presence of a small town directly under the route centerline along the measurement array which the aircraft avoided to the north. The cumulative probability distribution for VR-088 is shown in Figure 26. Even though the event distribution plot in Figure 25 does not appear Gaussian, the data

Figure 25. VR-088 Event Distribution.

does follow the ideal normal distribution straight line over most of the central part of the route. The total number of exceedances measured at each site is shown in Figure 27.

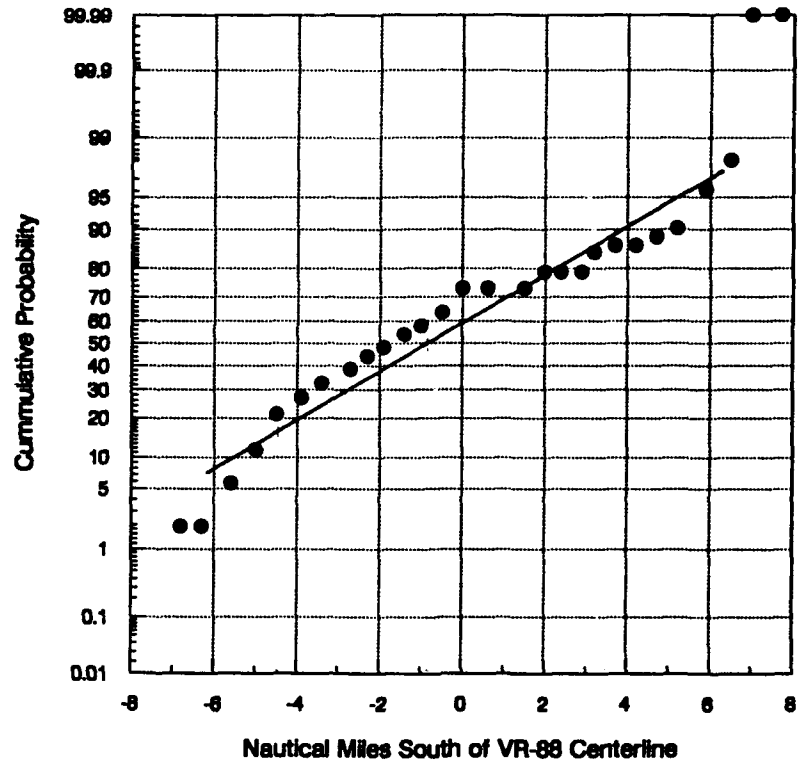
Figure 26. VR-088 Event Cumulative Probability Distribution.

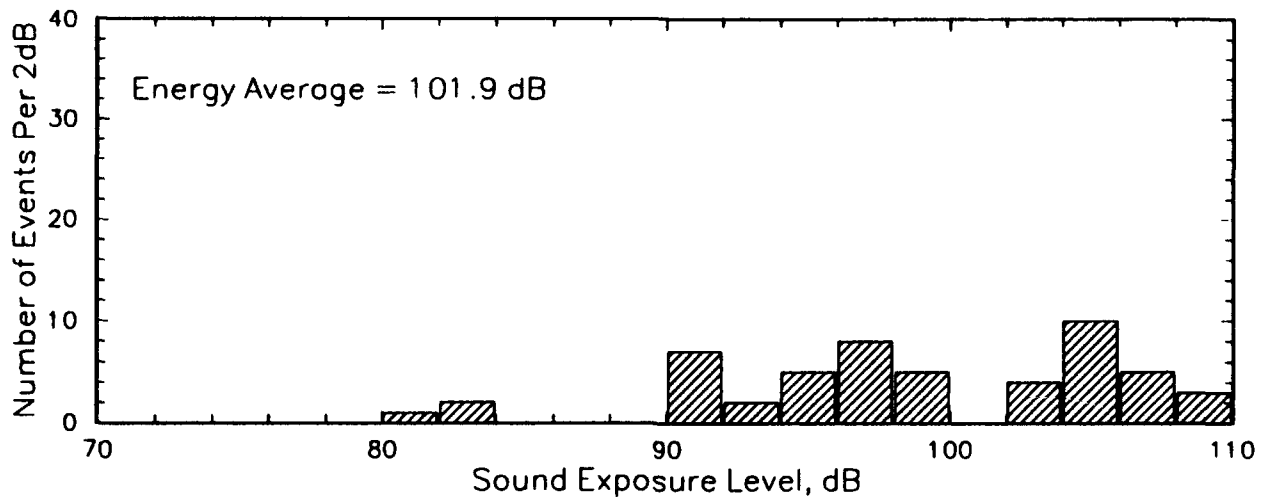
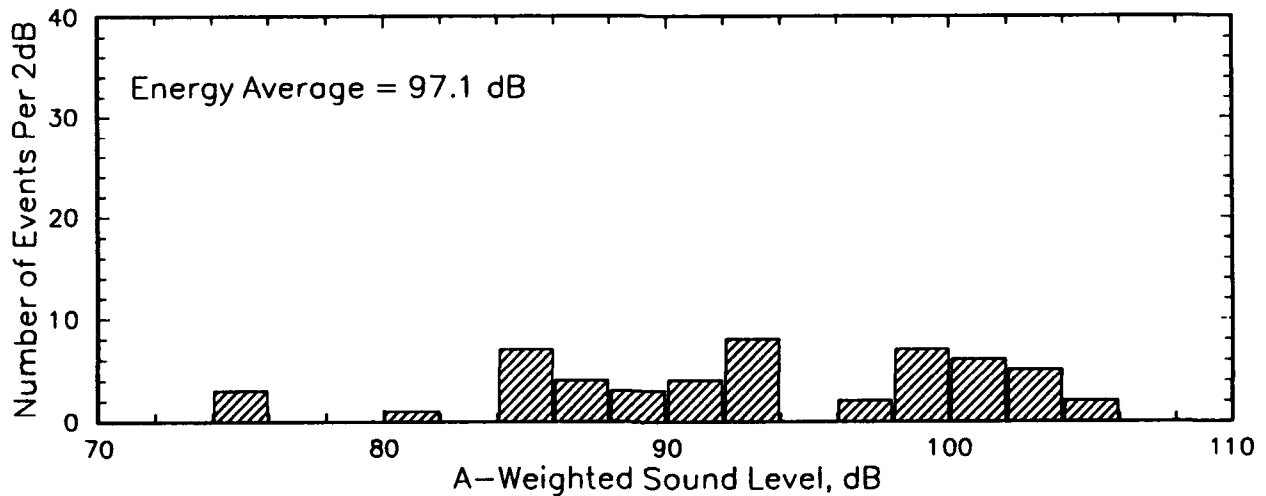
(a) Distribution of Highest SEL for Each Event.

(b) Distribution of Highest Maximum Level for Each Event.

Figure 28. Distribution of Event Sound Levels, VR-088.

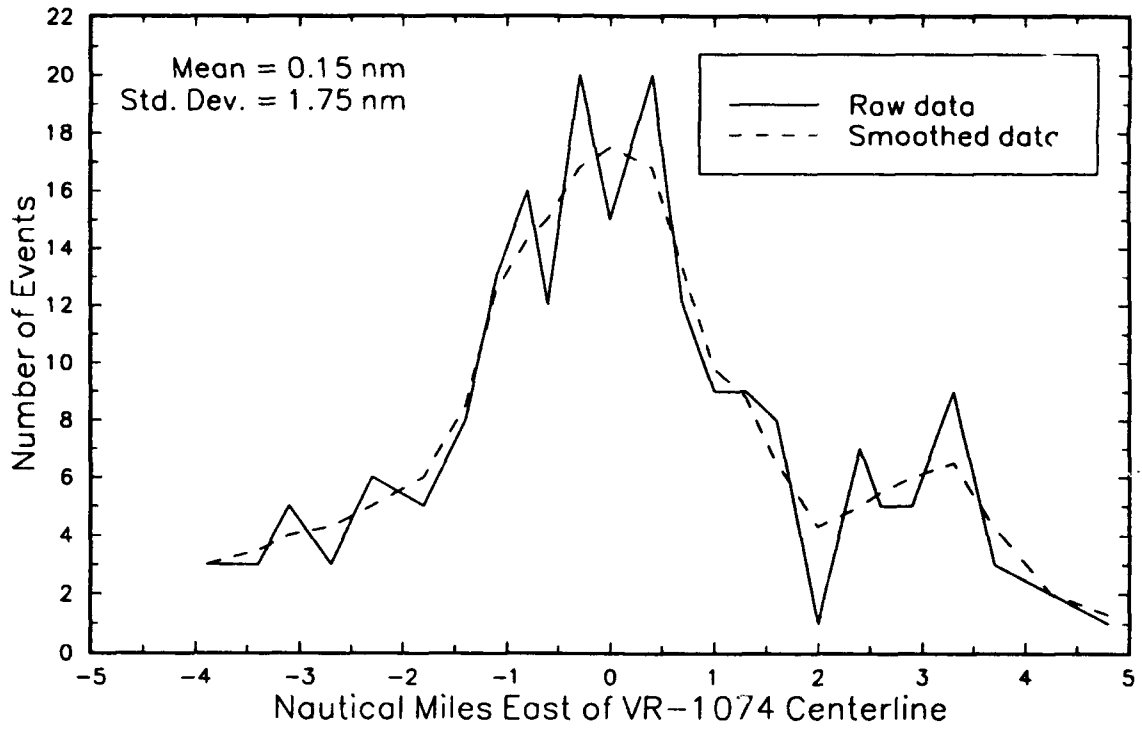
Figure 29. VR-1074 Event Distribution.

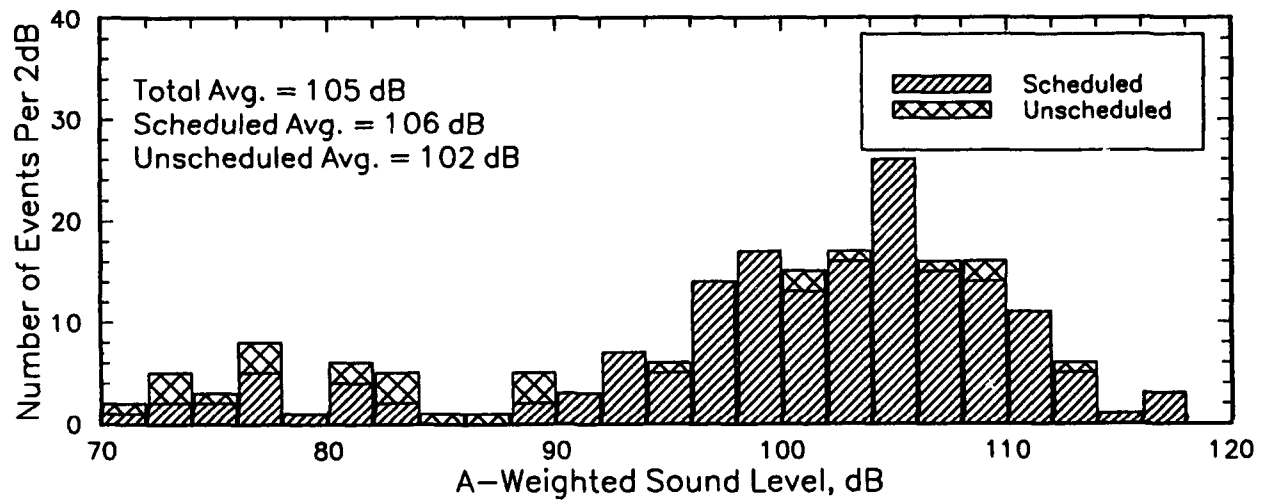
(a) Distribution of Highest SEL for Each Event.

(b) Distribution of Highest Maximum Level for Each Event.

Figure 32. Distribution of Event Sound Levels, VR-1074.

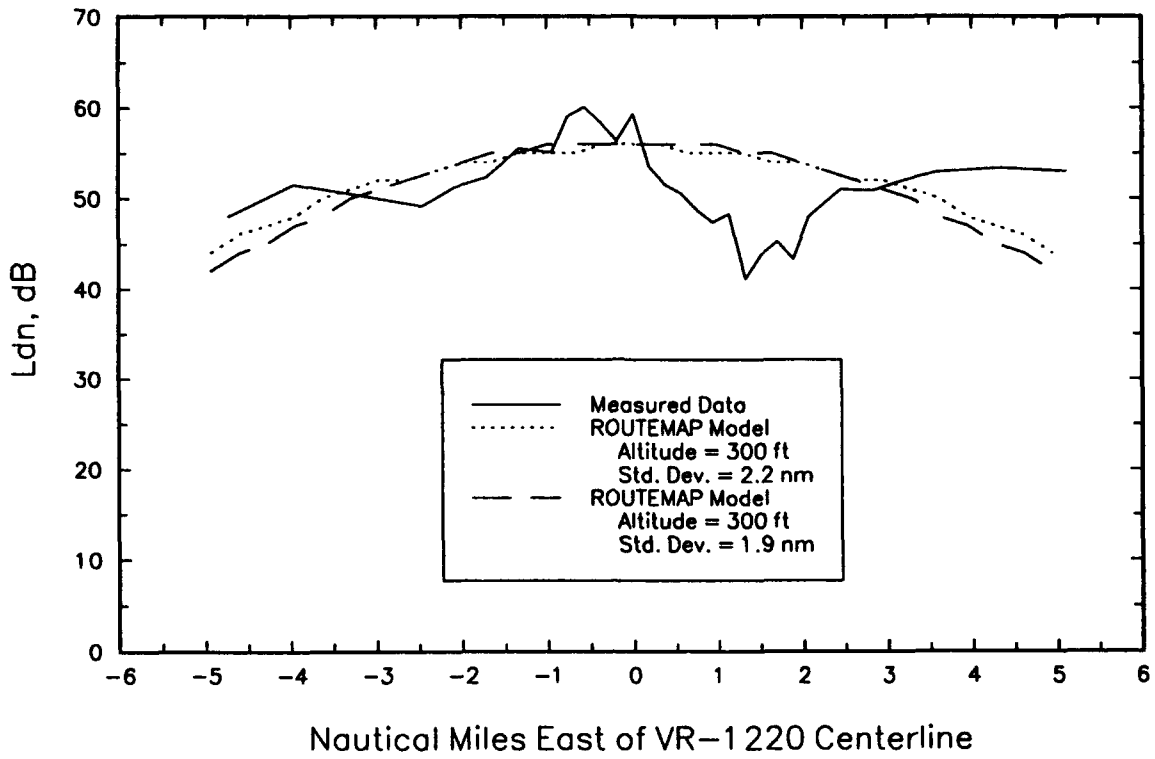
Figures 33 through 37 show the measured L_{dn} levels along with the levels as predicted by ROUTEMAP for similar operations. The L_{dn} (which is equivalent to L_{eq} since no night operations were detected) represents the energy average, over the measurement period, of low-altitude aircraft noise. L_{dn} includes all events which exceeded the monitor threshold at each site due to aircraft overflights.

Figure 33. VR-1220 Measured and Predicted L_{dn} .

Figures 33 through 37 compare the measured levels with ROUTEMAP predictions for two standard deviations: the measured value, and either 1.1 or 2.2 nm, as selected from the above rule. (VR-223 uses 1.1 nm; the others all use 2.2 nm.)

The previous recommendation⁴ had been to use a single value of 2.2 nm for nominal multi-track routes. It is seen in Figures 33, 35, and 37 (which represent routes 10 to 16 nm wide) that this single value yields centerline noise levels within 1 dB of those obtained if the actual standard deviation is used. In the overall assessment of airspace actions which involve many routes, it is reasonable to use a single standard deviation of 2.2 nm for routes between 10 and 16 nm wide. It is also reasonable to establish similar average values for other width ranges. In general, variation of the standard deviation by 25 to 30 percent leads to sound level differences of no more than about 1 dB. When analyzing the impact associated with a single specific route, however, the actual standard deviation for that width should be used.

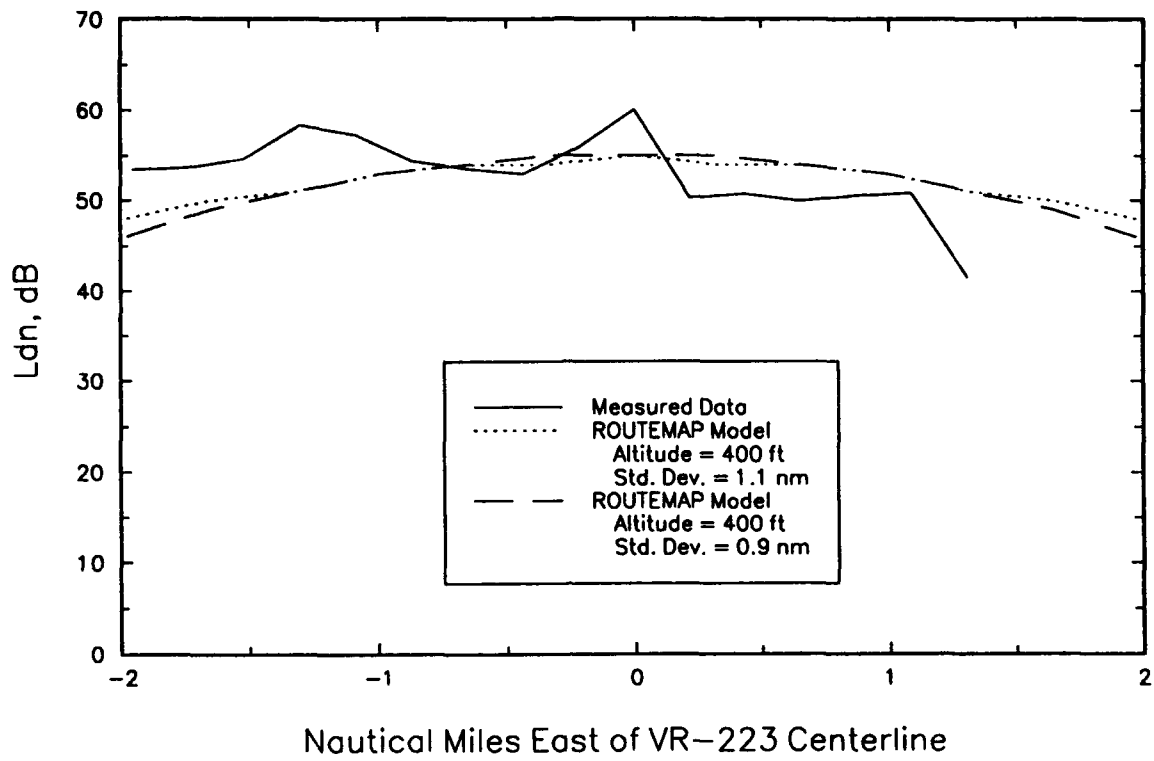
Figure 34. VR-223 Measured and Predicted L_{dn} .

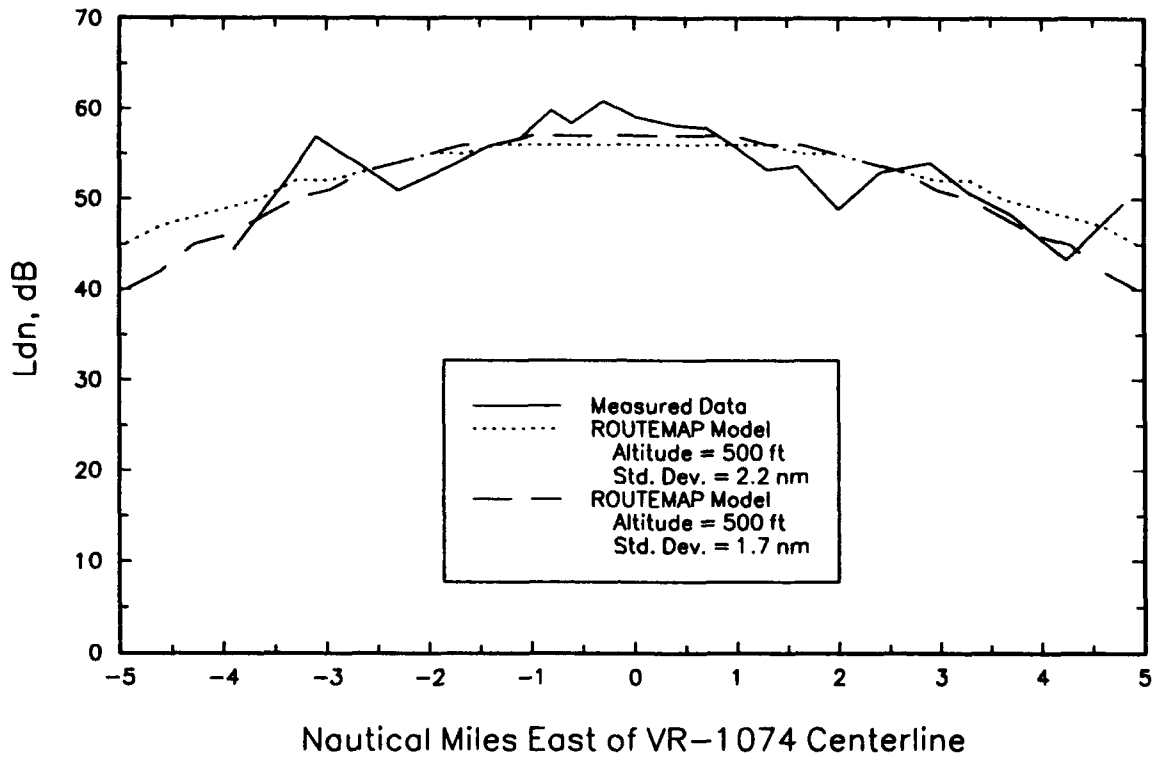
Figure 37. VR-1074 Measured and Predicted L_{dn} .
