USACERL Technical Report FM-93/16  
September 1993  
New Technology for EMP/EMI Shielded Structures

# Electrochemical Behavior of Ion-plated TiN and Cu-Cr Coatings

by  
Y.W. Lee  
M. Metzger  
J.M. Rigsbee

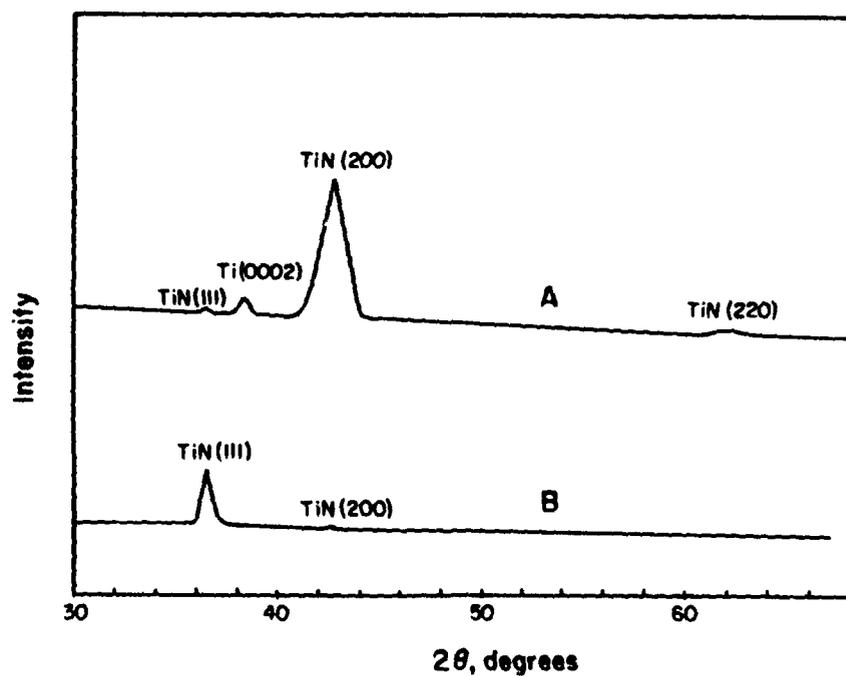
**Figure 1.** X-ray Diffraction Spectra of As-deposited TiN Coatings. (A, USACERL TiN and B, commercial TiN.)

In spite of the color difference, these two coatings were determined to be stoichiometric TiN based on the x-ray diffraction (XRD) spectra. XRD from a USACERL TiN coating on a glass substrate (Figure 1, curve A\*) shows several peaks of stoichiometric TiN and a small peak of hexagonal Ti, indicating that USACERL TiN is stoichiometric but contains a small amount of Ti. On the other hand, only diffraction peaks pertaining to stoichiometric TiN are observed in the commercially fabricated TiN coating on a glass substrate (Figure 1, curve B). It is worthwhile to note that the structure of the USACERL TiN has a (200) preferred orientation while the structure of the commercial TiN has a (111) preferred orientation.

It is emphasized that the elemental Ti peak is absent in the XPS spectra for the USACERL TiN in Figure 3. This contradicts the XRD result (Figure 1) that detected elemental Ti for the same sample. XPS should detect elemental Ti observed by XRD, considering the similar sensitivity factors of the techniques. A possible explanation for this contradiction is that all (or a majority of) elemental Ti detected by XRD may be present near the interface between the glass substrate and TiN coating rather than as a random

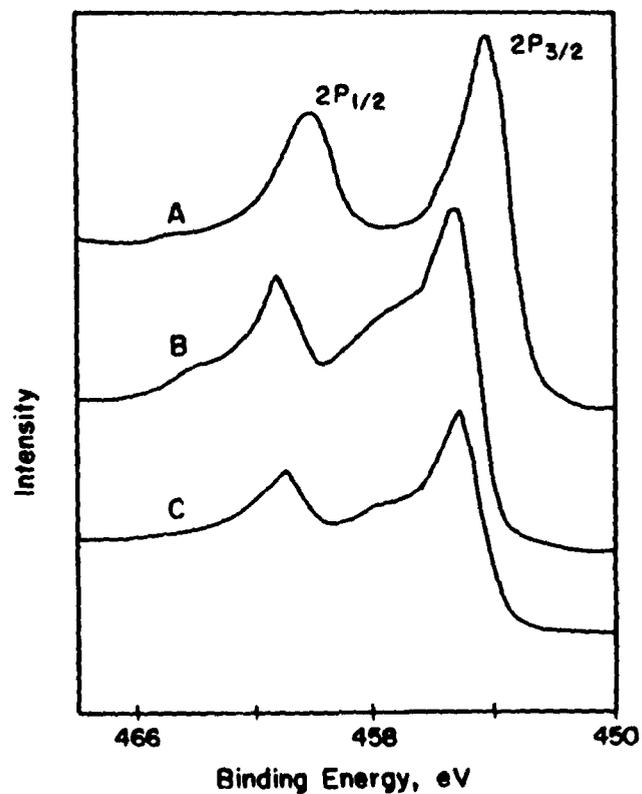
**Figure 2.** Ti 2p X-ray Photoelectron Spectra of Commercial TiN, USACERL TiN, and Pure Ti After Removal of 10-20 Å of the Surface Layer. (A, Ti; B, as-deposited commercial TiN; and C, as-deposited USACERL TiN.)

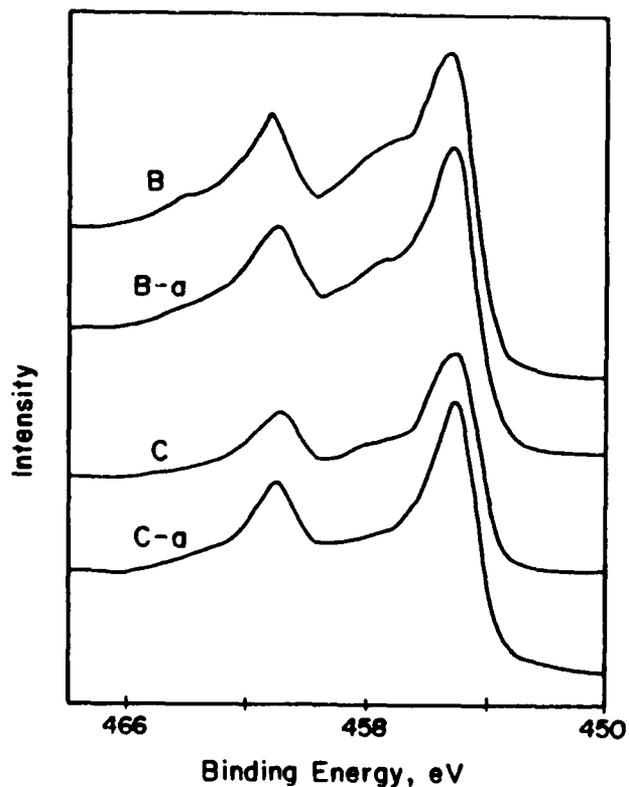
**Figure 3.** Ti 2p X-ray Photoelectron Spectra of TiN Coatings After Removal of About 100 Å of the Surface Layer. (Spectrum B and C are the same as in Figure 2, and Spectrum B-a and C-a are obtained after about 100 Å surface layer removal.)

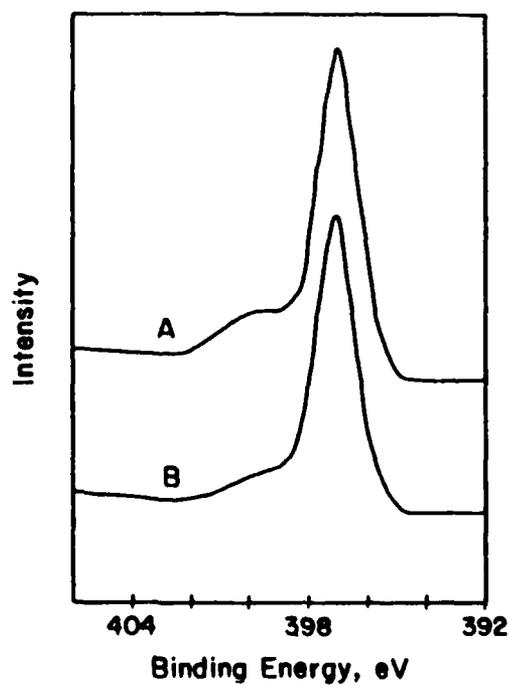
**Figure 4.** Nitrogen 1s XPS Spectra From TiN Coatings After Removal of About 100 Å of the Surface Layer. (A, commercial TiN and B, USACERL TiN.)

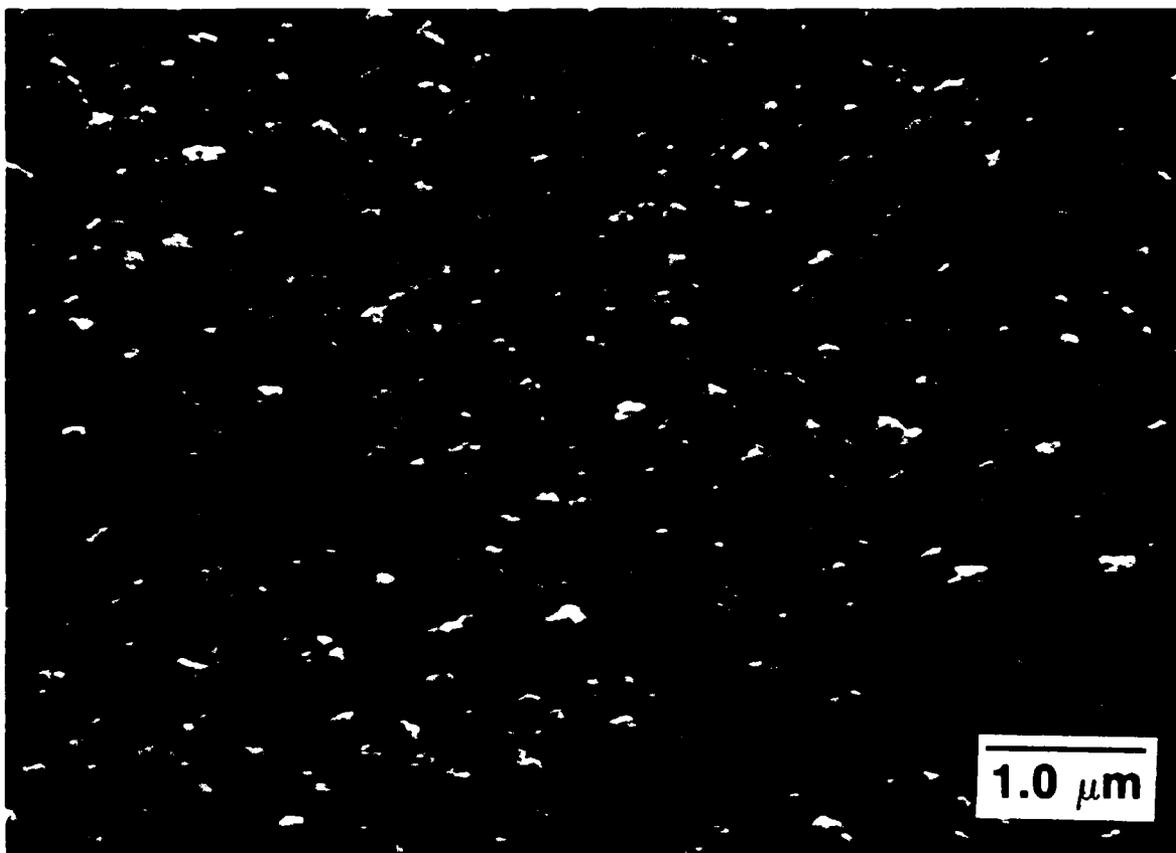
**Figure 5. SEM Micrograph of As-deposited USACERL TiN on an Al Substrate. (7000X.)**

Figure 5 is a SEM micrograph of as-deposited TiN coating surface on Al substrate which shows typical surface morphology with a columnar structure. Similar coatings at low magnifications are shown in Figure 6-A for TiN on a glass substrate and in Figure 6-B for TiN on an Al substrate. A number of small pores of a few micrometers in size are clearly visible in the TiN coating on Al, while they are not visible in the coating on glass. Submicroscopic pores, however, were observed in the TiN coating on glass. Auger analysis of TiN coating (Figure 7), shows only Ti and N peaks, suggesting that the coating is practically free of impurities.

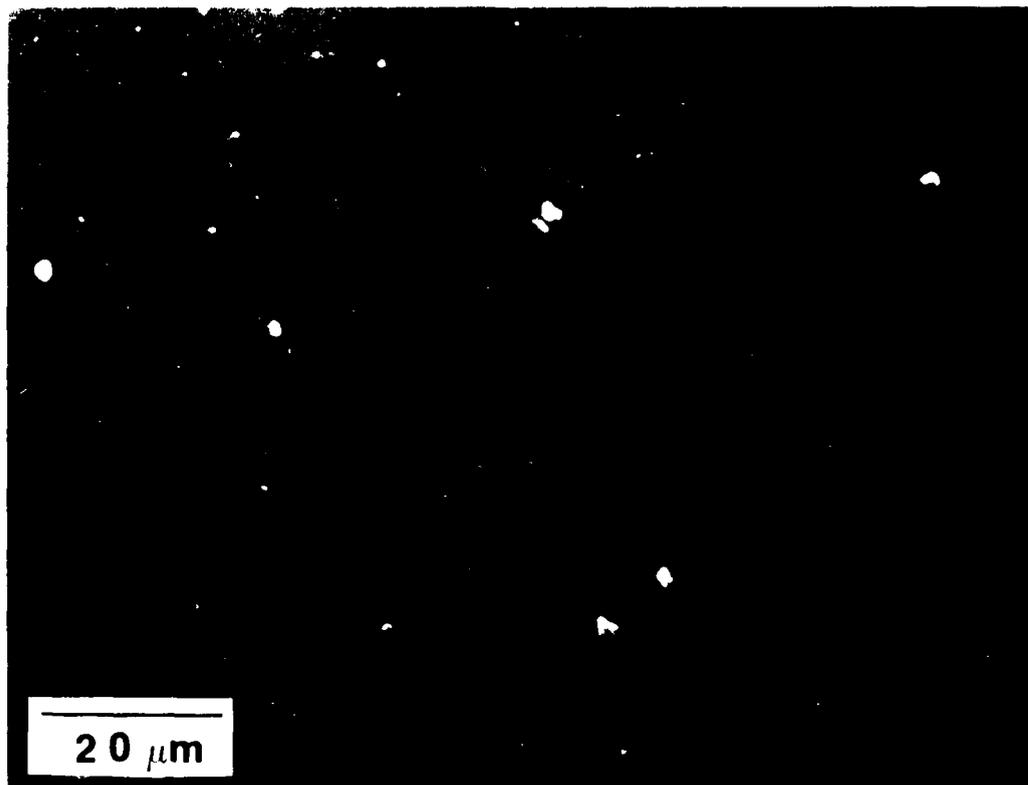
**Figure 6.** SEM Micrographs of As-deposited USACERL TiN on a Glass Substrate. (450X, A on glass and B on Al.)

The basic problem is the "pinholes" in the TiN coating applied to Al as shown in Figure 6-B. Because of the number of pinholes, the TiN/Al specimen is essentially a bielectrode with a major fraction of its area composed of TiN and a minor fraction composed of Al as schematically shown in Figure 16-A. When the specimen is immersed in an NaCl solution, the pit may nucleate at the surface of the exposed Al. The current density for pitting corrosion on such a small area of exposed Al is so high that this small area dominates the electrochemical behavior of TiN/Al, resulting in a TiN/Al polarization curve very similar to that of bulk Al as shown in Figures 12 and 13. As the pit enlarges, it undercuts the TiN coating (Figure 16-B) and finally causes cracking and spalling of the TiN coating as schematically shown in Figure 16-C. It is, however, emphasized that nucleation of pits on the exposed Al of TiN/Al has not been directly observed because the pits spread so fast.

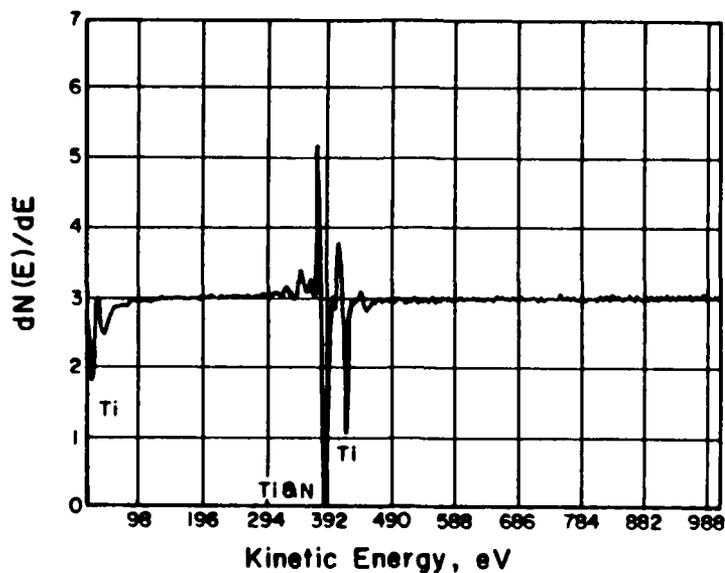
Figure 7. Auger Electron Spectra of As-deposited USACERL TiN After Removal of About 50 Å of the Surface Layer.

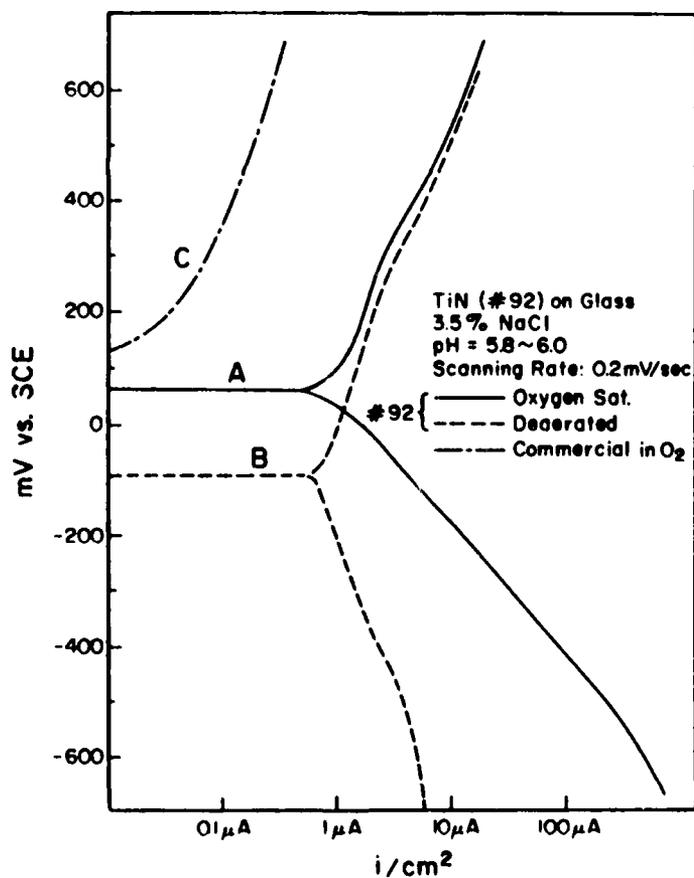
Figure 8. Potentiodynamic Anodic and Cathodic Scans of TiN/Glass in 3.5% NaCl, pH=6.0. (A, USACERL TiN in oxygen-saturated solution; B, USACERL TiN in deaerated solution; C, commercial TiN in oxygen-saturated solution.)

To answer this question, a commercial TiN on glass substrate was potentiodynamically scanned in the same solution, (Figure 8, Curve C). Note that the commercial TiN shows an anodic current of about  $0.1 \mu\text{A}/\text{cm}^2$  which is about 50 times lower than that of USACERL TiN. SEM examinations of the corrosion tested sample show no apparent corrosion as in the case of USACERL TiN.

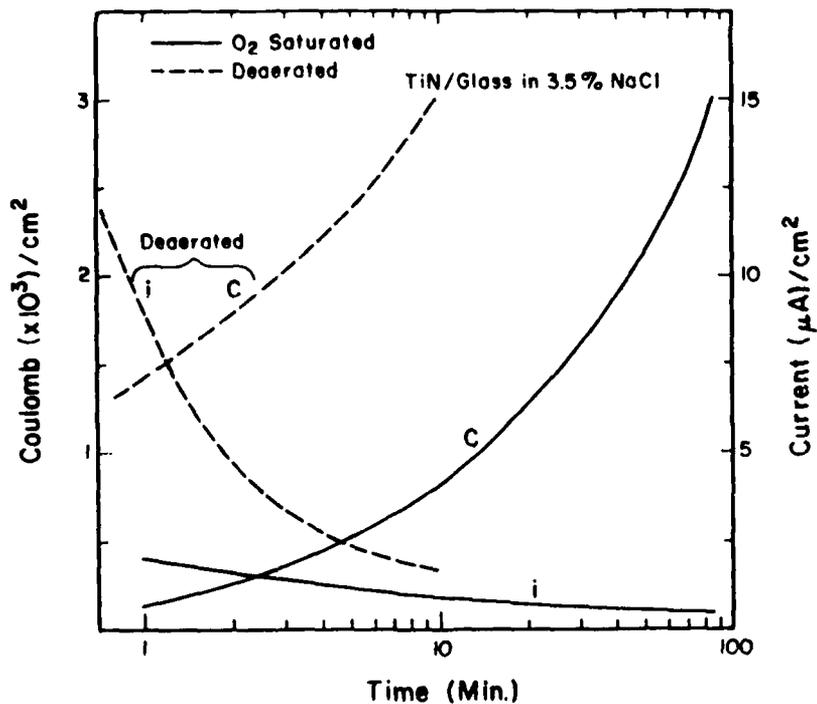
**Figure 9.** Potentiostatic Polarization Data of USACERL TiN/Glass in 3.5% NaCl, pH=6.0, at +300 mV vs SCE. (Dotted lines are for current density and coulombs in deaerated solution; solid lines in oxygen saturated solution.)

coating was exposed to the testing solutions for some time until the steady state corrosion potentials were reached. In an oxygen saturated solution, the time to reach steady state corrosion potential is about 10 minutes, but it is usually more than 1 hour in a deaerated solution. Because of this significant time difference, the working electrode (TiN coating) in the oxygen saturated solution may have been in a very different electrochemical state from the one in the deaerated solution when polarization tests began, possibly resulting in different polarization curves (Figure 9) and different surface chemistry (Figure 10).

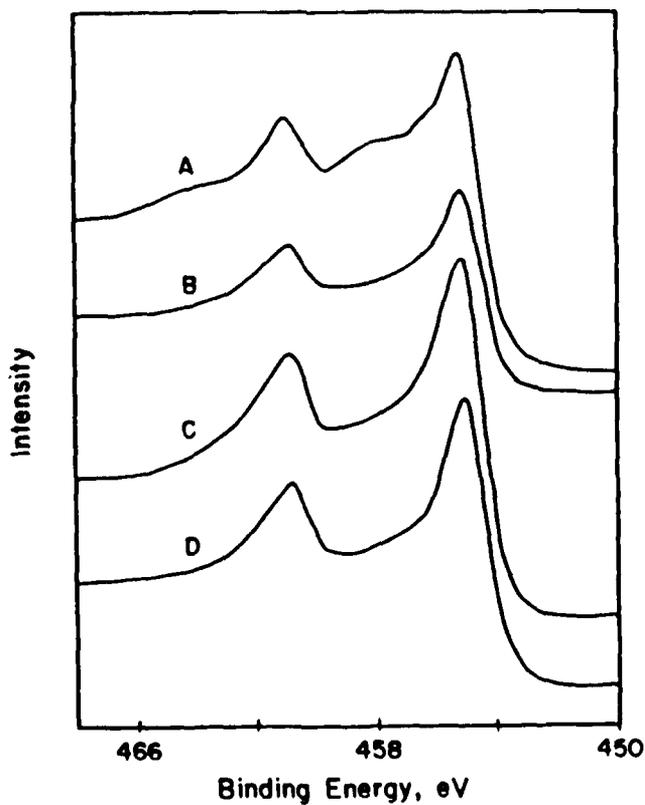
**Figure 10.** Ti 2p XPS Spectra of TiN After Potentiostatic Polarization Tests to 0.003 C at +300 mV vs. SCE in 3.5% NaCl, pH=6.0. (A and B in oxygen saturated solution, after removing about 10 and 100 Å of the surface layer. C and D in deaerated solution after removing about 10 and 100 Å of the surface layer.)

It is emphasized that the elemental form of Ti is not detected in the spectrum of corrosion tested samples (Figure 10). This is consistent with the spectrum of USACERL TiN and with the earlier discussion that the high anodic current of the USACERL TiN may be caused by the dissolution of elemental Ti present possibly at the interface. During polarization tests, Ti will be transported through pores or pinholes. Thus, the XPS technique should not detect the elemental form of Ti in the corrosion tested samples.

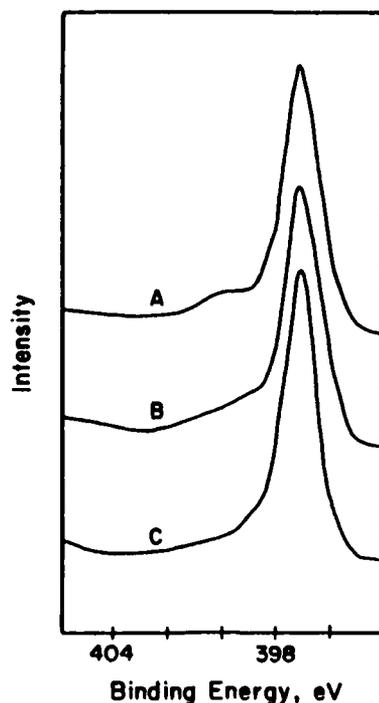
Figure 11. Nitrogen 1s XPS Spectra of TiN After Removal of About 10 Å of the Surface Layer After Potentiostatic Polarization Tests to 0.003 C in 3.5% NaCl, pH=6.0. (A, as-deposited; B, after test in oxygen-saturated solution; and C, in deaerated solution.)

XPS spectra of nitrogen 1s for the same samples are compared with the spectra for an as-deposited sample in Figure 11. A small peak at approximately 399.7 eV, assigned to  $TiO_xN_y$ , in the as-deposited sample (spectrum A) is reduced by the corrosion test in an oxygen saturated solution (spectrum B) and it entirely disappears in a deaerated solution (spectrum C). This may suggest that  $TiO_xN_y$  is not a stable compound and it dissociates under the corrosive environment. Thermodynamic data of  $TiO_xN_y$  are not available, hence it is not possible to test the stability of this compound. Total absence of  $TiO_xN_y$  in spectrum C may be partially explained by the higher current density in this sample (observed in Figure 9).

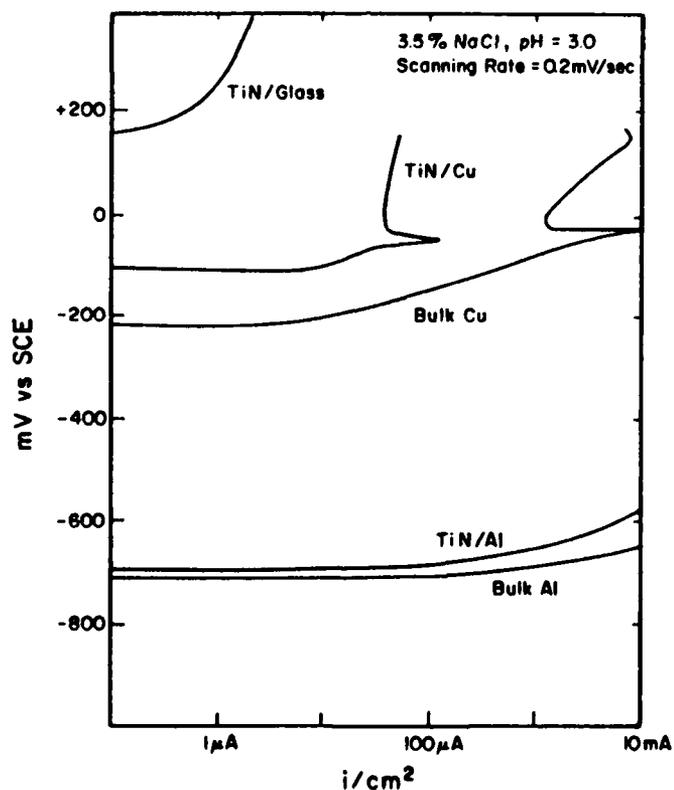
Figure 12. Potentiodynamic Polarization Scans in Oxygen-saturated 3.5% NaCl, pH=3, for TiN Coatings on Glass, Cu, and Al Substrates, and for Bulk Cu and Al Substrates.

CDA 100 Cu, 1100 Al, and 6061-T6 Al alloy substrates and ion-plated TiN coatings on these substrates were potentiodynamically scanned in oxygen saturated 3.5 percent NaCl, pH=3.0 (Figure 12). Note that the polarization curve of TiN/Cu follows the same general shape as the pure Cu but at a lower current. This is, however, still much higher than that of TiN/glass. A different situation prevails with TiN/Al which shows almost the same polarization curve as does the 1100 Al substrate. The corrosion potential of TiN/Al is close to that of Al, and it is about 0.9 V below that of TiN/glass. Similar polarization curves were obtained when the acidity of the solution was decreased to pH=6.0 (Figure 13). The main difference between the data represented in Figures 12 and 13 is that in pH=6.0 solution, the polarization curve of TiN/Cu is closer to that of TiN/glass. It is also clear from Figures 12 and 13 that in a NaCl solution the TiN coating protects the Cu substrate to some degree, but it does not protect the Al substrate. As explained below, this may be due to the different electrochemical behavior of Cu and Al (pitting of Al and general corrosion of Cu in a NaCl solution).

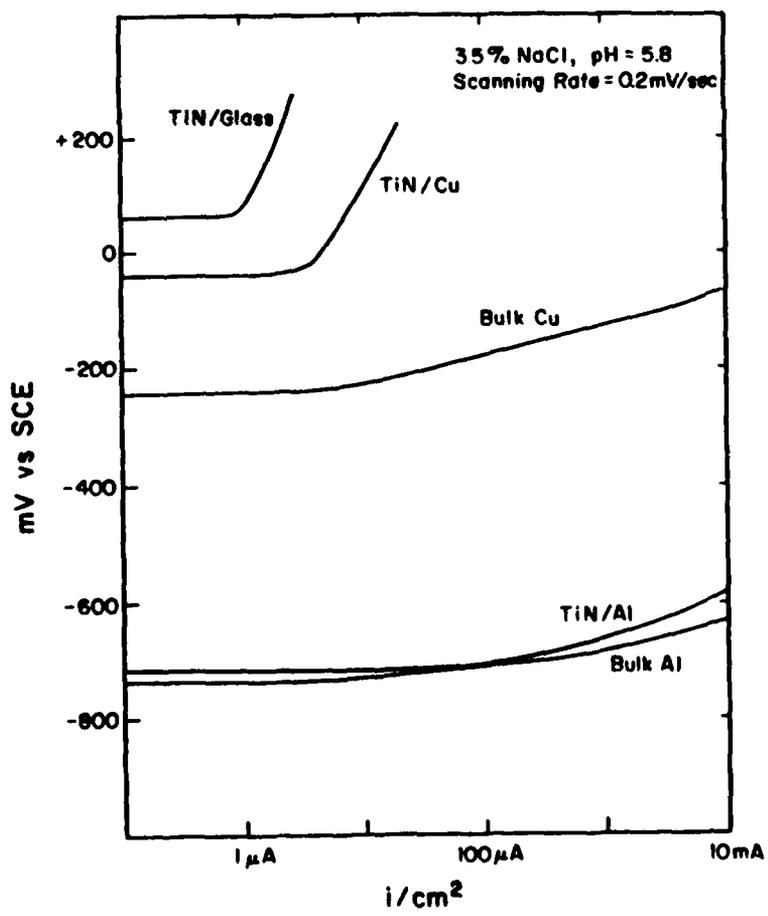
Figure 13. Potentiodynamic Polarization Scans in Oxygen-saturated 3.5% NaCl, pH=6.0.

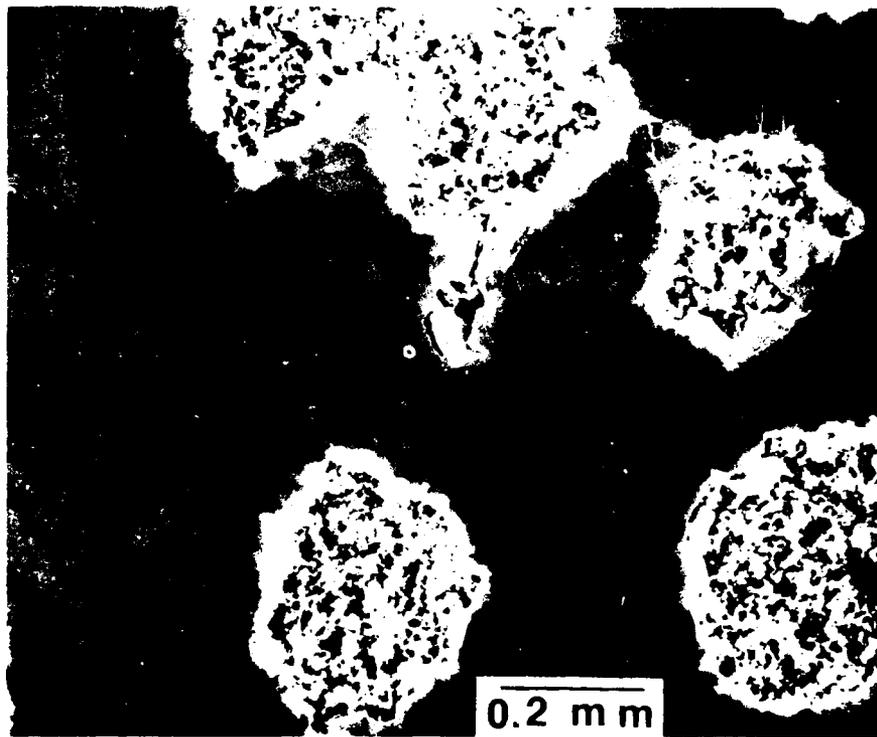
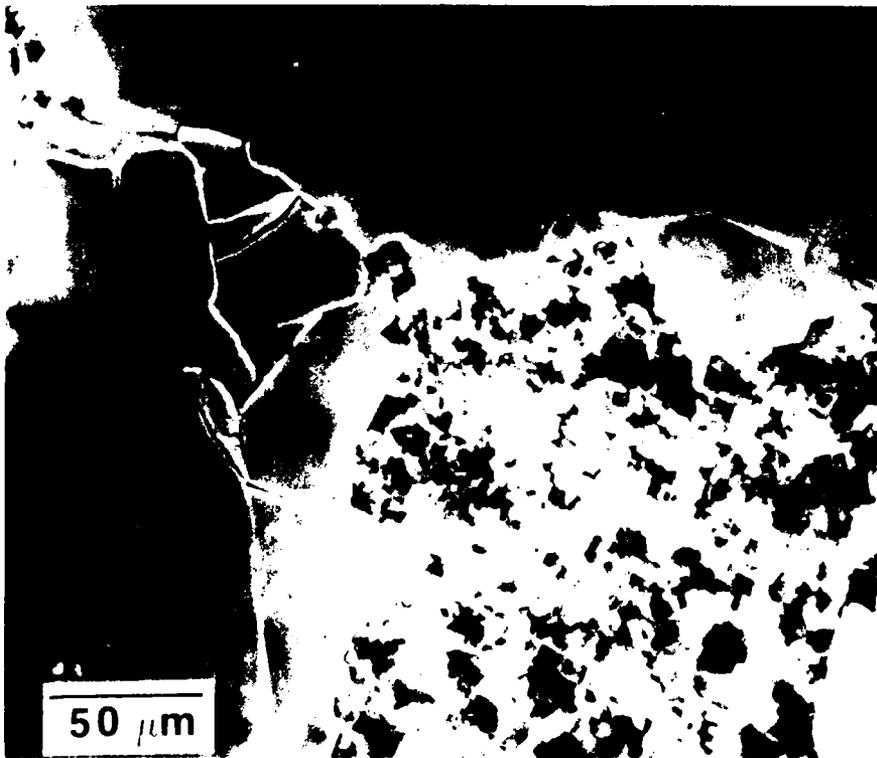
**Figure 14.** SEM Micrographs of TiN/Al Surface After Potentiodynamic Polarization Test in Oxygen-saturated 3.5% NaCl, pH=6.0.

Figure 14-A shows that a cluster of pits formed in TiN/Al has spread under the TiN coating and broken the TiN coating (Figure 14-B). SEM micrographs of cross sections through pits are shown in Figure 15 (A at 100 X magnification and B at 2000 X magnification) at the edge of the pit. Figure 15-B clearly shows cracking and spalling of the undercut TiN coating, but no visible corrosion of the TiN itself. Even though pitting of Al in a chloride solution is a well known phenomenon (de De Micheli 1978; Rais, Dalard, and Sohn 1985), a question arises as to how the pitting of Al substrates nucleates and grows under the TiN coating.

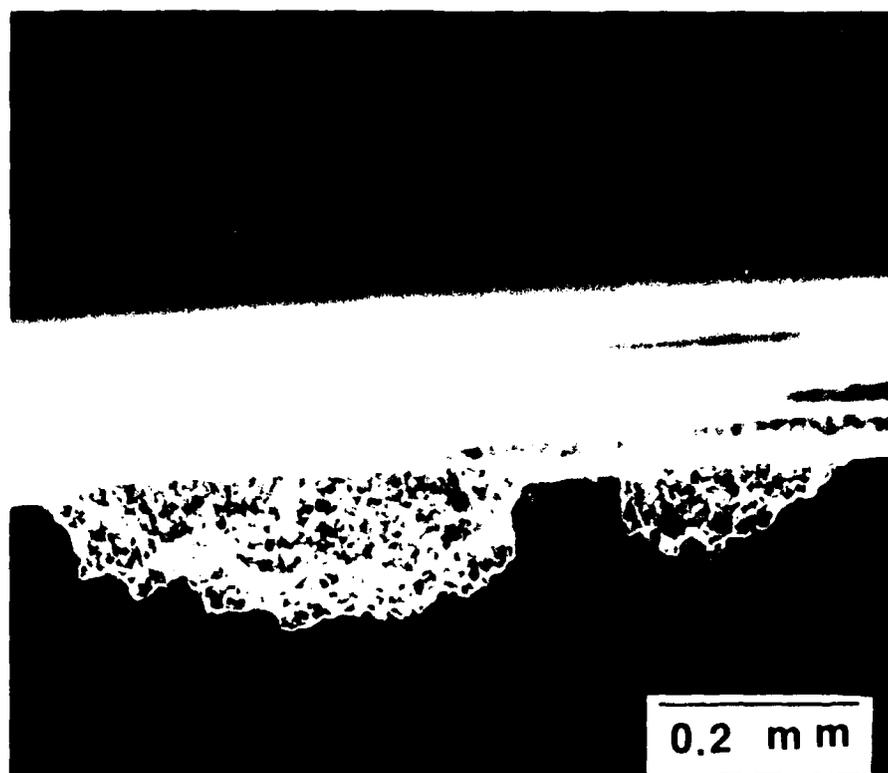
**Figure 15. SEM Cross Section Micrographs of TiN/Al Surface After Potentiodynamic Polarization Test in Oxygen-saturated 3.5% NaCl, pH=6.0.**

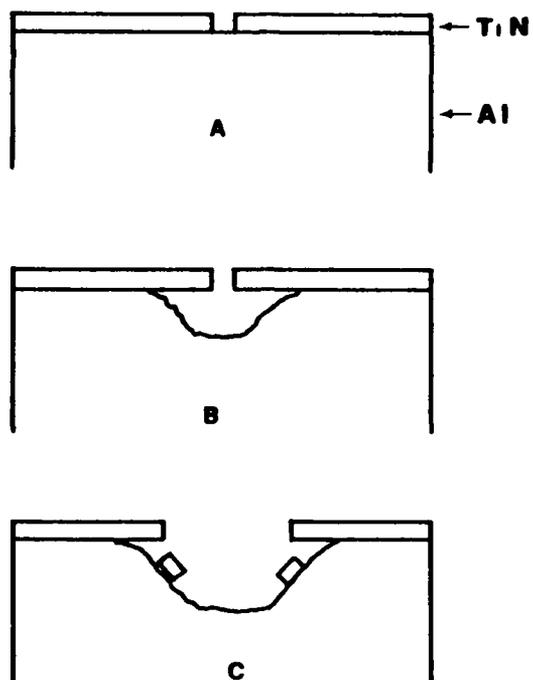
**Figure 16. Schematic Diagram Showing Pit Initiation and Propagation, and TiN Coating Cracking for TiN/Al in Chloride Solution.**

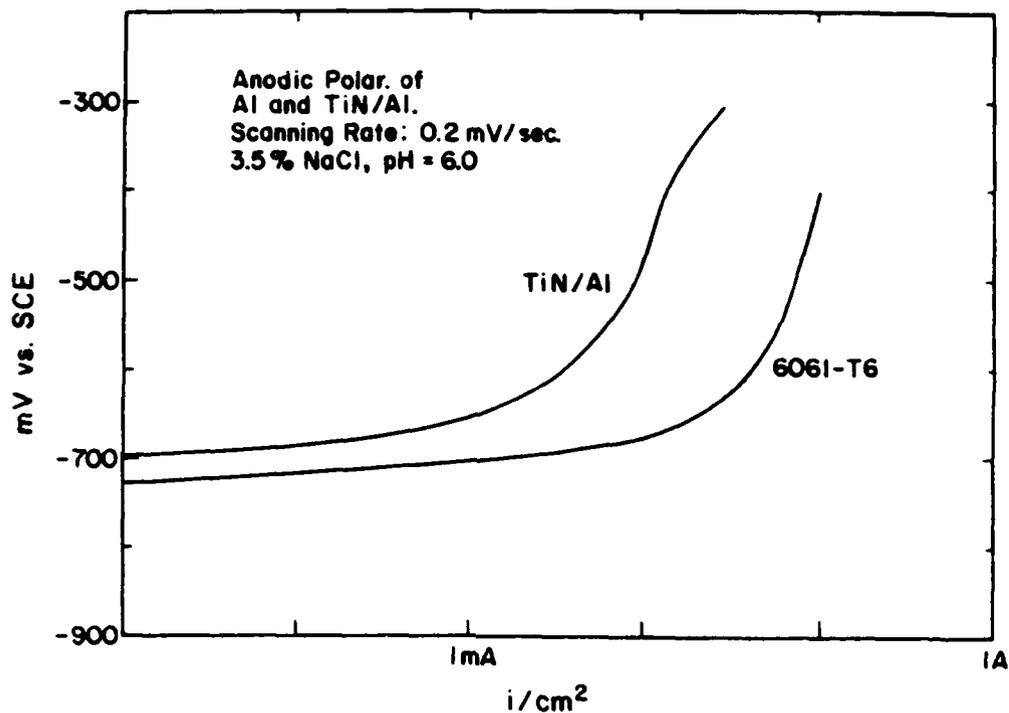
Figure 18. Potentiodynamic Polarization Scans for 6061-T6 Al and TiN/6061-T6 in Oxygen-saturated 3.5% NaCl, pH=6.0.

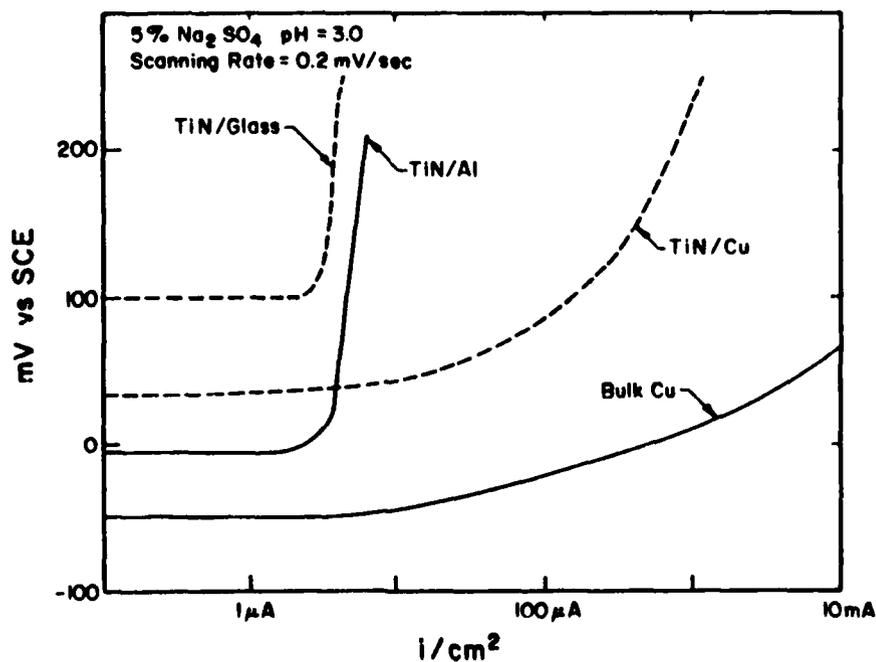
Figure 19. Potentiodynamic Polarization Scans in Oxygen-saturated 5% Na<sub>2</sub>SO<sub>4</sub>, pH=3 for TiN on Glass, Cu, and Al, and for Bulk Cu.

The electrochemical behavior of TiN/Al in the sulfate solution is quite different from that in the chloride solution. Figure 19 shows potentiodynamic scans for TiN/glass, TiN/Al (1100), TiN/Cu, and bulk Cu in oxygen saturated 5 percent Na<sub>2</sub>SO<sub>4</sub>, pH=3.0. A polarization curve for bulk Al is not shown in the figure (it is very similar to that of TiN/Al, but at a much lower potential, starting from about -600 mV versus SCE). Note the very low current for TiN/Al. In this solution, 1100 Al is passive, hence there is no rapid corrosion of the Al substrate exposed to the sulfate solution due to pinholes. SEM examination of TiN/Al reveals virtually no change in the surface morphology after the corrosion test.

is still very high compared to that of TiN/glass (Figure 19). Figure 20 shows cracking of the TiN coating caused by the spread of general corrosion of the Cu under the TiN coating. Note that a part of the cracked TiN around the original pinhole (marked by a small arrow) is raised, indicative of corrosion initiation at the pinhole. Because of this observation, it is possible that the pitting of TiN/Al in the chloride solution is also initiated at pinholes in spite of the lack of direct observation in this system.

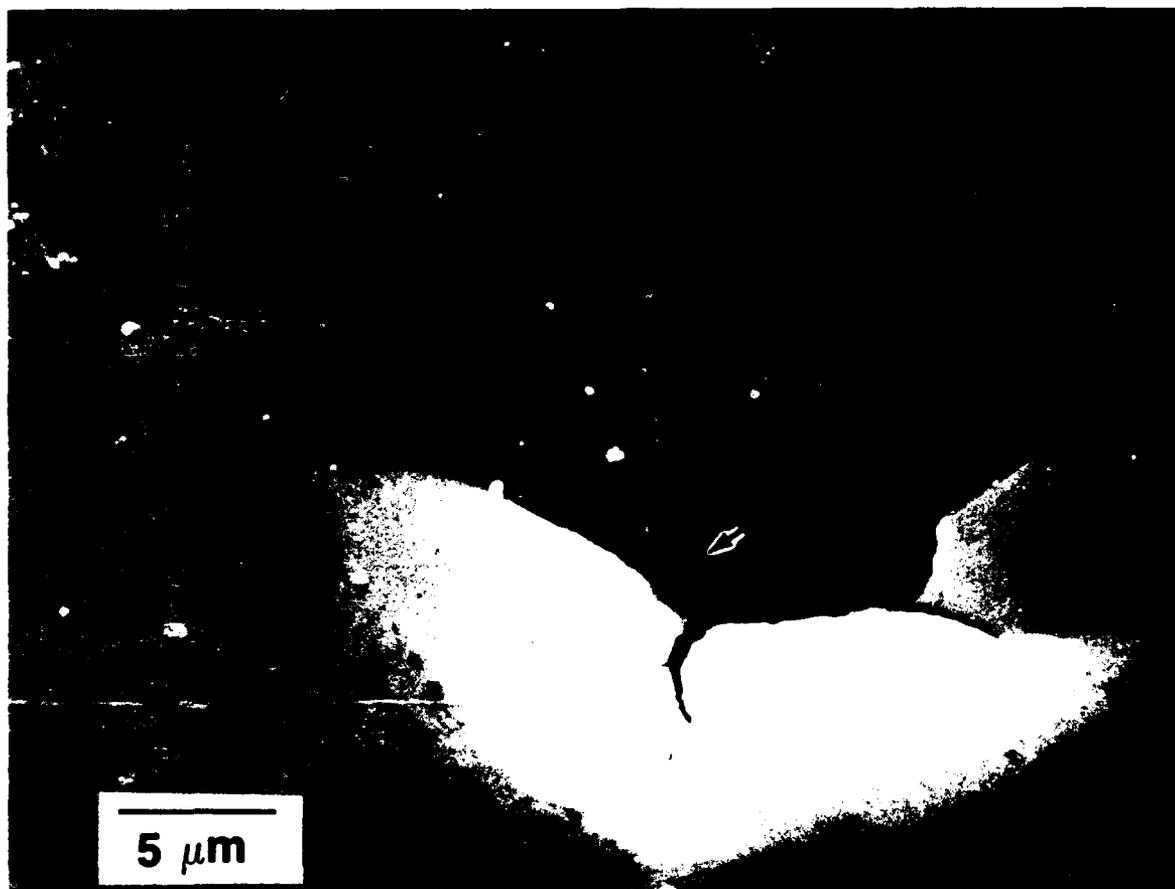
**Figure 20. SEM Micrograph of TiN on Cu After Anodic Polarization Test in Oxygen-saturated 5%  $\text{Na}_2\text{SO}_4$ , pH=6.0.**

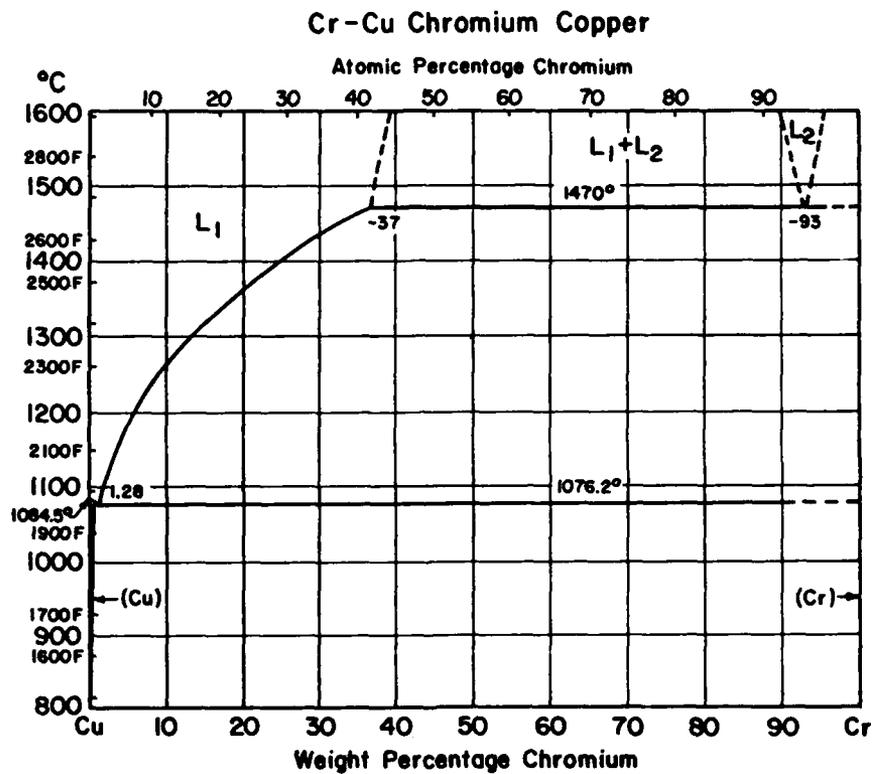
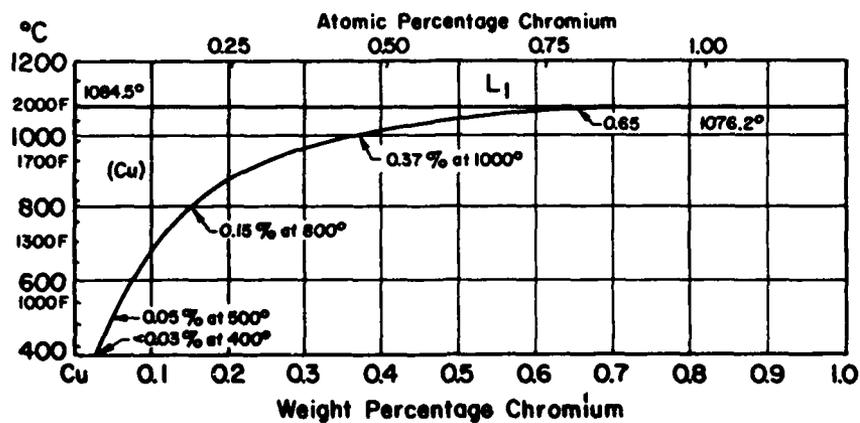
Figure 21. Equilibrium Cu-Cr Binary Phase Diagram.

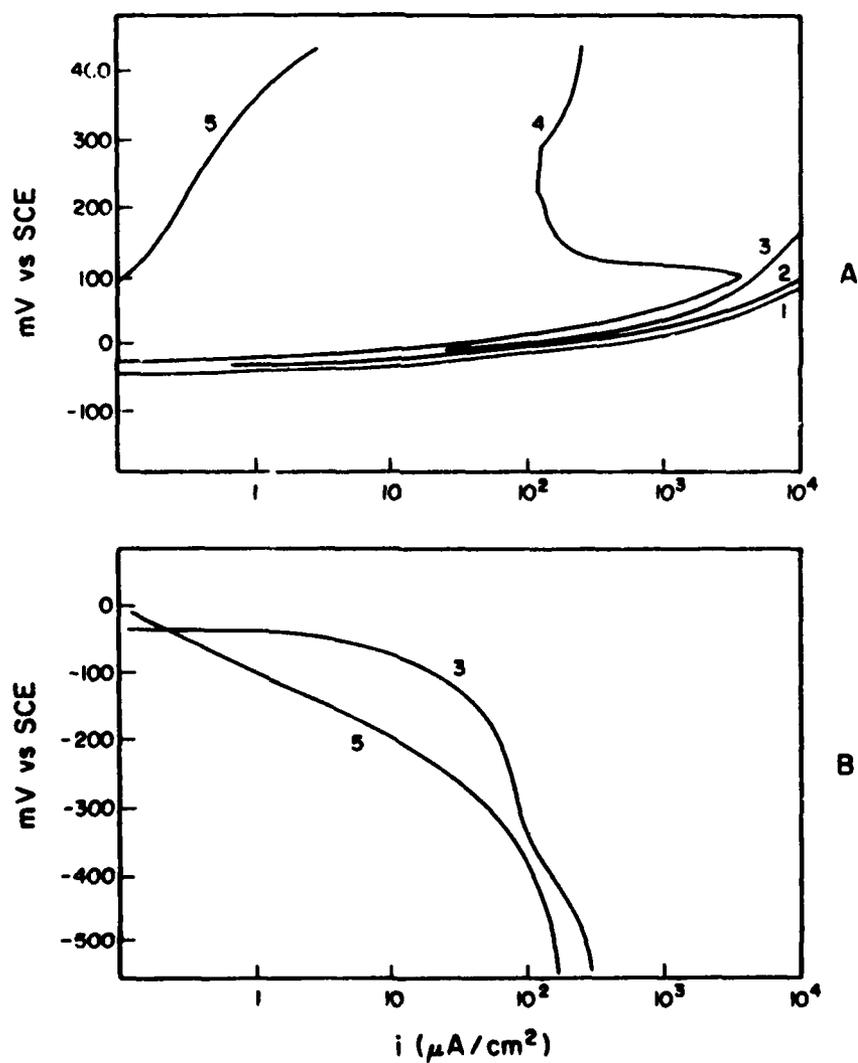
**Figure 23. Anodic and Cathodic Polarization Scans for Cu-Cr Alloy Coatings in Oxygen-saturated 5%  $\text{Na}_2\text{SO}_4$ , pH=6.0. [A, anodic; B, cathodic; 1, pure Cu; 2, CuCr(10); 3, CuCr(19); 4, CuCr(40); and 5, CuCr(85).]**

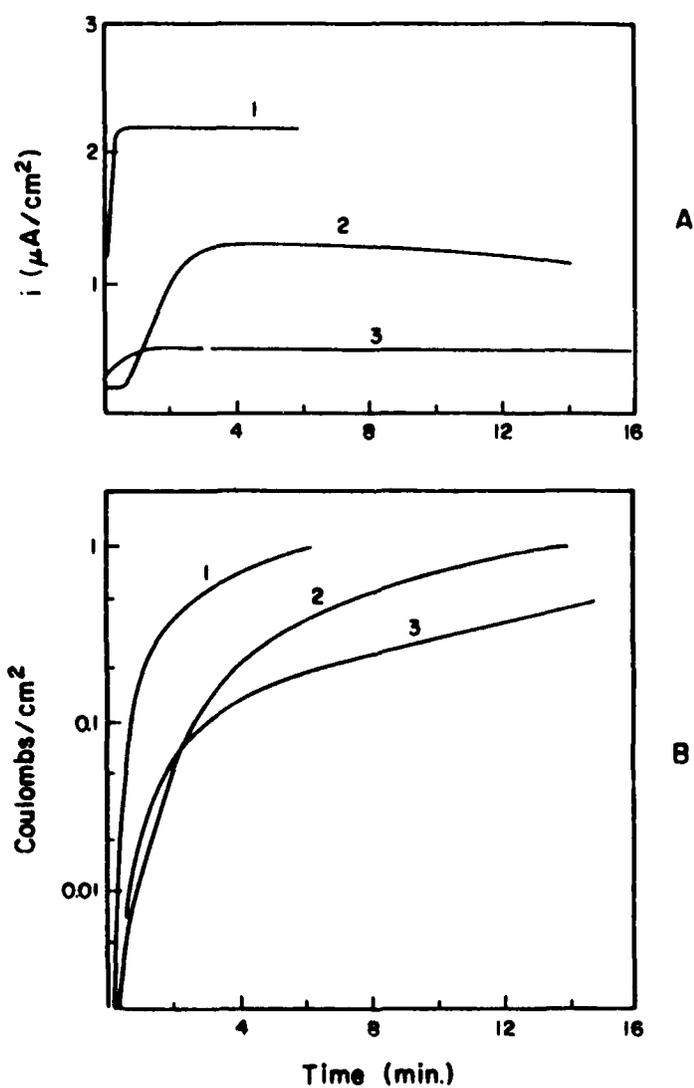
**Figure 24. Potentiostatic Scans of Cu-Cr Coatings Showing Current Density Change and Coulombs Change With Time at +25 mV vs SCE in Oxygen-saturated 5% Na<sub>2</sub>SO<sub>4</sub>, pH=6.0. [A, density change; B, Coulombs; 1, pure Cu; 2, CuCr(10); 3, CuCr(19).]**

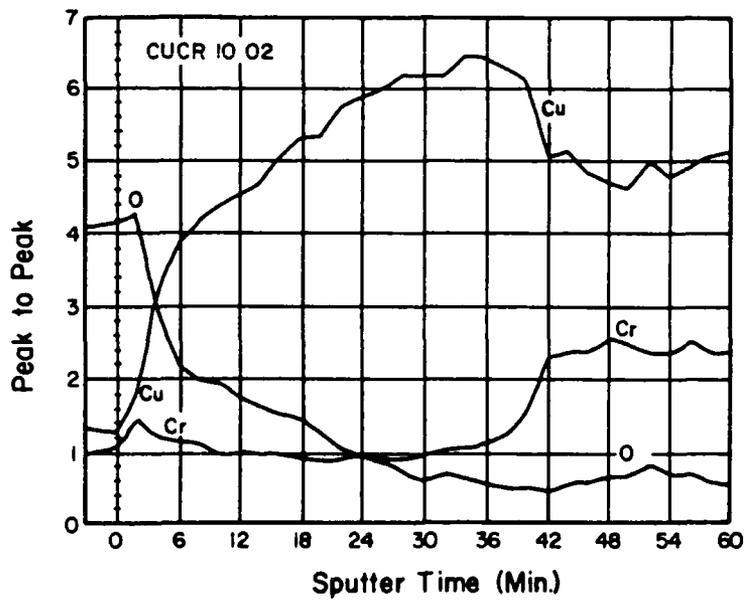
Figure 26. AES Depth Profile of CuCr(10) After Potentiostatic Test.

An Auger electron depth profile for the tested sample is shown in Figure 26. The sputtering rate is approximately 30 Å/min. Note the sharp change in Cu and Cr concentrations at about 1200 Å depth (42 minutes of sputtering time) indicating that the coating consists of two layers. In the first layer, Cu concentration increases with depth while the Cr concentration remains constant. In the second layer, both Cu and Cr concentrations are unchanged with depth. During the corrosion tests, if one element preferentially dissolves, or both elements dissolve at different rates, then the resulting concentration profiles will show gradual changes but no sharp change. The presence of a sharp change may indicate that the first layer is formed by redeposition of dissolved Cu and Cr on top of the original surface of the as-deposited sample. Considering the sensitivity factors of Cu and Cr Auger electrons, Cr concentration in the second layer is approximated as about 25 atomic percent, which is substantially larger than the original concentration in the 10 atomic percent as-deposited sample. This implies preferential dissolution of Cu, leaving behind a porous and Cr-enriched coating. However, some Cr dissolution cannot be ruled out because of the presence of Cr in the first layer. Gradual concentration profiles in the first layer indicate that the first layer consists of oxides (Cu<sub>2</sub>O and Cr<sub>2</sub>O<sub>3</sub>) and elemental Cu and Cr; relative amounts of oxides decrease with increasing depth. This explanation is consistent with the SEM observation in Figure 25 but it is not conclusive and requires a more organized study to understand dissolution and redeposition kinetics in Cu-Cr coatings.
