Simultaneous Pressure Measurement and High-Speed Photography Study of Cavitation in a Dynamically Loaded Journal Bearing

Prepared for the ASME/STLE Tribology Conference
cosponsored by the American Society of Mechanical Engineers and the Society of
Tribologists and Lubrication Engineers

1. AGENCY USE ONLY (Leave blank)		2. REPORT DATE February 1994	3. REPORT TYPE AND DATES COVERED Technical Memorandum	
4. TITLE AND SUBTITLE Simultaneous Pressure Measurement and High-Speed Photography Study of Cavitation in a Dynamically Loaded Journal Bearing			5. FUNDING NUMBERS WU-505-63-5A 1L161102AH45

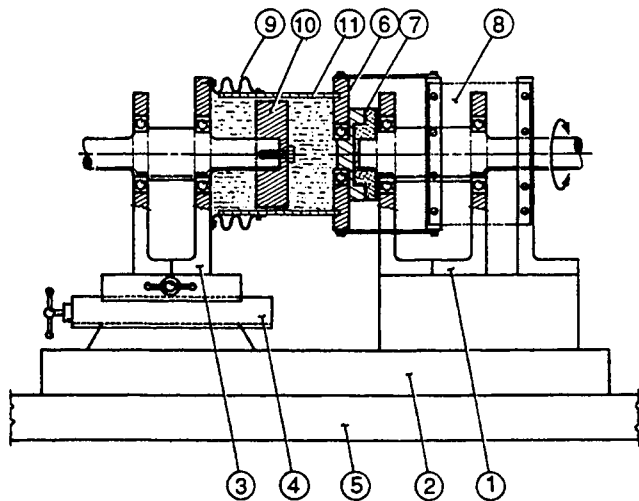
| 1. Sleeve support structure | 2. Steel base |
| 3. Journal support structure | 4. Cross slide |
| 5. Machine table | 6. Sleeve mounting plate |
| 7. Dynamic eccentricity device | 8. Flexure mechanism |
| 9. Bellow seal | 10. Journal |
| 11. Sleeve | |

Figure 1.—Schematic of test apparatus.

A schematic of the bearing test rig is shown in figure 1. The rig consisted mainly of a journal and a sleeve. The sleeve support structure was fixed to a steel base; the journal support structure was anchored to a cross slide, which was fixed to the base. The base was clamped down on a sturdy, flat machine table whose level was adjustable. Details on the alignment of the rig, the method of generating the static and dynamic eccentricities, the transparent sleeve and photographic setup, the lubricant supply and sealing of the rig, etc. are as described in reference 3. The modifications made to accommodate the pressure measurement are as follows:

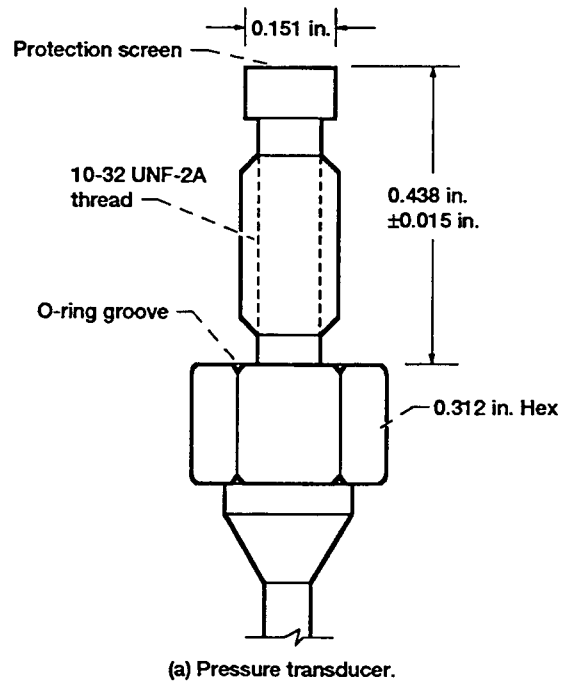
(a) Pressure transducer.

Figure 2.—Pressure transducer and its mounting plug.

Two Kulite strain-gage type miniature absolute pressure transducers, built to NASA Specification U-100, were used. The dimensions of the transducers are shown in figure 2(a). The transducers had a full-scale pressure of 100 psi (689.4 kPa) with 3X overload capability; a nominal full-scale output (FSO) of 100 mV under 10 V excitation; 0.03 percent FSO nonrepeatability; 0.01 percent FSO hysteresis error; 0.09 percent FSO nonlinearity error; and a natural frequency of 240 kHz. When used in conjunction with a multimeter (and with the signals

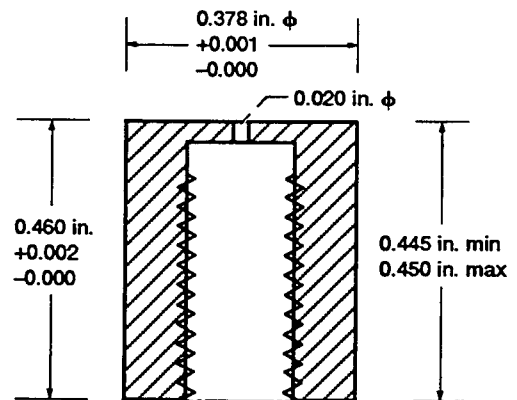
(b) Mounting plug.

Two brass plugs were made to house the transducers. The dimensions of the plugs are shown in figure 2(b). The plugs were press fit into the journal wall, then ground with the journal so as to minimize their interference of the cylindrical journal surface. The selection of the thickness of the plug cap and the size of the pressure sensing hole was a compromise between conflicting requirements: (1) The cap should be as thin as possible while still maintaining rigidity under the fluctuating pressure. (2) The hole should be as small as possible yet without causing excessive delay of the pressure signal. With the dimensions shown in figure 2(b), the error in pressure measurement due to the presence of the plugs was estimated¹ to be less than 150 Pa.

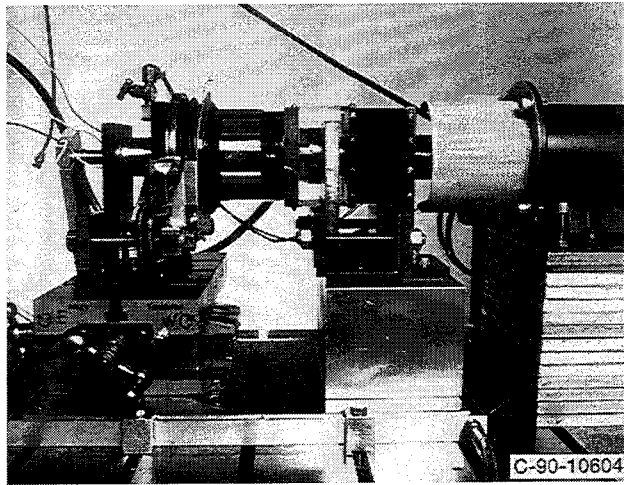
Figure 3.—A close-up view of the test rig.

The two plugs were installed at the same circumferential location, one at the midplane of the journal and the other halfway between the midplane and the edge. Figure 3 shows the journal with the transducers installed as viewed from the side of the movie camera. The joints between the transducers and the plugs were sealed with vacuum grease and O-rings. Air tightness was checked under a vacuum of 10^{-5} torr.

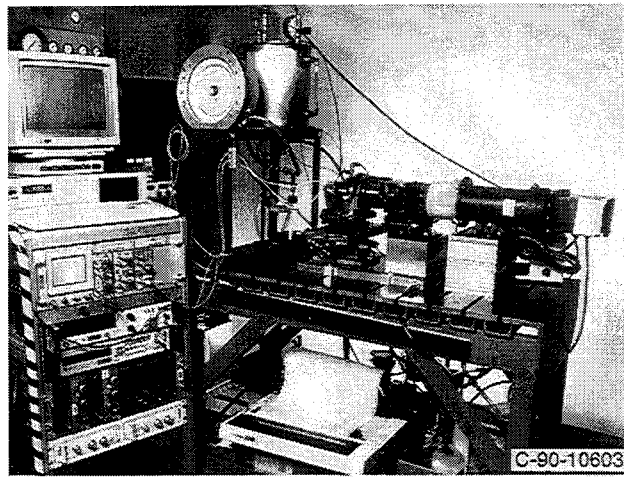
Figure 4.—Arrangement of instrumentation.

Excitation and signal conditioning for the transducers were provided by conventional bridge balance units. The output signals were amplified 10 times and then displayed on a dual-beam oscilloscope and were synchronized with the whirling sleeve by the one-pulse-per-revolution signal. Figure 4 shows the instrumentation arrangement.

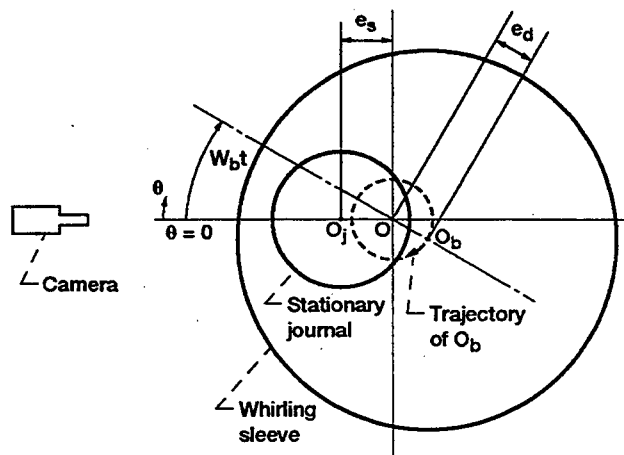
Figure 5.—Direction of whirl as viewed from the sleeve side.

magnetic pickup once per revolution. This one-tooth disk was used to mark the minimum oil film thickness occurring at $\theta = 0$,² a position that appeared in the middle of the movie camera's view (fig. 5).

In the experiment the sleeve always whirled in the clockwise direction as viewed from the sleeve side. Figure 5 shows the relative positions of the journal and sleeve centers and the coordinate system. For the case of centered whirl, the pressure was measured with the transducers placed at $\theta = 0$, and presented in a two-dimensional plot of pressure versus time. For the case of noncentered whirl the same run was repeated 16 times, each time with the transducers placed at a different θ location (22.5° apart). The 16 pressure traces were lined up using the one-pulse-per-revolution signal. The pressure field (as a function of θ and t) so obtained was plotted using a three-dimensional graphics package.

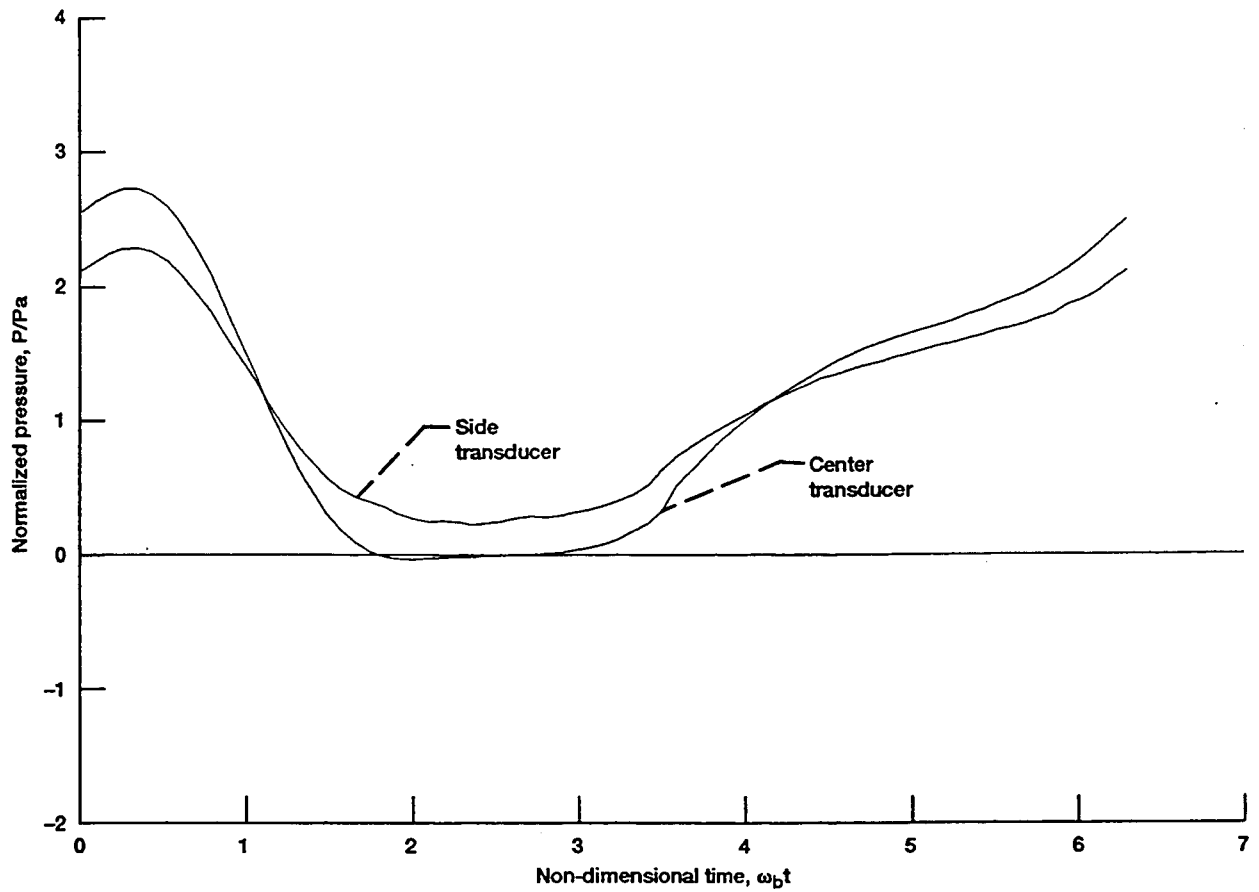
Figure 6.—Pressure versus time in the case of centered whirl, (transducers at $\theta = 0$, $\omega_b = 251.3$ rad/s).

A sample pressure trace in the case of centered whirl is shown in figure 6. The whirl amplitude was statistically set to be so large that the sleeve and journal surfaces contacted each other. Hence, the nominal eccentricity value was $\epsilon_d = 1$. The measured pressure was considerably lower than expected, however. This was most likely due to the flattening of the journal surface surrounding the pressure transducers. An error analysis of this surface defect is not available. If the amount of flattening could be used as a sort of effective clearance, then the effective eccentricity value might be taken as $\epsilon_d = 0.4$. A sample three-dimensional plot of the center-line pressure in the case of noncentered whirl is shown in figure 7. Note that the plot consists of 16 pressure traces obtained with the center transducer positioned successively at 22.5° intervals. The static eccentricity in this case was set at $\epsilon_s = 0.5$; the whirl amplitude was again set with the sleeve and journal surfaces in contact. Hence, the nominal dynamic eccentricity was $\epsilon_d = 0.5$.

The flat segment on any pressure curve in figures 6 and 7 corresponded to the cavitation region observed visually. Thus, the measurement revealed that the pressure in the cavitation region was very close to the absolute zero. As described by Sun and Brewe (ref. 4), the evaporation time of oil was much shorter than the time of dynamic operation; hence, oil vapor would always be present in the cavitation region. But the transducers were not capable of distinguishing the low vapor pressure from zero. It was also observed that air bubbles in the test

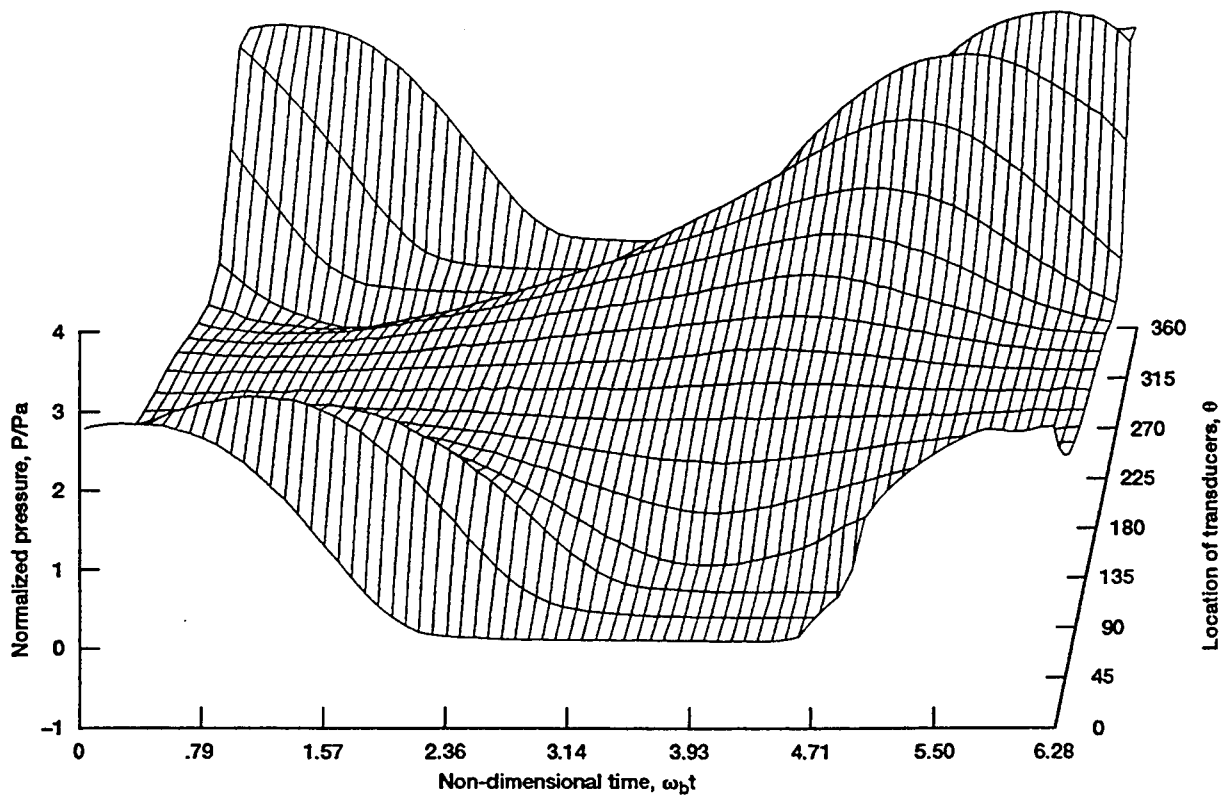
Figure 7.—Centerline pressure in the case of noncentered whirl, ($\omega_b = 251.3$ rad/s).

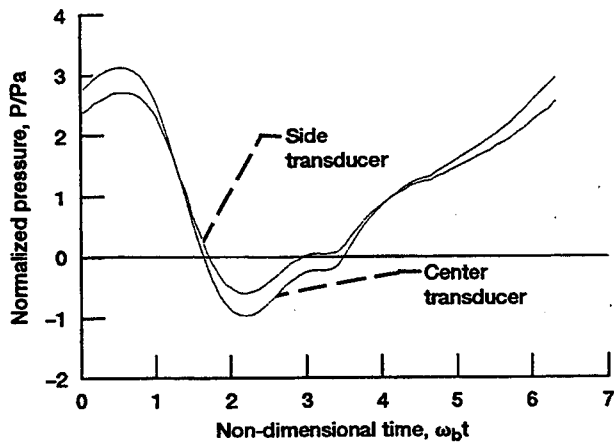
(b) Pressure variation.

Figure 8.—Cavitation bubble and simultaneously measured pressure, (transducers at $\theta = 0$ deg, $\omega_b = 62.8$ rad/s).

In figures 8 to 12, the photographs in parts (a) were extracted from the movies taken when the pressure variations shown in parts (b) were measured. The setting of the static and dynamic eccentricities in these figures (as well as in fig. 13) was identical to that in figure 7. In figure 8(a) the pear-shaped cavitation bubble went through its entire life in the upper half of the camera's view. Since the cavitation region cleared the pressure transducers, the latter recorded tensile stresses during part of the whirl cycle, as shown in figure 8(b). Sometimes, however, the cavitation bubble also appeared in the middle of the camera's view (fig. 9(a)). In this case the bubble only swept over the center transducer, as a result only the side transducer registered a tensile stress, as shown in figure 9(b). A similar situation occurred at a higher whirl speed (fig. 10). In this case the center transducer experienced the cavitation bubble, but the pressure in the bubble was clearly above the absolute zero level. This was caused by the fact that, at a higher whirl speed, more air bubbles joined the cavitation region resulting in a pressure visibly higher than the vapor pressure of oil.

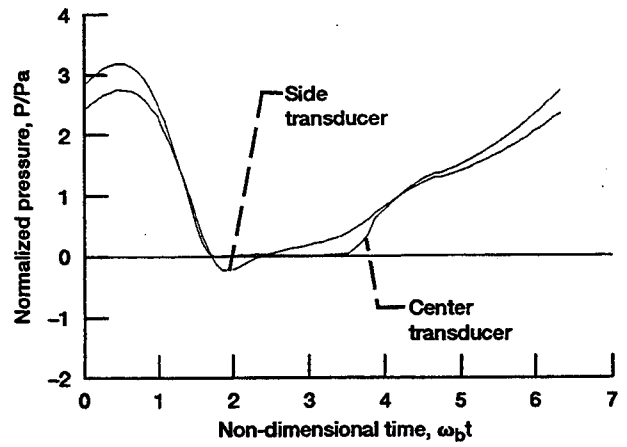
(b) Pressure variation.

Figure 9.—Cavitation bubble and simultaneously measured pressure, (transducers at $\theta = 0$ deg, $\omega_b = 62.8$ rad/s).

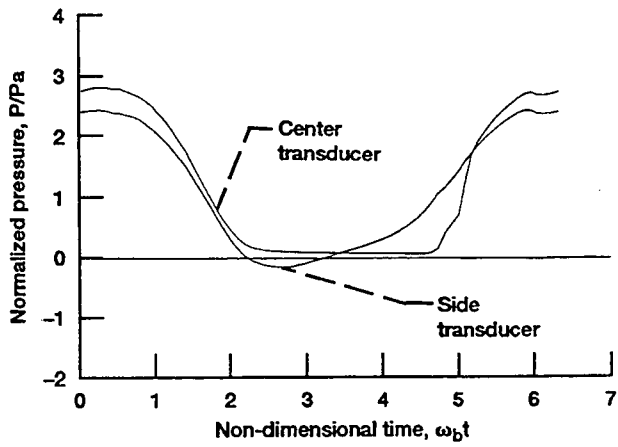
(b) Pressure variation.

Figure 10.—Cavitation bubble and simultaneously measured pressure, (transducers at $\theta = 0$ deg, $\omega_b = 251.3$ rad/s).

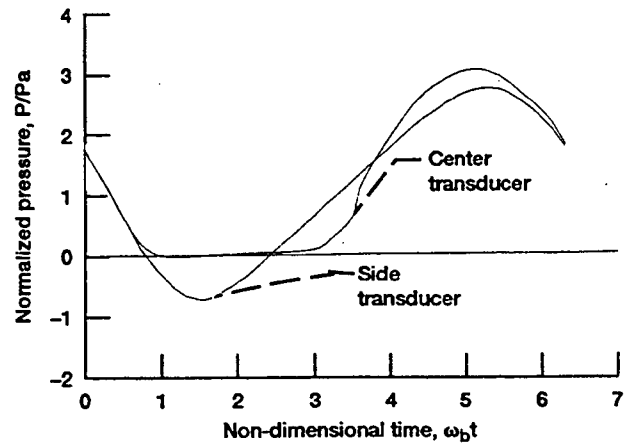
(b) Pressure variation.

Figure 11.—Cavitation bubble and simultaneously measured pressure, (transducers at $\theta = 315$ deg, $\omega_b = 251.3$ rad/s).

The photographs in figures 11(a) and 12(a) were extracted from a movie where the transducers were placed at $\theta = 315^\circ$. In the case of figure 11 the side transducer did not experience cavitation and it registered a tensile stress when its neighbor, the center transducer, was cavitated. As the cavitation region spread, its influence began to reach the side transducer. In the situation shown in figure 12, the side transducer might be described as at the verge of becoming cavitated.

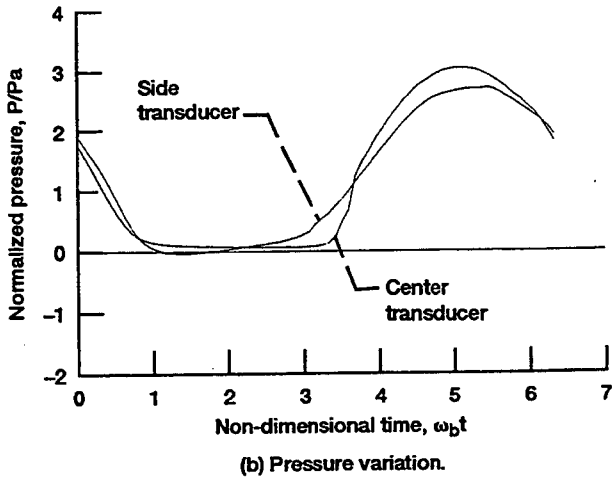
Figure 12.—Cavitation bubble and simultaneously measured pressure, (transducers at $\theta = 315$ deg, $\omega_b = 251.3$ rad/s).

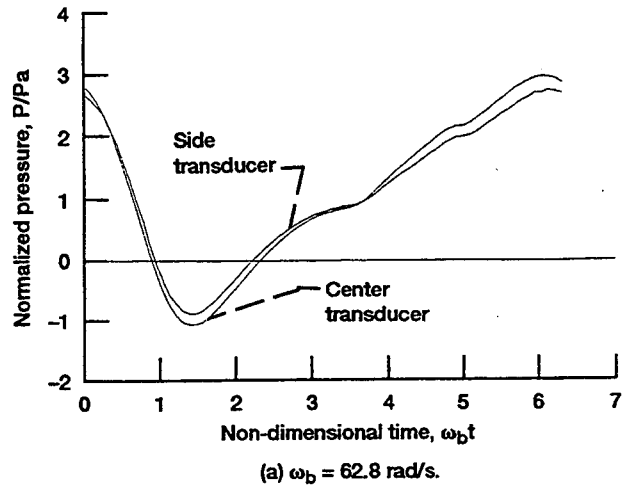
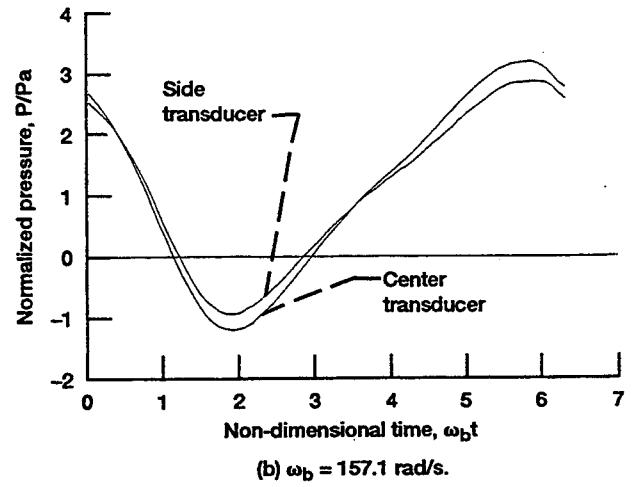
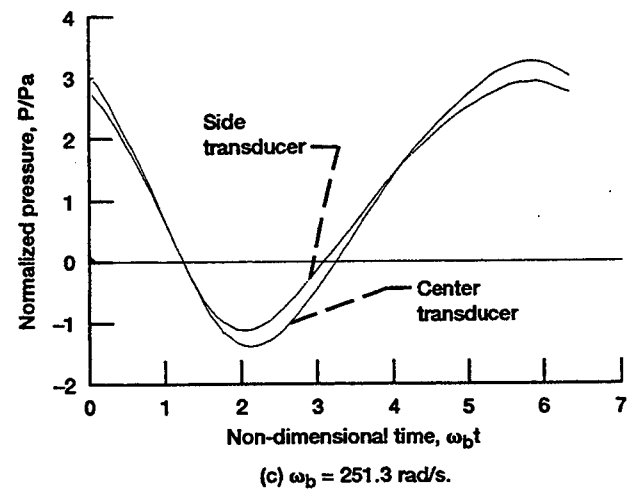
Figure 13.—Pressure variations at $\theta = 337.5$ deg.

As mentioned earlier, the minimum-minimum film thickness was found to be near $\theta = 337.5^\circ$. It turned out that the measured tensile stresses were also the largest here. Figure 13 shows that the transducers at this

location did not experience cavitation at any of the three whirl speeds. The largest tensile stress occurred at the center transducer at $\omega_p = 251.3$ rad/s; its magnitude was almost 140 kPa.
