**INVESTIGATION OF TENSION-COMPRESSION FATIGUE
BEHAVIOR OF A NOTCHED CROSS-PLY
METAL MATRIX COMPOSITE AT ELEVATED TEMPERATURE**

THESIS

Matthew W. Yocum
Second Lieutenant, USAF

December 1994

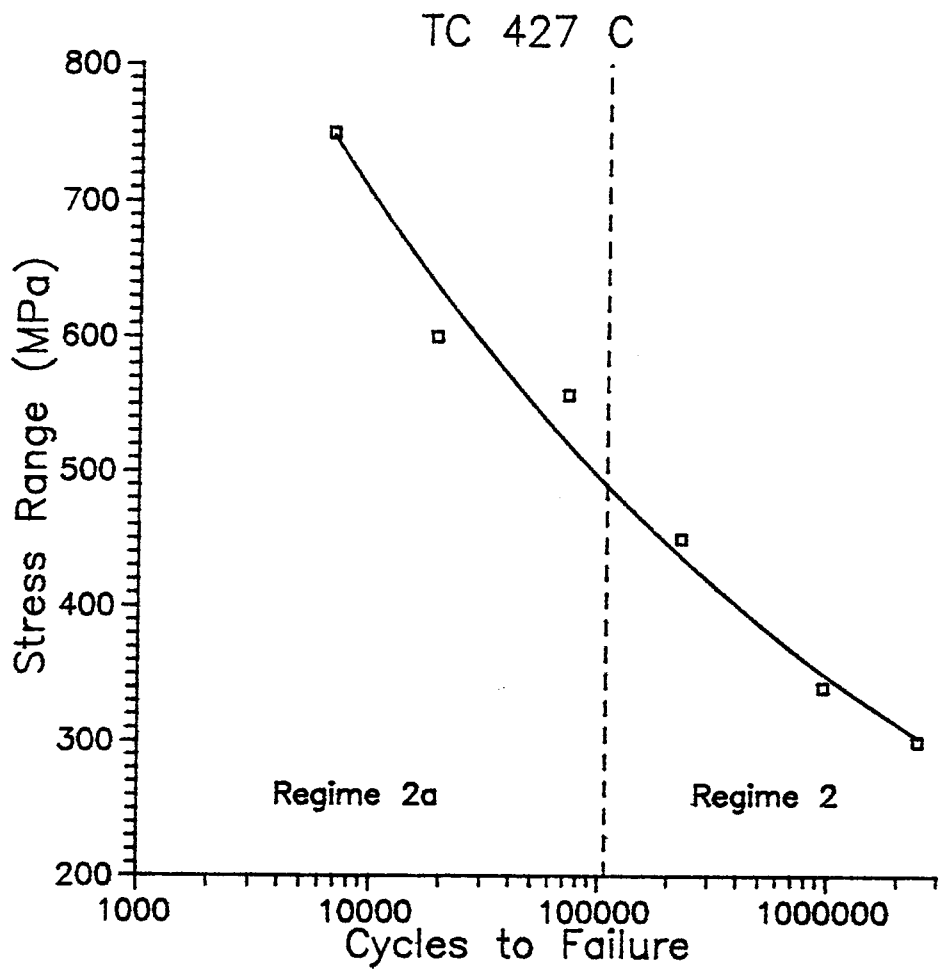
Figure 12. Failure S-N Curve
