## FINAL REPORT

Grant Interaction Between Microorganisms and Polymers  
Used For Layering In the Electronic Industry

Principal Investigator Professor Ralph Mitchell  
Harvard University  
Division of Applied Sciences  
Cambridge, MA 02138

October 1995

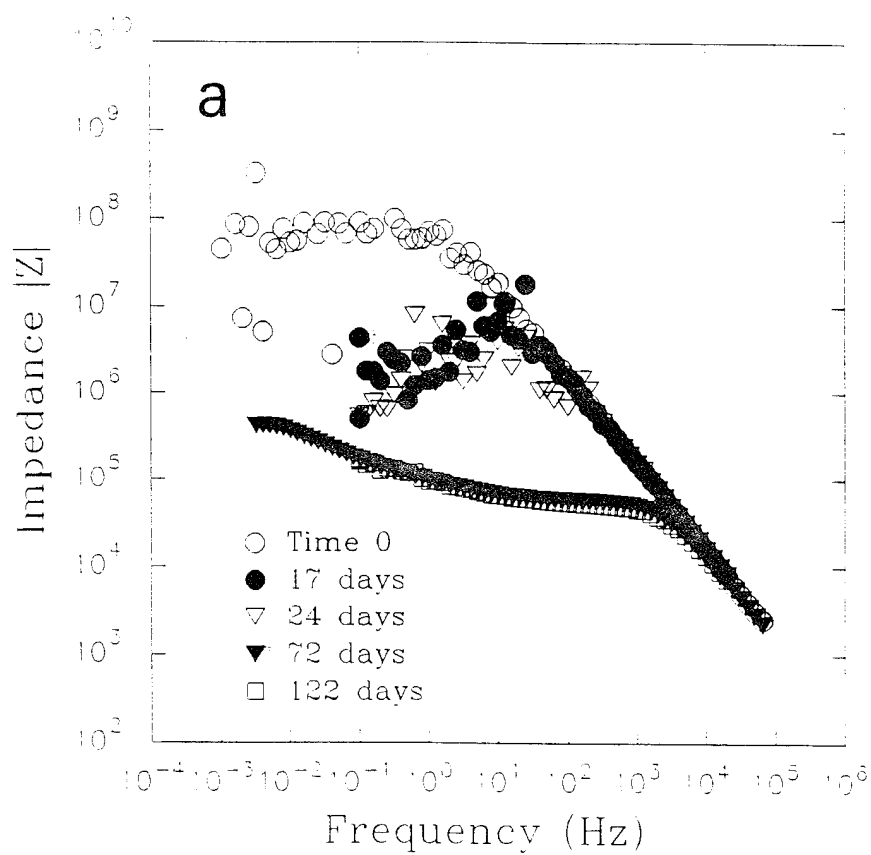
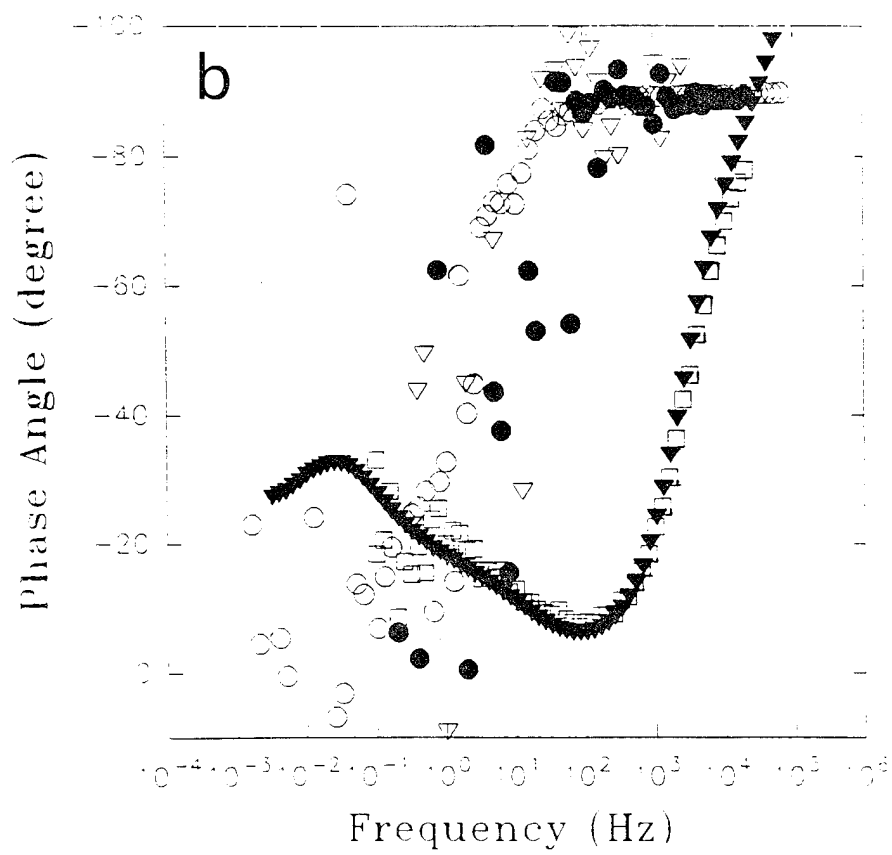
Fig. 3.3 Continued

Fig. 3.3 (a) Bode magnitude and (b) phase angle plots of polyimides inoculated with a fungal consortium and incubated at ambient conditions

The second decline of impedance, observed in the inoculated cells but not the sterile control cells (Fig. 3.3a and 3.4a), signified a further decrease in capacitance of the polymer film. Impedance magnitude was decreased from 10<sup>8</sup> at time zero to below 10<sup>5</sup> in the inoculated EIS cells within 72 days. During the same time period of incubation, sterile controls did not show similar spectra. This second change also reflected in the Bode phase angle plots, in which a second time constant was resolved, indicated the existence of at least one localized pore in the polymer. The presence of only one time constant in the sterile cells over the whole period of incubation supported the fact that the polymer was still intact after exposure to the sterile medium. A high impedance value indicates the intact non-porous nature of a coating.

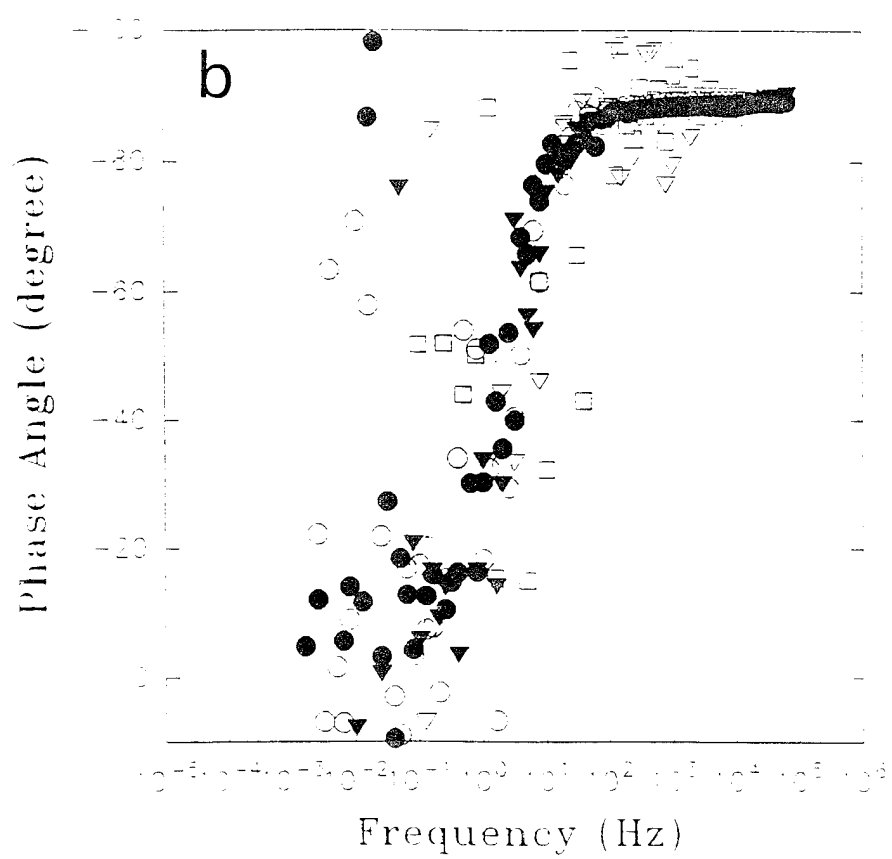
Fig. 3.4 Continued

Fig. 3.4 (a) Bode magnitude and (b) phase angle plots of polyimides held under identical condition as Fig. 1.3 except for the fungal inoculation

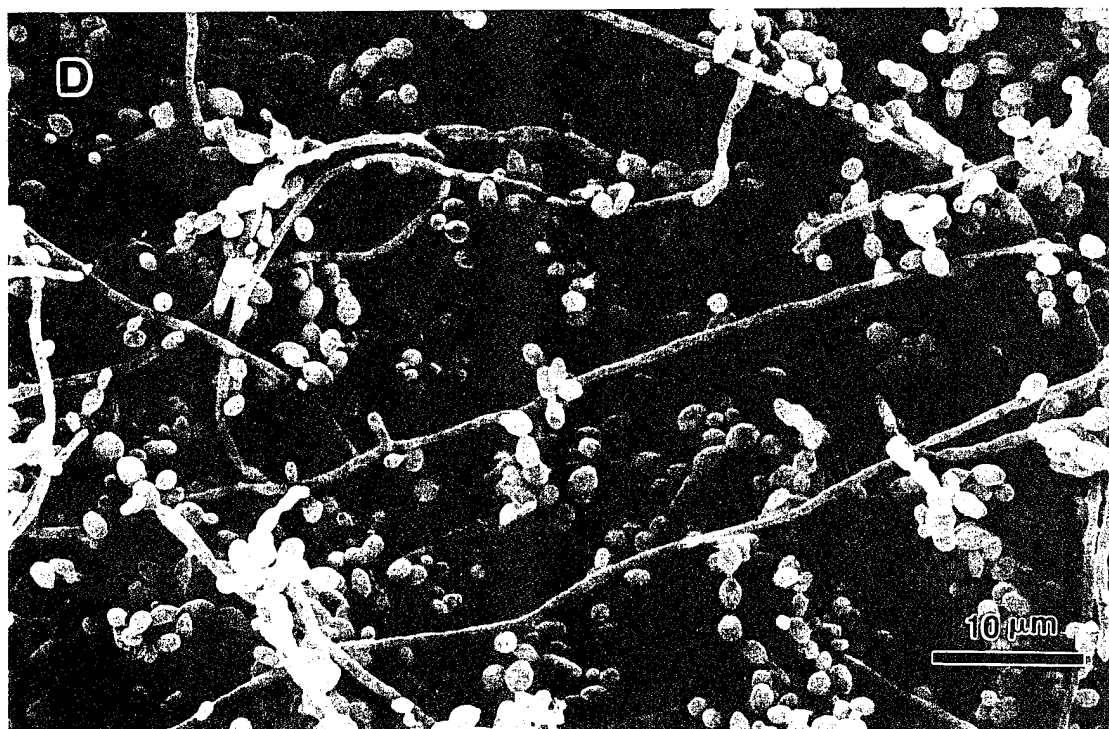
Fig. 4.2 Continued

Fig. 4.2 SEM micrographs of composite B, C, D, and E colonized by fungi after 30 days of incubation. (a) Bismaleimide/carbon fibers; (b) polyetheretherketone/carbon fibers; (c) epoxy/multidirectional carbon fibers; and (d) epoxy/unidirectional carbon fibers

Five composite materials, provided by K. Thorp at the University of Dayton Research Institute, were examined for attack by fungi. All of the coupons were colonized by our fungal consortium after one month of incubation. SEM micrographs showed fungal colonization of composite A (Fig. 4.1). This material contains a fluorinated polyimide resin in addition to glass fibers. Additional SEM micrographs of the incubated coupons indicated that the other four composites were also susceptible to colonization by fungi (Fig. 4.2). Penetration of the composite A resin by fungal hyphae is shown in Fig. 4.3.
