## Ice Jam Flooding on the Missouri River Near Williston, North Dakota

James L. Wuebben and John J. Gagnon

September 1995

Cold Regions Research &  
Engineering Laboratory

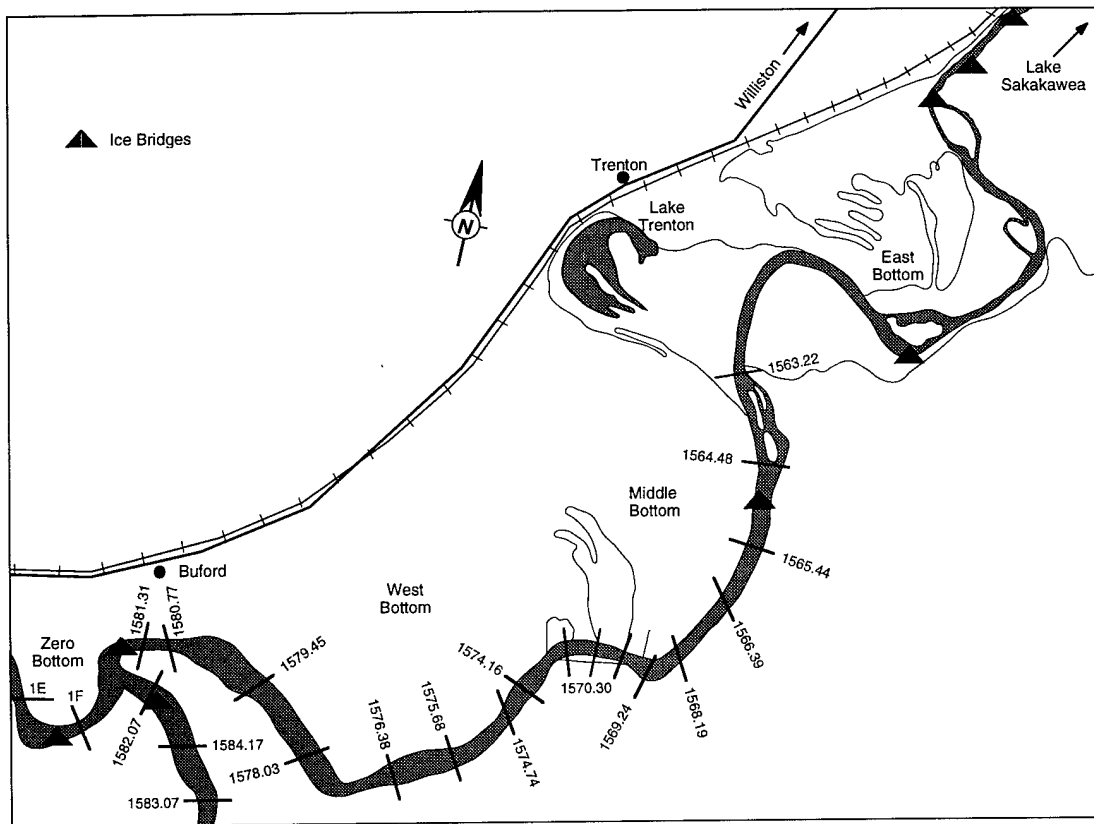
Figure 2. Details of the Buford-Trenton Irrigation District. The cross sections are the locations used by the Omaha District to monitor sediment aggradation. The locations where ice bridged across the river on 7 March 1992 are also shown.

The deposition of sediment in the calmer headwaters of Lake Sakakawea has resulted in a progressive loss of channel capacity and an upward shift in the stage–discharge relationship for the Missouri River in the Buford–Trenton area. The Omaha District (USACE 1992) found that from 1965 through the mid-1970s, Missouri River stages for a discharge of 40,000 cfs had shifted upwards by 2.5, 3.3 and 5.0 ft at water level gages 5A, 6 and 7, respectively. Water level gage 5A is located just below the Yellowstone River confluence, near HEC-2 cross section 1581.31. Water level gage 6 is adjacent to the West Bottom at cross section 1576.38, while gage 7 is adjacent to the Middle Bottom at cross section 1566.39.

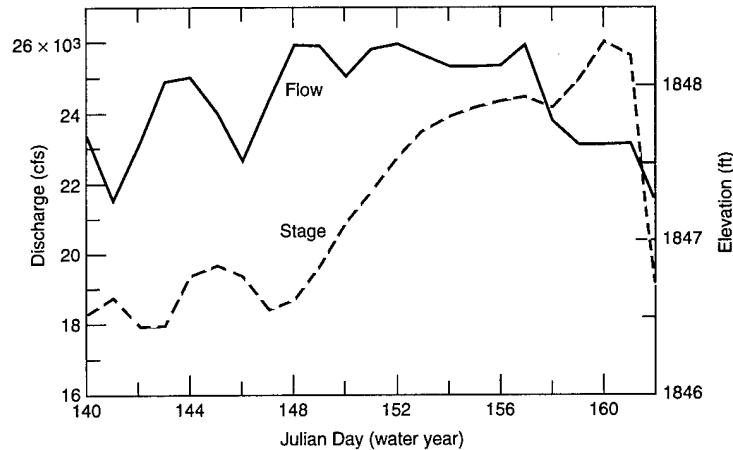
Figure 3 shows the estimated flow record based on combining the records from the gages at Culbertson and Sidney, Montana, as described above. Since the flow records are provisional and uncorrected for ice effects, the sharp reductions in discharge on the sixth and tenth of March may be due, at least in part, to the ice cover going out near the gages at Sidney and Culbertson, respectively.

Figure 3. Flow and stage record during the 1992 breakup.

Figure 3 also shows stage data for the water level gage located at the Route 85 bridge over the Missouri River. This gage (located at HEC-2 cross section 1552.70) shows an increase in stage during the decrease in discharge beginning on 6 March, which suggests a short-term ice stoppage or jam downstream. The record also reveals a drop in stage of over 3 ft after 9 March, reflecting the release of a jam or loss of ice cover in reaches farther downstream. No gage records were available between this gage and the confluence area. Lake Sakakawea water levels during the breakup period varied gradually from 1820.8 ft msl on 3 March 1992 to 1821.2 ft msl on 9 March 1992.

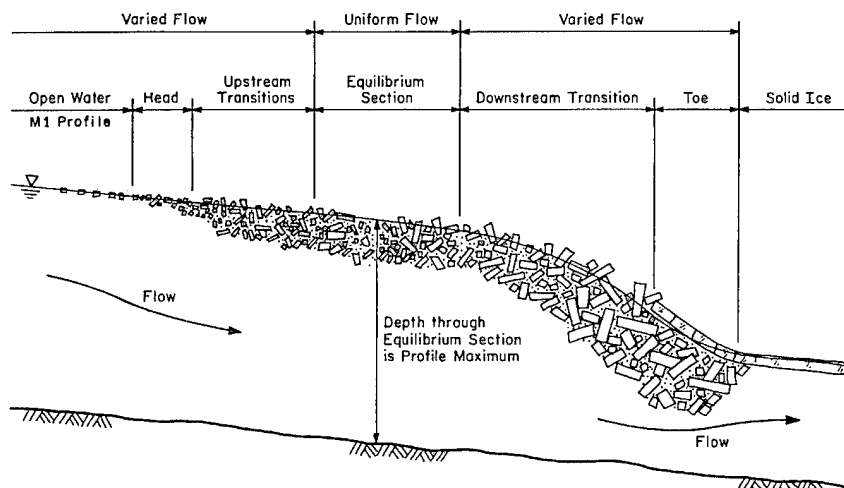
Figure 4. Longitudinal profile of a typical breakup ice jam.

jam is long enough, a fully developed or equilibrium jam reach may form, in which ice and flow conditions are relatively uniform. From the upstream end, or head, of the jam, flow depths again gradually decrease towards the lower flow depths associated with the open-water conditions upstream. Further information on ice and ice jam processes can be found in EM 1110-2-1612 (USACE 1982a).

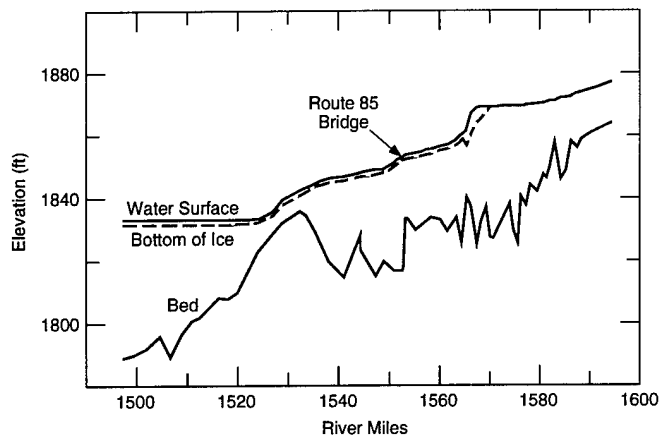
Figure 5. Simulation of the longitudinal profile of the March 1986 ice jam in the Middle Bottom area.

Using this information the HEC-2 computer program (USACE 1990) was used to calculate the resulting water surface profile as shown in Figure 5. The area of zero ice thickness, appearing as a nearly vertical line through the ice cover near HEC-2 cross section 1552.7, corresponds to the location of the Route 85 bridge. Because the HEC-2 ice option is actually a modification of the standard bridge option, ice cannot normally be simulated at cross sections where the bridge code appears in a data file. Since bridge widths are quite small relative to the river lengths typically modeled with HEC-2, the absence of ice in the bridge throat has a very localized effect on the computed water surface profile. Except in the immediate vicinity of a bridge, the effect of deleting the ice cover over such a short distance is normally negligible. Another option is to delete the bridge from the simulation if the ice effects are determined to be of greater significance.

In this jam, water reached the elevation of the road at the Borlaug Bridge site in the Middle Bottom. A Corps of Engineers survey found this location, as identified in a photograph, to have an elevation of 1868.5. Although it is difficult to determine accurately from the figure, the computed

water surface elevation at the nearest cross section to this site, 1567.44, was 1868.75 ft msl. Considering that no ice-related calibration of the open-water-verified HEC-2 data file was conducted, the agreement of the ice jam simulation with the known water surface elevation is surprisingly good.

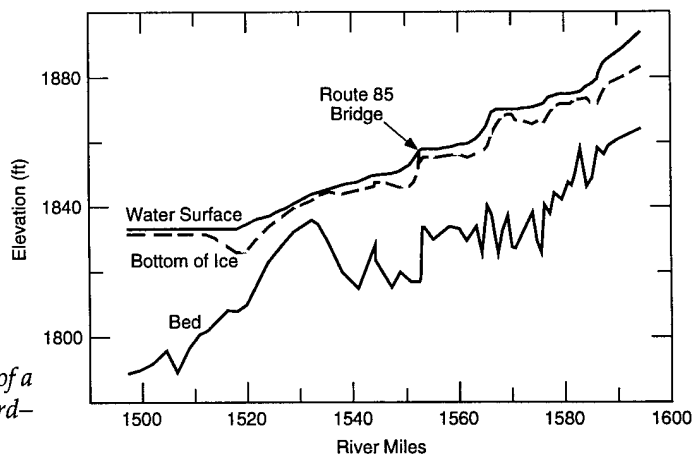
Had we not been able to obtain information on the location of the toe of the jam, we would have had little alternative but to assume that a fragmented ice cover existed throughout the river and that it was free to thicken into an equilibrium jam in response to forces imposed by the flowing water. As described earlier, this assumption would result in the maximum possible water levels for a given discharge. A simulation of this condition was also run (Fig. 6), and the computed water surface elevation in the vicinity of the Borlaug Bridge was 1870.13. Thus, assuming a fully developed ice jam below the known (or estimated) toe of the jam resulted in a computed water surface elevation 1.38 ft higher than that computed using the known toe location. Areas closer to the toe of the jam would have been more severely affected by the difference in assumptions, while points farther upstream would have seen lesser or no effect.

Figure 6. Simulation of the longitudinal profile of a fully developed ice jam throughout the Buford-Trenton area.

It must be reiterated that calculations assuming an equilibrium ice jam constitute the maximum possible water surface elevation for a given discharge. Actual water levels are most often less. Lower actual water levels can be found at locations close to the toe of the jam where the jam may not be fully developed. If there is enough ice to form an equilibrium jam, the actual water levels will also be lower than computed. If the discharge continues to rise or the strength of the ice accumulation deteriorates, a point can be reached where no stable jam is possible, and a lower, open-water rating curve again applies. The equilibrium model also assumes that a supply of broken ice is available. With lower discharges and stronger ice, the ice cover may remain intact and not subject to thickening into a jam.

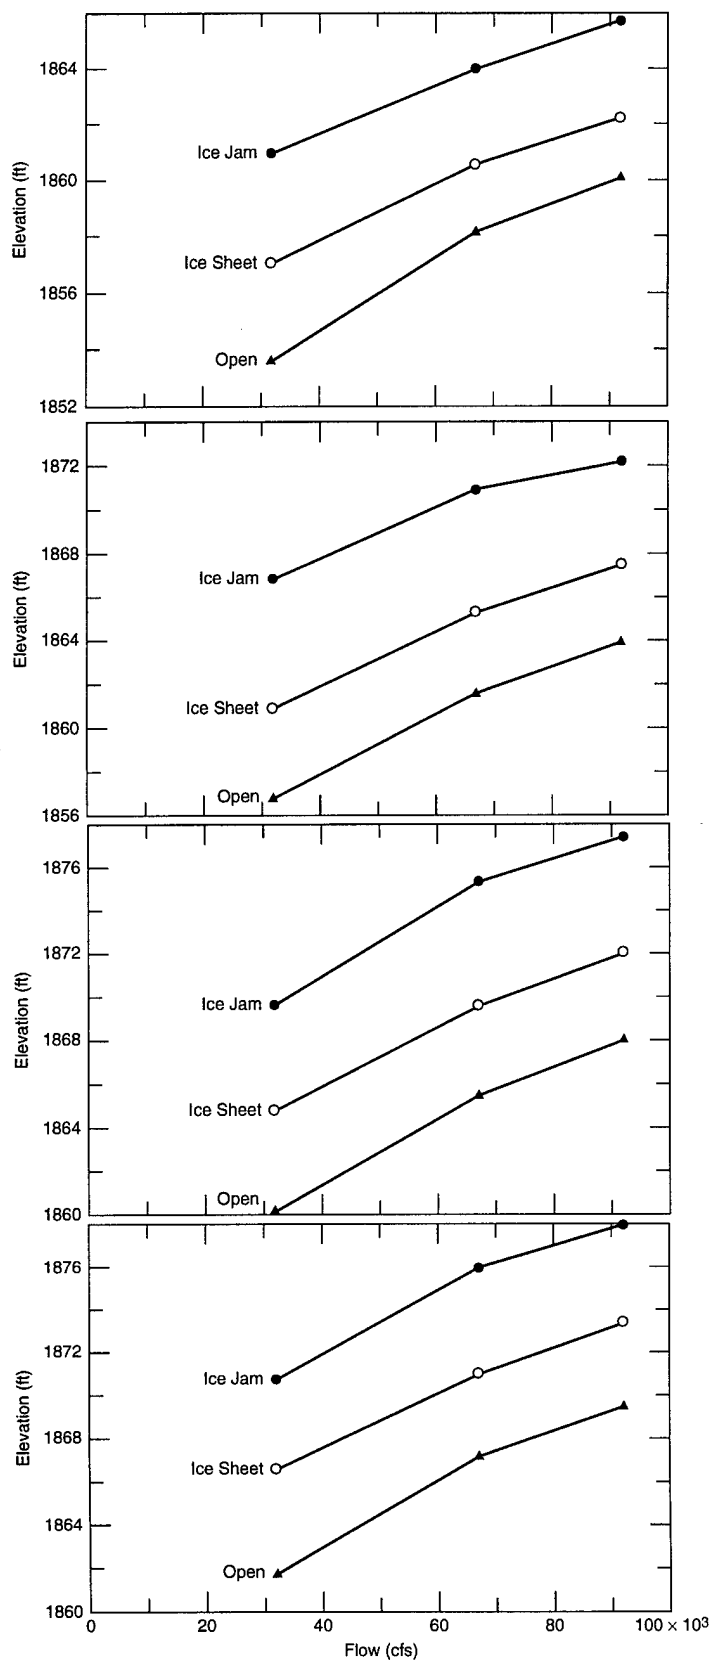
a. Cross section 1564.48.

b. Cross section 1568.19.

Figure 7. Rating curves for open-water, ice-covered and ice-jammed conditions.

Rating curves have been developed at several locations for discharges up to 92,000 cfs. This range would include events as large as a ten-year spring ice cover breakup period flows, as well as two-year open-water flows. Figure 7 shows conditions near cross sections 1564.48 and 1568.19 in the Middle Bottom, cross section 1578.03 in the West Bottom and 1581.31 just downstream of the Yellowstone confluence area. The curves represent open-water, ice-covered and ice-jammed conditions in order of increasing stage. Based on a review of air temperature records for the winters of 1970-71 through 1991-92, it would appear that the midwinter ice thickness would normally

Based on a typical freezeup flow of about 10,000 cfs, a spring discharge on the order of 25,000 cfs or greater would be required to initially dislodge a strong ice cover. This value is based on a rule of thumb that the stage must rise three to four ice thicknesses above the freezeup stage to initiate the breakup and run of a strong ice cover. An increase from 10,000 to 25,000 cfs, with a continuous ice sheet, would result in an increase in stage on the order of 5 ft in most areas within the District. A deteriorated ice cover can release with lesser increases in flow, but such events do not normally result in significant ice jams. Below that discharge, then, it might be assumed that the stage-discharge relation would follow the sheet ice curve. Above that discharge, stages would tend towards the ice jam curve, assuming that conditions approaching an equilibrium jam were possible.

At a somewhat higher discharge, the trend of increasing stage with discharge would begin to flatten out. Because of the wide floodplains throughout most of the area, once the raised lateral ditches were overtopped, the channel stage would be substantially stabilized. For example, at the Borlaug Bridge we know that the 1986 jam with an estimated discharge of 59,500 cfs nearly overtopped the lateral. The stage would certainly have leveled off near the elevation of the lateral, or even dropped if the lateral had been breached, had the jam not collapsed and released. Figure 7b appears to show that the stage would continue to increase to an elevation of at least 1872 in this area, but that is due to a fairly coarse HEC-2 data file in which the apparent low elevation on the lateral is somewhat higher than that at the Borlaug Bridge. By the time the ten-year breakup period flow (or two-year open water flow) is reached, the ice jam rating curves indicate that the laterals in both the Middle and West Bottoms would be overtopped.

In view of the limited length of historic jams, however, actual stages for these flow ranges would likely be less than shown, since a fully developed equilibrium jam would not exist throughout the area. Most reported jams were 0.5-2.5

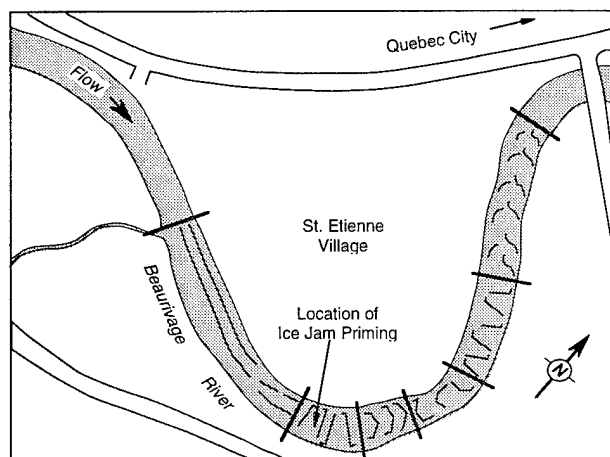
Figure 8. Map of Beaurivage River ice cutting. (After Jolicoeur et al. 1984.)

an evaluation of their performance in a river-bend. A general map of the area along with a depiction of the cutting patterns is shown in Figure 8.

In relatively straight reaches of a river, simply cutting slots down both sides of the river to release the ice cover from the riverbanks may be sufficient, while in curved reaches more elaborate cutting patterns may be required. Jolicoeur et al. (1984) reported on tests of ice trenching performed in an effort to find a cheaper, safer and more environmentally acceptable alternative to the explosive demolition of ice. In those tests a series of five cutting patterns were used to allow

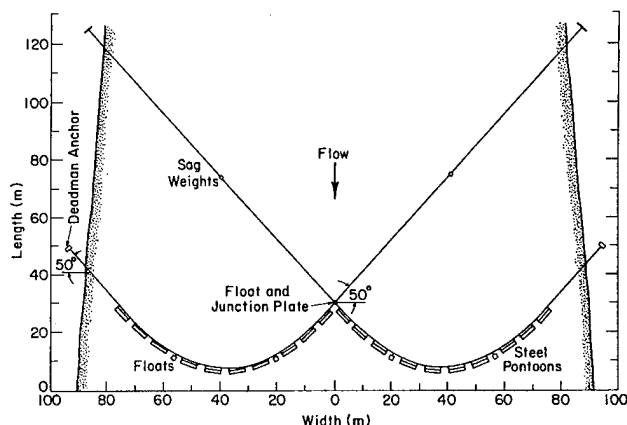
Figure 10. Plan view of the Allegheny River ice boom. (From Perham 1983.)

Costs for ice booms can vary with river size and ice conditions. Table 6 summarizes the costs for a number of flexible ice boom installations as compiled by Perham (1976). The costs listed have not been converted to a common year but correspond to costs at the time of design and construction as indicated in the table; costs for structures in Canada are in Canadian dollars. The only Corps of Engineers structure is the St. Marys River ice boom, which had a unit cost of about \$212/ft of river width spanned in 1975. More recently the Pittsburgh District constructed the Allegheny River ice boom shown in Figure 10. This boom
