**CRACK PROPAGATION MODES  
IN INJECTION MOLDED  
FIBER REINFORCED THERMOPLASTICS**

by  
**J.F. Mandell  
D.D. Huang  
F.J. McGarry**

April 1980

DEPARTMENT  
OF  
MATERIALS SCIENCE  
AND  
ENGINEERING

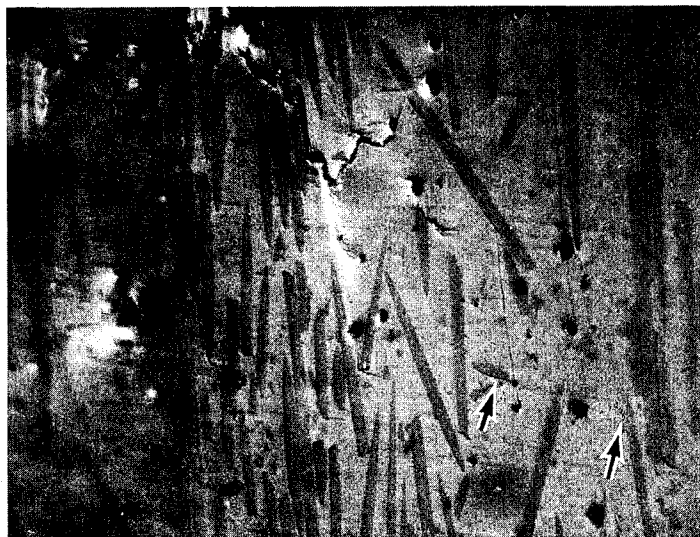
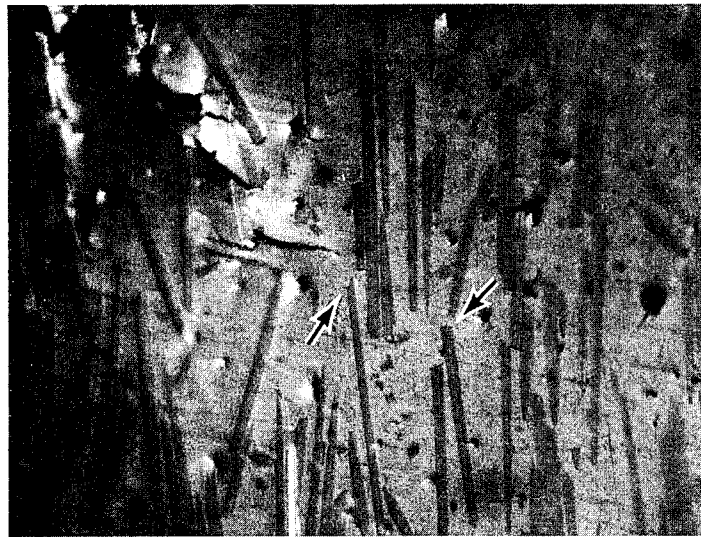
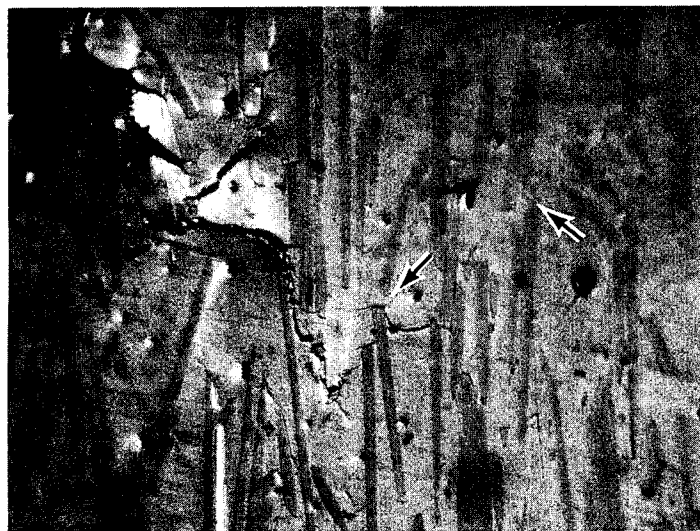
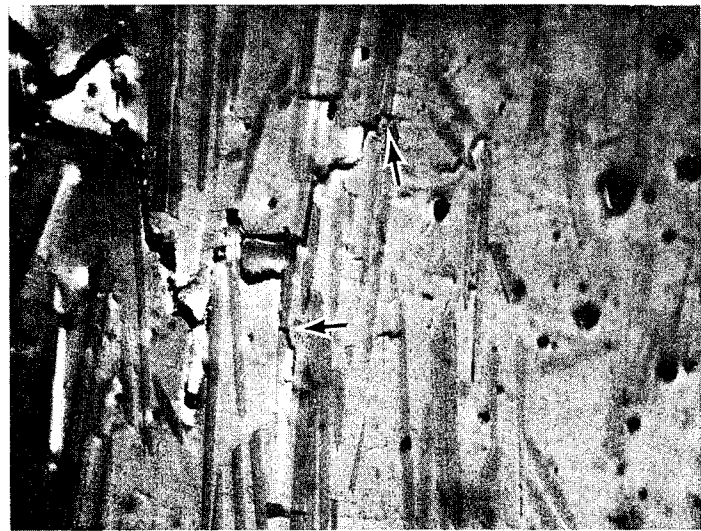
FIGURE 3 .

Figures 3 and 4 show the local mode of crack growth for the very brittle PPS matrix with glass and carbon fibers. The details of each are surprisingly different. The development of the crack tip zone is shown for the glass system in Figure 3 at four successively higher loads. The crack path can be correlated from one micrograph to the next by the arrow locations. There is a region ahead of the main crack in which small separate cracks are formed, mostly around fiber ends. These cracks coalesce at higher loads to form the main crack. This mode results in cracks primarily in the matrix and across fiber

ends, with little fiber pullout. Occasional fibers are broken by the crack, such as the one indicated by the lower arrow in (d). The PPS systems tend to contain many voids, which appear as dark circles in Figure 3.

CRACK TIP IN POLYPHENYLENE SULFIDE UNDER  
INCREASING LOAD (a) - (d); ARROWS INDICATE  
PATH CRACK WILL FOLLOW; ( $d_f \cong 11 \mu m$ ).

Differences in the local mode of crack growth are also observed in SEM micrographs of the fracture surfaces. The carbon reinforced systems in Figure 10 show variations from brittle matrix fracture for PPS to very ductile for N66, with some ductility evident for PC and PAI. The same sequence with glass fibers in Figure 11 (lower magnification than Fig. 10) shows similar effects. However, relatively few fibers are observed on the PPS surface, reflecting the local mode of formation of the crack in Figure 3.

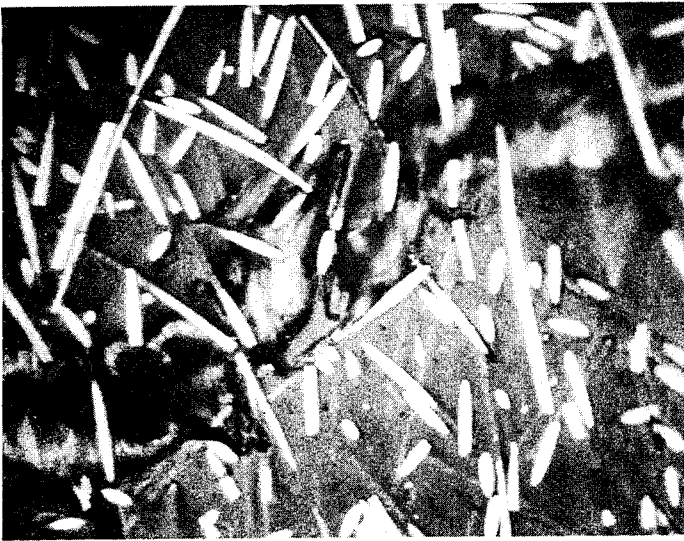
FIGURE 6 .

CRACKS IN CARBON REINFORCED POLYSULFONE (a);  
AND NYLON 66 (b) ALONG CRACK, AND (c) AT TIP;  
( $d_f \cong 10 \mu\text{m}$ ).

the carbon reinforced polycarbonate, which is typical of most of the ductile matrix systems. The main crack tip shown in (d) is actually a local continuous band of yielding and necking, with some fiber pull-out. Further back along the main crack (c) the yielded material tears apart in some regions, and finally the whole yielded path tears apart to form a real crack. The arrows (lower right) in (a) and (b) show the same spot before and after crack growth. The region ahead of the crack contains many locally yielded areas, especially near fiber ends, such as at the arrow. These coalesce to form the main continuous yielded zone, which later tears apart to form the crack. As in the PPS/glass, this coalescence mode allows the crack to seek out the path of least resistance, with occasional fibers crossed by the main yield zone extracted from the matrix. Figure 6 shows the same features for carbon reinforced polysulfone and Nylon 66.

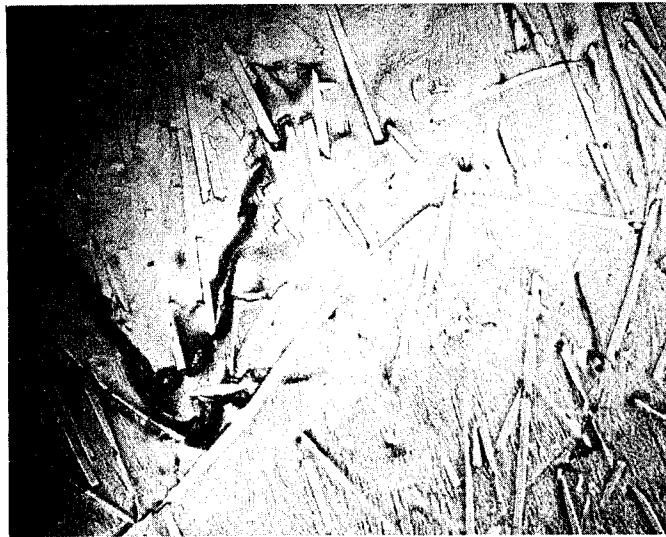
FIGURE 7 .

The ductile matrices with glass fibers show a similar mode of local ductile crack growth, as in Figure 7(b) for the Nylon 66 matrix. A combined mode is evident for the glass reinforced polycarbonate in Figure 7(a). Widespread local cracks or crazes are formed ahead of the main crack, mostly near fiber ends. However, close to the main crack tip local necking and yielding appears to dominate. In each of the glass reinforced systems, fibers were occasionally observed to break where they bridged the main crack or yield band; fiber failure was rarely observed with carbon fibers.

CRACK TIP IN GLASS REINFORCED POLYCARBONATE (a),  
AND NYLON 66 (b); ( $d_f \cong 11 \mu m$ ).

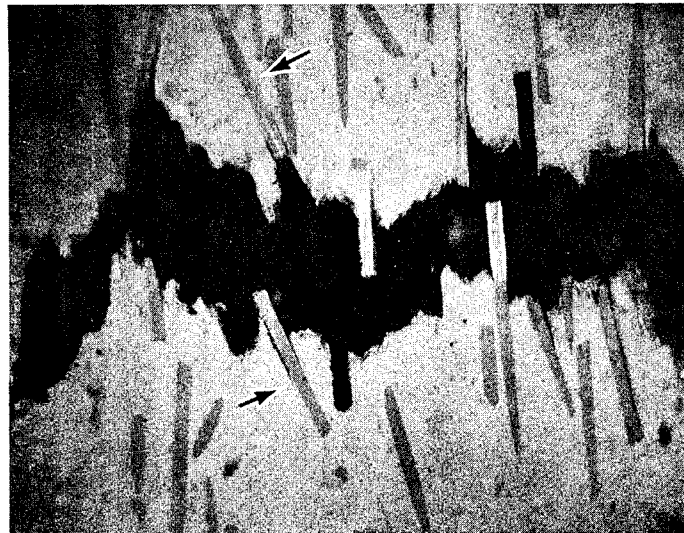
FIGURE 9.

of the arrow in (b). Figure 9 shows the development of damage at a notch root in the glass reinforced system. The arrows in (a) and (b) trace the development of fiber debonding ( which occurred first), yielding, and fiber fracture. (The fiber at the immediate notch boundary was cracked during notching.) The crack path (c) shows a broken fiber (arrows), and debonded, pulled-out fibers. Yielding was very localized in the PAI systems, but the brittle cracking observed in glass/PPS around fiber ends was not evident. Instead, the high strain capacity of the matrix appeared to result in fiber debonding and fracture, along with some local yielding.

GLASS REINFORCED POLY(AMIDE-IMIDE) SHOWING DAMAGE DEVELOPMENT AT NOTCH ROOT AT LOW (a) AND HIGH (b) LOADS, AND CRACK PATH (c); ( $d_f \cong 11 \mu m$ ).

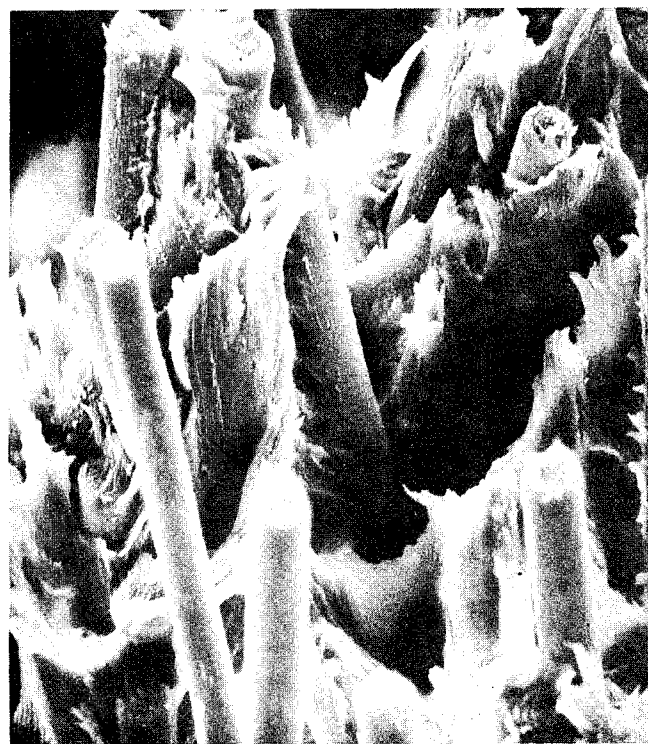
FIGURE 10.

FRACTURE SURFACES OF CARBON REINFORCED MATRICES;  
CLOCKWISE FROM UPPER LEFT: POLYPHENYLENE SUL-  
FIDE, POLY(AMIDE-IMIDE), NYLON 66, POLYCARBONATE;  
( $d_f \cong 10 \mu m$ ).

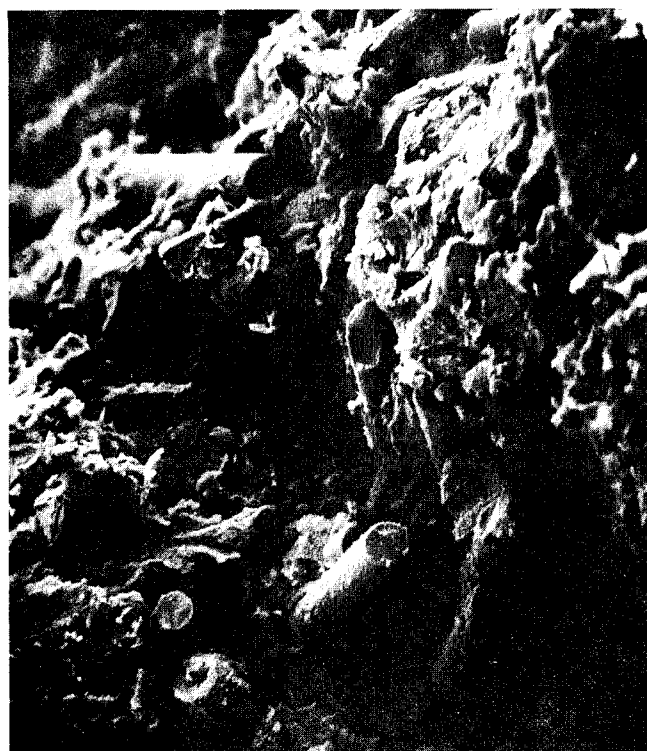
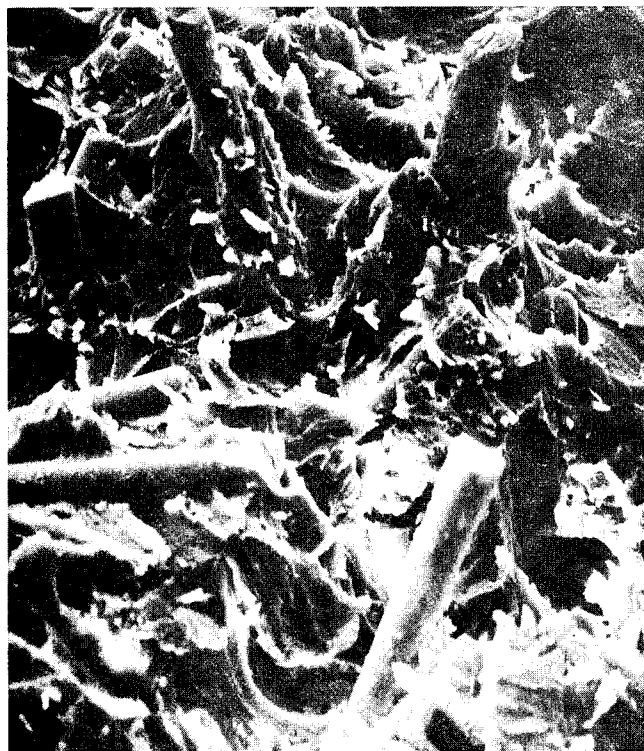
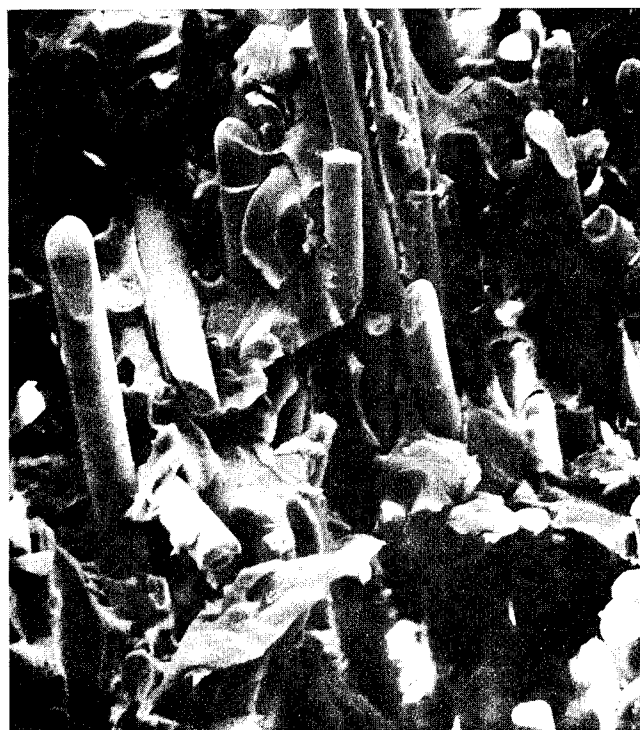
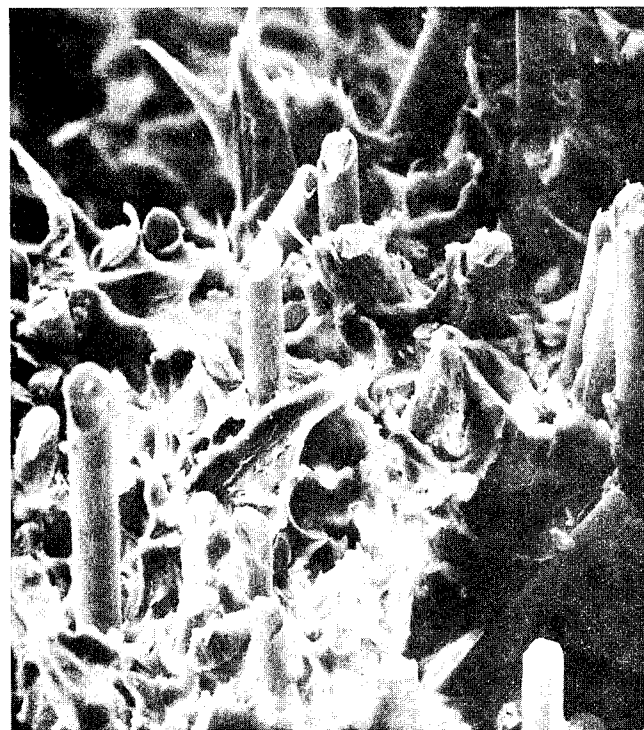
FIGURE 11.

FRACTURE SURFACES OF GLASS REINFORCED MATRICES;  
CLOCKWISE FROM UPPER LEFT: POLYPHENYLENE SUL-  
FIDE, POLY(AMIDE-IMIDE), NYLON 66, POLYCARBONATE;  
( $d_f \cong 11 \mu m$ ).
