US Army Corps
of Engineers
Construction Engineering
Research Laboratories

Technical Report REMR-OM-16
September 1995

REMR Management Systems—Navigation and Reservoir Structures, Condition Rating Procedures for Concrete in Gravity Dams, Retaining Walls, and Spillways

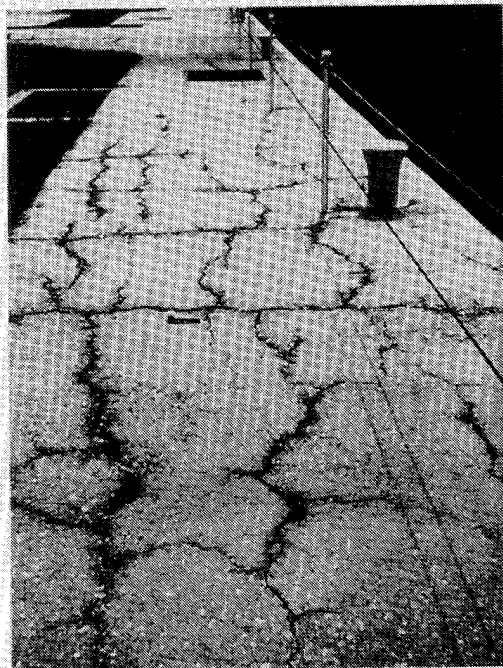
Fig. A.1.6a—Pattern cracking (fine)

Fig. A.1.6b—Pattern cracking (medium)

Fig. A.1.6c—Pattern cracking (wide)

Fig. A.1.6e—Pattern cracking (restraint of volume change)

Fig. A.1.6d—Pattern cracking (alkali-silica reaction)

Fig. A.1.6f—Pattern cracking (alkali-carbonate reaction)

Pattern cracking (category 23). Pattern cracking results from a relative volume change of interior and exterior concrete. Pattern cracking together with distortion generally indicates a volume increase such as occurs from alkali-aggregate reaction. The effect is generally shallow, less than 1 ft. Extensive pattern cracking makes coring advisable to determine depth and cause. Pattern cracking may progress to disintegration. The effect of cycles of freezing and thawing also contributes to further deterioration of concrete with pattern cracking.

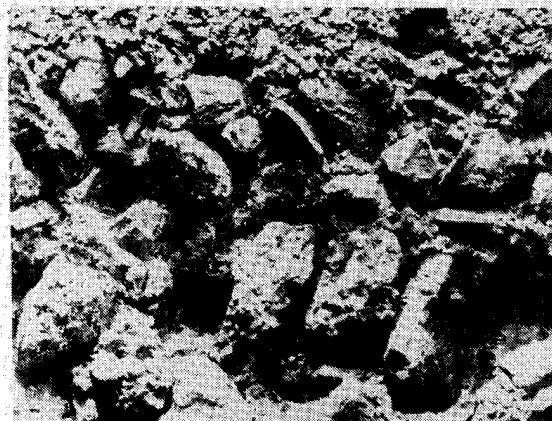
Fig. A.2.3—Cavitation damage

Cavitation (category 32). Cavitation results from the collapse of vapor bubbles in flowing water and is generally caused by high-velocity flow over abrupt changes in surface alignment. Cavitation causes additional changes in alignment. To prevent further damage, repairs should be made promptly and the cause of the damage should be eliminated. Deduct values from Table 4 are used. Measurement should be at the point of deepest cavitation.

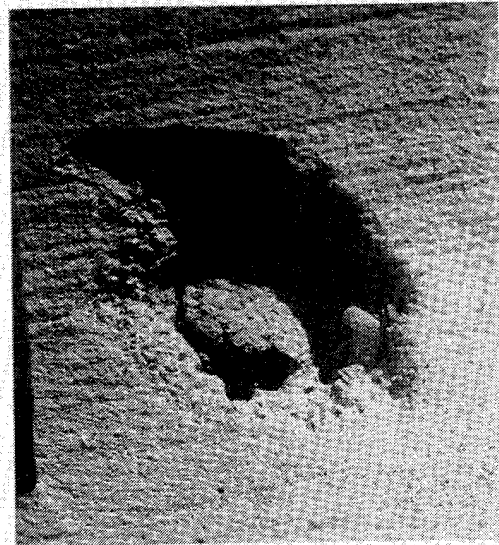
Fig. A.2.19—Popout

Popouts (category 34). Popouts generally are caused by freezing of saturated porous aggregate particles but may also result from alkali-aggregate reaction. They are more aesthetically offensive than structurally serious.

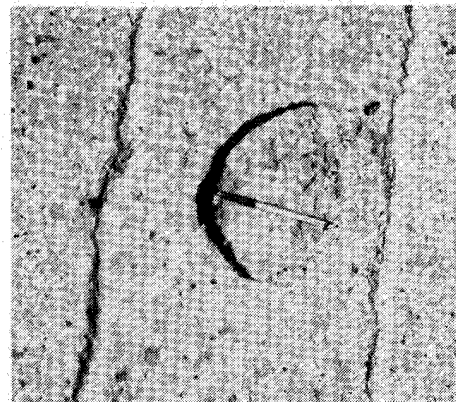
Fig. A.2.21.1—Small spall

Fig. A.2.21.2—Large spall

Spalling (category 36). Spalling is the breaking away of a fragment, usually wedge or conical shaped, by the action of pressure or a blow. Structural distortion may apply sufficient pressure at contraction joints to cause spalls. Corrosion of reinforcing steel or other embedded metal may spall the concrete cover. Also, trapped water in voids may result in a spall. No deduction is made for a joint spall less than 3 in. deep. A spall of less than 9 in. along a joint in a vertical surface is considered light. If a spall on a vertical surface has a calculated volume-loss deduct value that is larger than the applicable 5- or 10-point deduct value, use that value instead.

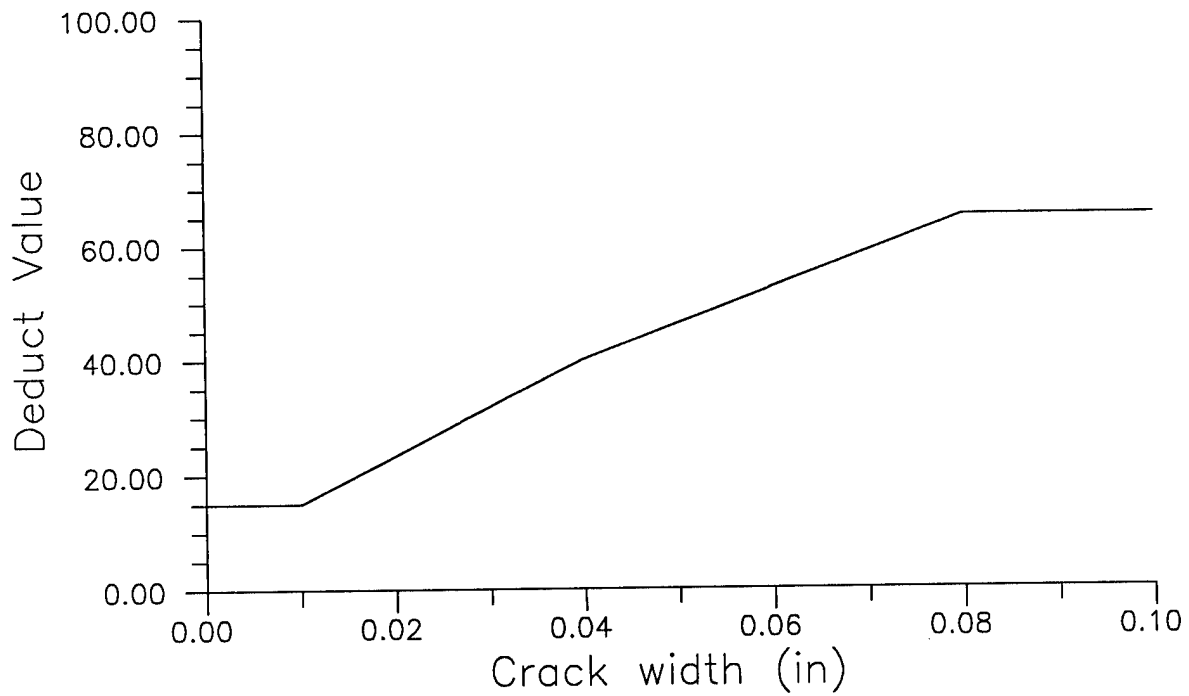
DIAGONAL CRACKING

<u>Crack widths, in.</u>		<u>Deduct values</u>
Very fine	≤0.01	15
Fine	>0.01, ≤0.04	6.67 + width X 833
Medium	>0.04, ≤0.08	40 + (width - .04) X 625
Wide	>0.08	65

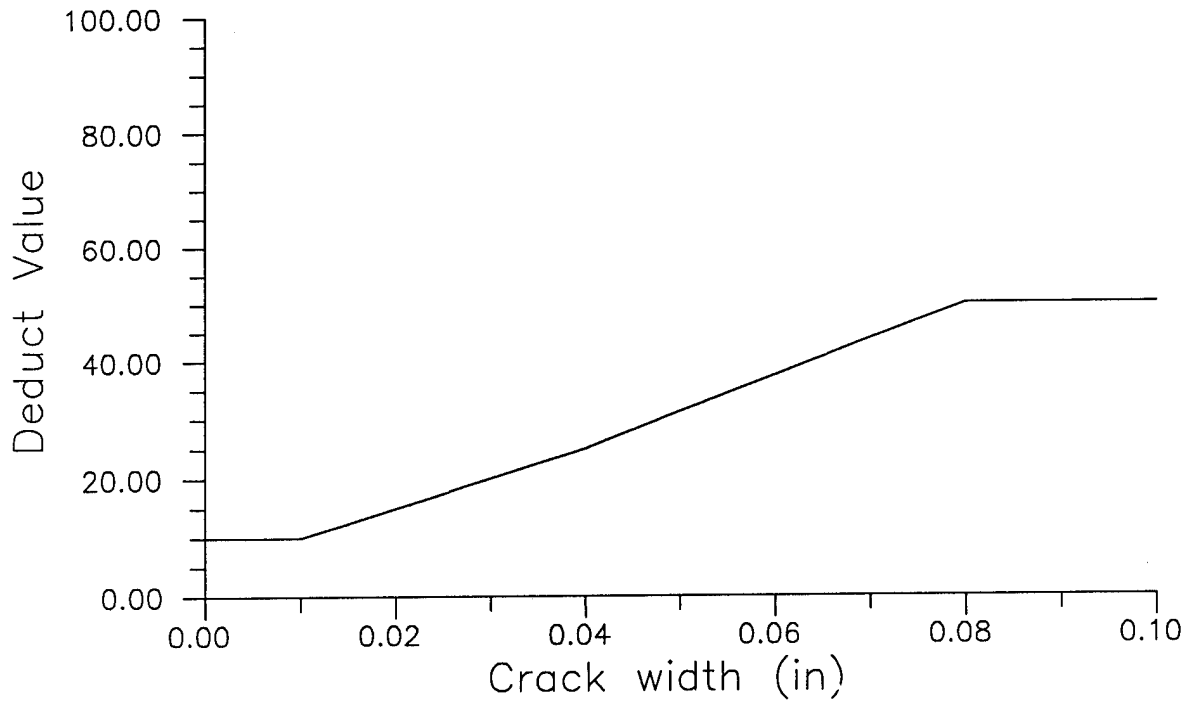
RANDOM CRACKING

<u>Crack widths, in.</u>		<u>Deduct values</u>
Very fine	≤0.01	10
Fine	>0.01, ≤0.04	5 + width X 500
Medium	>0.04, ≤0.08	25 + (width - .04) X 625
Wide	>0.08	50
