EVALUATION OF ROTMAN LENSES FOR SPACE-BASED RADAR

DEFENCE RESEARCH ESTABLISHMENT OTTAWA
REPORT NO. 1271

December 1995
Ottawa

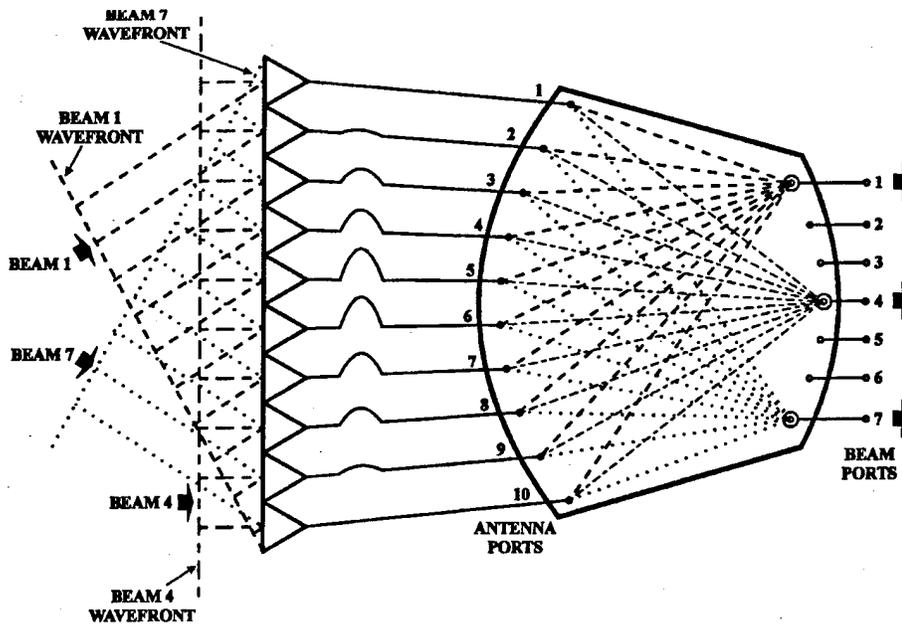
Figure 1 Linear Array Fed by a Rotman Lens

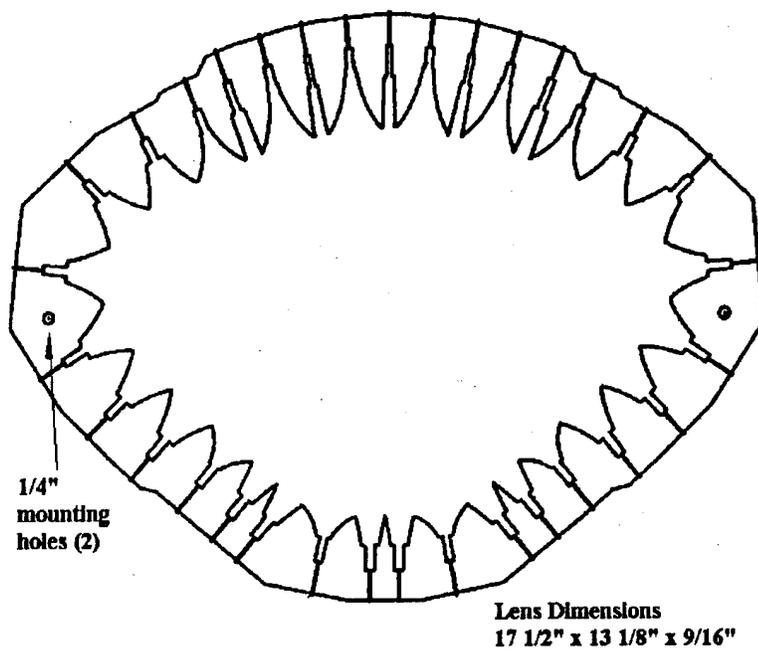
An identical lens design was used for all four of the small lenses; this design is shown in Figure 2.^(9,11) Figure 3 shows the design of the large lens.^(9,11) In these two cases, the external lens contour is shown along with the foil mask outline. The interior of the lens cavity has a solid copper foil mask sandwiched between the dielectric layers, with a multiple section impedance matching transformer extending to each port. On the small lens design, two 0.25 inch through holes, used to secure the lenses in the shipping container, are shown close to the edge of the lens. The cross-section of the lenses is shown in Figure 4.^(9,11) The lenses are symmetric about the copper foil. A thin layer of adhesive between adjacent layers bonds them securely together. The thick aluminum plate on each exterior surface provides the required dimensional stability; as well, the inner surfaces serve as the ground plane providing the outer bounds of the lens area.

Figure 2 Stripline Contour of Small Rotman Lens

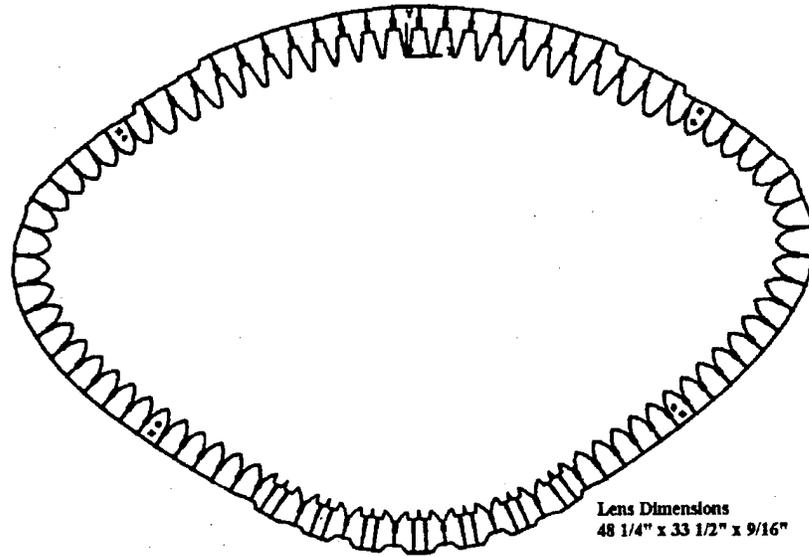
Figure 3 Stripline Contour of Large Rotman Lens

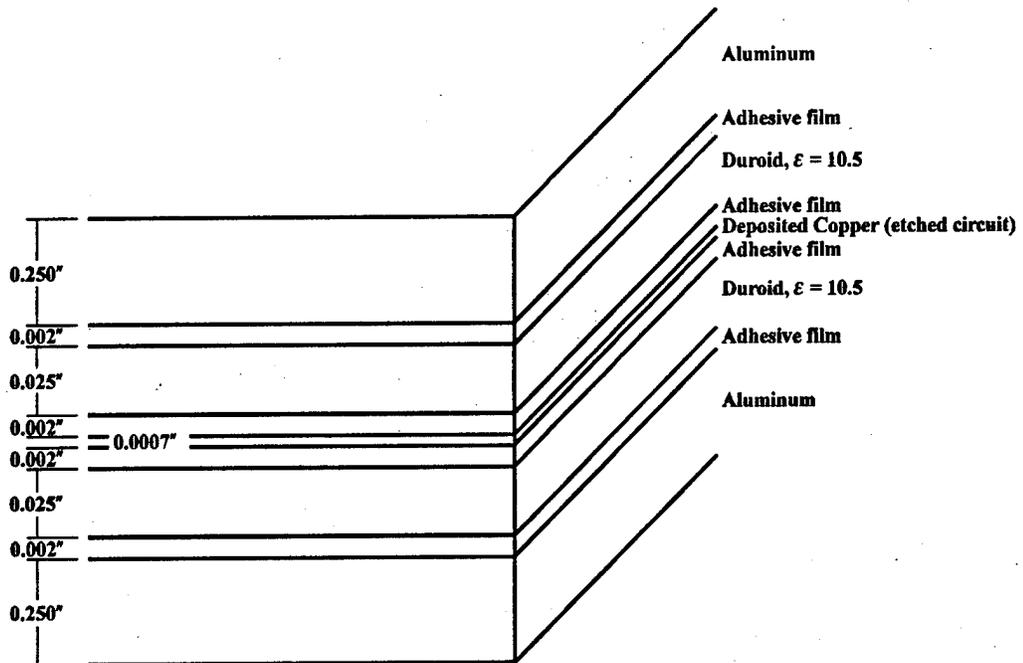
Figure 4 Cross-Section of the Rotman Lens

Figure 21 is a cross-section of the splice area, and it clearly shows the inside edges of the external aluminum plates, the adhesive layers, the dielectric material, and the copper sheeting. The interfaces between the different layers can be seen, and appear to be clean and intact, especially in comparison to the other specimens. It can be seen that, in the area of the splice, the thickness of the adhesive layers joining the fingers of the splice within the top and bottom layers of the particular section shown is inconsistent. On the top layer the adhesive is about 12 μm thick, while on the bottom layer it is about 50 μm thick. Also, in the top layer, the space at the end of one of the fingers has been filled with adhesive. The lower photo shows the detail of the boundaries between the copper sheeting and the dielectric. The thickness of the adhesive is uniform, and the interface is without air gaps or disbond. It should be noted that the copper sheeting is actually approximately 40 μm thick, rather than 20 μm (corresponding to 0.0007" shown in Figure 4). The thickness of the dielectric and the adhesive is consistent with that shown in Figure 4.

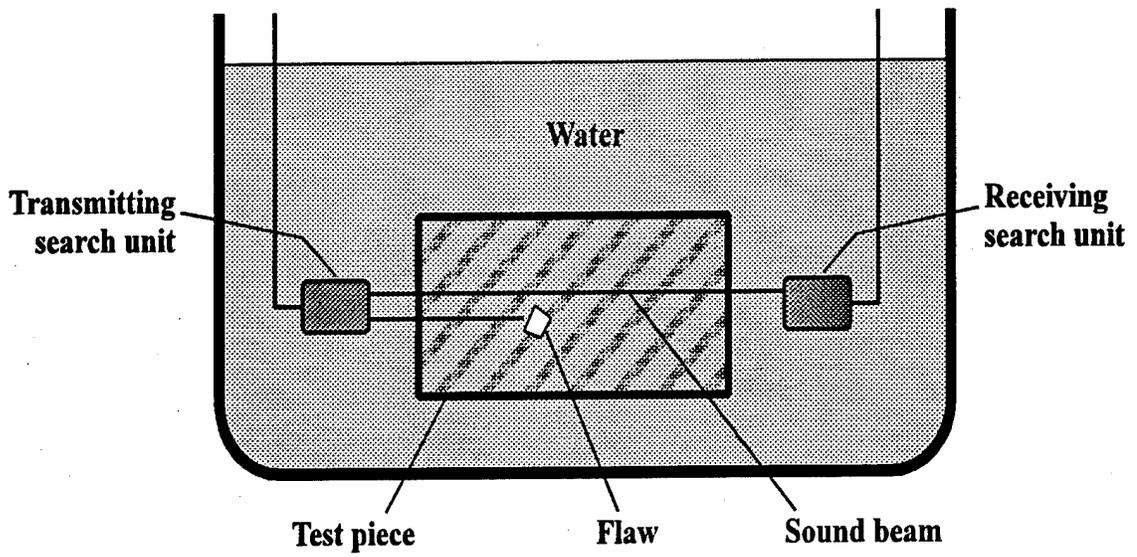
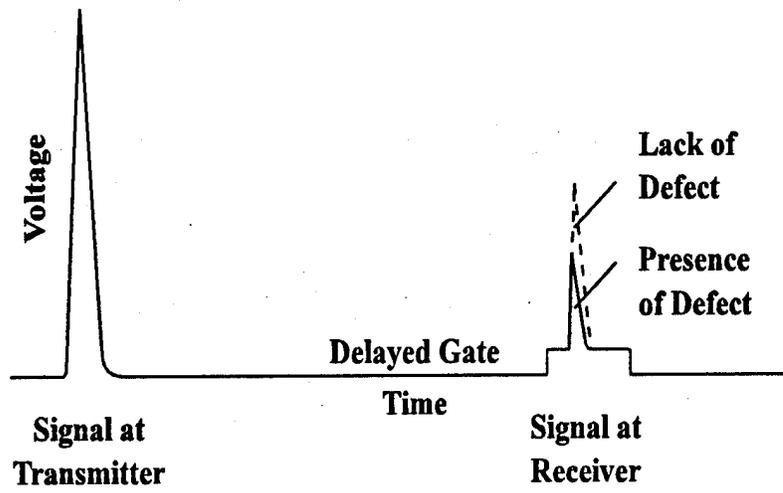
(a) Test Configuration

(b) CRT Display

Figure 5. Through Transmission Test Configuration and Schematic of a Typical Oscilloscope Display

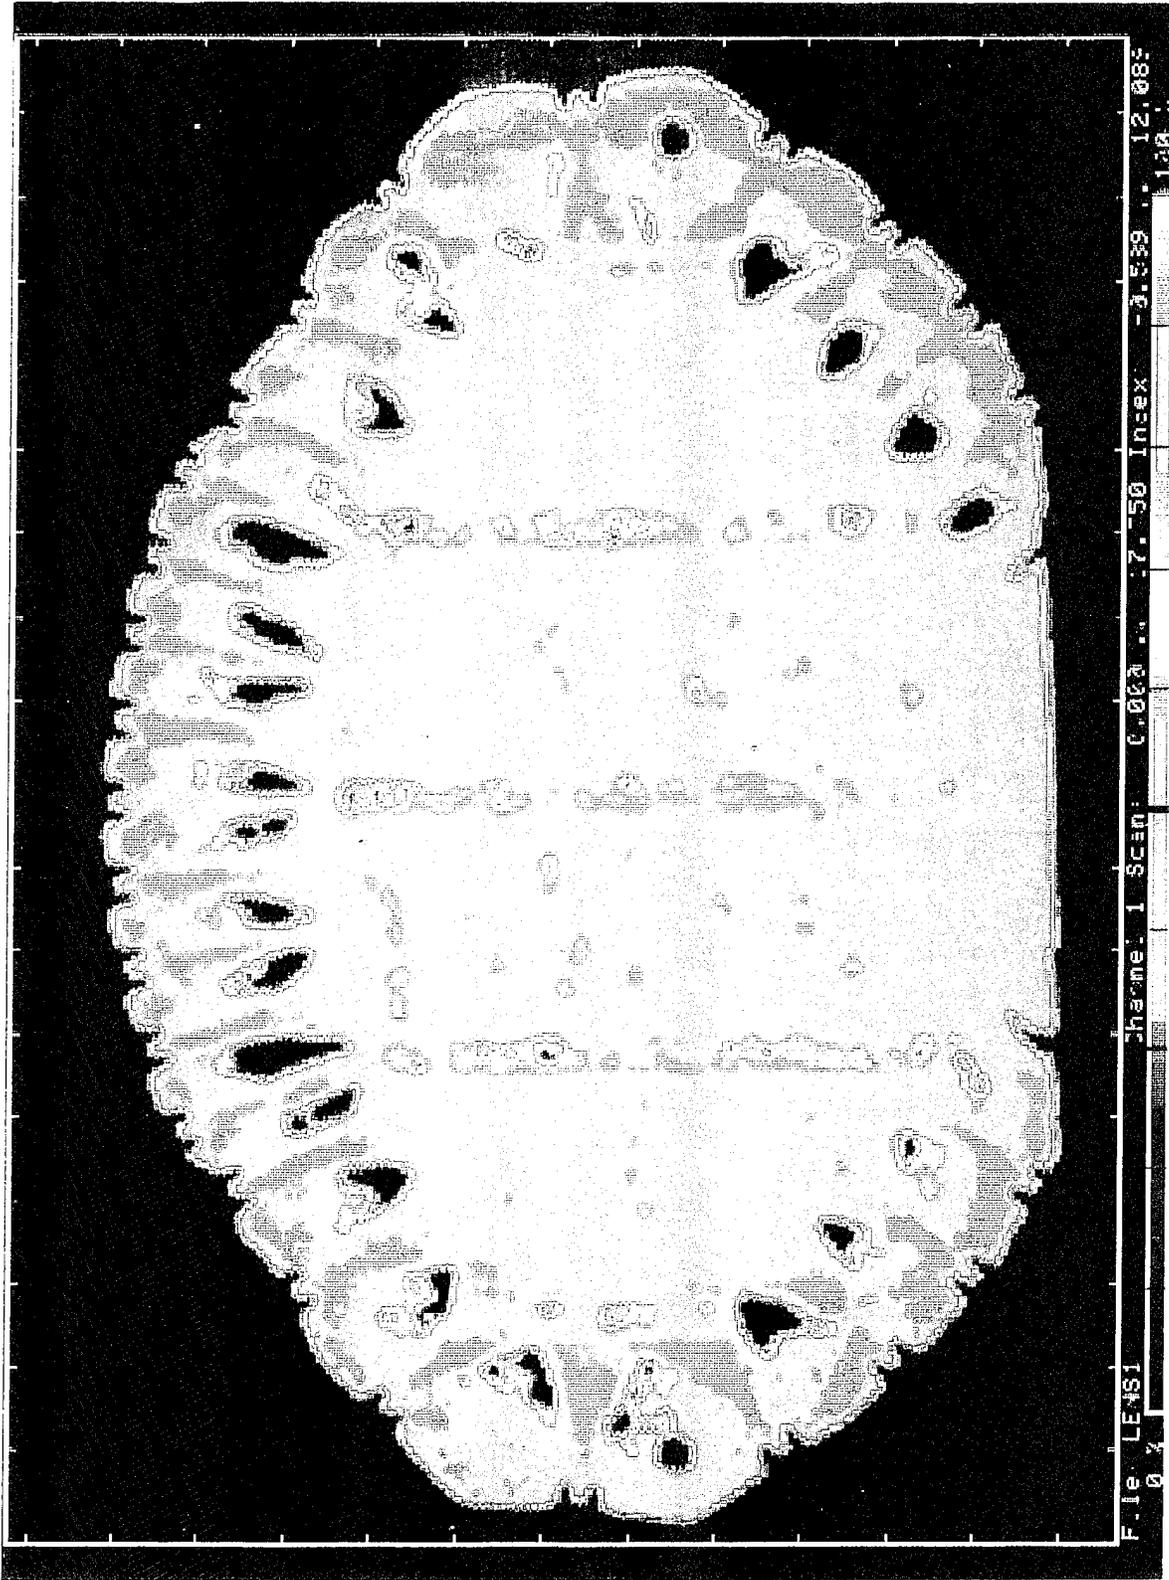
Figure 6 shows the results of the scan of lens A at 5 MHz. The lens outline can clearly be seen. The vertical lines are evidence of machine work on the aluminum plate prior to assembly. These result from overlap during milling operations, performed to flatten the inner and outer surfaces of the 0.25 inch thick aluminum ground planes. This machine work can be seen on examination of the external surfaces of the lens; however it is the reflection from the internal surfaces that is producing this feature on the display, because the reflections from the outer surfaces have been gated out during the scan analysis. In addition, this was confirmed by the comparison of scans of this lens, both before and after the polishing of its external surfaces to remove the blemishes and surface texture. The blotching is caused by the texture of surface imperfections at one or both of the internal surfaces. By comparing with Figure 2, one can see that dark areas close to the outer edge of the lens lie between the impedance matching transformers. These areas may possibly be air bubbles which were trapped between the adhesive layers, held apart by the adjacent copper foil during manufacture, or adhesive which flowed there while the lenses were being heated under pressure during manufacture. There is also evidence of abnormalities along the vertical milling overlap lines because of areas of increased

Figure 6 Final Scan of Rotman Lens RL 1.10A at 5 MHz
Single Board Construction (Not Spliced)

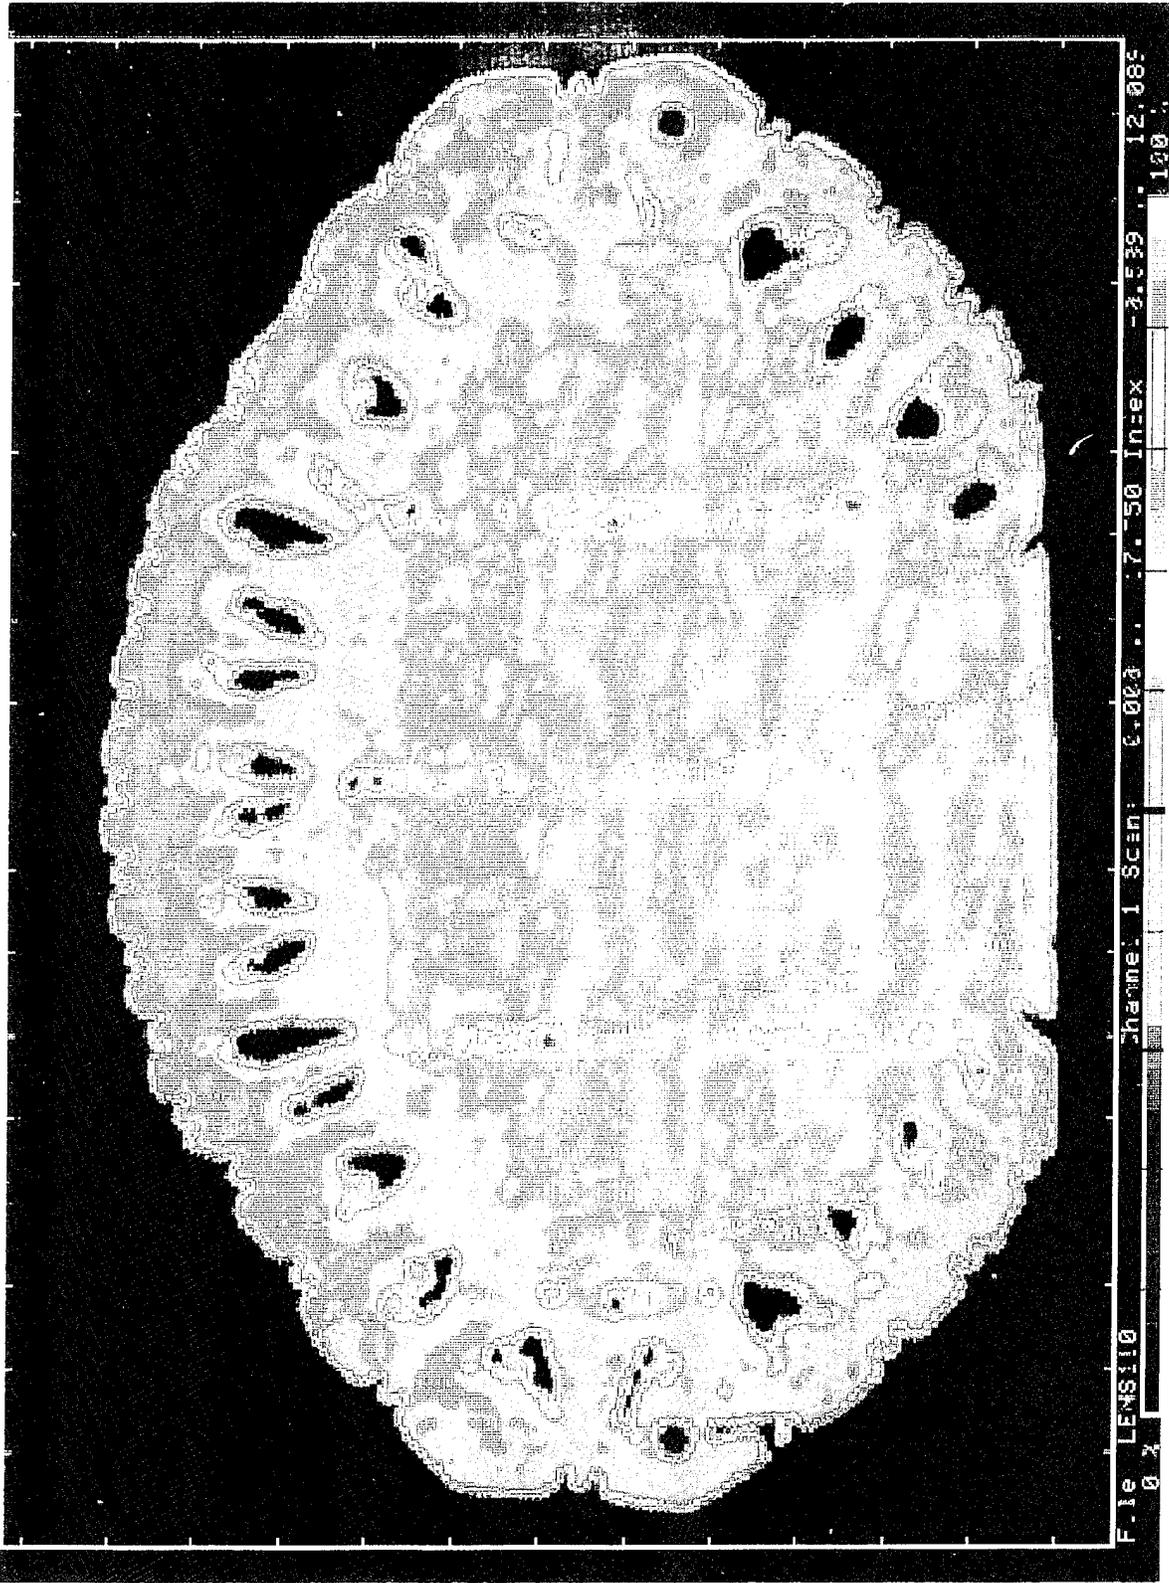
Figure 7 Final Scan of Rotman Lens RL 1.10A at 10 MHz
Single Board Construction (Not Spliced)

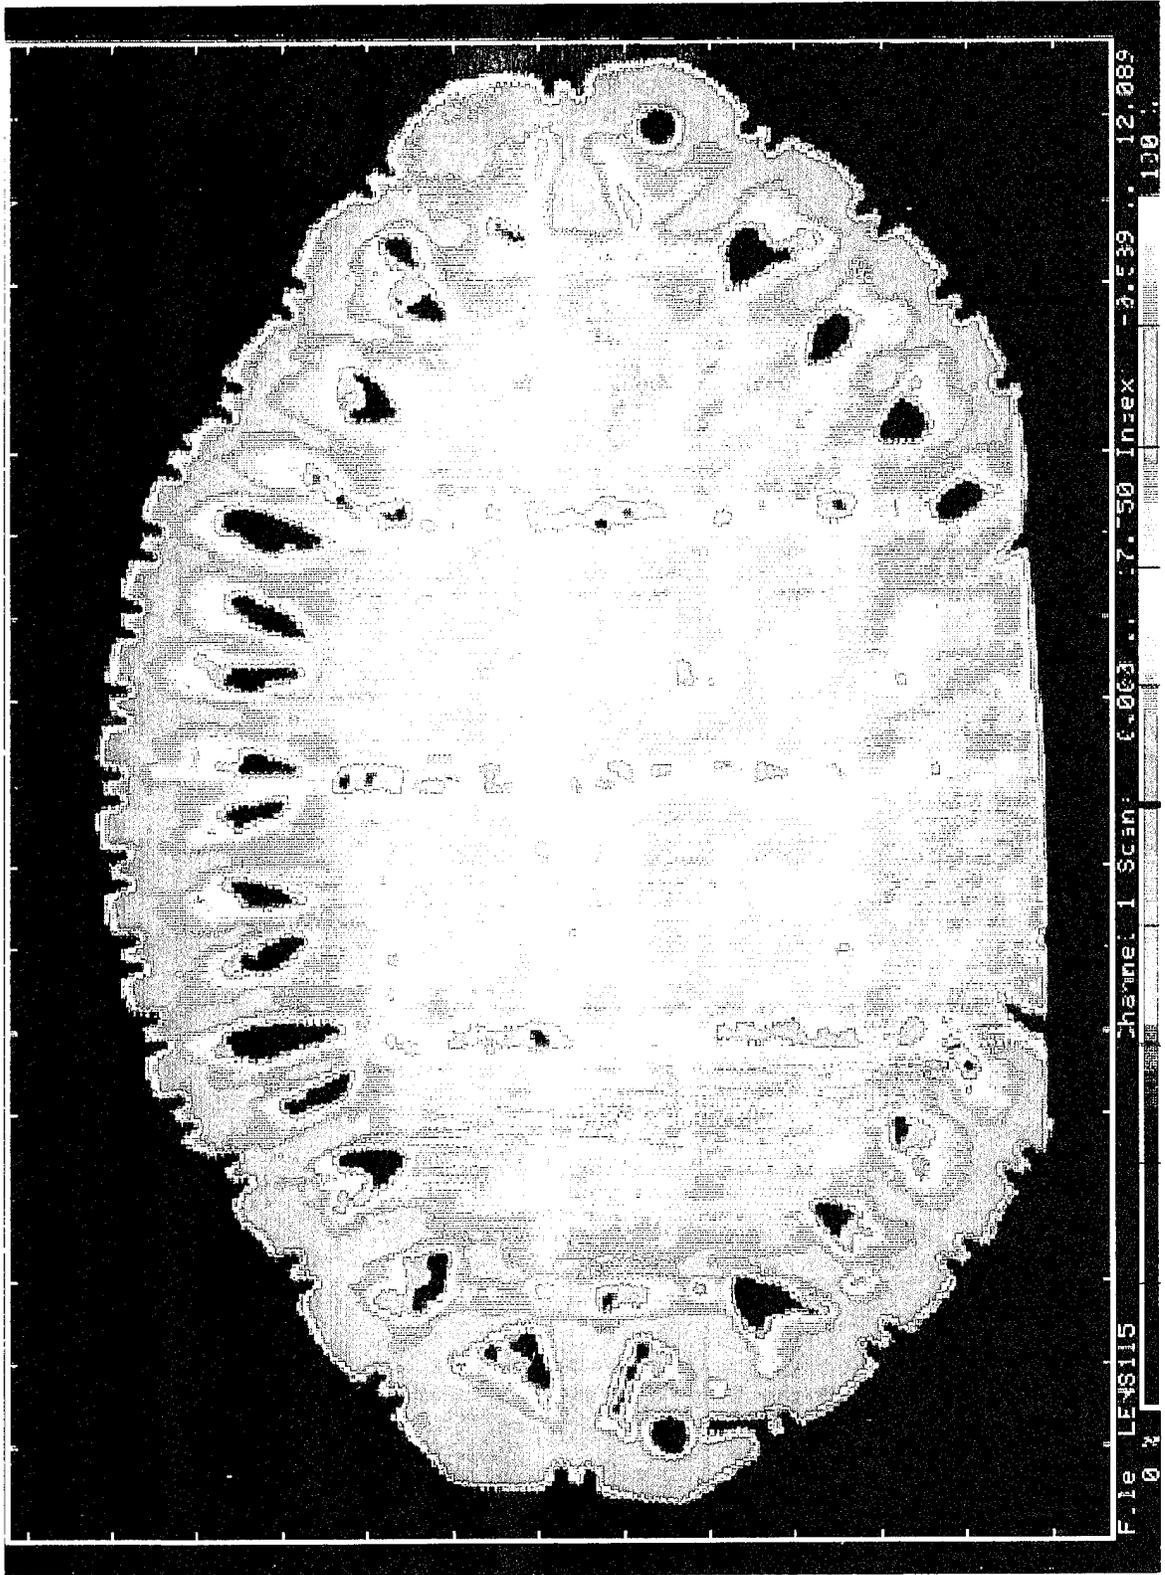
Figure 8 Final Scan of Rotman Lens RL 1.10A at 15 MHz
Single Board Construction (Not Spliced)

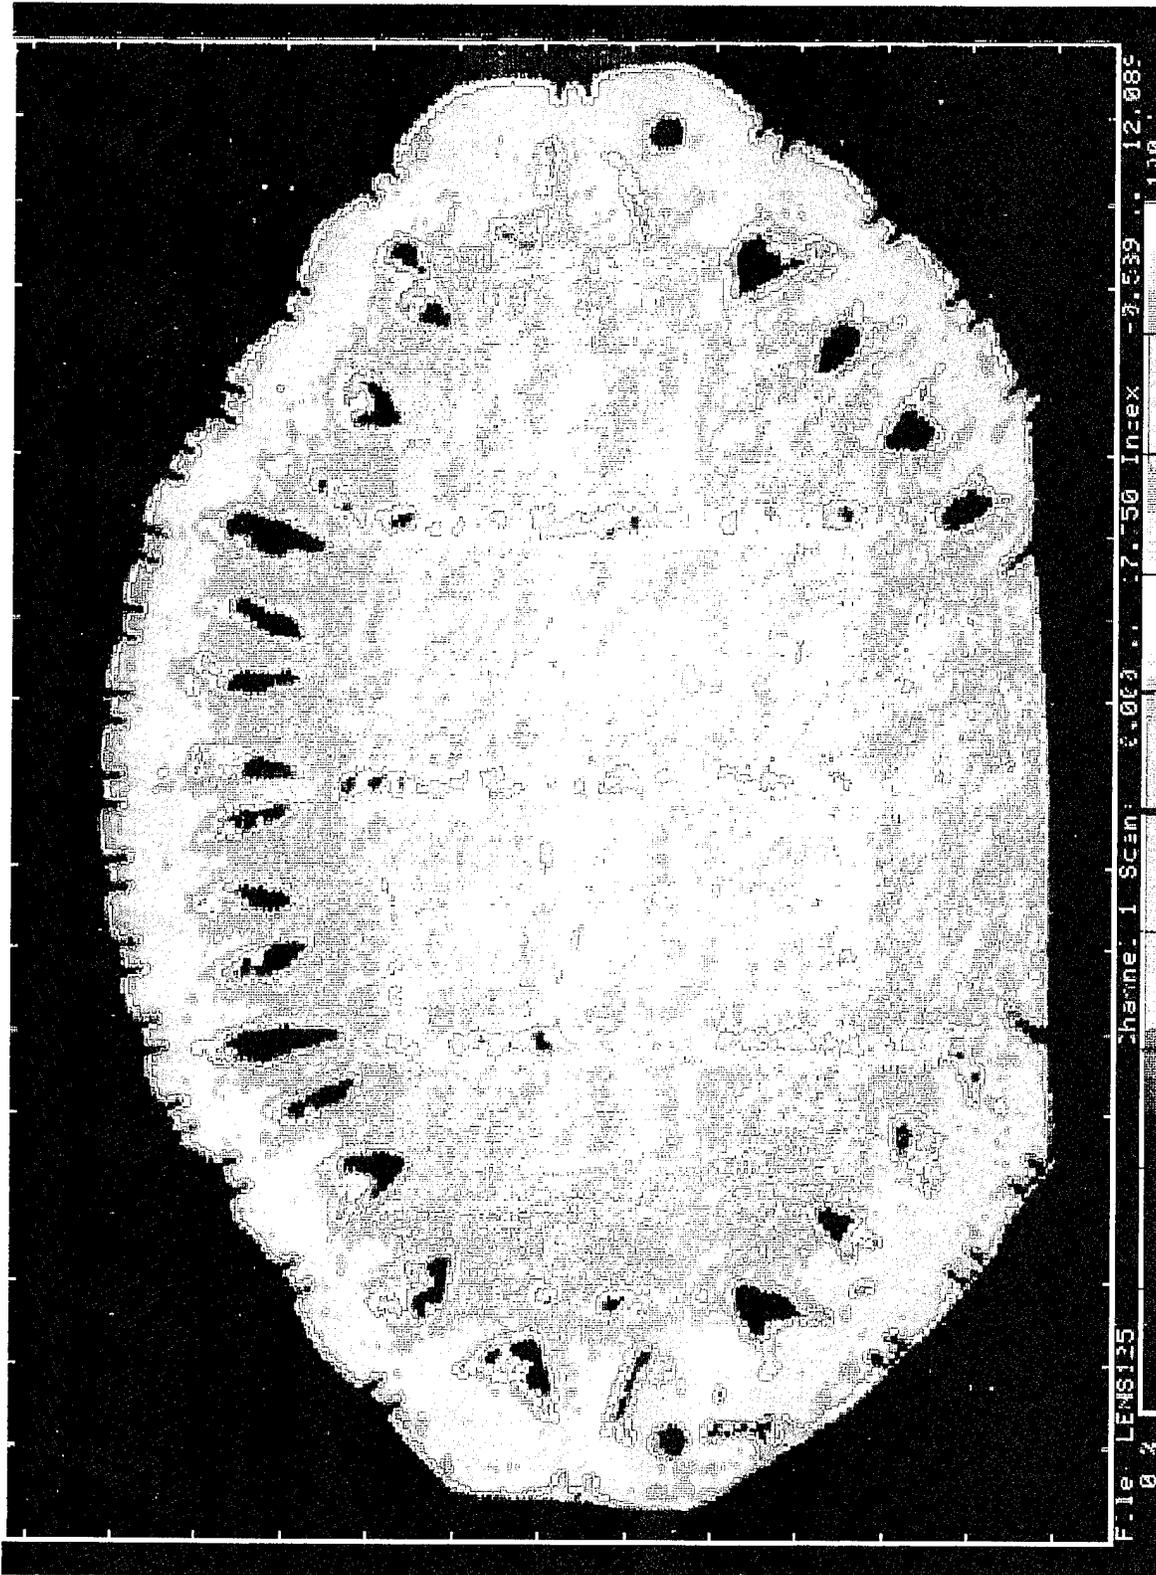
Figure 9 Final Scan of Rotman Lens RL 1.10A at 25 MHz
Single Board Construction (Not Spliced)

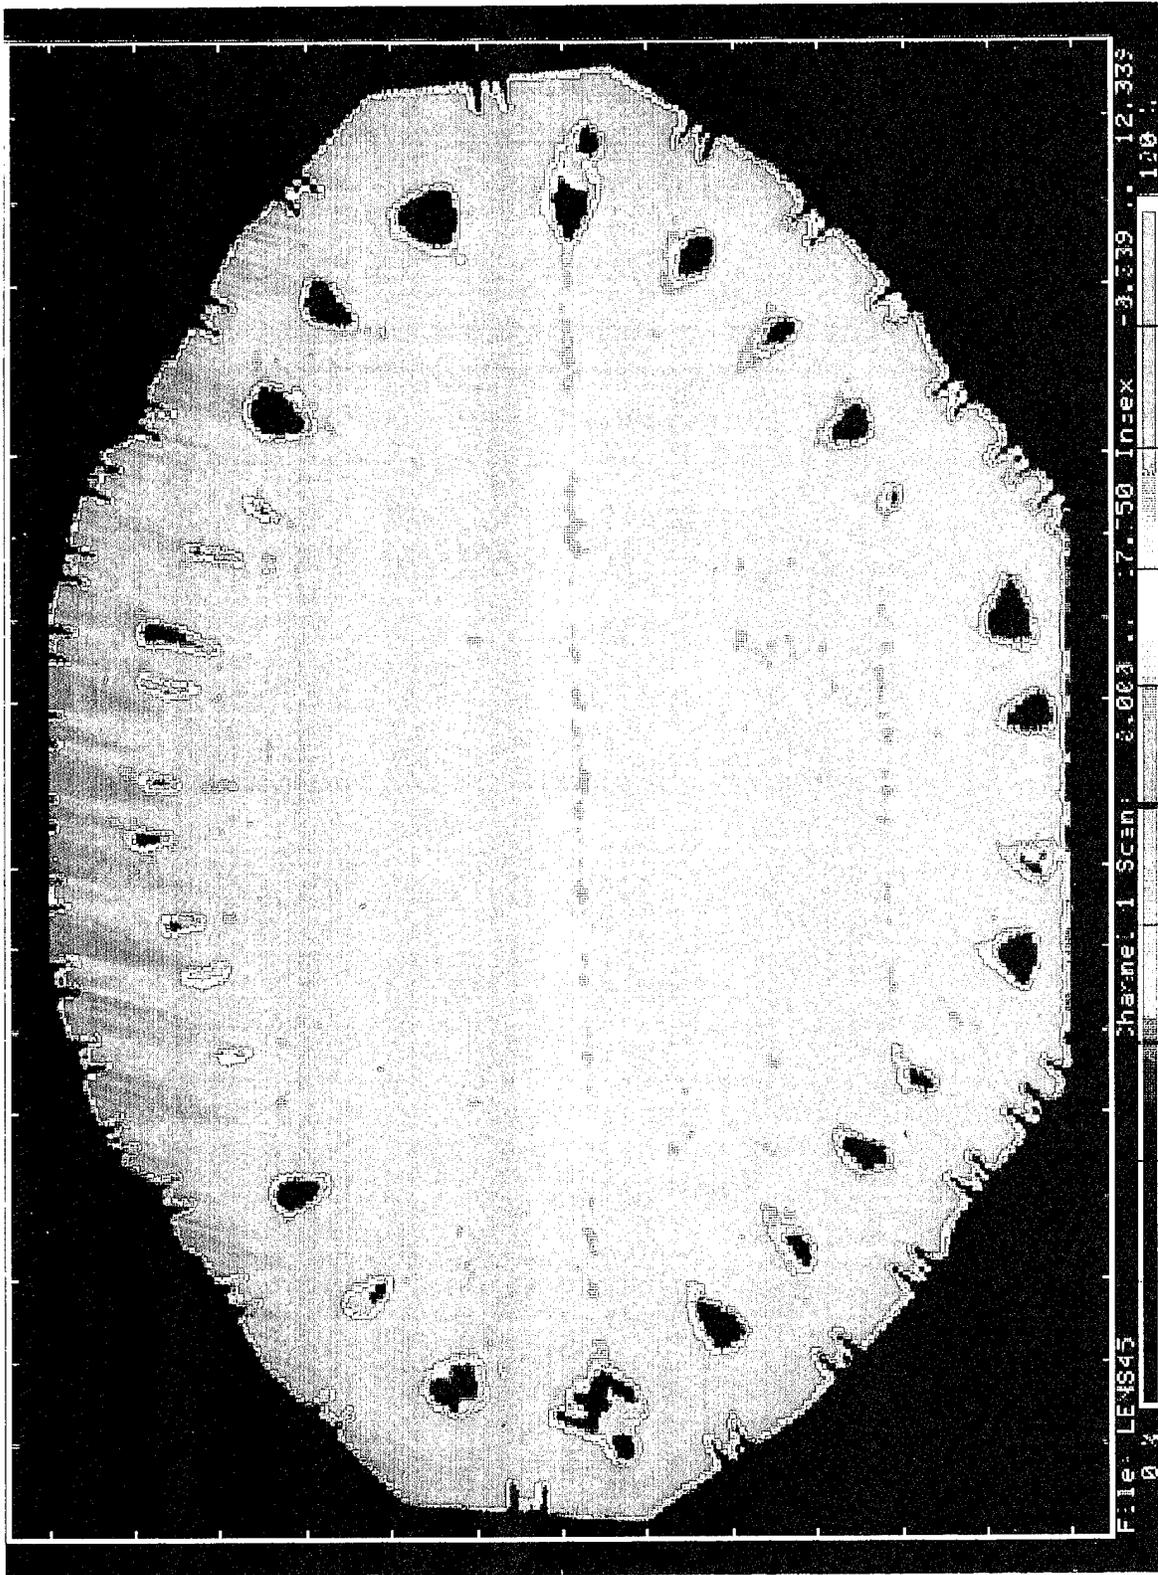
Figure 10 is the result of the scan of lens B. The results are similar to those in Figure 6; the principal differences are that the lines from the machine work on the aluminum plate are across the wide dimension of the lens rather than across the narrow one, and evidence of possible air gaps along the milling overlap lines is not so strong. Although measurements were made at all four frequencies, only the result for 5 MHz is shown because of the similarity of the results. As above, using Figure 2 as a guide, it again can be seen that there are likely cavities between the matching transformers, and that the image of each of the two 0.25 inch mounting holes has been merged with one of the inter-transformer irregularities. The milling overlap lines are barely visible. With the exception of the above comments, this lens appears to be exceptionally clean and free of internal anomalies.

Figure 10 Final Scan of Rotman Lens RL 1.10B at 5 MHz
Single Board Construction (Not Spliced)

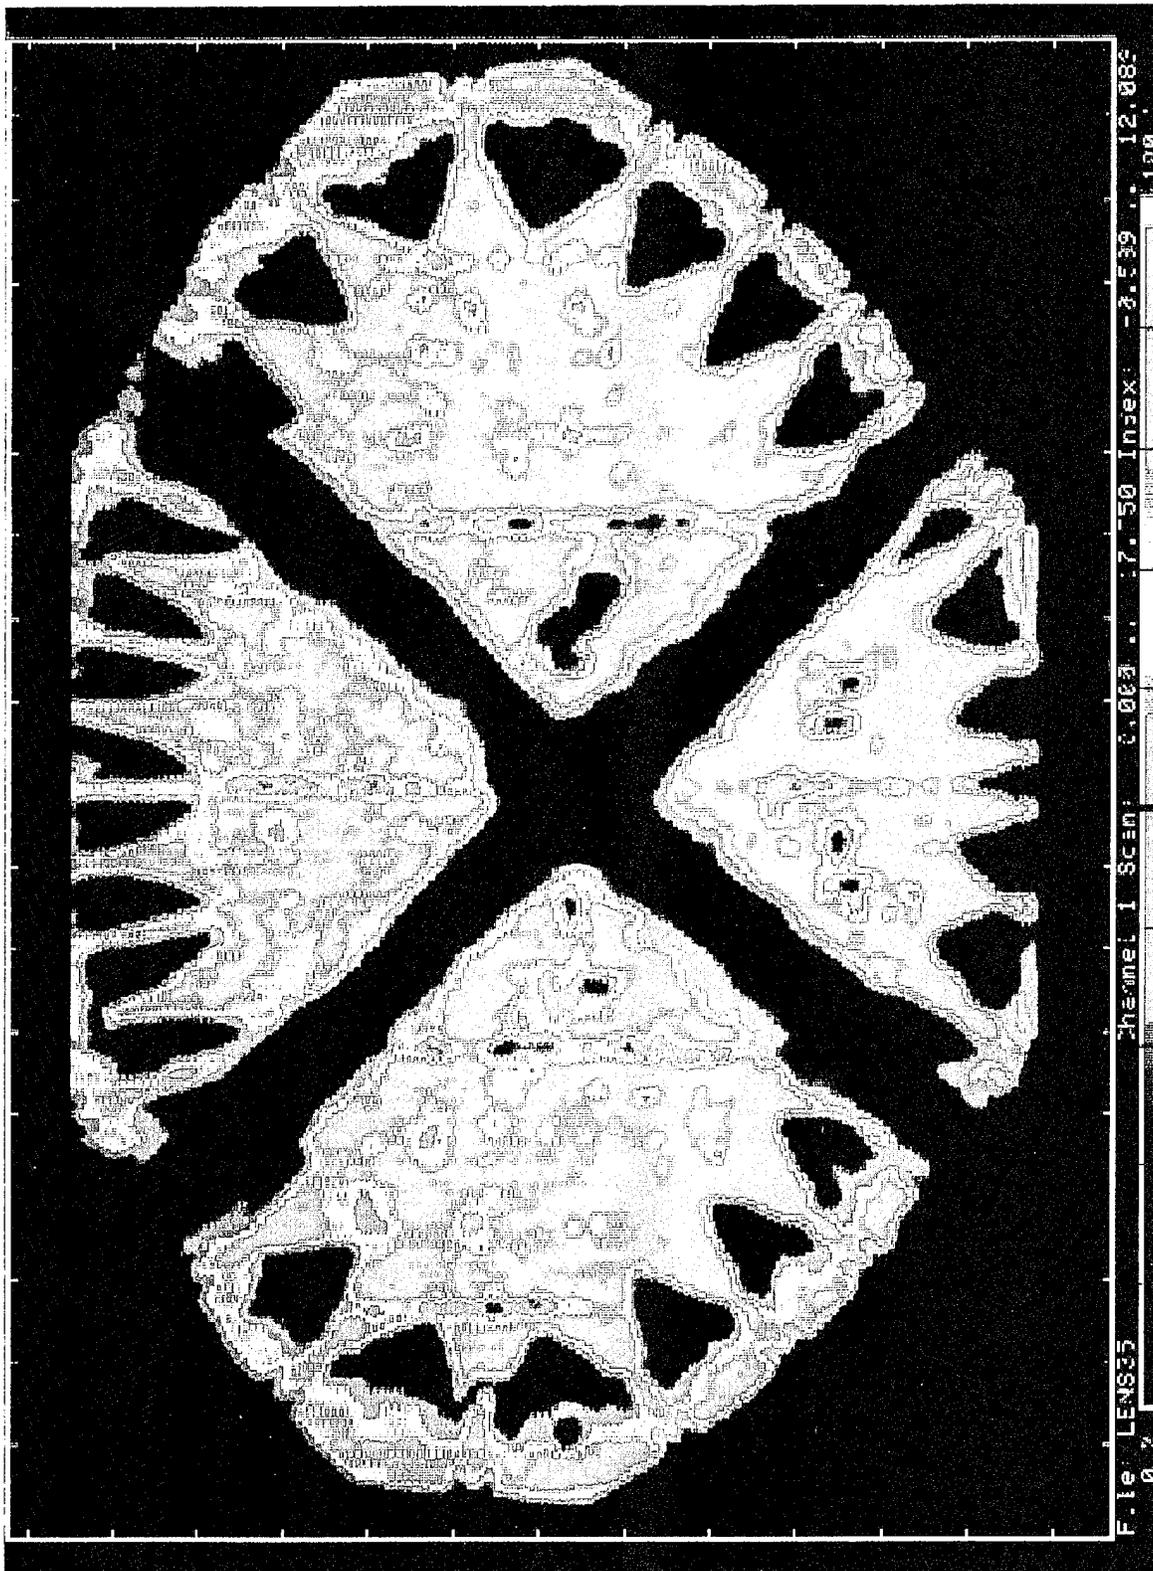
The scan of lens C for 5 MHz is shown in Figure 11. As above, the results of the measurements at all the frequencies were similar, so only one result is shown. Evidence of possible voids can be seen between all the matching transformers, along the milling overlap lines, and scattered throughout the body of the lens. In lenses C and D, field probe holes were drilled from each side through the external aluminum plate into the dielectric layer to allow a small probe to be inserted for measuring electromagnetic wave propagation within the lens. Figures 11 and 12 showing the scan data can be compared to the scale drawing in Figure 13 for location of the 1/4 inch mounting holes, the dielectric splice and the field probe holes. The field probe holes appear oval on the scans because the image of each hole represents both that of the hole and the two adjacent screw mounting holes, and these individual features could not be resolved by the scan process. A detail of this is also shown in Figure 13. Twelve holes were drilled in each side of the lens, in four sets of three. Each set lies along a line between the centre of the lens on the beam port side and the antenna port side. A very wide region of suspicion surrounds both axes of the splice, with an apparent opening at each end of each axis. This may indicate some problem during manufacture.

Figure 11 Final Scan of Rotman Lens RL 1.10C at 5 MHz
Four Board Construction

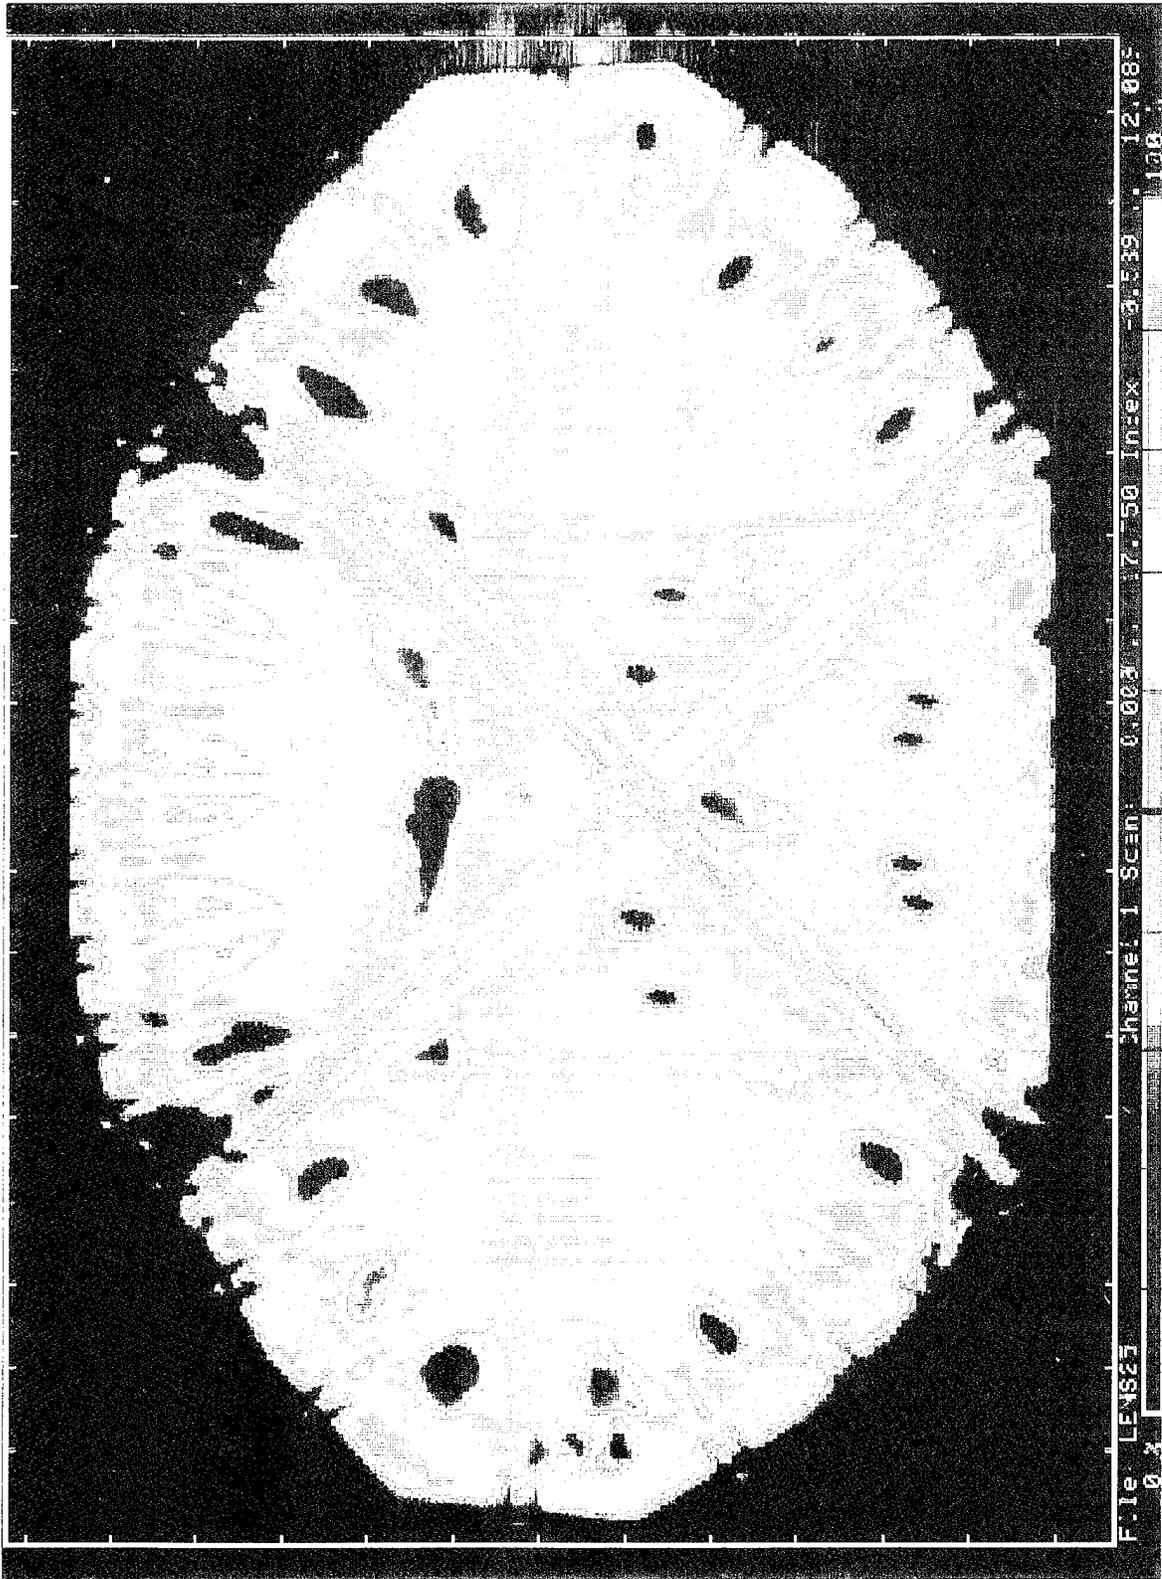
Figure 12 Final Scan of Rotman Lens RL 1.10D at 5 MHz
Four Board Construction, Polished

Figure 12 shows the results of the scan of Lens D for 5 MHz. As above, only the one result is shown because of the similarity of the results at the different frequencies. By comparing the scans to Figure 13, the locations of some of the field probe holes can be identified. The holes closest to the beam port side and toward the centre of the lens can be readily located. The holes closest to the antenna ports in each of the sets are difficult to locate because they are hidden by the anomalies at the edge of the lens. The milling overlap lines, vertical in this case, can be seen, but are not dominant. The splices are clearly visible, forming two "X" shaped crosses on each of the scans. It is assumed that the splice in each layer will have the same colour on the C-scan; splice A-B is pink in the scans and splice C-D is red. There is a misalignment between the splices in the upper and lower layers. Several significant suspect areas can be seen in the interior of the lens adjacent to the dielectric splice, and there appears to be some sort of irregularity in the lens at each end of each dielectric splice. Possible cavities between the matching transformers are also evident in the scan of lens D, and the image of each of the two 0.25 inch mounting holes has been merged with the returns from anomalies between adjacent output transformers.

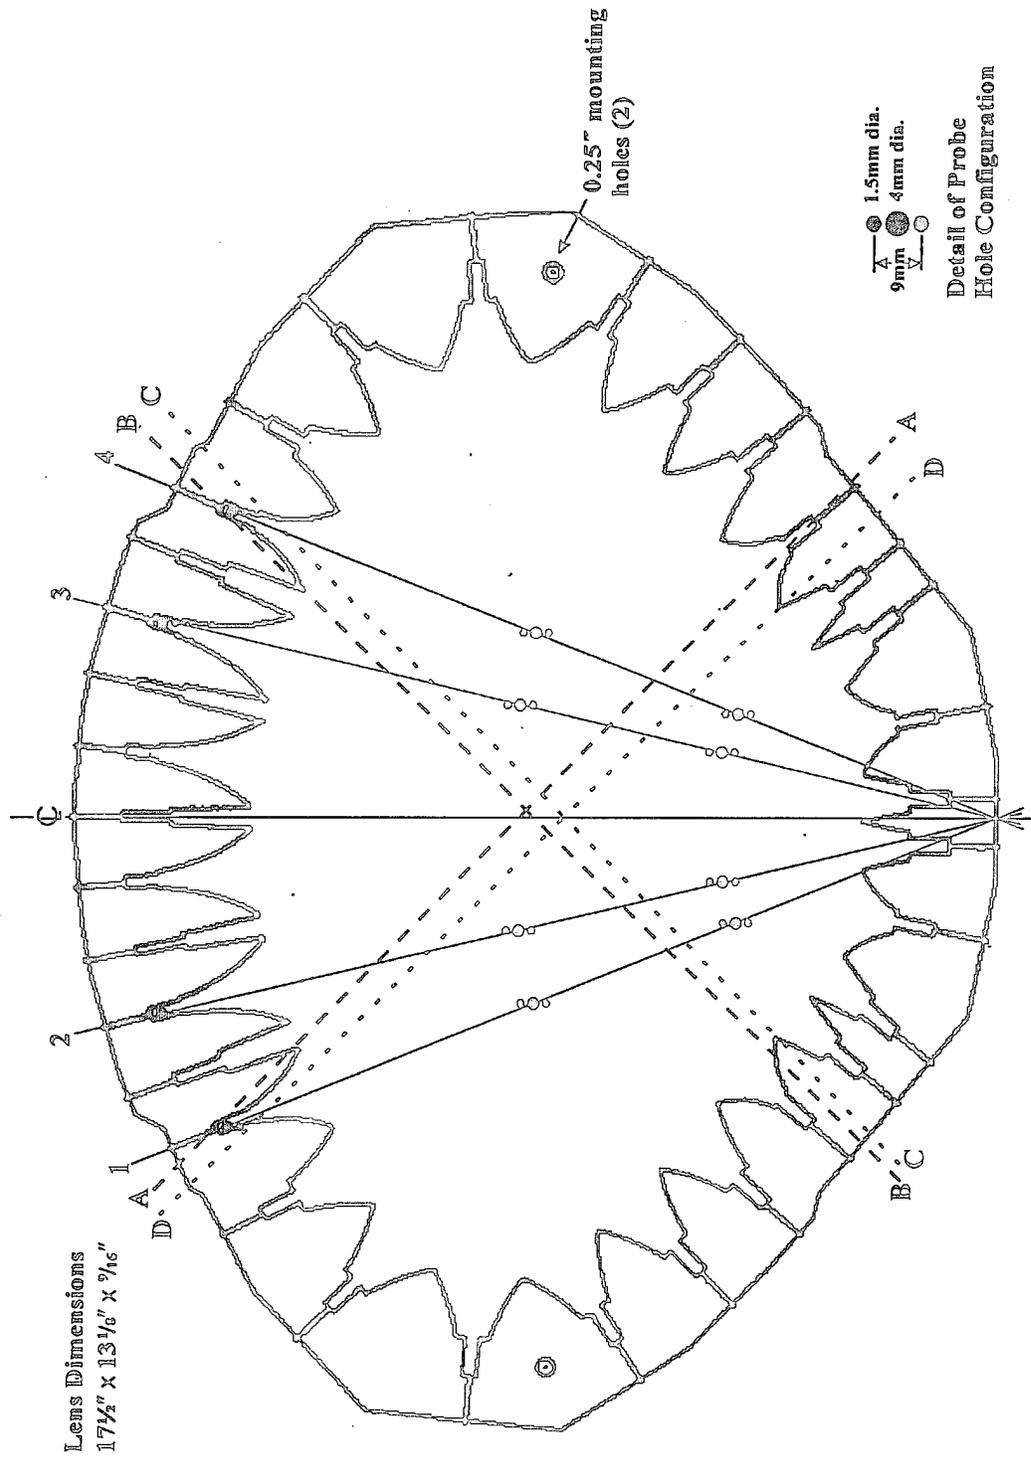
Figure 13 Stripline Contour of Small Rotman Lens Showing Location of Field Probe Holes and Dielectric Splice.
