EVALUATION OF ROTMAN LENSES FOR SPACE-BASED RADAR

DEFENCE RESEARCH ESTABLISHMENT OTTAWA
REPORT NO. 1271

December 1995
Ottawa

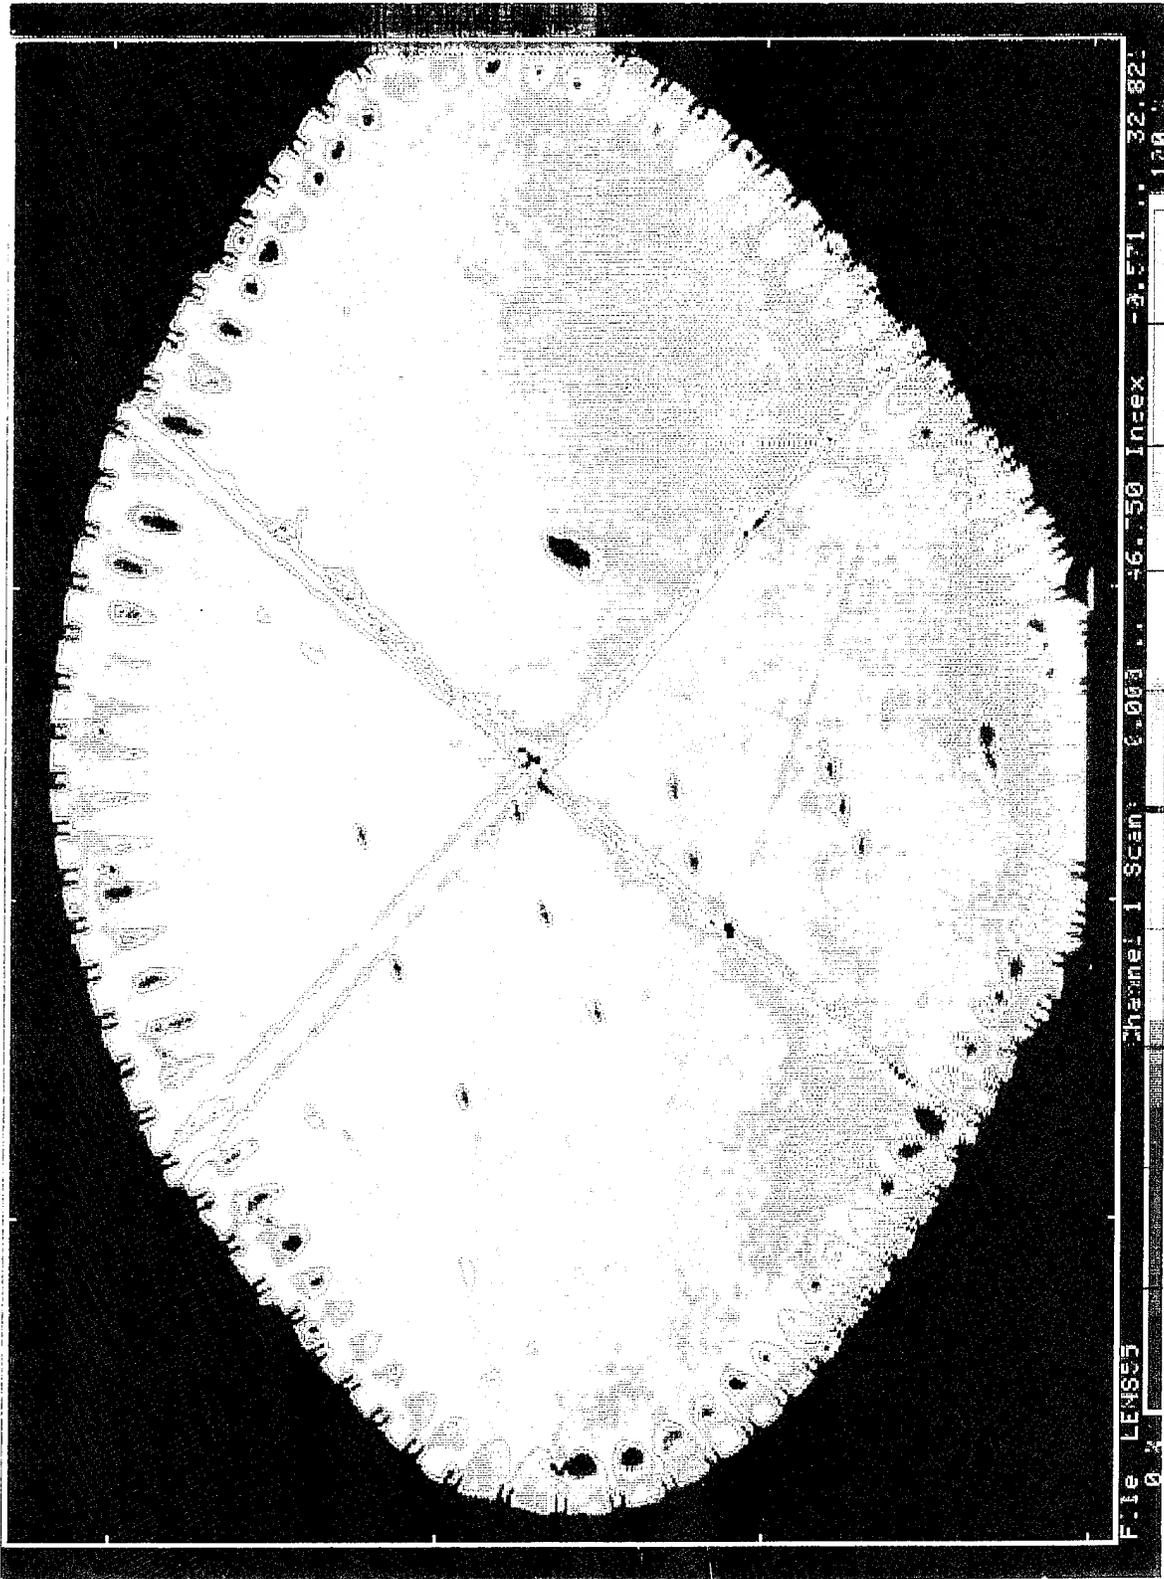
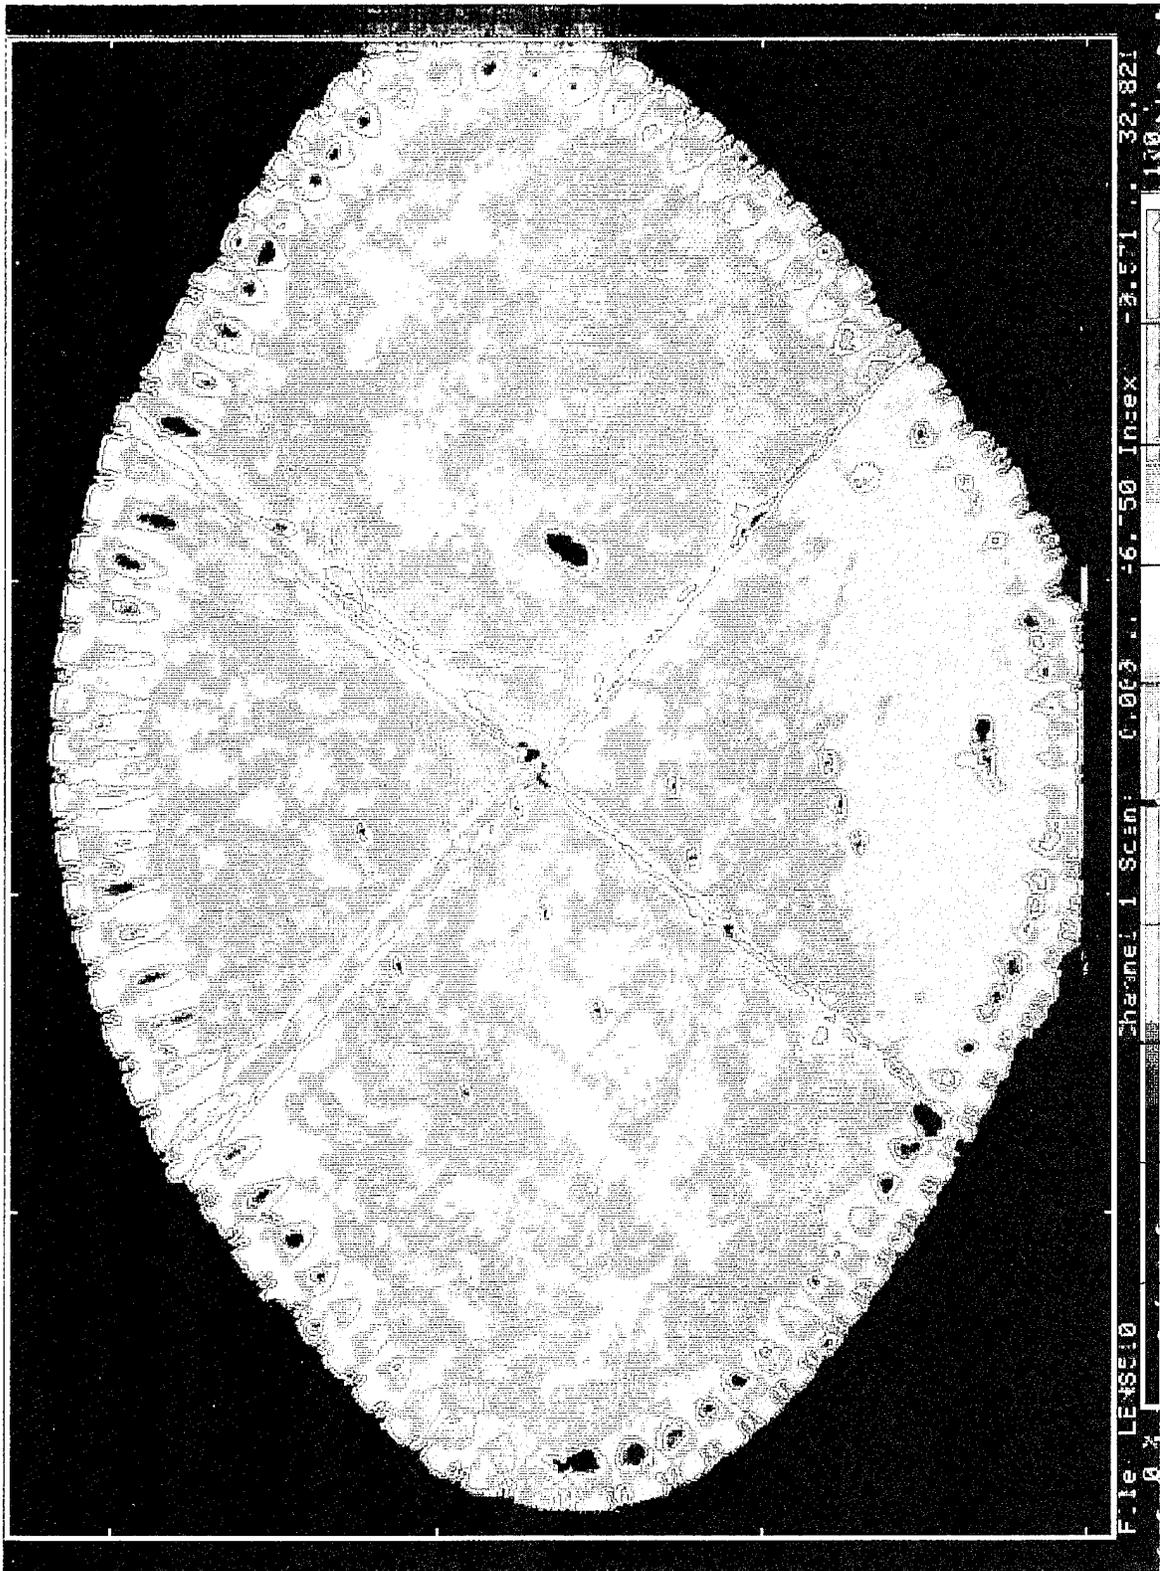
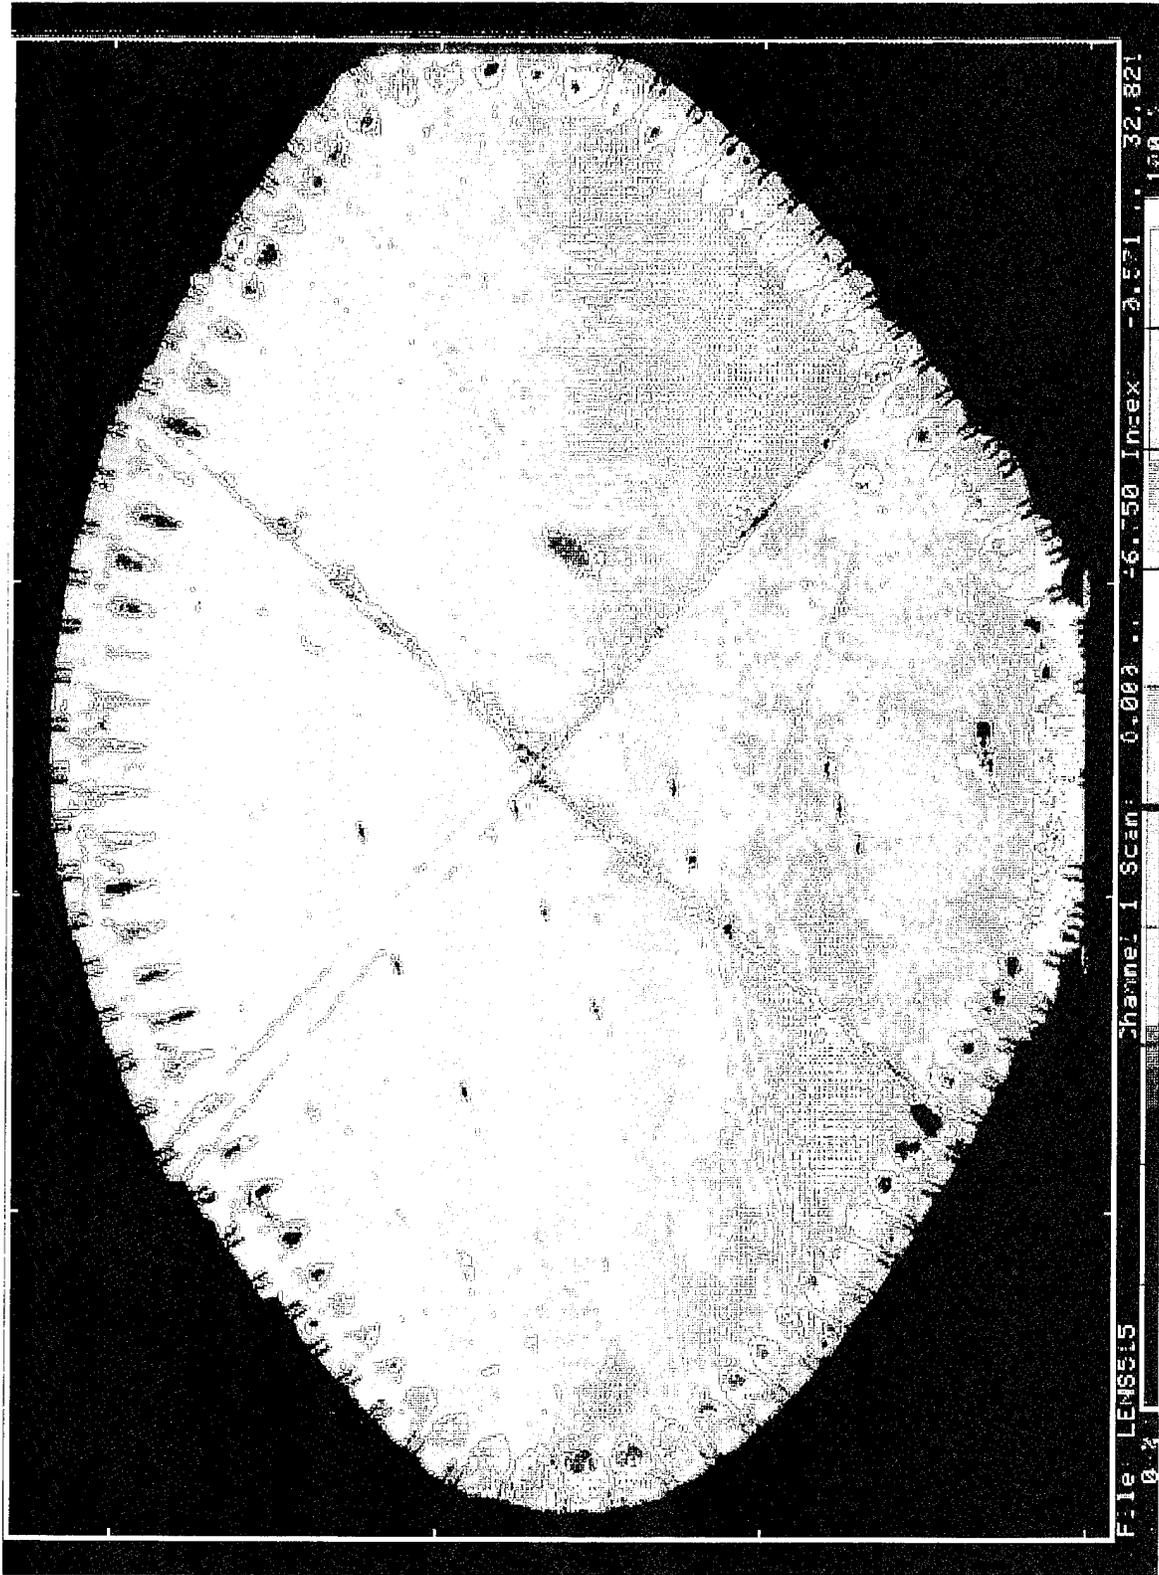
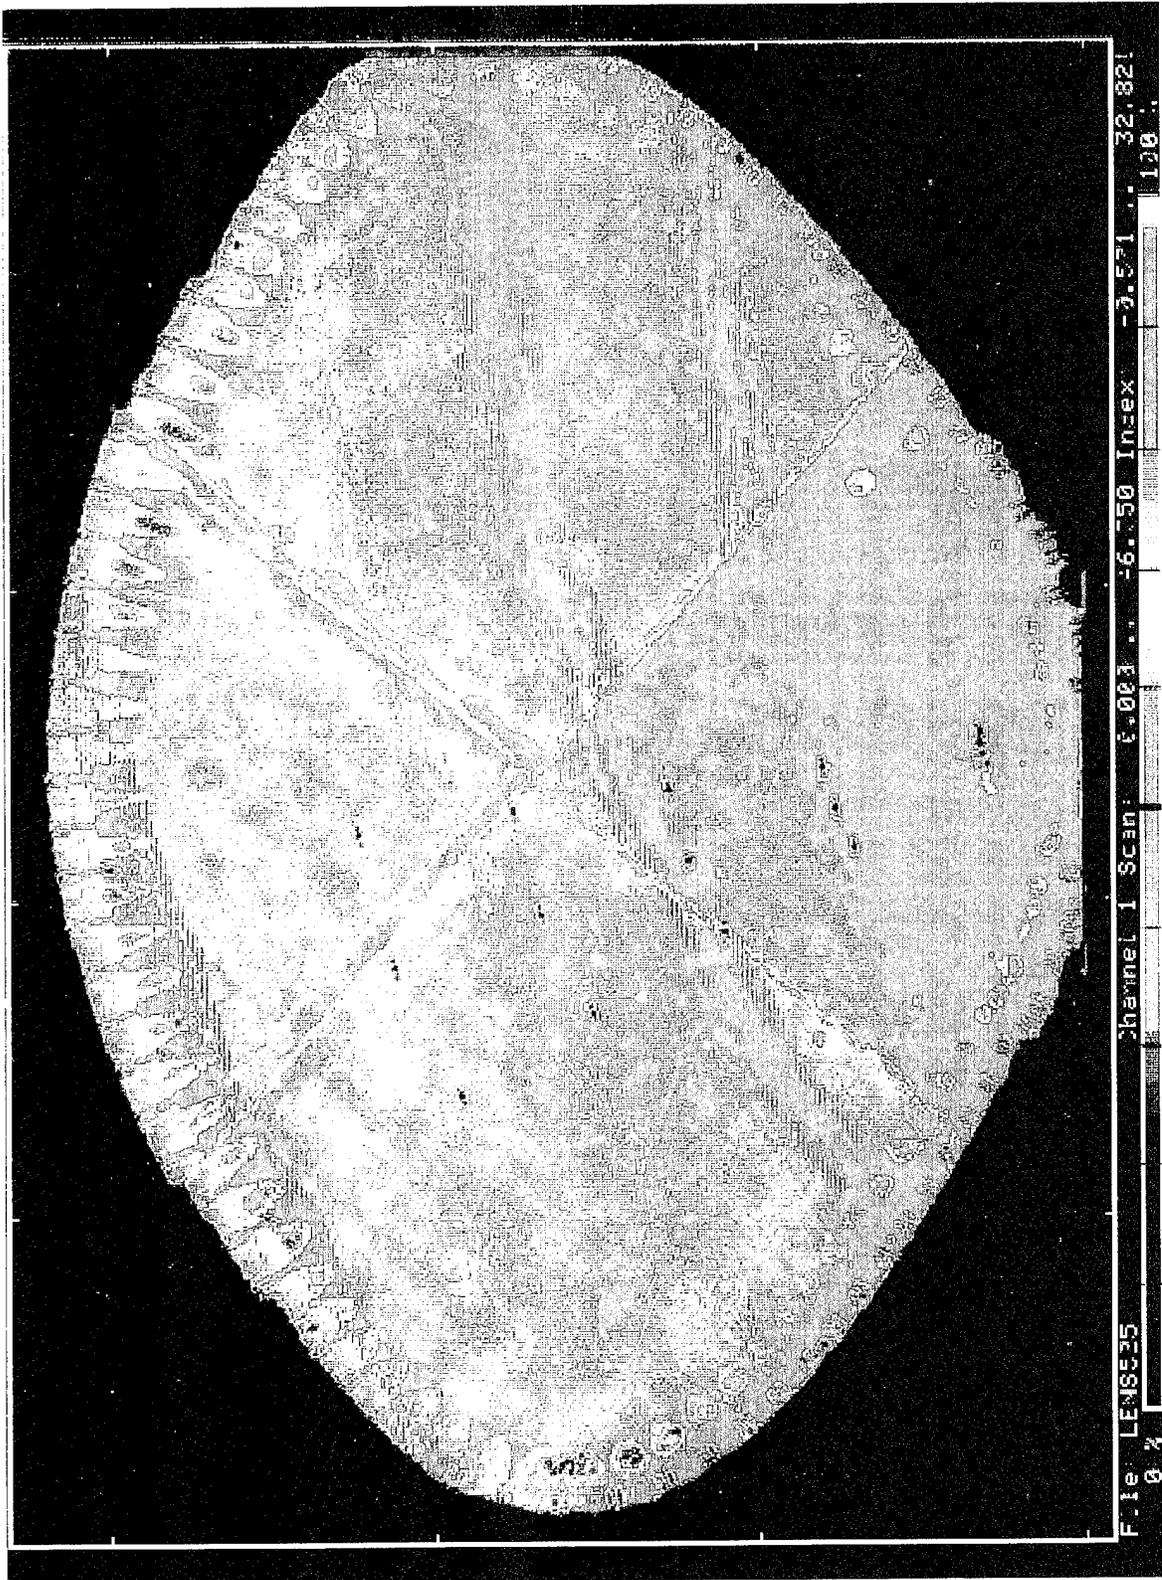
The scans of the large Rotman lens are in Figures 14 to 17. Significant potential voids can be seen, primarily along the splice lines, between the impedance matching transformers, and in one other area. Eighteen field probe holes were drilled along three lines on each side of the lens, extending from the beam port side to the antenna port side. Those closest to the beam port side are close together, and cannot be resolved. The third hole in the first set lies on a splice line and cannot be resolved, and the furthest holes lie between impedance matching transformers, and can be found by careful inspection due to their characteristic shape. The location of the probe holes and the splices is indicated in Figure 18.

Figure 14 Final Scan of Large Rotman Lens at 5 MHz
Four Board Construction, Not Polished

Figure 15 Final Scan of Large Rotman Lens at 10 MHz
Four Board Construction, Not Polished

Figure 16 Final Scan of Large Rotman Lens at 15 MHz
Four Board Construction, Not Polished

Figure 17 Final Scan of Large Rotman Lens at 25 MHz
Four Board Construction, Not Polished

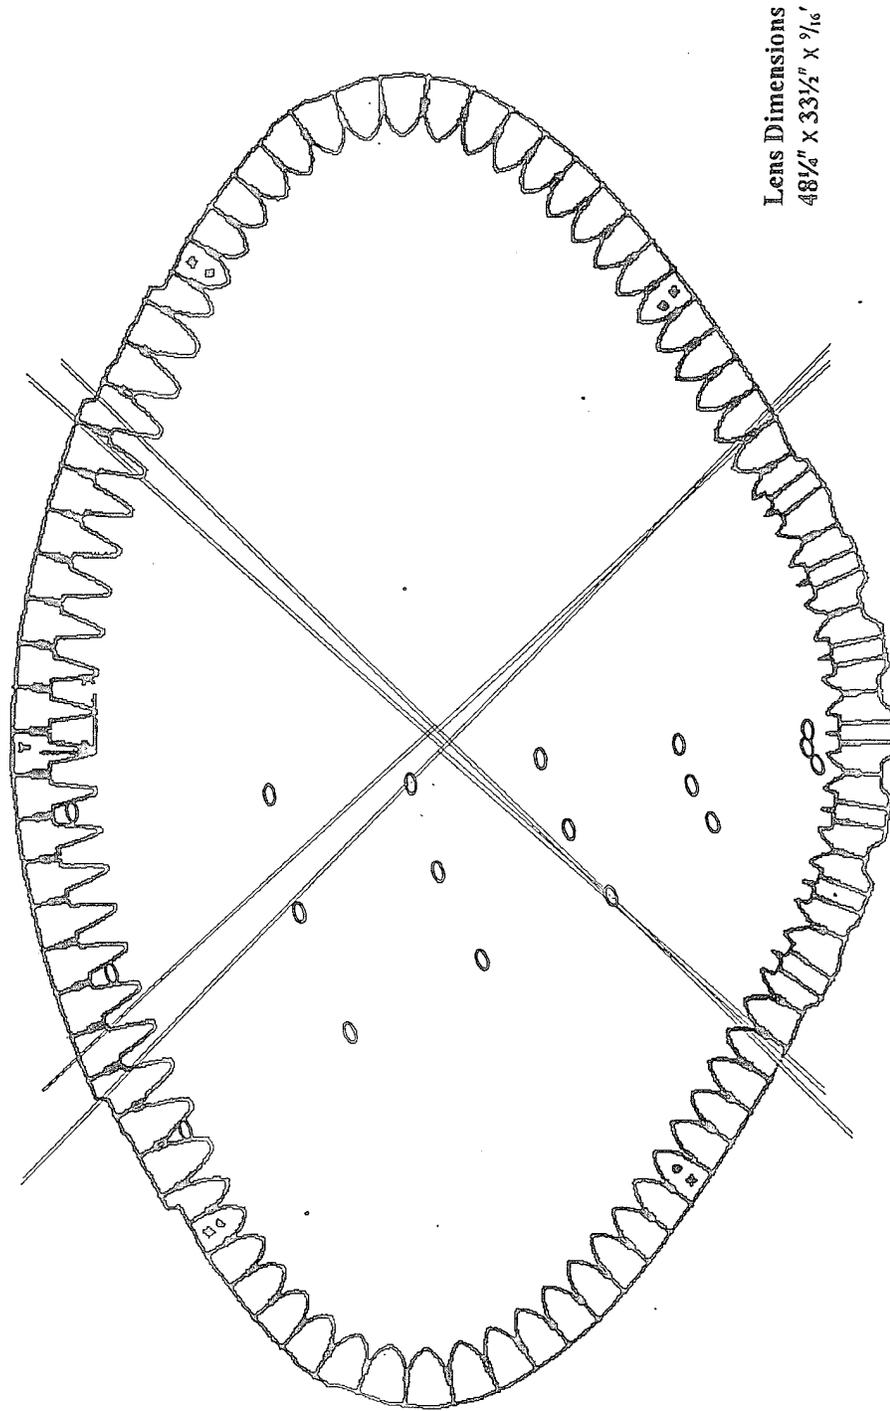
Figure 18 Stripline Contour of Large Rotman Lens Showing Location of Field Probe Holes and Dielectric Splice.

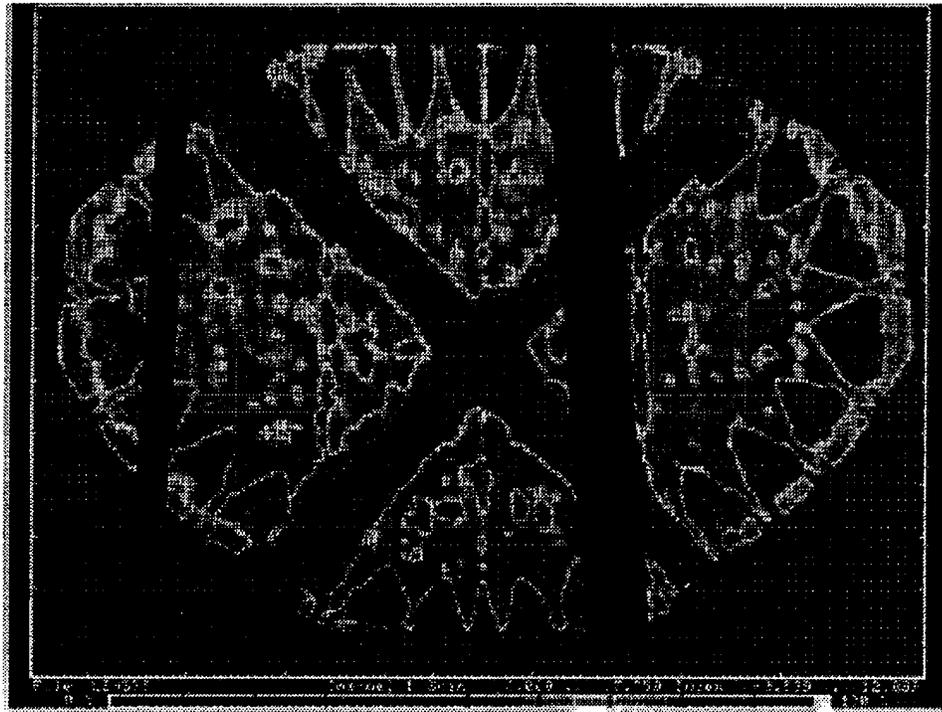
Following the verification of the integrity of the scanning process, an additional cut in the lens was made. The locations of the two cuts are shown in Figure 20. The narrower vertical cut on the left was made for the verification of the integrity of the ultrasonic scanning process, described above, and the wider vertical cut on the right was for producing the specimens for examination. The "X" shaped pattern in the centre of the lens is the discontinuity associated with the splice.

Figure 20 Ultrasonic Scan of Rotman Lens RL 1.10C Showing Cutting Lines for Metallurgical Inspection

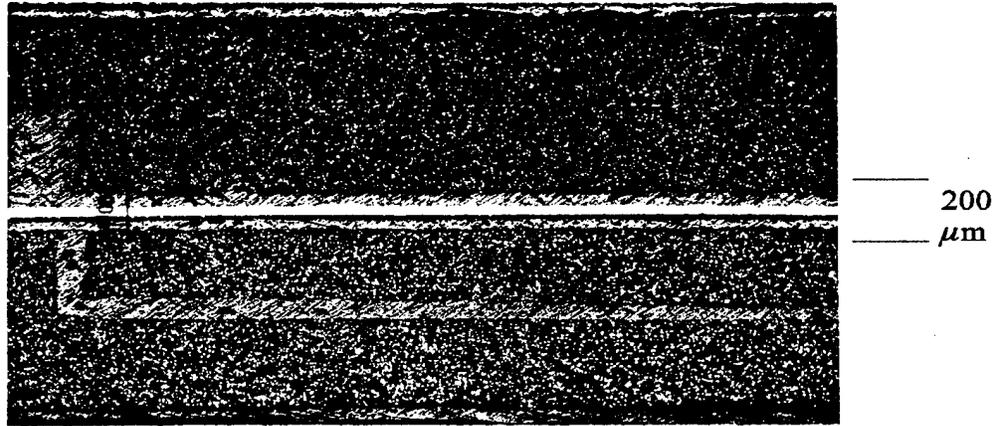
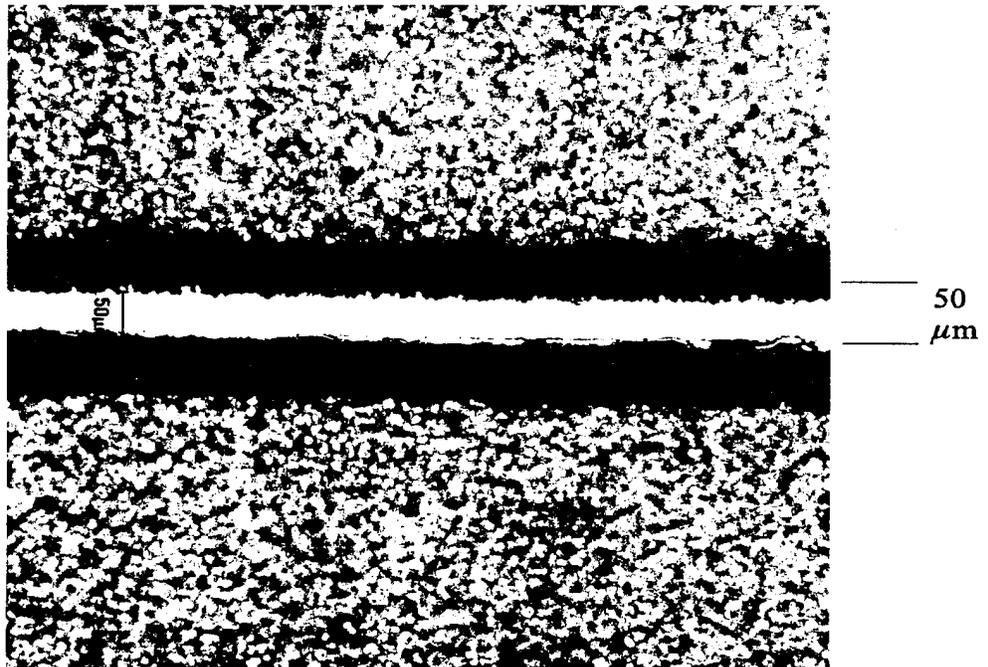
Figure 21 is a cross-section of the splice area, and it clearly shows the inside edges of the external aluminum plates, the adhesive layers, the dielectric material, and the copper sheeting. The interfaces between the different layers can be seen, and appear to be clean and intact, especially in comparison to the other specimens. It can be seen that, in the area of the splice, the thickness of the adhesive layers joining the fingers of the splice within the top and bottom layers of the particular section shown is inconsistent. On the top layer the adhesive is about 12 μm thick, while on the bottom layer it is about 50 μm thick. Also, in the top layer, the space at the end of one of the fingers has been filled with adhesive. The lower photo shows the detail of the boundaries between the copper sheeting and the dielectric. The thickness of the adhesive is uniform, and the interface is without air gaps or disbond. It should be noted that the copper sheeting is actually approximately 40 μm thick, rather than 20 μm (corresponding to 0.0007" shown in Figure 4). The thickness of the dielectric and the adhesive is consistent with that shown in Figure 4.

Figure 21 Optical Micrographs of the Cross-Section of the Splice Area of Lens C

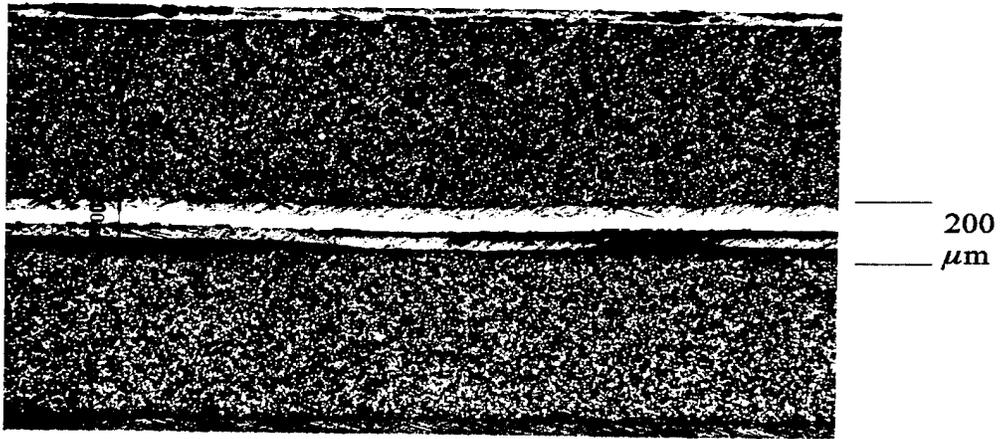
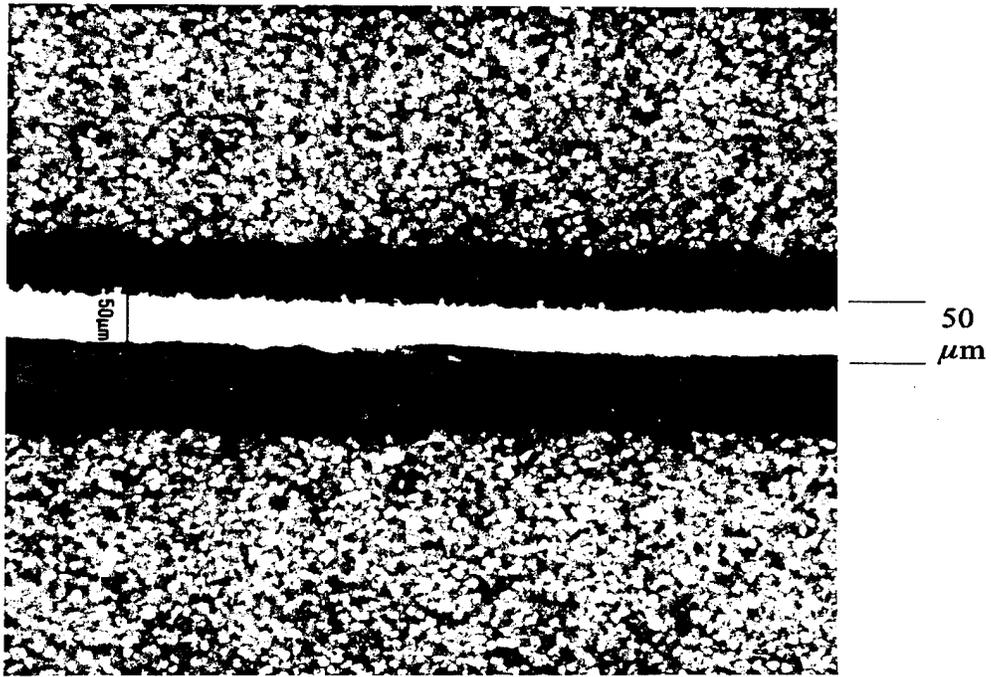
Figure 22 Optical Micrographs of the Cross-Section of Lens C Showing Air Gaps Along the Dielectric/Adhesive Interface

In Figure 22, air gaps can be seen along the interface between the dielectric material and the adhesive. For the most part, the boundary between the adhesive and the copper foil was without air gaps. The air gaps were as wide as 30 microns and their locations matched the locations of the flaws on the C-scans. It is unlikely that these gaps were generated during the cutting or polishing processes, since other regions of the same specimen were good, similar to those shown in Figure 21.

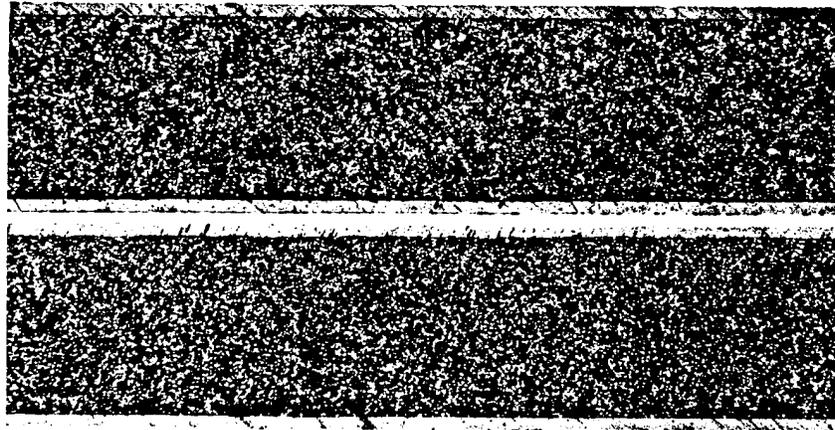
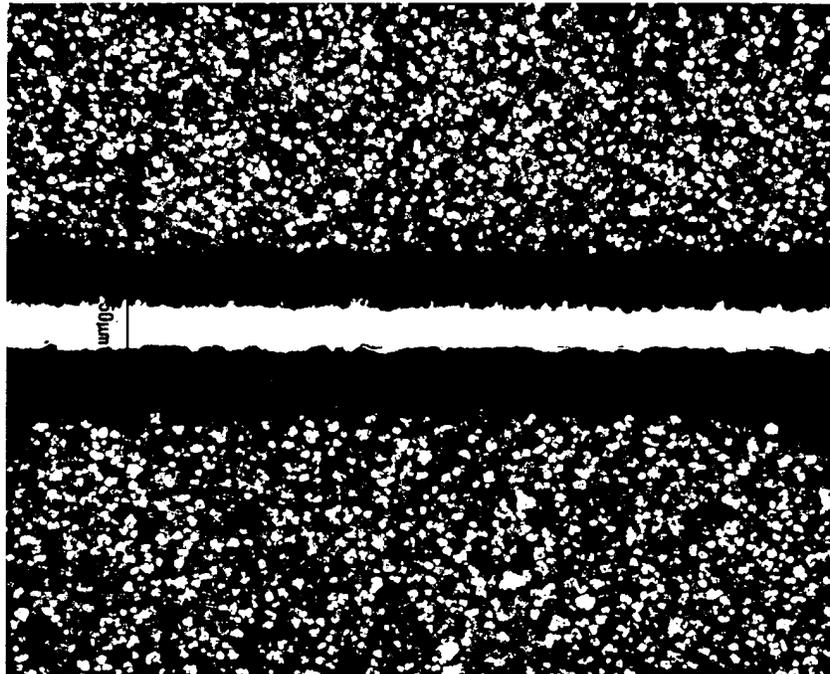
Figure 23 Optical Micrographs of the Cross-Section of Lens C Showing Disbond Between the Dielectric Material and the Adhesive

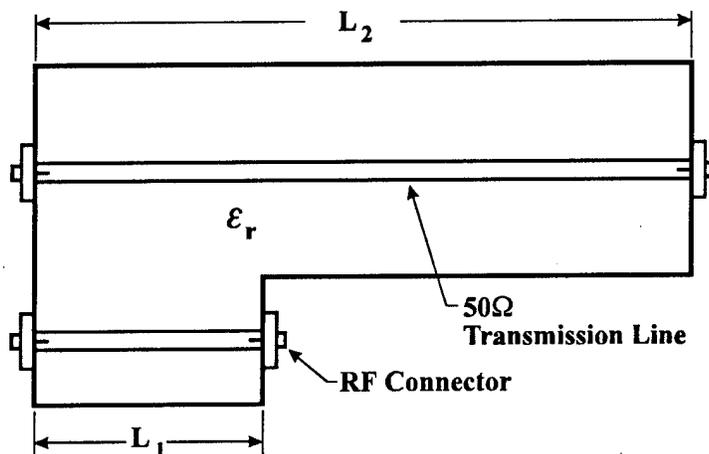
For the measurement of the effective dielectric constant of the material within the substrate, two transmission lines having the same impedance are etched onto a substrate, with one of them substantially longer than the other. This large difference in the length of the lines serves to increase the difference in transit time and rate of phase change with frequency between the lines. The setup for the measurement of the dielectric constant using two lines is illustrated in Figure 24 for 50 ohm transmission lines. Connections are made to the lines through end-launch RF connectors. In the case of transmission lines having an impedance that differs from 50 ohms, transitions are necessary so that the lines are matched to the source and load impedances to minimize reflections.

Figure 24 Experimental Setup for the Two Line Method

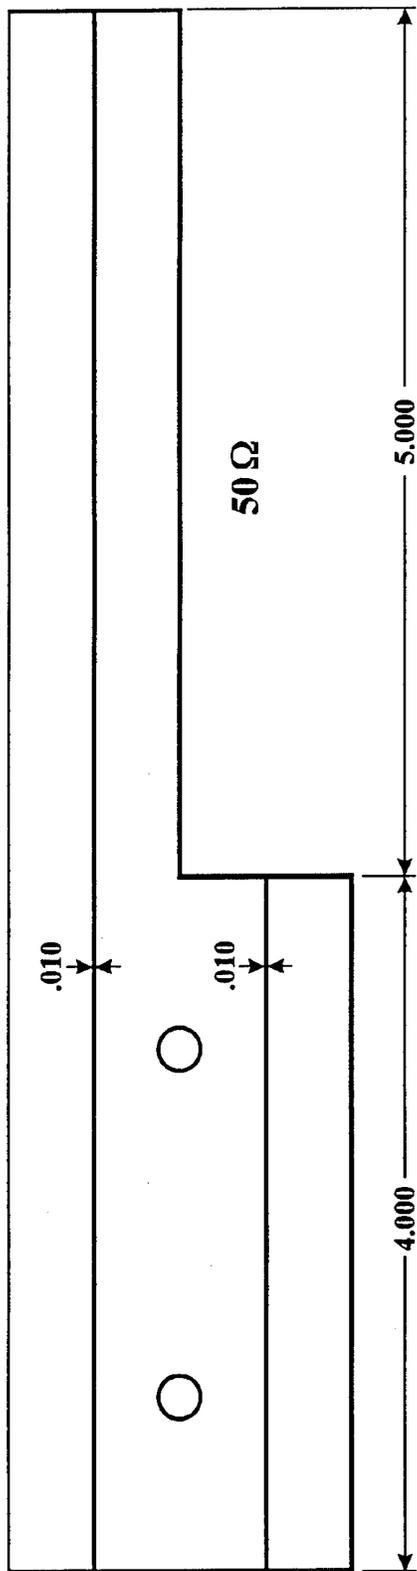
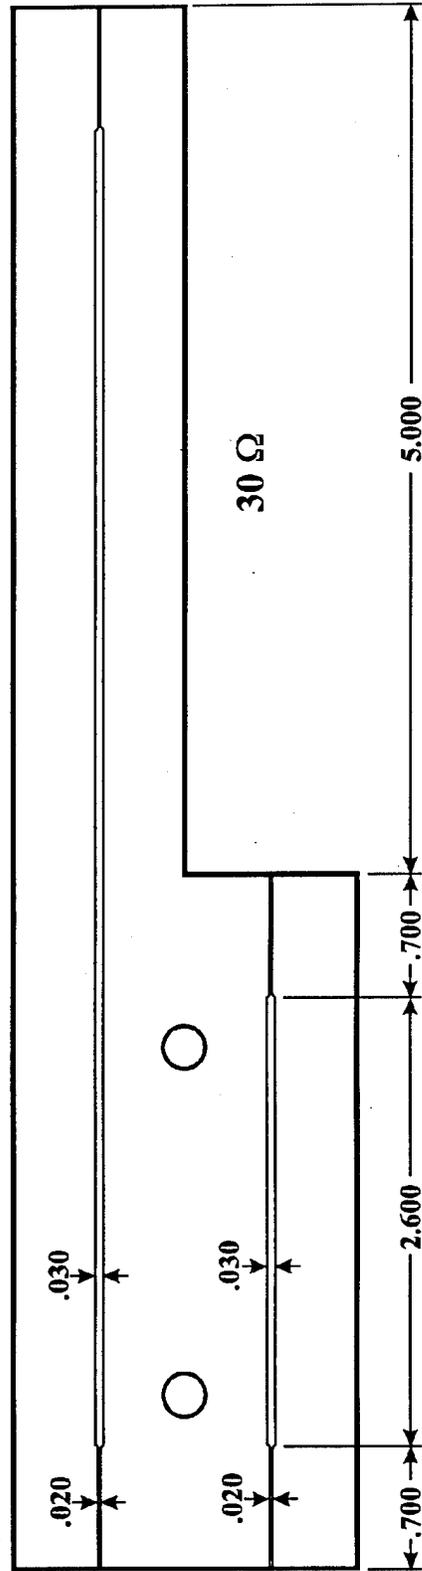
Figure 25. Dielectric Constant Measurement Using 30 and 50 Ohm Lines

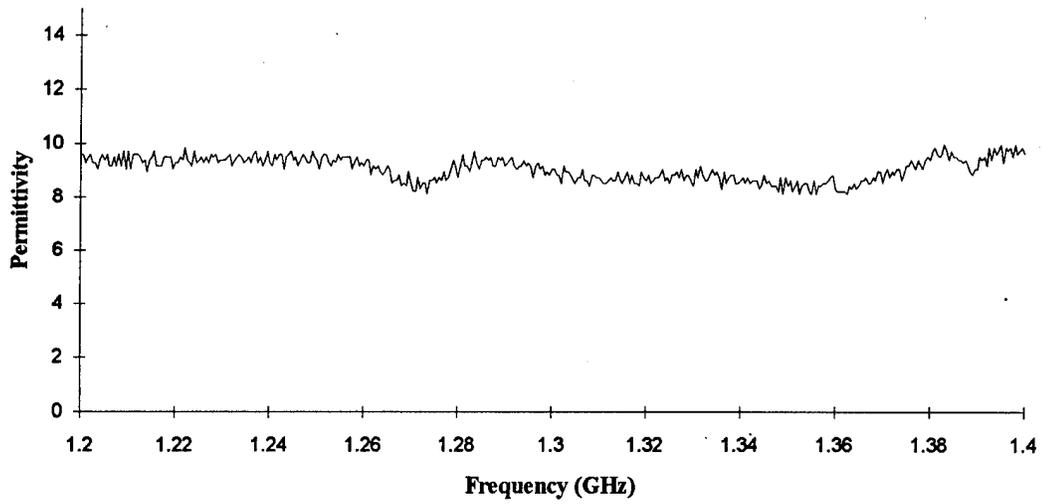
In Section 3.2, two different methods were described for the determination of the permittivity of the dielectric. One of these was based on the measurement of the difference in the delay of the two transmission lines and used Equation (2), and the other on the rate of change of the difference of the phase of the two lines as the frequency is changed, using Equation (6). Figures 27 and 28 are plots of the permittivity of the dielectric derived from the measurement of lines having a characteristic impedance of 50 ohms; the curve in Figure 27 is derived from the delay data, and that in Figure 28 on the phase data. It can be seen that the average

Figure 27 Permittivity Based on Delay Data for 50 Ohm Lines

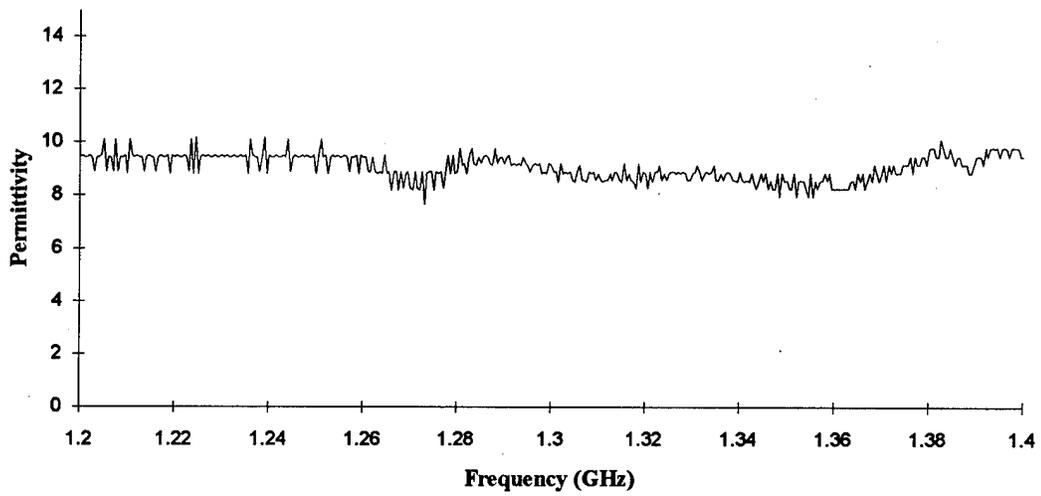
Figure 28 Permittivity Based on Phase Data for 50 Ohm Lines

variations as the frequency is varied are similar. In the curve derived from the phase data, however, the permittivity appears to have a tendency to take on discrete values; the reason for this is not understood, although it is expected that it might be a function of the measurement process, or be a result of some constraint of the measurement process. It was not investigated further. The permittivity values for the dielectric using 30 and 1 ohm lines were determined from the delay data. Figure 29 is a plot of the difference between the curves of Figures 27 and 28. The mean difference appears to be close to zero, indicating that the values track well, but it is important to notice that substantial variations between the two methodologies have occurred. Because 1000 readings were taken at each frequency, the differences were deemed not to be as a result of random time domain fluctuations in the readings. The differences up to 1.0 are significant, as the dielectric constant must be known much more accurately than that in order to obtain repeatable results after the fabrication of devices. In addition, in order to balance the Rotman lens, the dielectric constant must be within a few percent in order to prevent the signals in the upper and lower layers of the stripline structure from differing significantly in phase. For consistency, the permittivity obtained from the delay data is taken as being representative of the true values.

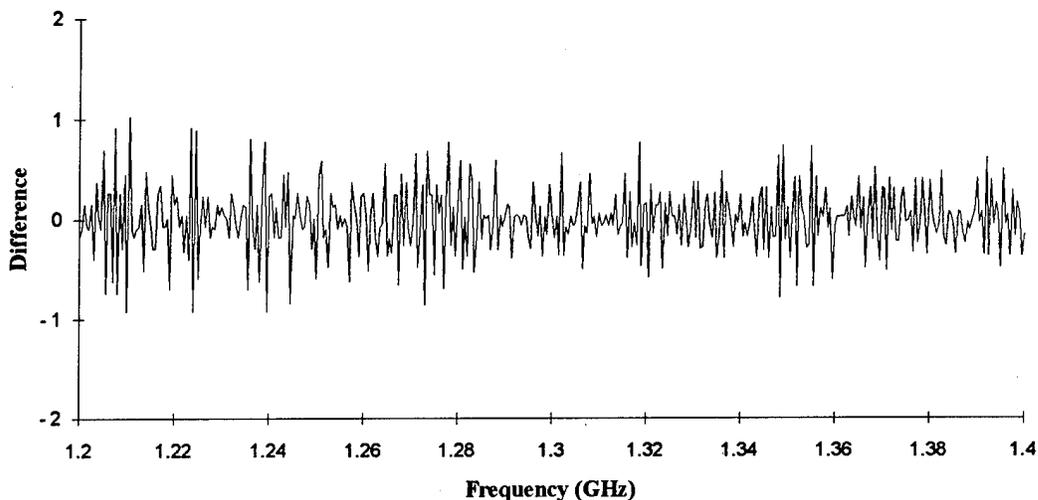
Figure 29 Difference in Permittivity From Delay and Phase Data on 50 Ohm Lines

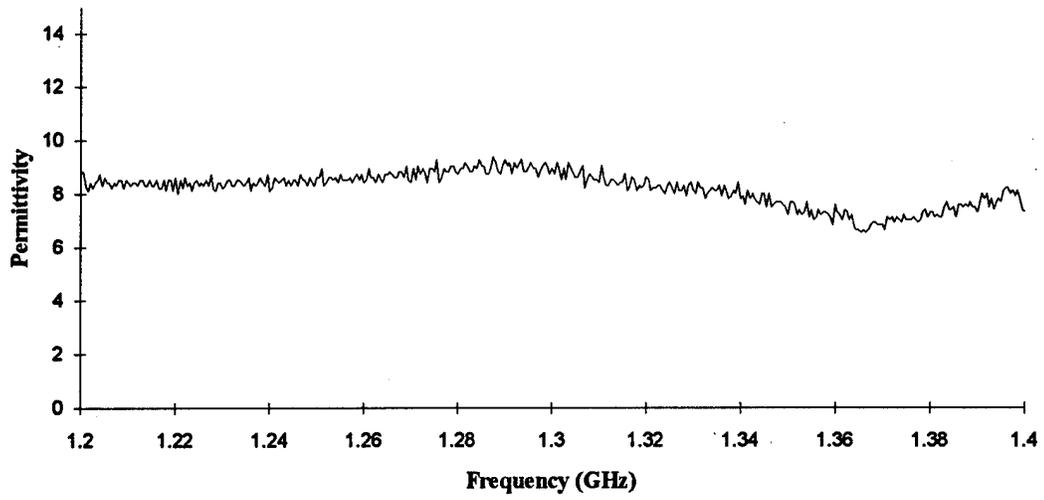
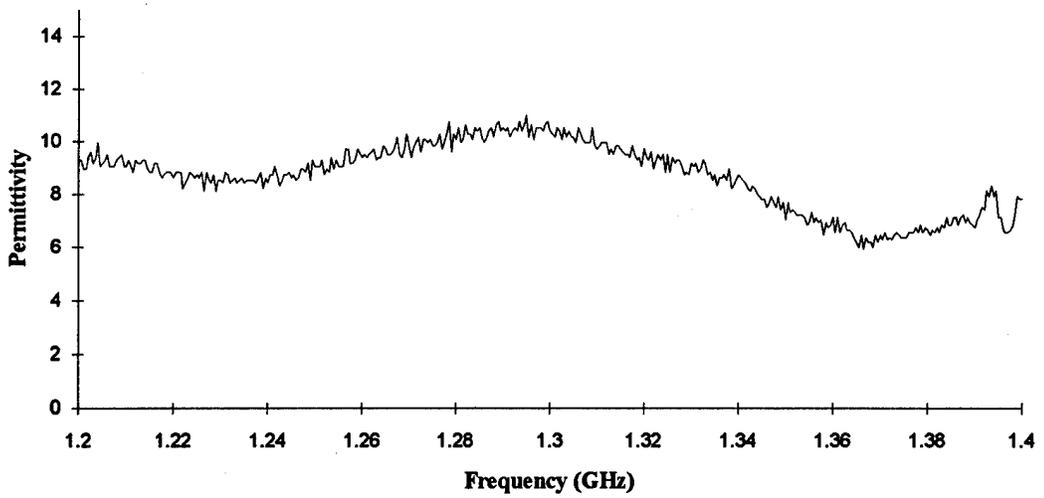
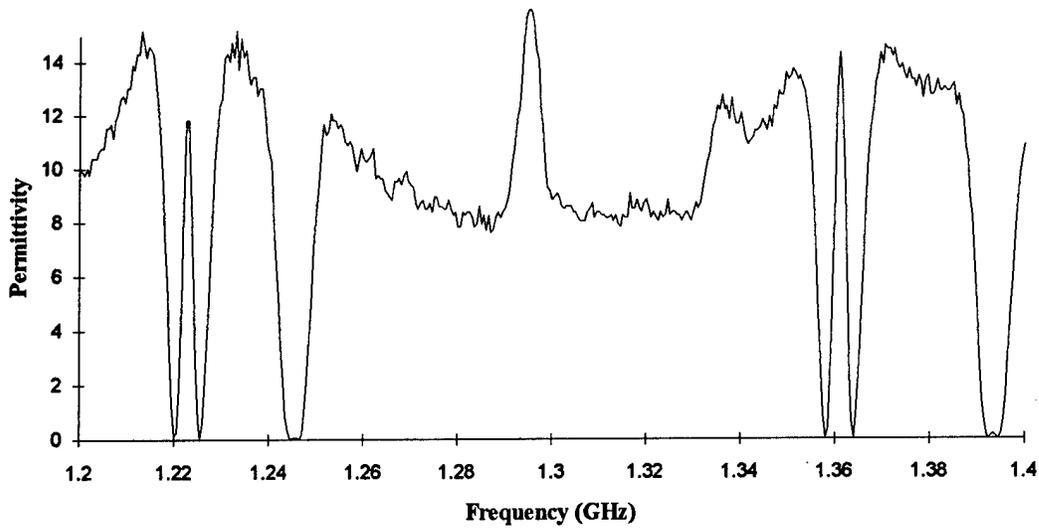
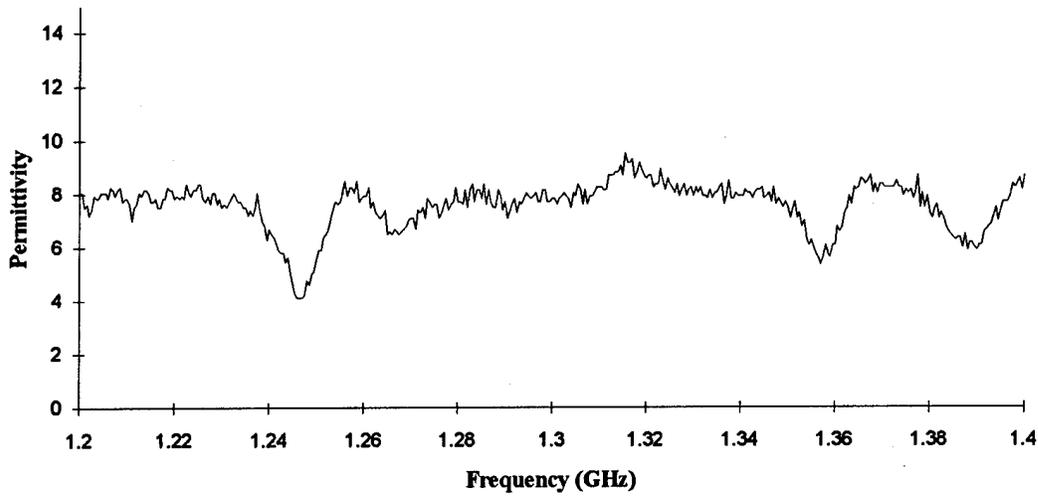
The permittivity of the dielectric obtained through the analysis of the delay data from 30 and 1 ohm lines has also been obtained. It is shown in Figures 30 to 33. Structures were fabricated by Buckbee-Mears, St. Paul, MN, and CMR, Montreal, PQ. There is some consistency in the values obtained. For 50 ohm lines, the average permittivity is the highest, dropping somewhat for the 30 ohm lines, and reaching its lowest value for the 1 ohm lines. The two curves for 30 ohm lines show local maximum values near 1.3 GHz, and minimum values near 1.37 GHz. There seems to be a problem with the 1 ohm transmission line structure made by Buckbee-Mears. It

**Figure 30 Permittivity Based on Delay Data for 30 Ohm Lines
Fabricated by Buckbee-Mears, St. Paul, MN**

**Figure 31 Permittivity Based on Delay Data for 30 Ohm Lines
Fabricated by CMR, Montreal, PQ**

**Figure 32 Permittivity Based on Delay Data for 1 Ohm Lines
Fabricated by Buckbee-Mears, St. Paul, MN**

**Figure 33 Permittivity Based on Delay Data for 1 Ohm Lines
Fabricated by CMR, Montreal, PQ**

has a number of deviations from the average. In an attempt to investigate these, the measurements were repeated with different cables and cables of different lengths. It is possibly caused by interactions at the connector, or inadequate bonding of the structure. Spar Aerospace also reported this problem in their contract report.⁽¹¹⁾
