NASA TN D-2685

SEALED-FOAM, CONSTRICTIVE-WRAPPED,
EXTERNAL INSULATION SYSTEM
FOR LIQUID-HYDROGEN TANKS
OF BOOST VEHICLES

by Lewis Research Center Staff
Lewis Research Center
Cleveland, Ohio

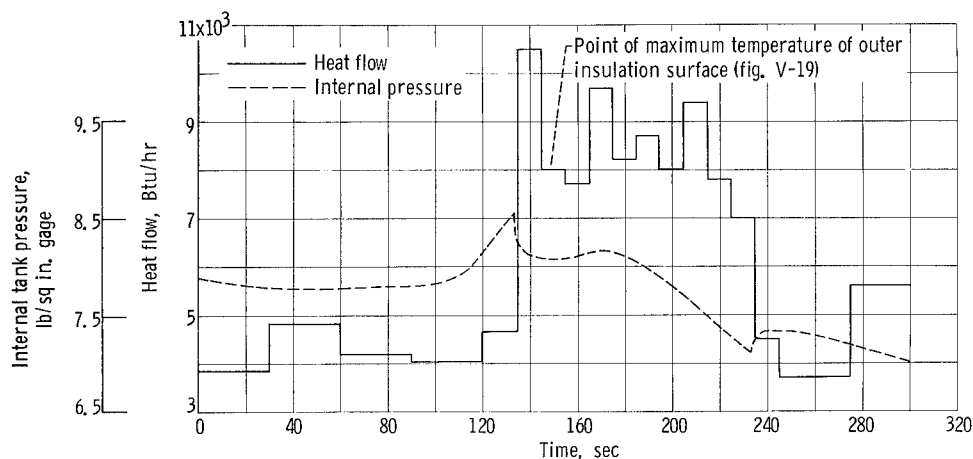
Figure V-22. - Heat flow and internal tank pressure during quasi-simulated launch test of insulation system 4 (table V-III, test C).

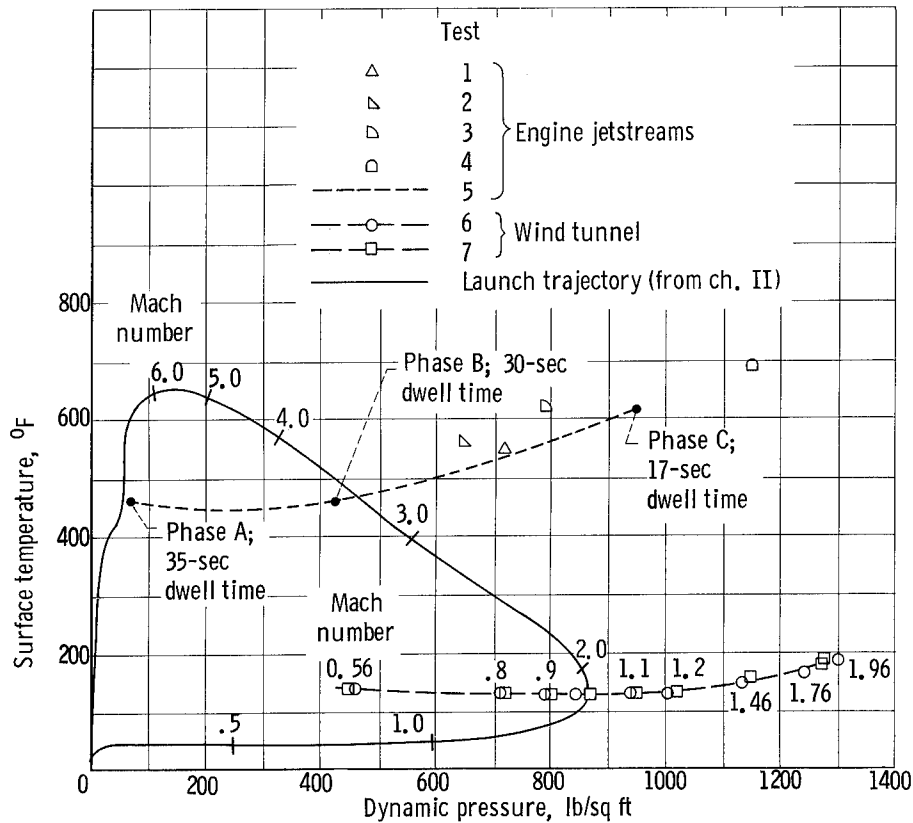
Figure VI-11. - Dynamic pressure and surface temperature on test specimens in aerodynamic heating tests.

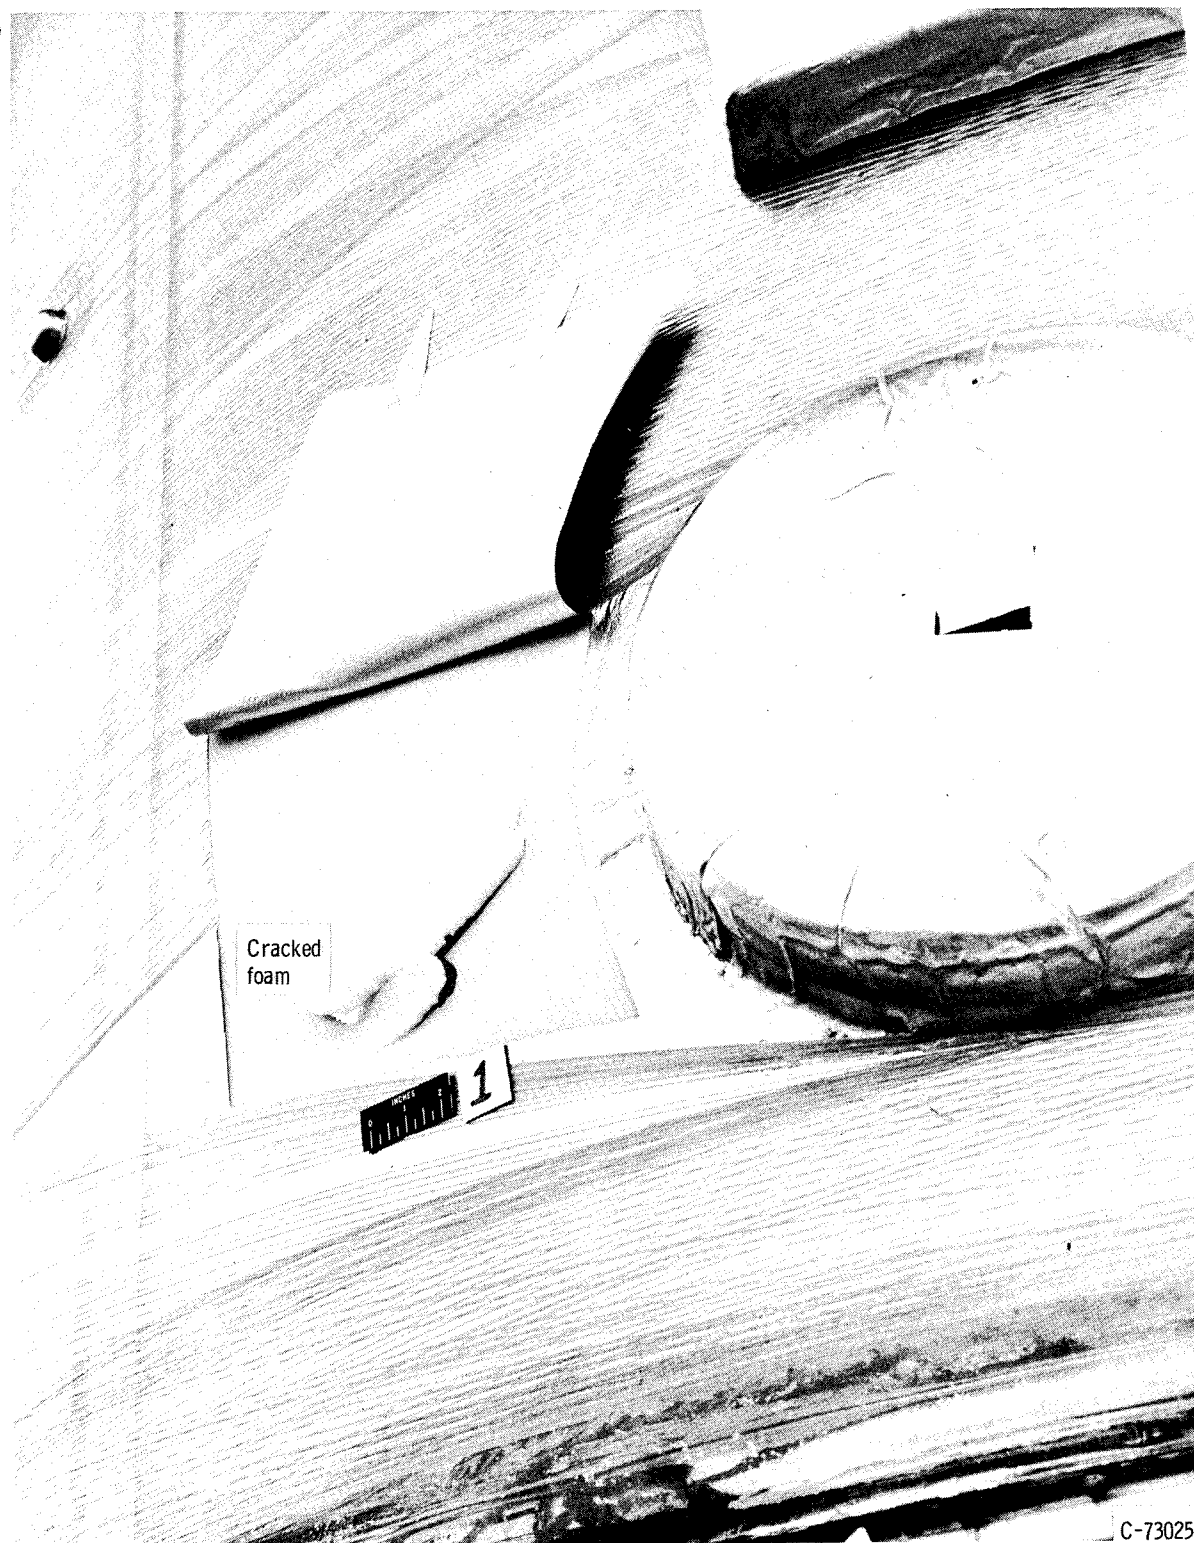
(b) MAM laminate folded back exposing cracked foam.

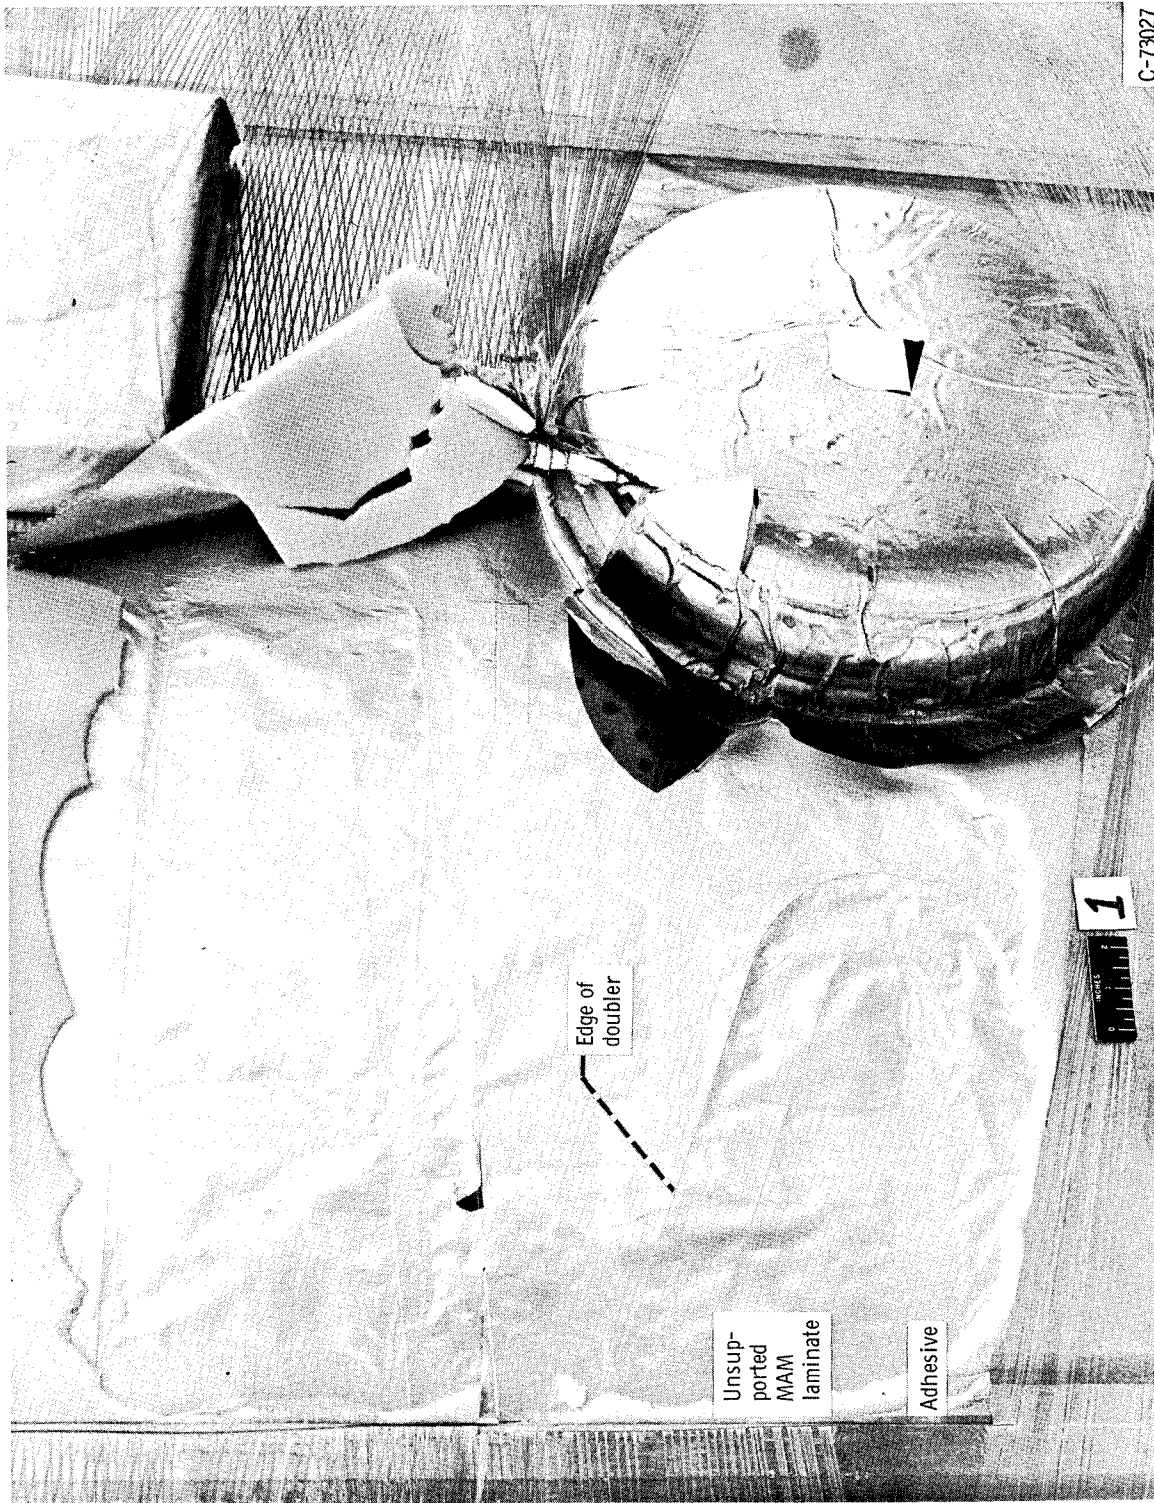
(d) Inside layer of MAM laminate exposed showing impression of doubler.

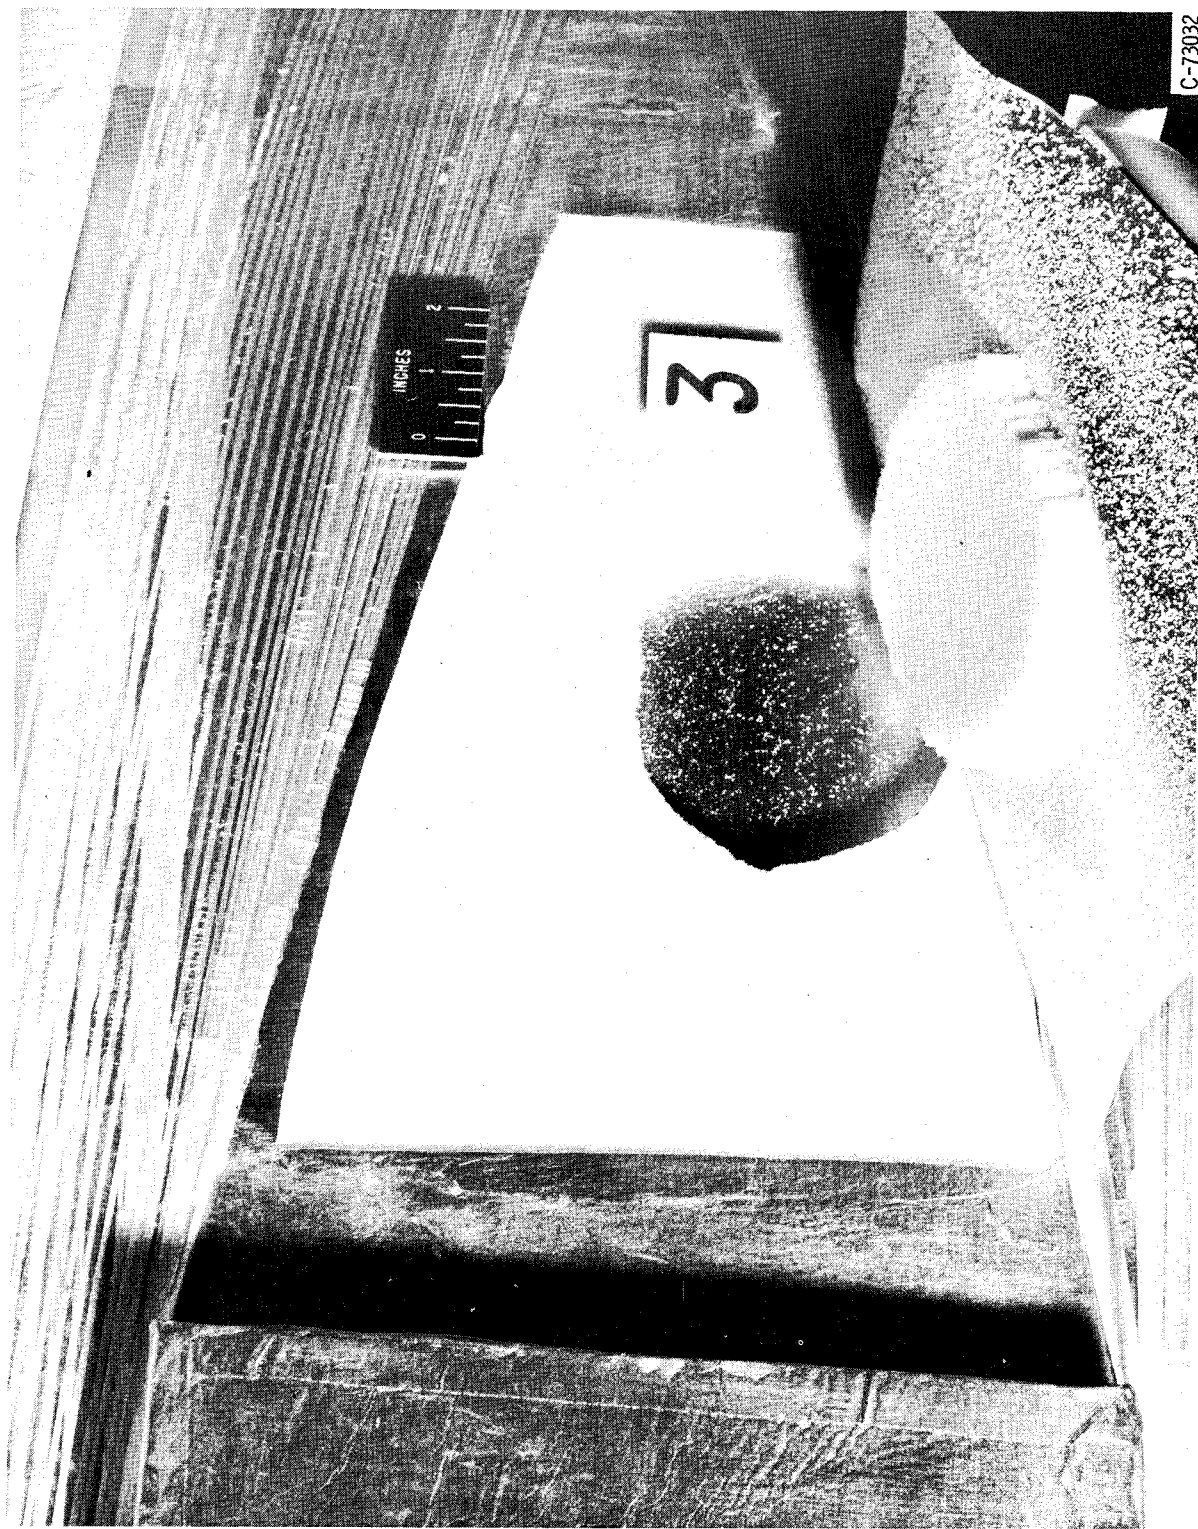
(b) MAM laminate and cracked foam folded back.
