**FINAL REPORT**  
**INVESTIGATION OF SMOOTH-BONDED METAL LINERS**  
**FOR GLASS FIBER FILAMENT-WOUND PRESSURE VESSELS**

Prepared for  
NATIONAL AERONAUTICS AND SPACE ADMINISTRATION  
May 1967  
CONTRACT NAS 3-6293

NASA CR-72165

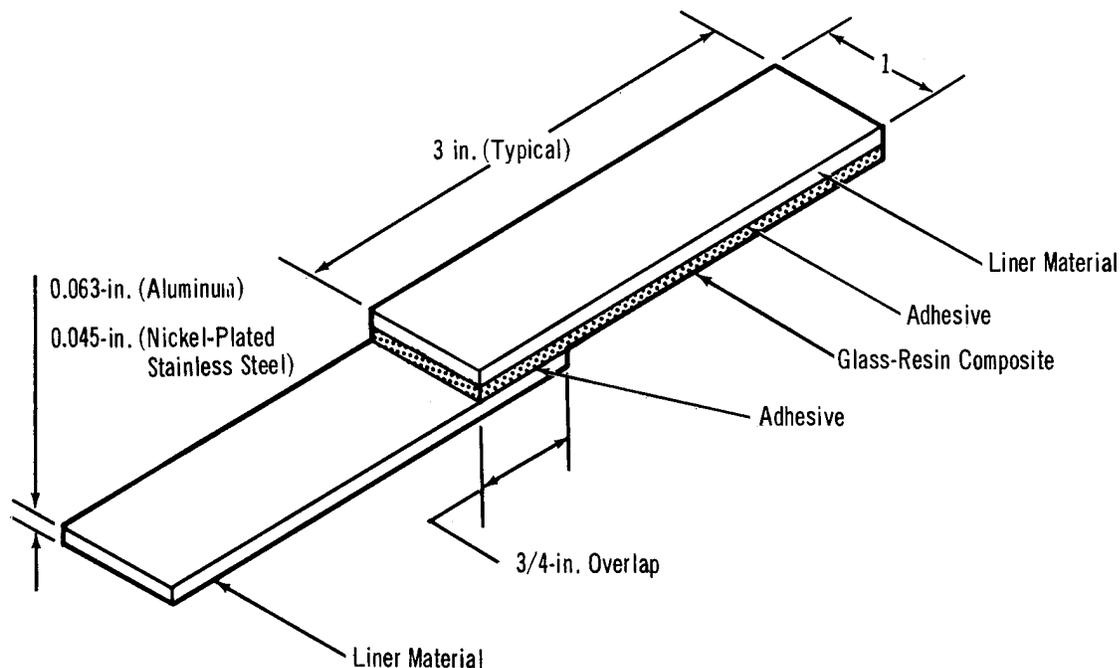
Figure 5. Adhesive Tensile Shear Test Specimen

Tensile-lap shear testing: The test specimen consisted of three components: the metallic adherends, the adhesive system, and the preimpregnated fiber-glass tape. The components were arranged as shown in figure 5.

The specimen was constructed to represent as closely as possible the bonded structure of the filament-wound pressure vessel. The bond overlap was lengthened to 3/4 in. from the standard 1/2 in. called for in ASTM D 1002-64T. The inclusion of a fabric within the bond line, plus the introduction of the epoxy-glass composite surface as one of the adherends, complicated the 1/2 in. overlap area to the extent that an increase in the bonding area was deemed necessary to provide an accurate representation of the bonded structure. The composite surface, which was used as one of the adherends, was prepared from two plies of preimpregnated tape, which had been bonded to a metal coupon.

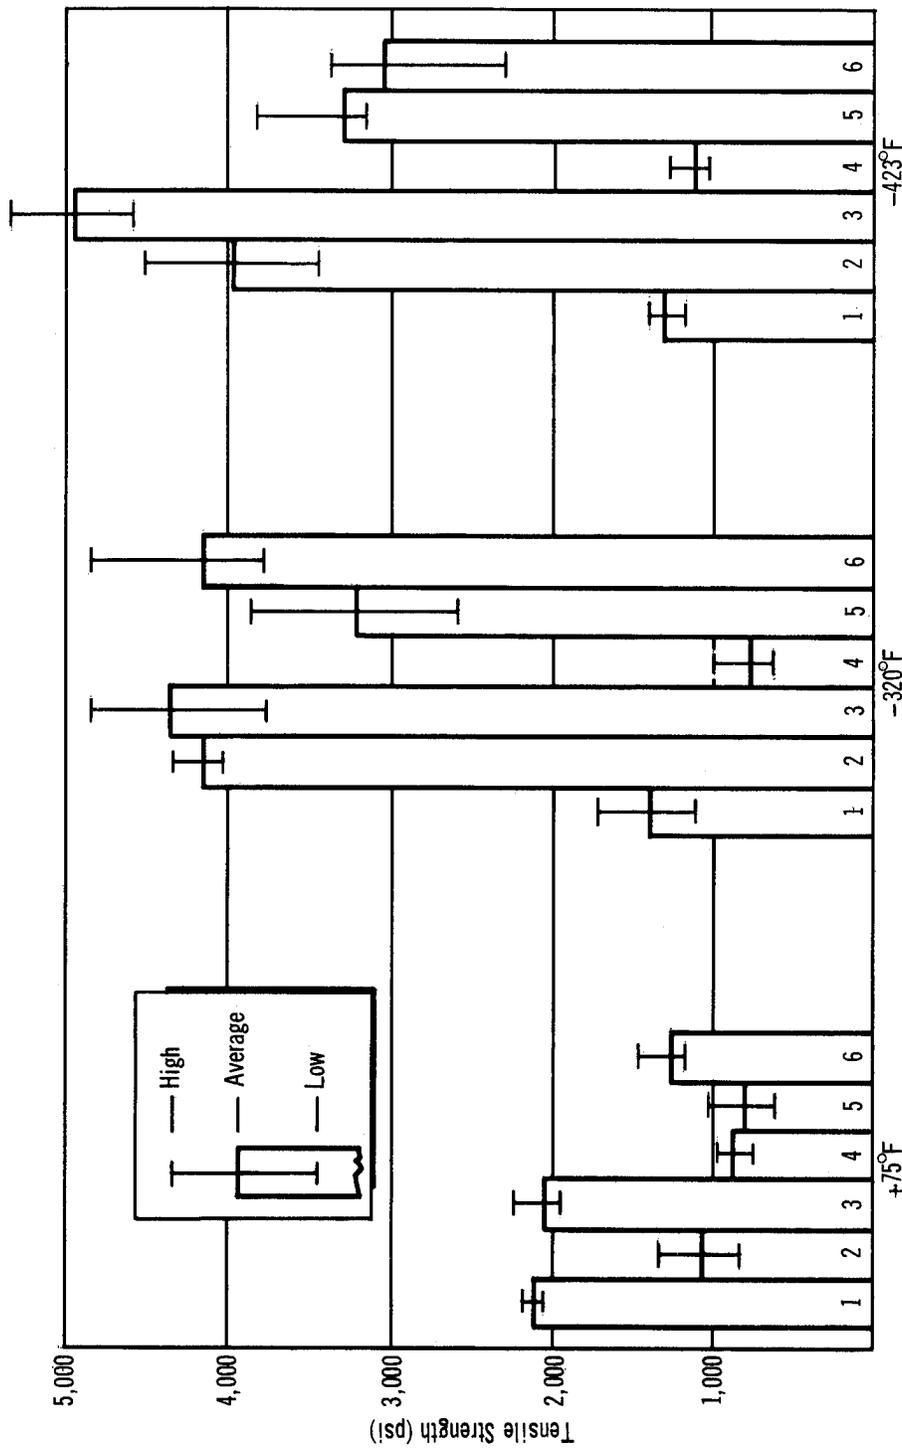
Figure 6. Tensile Lap Shear Tests, Aluminum Adherends

- 1. 5101 and Nylon
- 2. L-100 and Glass
- 3. L-100/5101 and Glass
- 4. FM-1025 and Nylon
- 5. L-100 and Nylon
- 6. L-100/5101 and Nylon

Five specimens each of the six candidate adhesive systems for each liner were tested at +75°F, -320°F, and -423°F. Results are shown in figures 9 and 10.

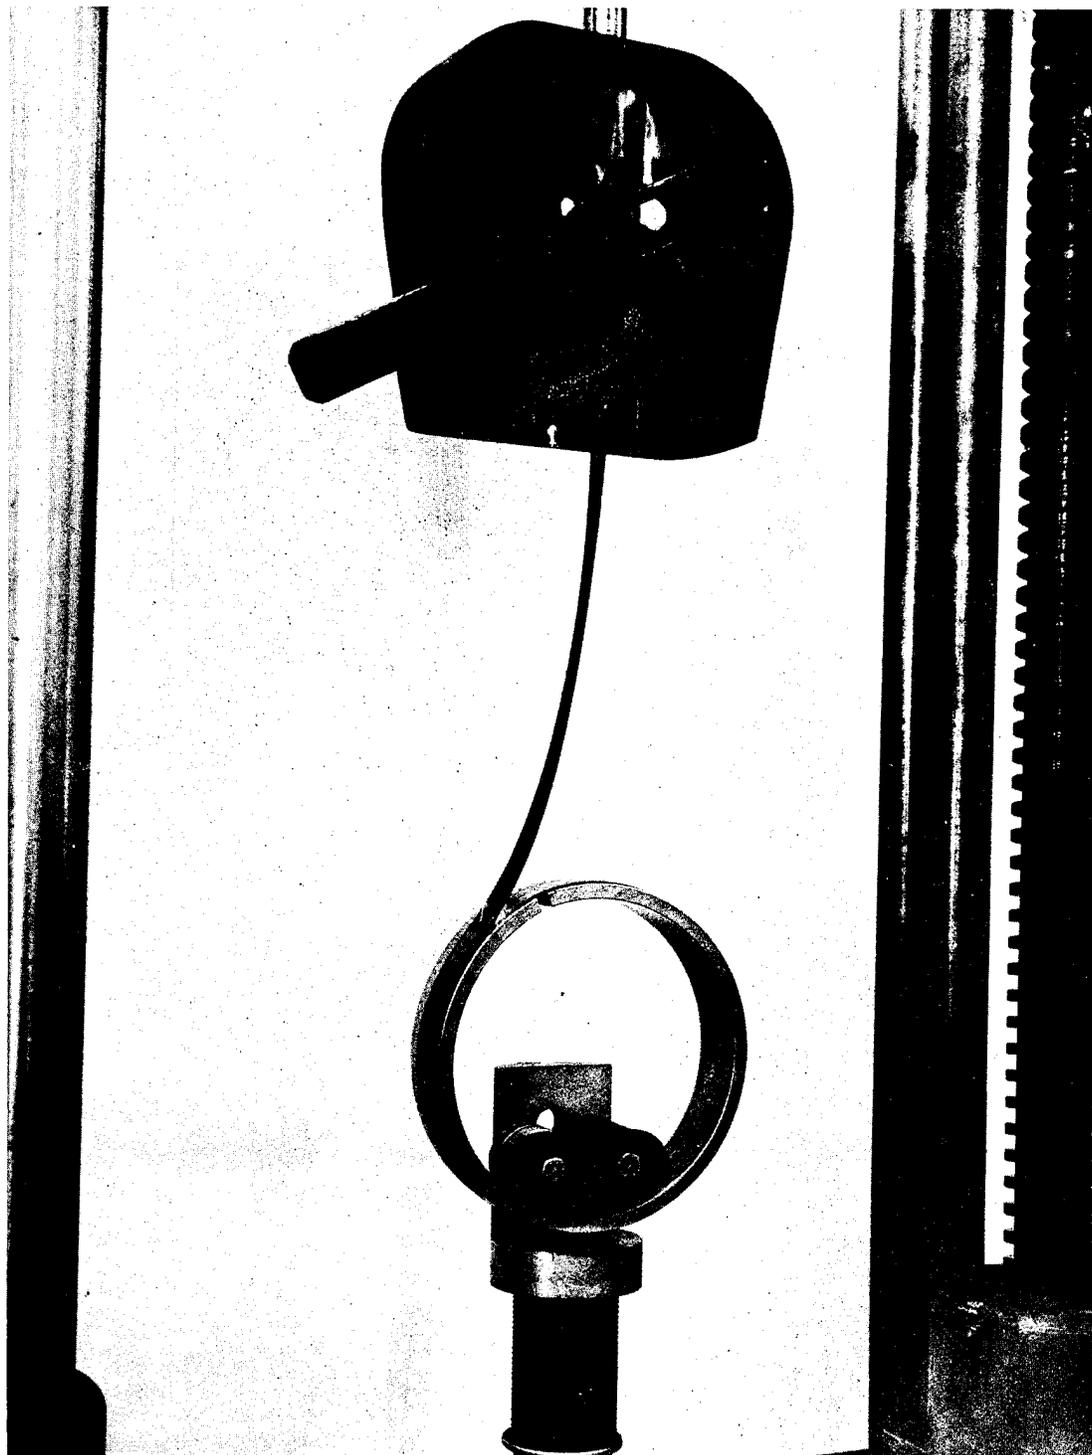
Figure 11. Drum Peel Test Setup

The testing jig consists of a simple drum and yoke mechanism (fig. 11). The metal-glass composite ring is inserted in the testing jig and the "peel-off tab" is gripped in the jaw of the testing machine. Once started, the specimen and drum continue to rotate until the glass filament section of the ring composite is peeled off the metal ring. During the test, load versus machine crosshead travel is recorded. After a constant force has been reached, the average peel strength in lb/in. of specimen width is determined. The rate of crosshead travel was held constant for all testing (6 in./min).

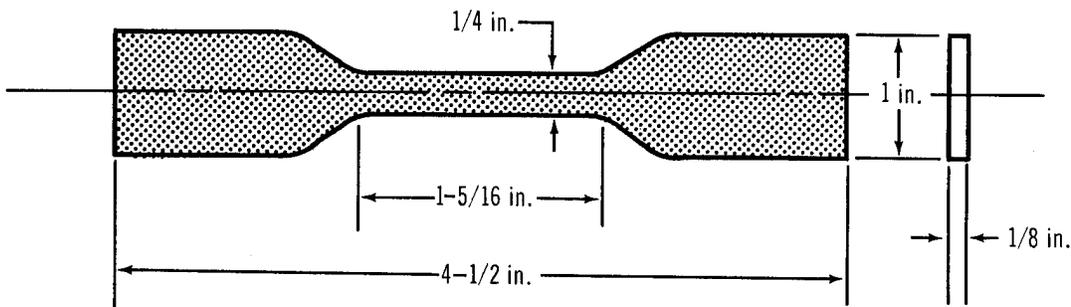
Figure 12. Uniaxial Tensile Specimen

Three specimens of each selected adhesive system were tested at each of the three temperatures in accordance with ASTM tentative standard D638-61T for testing plastics. For tests at cryogenic temperatures, the specimens were soaked until thermal equilibrium was reached (minimum specified time of 10 min). The specimens were tested at a head travel rate of 0.1 in./min.

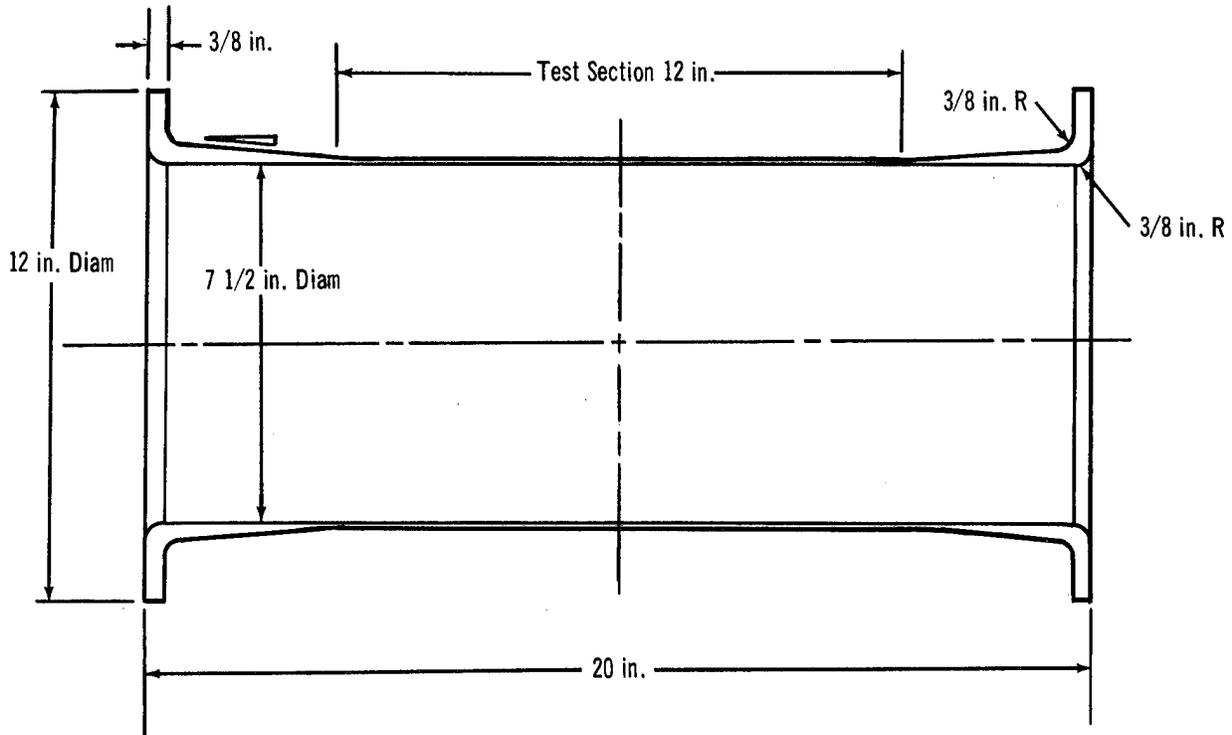
Figure 15. Subscale Pressure Vessel

Configuration. - A 7-1/2-in.-diam by 20-in.-long, open-ended cylinder vessel configuration was chosen for the program (fig. 15). This same configuration had been used for numerous Douglas Independent Research and Development programs and for the liner screening of Contract No. NAS 3-2562 (ref. 2). The configuration was simple; compound curvature effects were eliminated, and the vessel interior was easily accessible for liner examination and strain gage application. The flanged design is also suitable for standard cryogenic sealing techniques.

Design. - The vessel was designed by netting analysis to achieve a longitudinal-to-circumferential strain ratio of 1/1 in the test section. This was accomplished by using one longitudinal layer and two hoop layers of the preimpregnated collimated glass-fiber tape. The design was approved by the NASA LeRC Project Manager.

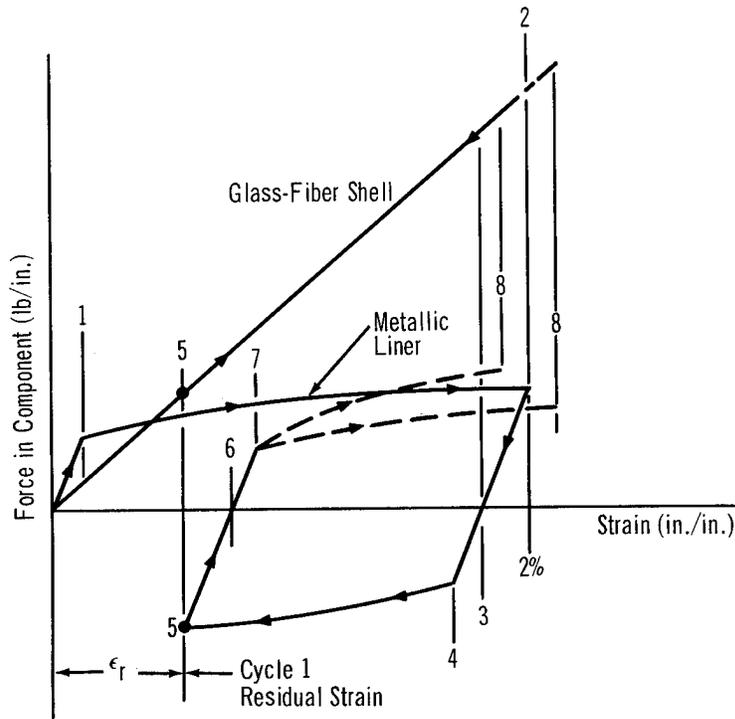
Figure 16. Probable Composite Cyclic Behavior

- (6) Upon repressurization of the vessel, the compressive load in the liner is relieved so that it strains elastically to point (6); the load in the liner is now zero. The liner continues to strain elastically to point (7). The yield point of the liner on the second cycle is unknown; it may be the same or higher or lower than the yield point on cycle one.

- (7) The liner is again strained plastically in tension. Because the vessel is cyclic pressurized to the same internal pressure, the total force in the structural wall (liner plus glass-fiber composite) must remain the same. If subjected to strain hardening, the liner will accept more load than it did on cycle No. 1. Consequently, there is less load for the glass-fiber shell to accept, and the strain achieved by the vessel will be less on cycle No. 2 (Point 8). Conversely, subjected to strain softening, the liner will accept less load on cycle No. 2. The glass-fiber shell is forced to accept more load, and the strain achieved by the vessel will increase on cycle No. 2 (Point 8').

The number of cycles that can be achieved by a fiberglass vessel operating at a strain of 2% depends on the bonded liner's resistance to fracture when subjected to high plastic-tensile and compressive strains associated with pressure cycles as illustrated in figure 16.

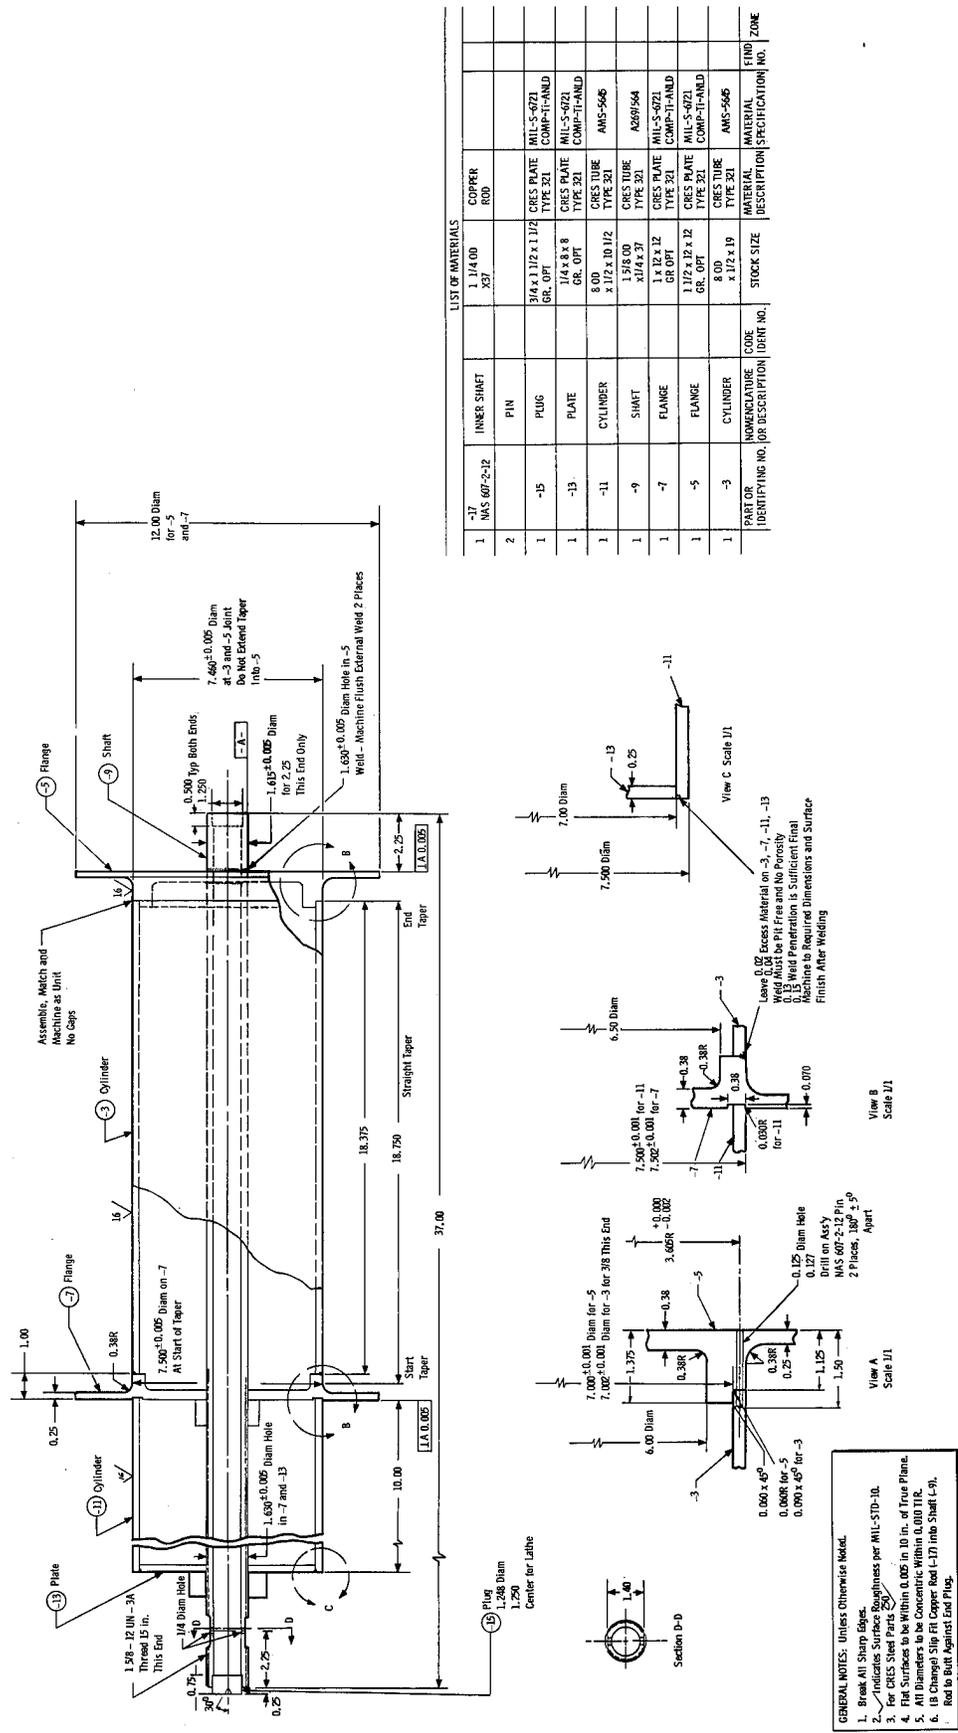
Figure 18. Mandrel for Cryogenic Test Pressure Vessel

Mandrel: The mandrel which was used for fabrication of the subscale pressure vessels is illustrated in figure 18. The mandrel is constructed of corrosion-resistant 321 stainless steel to provide durability. The essential parts are: a slightly tapered cylindrical section (for ease of removal) and two flanged sections. One flanged section is welded to the cylindrical portion. The other flanged section forms a very close, ridge-free fit with the cylindrical section when the drawbar assembly attached to the flanges is tightened.

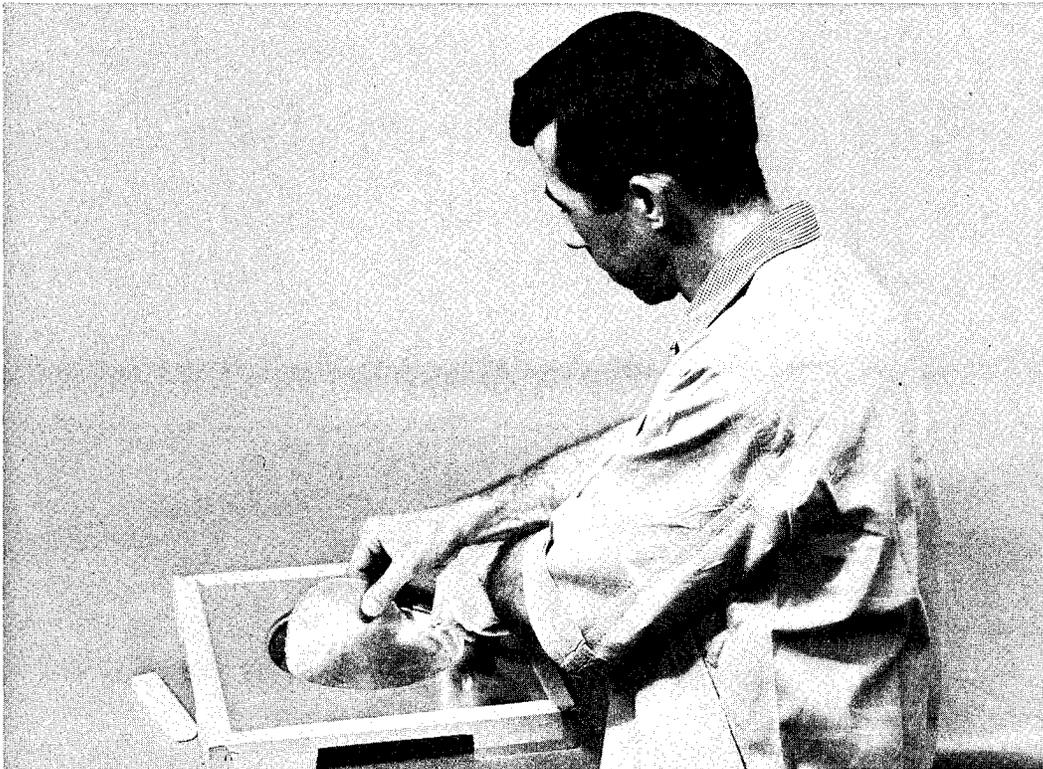
Figure 21. End-Flange Liner Fabrication

a. Forming with Teflon Tool

b. Removal of Center Blank

Procedure: Electroformed liners were originally to be delivered in situ on the winding mandrel to the configuration shown in figure 19. Difficulties, which were encountered in electroforming to the tapered shape led to the incremental increase in thickness shown in figure 20. Aluminum liners were fabricated by wrapping one layer of foil onto the mandrel, which had been prepared with the end-flange aluminum liners already in place. The end-flange liners were fabricated to the required size and curvature in a female mold (fig. 21).

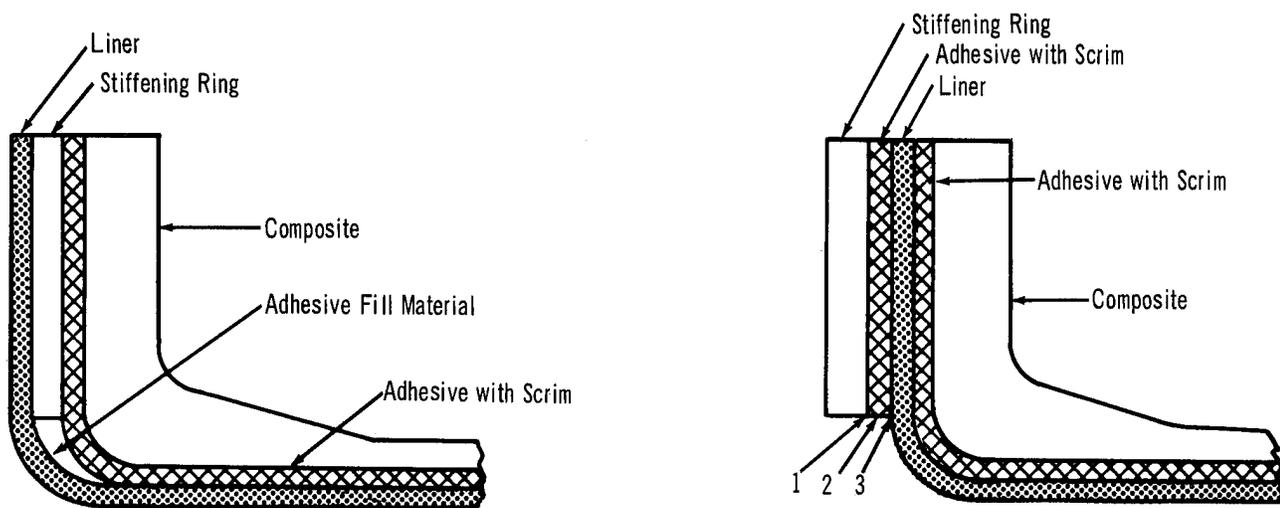
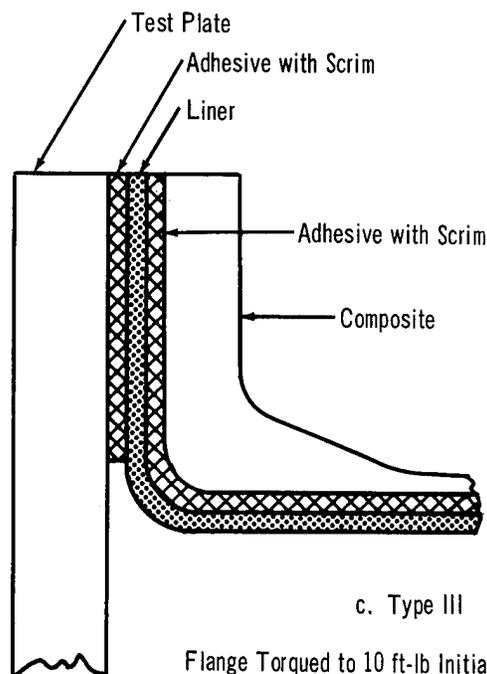
Figure 22. Flange End-Seal Methods

Flange Torqued to 10 ft-lb Initially. Torqued to 100 ft-lb After Adhesive Cures

Vessel TA-3: This vessel was fabricated with the flange construction shown in figure 22c. This differed from that of vessel TA-2 because of the unavailability of the NAFLEX test seals (damaged during a previous test).

Vessel TA-2: This vessel was tested at  $-423^{\circ}\text{F}$ . End-seal configuration was of the type shown in figure 22b.

Vessel TA-3: This vessel was cyclic tested at  $-423^{\circ}\text{F}$ . End-seal configuration was of the type shown in figure 22b. The vessel was cycled to 2% strain at 550 psi for 101 cycles. This was followed by two attempted burst cycles. The maximum pressure attained on the burst attempts was 580 psi. Because of excessive leakage, the vessel could not be burst. The post-test leak check revealed three areas of leakage near the liner longitudinal seam. No leakage was detected at or near the bonded-on flange plate.

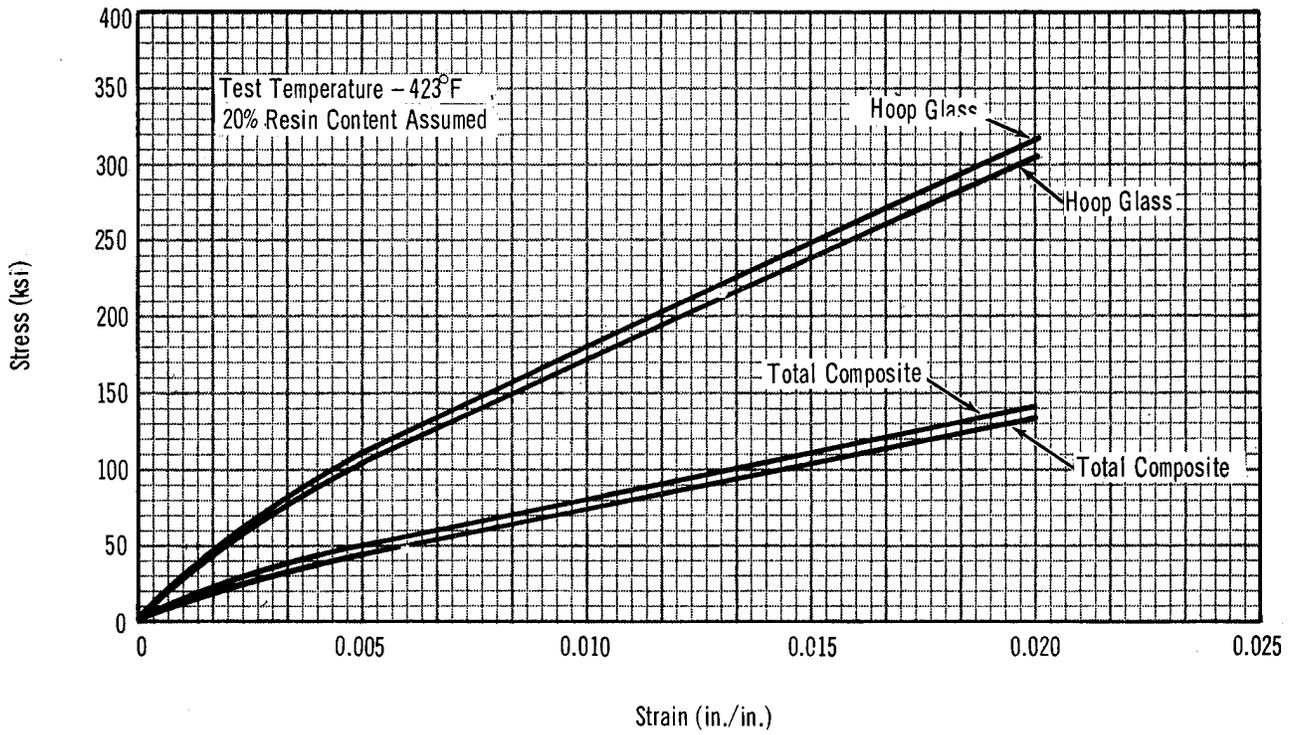
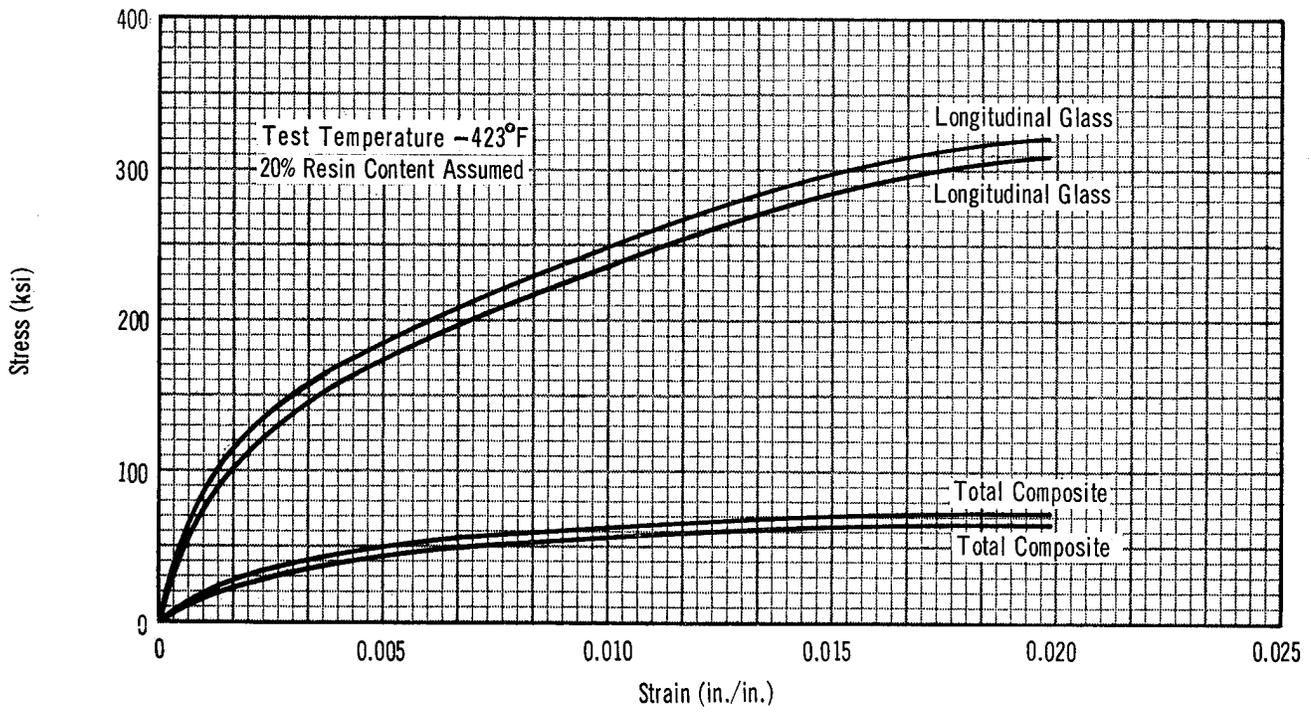
Figure 23. Stress-Strain Diagram, - 7 1/2-in.-Diam Vessel D1

Development vessel D1 was pressure tested at a temperature of  $-423^{\circ}\text{F}$ . The vessel attained a maximum hoop strain of 2.1% at an internal pressure of 569 psi, at which time the vessel leaked excessively. Stress-strain curves for the vessel are given in figure 23. The desired objective of hoop to longitudinal strain ratio of 1/1 in the test section was achieved.

The internal pressure was applied to the vessel at a rate to cause a strain of approximately 1%/min. to 130 psi. At this point, all vacuum was lost in the chamber. The internal pressure was increased to a maximum of 569 psi at a rate which caused the vessel to strain approximately 4%/min. The vessel did not burst.

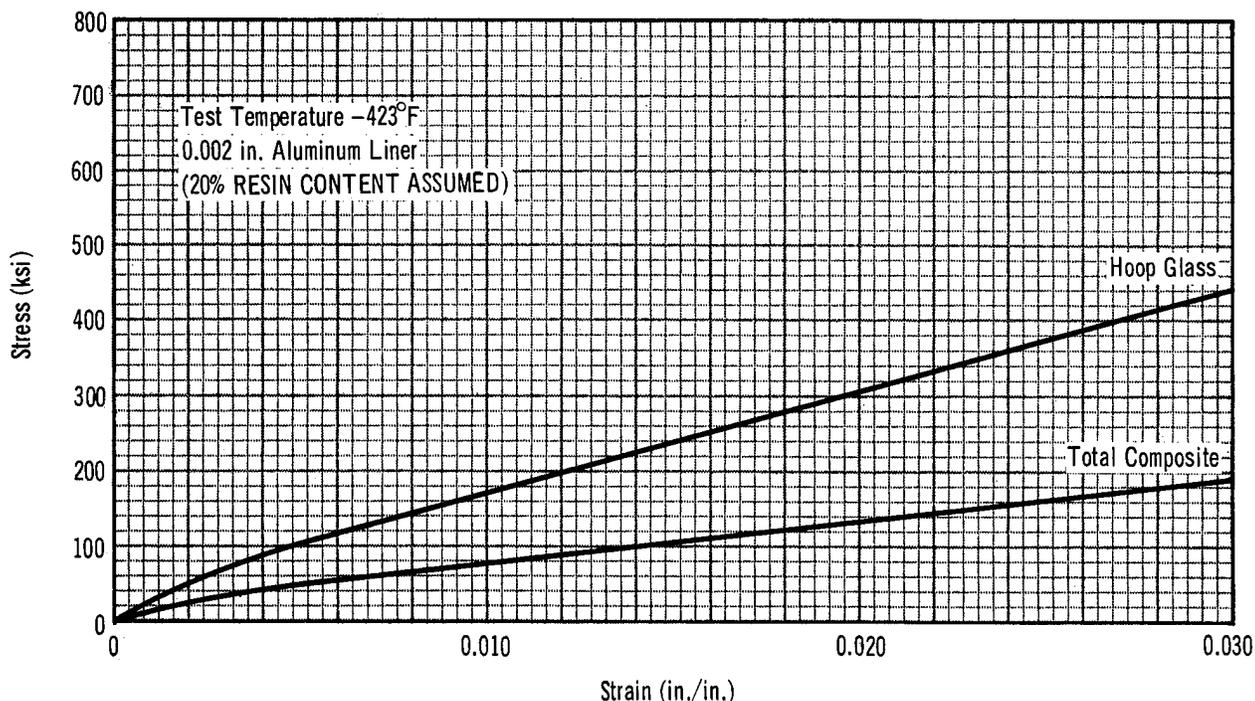
Figure 24. Hoop Stress-Strain Diagram - Vessel D2

The fiberglass lay-up was identical to that of vessel D1, except that the flange was fabricated with preimpregnated glass cloth. The vessel was tested at  $-423^{\circ}\text{F}$ . Maximum pressure reached 815 psia. Excessive leakage through the liner doubler-joint and/or end seal prevented continued pressurization. A maximum hoop strain of 3% was attained. The stress-strain curve is shown in figure 24.

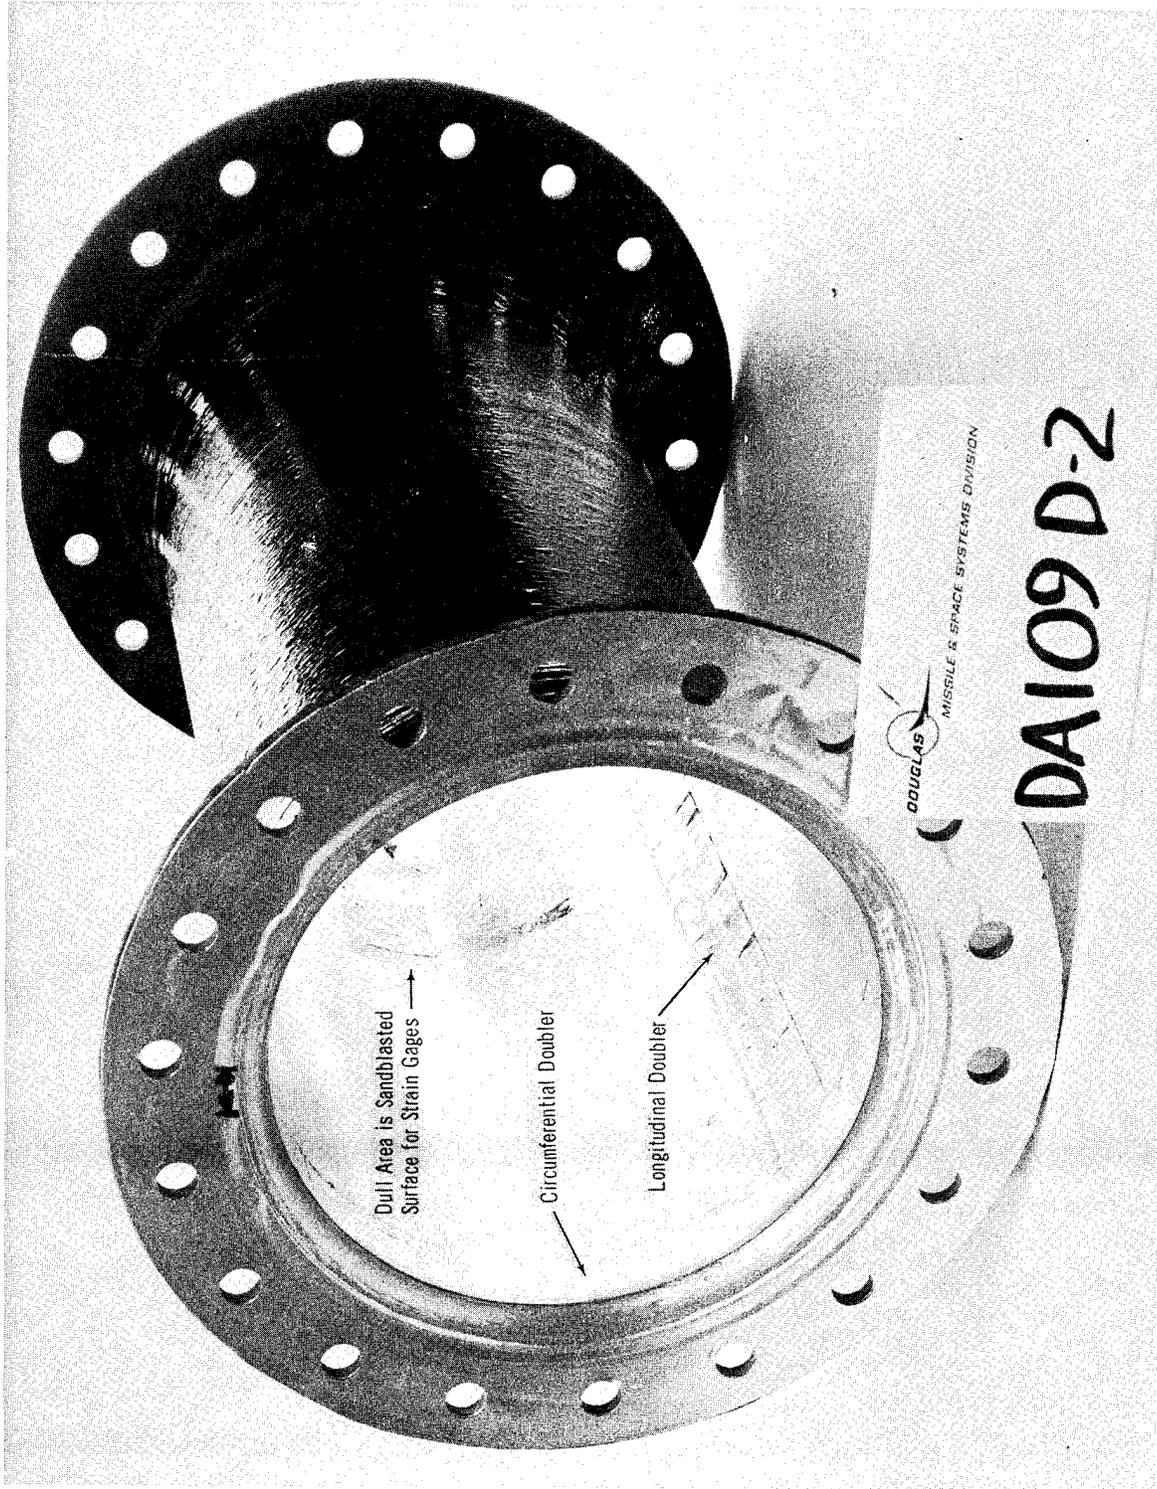
Figure 25. Vessel D2. Post-Test, General View

Post-test inspection revealed that the liner in all but the longitudinal doubler area looked excellent. There were no cracks, wrinkles, or buckles. The circumferential doublers appeared satisfactory. There were some voids that appeared as indentations but no cracks, bubbles or debonding.

In the seal area at the inner edge of the backup ring, cracking of the foil occurred. At one end there were two cracks, one was 3/4-in. long and the other was 1/4-in. long. At the other end there was one crack 3/4-in. long. The longitudinal doubler contained voids that appeared as delaminations and bubbles in the test section, particularly along the edges (fig. 25). Cracking of the doubler occurred in some of the delaminated buckled areas.

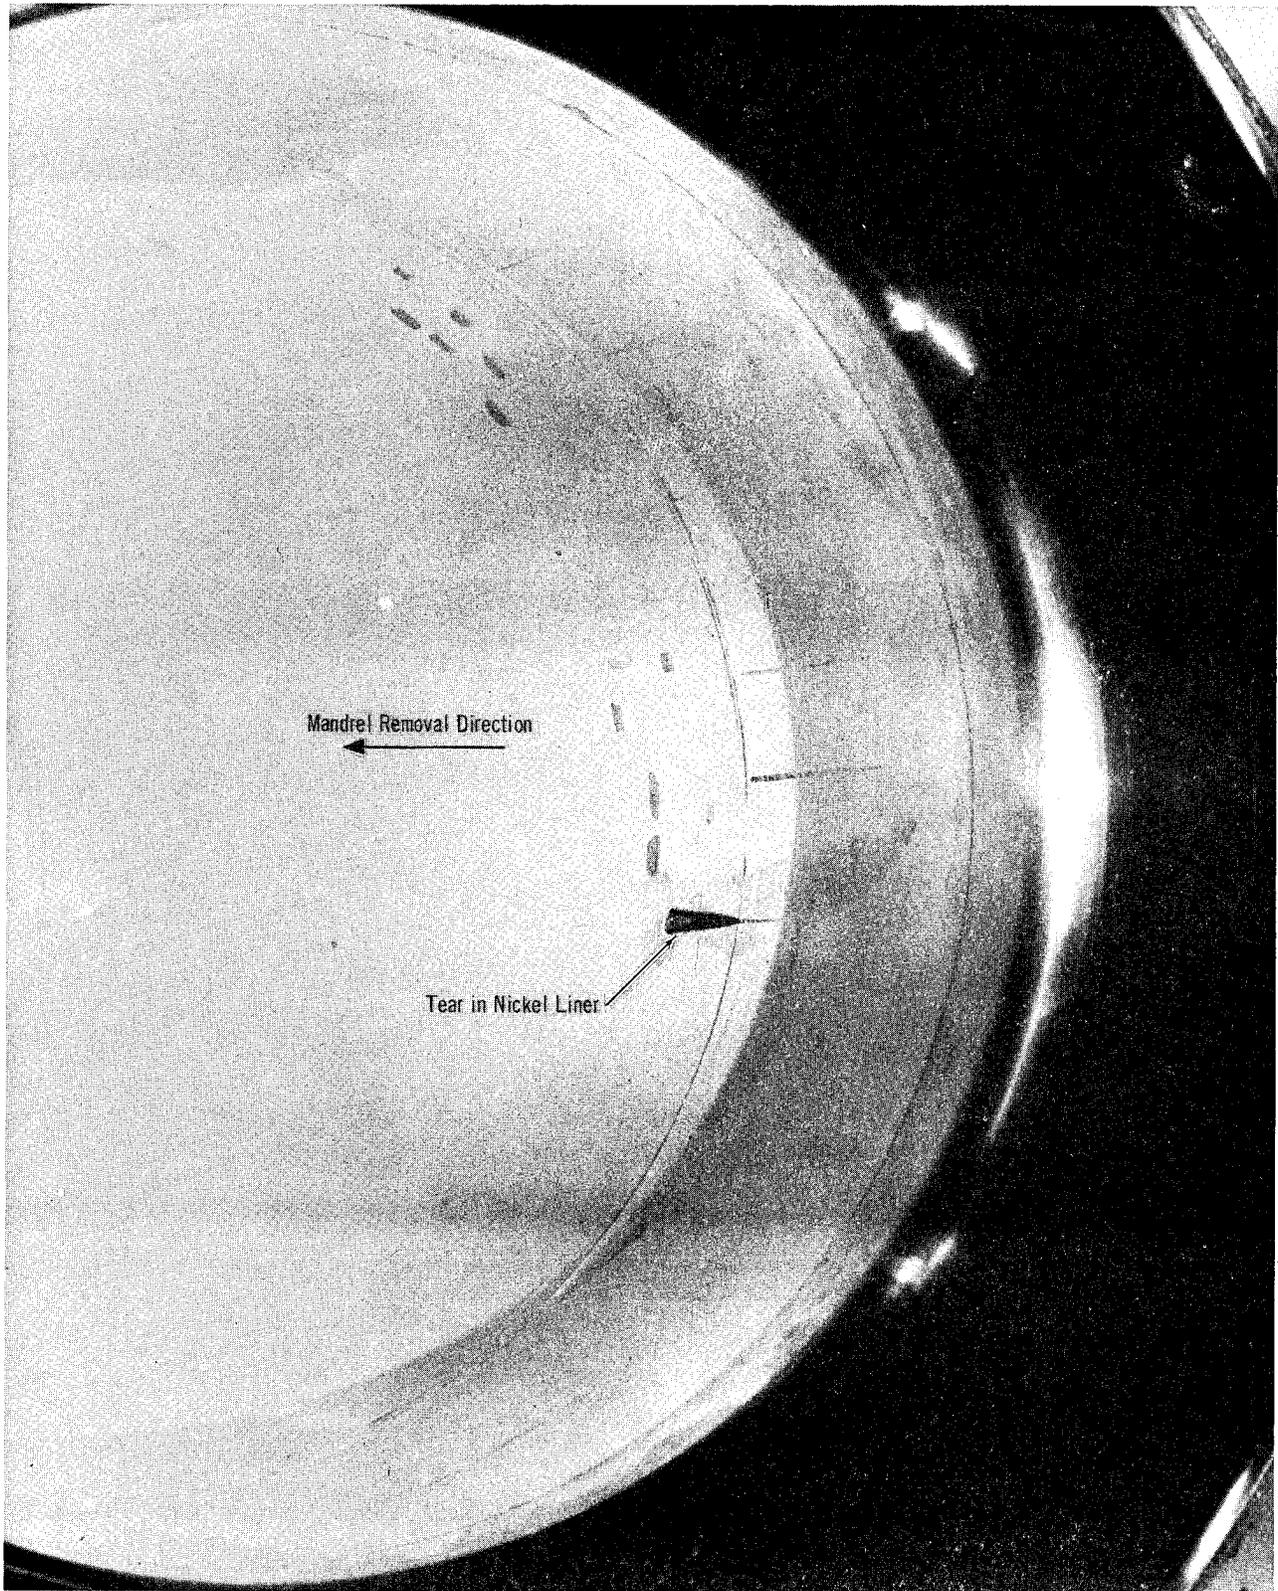
Figure 29. Vessel TN-1, Tear in Nickel Liner

Removal of the mandrel following vessel cure was extremely difficult. The procedure that proved successful was to wrap the vessel with heating tape, and chill the mandrel interior with dry ice. During mandrel removal, the liner was torn for a distance of approximately 1-in. long by 1/2-in. wide, at a point where the deposition had bonded to the stainless steel mandrel (fig. 29). The liner tear was repaired with aluminum foil overlay.

Lockheed personnel indicated that future vessel removal could be guaranteed. Obviously, the passivation of the mandrel surface had not been complete with the development liners. Future passivation processing could include a chromic acid immersion, nitric acid immersion, and hot water rinse.

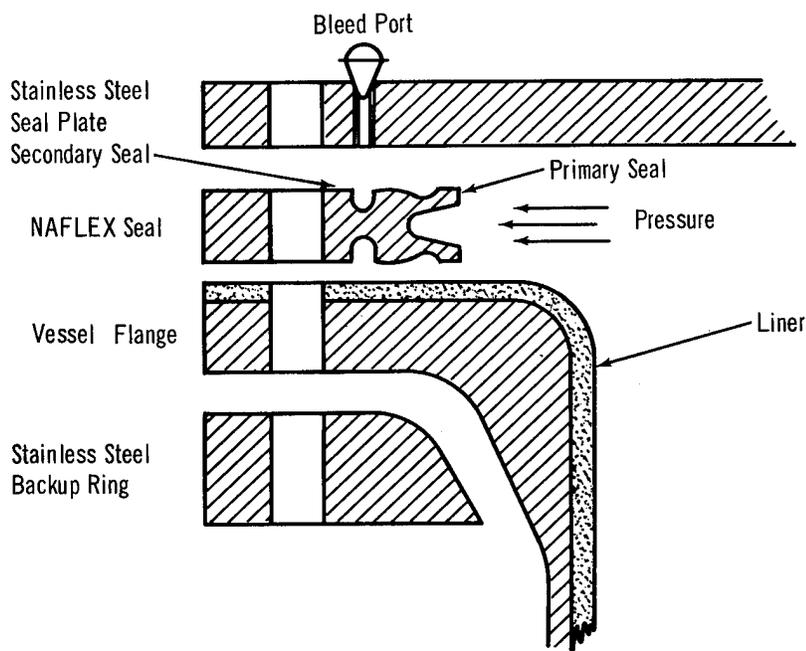
Figure 32. NAFLEX Seal

Several of the initial first-phase test vessels were sealed with NAFLEX seals\* (fig. 32). The use of the evacuated seal established that the leakage into the vacuum chamber was through the liner exclusively. The seal performed well in the two vessels so instrumented. However, the teflon coating on the sealing surfaces of each of the two sets of seals was damaged during the burst tests. The time which would have been involved in refurbishing the seals would have caused gross schedule slippage, so a new method of sealing was sought. The solution, which turned out to be successful from all standpoints, was the sealing method shown in figure 22c. That is, the test plates were simply bonded to the liner-vessel flange with 100% polyurethane adhesive (L-100/MOCA) and No. 112 glass cloth.

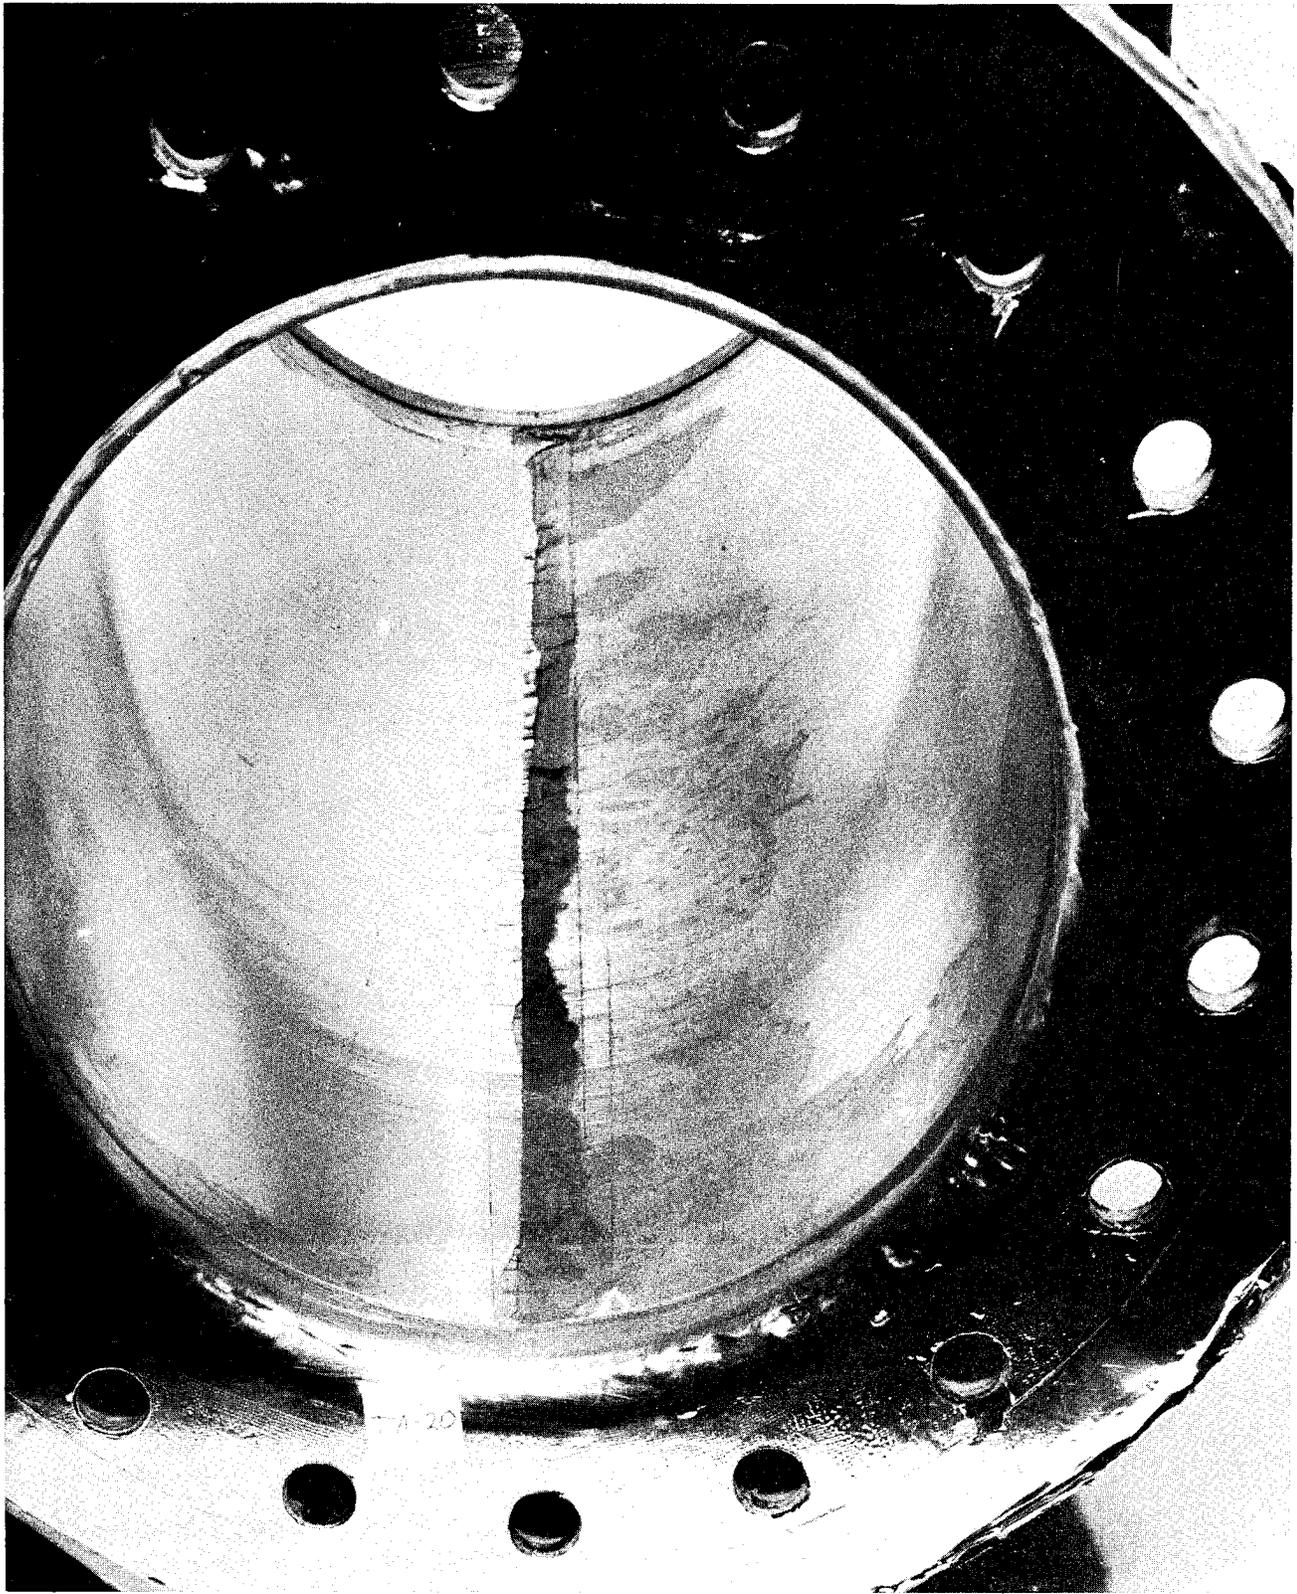
Figure 44. Vessel TA-20, Longitudinal Seam Deformation

Post-test examination of the vessel indicated a leak in the liner at the sealed leakage area. This is the area which had leaked during the ambient temperature test and had then been repaired.
