DESIGN, FABRICATION, TEST, AND EVALUATION OF A PROTOTYPE 150-FOOT LONG COMPOSITE WIND TURBINE BLADE

Herbert W. Gewehr
Kaman Aerospace Corporation

September 1979

Prepared for
NATIONAL AERONAUTICS AND SPACE ADMINISTRATION
Lewis Research Center
Under Contract NAS3-20600

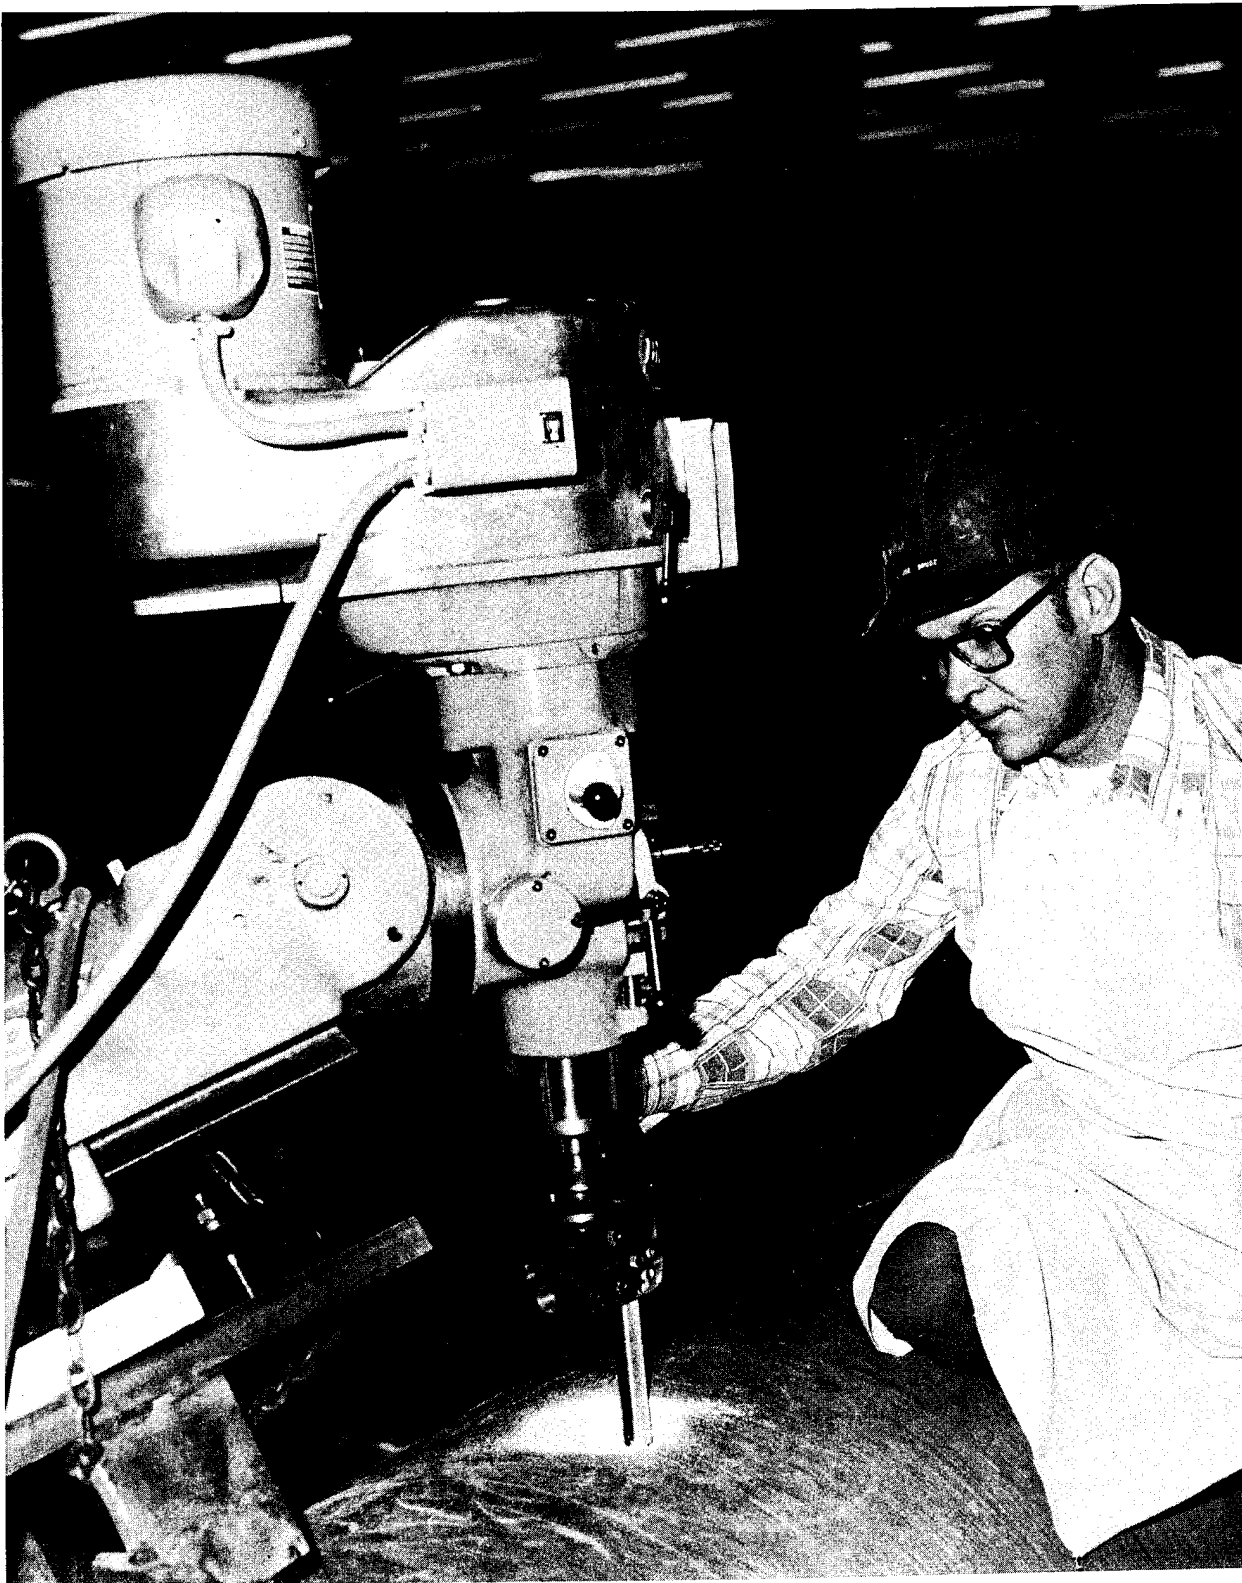
Figure 67. Machining Holes in Composite Spar for Hub Adapter Bolts.

A Bridgeport vertical milling machine was mounted directly on the hub adapter to avoid the expense of constructing a separate tool to bore holes in the spar and steel hub adapter for the attachment bolts. A support fixture welded to

the adapter was successively repositioned around the spar to drill all 18 holes. It was required that a single machine setup for each hole be maintained for all cutting operations on that hole to insure dimensional control of critical tolerances. For this program, it was considered acceptable to weld the milling machine supporting structure directly to the steel adapter because the adapter was not a critical part of the blade, and was overdesigned to preclude test failures. The supports were removed and the adapter surface was ground smooth after the adapter installation was complete.

The spar was set up on its trailing edge web for installation of the hub adapter. The adapter was inserted into the spar and pilot holes were drilled from inside out through the composite spar using pre-drilled holes in the adapter as guides. One-inch bolts were inserted to hold the adapter in place while the full size holes were machined in the spar from the outside using the tooling setup shown in Figure 67. A single setup was employed for all machining on each hole, which included boring the hole in the composite, increasing the size of the pilot hole in the steel adapter, and spotfacing both sides of the adapter plate. This procedure insured achievement of tolerance control required for the single shear spar-to-adapter connection.
