Dredging in an Active Artillery Impact Area Eagle River Flats, Alaska

Michael R. Walsh, Edwin J. Chamberlain, Karen S. Henry, September 1996
Donald E. Garfield and Ed Sorenson

**U.S. Army Corps
of Engineers**
Cold Regions Research &
Engineering Laboratory

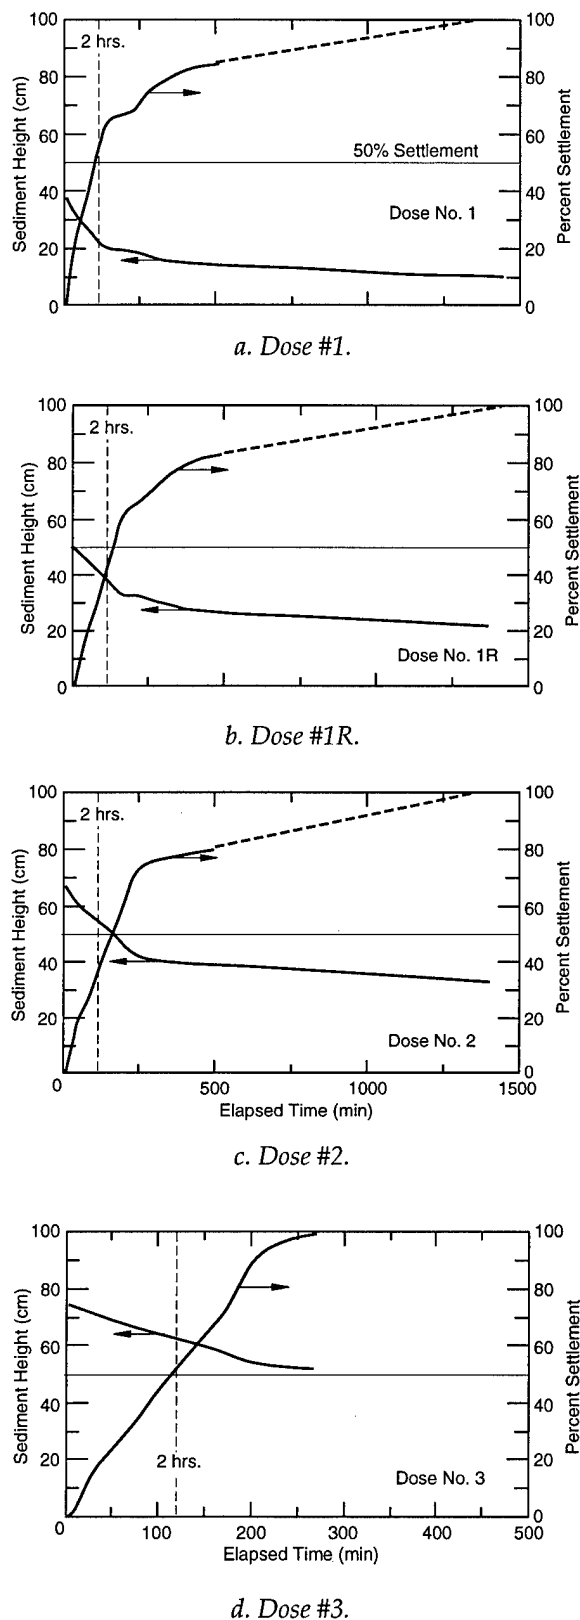
Figure 3. Sedimentation test results in Montgomery tube.

These tests confirmed our preliminary study and gave us confidence that we could readily conduct the dredging, filling and decanting operations in daily cycles. However, we had to be assured that any white phosphorus in suspension would drop from suspension in the two-hour window of time. We conducted a fourth sedimentation test, this time with white phosphorus particles in suspension. We spiked the sediment with white phosphorus particles obtained from the Flats by Marianne Walsh of CRREL. White phosphorus particles of the size considered to affect the health of the waterfowl were used ($\approx \phi 0.1$ mm [Walsh personal communication*]). Water samples were taken through ports located at 15-cm intervals in

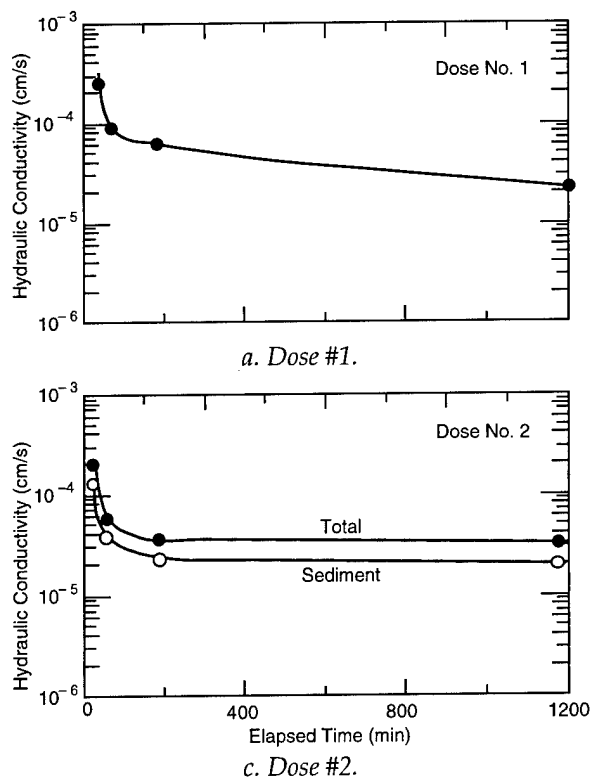
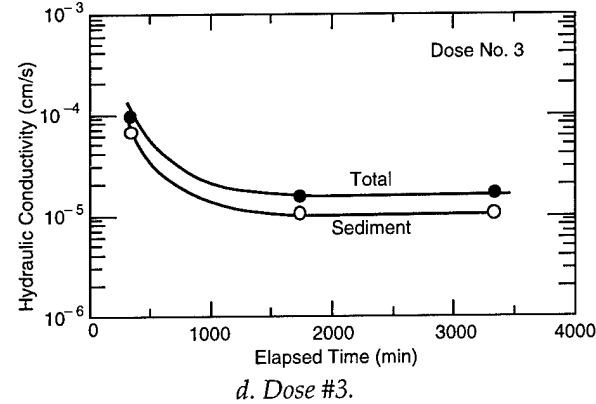
Figure 10. Permeability of sediment in column.

We hypothesized that the sediments from the dredging operation would quickly clog the voids in the gravel pad and significantly reduce the hydraulic conductivity. It was expected that the subsequent buildup of sediment would further reduce the infiltration rate into the EOD pad. To gain additional insight on the sediment's effect on infiltration, we conducted laboratory tests to determine the hydraulic conductivity of the sediment. The following relationships were used in determining hydraulic conductivity:

As a result we concluded that some type of liner was required for the settling pond. We briefly investigated the feasibility of using a geosynthetic liner, but cost and availability considerations led us to explore other options to reduce the potential infiltration into the EOD pad. We were made aware of a peaty silt material that was available in abundance near Fort Richardson. This material appeared to have a very high organic content, making it unsuitable for most engineering projects. However, since this material was readily available, we decided to evaluate its suitability as a liner for the settlement pond.

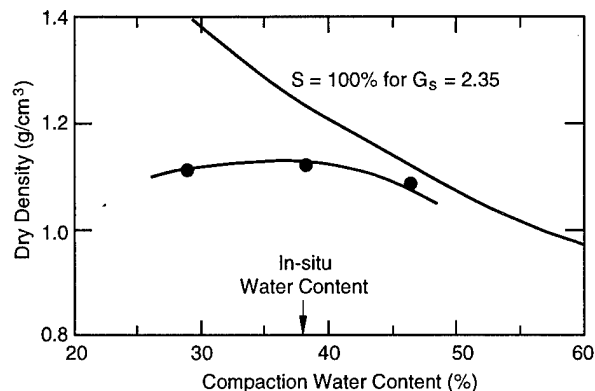
Figure 11. Results of Proctor tests of peaty silt.

To do this we subjected samples of the peaty silt to compaction and hydraulic conductivity tests in the CRREL laboratories. The laboratory compaction (standard Proctor) and hydraulic conductivity tests were conducted according to ASTM standard methods D 698 and D 5084, respectively. The compaction water contents ranged from about 29% to about 46%, bracketing the initial in-situ (in the borrow pit) water content estimate of about 38%. The results of the compaction tests are tabulated in Table 6 and shown in Figure 11. The optimum water content for the peaty silt material is about 38%, the same as the expected in-situ water content. This result appeared fortuitous, because it meant that we might not have to make a special effort to adjust the water content of the peaty silt.

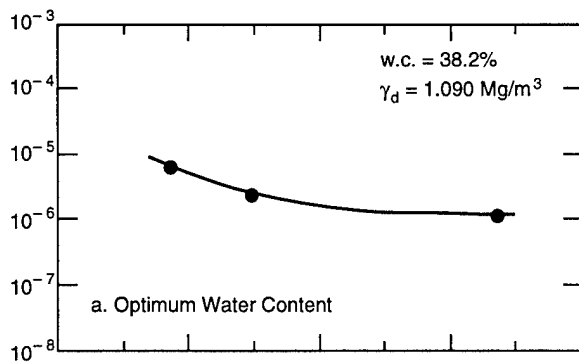
Figure 12. Results of laboratory permeability tests.

Laboratory hydraulic conductivity tests were conducted for the same water content regime as the compaction tests. The tests were conducted for effective stress levels of 7, 14 and 35 kPa (1, 2 and 5 psi) to determine the effectiveness of increasing thickness (e.g., increasing stress) as the sediment thickness increases during the dredging operations. The results are tabulated in Table 7 and illustrated in Figure 12. The two tests conducted at 38% and 46% (above optimum) water content showed hydraulic conductivities less than 1×10^{-5} cm/s, the magnitude decreasing with in-

creasing stress level. The results (Fig. 12c) for the test specimen with a water content of about 29% (9% below optimum) did not pass the 1×10^{-5} cm/s litmus test. This was not unexpected, as according to Lambe and Whitman (1969) the hydraulic conductivity for fine-grained soils significantly increases at water contents below the optimum level. The importance of this finding is that the field water content during compaction must be near or above 38%. This appeared to be no problem as the water content in the borrow pit was estimated to be 38%.

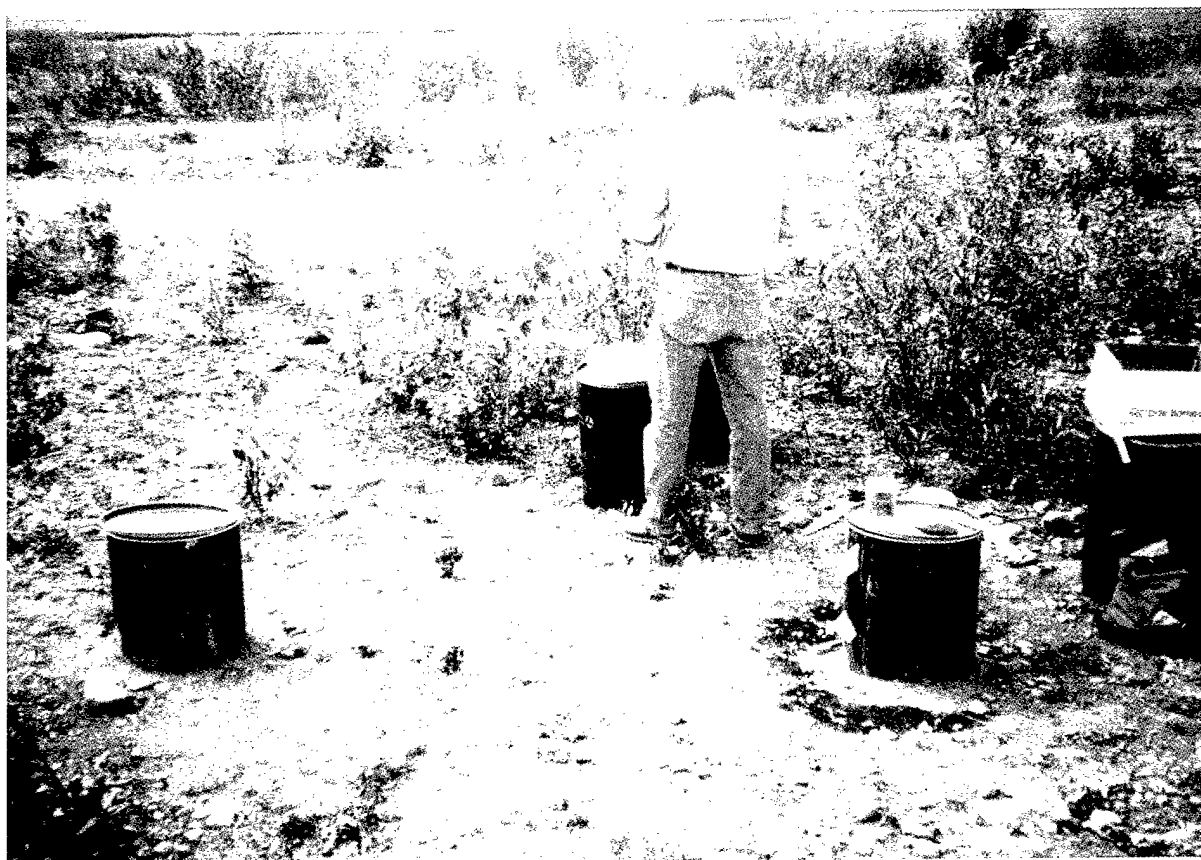
Figure 13. Hydraulic conductivity barrel test cells on the EOD pad.

The site for the first series of tests was selected to be representative of the EOD pad. Modified barrels were used for the test chambers. The bottoms of 82.5-L steel barrels, 40 cm in diameter and 64 cm high, were removed and the barrels were set into the test pad as illustrated in Figure 14. The barrels were set into circular channels cut carefully into the pad to about a 15-cm depth. The annular space between the outer barrel walls and the gravel was backfilled with a wet mixture of sand and bentonite clay to prevent leaking of the water placed in the barrel for the infiltration tests. The interior annulus was refilled with a mixture of

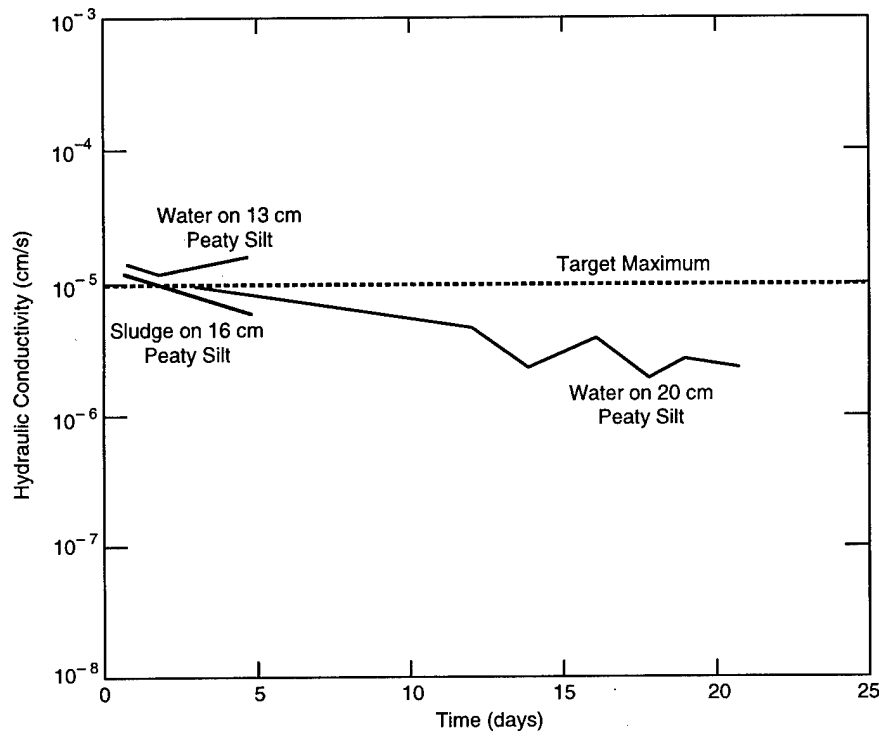
Figure 19. Results of barrel infiltration tests for sediment on peaty silt liner.

The hydraulic conductivities obtained from field test results with the peaty silt are slightly greater than the results obtained for low stress in the laboratory. The reason for this is that the water content in the field was much higher than expected, about 60% rather than 38%. This can be seen in Figure 20, where the hydraulic conductivities and dry densities are plotted versus the water contents for both the laboratory and the field tests. The higher-than-expected water content is probably due to the considerable rainfall that occurred after the peaty silt was stockpiled in the basin area. Nonetheless, the goal of achieving a hydraulic

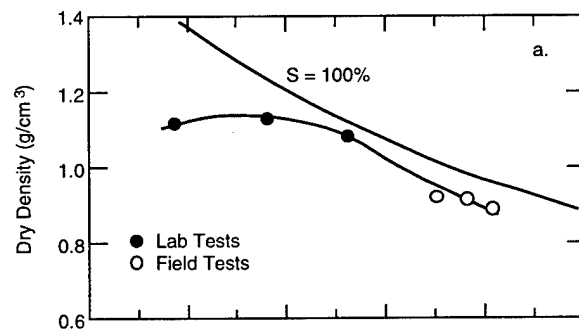
Figure 20. Composite of lab and field permeability test results for peaty silt.

conductivity of 1×10^{-5} cm/s or less in the basin area with the peaty silt as a liner is achievable. Figure 20b shows that as long as the water content is in the range of about 38–60%, the peaty silt will provide the desired protection against infiltration. At water contents below 38% the hydraulic conductivity of the peaty silt increases significantly, much as would be expected.

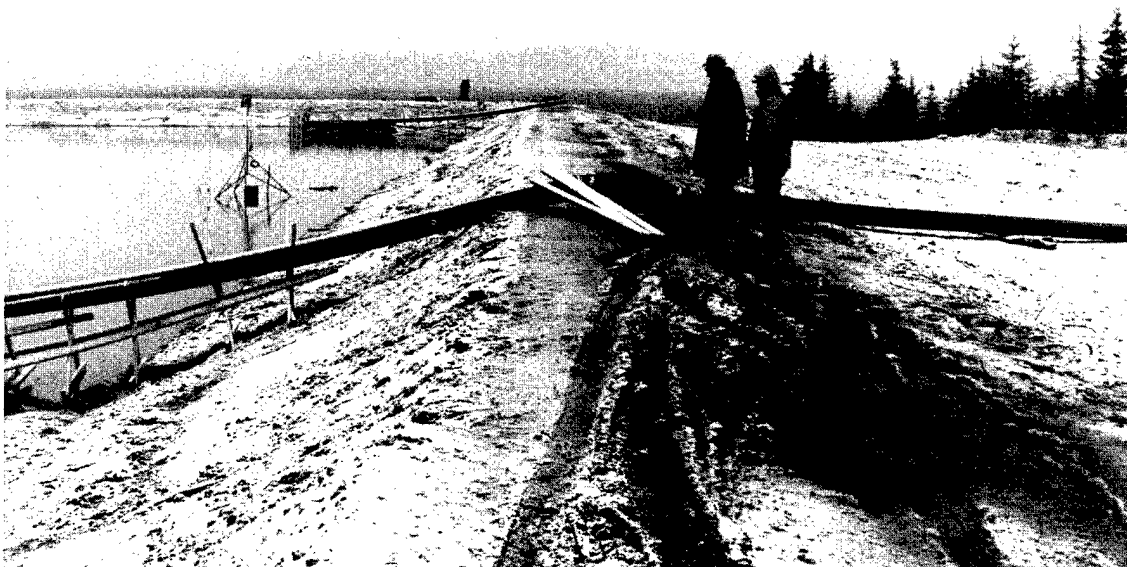
Figure 21. Retention basin berms.

Prior to deployment of the dredge, much site preparation and construction work needed to be carried out. Among the major projects were construction of the retention basin and its associated structures, the drop inlet structure and inflow pads; a road from the EOD pad to Clunie Creek, where the dredge was to be deployed into the

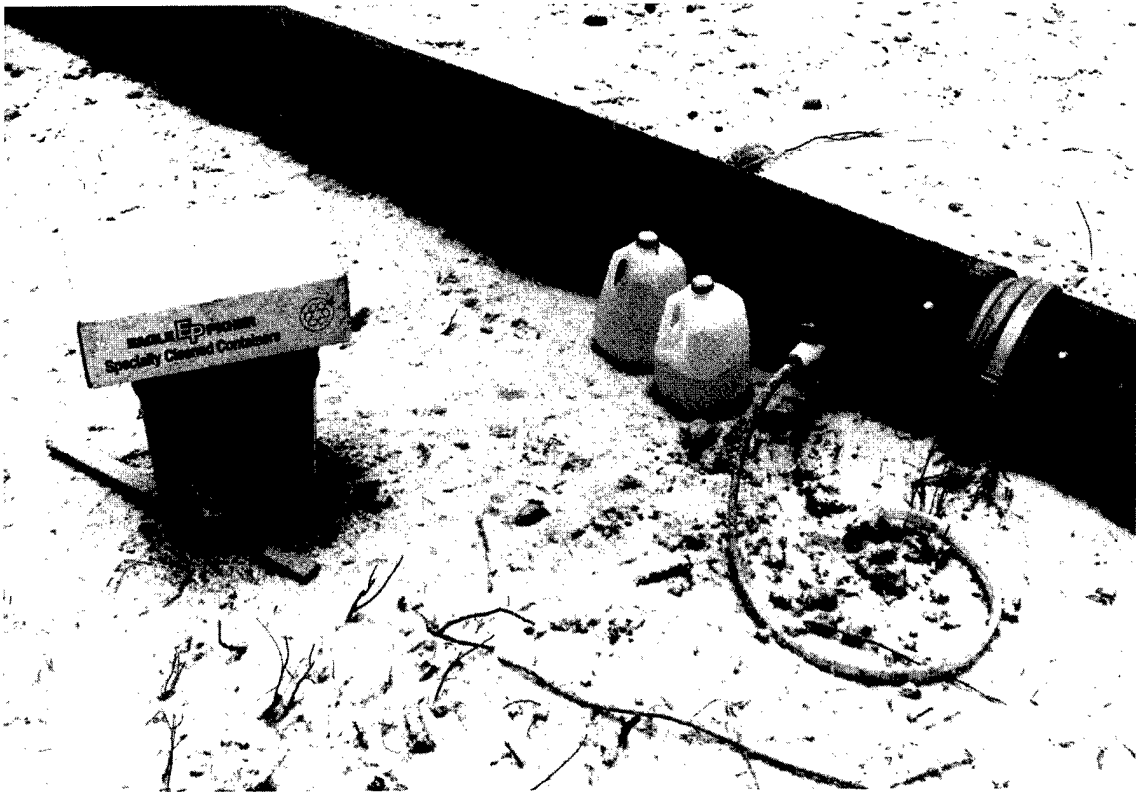
Figure 25. Dredge spoils sampling station.

Sample strategy: Composite sample method. Samples are taken at 15-minute intervals by directing a stream of spoils from the spoils line through the pitless adapter, valve and 1 m of Tygon tubing into a 19-L PE bucket. After four samples have been taken, the volume is stirred and a 500-ml composite sample taken using a PE ladle. The sample container is a clear, wide-mouth 500-ml glass sample jar, level 2A clean (Eagle-Pitcher P/N 232-16C). Time, date and approximate dredge location are noted. The bucket is then emptied and rinsed twice with distilled water for reuse.
