TECHNICAL REPORT M1

**SEDIMENTATION STUDY OF THE MISSISSIPPI RIVER  
SANTE FE CHUTE, DOOLAN CHUTE  
HYDRAULIC MICRO MODEL INVESTIGATION**

September 1996

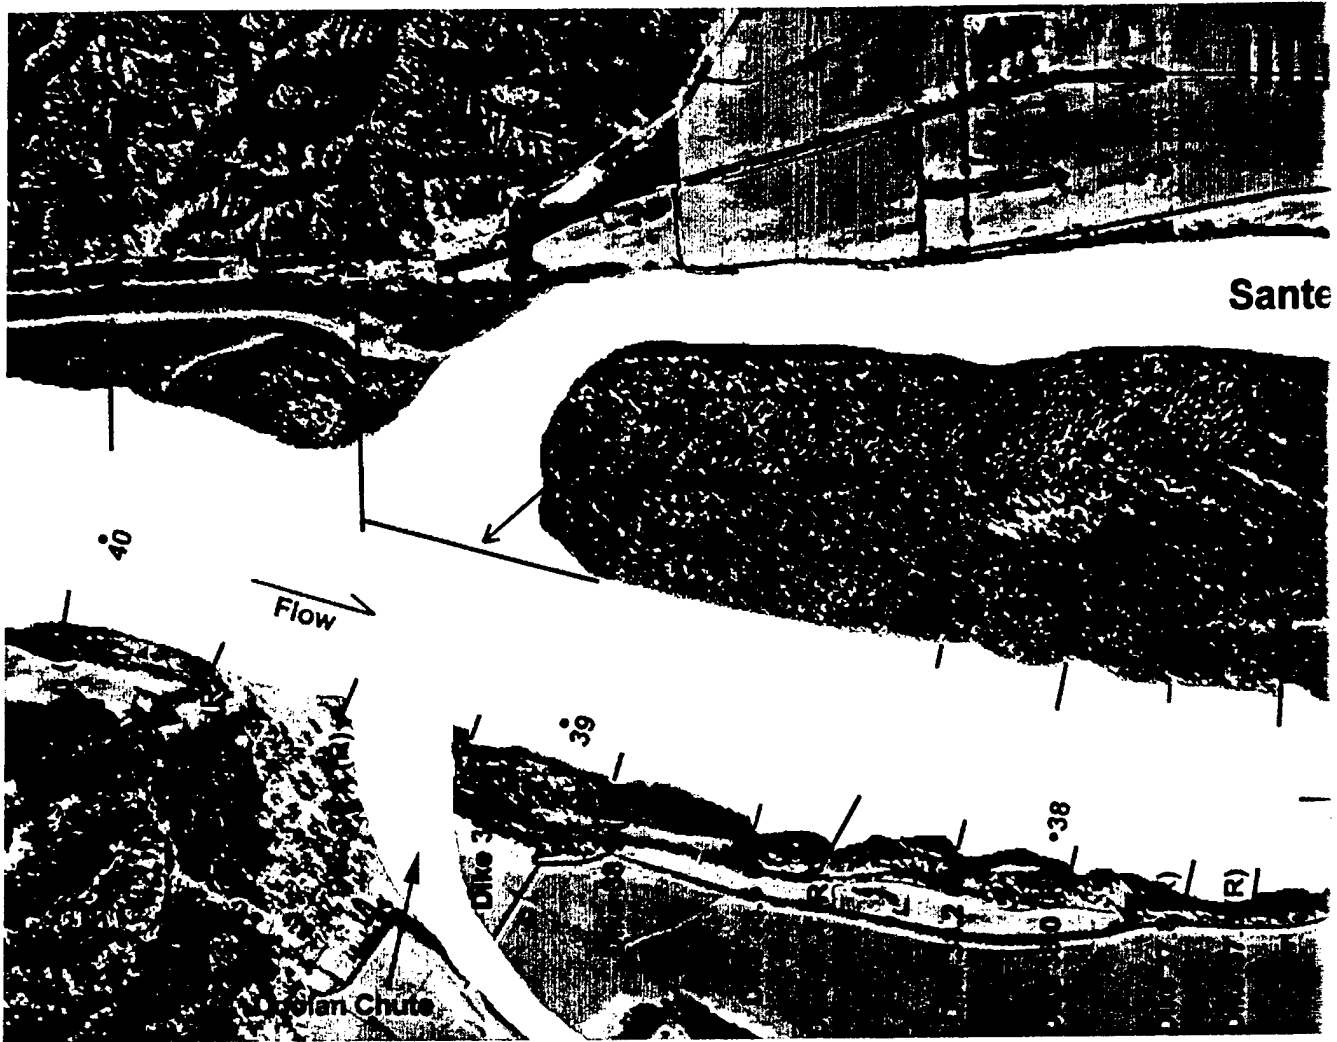
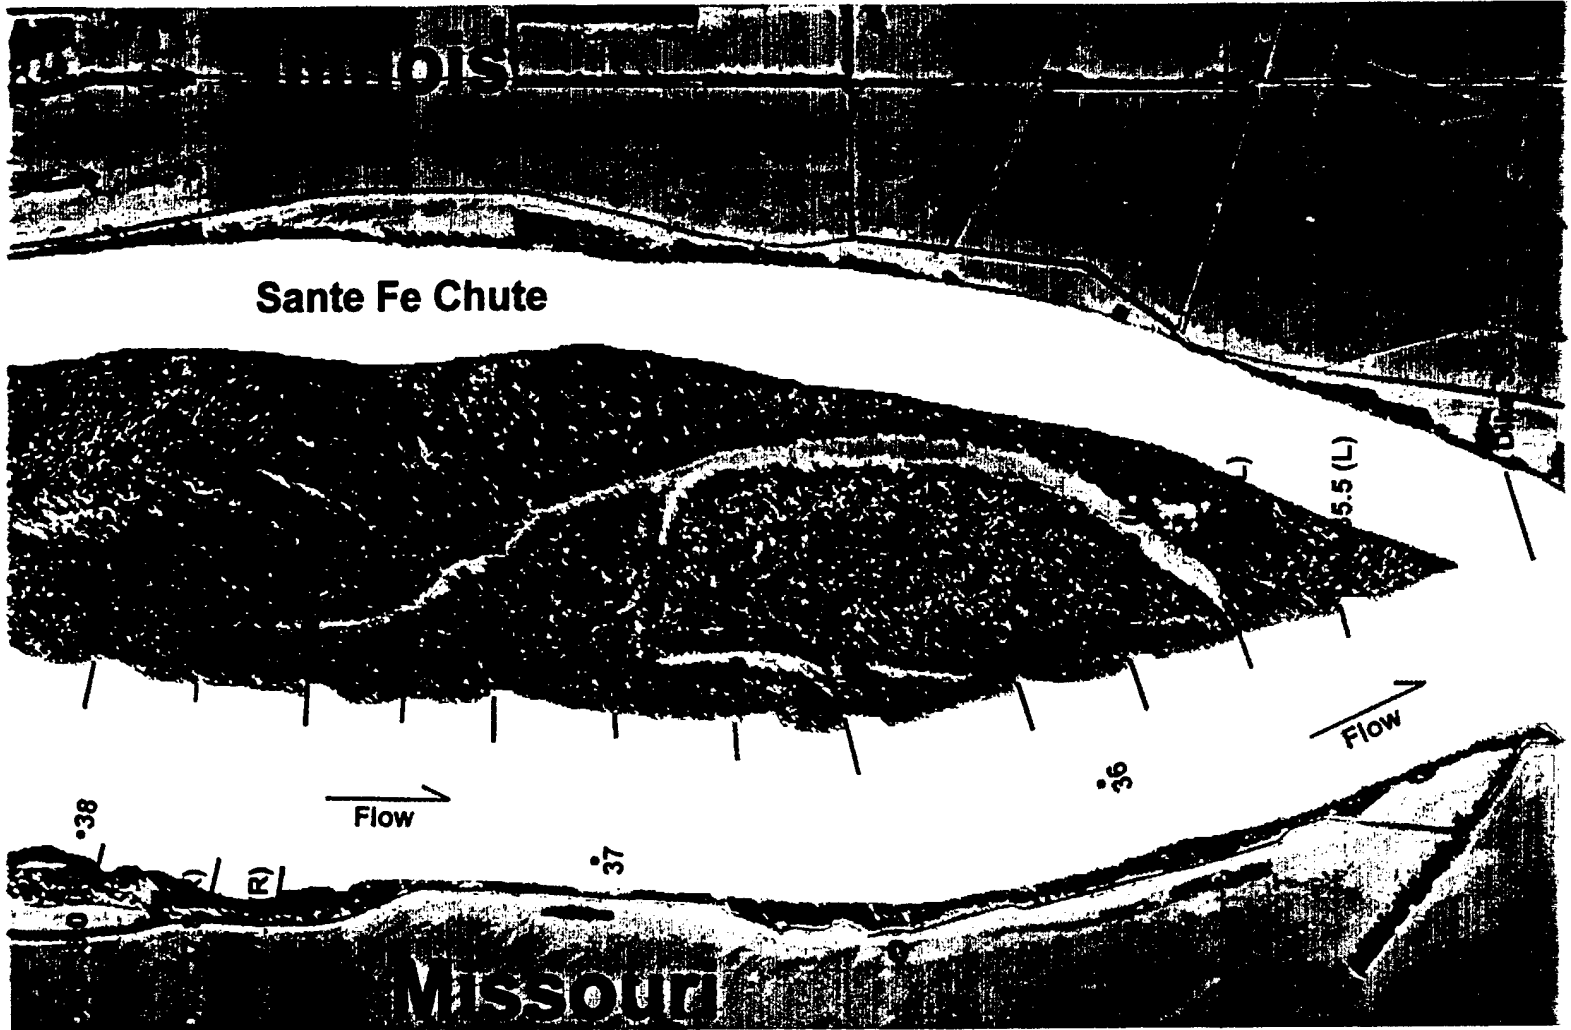
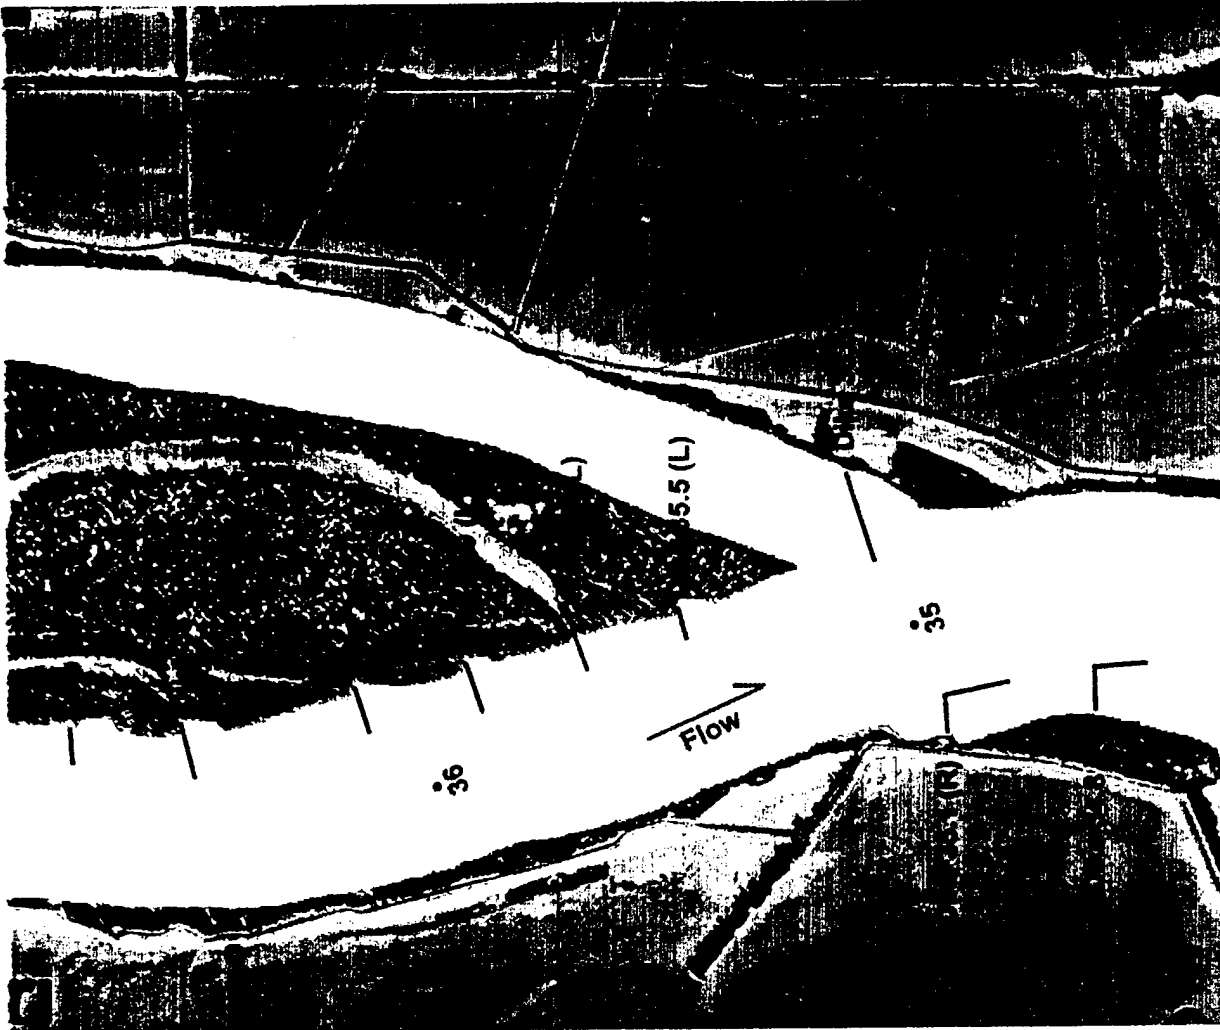
<b>U.S. ARMY ENGINEER DISTRICT, ST. LOUIS CORPS OF ENGINEERS ST. LOUIS, MISSOURI</b>	
PREPARED BY: R. Hellick CHECKED BY: R. Dewdney	Sante Fe/Doolan Chute Micro-Model Study Mississippi River Miles 40 - 35	
DATE: 28 July 1998	<u>Photograph of Sante Fe Study Reach</u>	
		PLATE NO  1

Plate 1 is a map depicting the characteristics, configuration, and nomenclature of the Mississippi River, miles 40 to 35. The upper end of Sante Fe Chute begins at River Mile 39.7L. This side channel parallels the main channel for a distance of approximately 5 miles. Doolan Chute begins at river mile 39.0R and re-enters the main channel at river mile 31.0R.

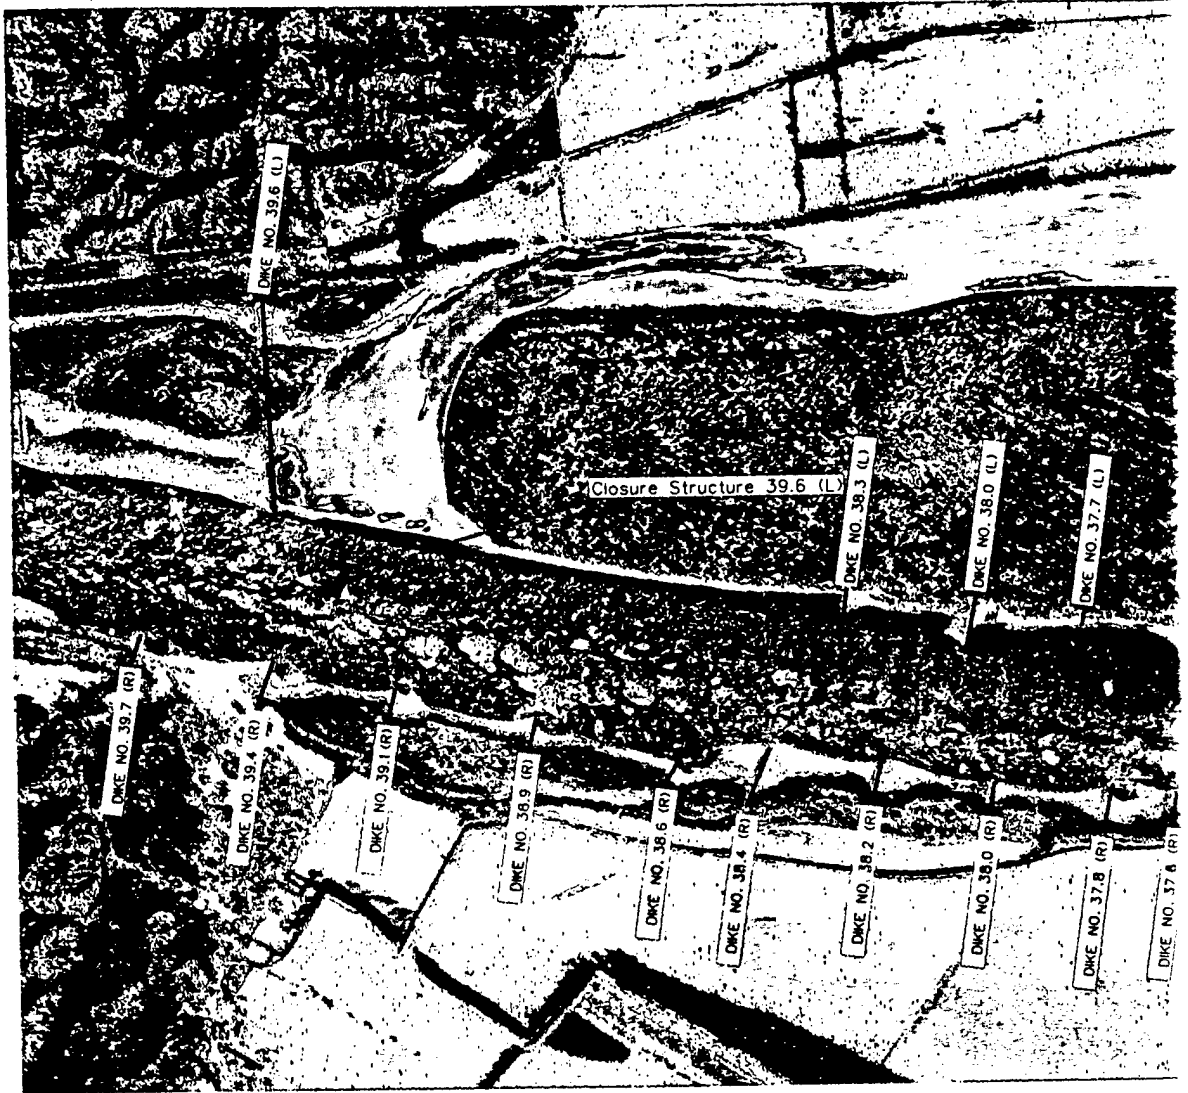
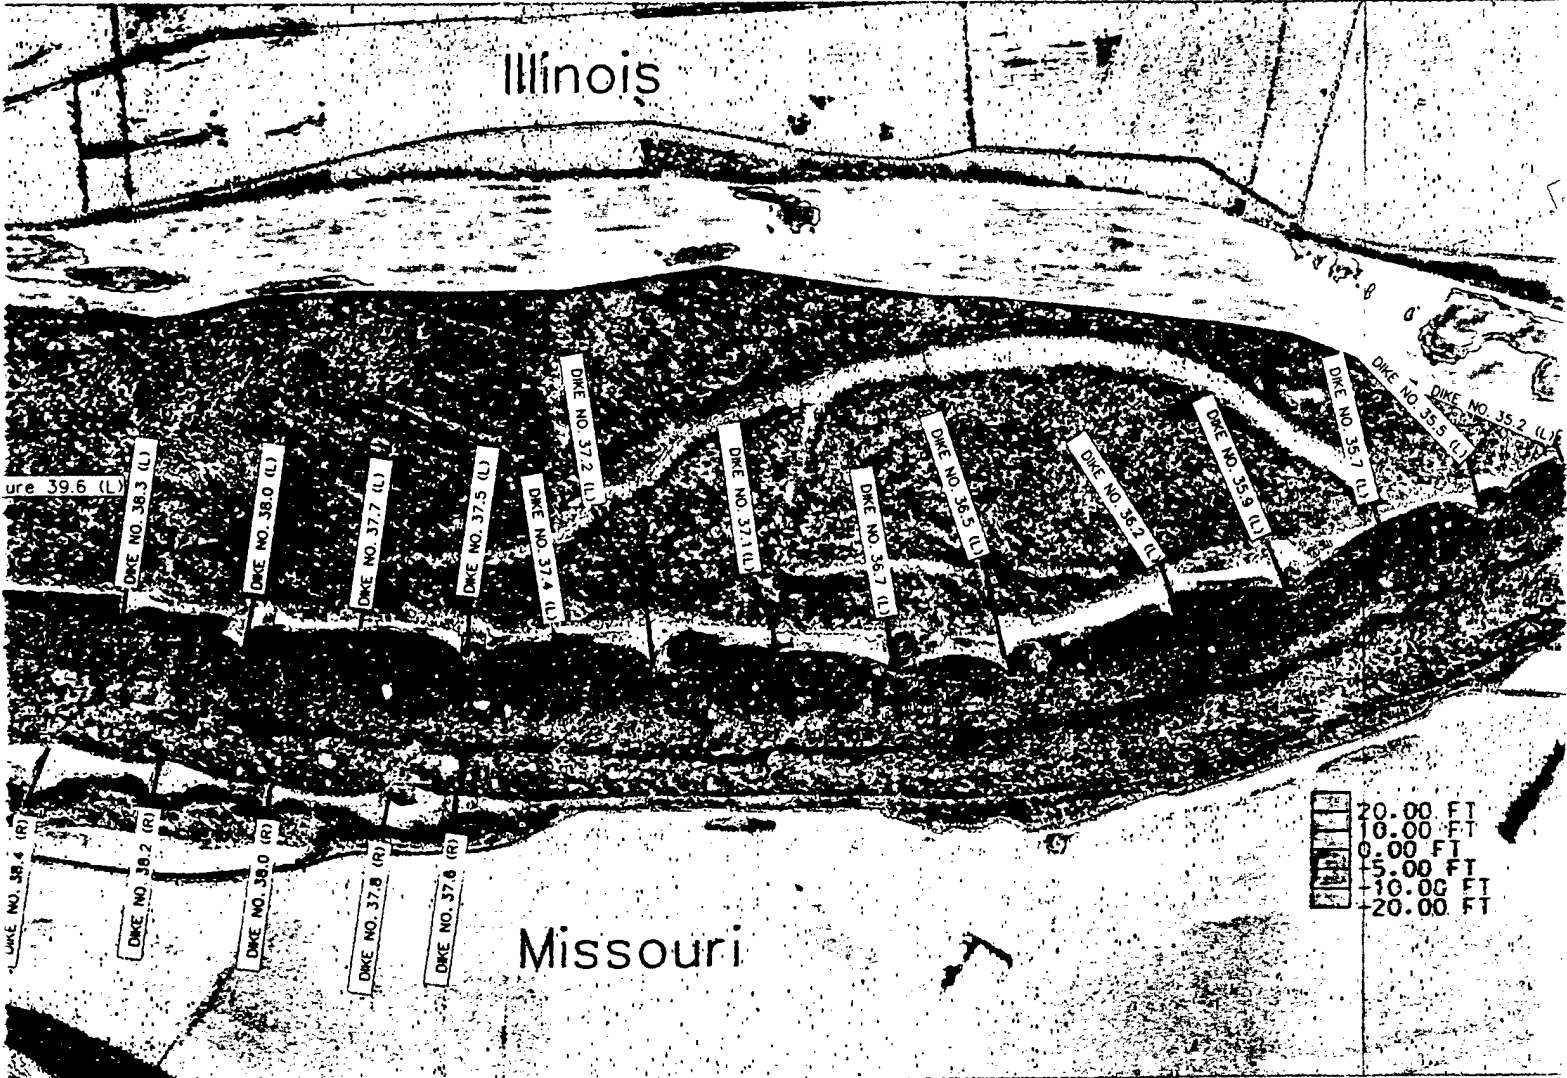
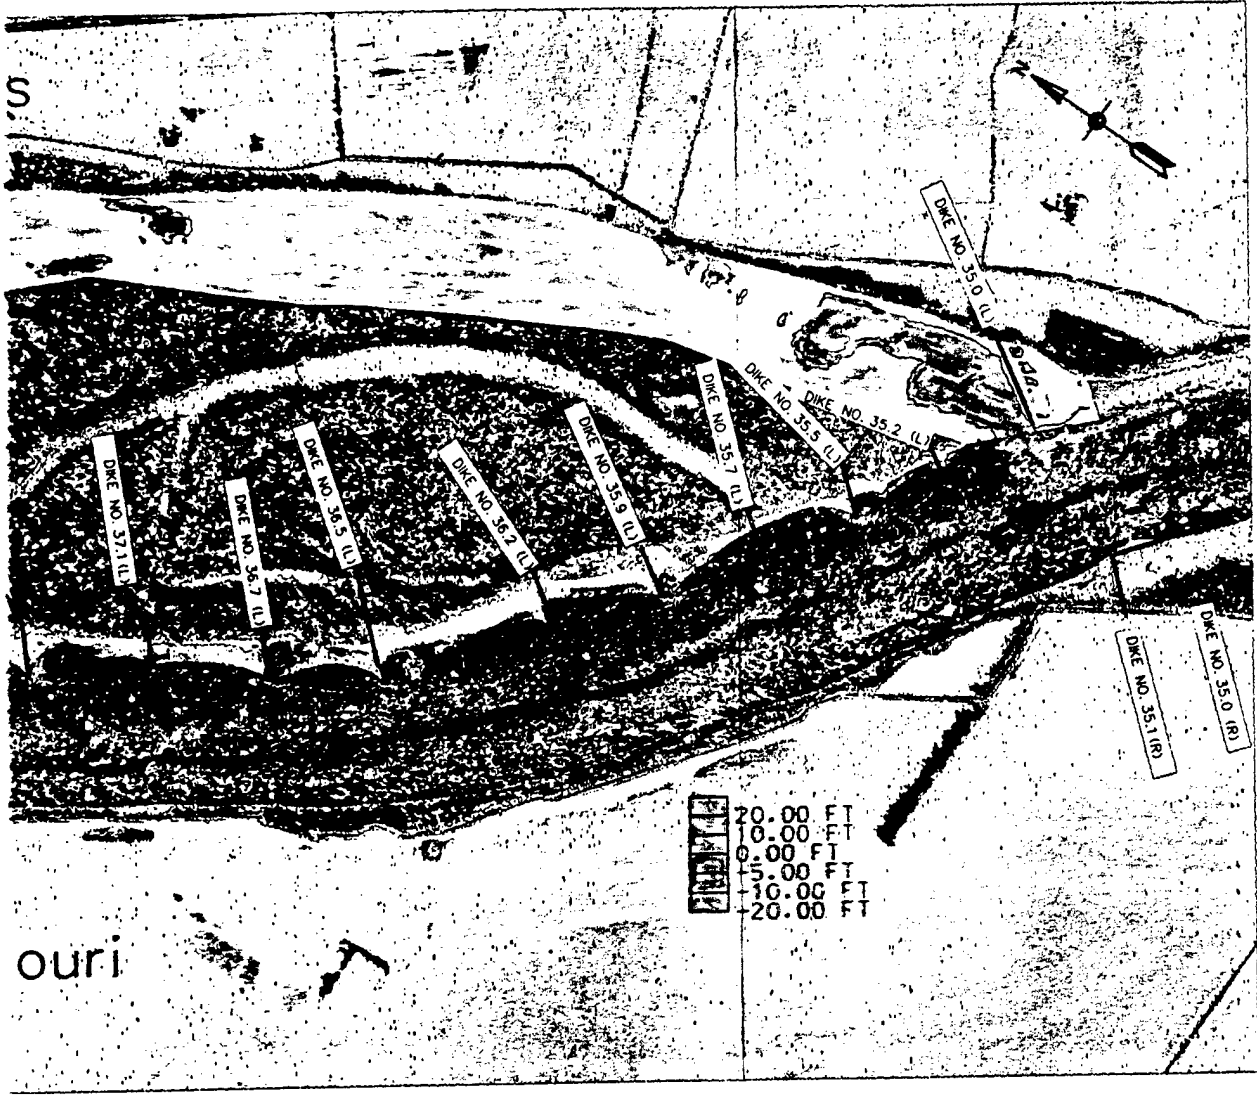
PLATE NO. <b>2</b>
<small>DESIGN FILE: D:\DGM\MODEL\SANTEFE\95R02.dwg</small>		<small>PLOT SCALE: 1" = 2000'</small>
<small>PLOT DATE: 24 Sept 1996</small>

In 1992, river engineers of the St. Louis District made an inspection of this chute and noted, as verified by the 1995 survey, that there were minimal water depths throughout most of Sante Fe Chute. The jet boat used for inspection drew approximately 6 inches of draft and had a very difficult time navigating in the chute. Several times the jet boat touched bottom. Engineers observed that for the most part, the left descending bank of the chute was erosional and vertical.

Several prototype surveys were used to determine the general bed characteristics that existed in the prototype (Plates 2, 8, and 9). A 1994 low water ice photograph of the study reach of the Mississippi River was also used to compare surface flowlines (Plate 12).

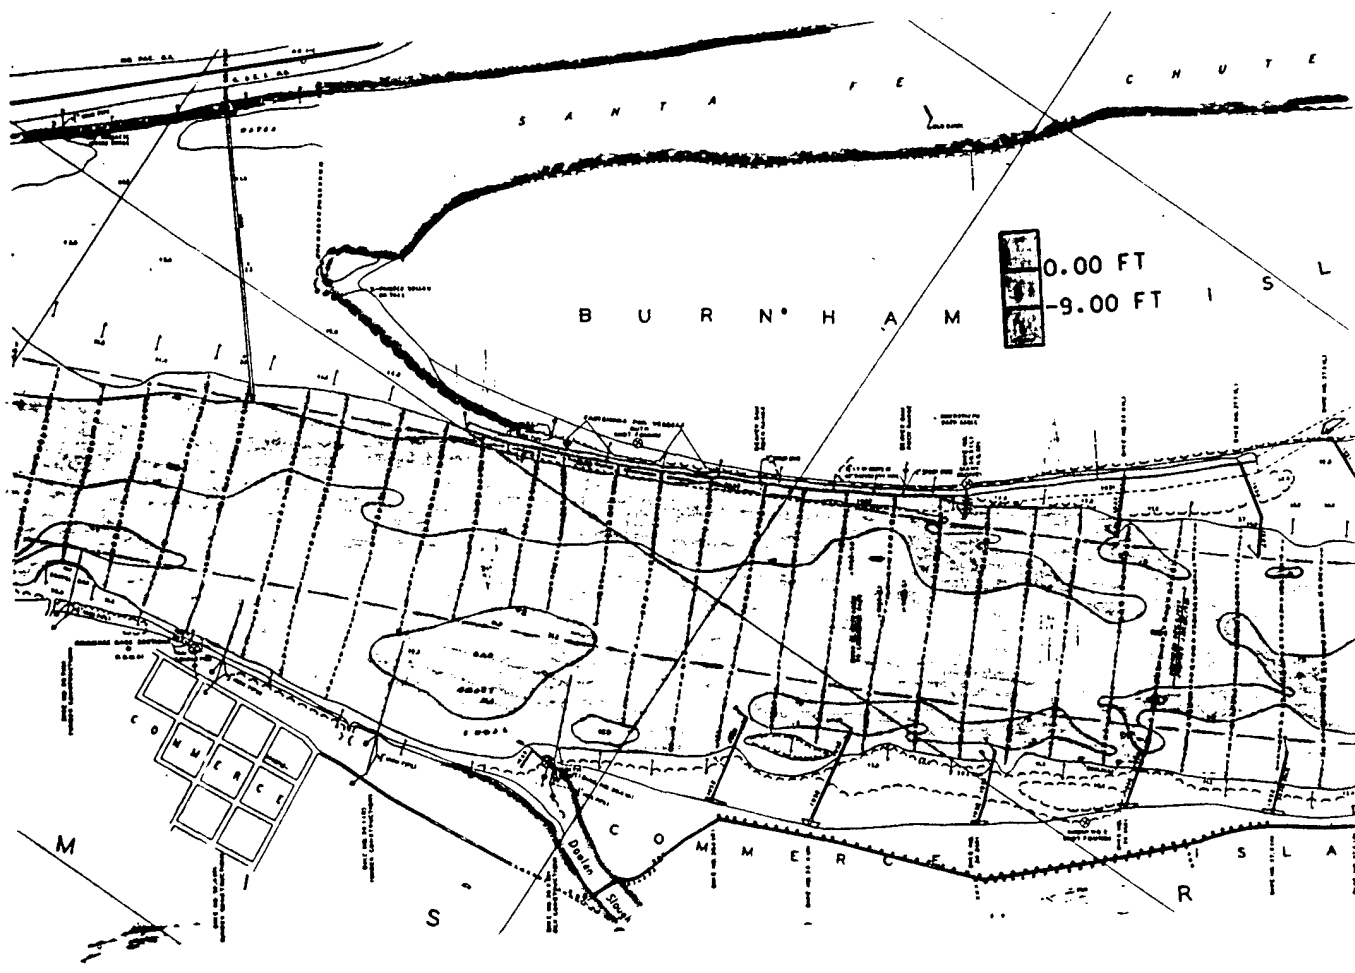
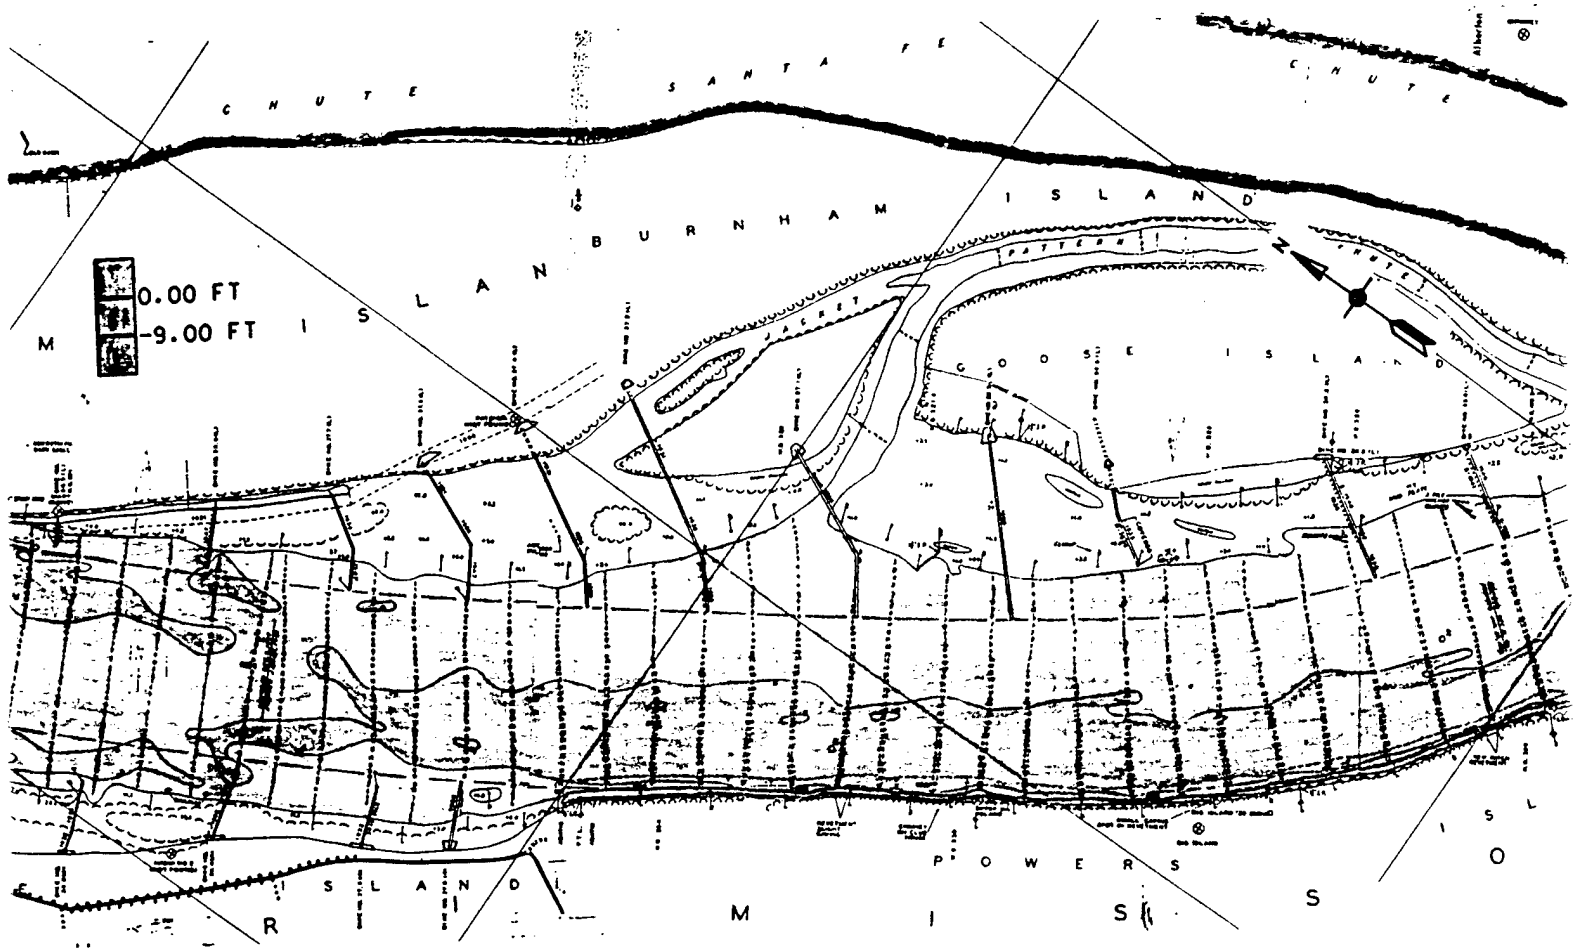
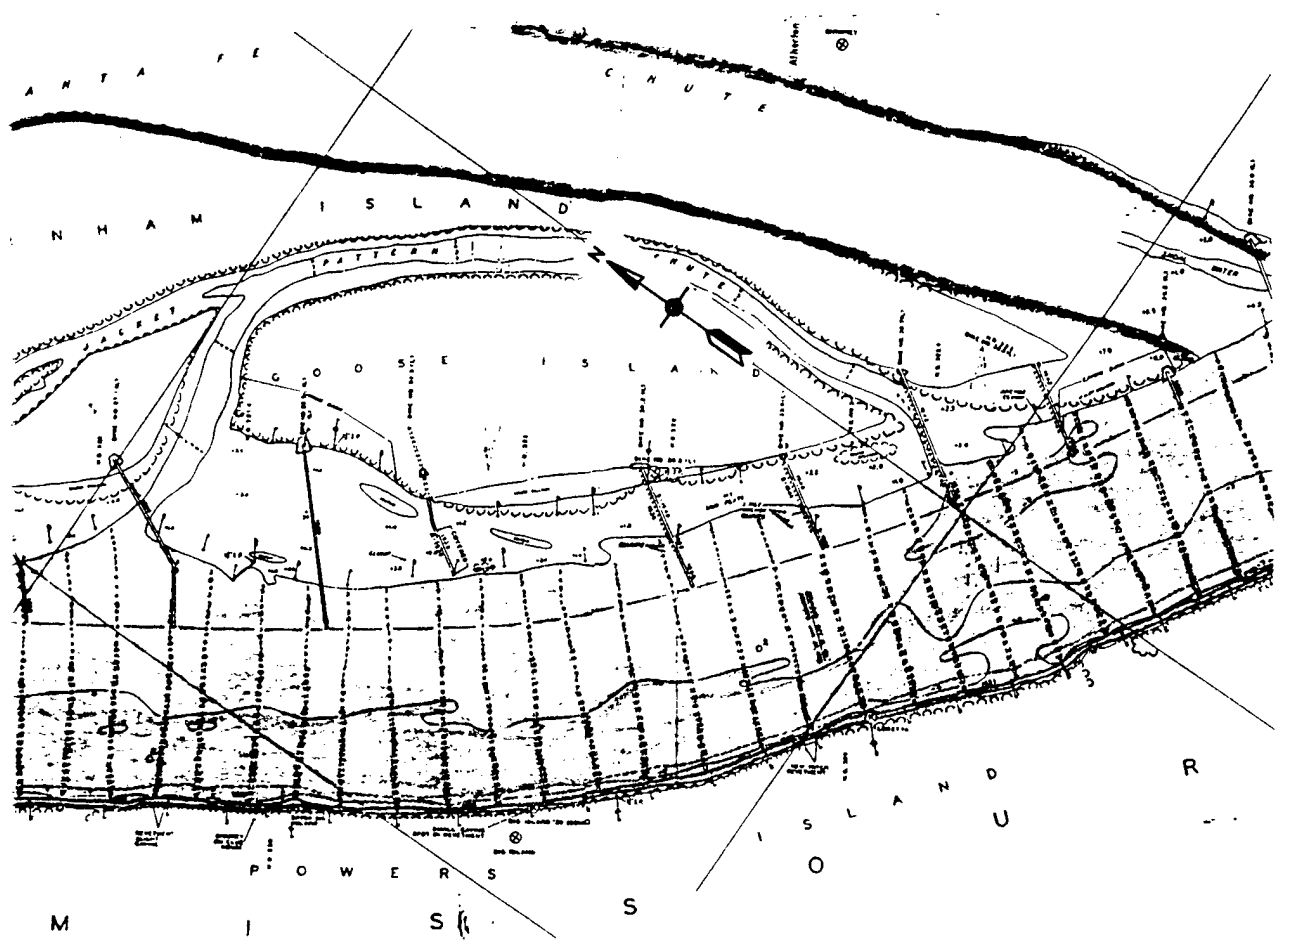
<small>PLOT SCALE: 1 in = 1000 ft</small>	<small>PLOT DATE: 24 Sept 1958</small>
<small>PLATE NO</small> <b>3</b>

Plate 3 depicts the historical condition of the chute in 1958. The entrance of the chute occurred on the right descending bank at mile 38.9. The entrance width was approximately 600 feet. The channel depth in this area was approximately 0 feet relative to the Low Water Reference Plane (LWRP), or approximately +5 at the Cape Girardeau gage. Although vegetation markings in the chute just

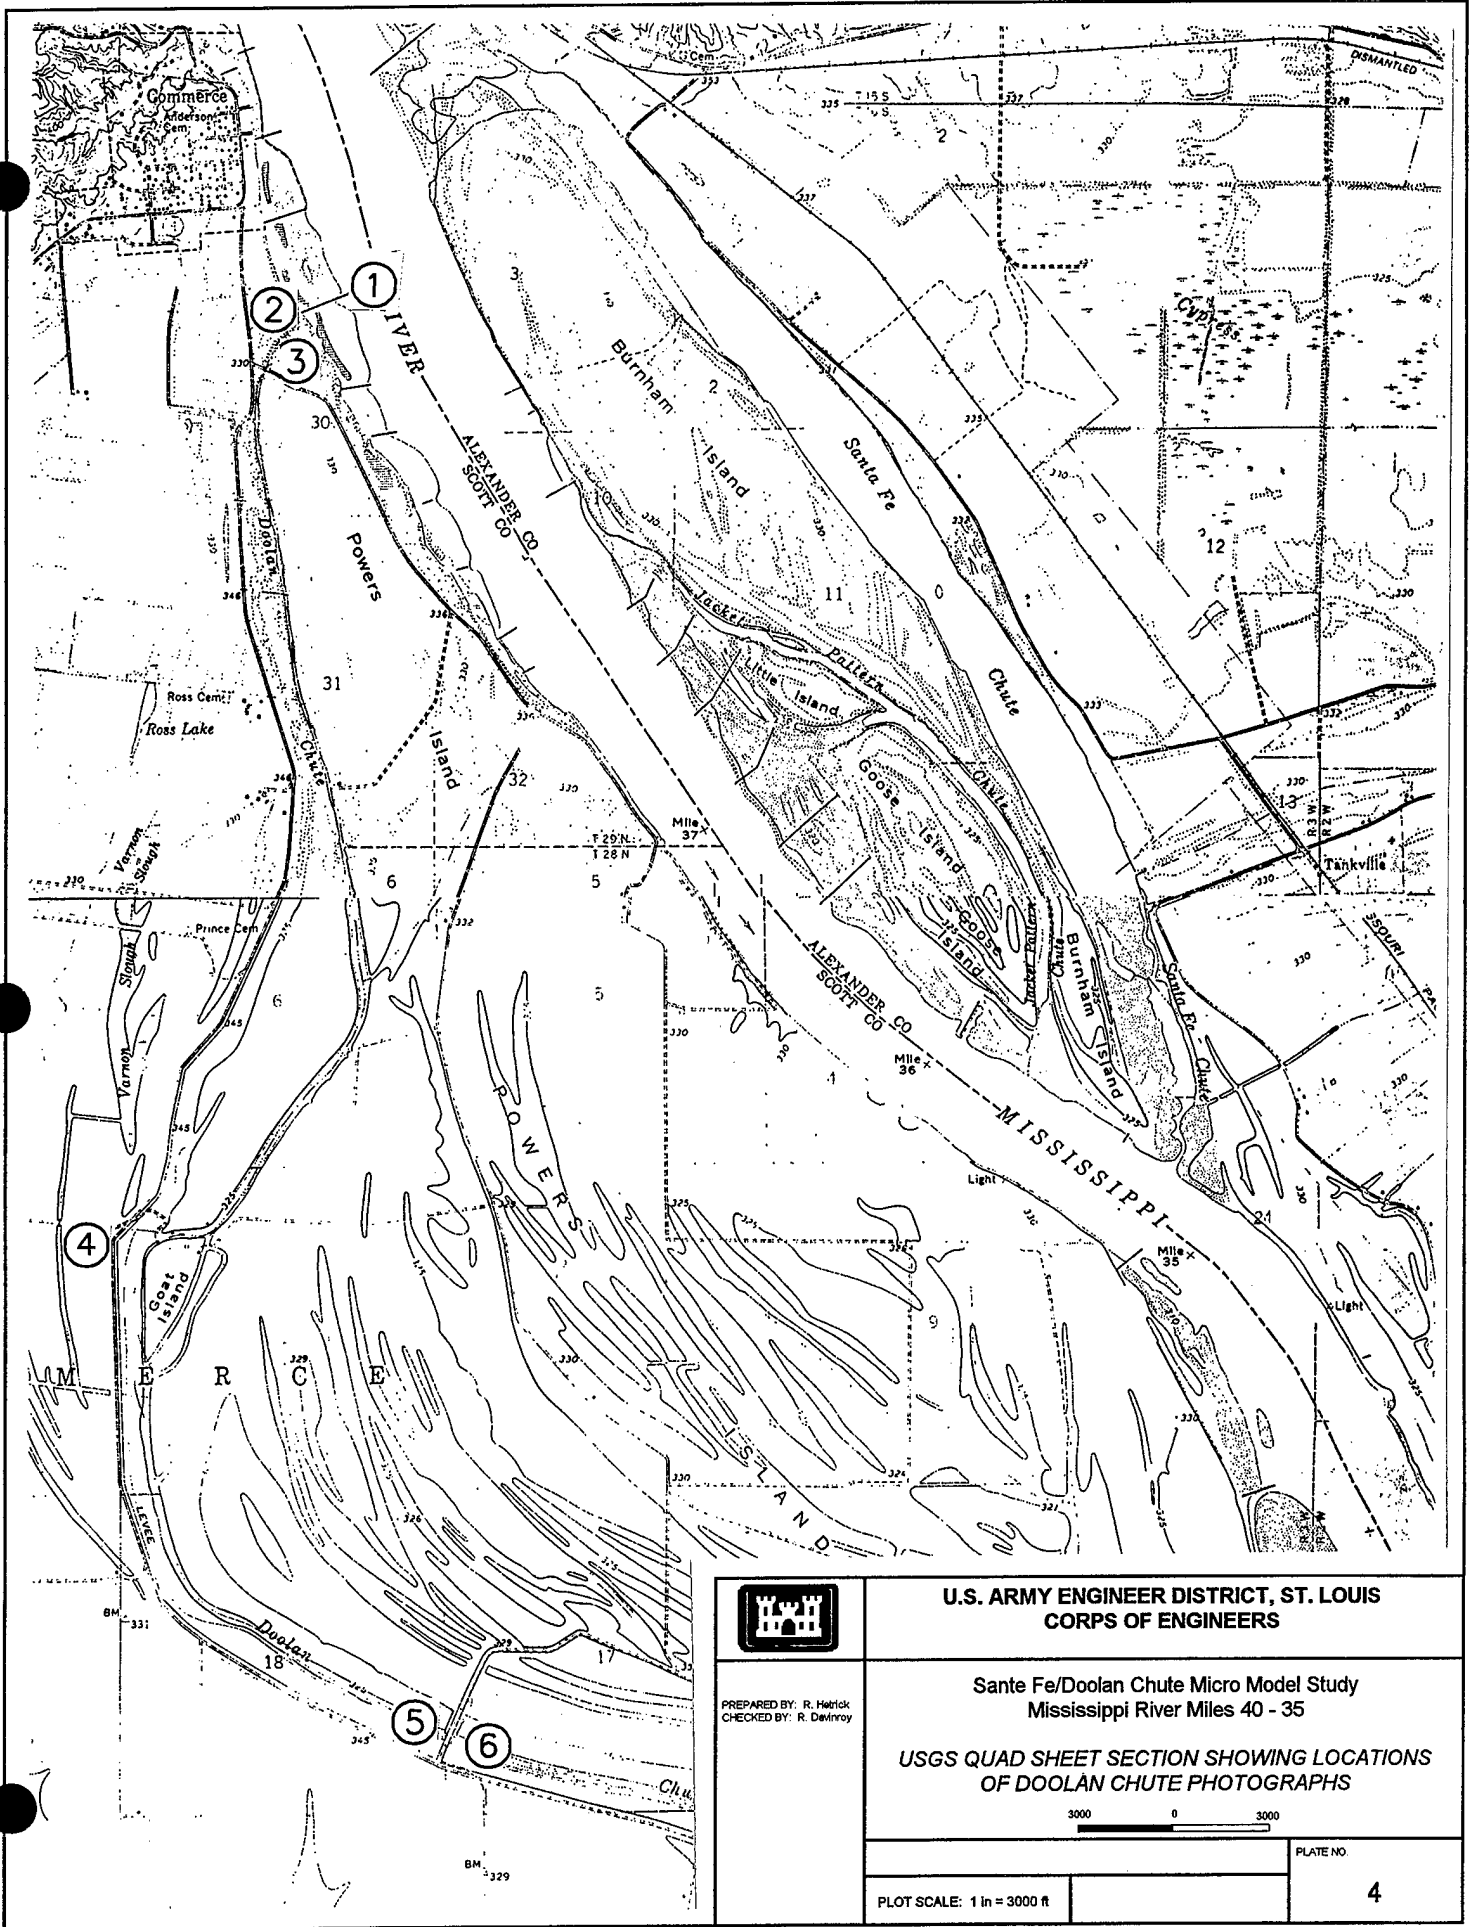
A site investigation of Doolan Chute was conducted by Robert Hetrick during the week of 19 February to gain a better understanding of the present day conditions of the chute remnants. Plate 4 is a USGS quad sheet of the Doolan Chute area. This map shows the locations of the photographs taken in the field. Remnants of Doolan Chute still exist today. Although the chute is no longer attached to the main channel, approximately 70 percent of the original reach still exists.

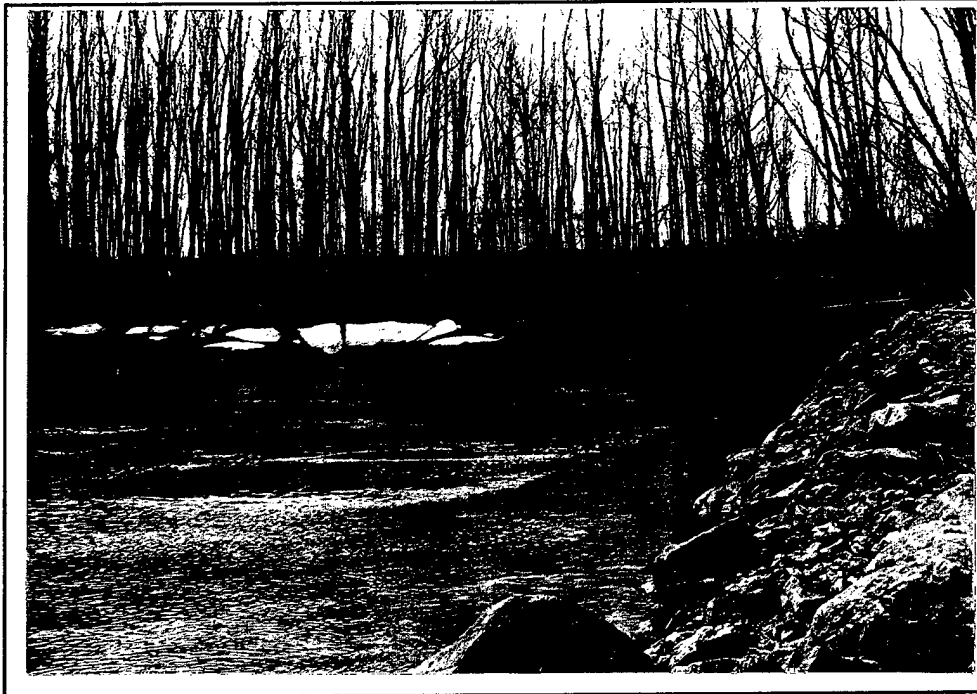
Photograph #1; Doolan Chute

From the tip of dike 39.1, as shown on Plate 5 (Photograph #1), there was no indication of any chute. The bankline was constant across this section, as well as the density and age of the vegetation. Approximately 300 feet inland of the

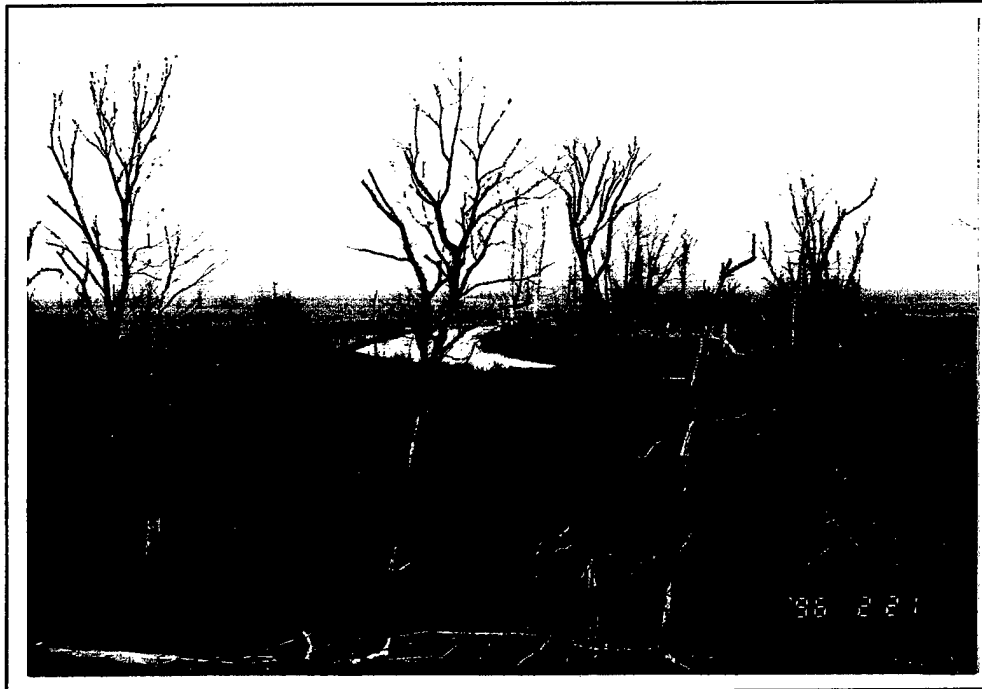
Photograph #4; Doolan Chute

The lower photograph on Plate 6 (Photograph #4) was taken from the levee looking upstream along the northern section of Goat Island. The chute contained a defined channel that was approximately 75-100 feet in width. The transition from the poorly defined channel to the well defined channel occurred approximately  $\frac{1}{2}$  to  $\frac{3}{4}$  mile upstream of Goat Island.

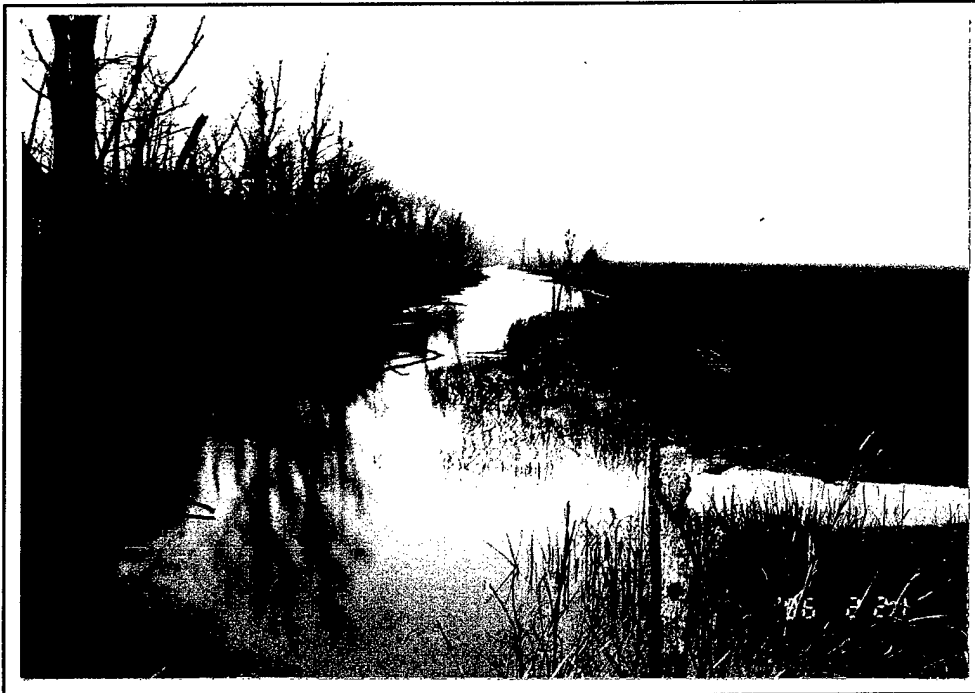
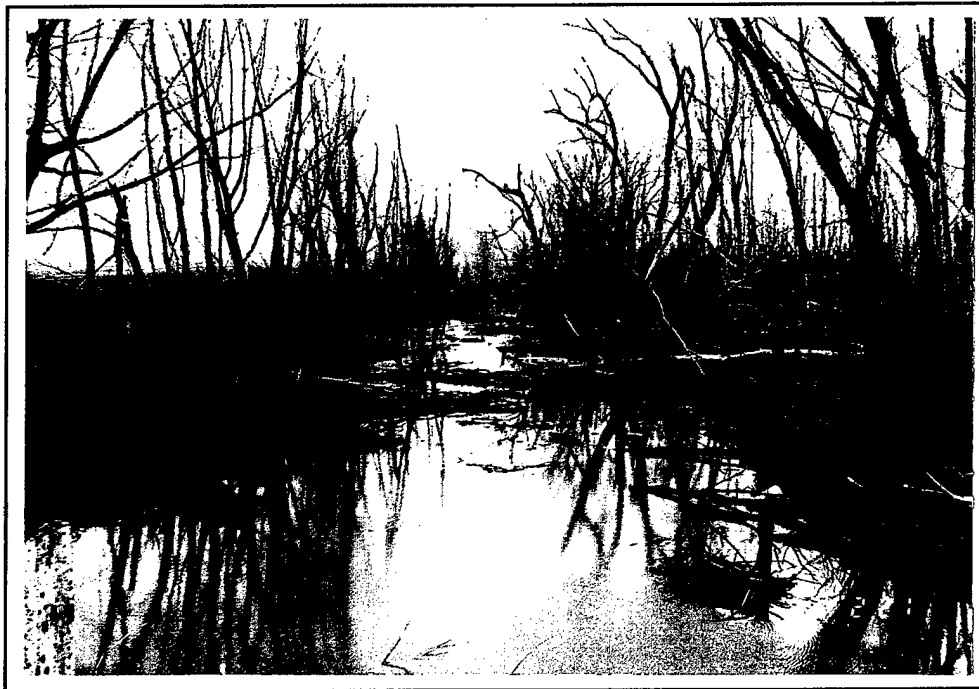
The photographs on Plate 7 (Photographs #5 and #6) were taken looking upstream and downstream, respectively, from the road that crossed Doolan Chute, approximately 2 miles downstream of Goat Island. The photographs show the typical channel characteristics that were present between Goat Island and the road crossing. At the road crossing, there was an 8-10 foot diameter steel culvert.

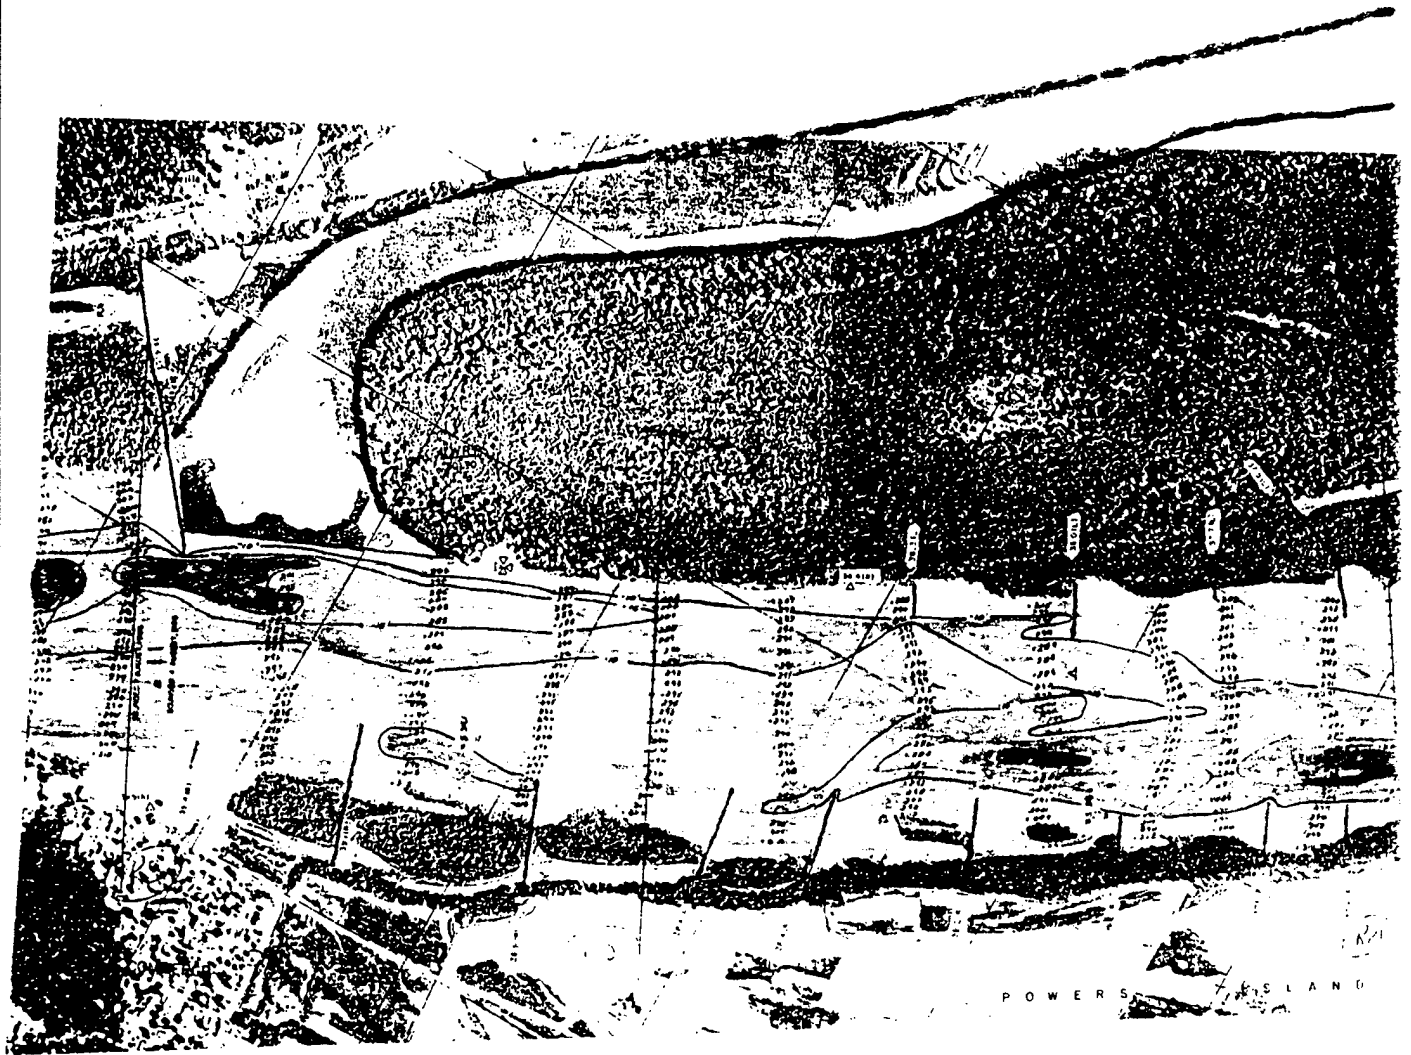
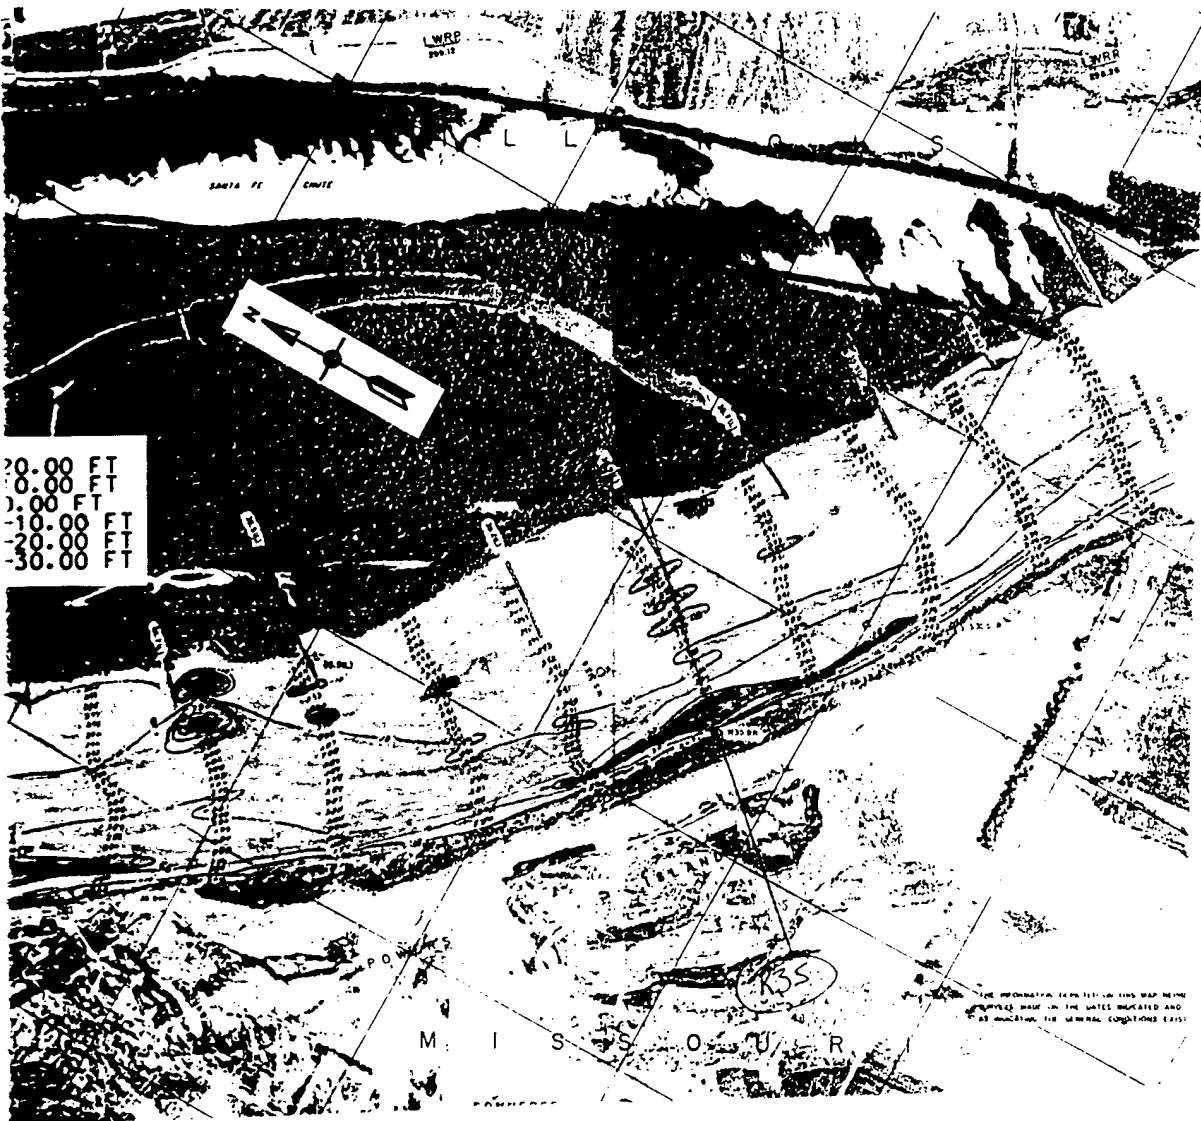
<b>U.S. ARMY ENGINEER DISTRICT, ST. LOUIS CORPS OF ENGINEERS ST. LOUIS, MISSOURI</b>
	Sante Fe/Doolan Chute Micro Model Study Mississippi River Miles 40 - 35 <b>1986 PROTOTYPE SURVEY</b>
PLOT SCALE: 1" = 400' FT      PLOT DATE: 24 Sept 1986      PLATE NO: <b>8</b>

Plates 8 and 9 are 1986 and 1993 plan view hydrographic survey maps of the Mississippi River main channel. At River Mile 40, a crossing existed with navigation depths averaging between -15 to -20 feet LWRP. The channel transitioned to the left descending bank adjacent and just parallel to the closure structure at mile 39.4L. The depths varied between -20 and -50 feet LWRP, depending upon which survey was used (it must be noted that the survey of 1993 was a high water survey, while the survey of 1986 was a low water survey).

The channel remained against the left descending bank until approximately mile 38.3, where it transitioned to the right descending bank. Depths in this area were between -10 and -15 feet LWRP. The channel remained against the right descending bank through the study reach, forming a long bendway channel. With exception, one particular dike on the left descending bank at Mile 36.7L produced a scour hole in excess of -30 feet LWRP (1986 survey).
