TECHNICAL REPORT M1

**SEDIMENTATION STUDY OF THE MISSISSIPPI RIVER  
SANTE FE CHUTE, DOOLAN CHUTE  
HYDRAULIC MICRO MODEL INVESTIGATION**

September 1996

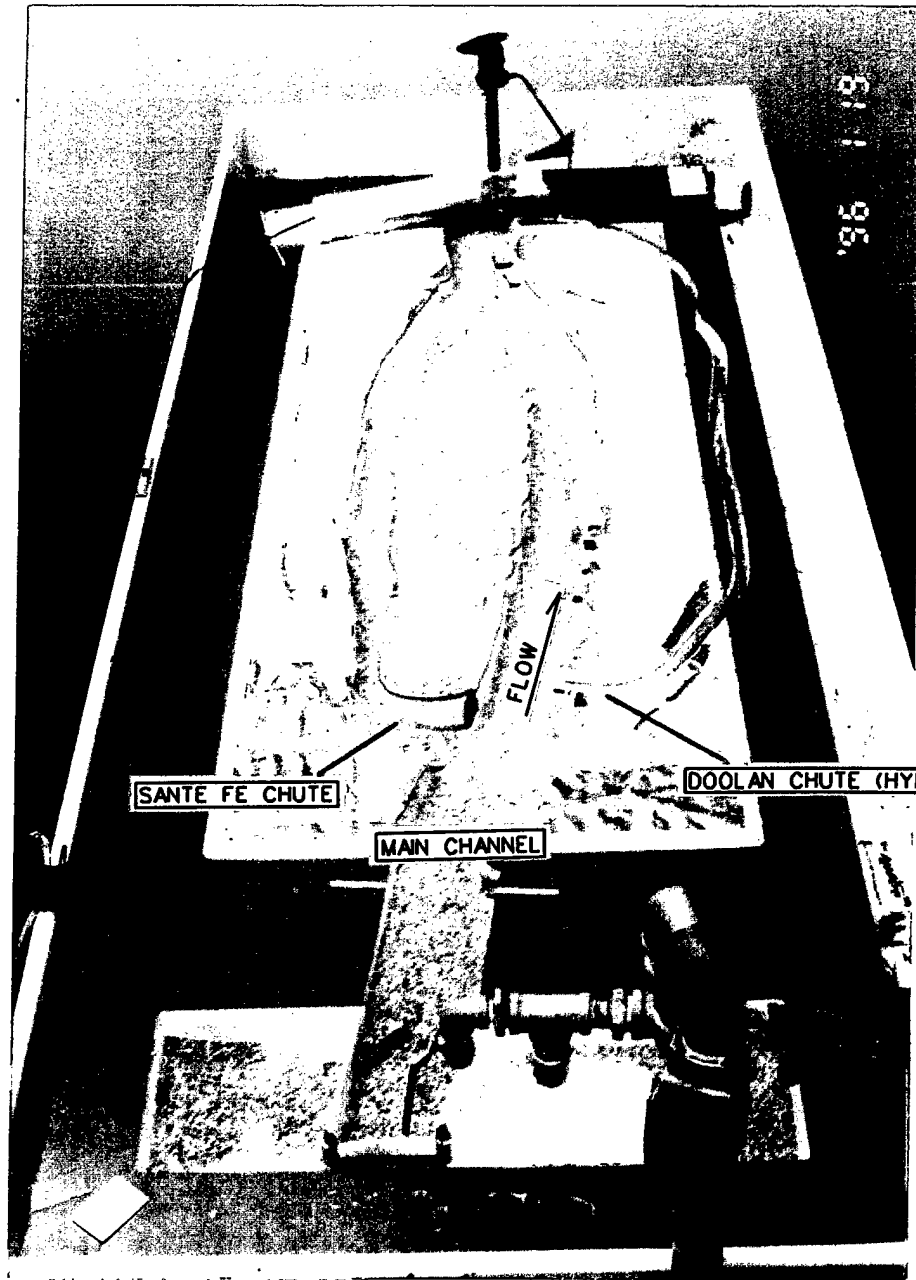
Plate 10 is a photograph of the Sante Fe/ Doolan Chute hydraulic micro model used in this study. The scales were 1 inch = 600 feet, or 1:7200 horizontal and 1 inch = 100 feet, or 1:1200 vertically for a 6:1 distortion ratio. This distortion supplied the necessary forces required for the simulation of sediment transport conditions similar to the prototype. The bed material was granular plastic urea, Type II, with a specific gravity of 1.23.

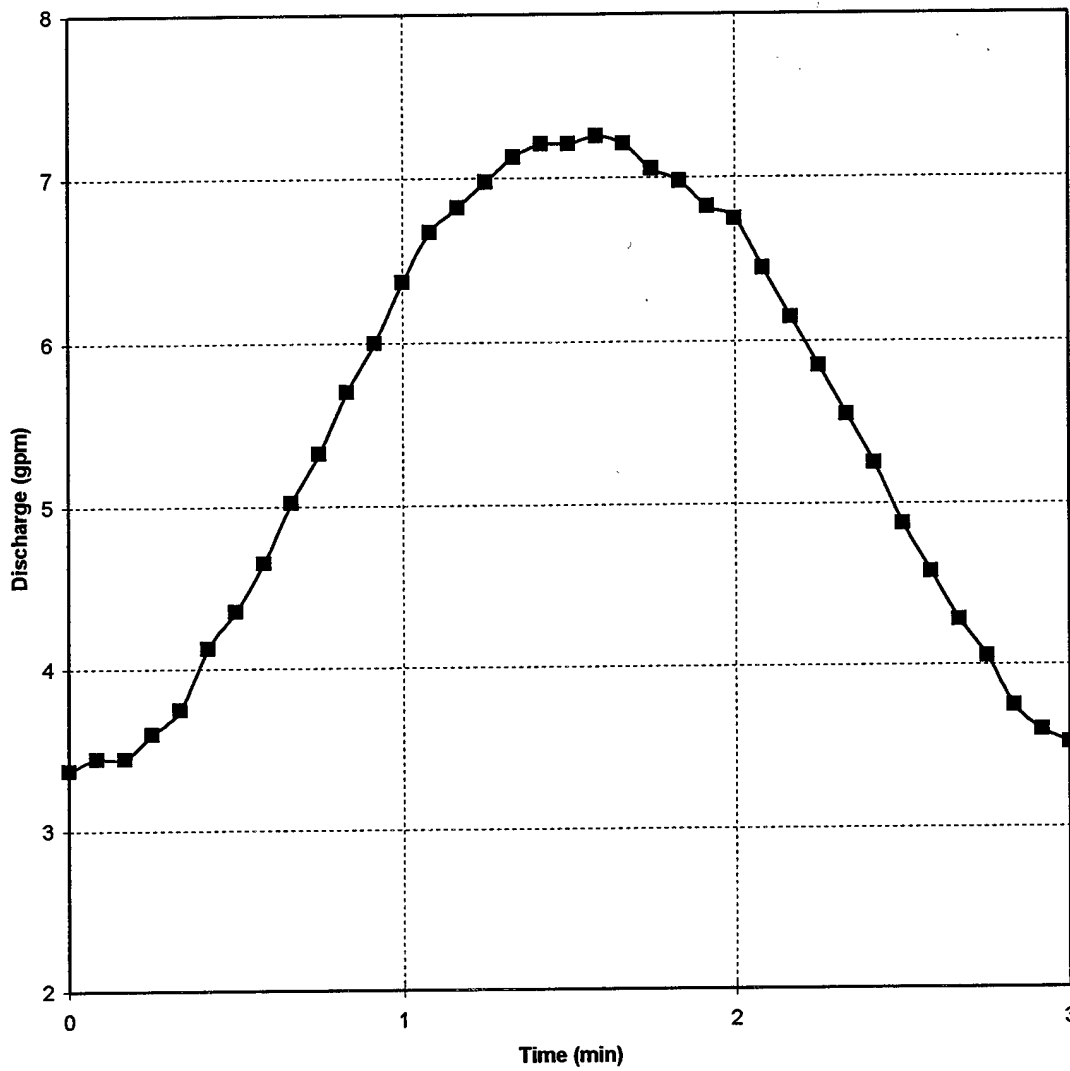
Plate 11 illustrates the design hydrograph used in this study. This hydrograph served as an effective discharge response (2). Because of the constant variation experienced in the prototype, the effective discharge was used to theoretically analyze the average expected sediment response during any given year. The time increment or duration of the design hydrograph was 3.5 minutes.

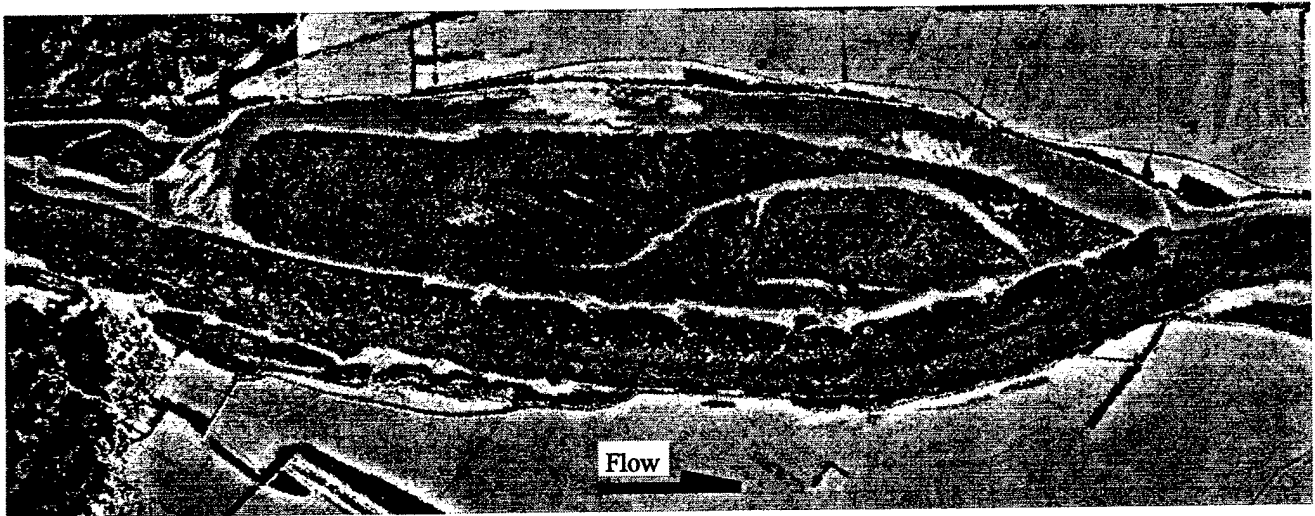
12

Several prototype surveys were used to determine the general bed characteristics that existed in the prototype (Plates 2, 8, and 9). A 1994 low water ice photograph of the study reach of the Mississippi River was also used to compare surface flowlines (Plate 12).

Plates 14 and 15 are flow visualizations of the main channel and Sante Fe Chute, respectively. Nearly identical patterns were seen in the flow visualization of the base test condition in the micro model as compared to the ice photo on plate 12.

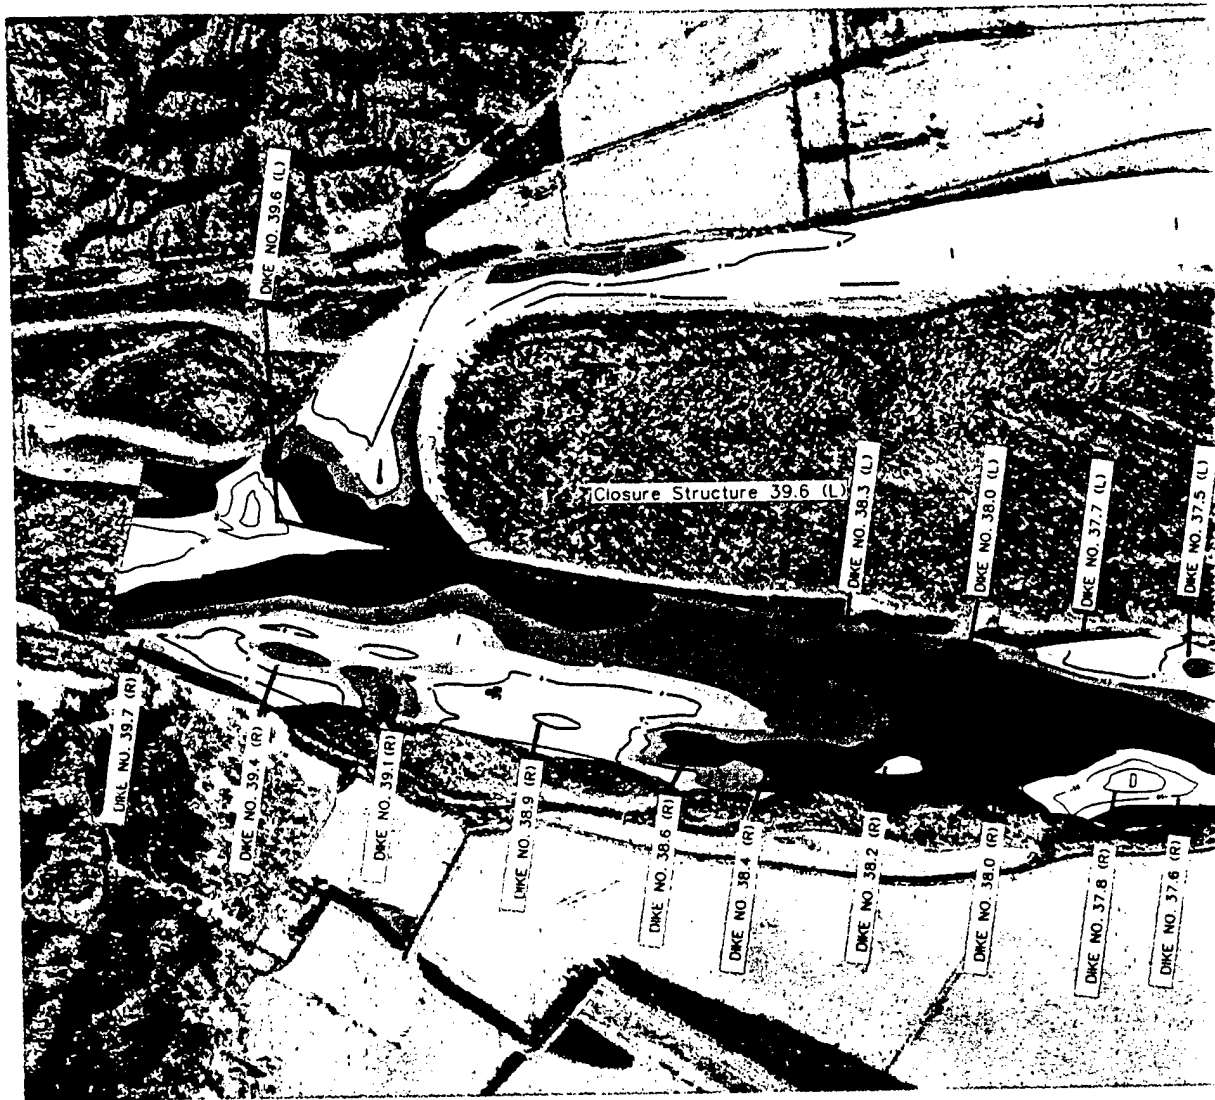
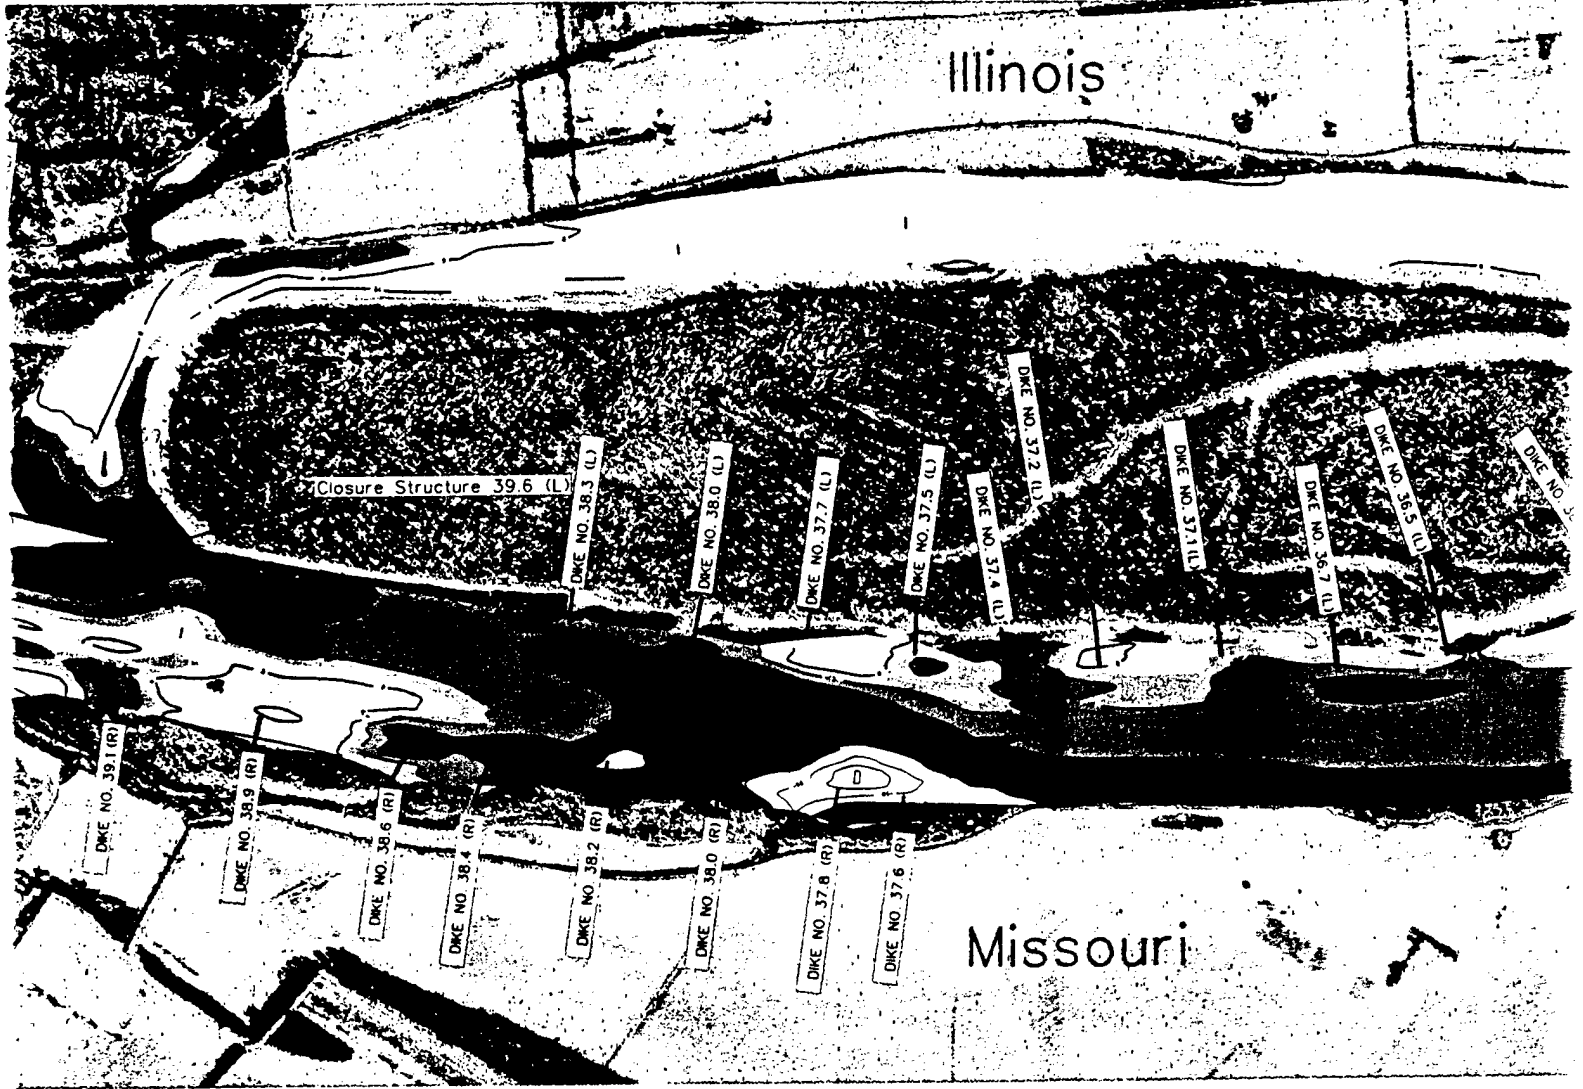
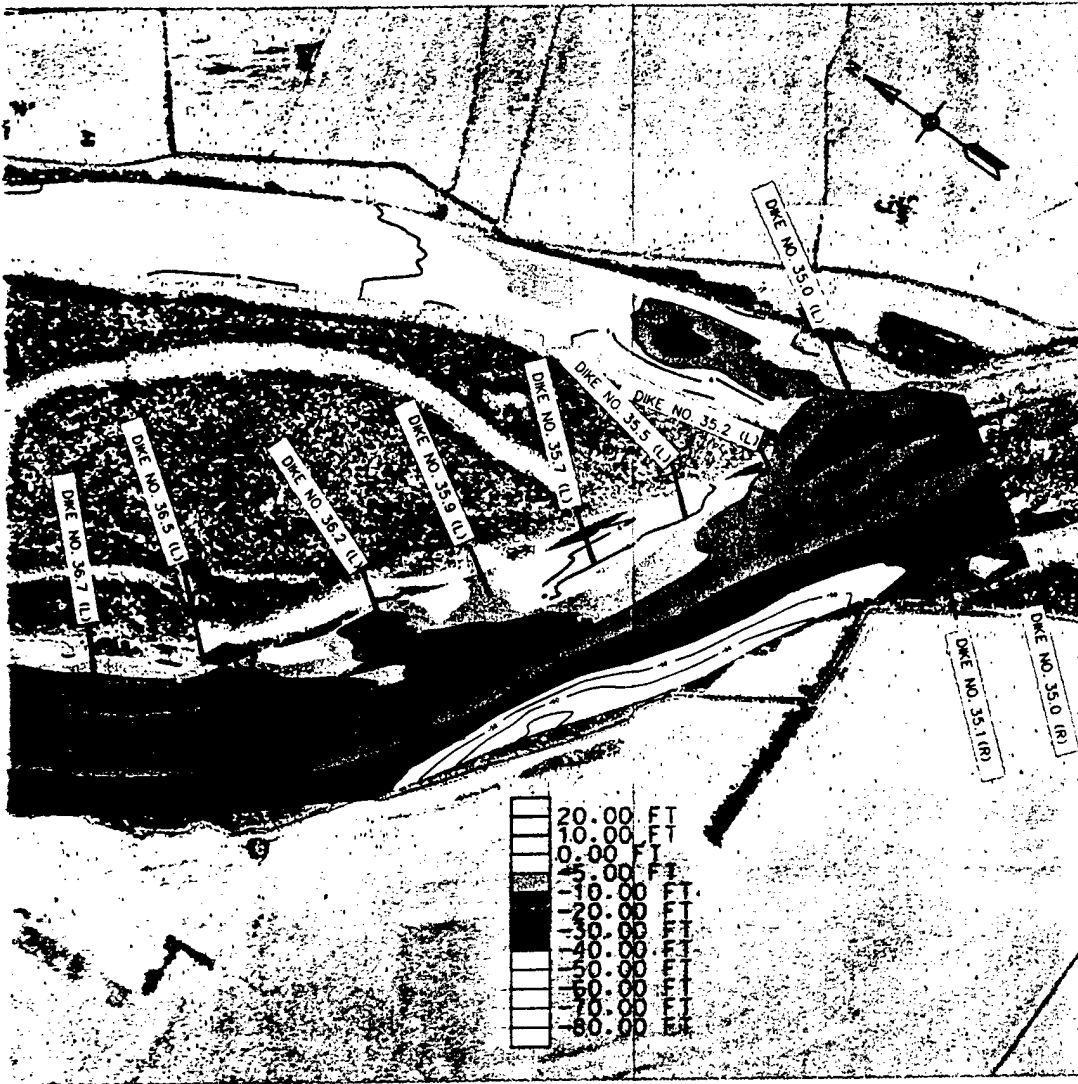
Plate 13 shows the resultant bed configuration of the micro model base test. This survey served as the comparison survey for all future design alternative tests. The base test was developed from the simulation of successive design hydrographs until bed stability was reached and a similar bed response was achieved as compared with prototype surveys.

- a. Mile 39.4. Upper End of the Study Reach. The navigation channel had a tendency to fall directly against the closure structure at Mile 39.4. A sandbar formed adjacent to the channel between Miles 39.7R and 38.6R.
- b. Between Mile 38.4 and Mile 38.0, a crossing formed with depths between -10 and -20 feet LWRP. This area has been an historic dredging site. The two prototype surveys (Plate 8 and 9) show the tendency for shoaling in this area.
- c. At Mile 37.8R, a scour hole developed at dikes 37.8R and 37.6R. The channel remained against the right descending bank for the remainder of the study reach.
- d. The channel became deep (-50 to -60 LWRP) between river miles 36.2R and 35.1R.

e. In Sante Fe Chute, there was a tendency for some deepening to occur on the landward side of the closure structure. Just downstream of this area, the bed immediately developed as a high bar to elevations in excess of 0 LWRP.

f. On the left descending bank of Sante Fe Chute, in the vicinity of River Mile 39.0, a scour hole to depths in excess of -20 LWRP developed. From this point downstream, the bed was considerably high and flat, with depths in excess of 0 LWRP.

h. In Sante Fe Chute, just upstream of Dike No. 35.0L, a scour hole with depths between -10 and -20 LWRP was artificially molded in the bed. This hole represented the recent dredging site used for the construction of levee repairs after the 1993 flood (see Plate 2). Because of the main channel backwater influence, this hole remained intact during all future tests.

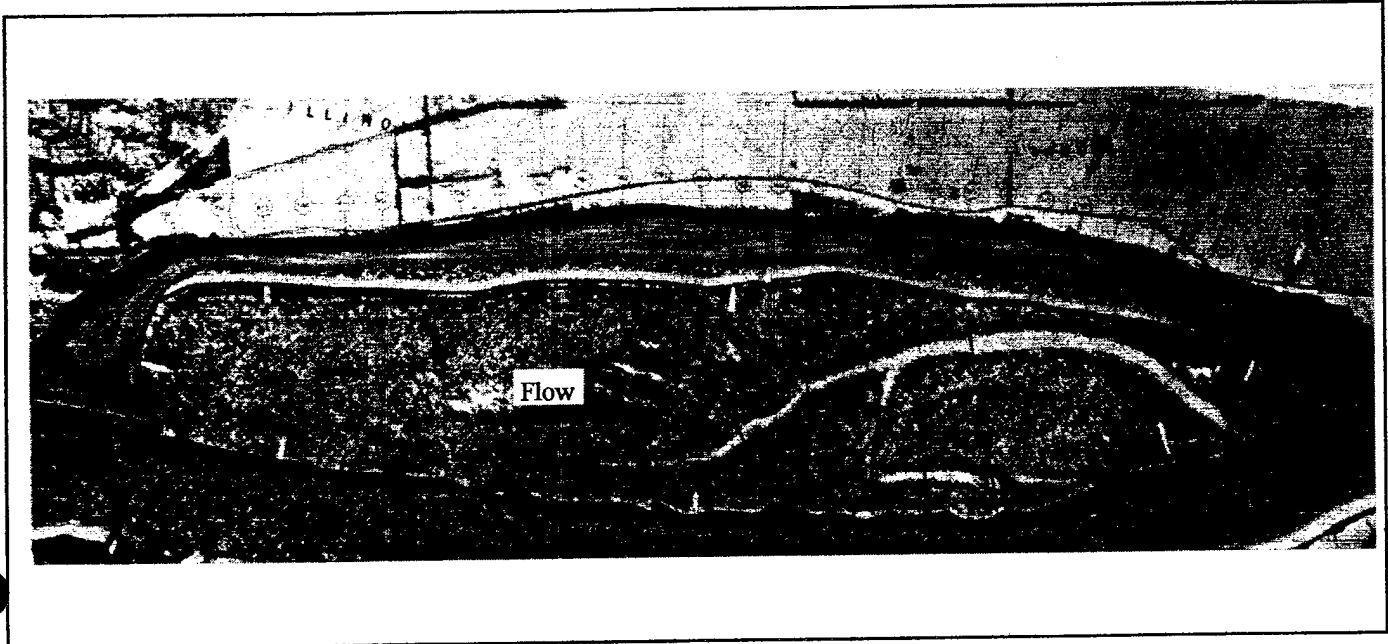
g. Very little energy or sediment transport potential was observed in Sante Fe Chute, especially in the lower one half of the channel. From flow visualization tests, it became apparent that the main channel backwater influence created this condition at all simulated flow conditions.

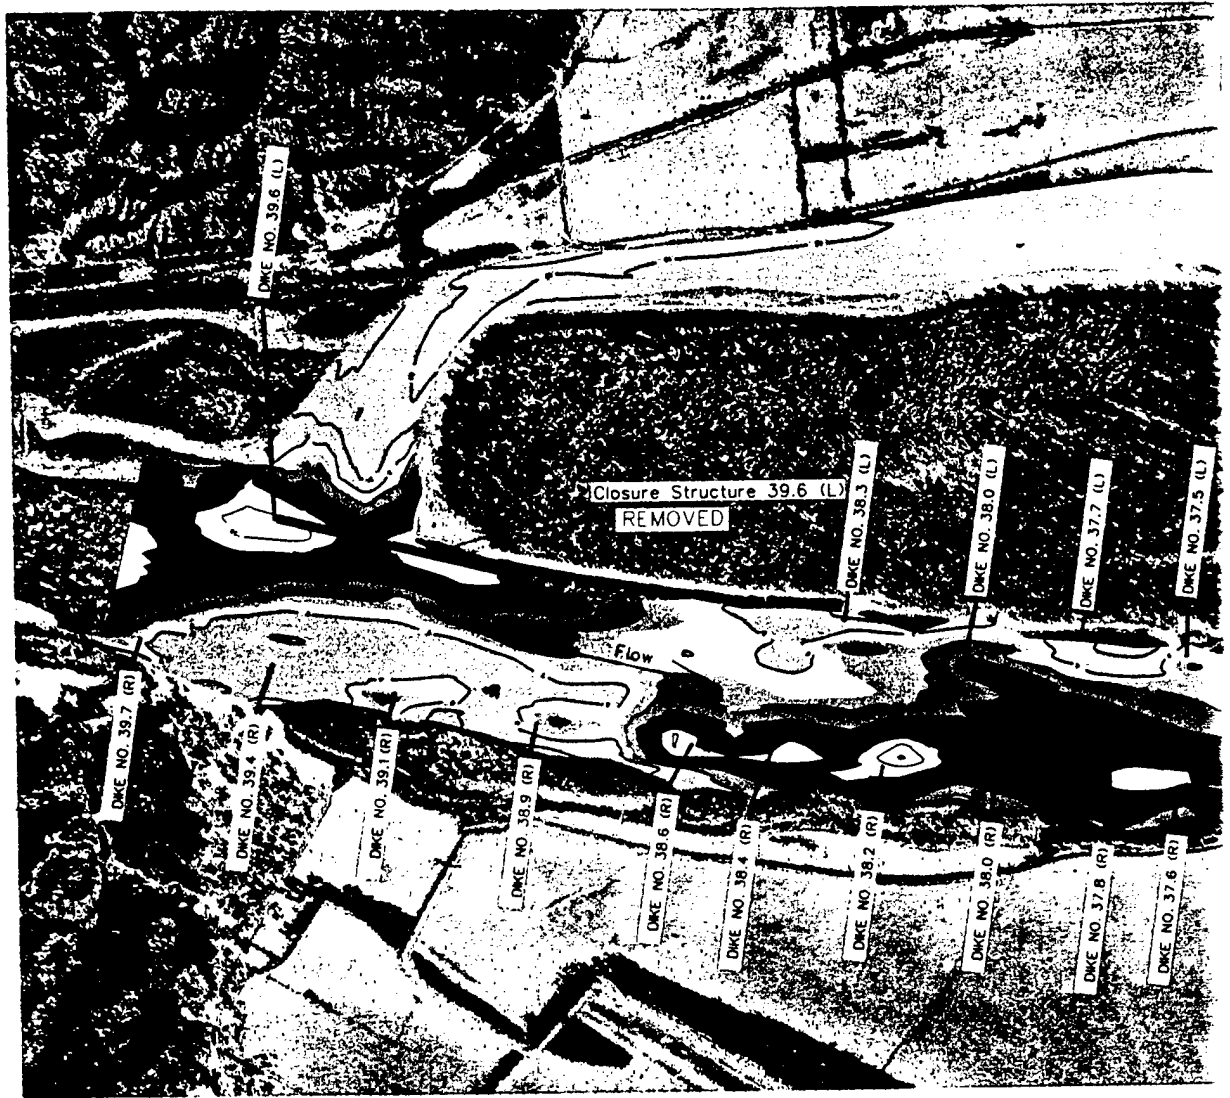
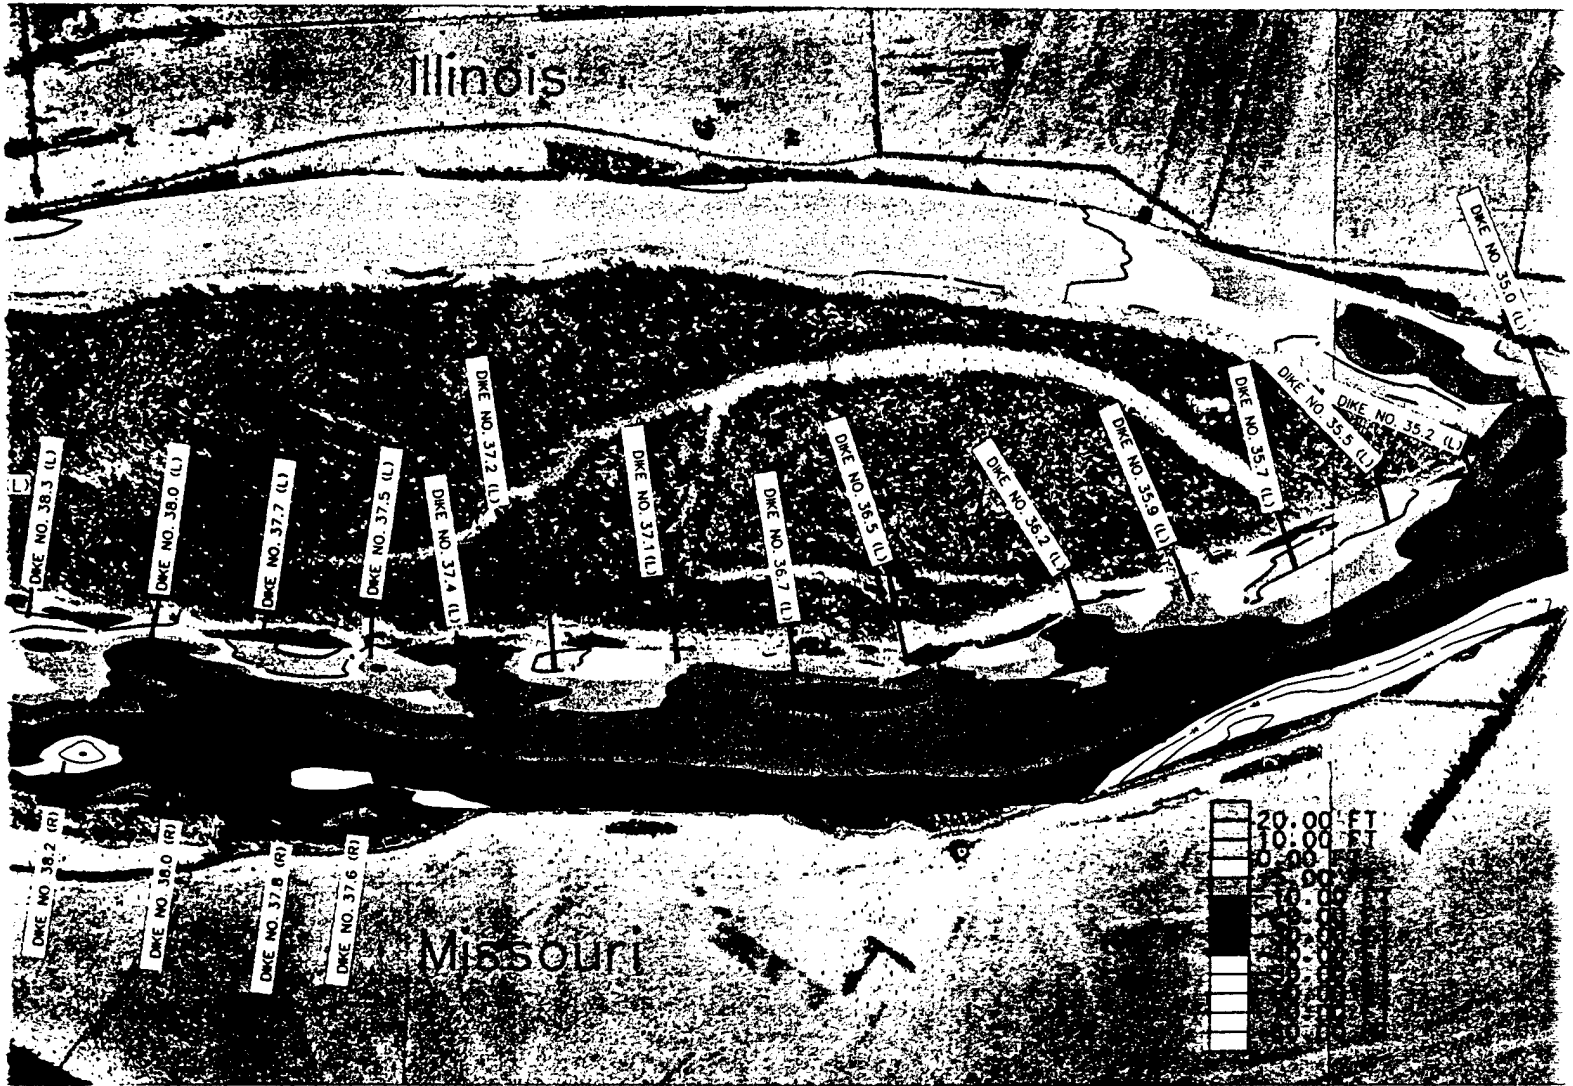
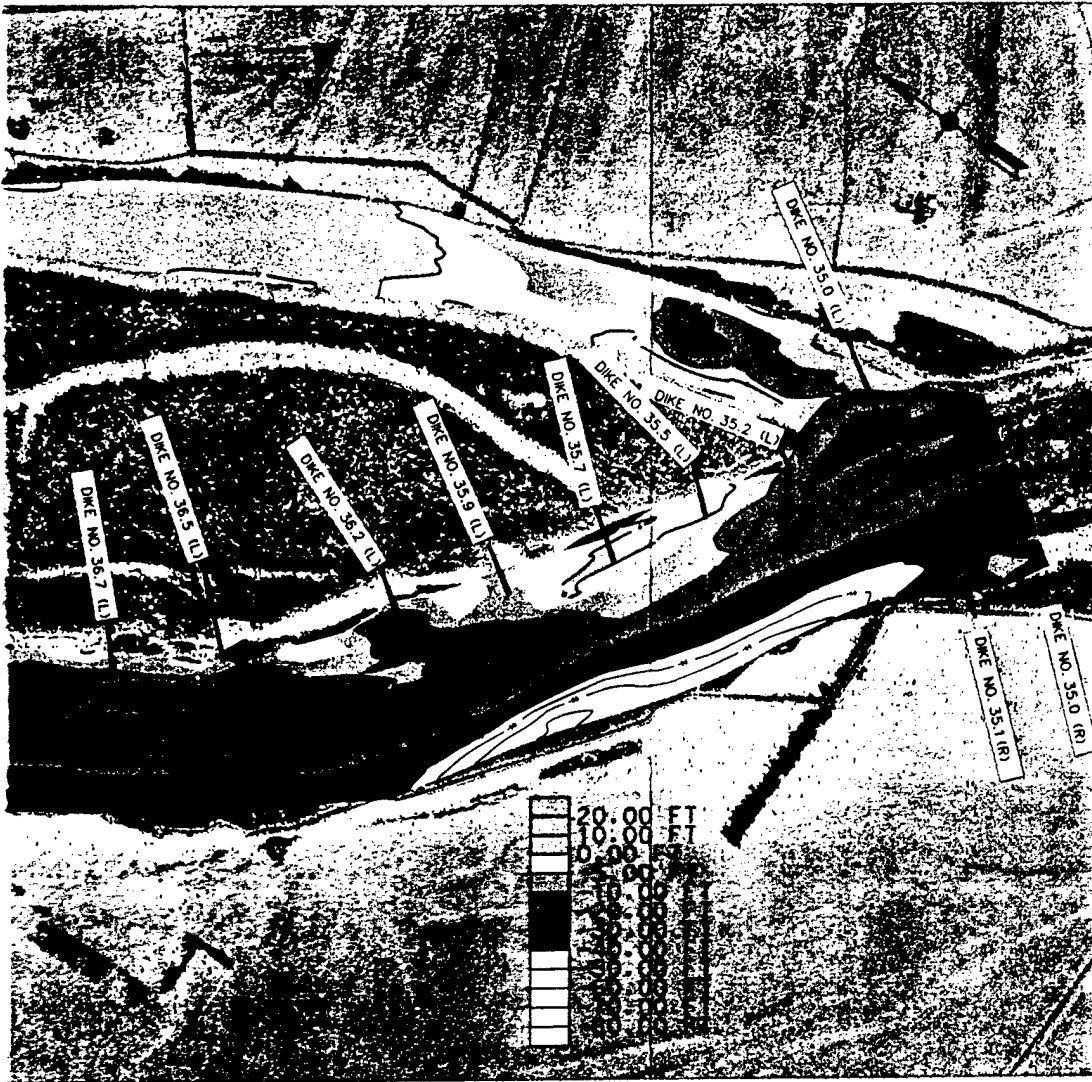
Alternative A. Removal of Closure Structure 39.6L. Plate 16 is a plan view contour map of the resultant bed configuration of alternative A. Results of this test indicated that removal of the closure structure caused the downstream navigation channel to shoal excessively (0 to -10 LWRP). The tendency for channel flushing in Sante Fe Chute was non-existent, with some additional sediment actually entering the side channel and filling in the scour hole located near River Mile 39.0.

- Additional sediment allowed into Sante Fe chute by closure structure modification will cause deposition throughout the entire chute and fill in the scour hole that exists near River Mile 39.0.

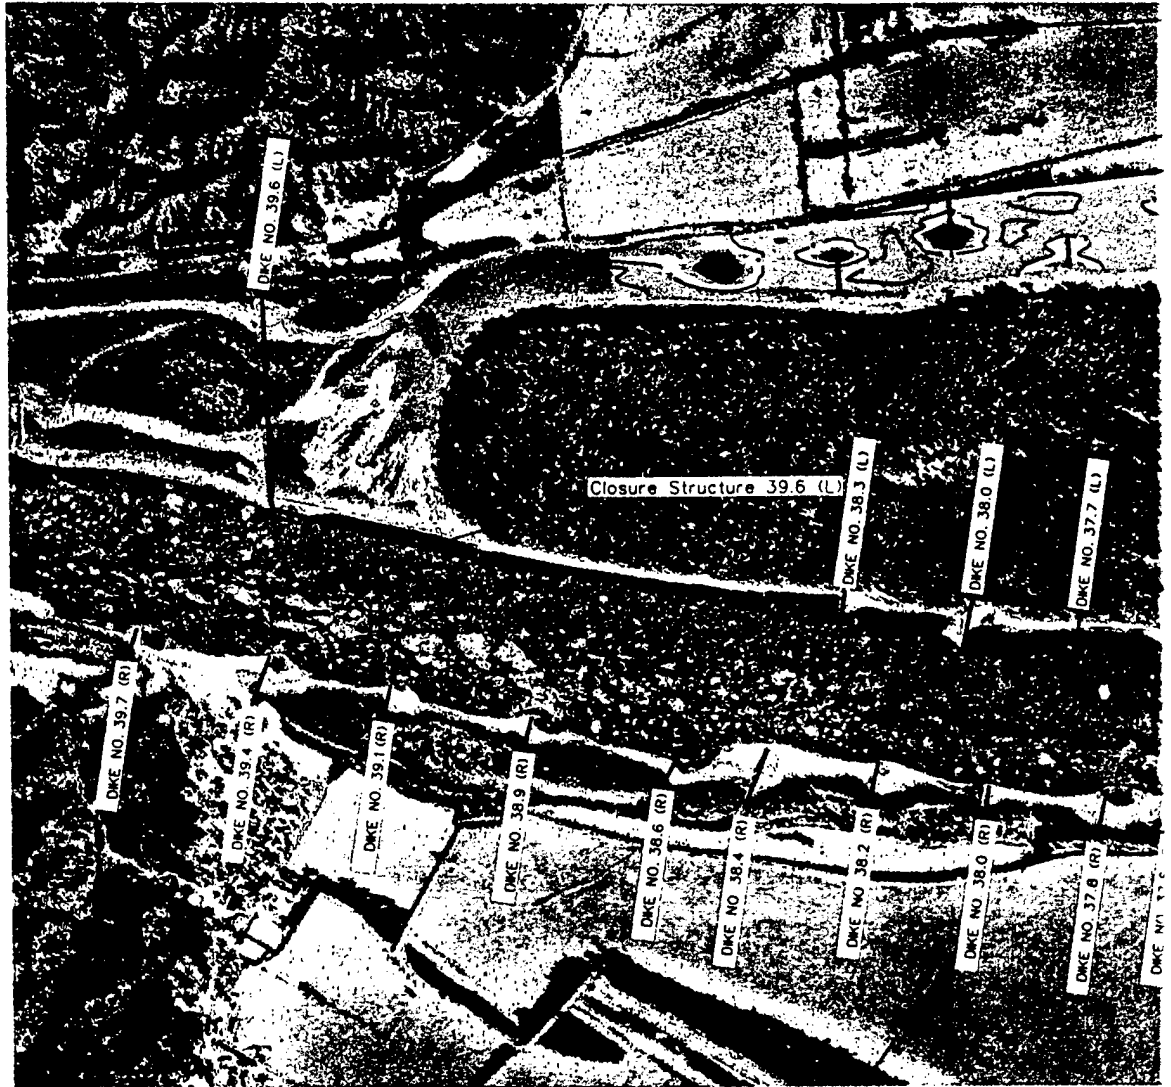
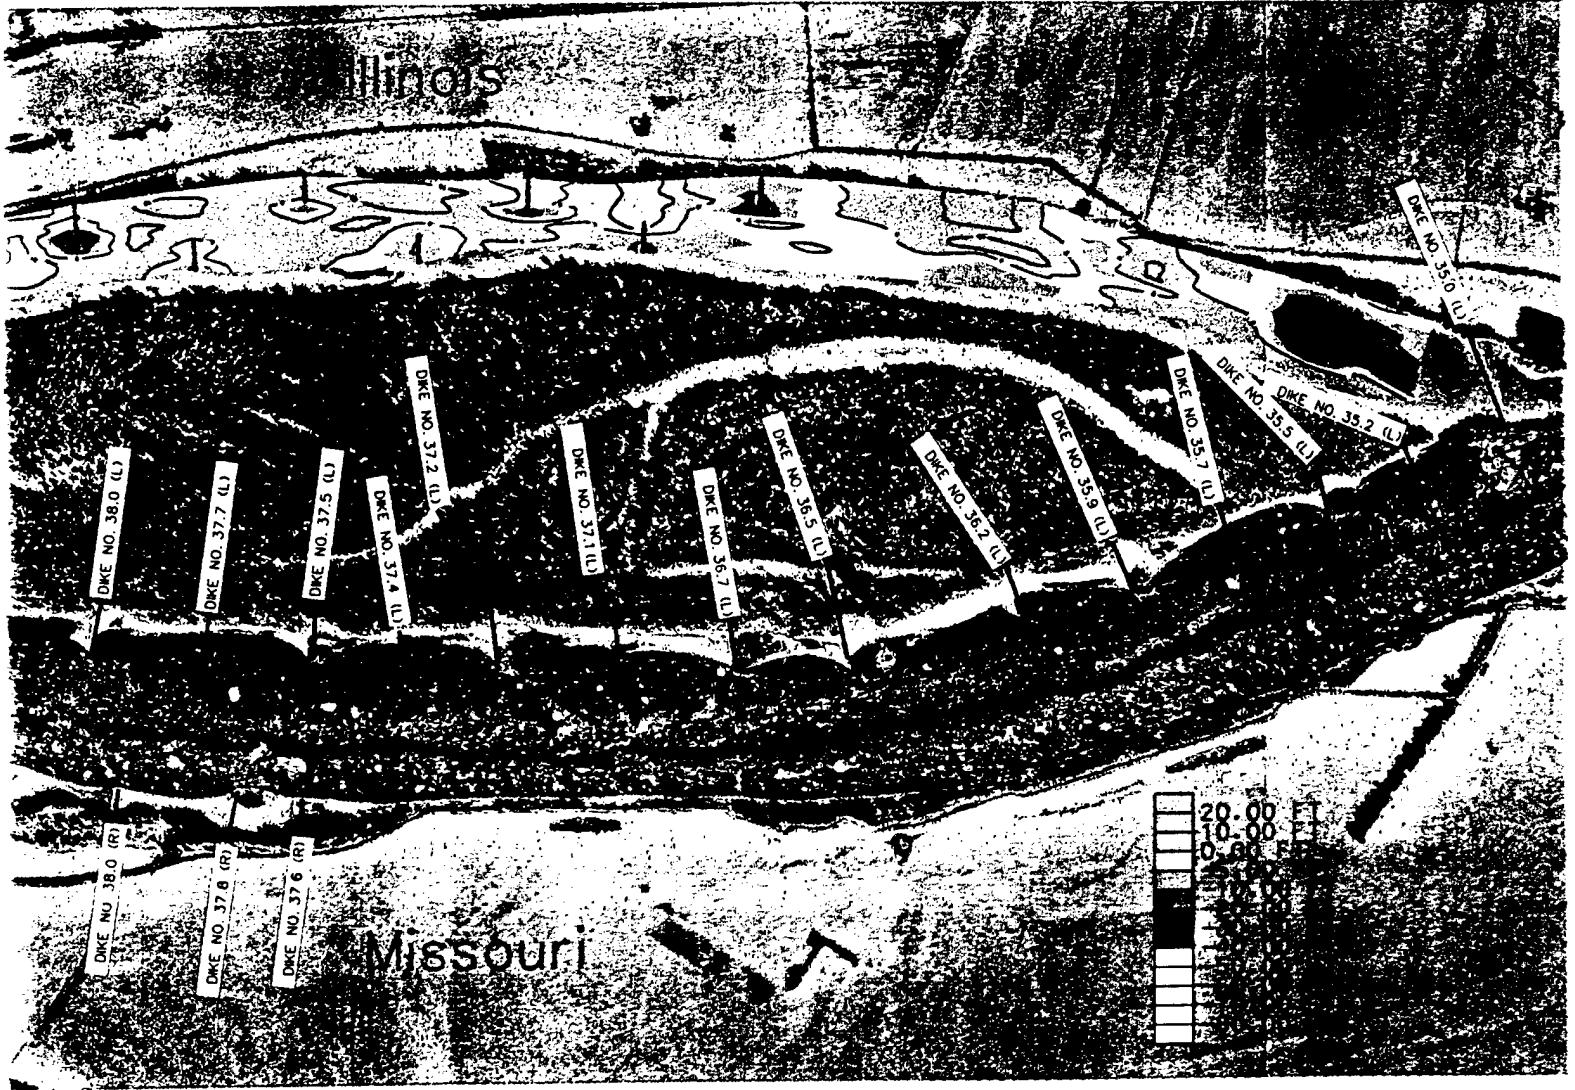
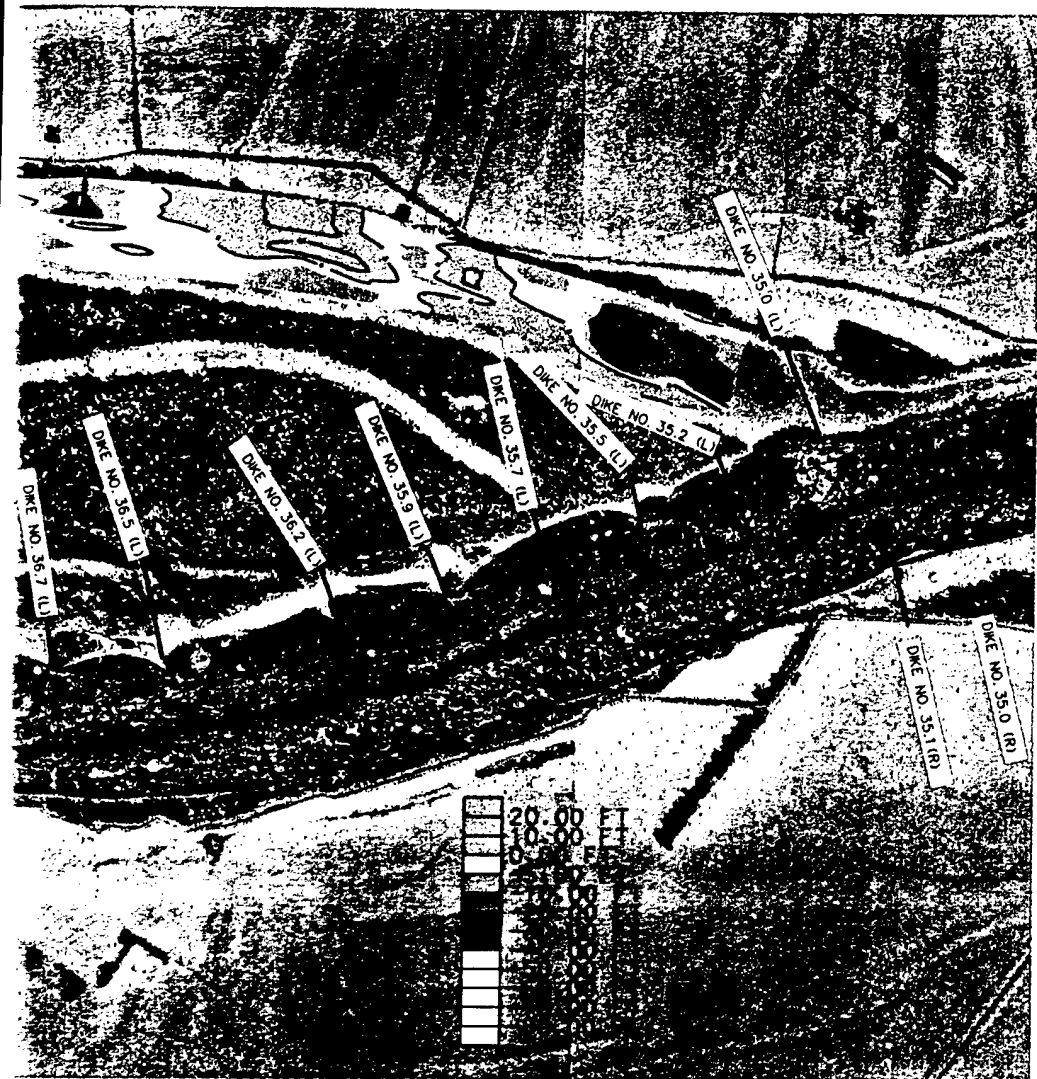
Alternative B. Alternating Level Crested Hardpoints at +30 LWRP. Plate 17 is a plan view contour map of the resultant bed configuration of alternative B. Tests indicated that small scour holes with depths between -10 and -20 LWRP could be developed in the upper half of Sante Fe Chute. The bed development energy within the channel drastically reduced approximately halfway through the dike field.

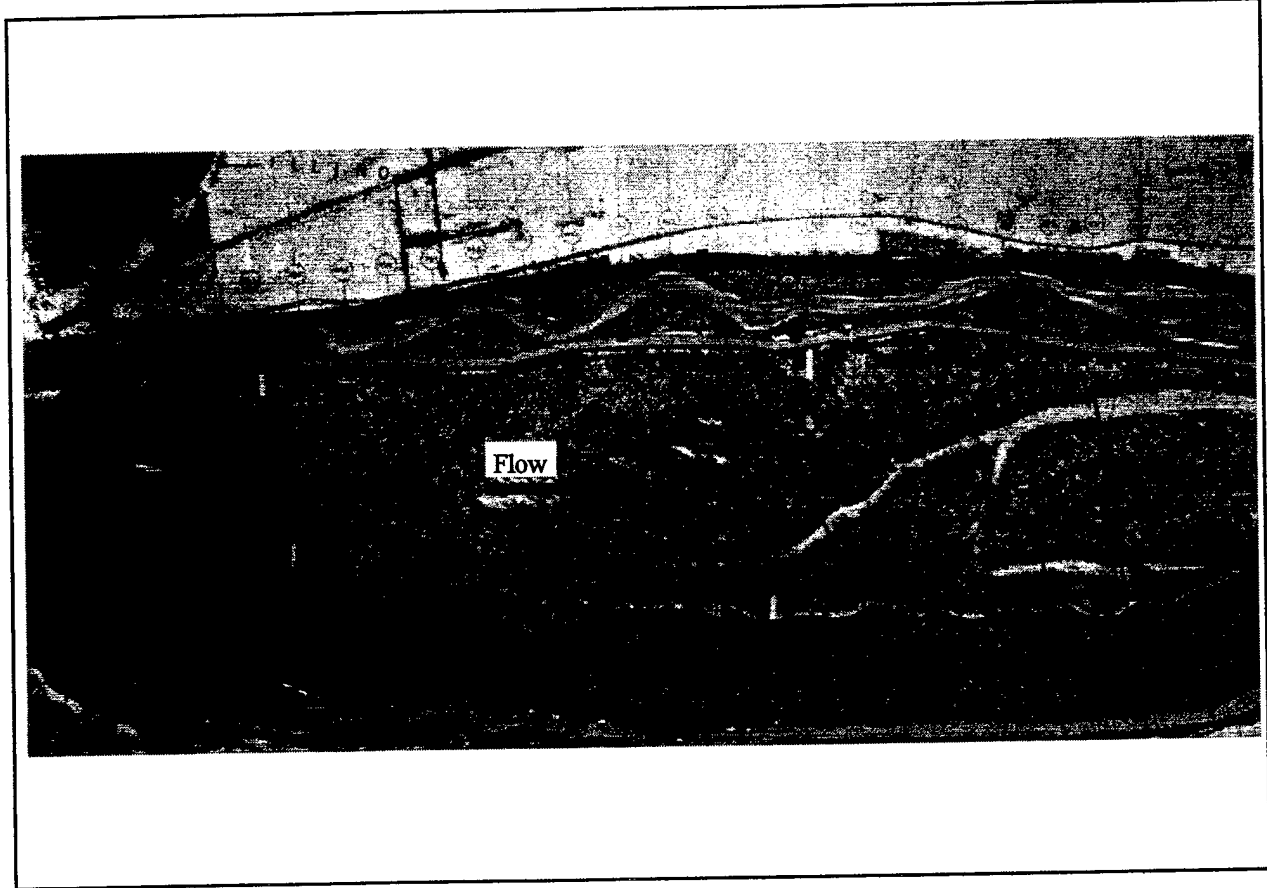
Plate 18 is a plan view flow visualization of alternative B. The flow visualization illustrated that a sinusoidal flow pattern was developed after installation of this plan.

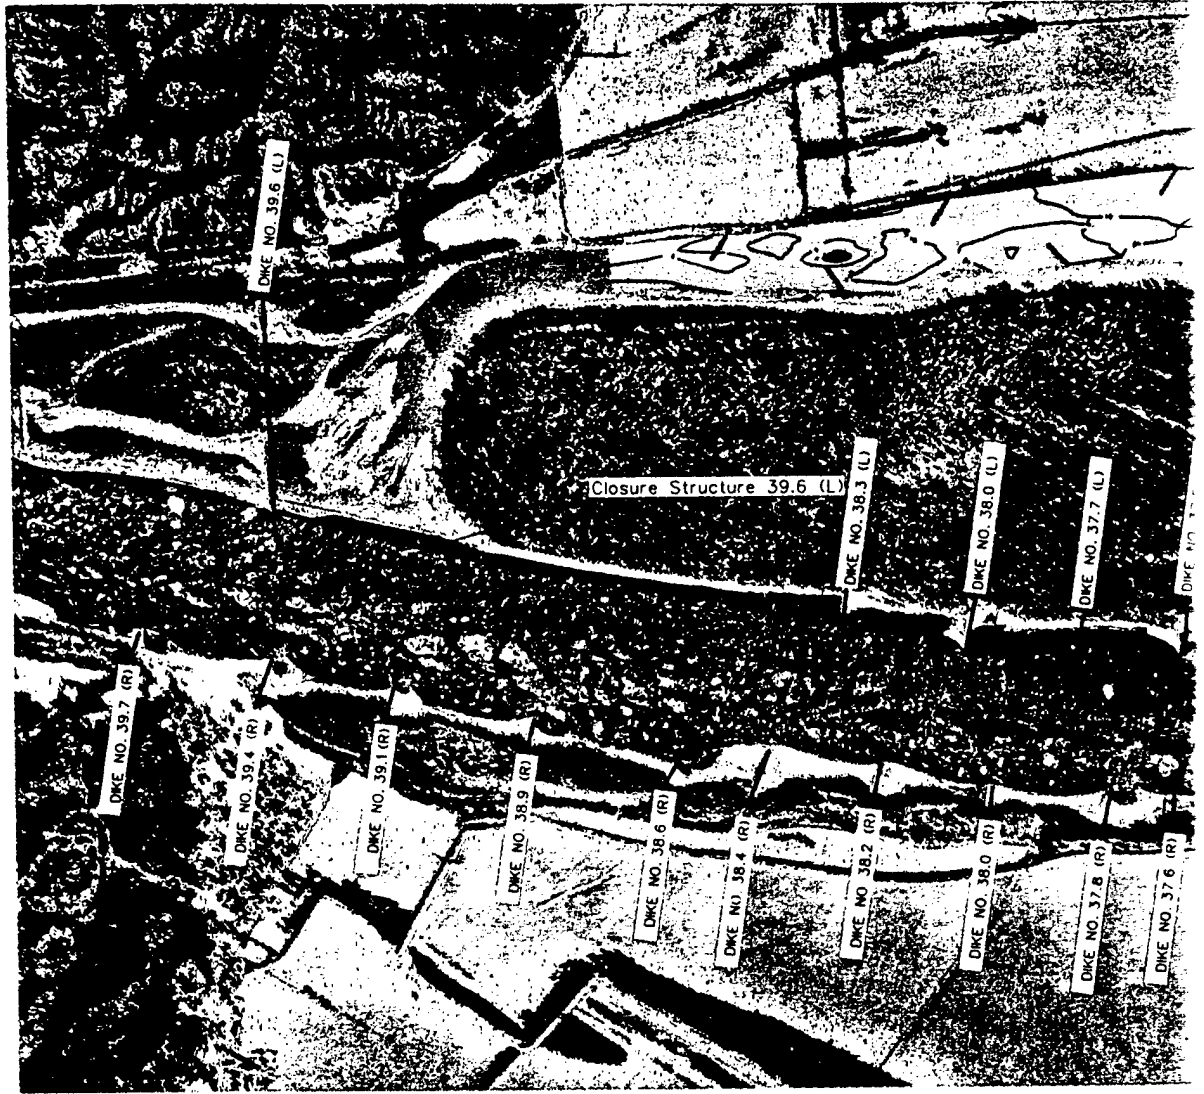
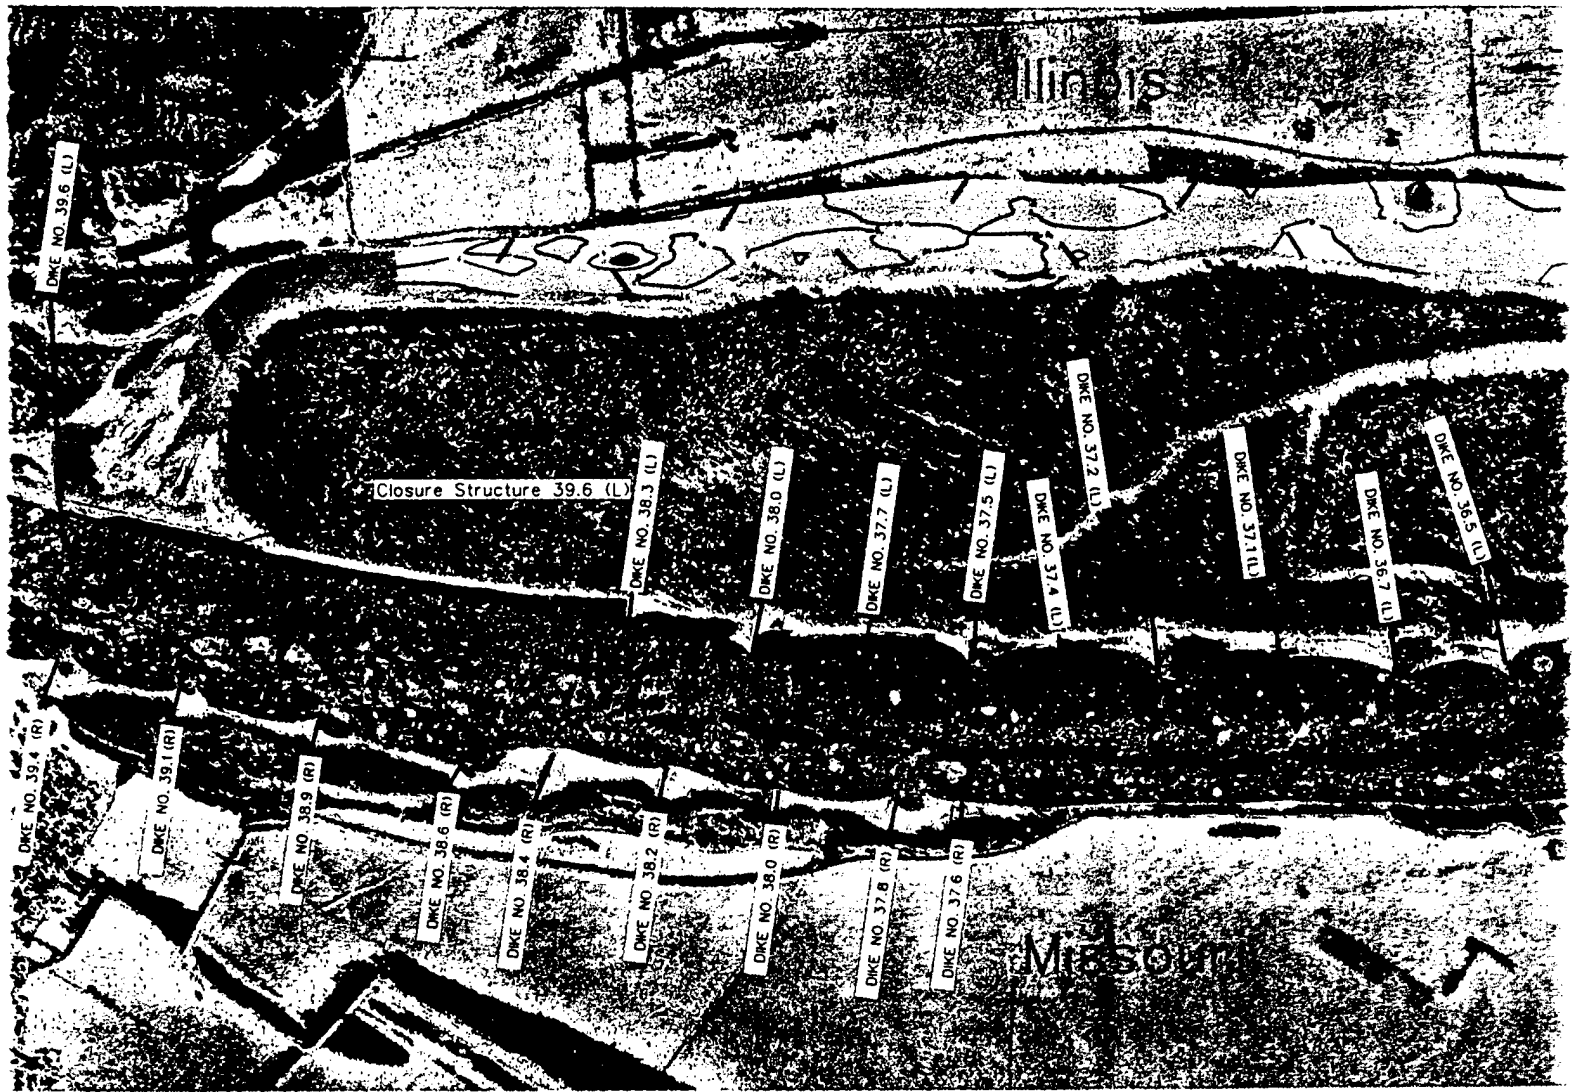
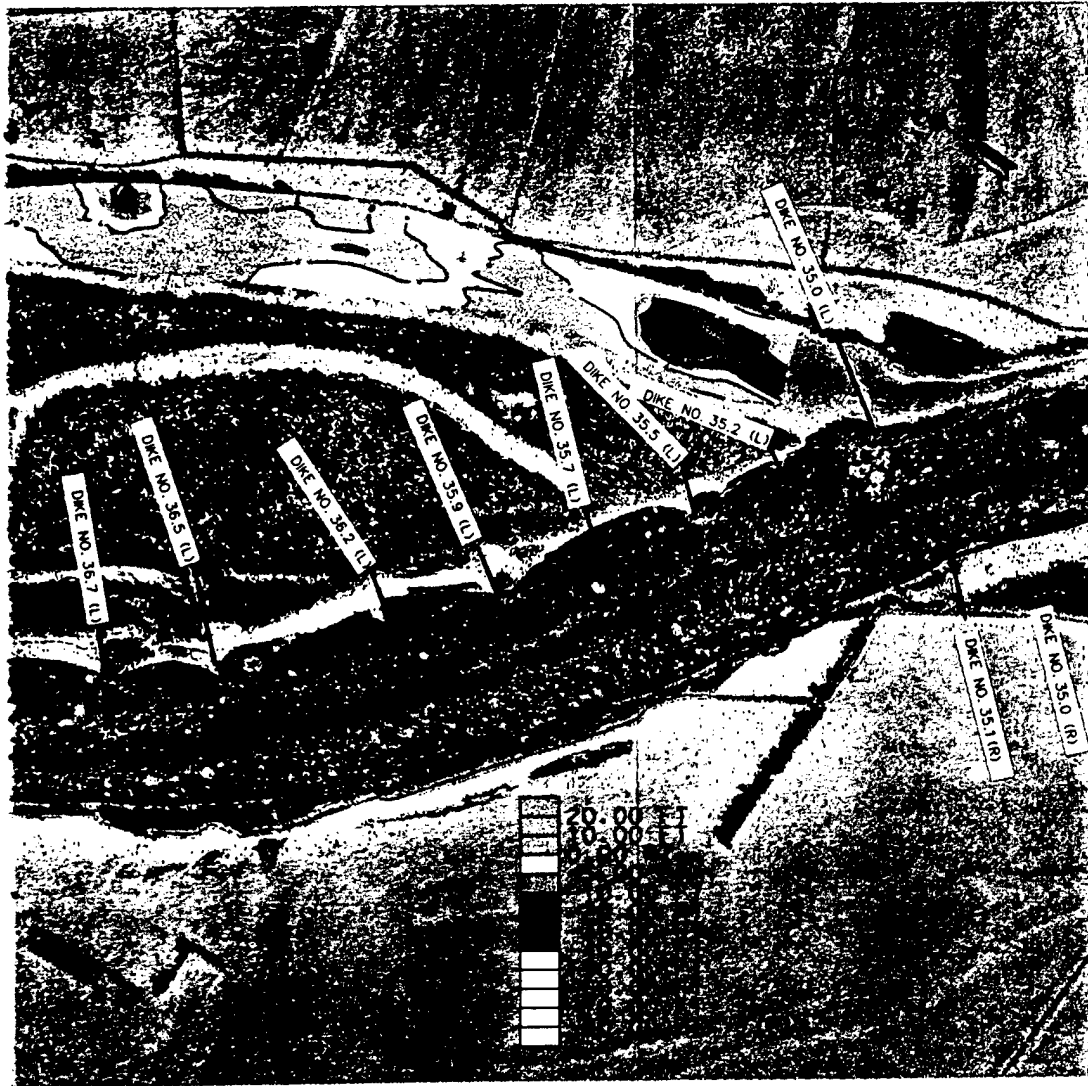
</div> <div style="display: flex; justify-content: space-between;"> <span>PLATE NO.</span> <span>19</span> </div>

Alternative C. Alternating Level Crested Hardpoints at +30 LWRP with Upstream Angle. Plate 19 is a plan view contour map of the resultant bed configuration of alternative C. Tests indicated that some channel development could be developed in Sante Fe Chute with this plan.
