TECHNICAL REPORT M1

**SEDIMENTATION STUDY OF THE MISSISSIPPI RIVER  
SANTE FE CHUTE, DOOLAN CHUTE  
HYDRAULIC MICRO MODEL INVESTIGATION**

September 1996

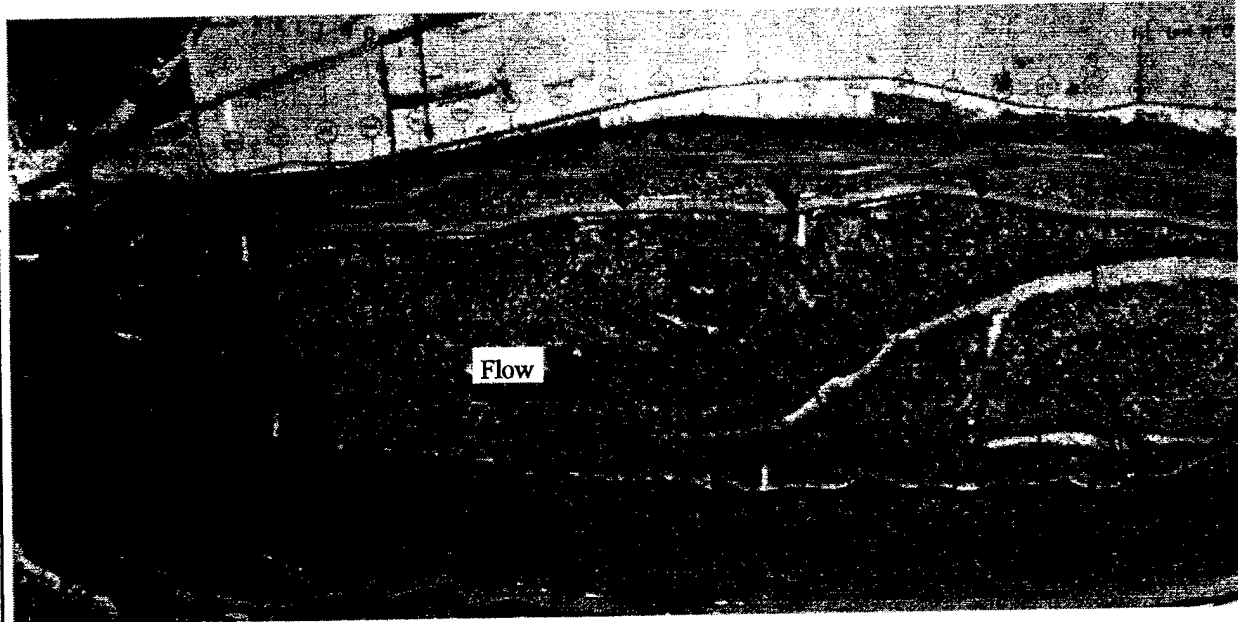
<b>U.S. ARMY ENGINEER DISTRICT, ST. LOUIS CORPS OF ENGINEERS ST. LOUIS, MISSOURI</b>	
	Sante Fe/Doolan Chute Micro-Model Study Mississippi River Miles 40 - 35  <i>Flow Visualization of Alternative C</i>	
PREPARED BY: R. Hetrick CHECKED BY: R. Davitroy	PLATE NO.  20

Plate 20 is a plan view flow visualization of alternative C.

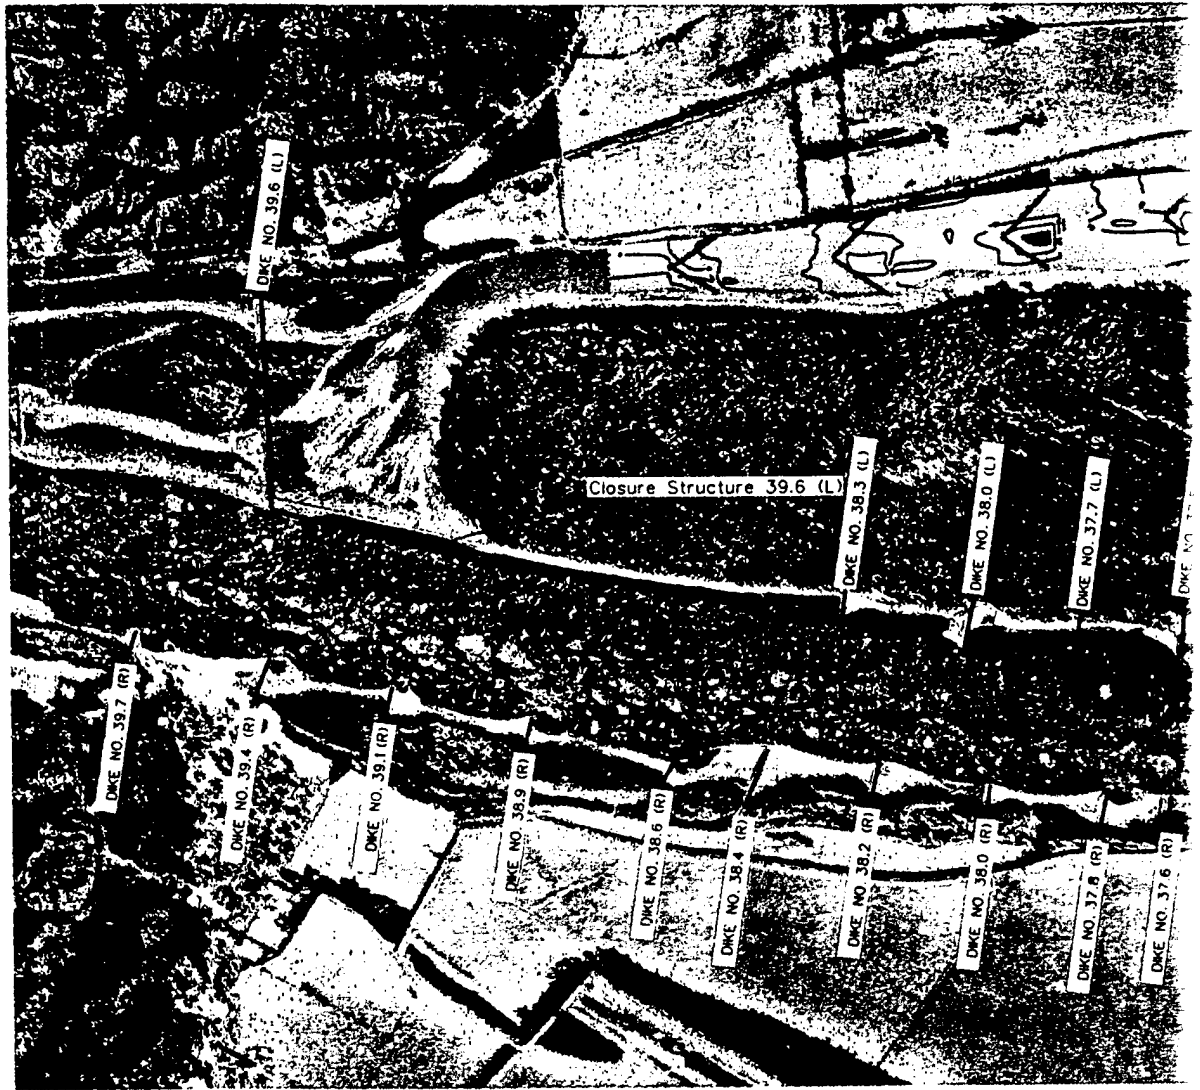
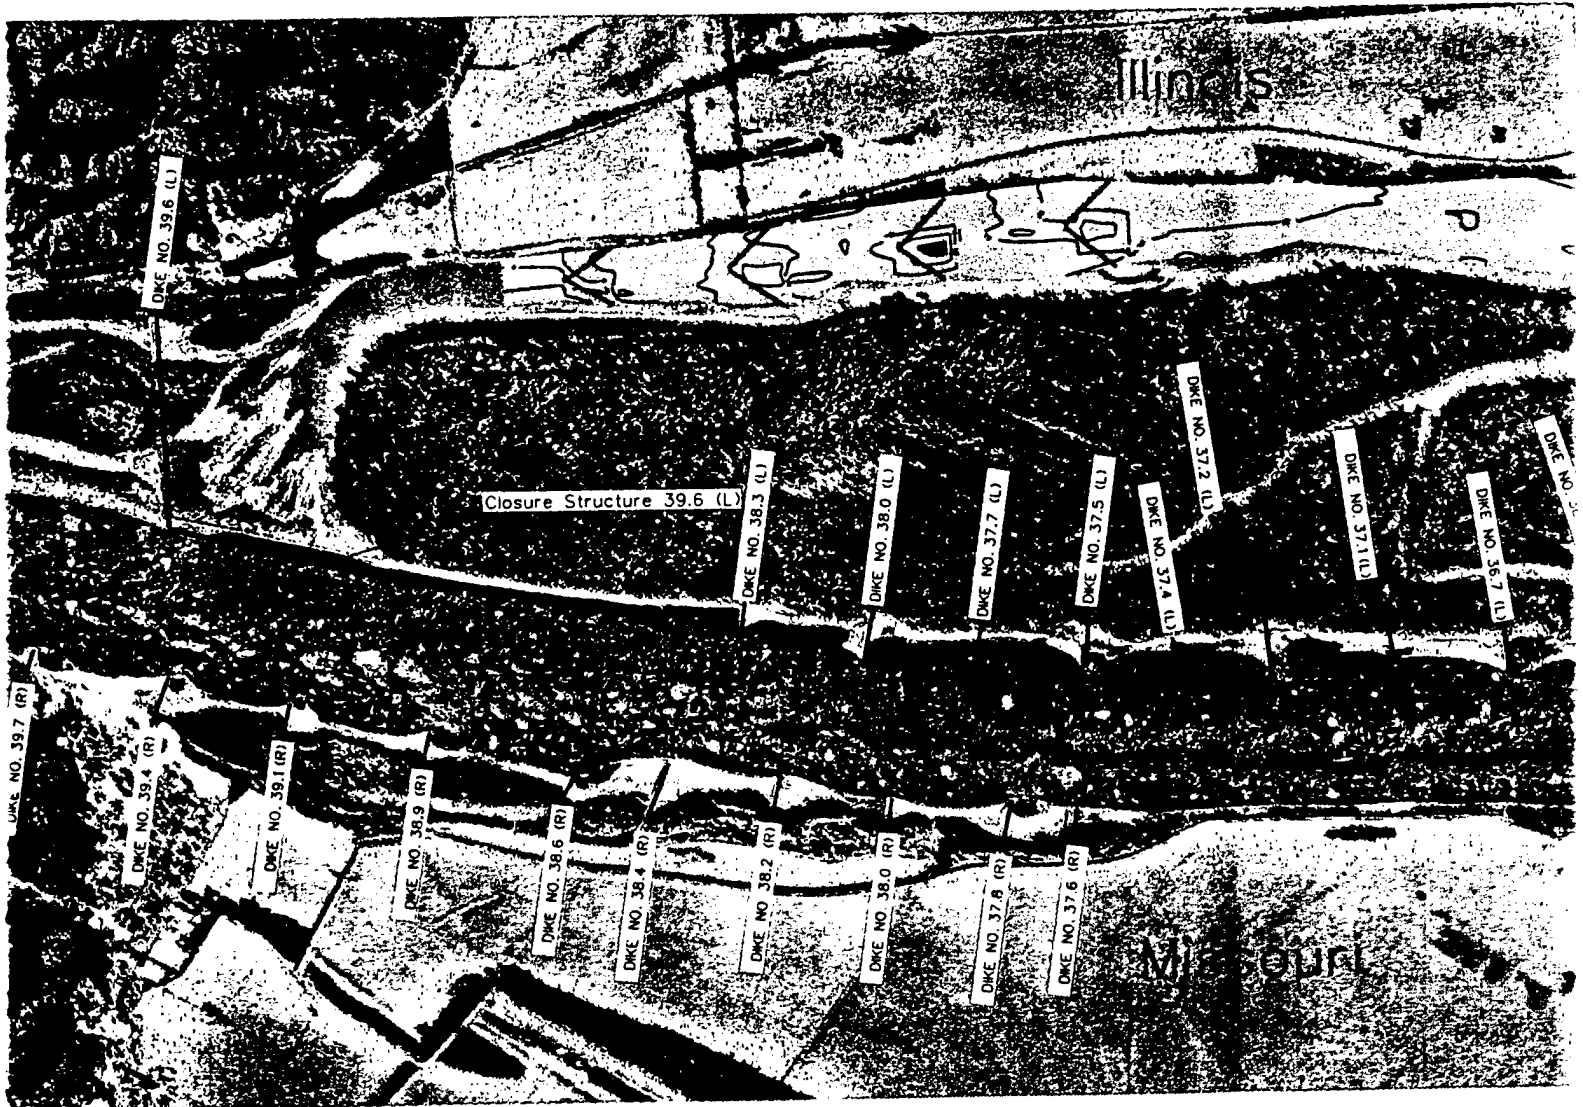
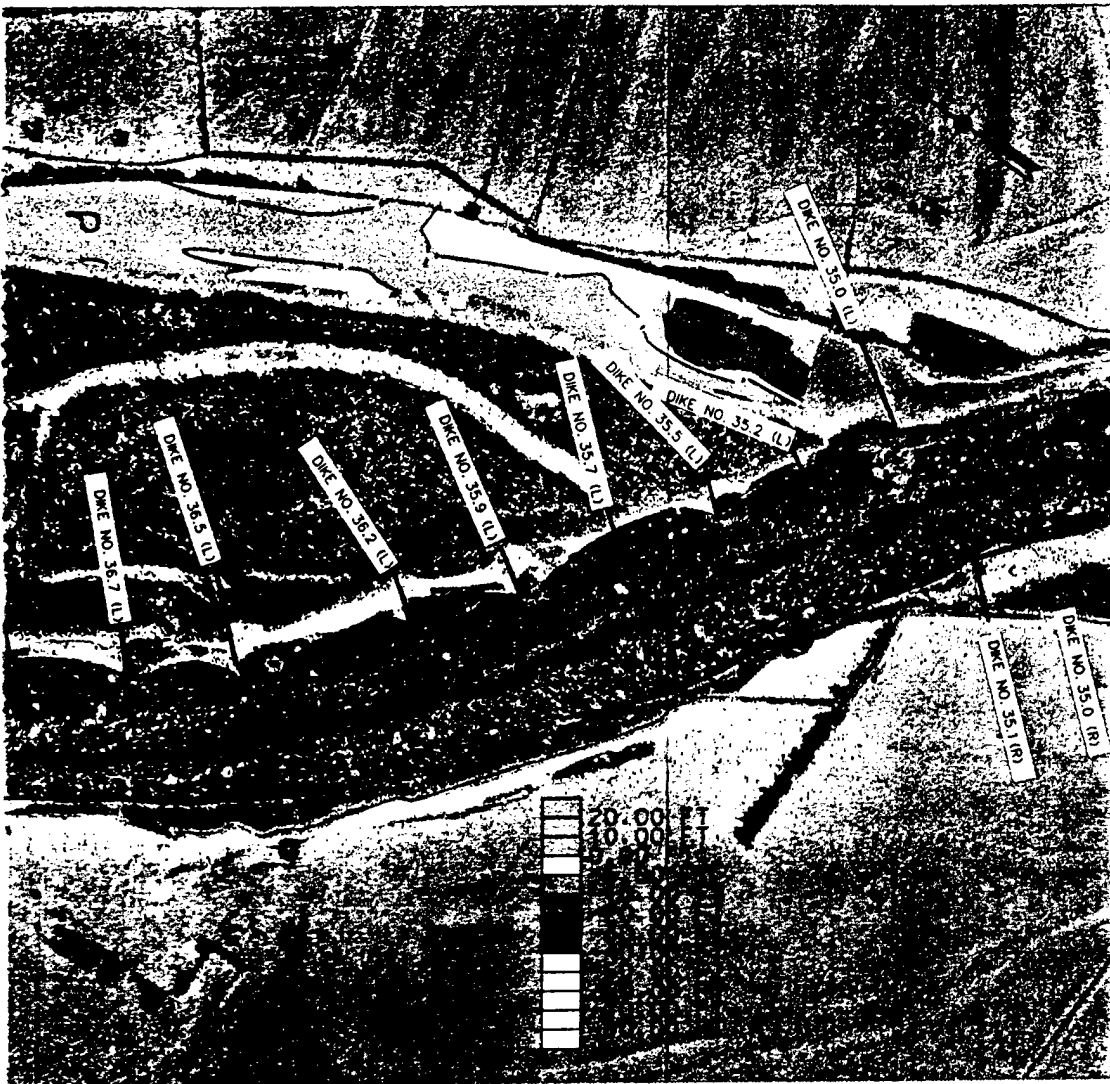
Alternative D. Chevrons, Sloping from +30 LWRP at Bankline to +15 LWRP at Mid-channel. Plate 21 is a plan view contour map of the resultant bed

configuration of alternative D. Tests indicated that some marginal scour holes could be developed in the middle of Sante Fe Chute with this design.

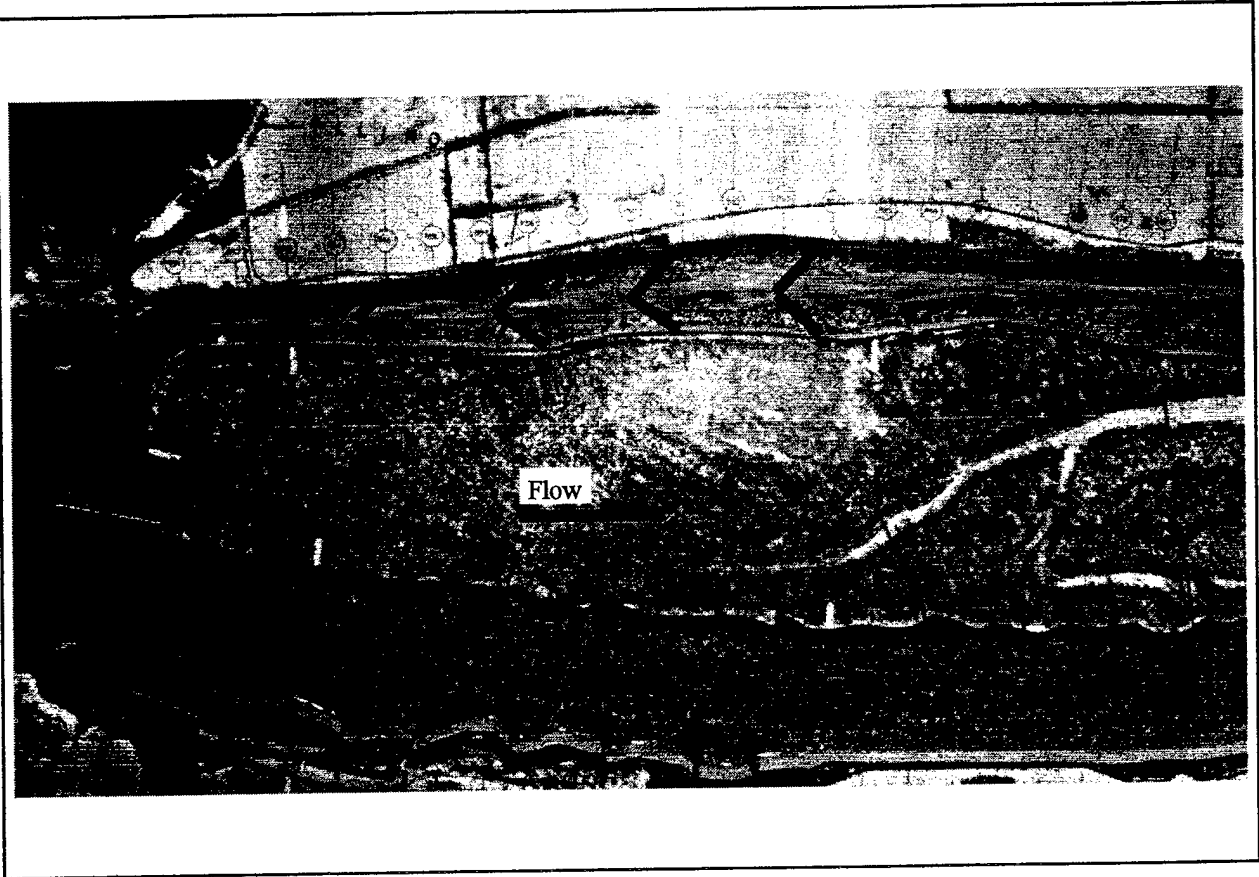
<b>U.S. ARMY ENGINEER DISTRICT, ST. LOUIS CORPS OF ENGINEERS ST. LOUIS, MISSOURI</b>	
	Sante Fe/Doolan Chute Micro-Model Study Mississippi River Miles 40 - 35 <i>Flow Visualization of Alternative D</i>	
PREPARED BY: R. Hehrick CHECKED BY: R. Davinroy		PLATE NO. 22

Plate 22 is a plan view flow visualization of alternative D. The flow visualization illustrated that flow was concentrated toward the middle of the side channel and away from the outer banks.

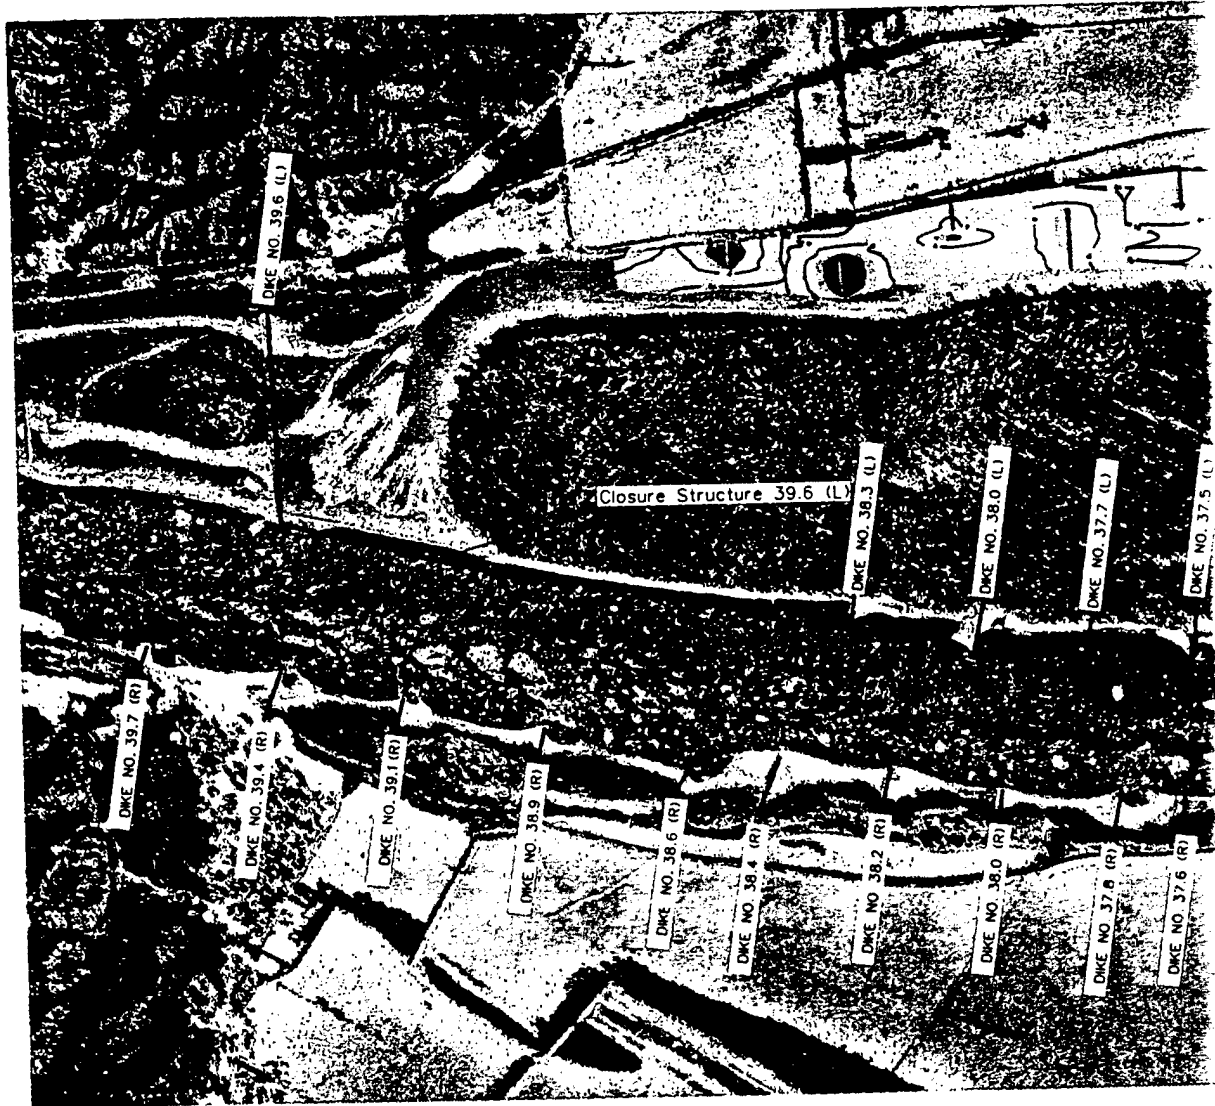
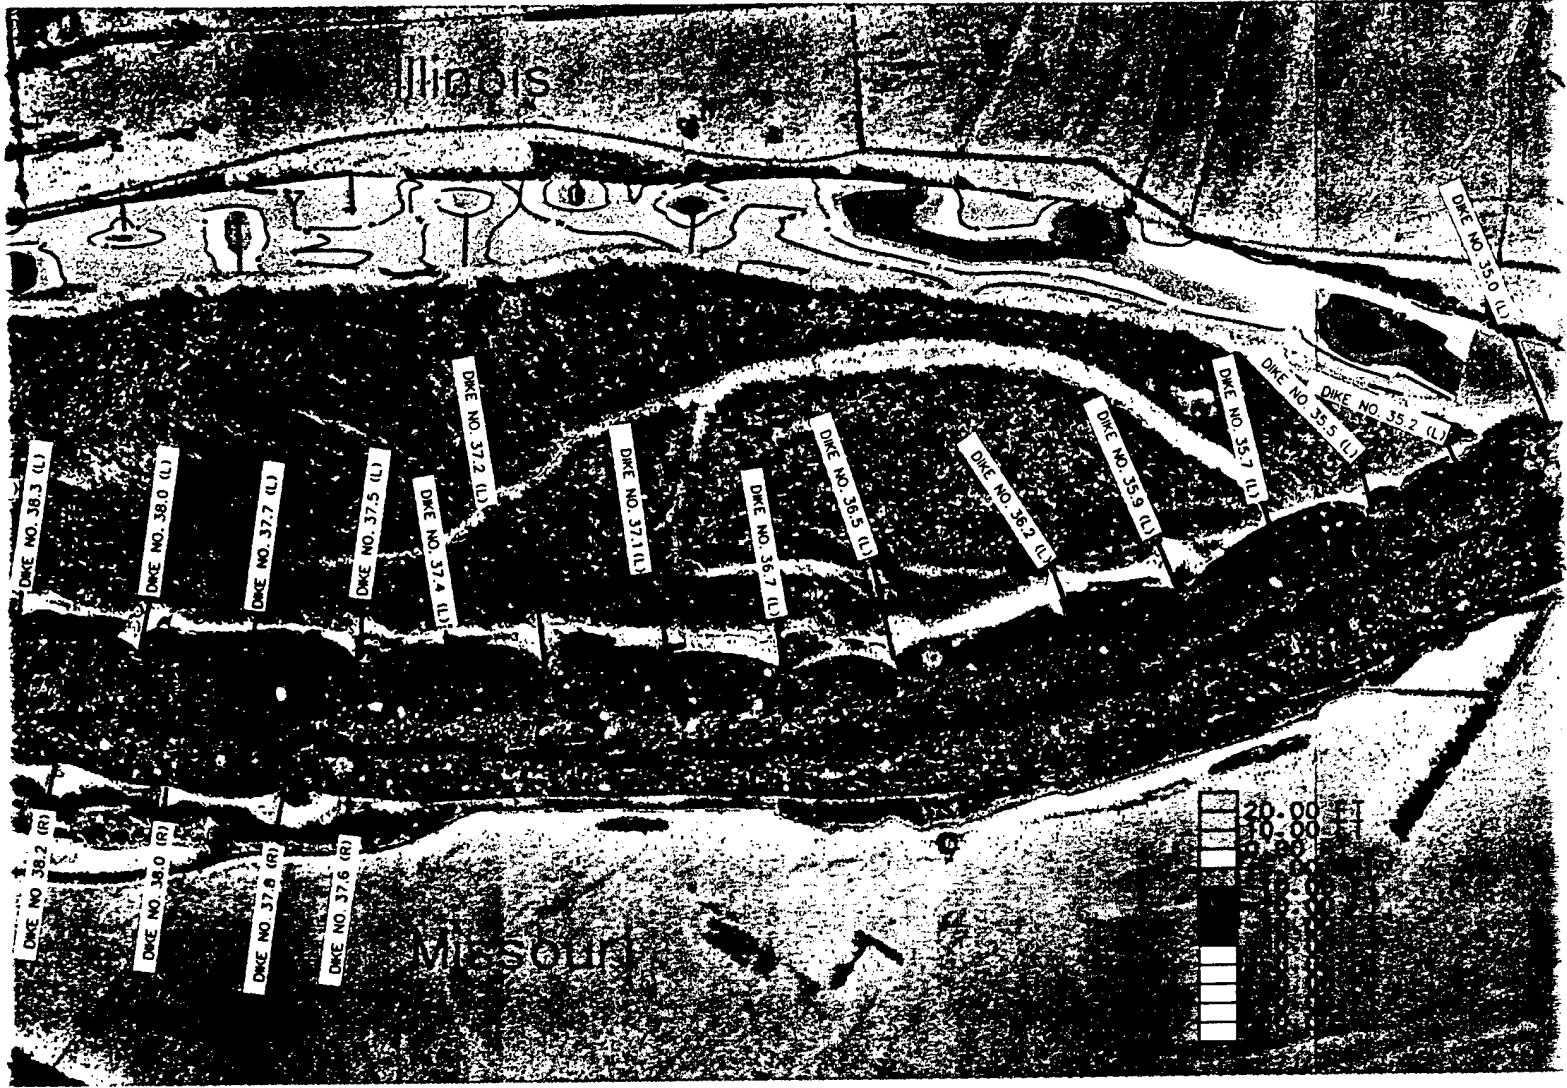
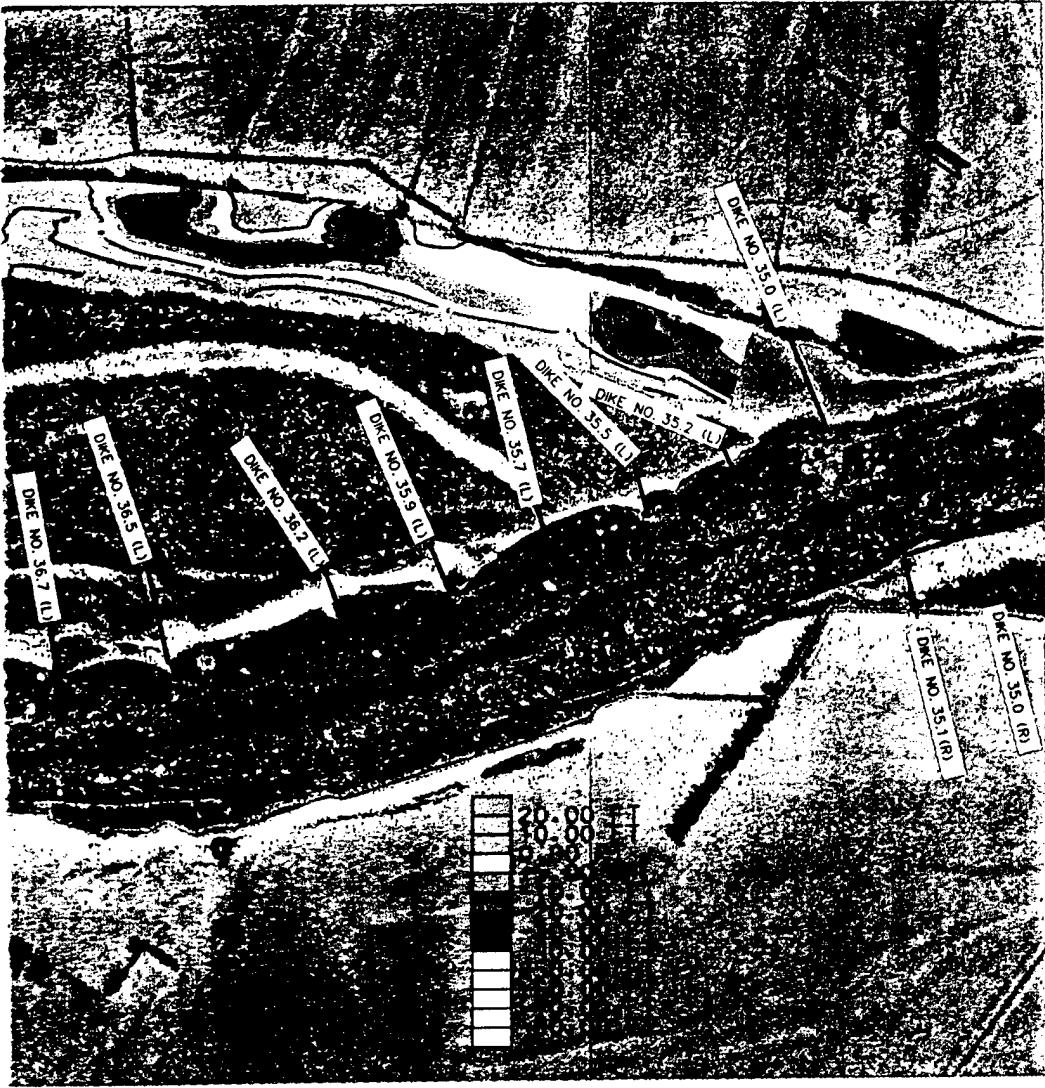
PLATE NO. 23
<small>DESIGN FILE: D:\DOOR\MODEL\SANTEFE\ALTE.DGN</small> <small>PLOT SCALE: 1" = 2000'</small>		<small>PLOT DATE: 24 Aug 1994</small>

Alternative E. Alternating Level Crested Hardpoints at +30 LWRP with Length Modification and Downstream Dredging. Plate 23 is a plan view contour map of the resultant bed configuration of alternative E. Tests indicated that larger and deeper scour holes could be developed as compared with alternative A. In the lower half of Sante Fe Chute, scour holes were artificially molded in the bed to simulate dredging. Material from these holes was placed in adjacent areas to create an alternate bar scheme. All tests indicated that the artificially created bed configuration pattern remained unchanged during all design flow conditions due to the downstream backwater effects from the main channel.

- Alternative E created the most diversity in Sante Fe Chute. This alternative caused favorable redistribution of existing bed sediments while forming alternating scour and depositional areas. The resultant bed configuration from this plan created a sinuous flow pattern.

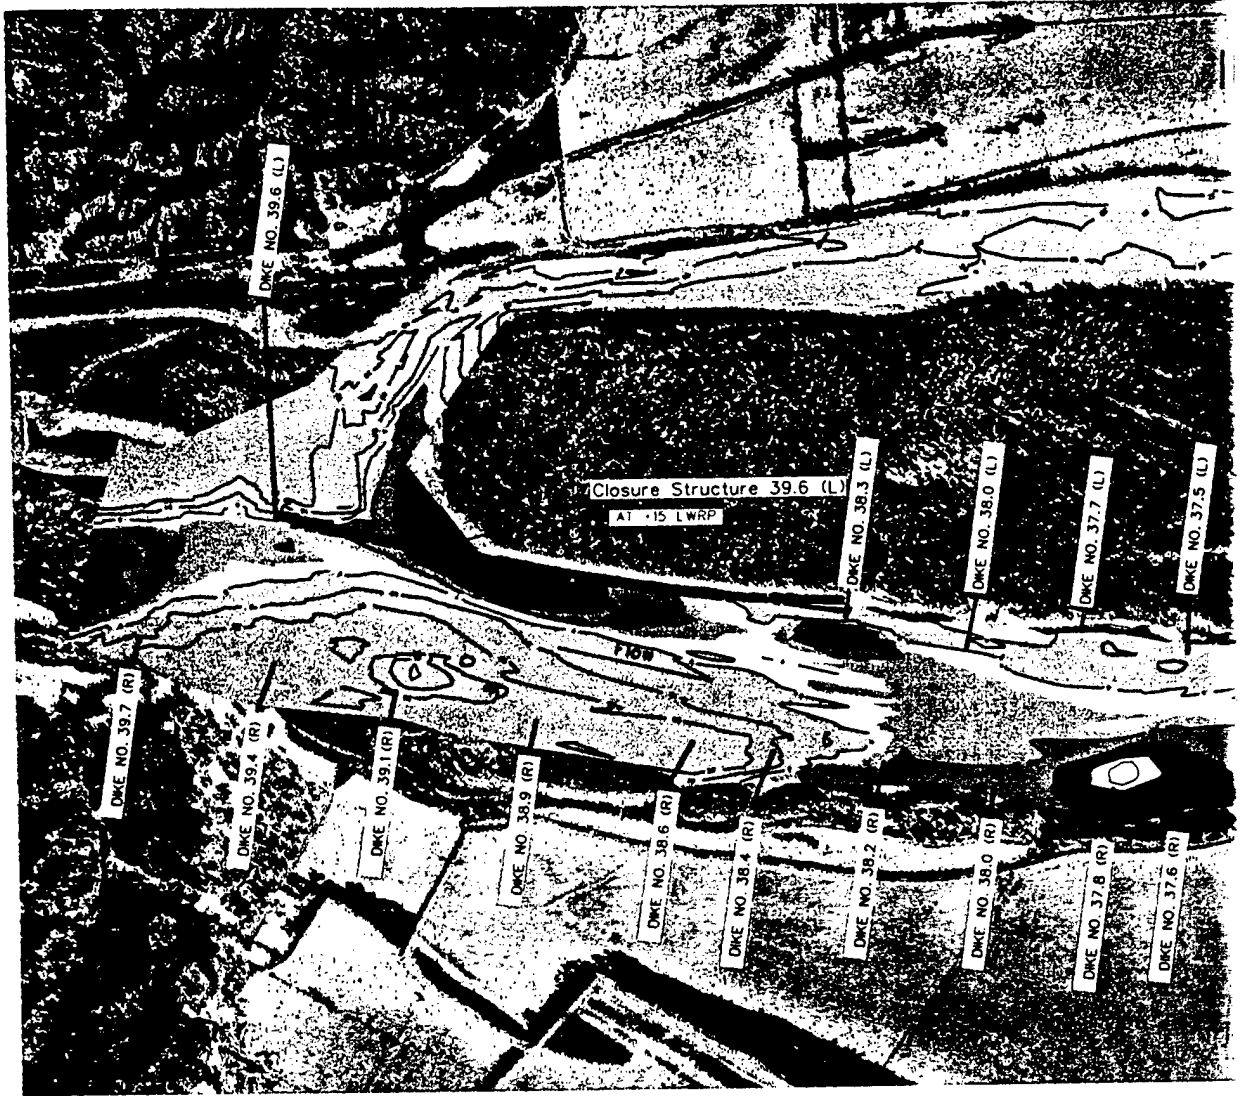
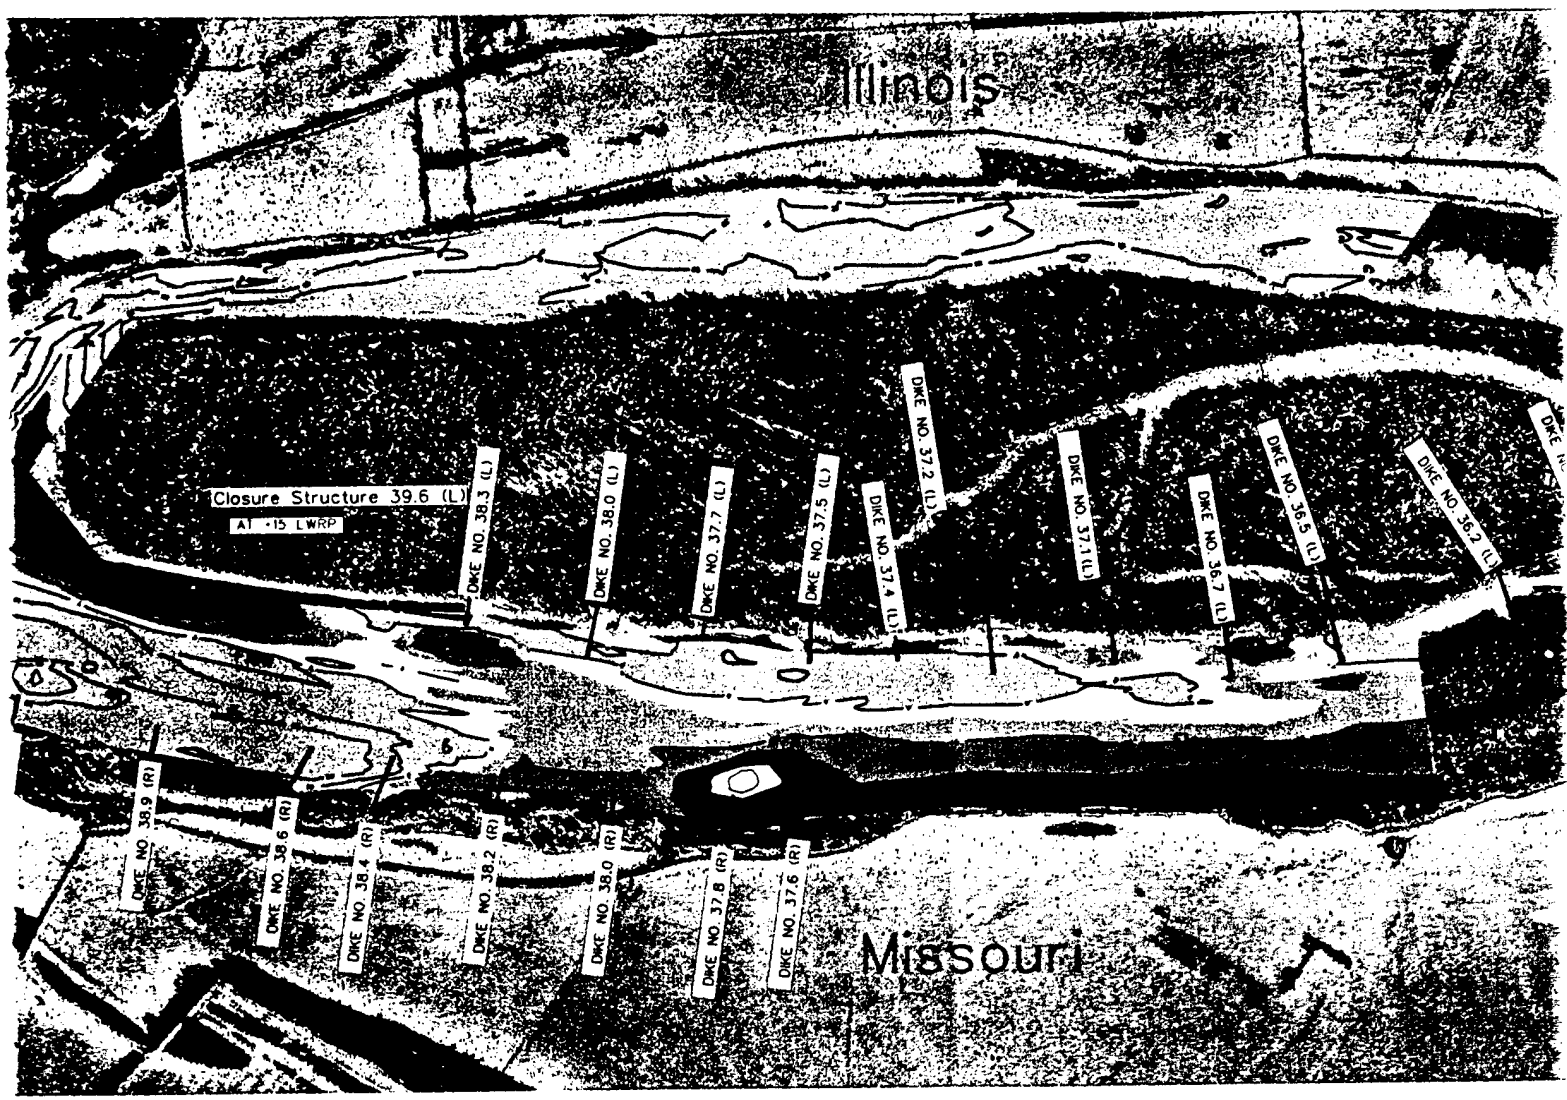
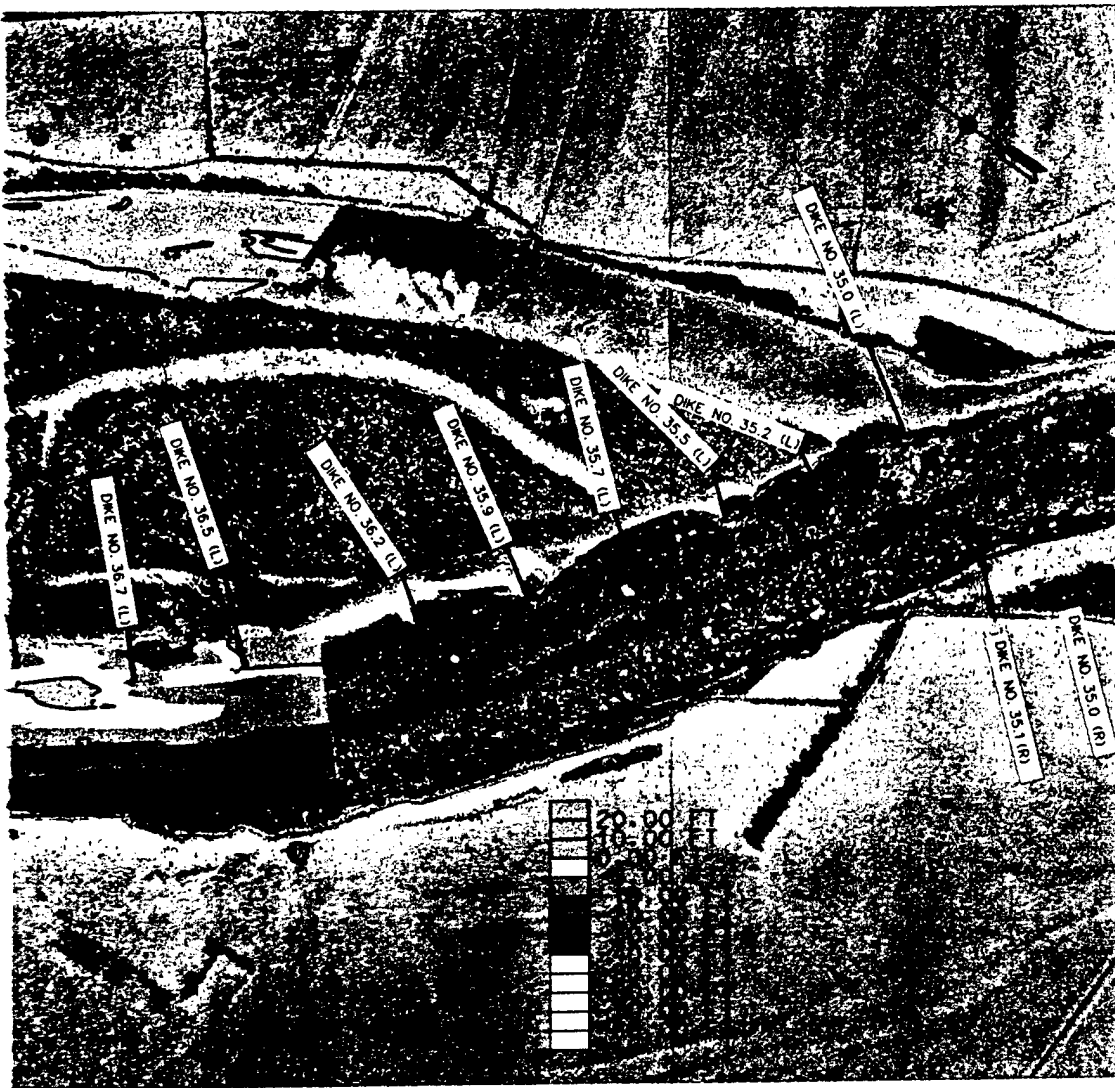
Alternative F. Closure Structure 39.6L at +15 LWRP. Plate 24 is a plan view contour map of the resultant bed configuration of alternative F. The results were very similar to alternative A. The downstream crossing shoaled excessively. Sediment entered Sante Fe Chute and filled in the scour hole near River Mile 39.0.

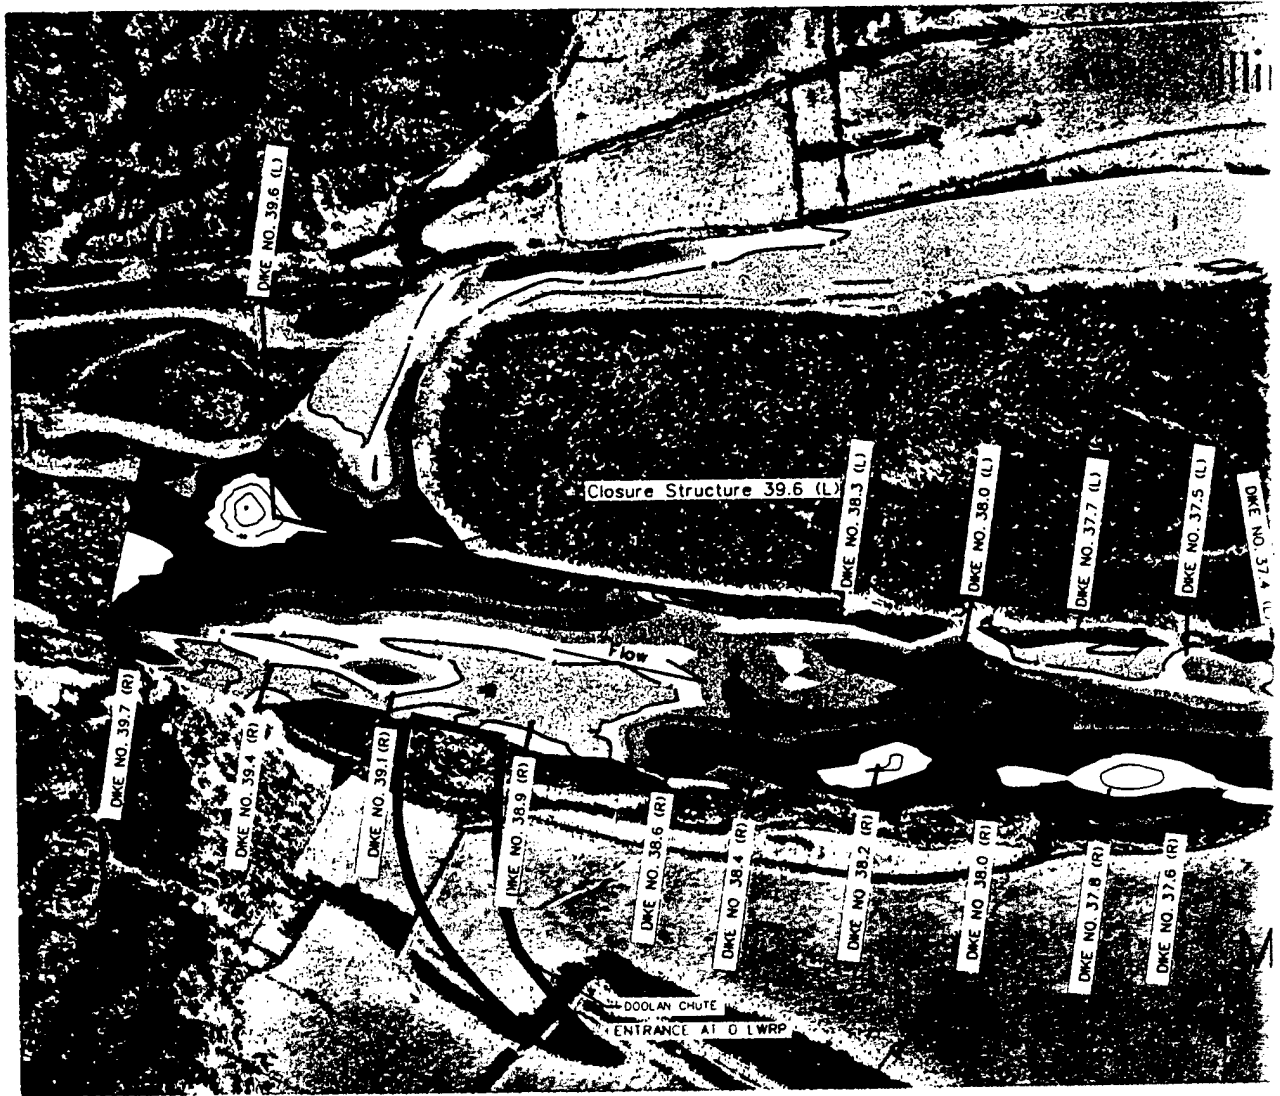
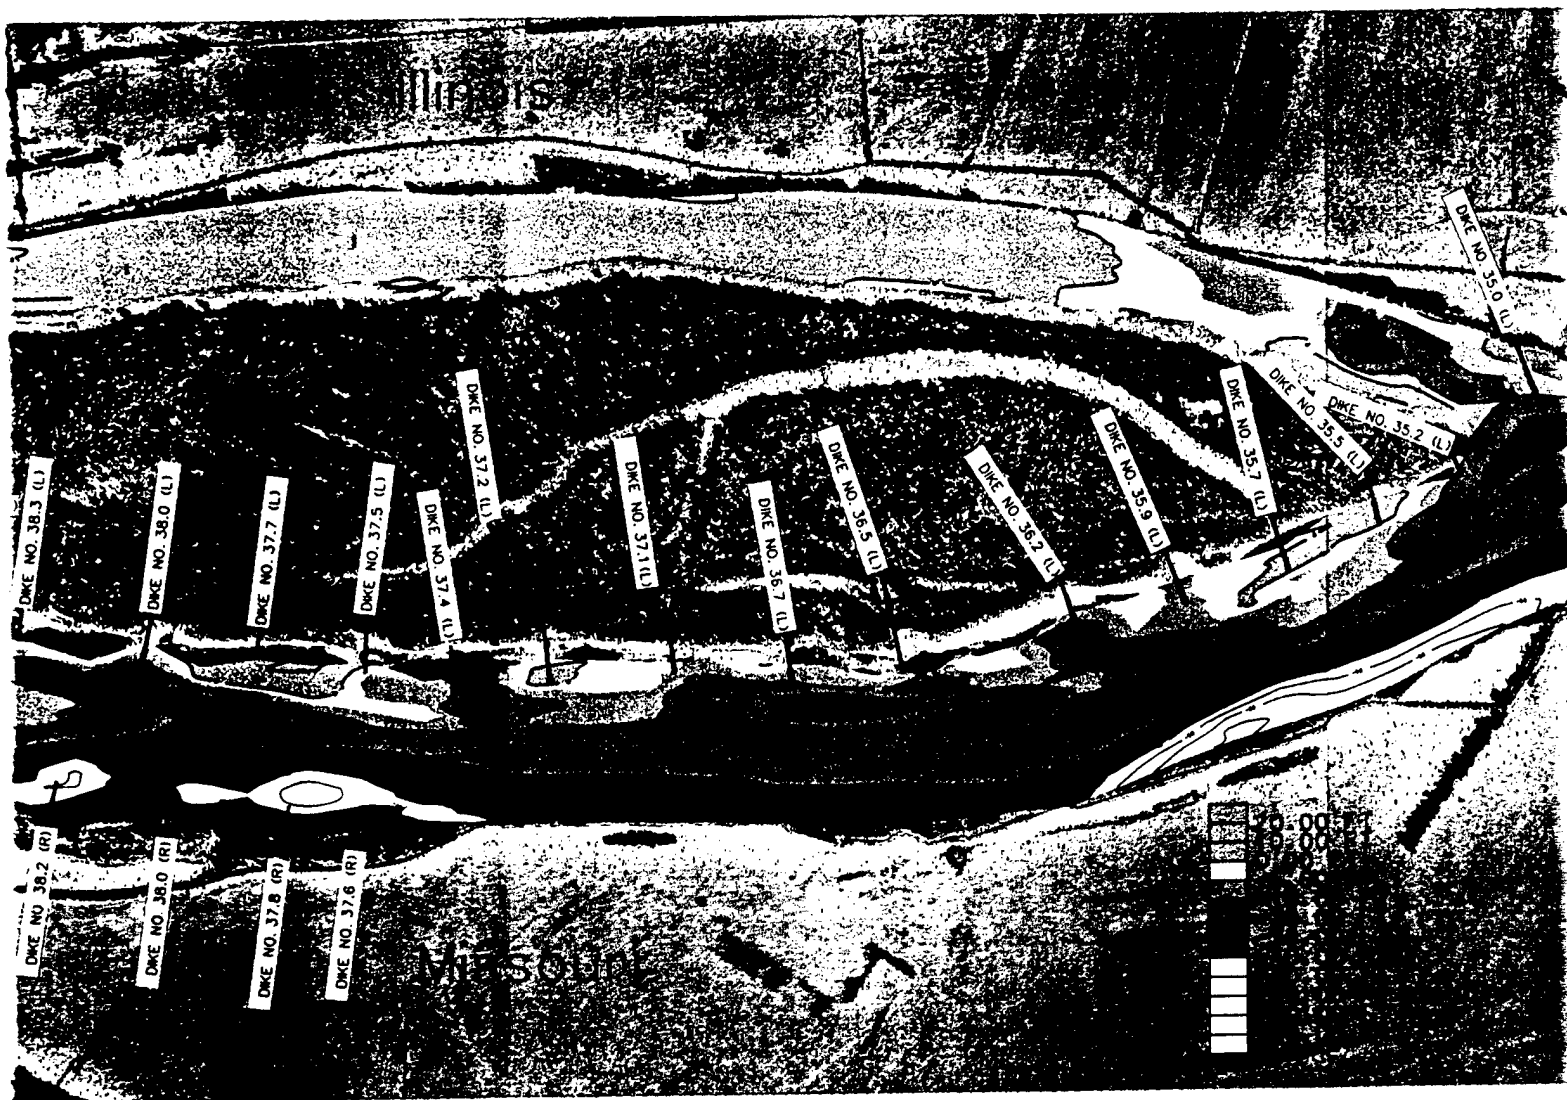
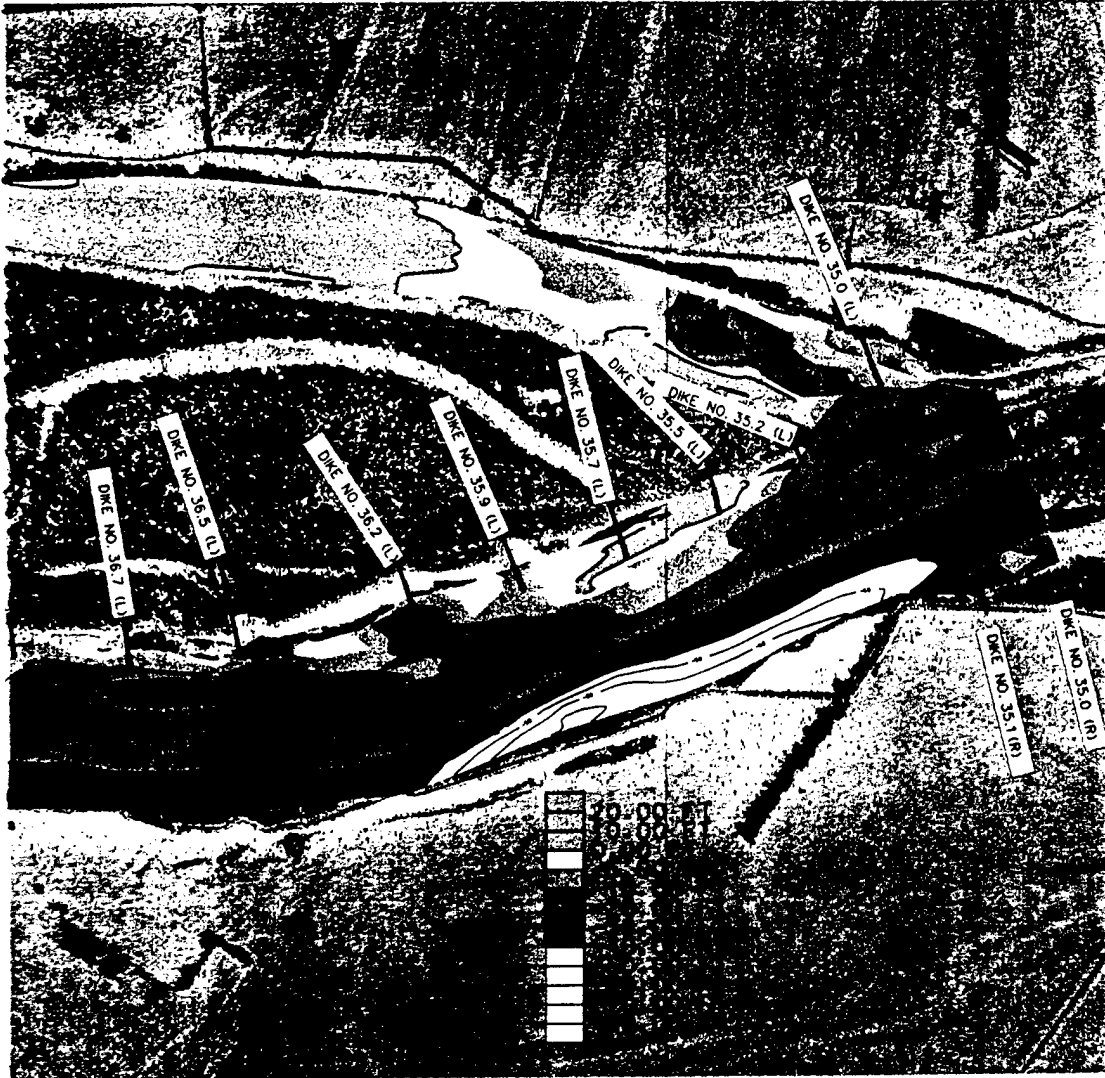
<p>DESIGN FILE: D:\DOOR\MODEL\SANTEFE\ALTH.DGN</p>	<p>PLATE NO. 26</p>
<p>PILOT SCALE 1" = 2000' 11"</p>	<p>PILOT DATE: 24 Sept. 1966</p>

Alternative H. Doolan Chute Linkage With the Main Channel, Entrance Conditions at 0 LWRP. Plate 26 is a plan view contour map of the resultant main channel bed configuration for alternative H after 15 hydrographs. Results of this test indicated a tendency for shoaling in the downstream crossing of the main channel.
