TECHNICAL REPORT M1

**SEDIMENTATION STUDY OF THE MISSISSIPPI RIVER  
SANTE FE CHUTE, DOOLAN CHUTE  
HYDRAULIC MICRO MODEL INVESTIGATION**

September 1996

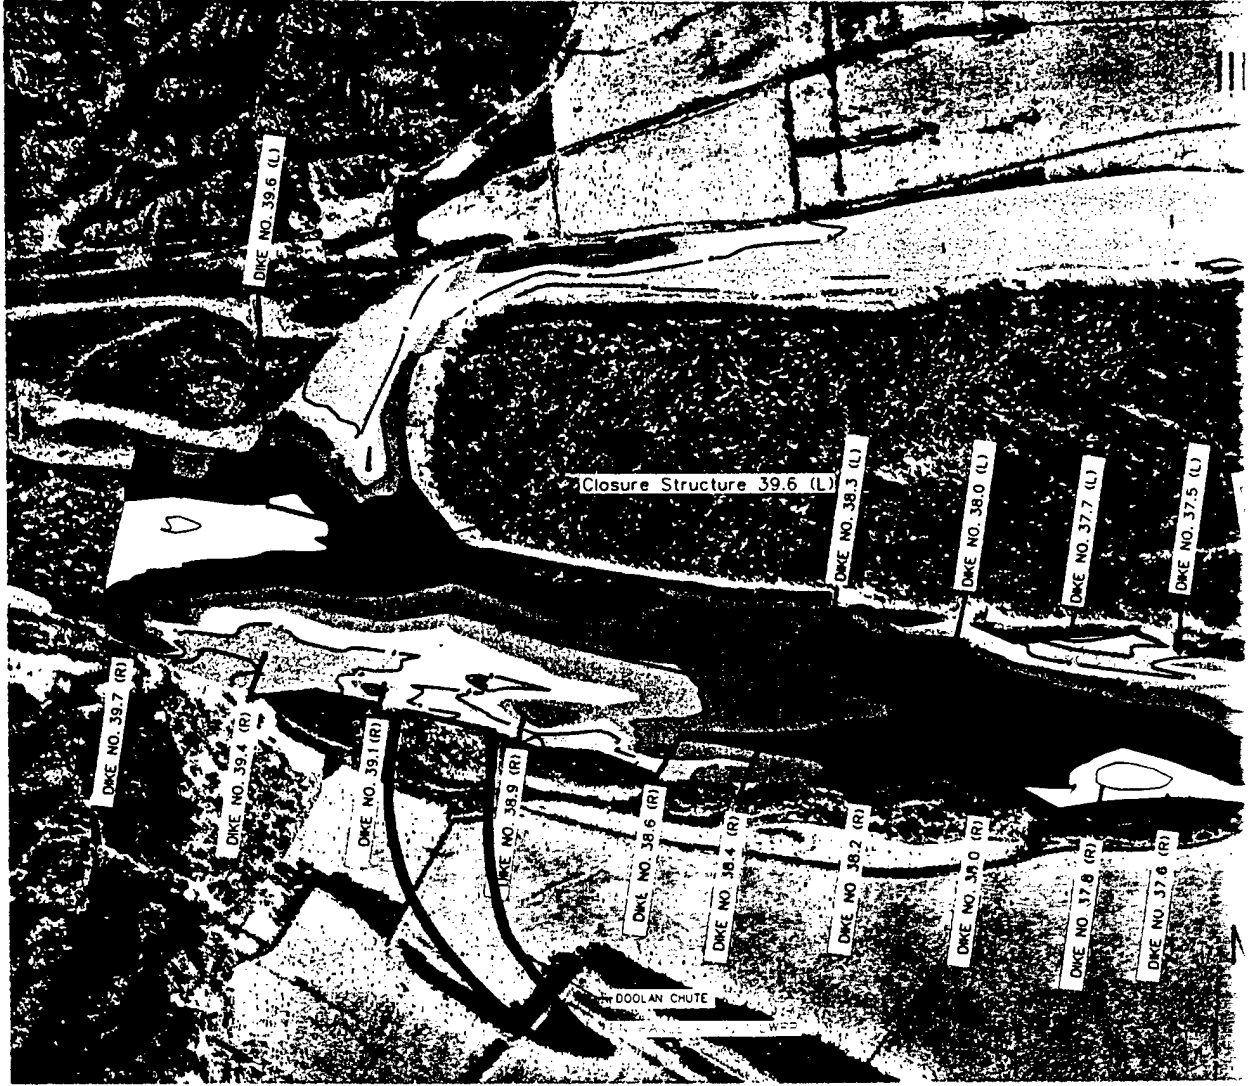
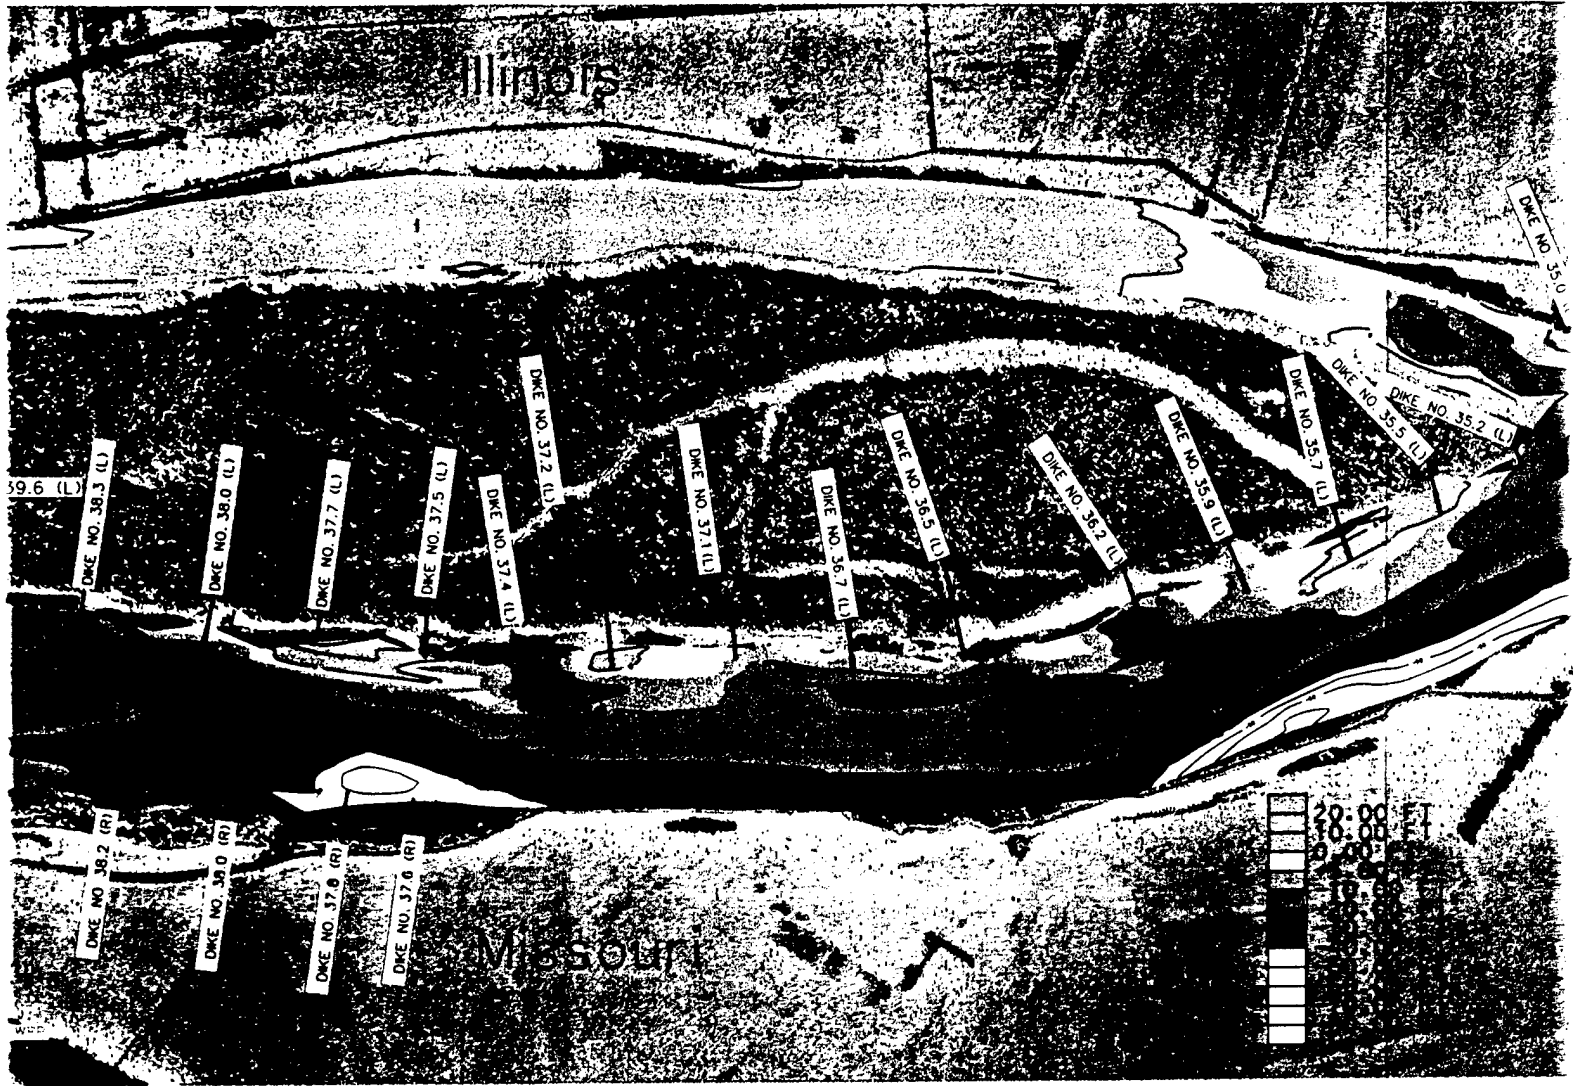
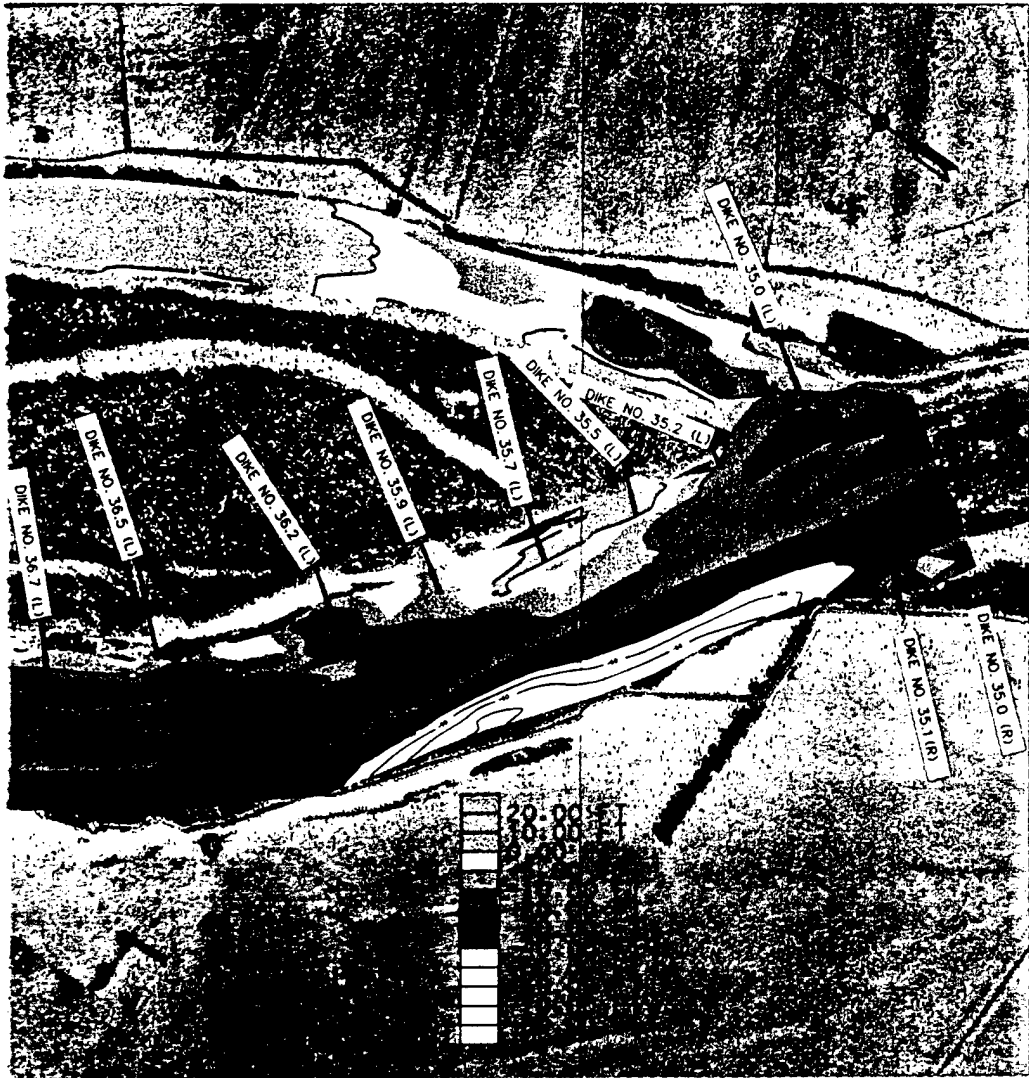
Alternative I. Doolan Chute Linkage With the Main Channel, Entrance Conditions at +20 LWRP. A closure structure was placed at the entrance of Doolan Chute to limit flow through the chute to stages only above +20 LWRP. Plate 27 is a plan view contour map of the resultant main channel bed configuration for alternative I. This alternative did not cause shoaling in the downstream crossing of the navigation channel. Bed stability in Doolan chute required 7 more hydrographs to develop than alternative H.
