**US Army Corps
of Engineers**
Waterways Experiment
Station

Final Report
CPAR-GL-97-1
May 1997

Controlled Field Tests of Retrievable Microtunneling
System with Reaming Capabilities

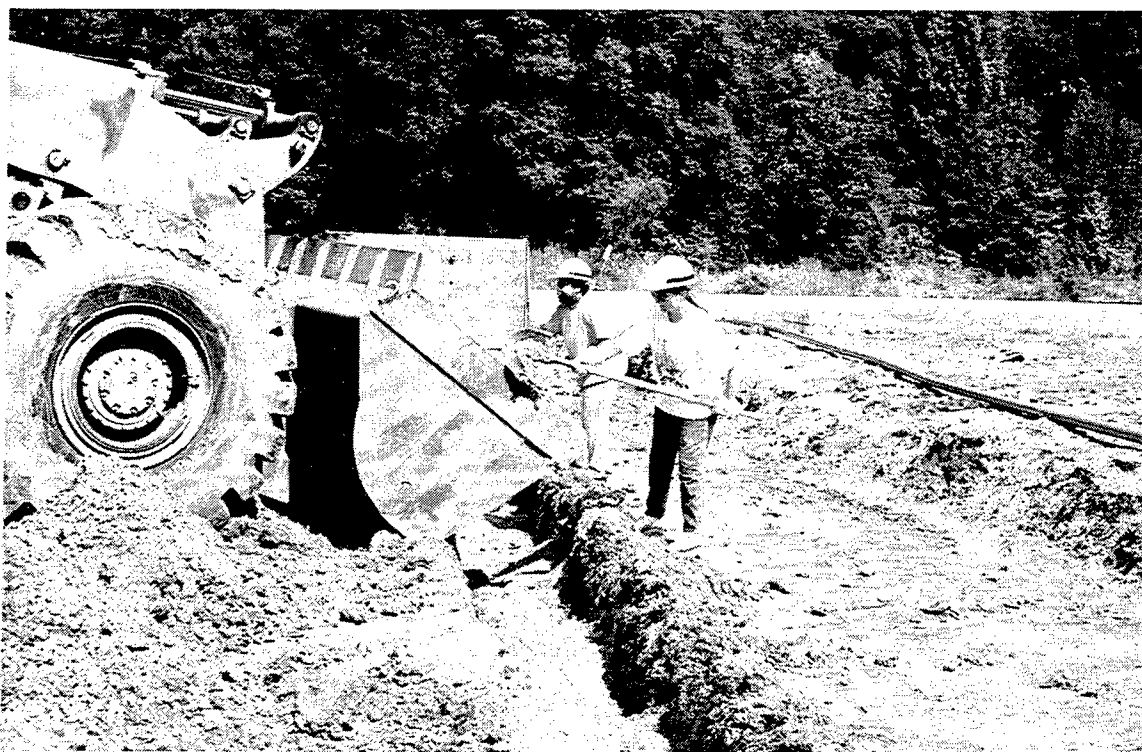
Figure 4. Photograph of test bed instrumentation installation for retrievable microtunneling tests

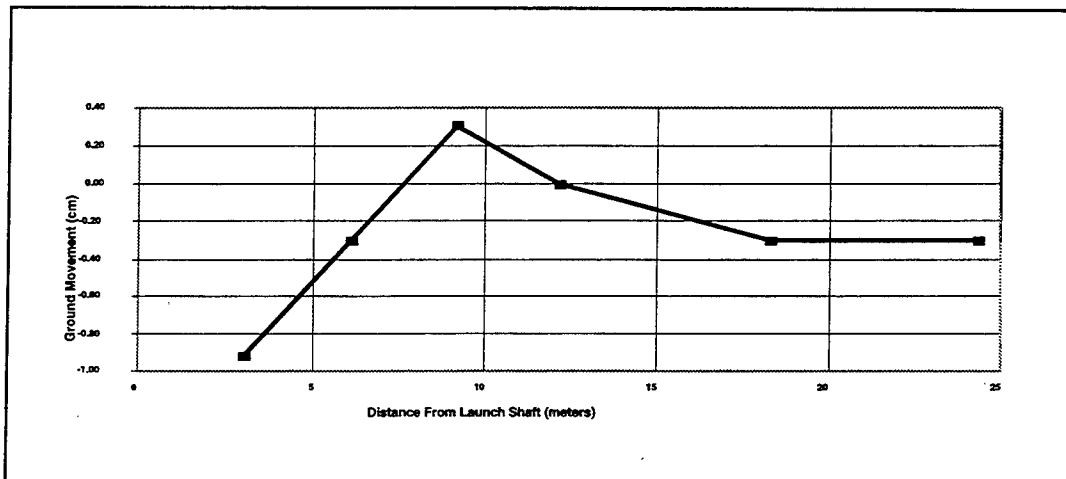
Figure 10. Ground movements 0.6 m (2 ft) above crown after retraction (Negative movements are settlement.)

Ground movements measured during this phase of the test are shown in Figure 10. The maximum settlement of 9 mm (0.35 in.) occurred near the drive shaft and was partly caused by loss of soil into the shaft through the sheet-pile walls. Settlements were less than 6 mm (0.25 in.) elsewhere, or well within typical specification tolerances.

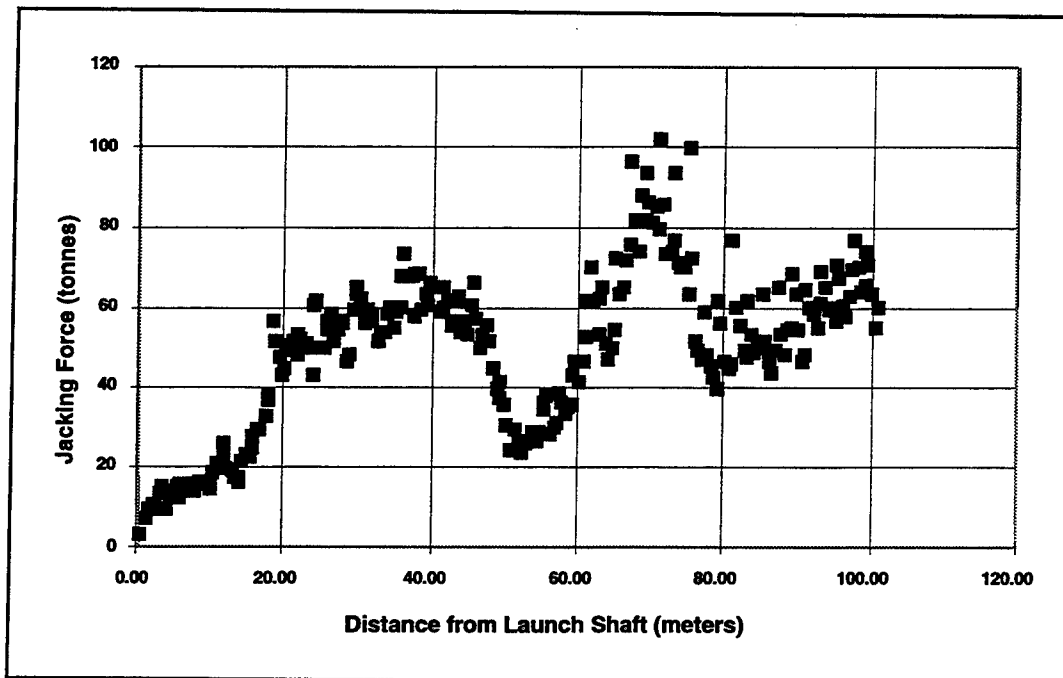
Figure 15. Jacking forces during initial drive

Figure 15 summarizes the jacking forces as the machine and temporary pipes progressed through the 100-m (330-ft) drive with the 660-mm (26-in.) OD steel temporary pipes.

Predictably, significant changes in jacking forces occurred at the interface of each soil zone. In addition, at two locations (43 to 52 m (140 to 170 ft) and 73 to 78 m (240 to 255 ft)) jacking forces decreased sharply. In both cases, this phenomenon occurred when the machine exited a sandy zone and entered cohesive soils. It would be expected that the frictional component of the jacking force would increase at a slower rate in cohesive soils. This effect is largely due to two major factors. First the normal stresses acting on the pipe are generally lower in clays than in sands at the same depth of cover. The lower normal stresses are due in part to the clay's cohesion, providing a stable overcut around the pipe, whereas sand tends to close in around the pipe quickly. Secondly, the coefficient of friction is lower for clay than for sand.

applied to explain the decrease in jacking forces observed in the sand/clay gravel mixed face interval shown in Figure 15.

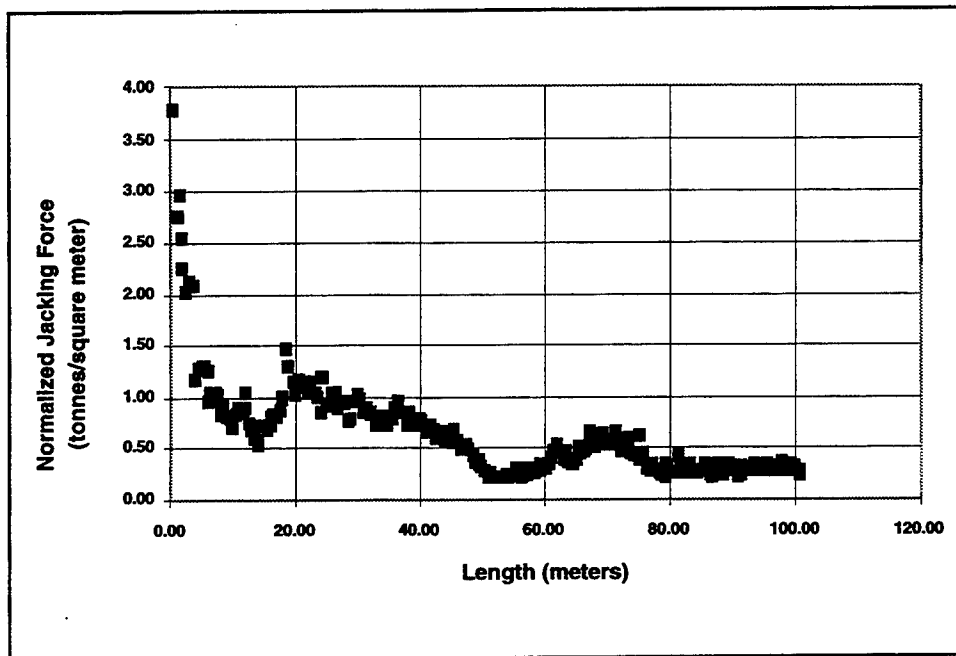
Figure 17. Jacking stresses during initial drive

As shown in Figure 17, average jacking stresses (Jacking Force/Surface Area) for the initial drive declined sharply from approximately 3.3 to 1.0 tonnes/m² (0.33 to 0.10 tsf) at approximately 6 m (20 ft) into the initial drive with steel temporary pipes. This is typical since the face pressure is a significant component of the total jacking force at the beginning of the drive where there is little surface area over which frictional forces can act. The frictional component over the unlubricated shield section is also disproportionately high, for reasons explained above. The average jacking stress remained constant at approximately 1.0 tonnes/m² (0.10 tsf) through the sand zone, then decreased gradually through the buckshot clay zone to a minimum value of 0.3 tonnes/m² (0.03 tsf) near the end of this section at 50 m (165 ft) into the drive. As the machine exited the clay and reentered the next zone of sand, the average jacking stresses again increased gradually to 0.6 tonnes/m² (0.06 tsf). As the machine exited the sand at 73 m (240 ft) and entered the clay gravel section, the average jacking stress again gradually decreased to 0.3 tonnes/m² (0.03 tsf) and remained approximately constant for the final 90 ft (27 m) of the

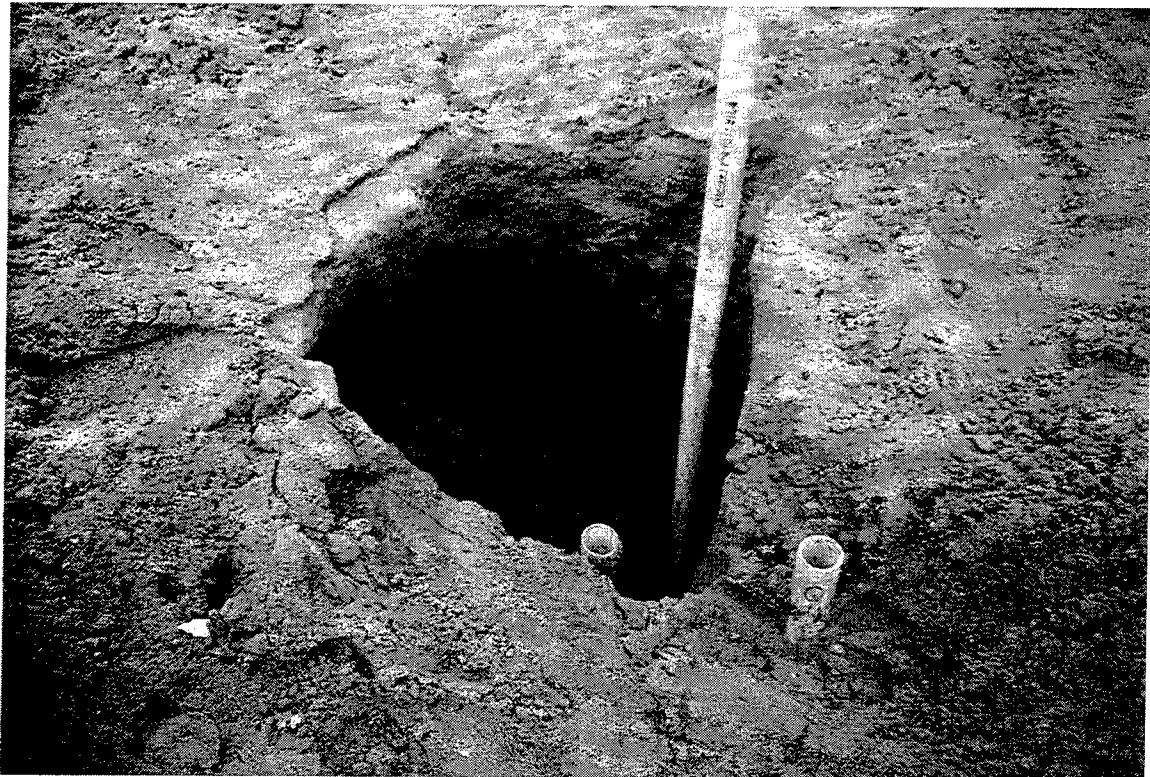
Figure 19. Photograph of surface void at sta 0+06 m (0+20 ft) during reaming drive of retrievable machine test

The third and last large settlement event on the reamer drive occurred at sta 0+06 m (0+19 ft) in the sand near the original drive shaft. This event was caused by allowing the slurry to continue to circulate, for less than 1 minute, while the machine was stopped. The result was settlement of 55 cm (21.7 in.) at the settlement plate, 1.1 m (3.5 ft) above the crown, and 54 cm (21.4 in.) at the settlement plate, 0.5 m (1.5 ft) above the crown. (The measured settlement

exceeded the nominal distance between the settlement plate and the pipe crown because the plate tipped somewhat as it settled.) A surface void approximately 1 m deep by 0.6 m wide (3 ft deep and 2 ft wide) developed, as shown in the photograph in Figure 19. The surface appearance of this void was quite similar to all the large settlement events observed during this test. The inclinometer casing partially bridged over the void, registering only 3.6 cm (1.42 in.) settlement 0.5 m (1.5 ft) above the crown. This event, like the others, highlights the importance of careful attention to small details by the operator and crew. At the high slurry flowrates and velocities typically used in microtunneling, only a very short time is required to erode soil at the face and cause large settlements. The operator must vigilantly control slurry circulation and machine torque to avoid such unacceptable events.

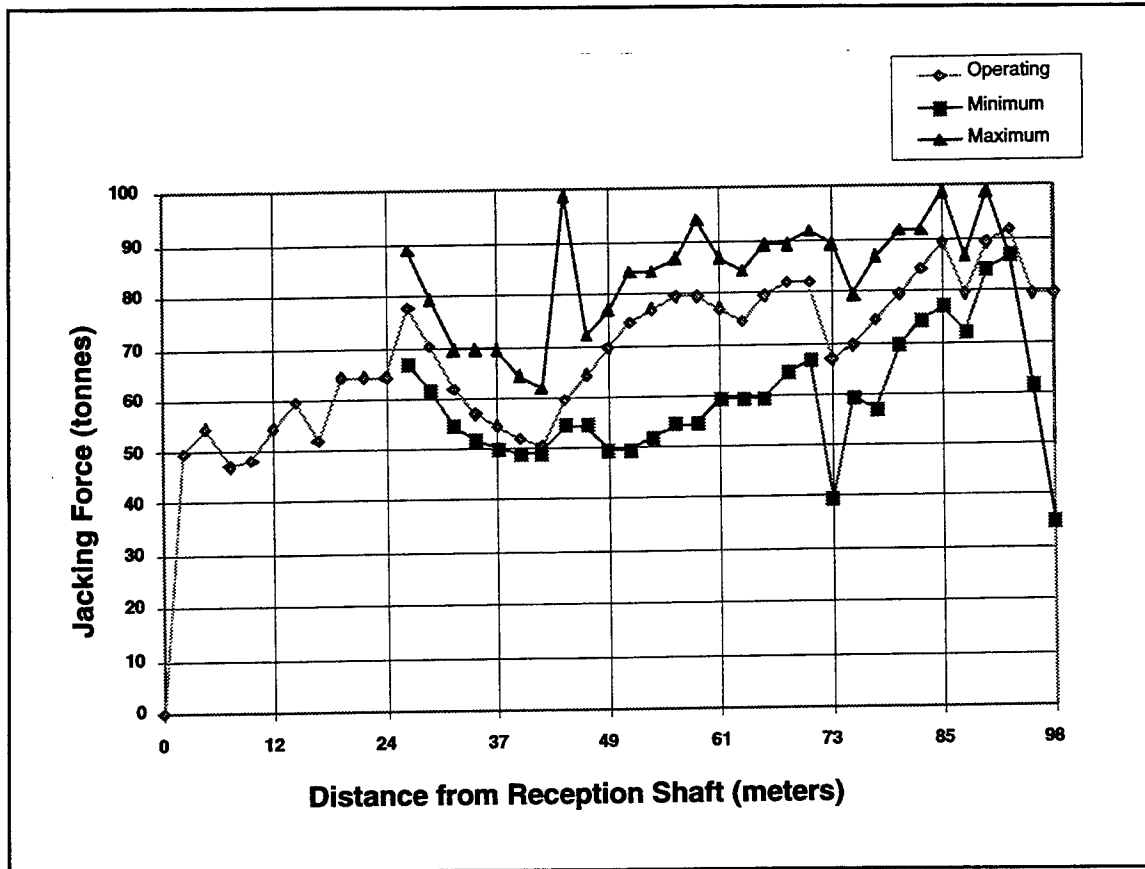
Figure 20. Jacking forces during reaming drive

During the reaming operation, jacking loads were continuously monitored. As shown in Figure 20, maximum jacking forces for the reamer drive were 100 tonnes (110 tons). This was approximately the same as for the initial drive, even though the surface area per running meter (running foot) of the concrete pipe was 30 percent greater at 2.7 m^2 (8.8 ft^2), compared to 2.1 m^2 ($6.8 \text{ ft}^2/\text{ft}$) for the steel temporary pipe. The overcut on the steel temporary pipes was 10 mm ($3/8$ in.), while the overcut was 28 mm (1.1 in.) on the concrete pipe, both measured on the radius.

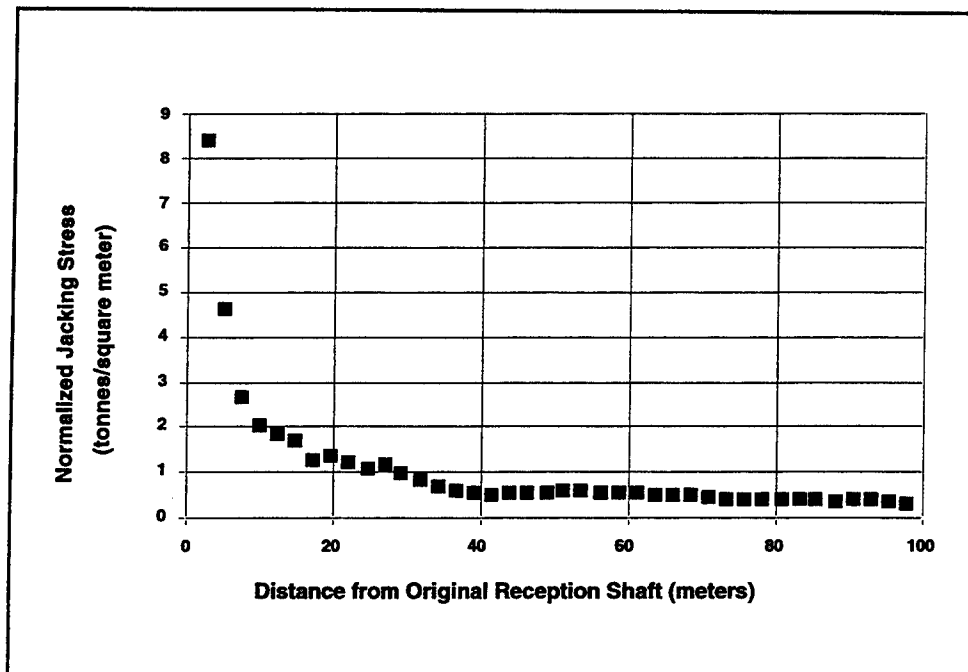
Figure 21. Jacking stresses during reaming drive

The average running jacking stresses during reaming and concrete pipe installation decreased sharply from 7.8 tonnes/m² (0.78 tons/ft²) to 2.0 tonnes/m² (0.20 tons/ft²) over the first 9 m (30 ft) of the drive. These decreases were due to the disproportional effects that the face pressure and skin friction on the reamer body exerted on the overall jacking force in the first few meters of the drive. The jacking stress then gradually decreased to a minimum value of approximately 0.3 tonnes/m² (0.03 tons/ft²) toward the end of the drive. This trend indicates that face pressures and skin friction on the body of the reamer and control assembly were significant factors in the overall jacking force during reaming. Frictional forces on the pipe were relatively low, again due to the large overcut and generous lubrication. Jacking stresses on the 850-mm (33.5-in.) OD concrete pipe measured during the reaming operations are summarized in Figure 21. As with the jacking stresses for the initial drive, these values are the running averages, not jacking stresses for the individual soil sections.
