Unique Aspects of Micromechanics in Ballistic Penetration

ARL-TR-1412

Weapons and Materials Research Directorate, ARL

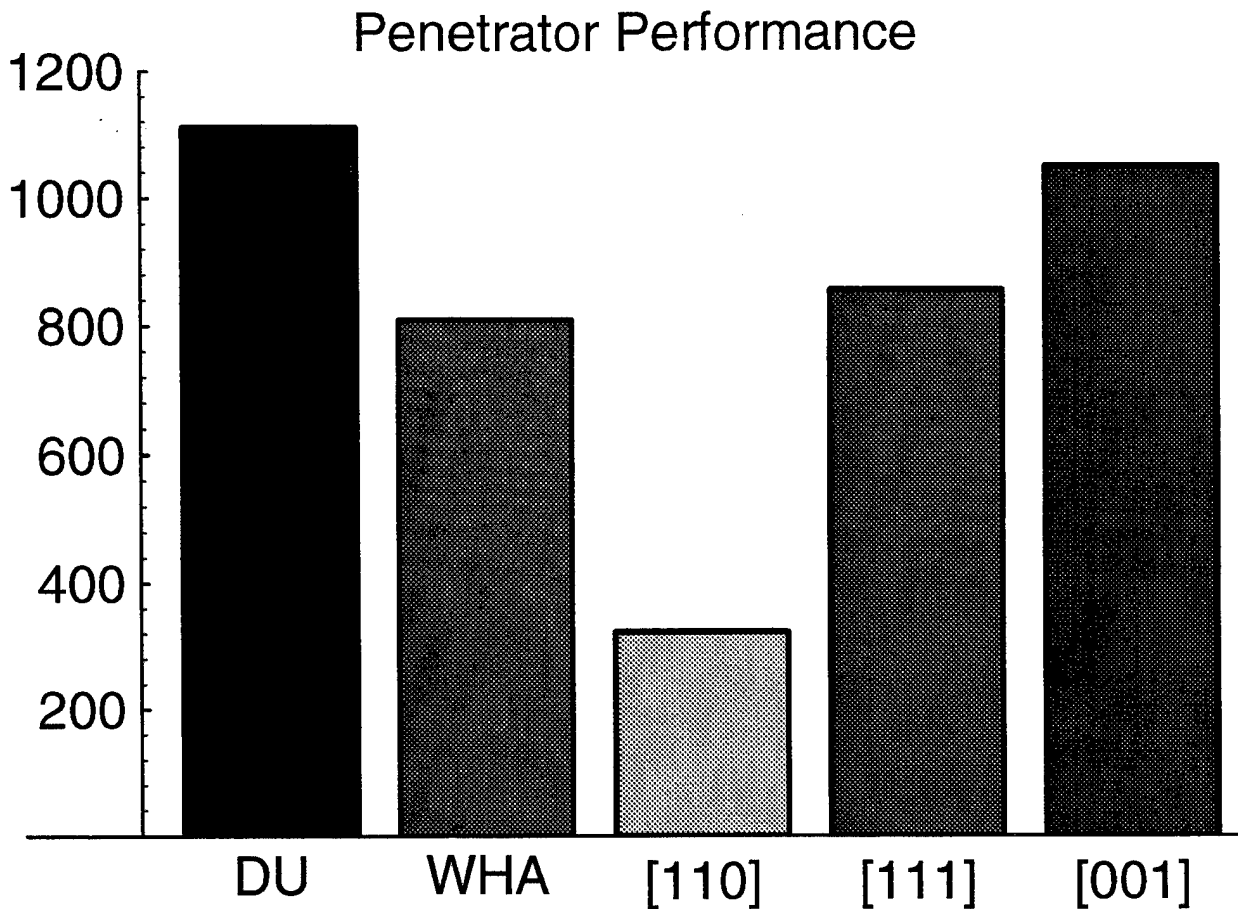
Figure 1. Results of Ballistic Tests Against Semi-Infinite RHA.

The ballistic experiments have been described previously [1]. Figure 1 graphically summarizes the results. Each crystal rod had a selected unique crystallographic direction parallel to the penetrator axis. The observed results are a strong function of crystallographic symmetry, and in contrast with quasi-static stress-strain tests, the [111] (three-fold symmetry axis) single crystal was not the best performer. The [001] (four-fold symmetry axis) rod actually exceeded current tungsten heavy alloy penetrators and approached the performance of depleted uranium [1].

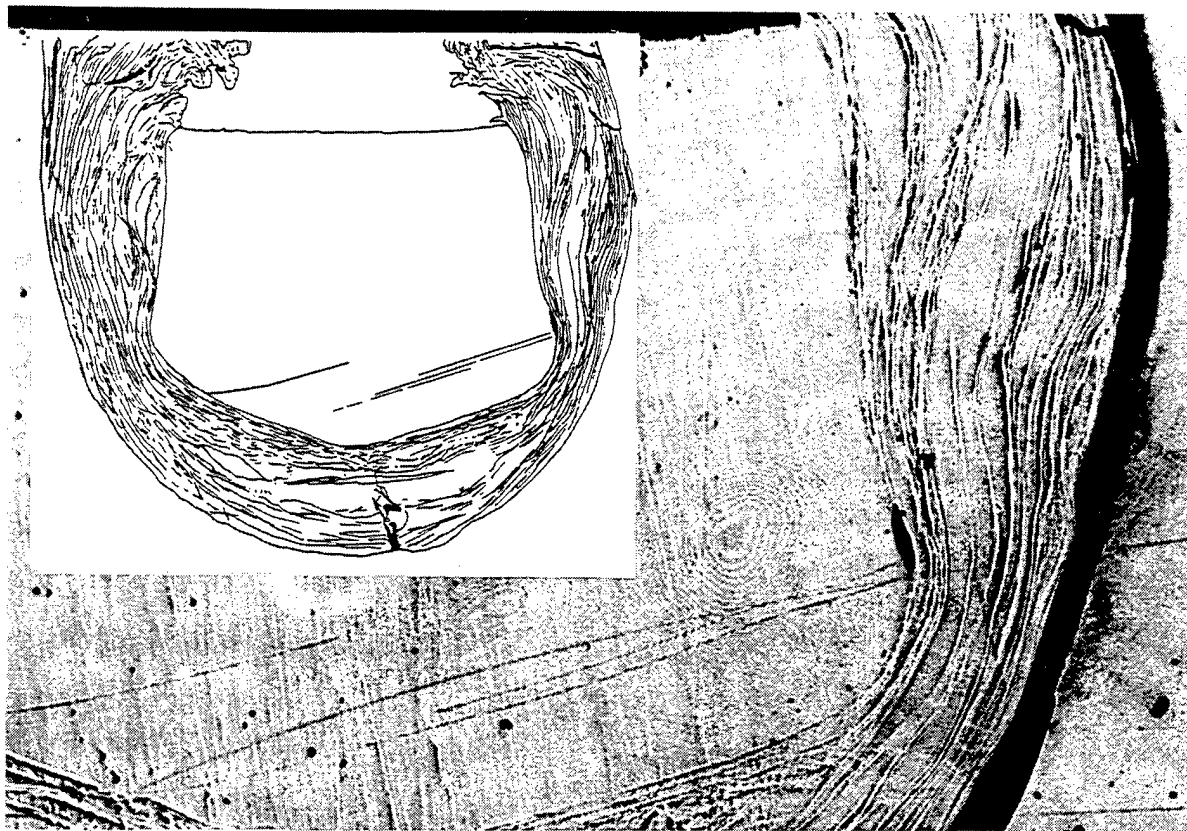
Figure 5. Axial Section of [111] Penetrator: Flow Line Patterns and Internal Bands Near Lower Right Corner. Inset: Schematic of Residual.

3.2 [111] Penetrator. An axial section through the [111] residual penetrator is shown in Figure 5. Diffraction patterns showed that the well-defined, blunt-nosed residual rod (schematic inset in Figure 5) is a single crystal, with some uniform lattice distortion but little net lattice rotation. Material in the flowed regions was primarily polycrystalline, with some lamellar bands surrounded by regions of equiaxed recrystallized grains. A few relatively large lamellae, mostly embedded directly ahead of the residual rod, were still single crystals, although severely bent and deformed. These regions appear schematically below the residual crystal in the Figure 5 inset. Figure 6 shows a series of diffraction patterns from the largest crystal fragment. As a reference, the X-ray pattern at point (a) is typical of the main body of the residual rod. Diffraction patterns from points (b), (c), and (d), all within the largest fragment, showed heavily textured rings along with broad, structured discrete reflections. The crystal orientation changed continuously from point (b) to point (d). It appears that the separated segment was in the process of being forced out of the way of the oncoming rod, surrounded by material previously recrystallized.

The precise nature of the few narrow bands appearing in the residual crystal could not be determined, but close examination suggests that they are flow bands whose propagation separates a crystal segment from the main rod. In the micrograph of Figure 5, a pair of closely spaced bands appears in the lower right corner. On the far right are layers of material that has already been discarded and forced out of the path of the rod. Just above the tip of the band is a small void between the rod and the discarded material, possibly opened up as the segment in the process of discard began to move to the right. We can infer that the segment below the band is just beginning to separate, the deformed and partially recrystallized region embedded directly below the rod resulted from a preceding discard, and the entire continuous layer of material surrounding the residual and extending to form the hollow tube is the result of a succession of such events.

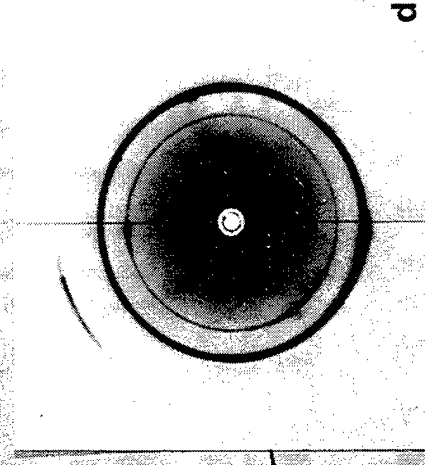
(Right) Reorientation of separated single crystal segment during radial flow at front of penetrator.

(Above) orientation of observation surface.

(Left) Diffraction pattern from center of [111] residual rod (location a).

Diffraction patterns from locations a), b), c), in single crystal fragment embedded in flow ahead of remanent residual rod.

Figure 6. X-ray Analysis of Separated Crystal Segment Ahead of the [111] Residual Rod.

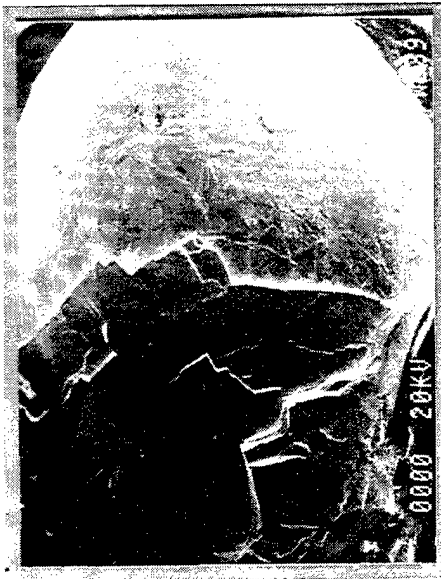
Figure 9. Convex Surface of [100] Penetrator Fragment (nose down): (a) Overview; (b) Tabular Packets; (c) Diffraction Pattern.

Examination of a second [001] penetrator further elucidated the nature of this rotation and the true three-dimensional character of the deformation process. This penetrator cracked during flight and impacted the target in two closely spaced coaxial segments, and thus the residual did not have full integrity. After sectioning, most of the residual dropped out intact, leaving a partial shell of deformed layers adhered to the concave surface at the bottom of the penetration tunnel in the target block. Figure 9a is a scanning image of the convex surface of this extracted fragment at low magnification (nose pointed down). The convex surface appears covered with tabular rectangular packets, often rotated relative to one another (Figure 9b). Although a thin surface layer was deformed and partially recrystallized, discrete diffraction spots were distinctly visible in these packets (Figure 9c). It appears that material flow in the [001] crystals is not purely radial but that the flow packets of {001} layers also have a rotational degree of freedom about the normal to the packet. This would imply a very substantial degree of independence for these entities after cleavage. The rectangular edges of the packets also appear to be defined by {001} cleavage planes, but this could not be directly confirmed.
