NASA Technical Paper 1624

Wear Particles of Single-Crystal Silicon Carbide in Vacuum

Kazuhisa Miyoshi and Donald H. Buckley
Lewis Research Center
Cleveland, Ohio

1980

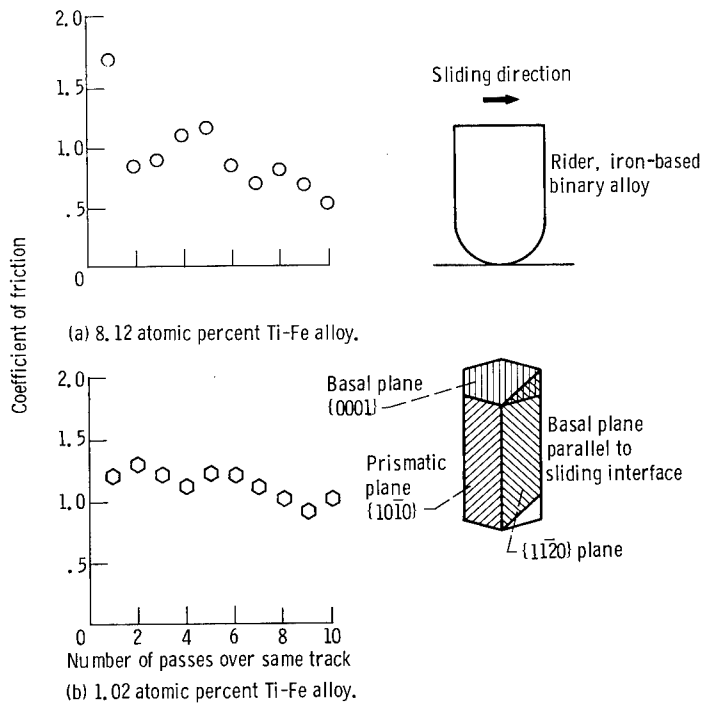
Figure 2. - Coefficient of friction as function of number of passes of alloy riders across single-crystal silicon carbide (0001) surface in high vacuum. Sliding velocity, 3×10^{-3} meter per minute; load, 0.2 newton; room temperature; vacuum, 10^{-8} pascal.

Multipass sliding friction experiments were conducted with iron-base binary alloys with various concentrations of solute alloyed in iron in contact with single-crystal silicon carbide in vacuum. The binary alloy systems were iron alloyed with titanium, chromium, manganese, nickel, rhodium, or tungsten. The tribological behavior of these materials has already been discussed in references 6 and 11. Briefly, the friction-force traces obtained in this investigation are generally characterized by a sharp break in the friction-force, that is, stick-slip behavior. The coefficients of friction for alloys, having high solute concentration (see example in fig. 2(a)) or chemically active alloying elements (Mn, Ni, W, and Ti) generally decreased with the number of passes, when repeated passes of the alloy riders were made over the same single-crystal silicon carbide surface. The coefficient of friction for first pass sliding differed from those for the second and multiple pass sliding. This difference was due to a large amount of alloy transfer that took place to the silicon carbide surface in the first, single-pass of the rider. On the other hand, the coefficients of friction for the alloy, having low solute concentration (see fig. 2(b)) or chemically less active alloying elements (e.g., Rh) were generally small changes and fluctuated with the number of passes.

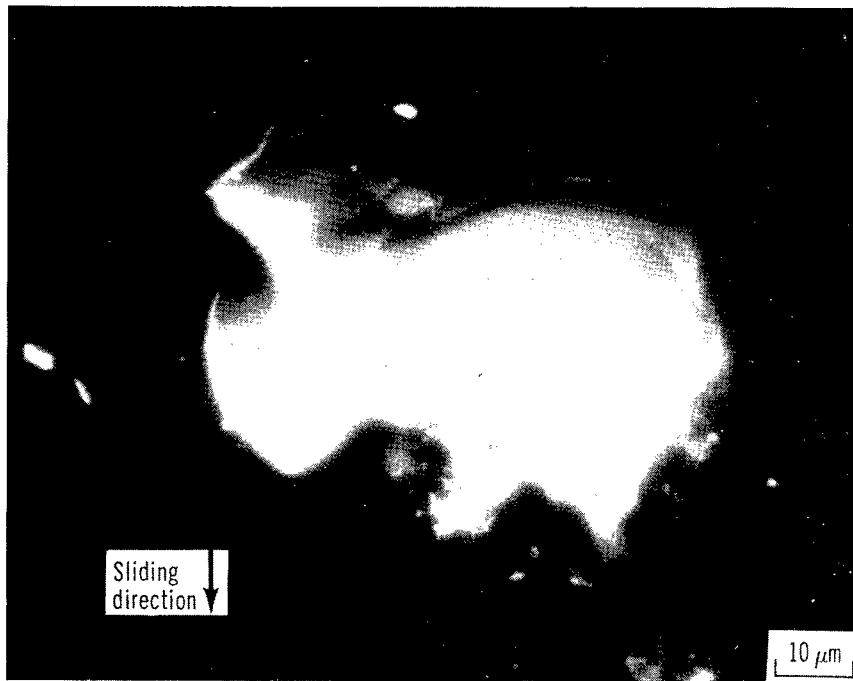
Figure 4. - Large fracture pit of single-crystal silicon carbide in contact with 8.12 atomic percent Ti-Fe alloy as a result of ten passes of rider in vacuum (10^{-8} Pa). A scanning electron micrograph of wear track on silicon carbide (0001) surface. Sliding velocity, 3×10^{-3} meter per minute; load, 0.2 newton; room temperature.

Figure 4 presents a scanning electron micrograph of a wear track on a silicon carbide surface accompanied by an exceptionally large fracture pit. A large light area at the beginning of wear track is a fracture pit where the wear track was generated by 10-pass sliding of a 8.12 atomic percent titanium-iron alloy rider across the surface. Most of the silicon carbide wear debris has already been ejected from the wear track. The smooth surface at the bottom of the fracture pit is due to subsurface cleavage along {0001} planes.

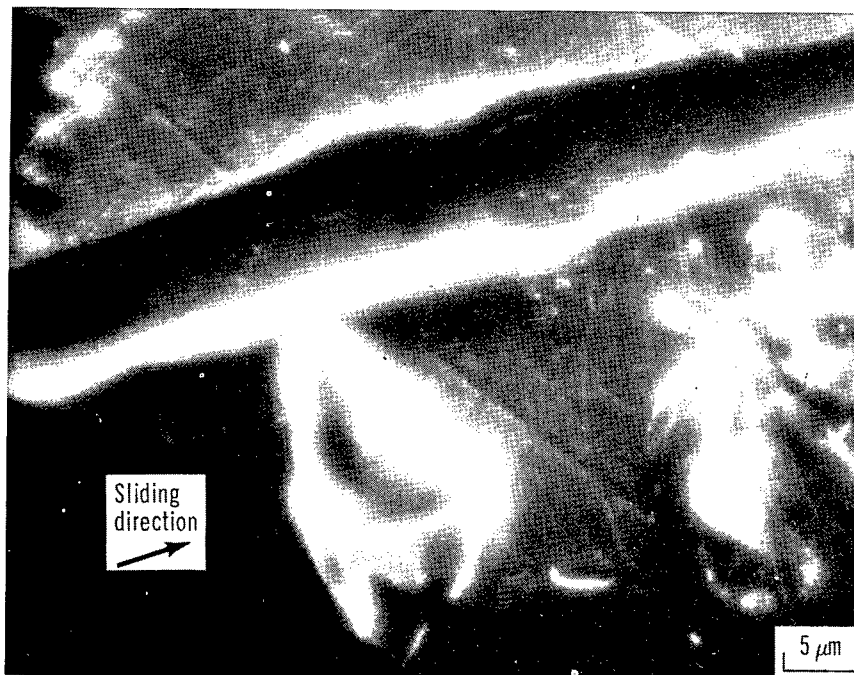
(a) Grooves and spherical indentations.

(b) Groove.

Figure 9. - Grooves and indentations formed by plowing and indenting of spherical wear debris as result of ten passes of rider in vacuum (10^{-8} Pa). Scanning electron micrographs of wear scar on 1.02 atomic percent Ti-Fe alloy rider. Sliding velocity, 3×10^{-3} meter per minute; load, 0.2 newton; room temperature.

Figure 9 consists of scanning electron micrographs of rider wear scars after sliding against a silicon carbide surface. These figures reveal spherical indentations and straight grooves along the sliding direction on the rider surfaces formed by indenting and plowing the spherical wear debris. Such a spherical wear particle and its indentation and groove were primarily observed for the alloys with low solute concentrations presented in table II. These results reveal that (1) a nearly spherical wear particle can be produced by sliding friction, (2) the wear particle plows the surface of the alloy rider during sliding, that is, the hardness of the particle is much greater than that of the alloy rider surface, and (3) the wear particle includes the element of silicon, as shown by the X-ray map of Si K_{α} . The next question is what is the real
